# **Greyfriars Church, Reading, Berkshire**

## **Archaeological Evaluation Report**

September 2020

**Client: Ash Contracting Ltd**

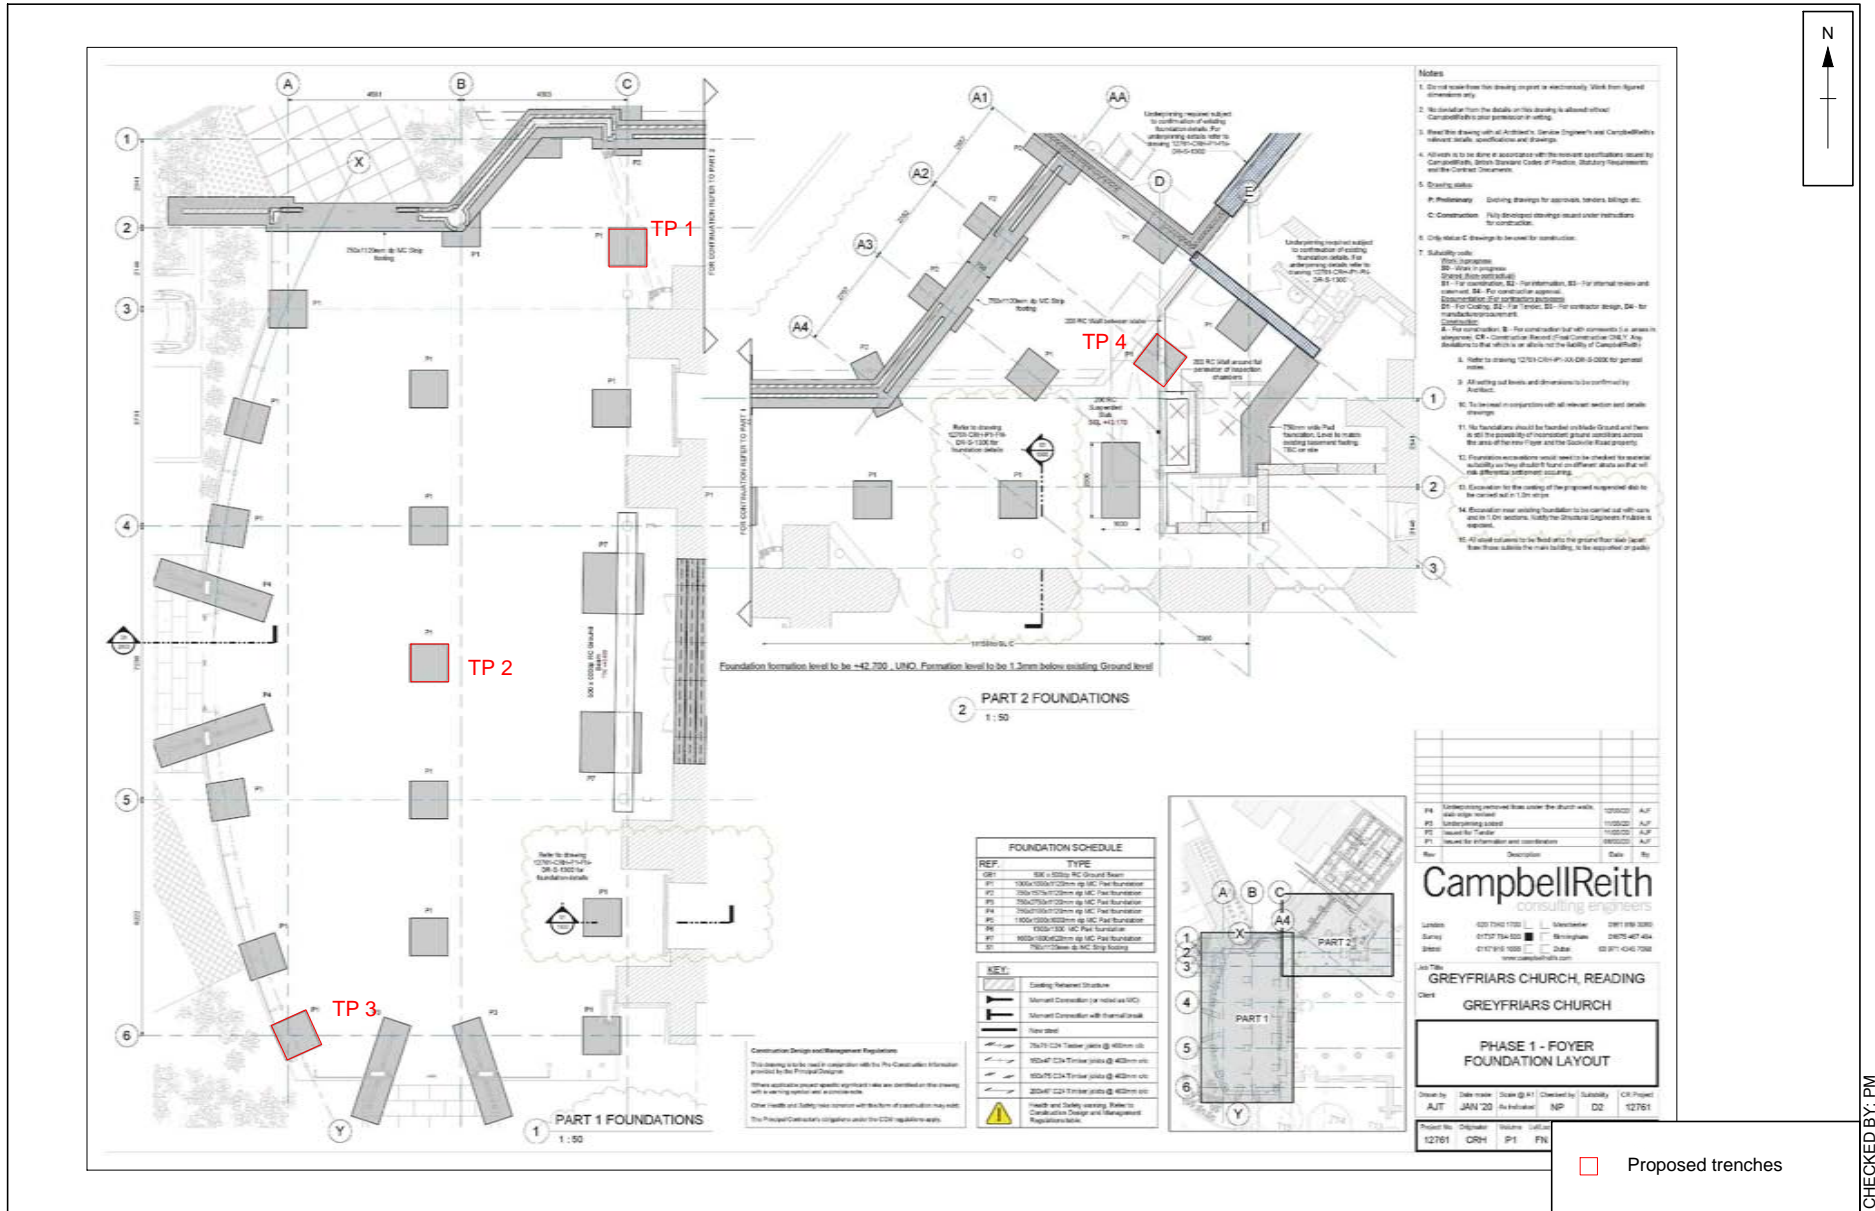
Figure 2: Test pit locations

2.2.1 Following the demolition of the existing foyer, the evaluation comprised the investigation of four hand-excavated test pits (Fig. 2; Plate 1). Test Pits 1–3 all measured 1m by 1m, while Test Pit 4 measured 1.5m by 1.5m. In accordance with the WSI (OA 2020), Test Pits 2 and 3 were positioned in the proposed location of the central and southern foundation pads for the proposed foyer in the west of the site, and Test Pit 4 was located in the north of the site to the rear of Nos 2 and 4 Sackville Street. Test Pit 1, however, was relocated and excavated in the location of a new foundation pad adjacent to the north-west corner of the church.

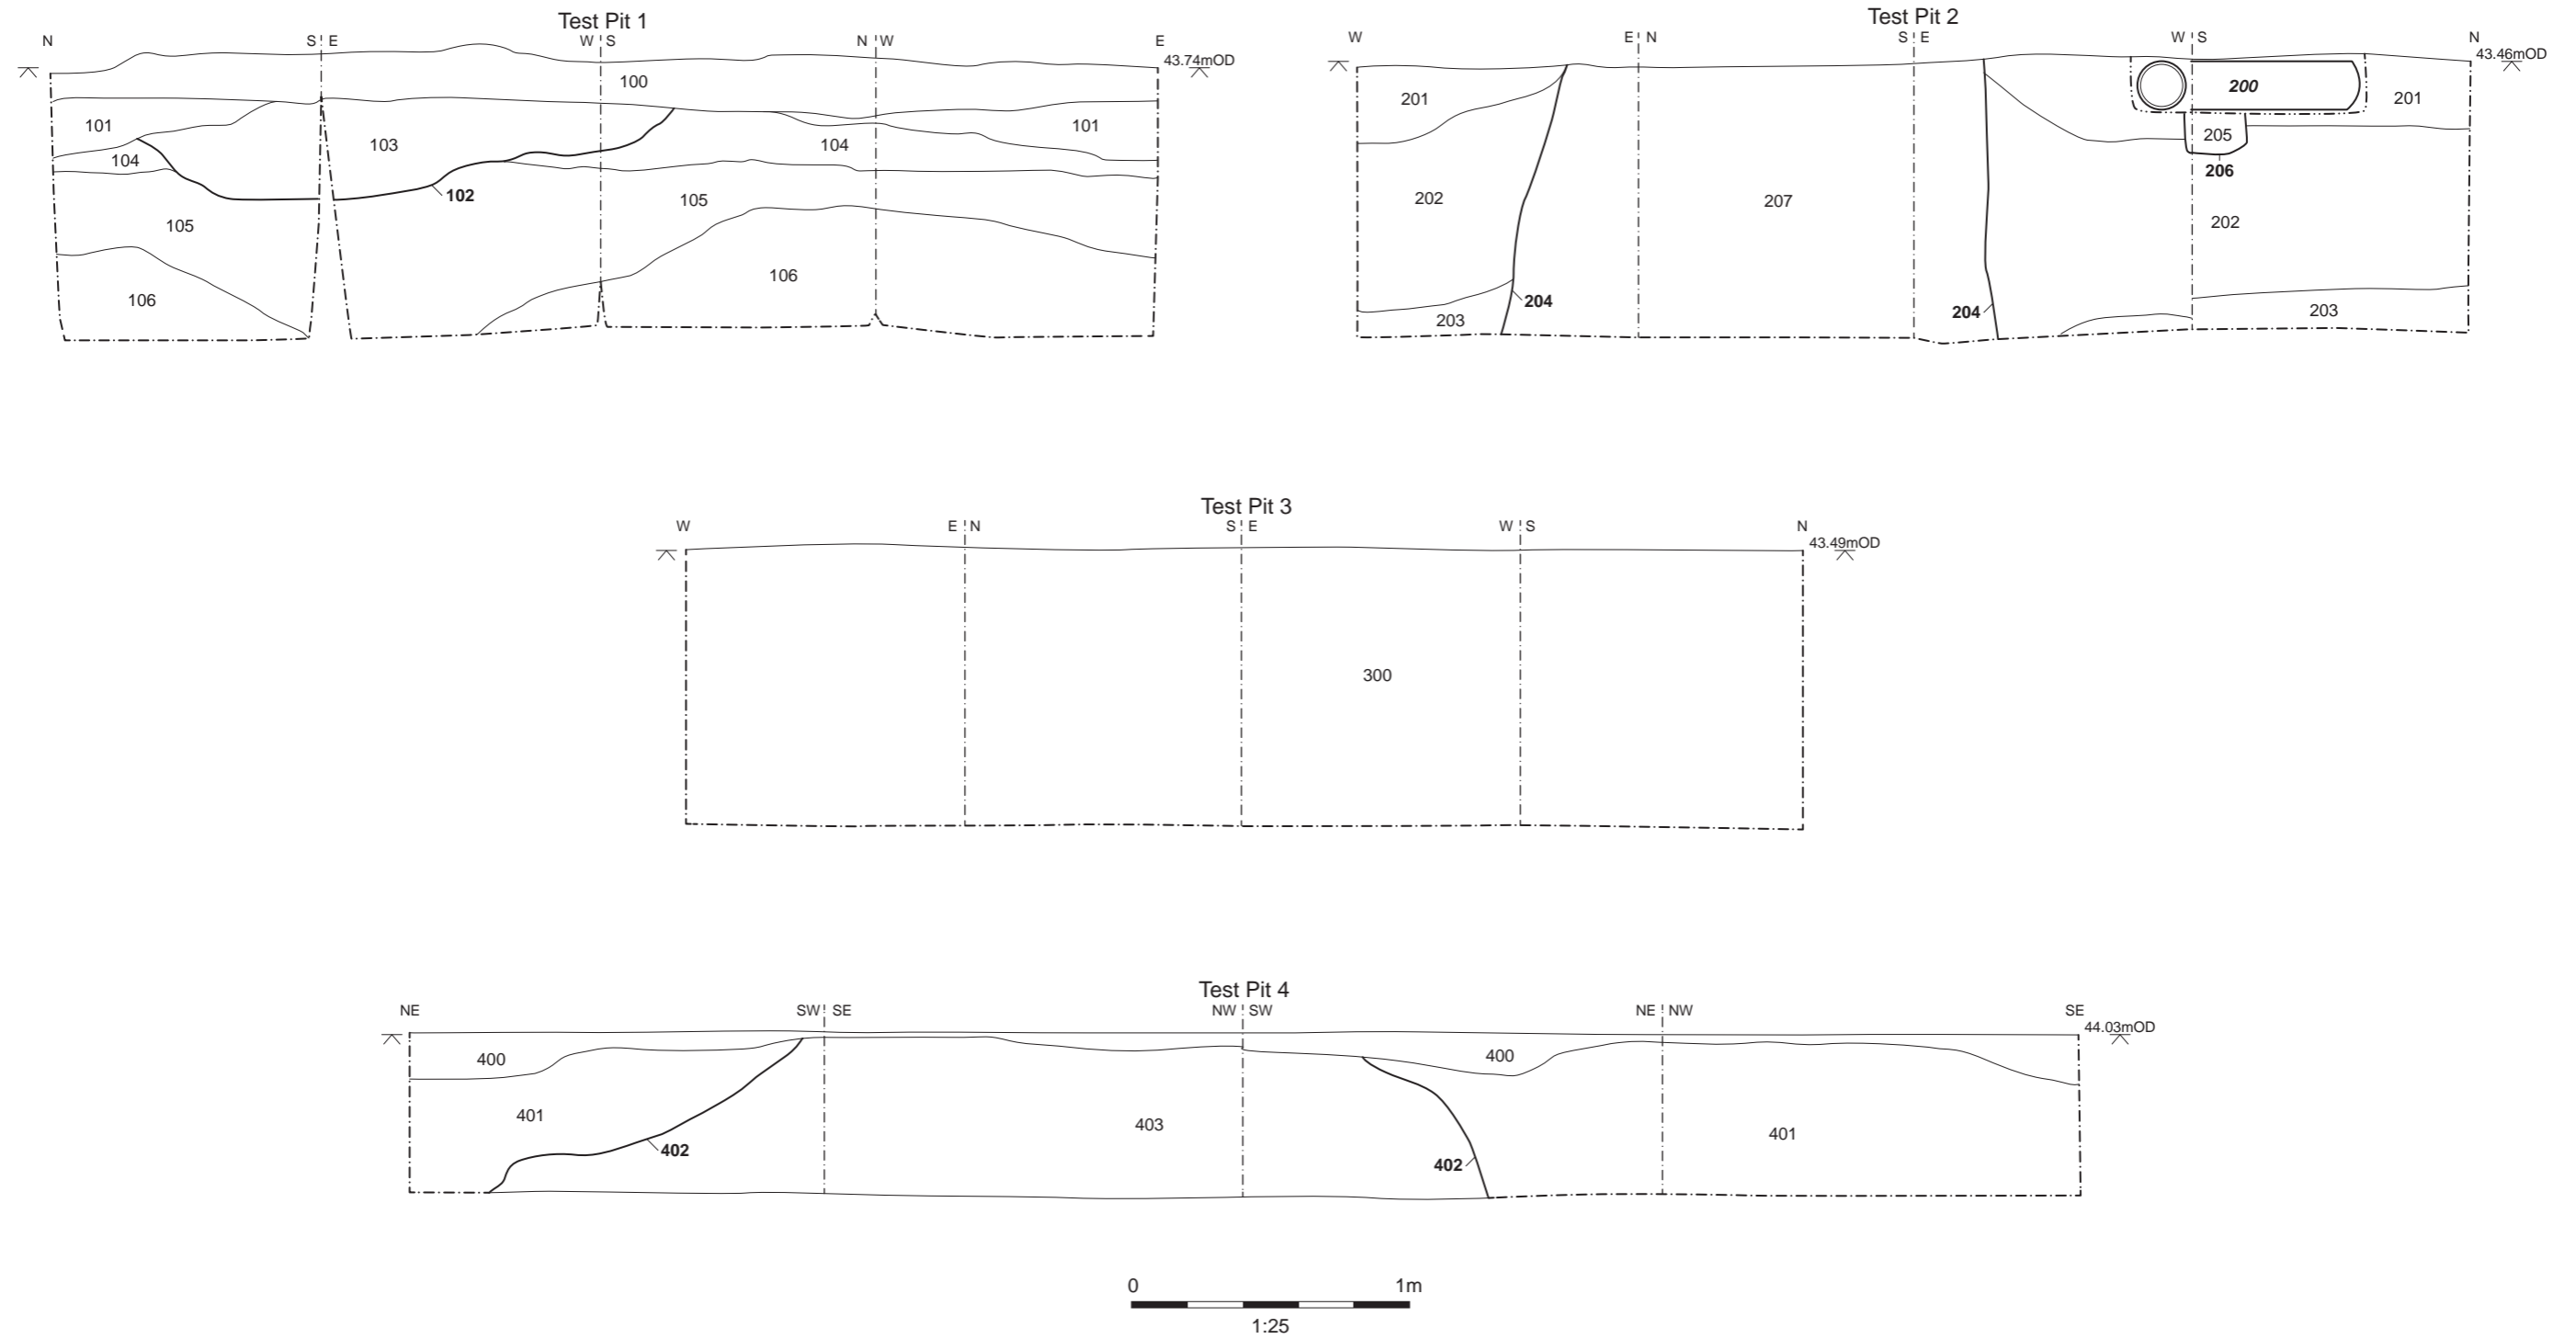
Figure 3: Sections

3.4.2 Extending across the test pit and sealing underlying deposits was a 0.15–0.20m thick layer of probable construction/demolition debris (100) comprising loose, light grey silty clay with inclusions of modern concrete rubble and brick. Underlying this in the north-east of the test pit was a further construction/demolition deposit (101) of light reddish brown silty sand with gravel and rubble inclusions, up to 0.22m thick.

3.4.3 Underlying deposits 100 and 101 was a layer of light reddish brown silty sand (104), up to 0.21m thick. A probable construction cut (102) measuring more than 0.35m wide and up to 0.38m deep cut into deposit 104. Exhibiting moderately sloping sides and an uneven base, it contained a single fill of loose, light reddish brown silty sand (103) from which no finds were recovered.

3.4.4 A possible subsoil (105) consisting of compact, dark reddish brown silty sand was overlain by deposit 104 and was partially truncated by cut 102. It was recorded directly overlying the probable natural deposit (106) of light yellowish sand and gravel, and appeared to fill a natural depression/hollow within the bedrock geology, which was exposed at a minimum of c 0.55m below the present ground level.

- 3.5.2 The probable natural geology was immediately exposed upon excavation within the east of the test pit and comprised a yellowish orange sandy gravel (207). A large probable pit (204) cut into the natural, occupying the majority of Test Pit 2. The exposed extent of pit 204 measured 0.74m wide and over 1m deep, and it had near vertical sides; its base was not reached as it exceeded the excavated depth of the test pit. A sequence of three fills of mid brown silty sand were exposed within pit 204. All three fills contained small quantities of medieval pottery, with sherds dating to c 1150–1350 recovered from lower fills 202 (three sherds) and 203 (two sherds), and a single sherd dating to c 1200–1400 from upper fill 201. The latter also contained a single piece of animal bone.

- 3.5.3 Located in the south-west corner of Test Pit 2, a small oval pit/posthole (206) cut into fills 201 and 202 of pit 204. Measuring 0.16m wide and 0.13m deep, it had near vertical sides and a flat base. No finds were retrieved from its dark brown silty sand fill (205).

- 3.5.4 Both pit 204 and pit/posthole 205 were cut by a later post-medieval/modern ceramic land drain (201), 0.18m in diameter. It crossed the south-west corner of the test pit on a NW–SE alignment.

- 3.6.1 Positioned in the proposed location of the southern foundation pad, Test Pit 3 measured 1m by 1m and was excavated to a depth of 1m. Excavation revealed a simple stratigraphic sequence of a single mixed deposit of gravel and sandy silt (300). It contained fragments of modern ceramic building material (CBM), concrete and plastic, suggesting that the deposit represents the dumping of later post-medieval/modern material/rubbish or a levelling deposit probably associated with the current use of the site.
- 3.6.2 The natural geology was not exposed in the test pit, and no archaeological deposits or finds of pre-modern date were identified.

- 3.7.2 Extending across the test pit and sealing underlying deposits was a layer of construction/demolition debris (400), measuring 0.02–0.14m thick.
- 3.7.3 Underlying deposit 400 in the south-west of the test pit was a loose, dark reddish brown silty sand with frequent gravel inclusions (403), up to 0.56m thick. Deposit 403 contained modern waste material, including CBM and rubble, suggesting that it may have constituted a dumping/levelling deposit associated with the later post-medieval/modern use of the site. This directly overlay the natural yellowish brown silty sand and gravel (404), which was exposed in the south-west of Test Pit 4 at a depth of 0.58m.

- 3.7.4 Occupying the majority of the test pit was a probable construction cut (402) perhaps for a former building foundation, which cut into deposit 403 and the natural geology (404). Measuring more than 1.36m wide and continuing beyond the limits of the test pit, it exhibited moderately sloping to steep sides; the base of the feature was not

reached as it exceeded the excavated depth of the test pit. Feature 402 contained a modern backfill (401).

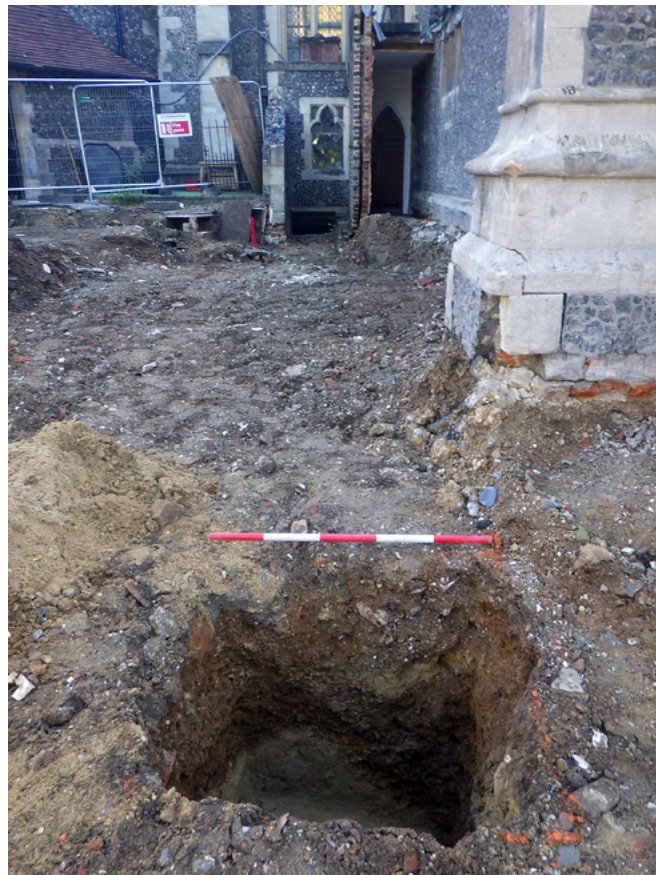
Plate 2: Test Pit 1, looking east

3.4.1 Test Pit 1 was located in the proposed position of a foundation pad adjacent to the north-west corner of the extant church. It measured 1m by 1m and was excavated to a depth of c 1m.

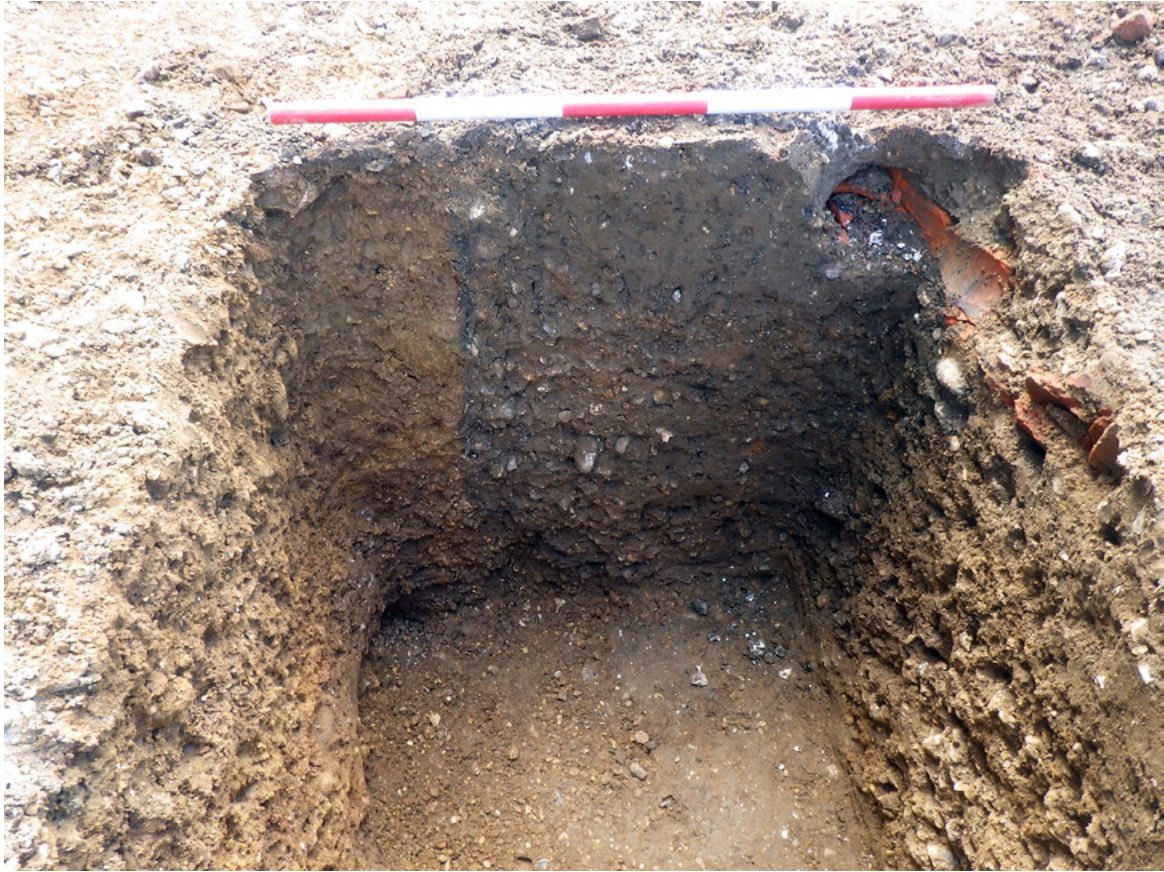
Plate 3: Test Pit 2, looking south

3.5.1 Located in the proposed position of the central foundation pad, Test Pit 2 measured 1m by 1m and was excavated to a depth of c 1m.

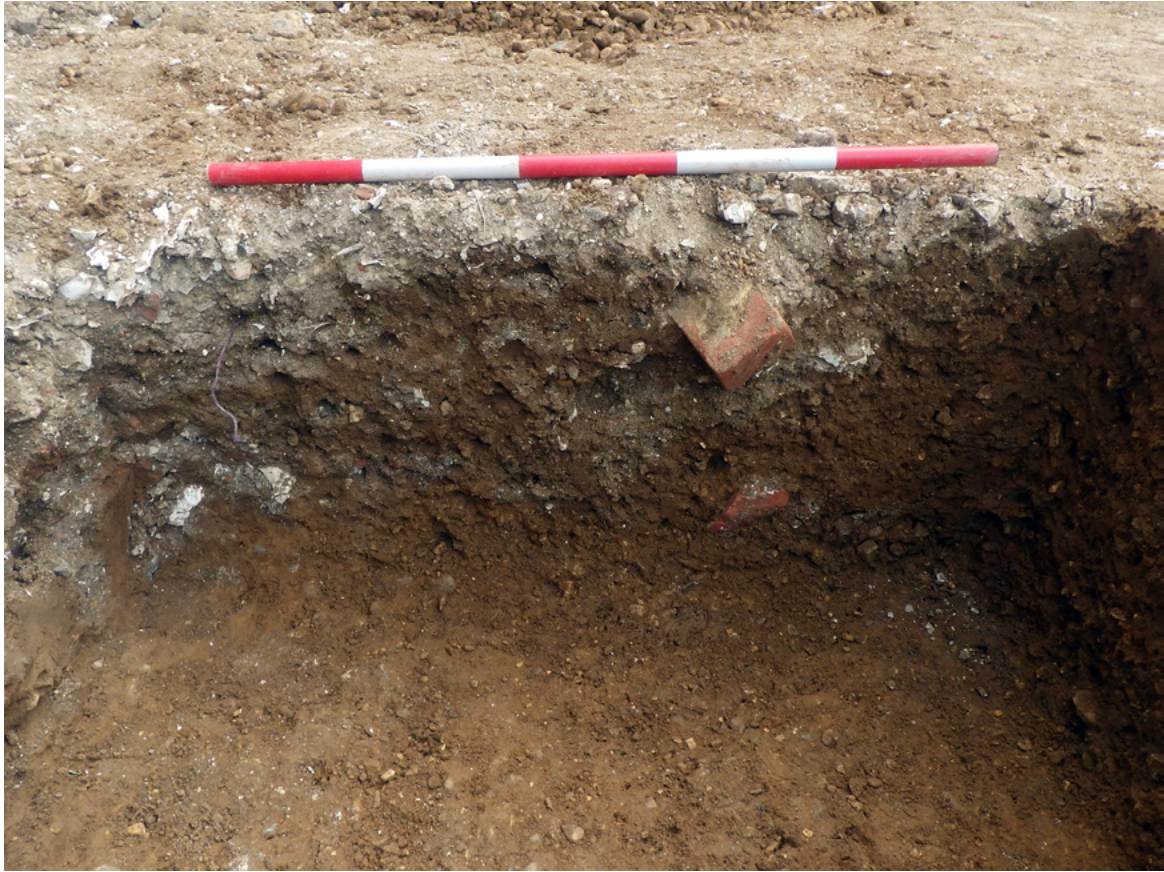
Plate 5: Test Pit 4, looking south-east

- 3.7.1 Test Pit 4 measured 1.5m by 1.5m and was excavated to a depth of 0.58m. It was positioned in the north of the site to the rear of Nos 2 and 4 Sackville Street.
