Land at Albion Place Oxford

Archaeological Watching Brief Report

May 2008

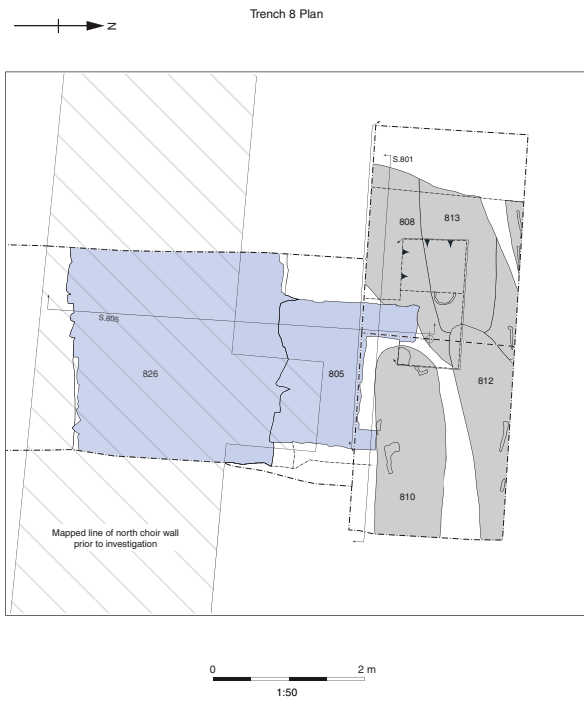
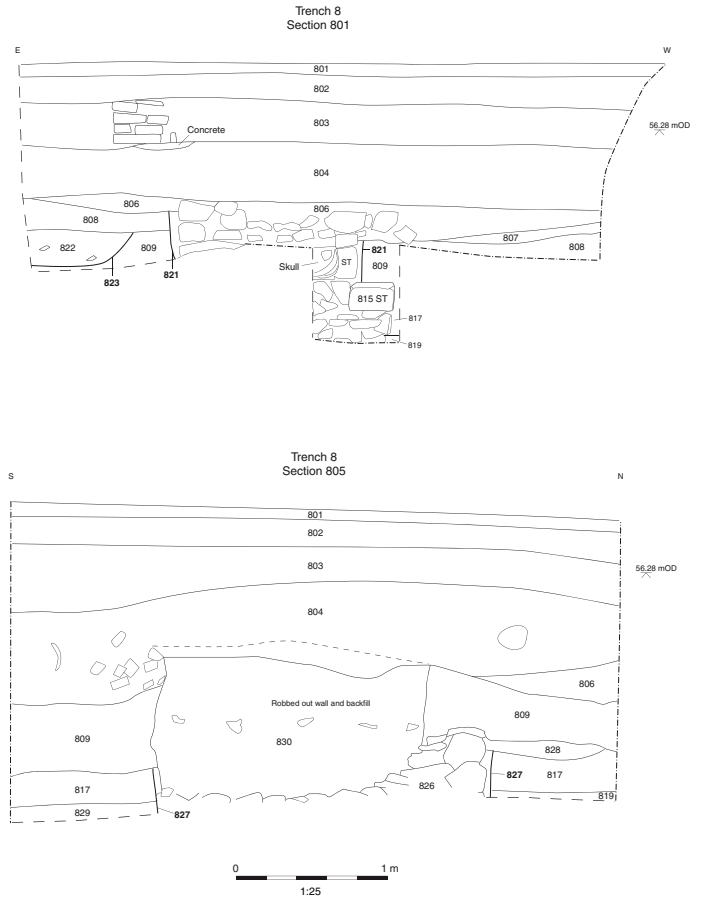
Figure 3 : Plan of Trench 8 and sections

7.4.1 This test pit was excavated in the north-central part of the site. The test pit measured 3.4 m x 1.6 m x 1.8 m depth. At least six approximately east-west aligned burials were revealed at the base of the test pit (at c 55.23 m OD). During cleaning of the grave cuts pottery was retrieved from four of the grave fills. This was generally of a 13th -14th century date (see Appendix 1 and Section 2.1).

7.4.2 A squared stone buttress (805) and east west aligned stone wall (826) were revealed to the south of the trench (see Fig.3). The buttress was found at 55.18 m OD and was at least 0.70 m deep. The structure had at least one (0.2 m) offset to the north and Grave 810 overlay this offset.

7.4.3 Wall 826 was 2.3 m wide (the depth was not revealed) and represents the north wall of the Priory Choir. A section across the test pit (Fig.3) shows the upper part of the wall has been robbed. The robbing infill (830) is sealed by 'garden soil' 804, which contained 18th-19th century pottery.

7.4.4 As a result of the Test Pit investigation proposed pile location 8 which would have impacted on the burials was moved to the south of the Priory wall. Here all deposits or structures internal to and related to the Priory choir had been truncated by modern impacts to the depth of sterile flood plain deposits at 54.85 m OD.
