Hampton Court Palace  
Richmond  
London  
Clare Learning  
Centre Project

**Archaeological Watching Brief  
and Building Recording Report**

**Oxford Archaeology**

**Document Title:** Hampton Court Palace, Richmond, London. Clore Learning Centre Project

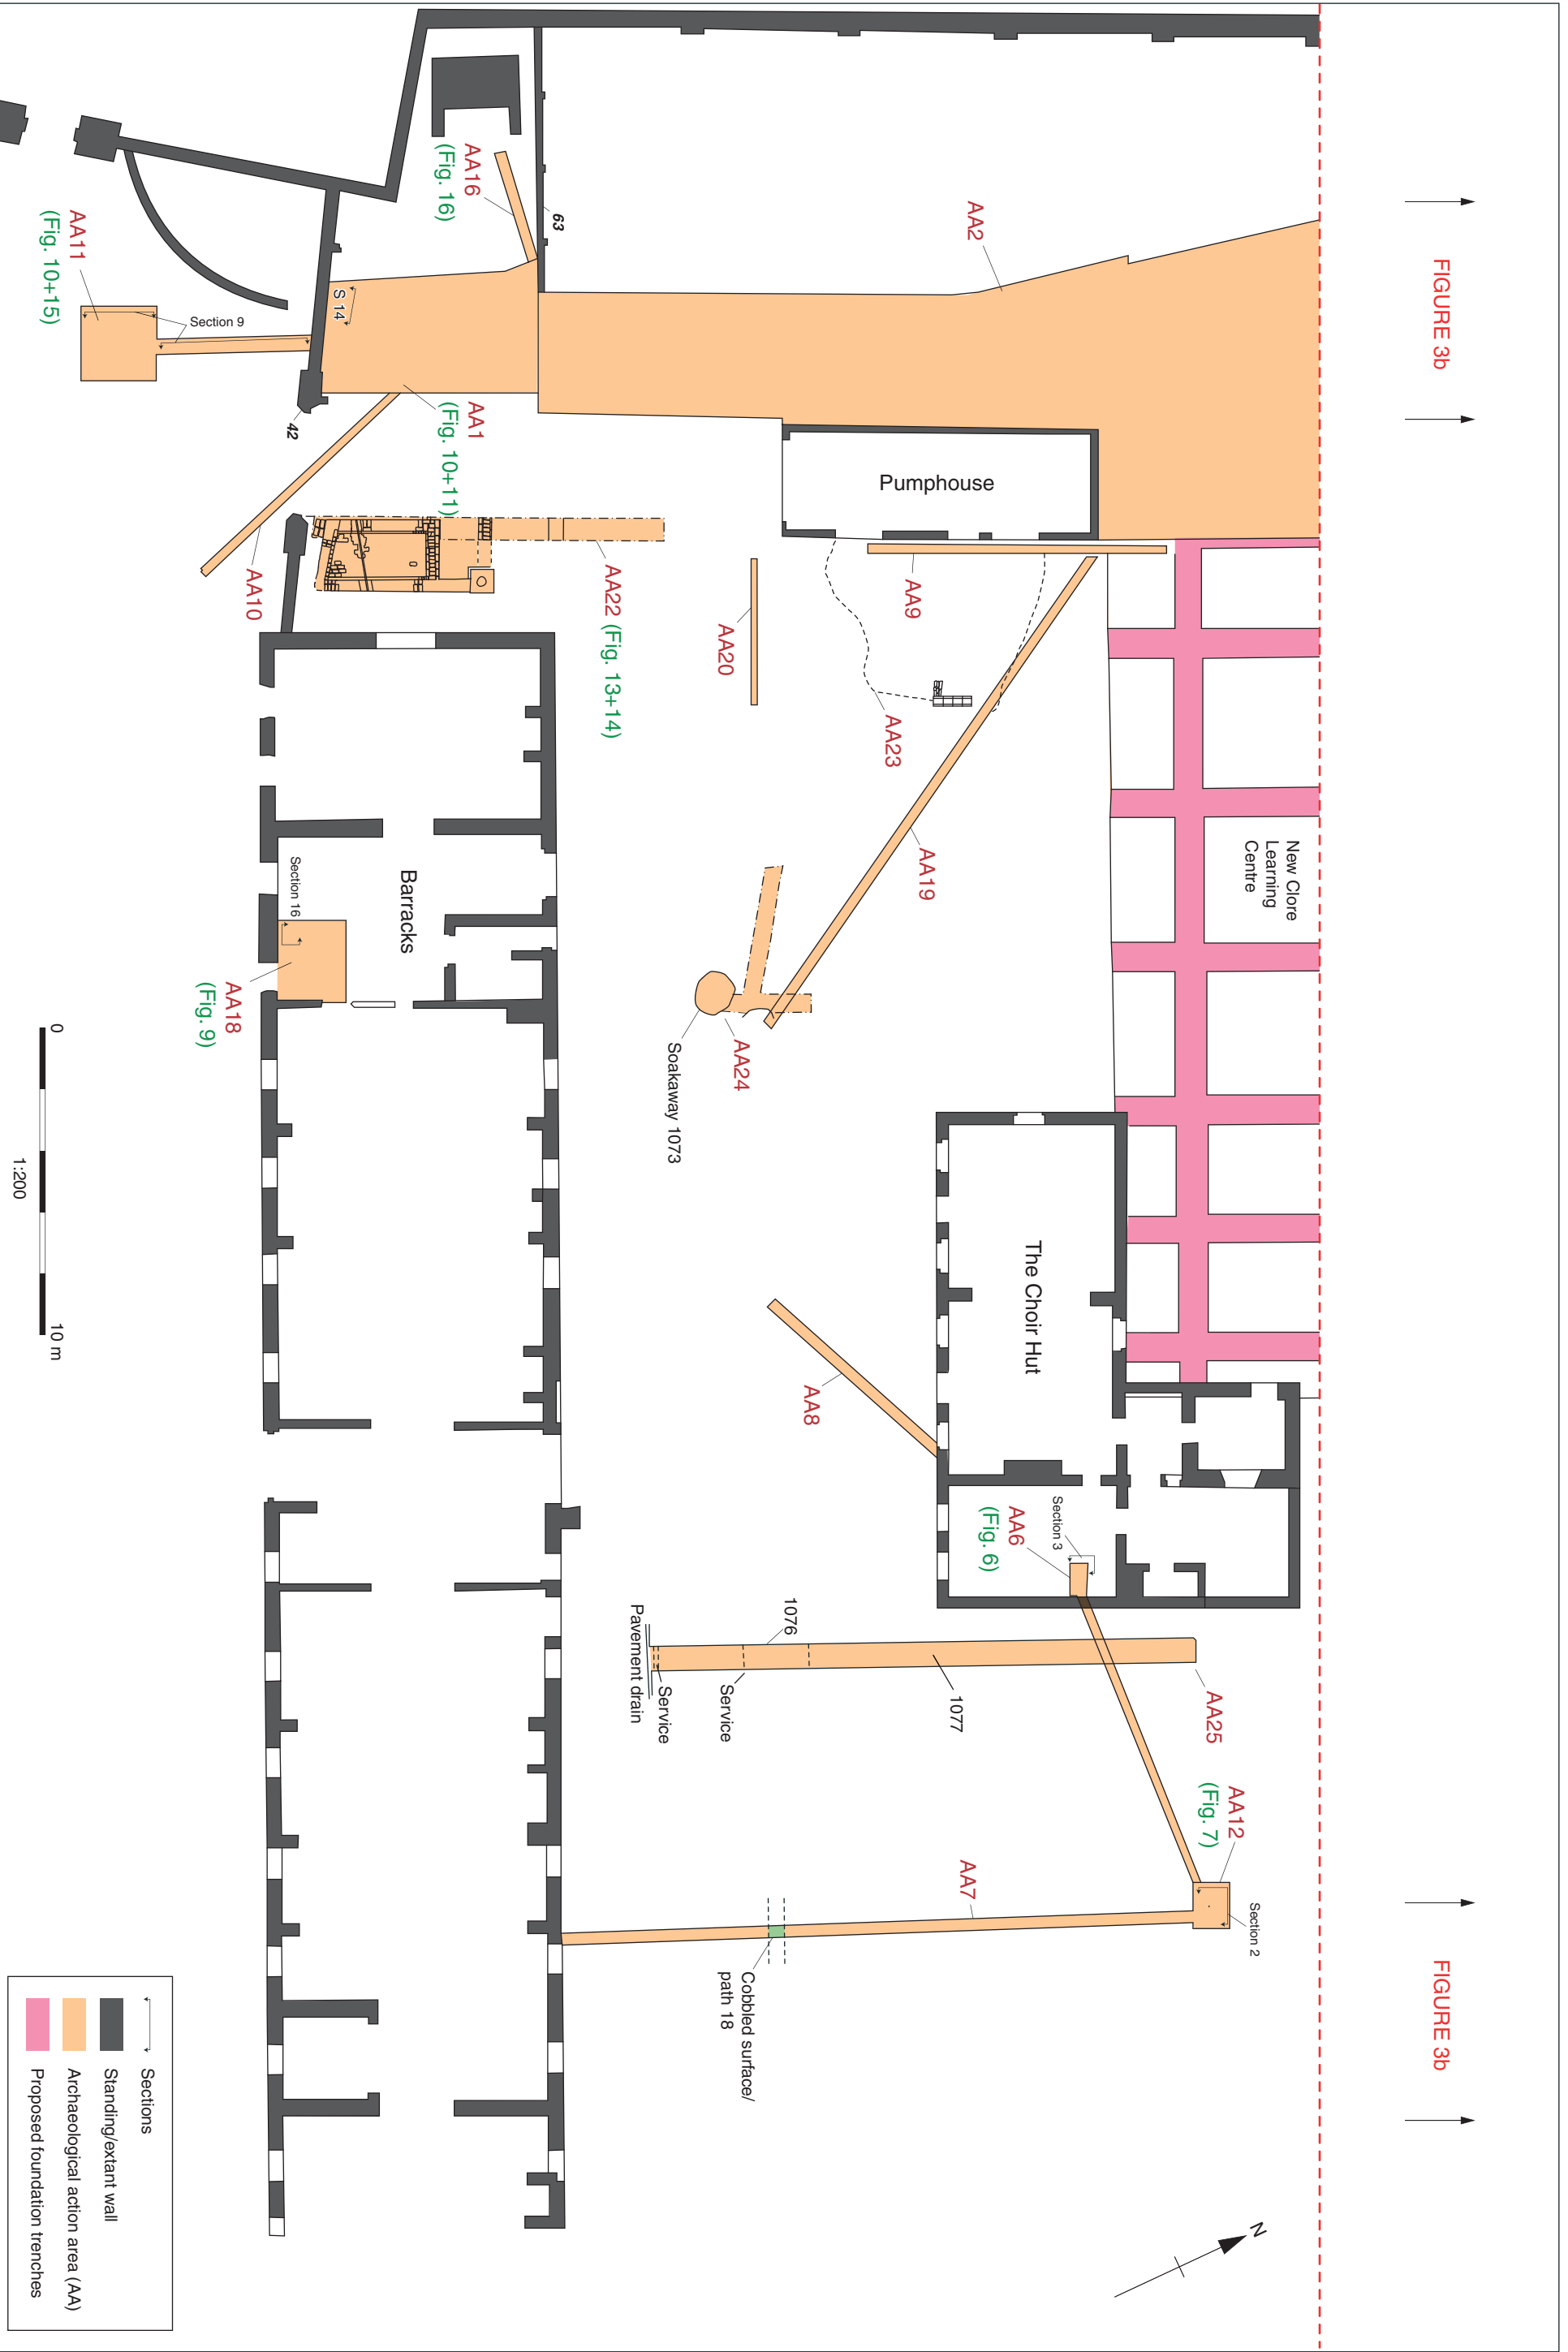
Figure 3: Plan of Archaeological Actions (AAs)

↔	Sections
▬	Standing/extant wall
▬	Archaeological action area (AA)
▬	Proposed foundation trenches

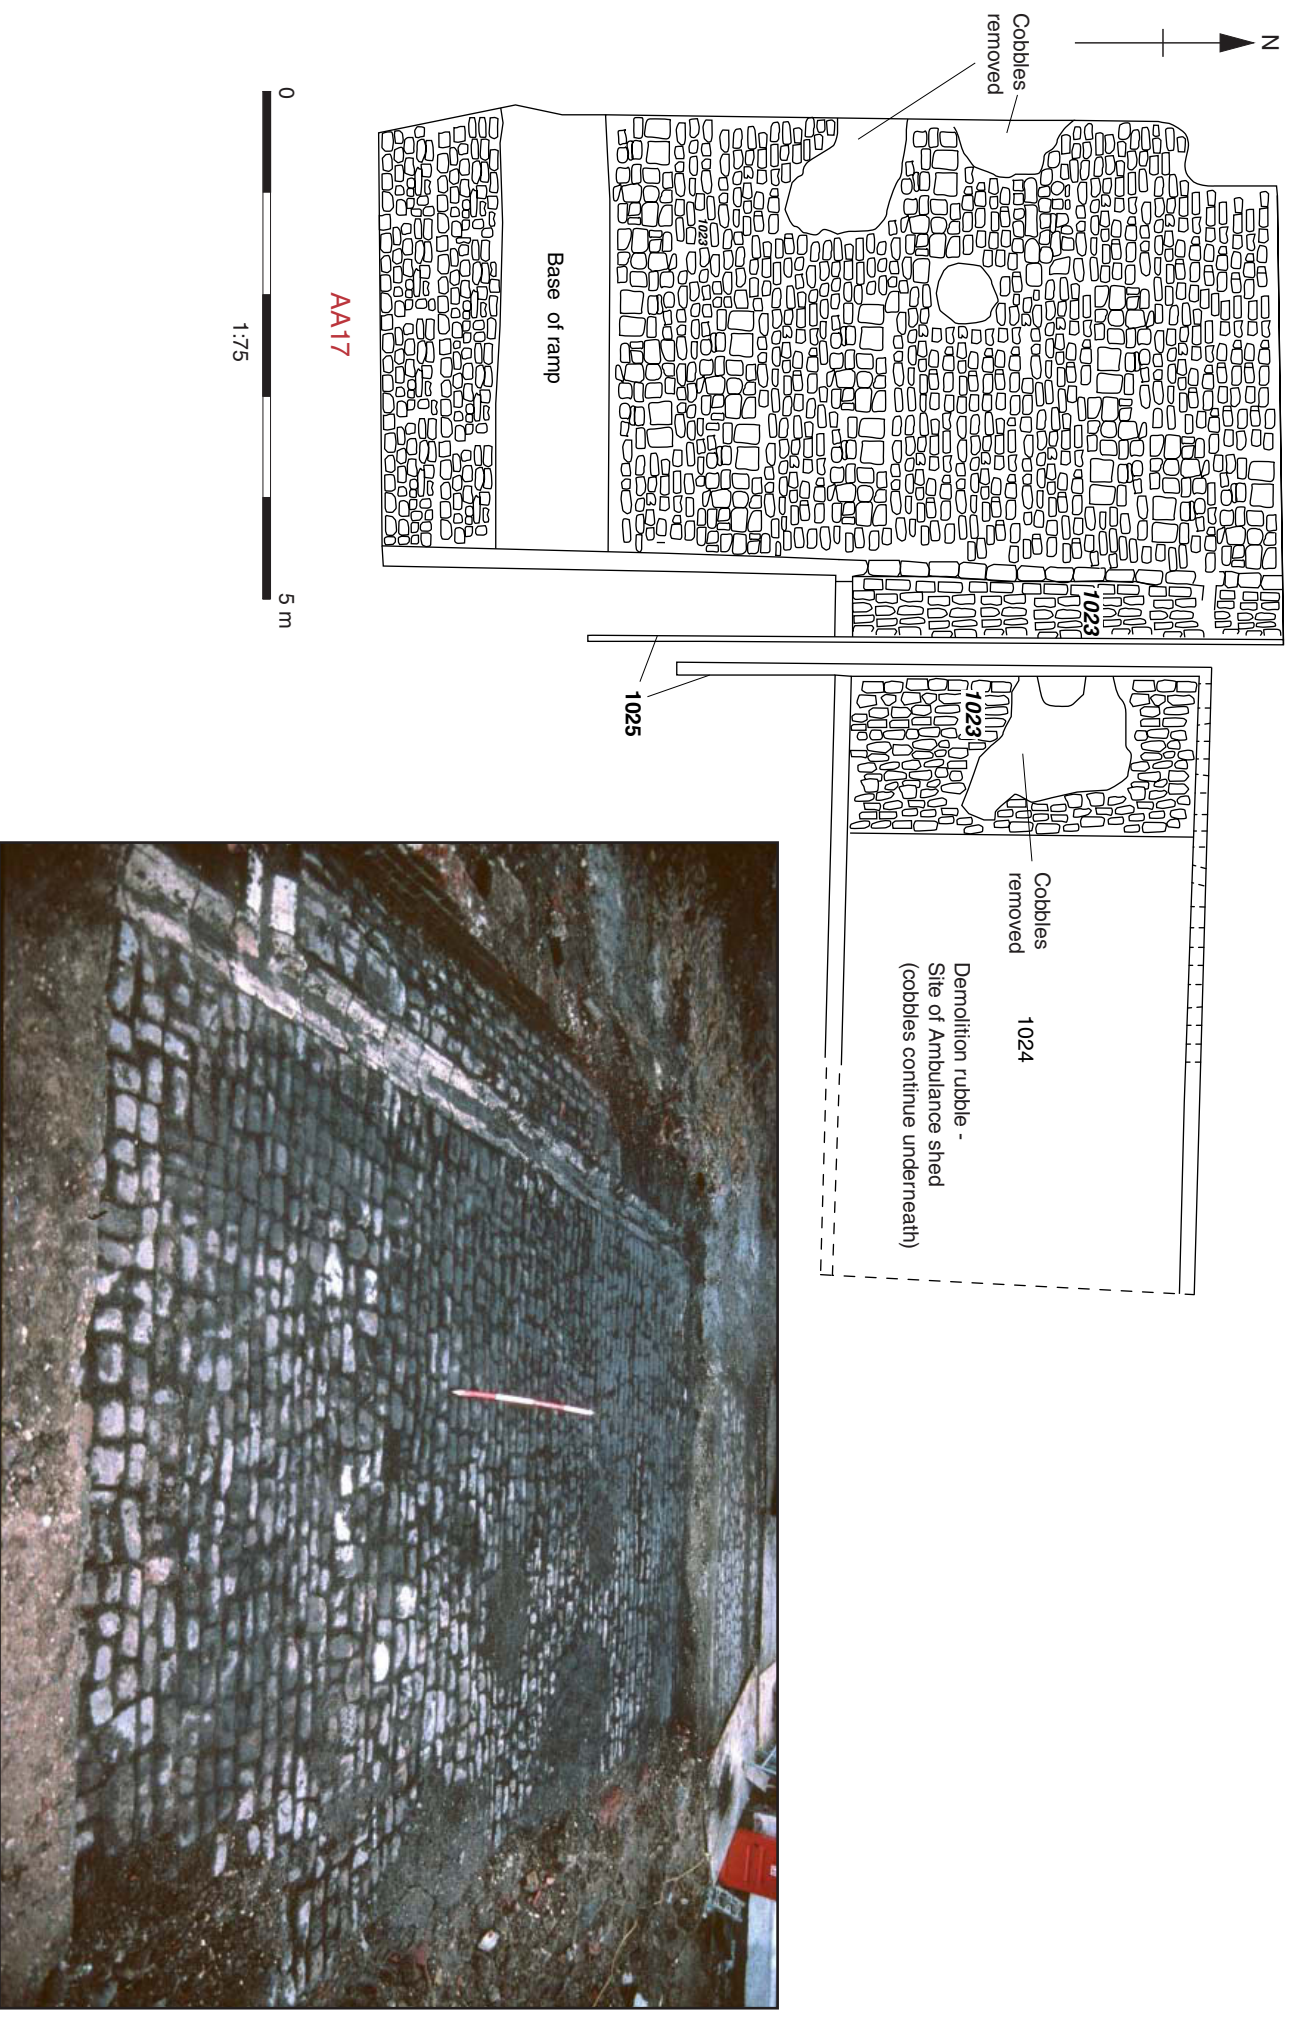
Figure 8: Part of late 19th century cobbled surface

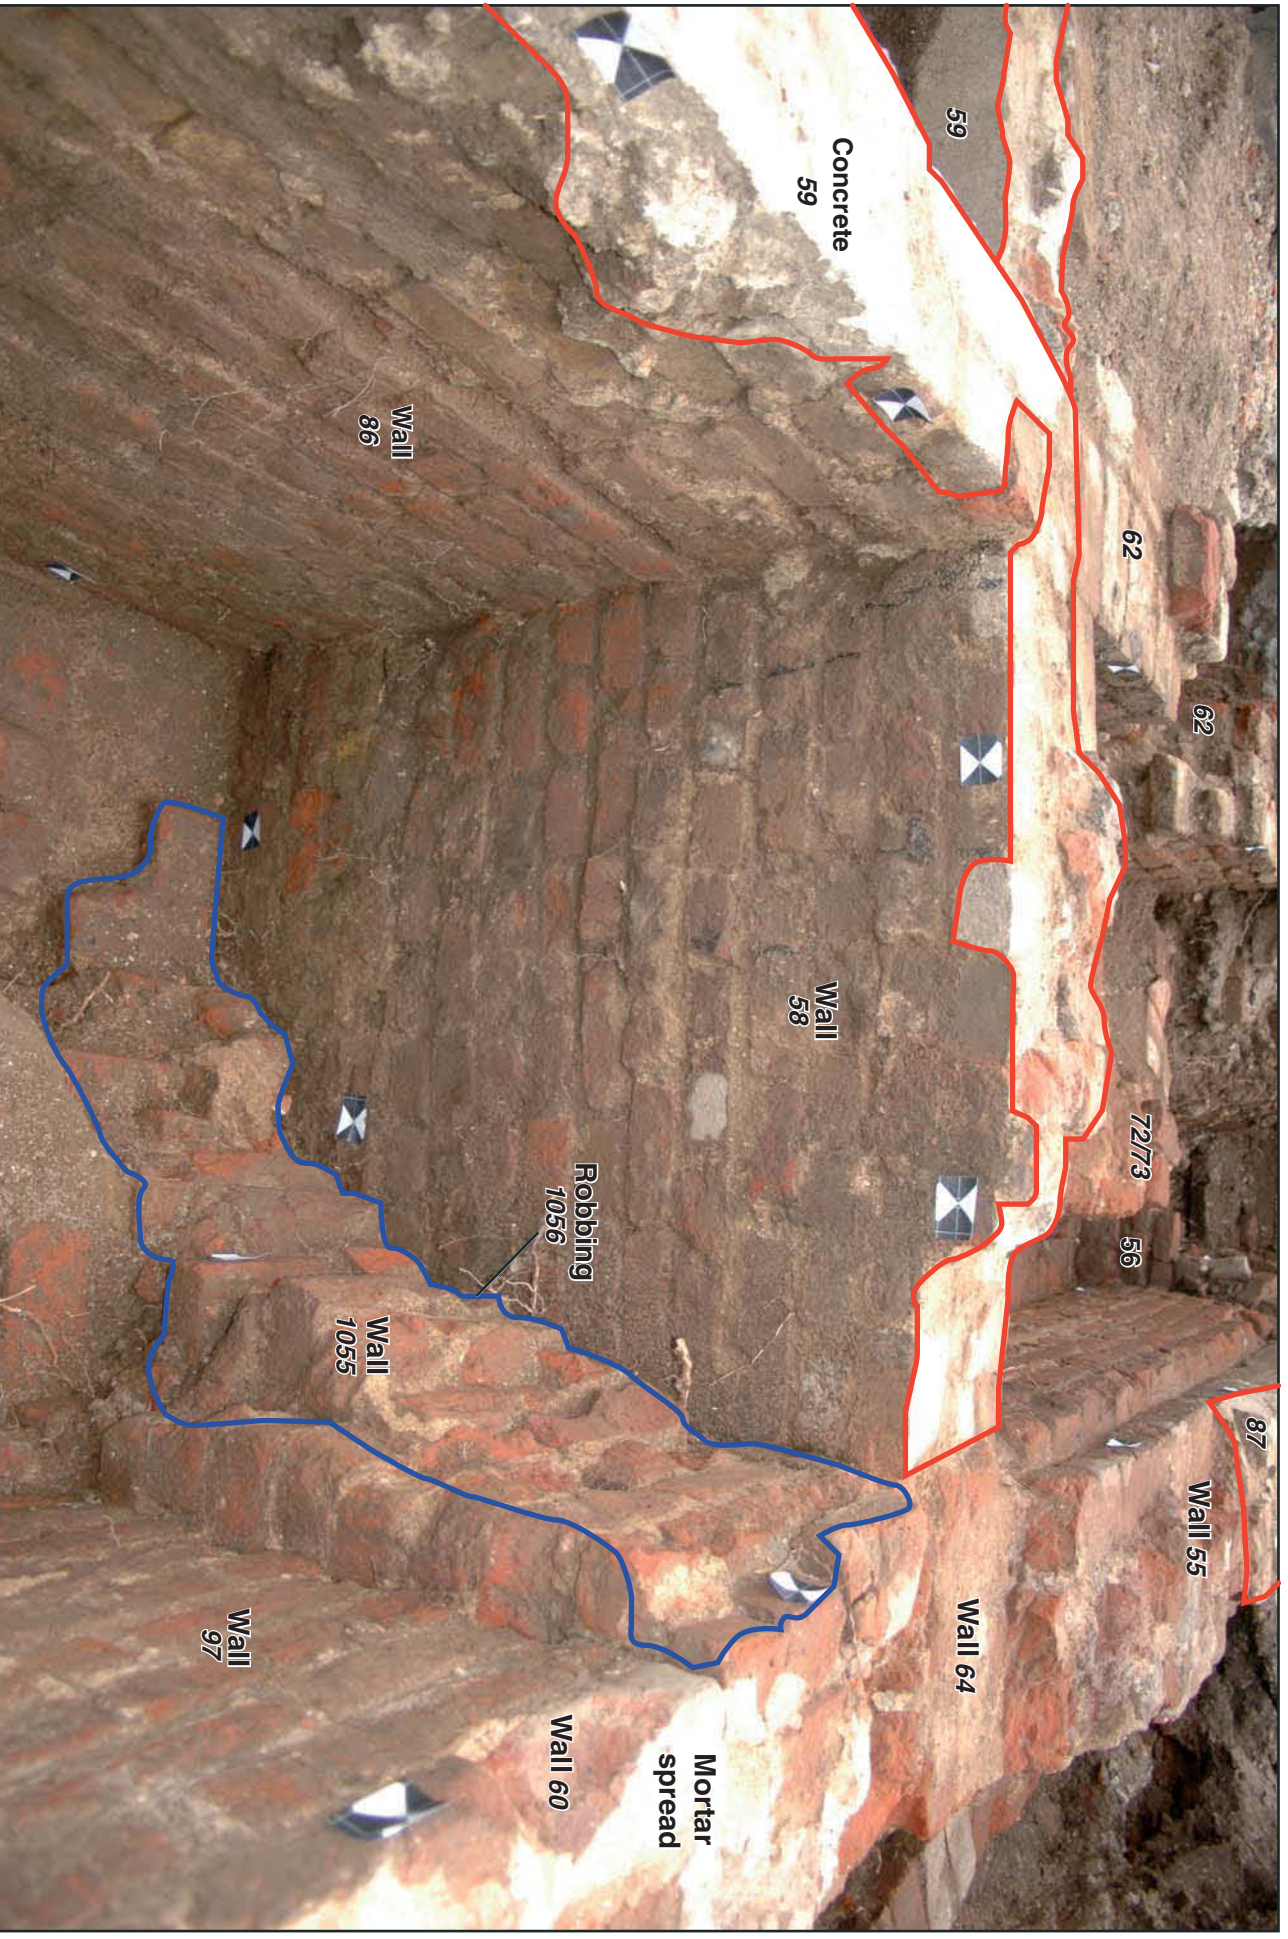
Figure 11: Digital photo showing phasing of latrine block, looking South

- 3.6.20 A distinct change in build at the top of the existing foundations indicates that the structure was modified, or totally re-built above ground. The mortar type changed from soft lime-based mortar to firm grey/white cement, presumably dating to the Victorian period (Fig. 11). Walls 58 and 86 had a new superstructure added with a concrete urinal (59) built on the east side of the latrine. A concrete step (87) was added on top of wall 55 (Plate 5), probably in this phase, possibly suggesting an entrance on the west side of the overall structure at this time.

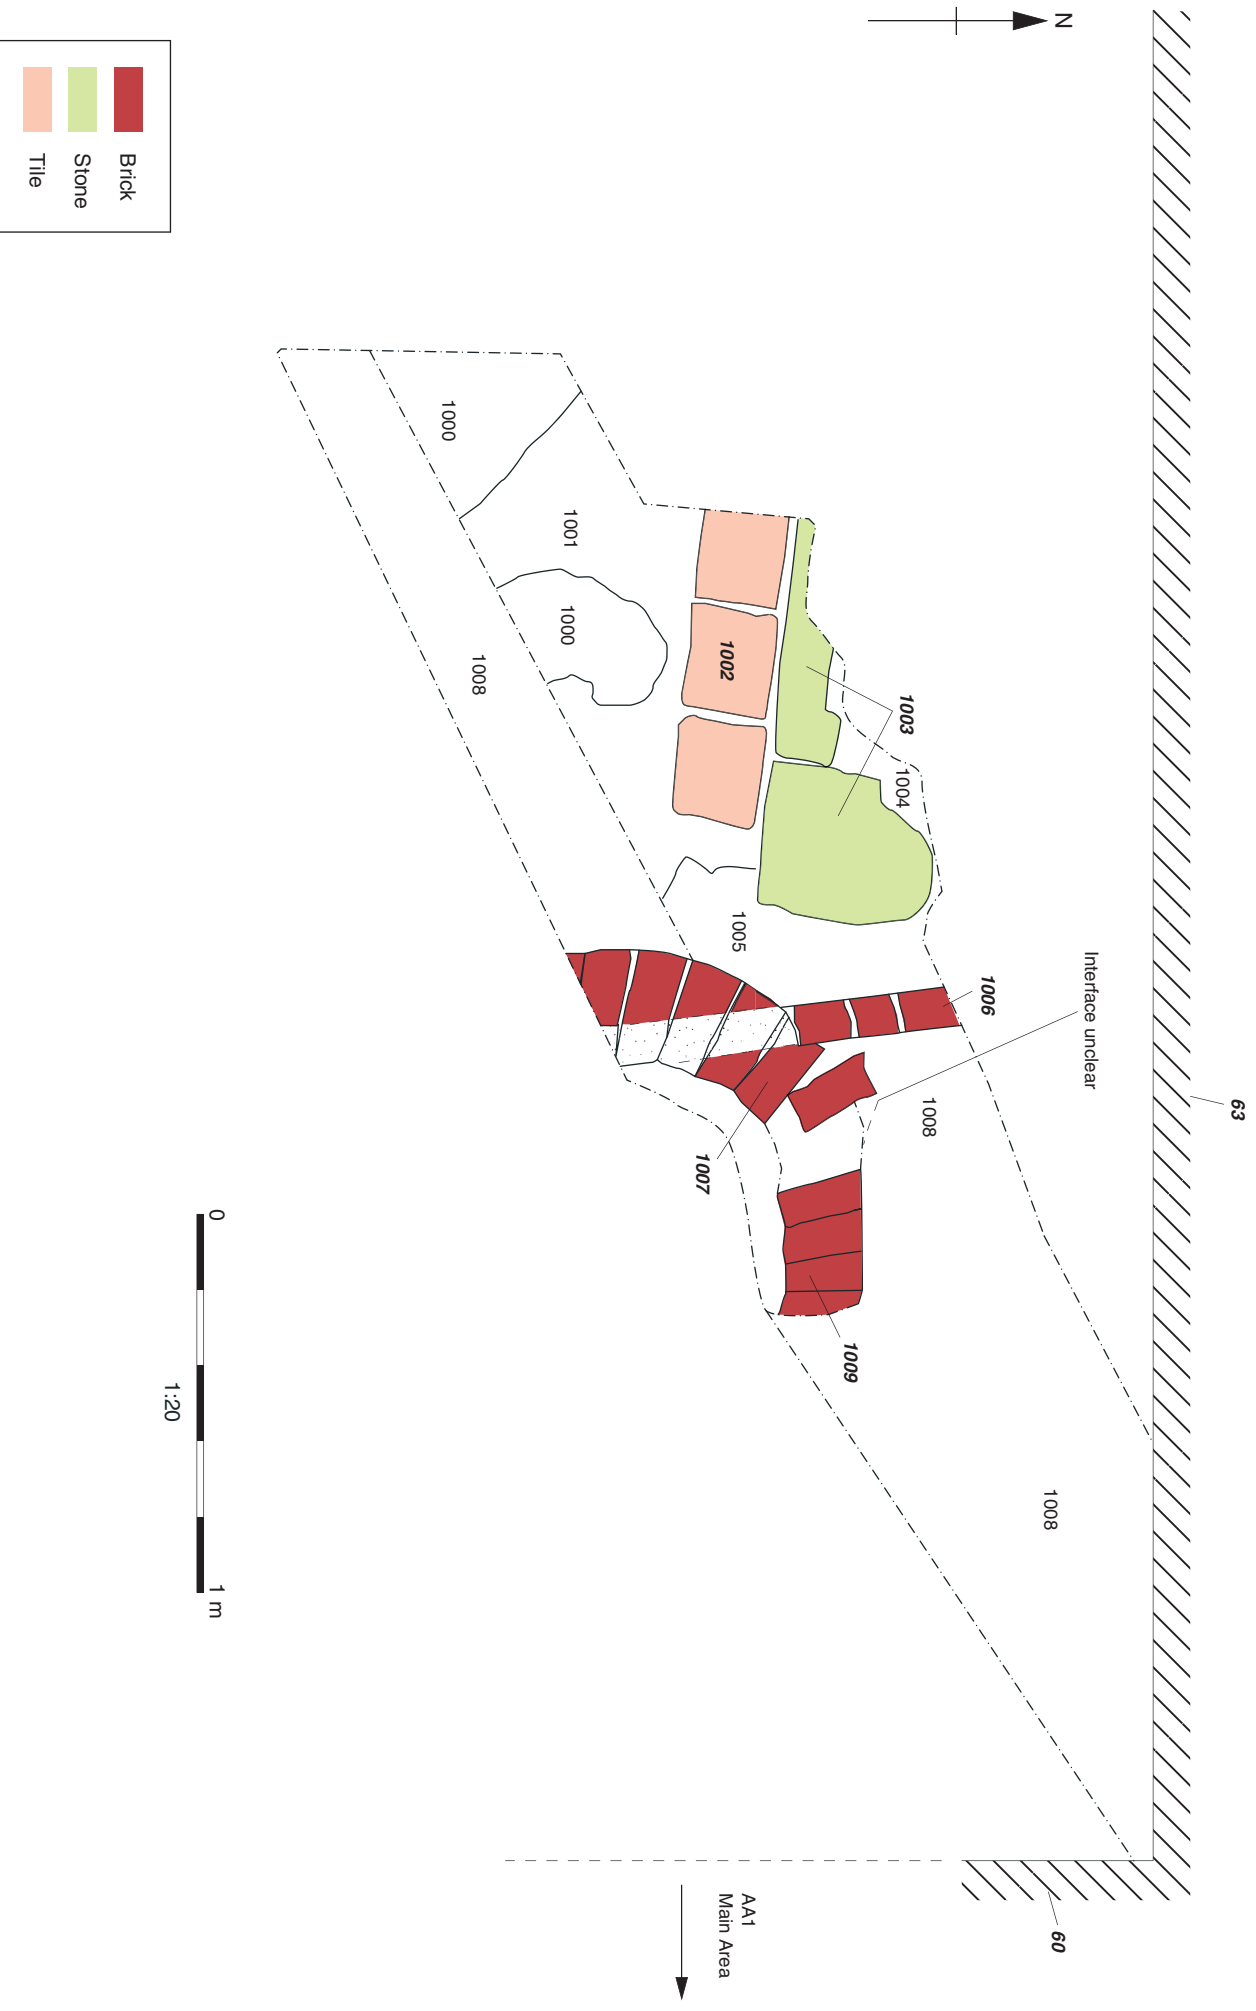
Figure 16: Plan of possible well 1007 in AA16

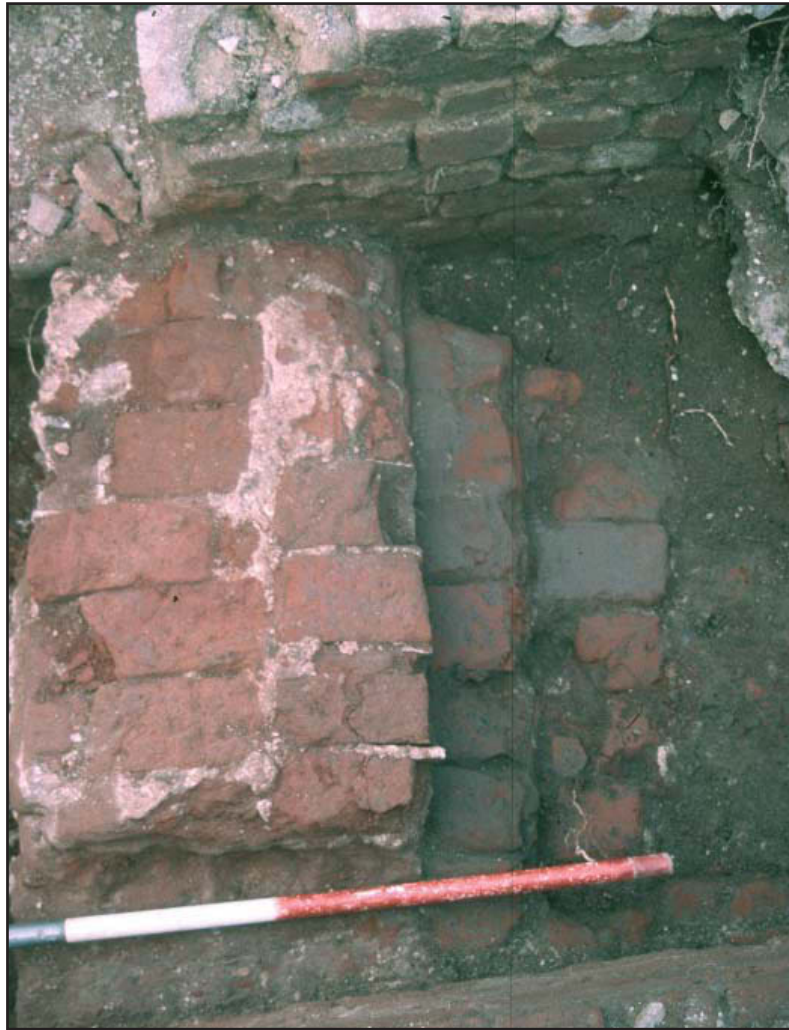
Plate 1: AA1 Tudor walls 72 and 73

- 3.6.4 Layer 70 was cut by a shallow construction trench (69) that was aligned west-north-west/east-south-east. The trench was filled by the truncated remains of a red-brick wall (73), presumably a footing, which was 0.5 m wide and extended for a length of 1.92 m within the confines of the trench. The bricks were bonded with mortar and the average brick dimensions were 240 mm x 120 mm x 50 mm. The wall survived to a height of 0.8 m, comprising thirteen courses laid in stretcher pattern. Three shallow depressions were noted in the top of wall 73.

- 3.6.5 Wall 73 was abutted on its south side by a thin deposit of silty clay (98) and then a further brick structure (72) utilising the same type of bricks and mortar, suggesting that the original wall had been widened. A length of 1.9 m was visible within the trench and the additional wall was 0.4 m wide. Assuming the two walls were in use at the same time, the overall foundation width was 0.9 m. Both walls terminated in a straight edge some 0.25 m from the west edge of the trench. A group of five ceramic tiles (71) lay on top of truncated wall foundation 72 - these tiles appear to have been part of the wall construction technique rather than a floor surface. The level on the exposed top of wall 73 was 8.25 m OD.

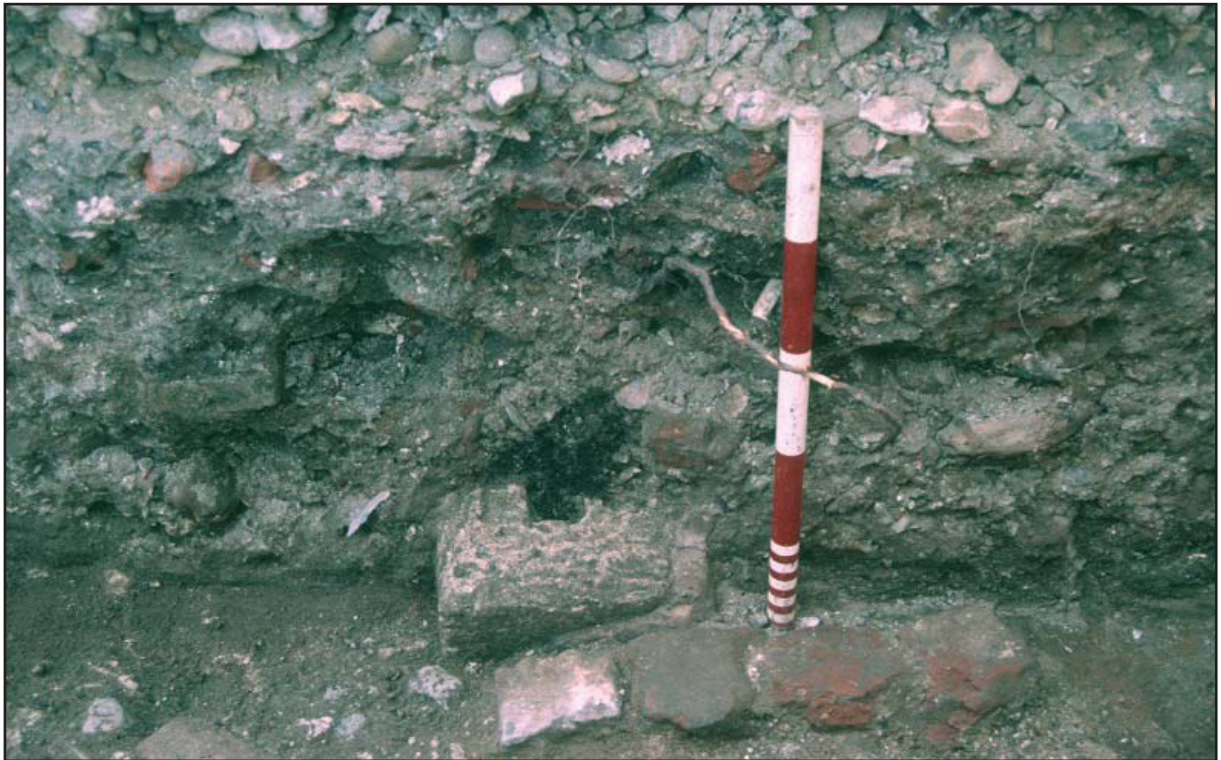
Plate 2: AA1 Stone post base and rotted post, ctx 51, 52

Adjacent to structure 61 against the west side of the excavated area lay a worked limestone block with chamfered upper surface (52) that was at least 0.1 m thick (Plate 2). The stone extended under the west baulk but the exposed portion suggested that it was square. The rotted remains of a wooden post (51) affixed into a square socket in the top of the stone were observed in section. The post survived to a height of 0.1 m and the post was originally 0.12 m wide. The post with its base and the possible path appear contemporary, and could go with structures associated with the early barracks, though the alignments appear inconsistent and so equally they could be later.

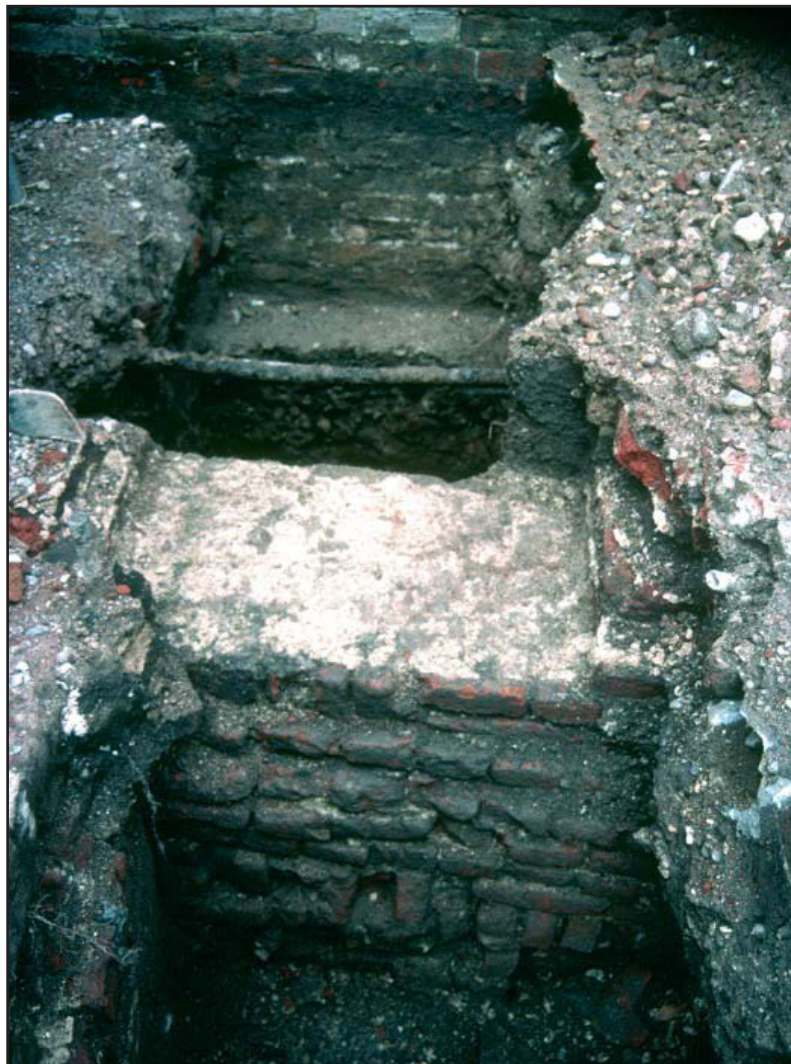
Plate 4: Wall 56 looking north

- 3.6.7 The southern return of the wall (1017) was cut by the construction trench (1021 = 1026) for a west-north-west/east-south-east aligned wall (1020 = 56; Fig. 10, section 14; Plate 4) that was built upon a lower foundation structure (1022). The lower foundation was constructed in bricks measuring 220 mm x 110 mm x 80 mm bonded with mortar in a stretcher pattern. The bricks forming wall 56 = 1020 are standard sizes (HCP Types I, J, K, N), so the wall is of a later period than walls 72/73 and 1017 (see Poole, section 5). On the basis of the brick typology, wall 56 = 1020 dates to the late 17th or early 18th century (Poole, section 5, this report). The lower foundation extended up to the west face of the truncated remains of Tudor wall 1017, then utilised the remains of the earlier wall (1017) for the foundation. The wall face of 56 = 1020 exhibited a change in build after three visible courses of bricks laid in stretcher pattern. A line of headers and apparently mixed rubble comprised the base of 56, over which were laid varying courses of stretchers and headers, stretchers and in one course, headers only. The base of the wall had been disturbed by a modern pipe trench (1034/1035).

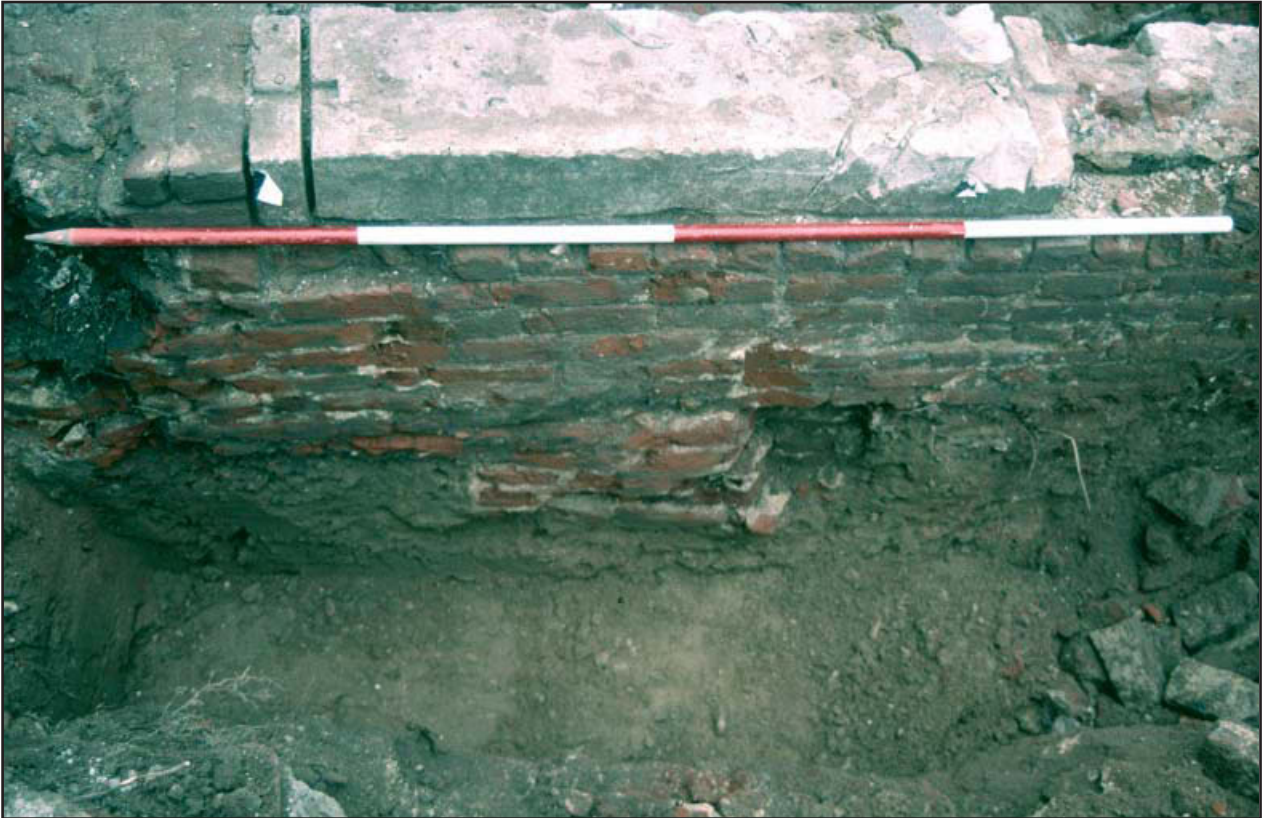
Plate 5: Stone/concrete step on wall 55

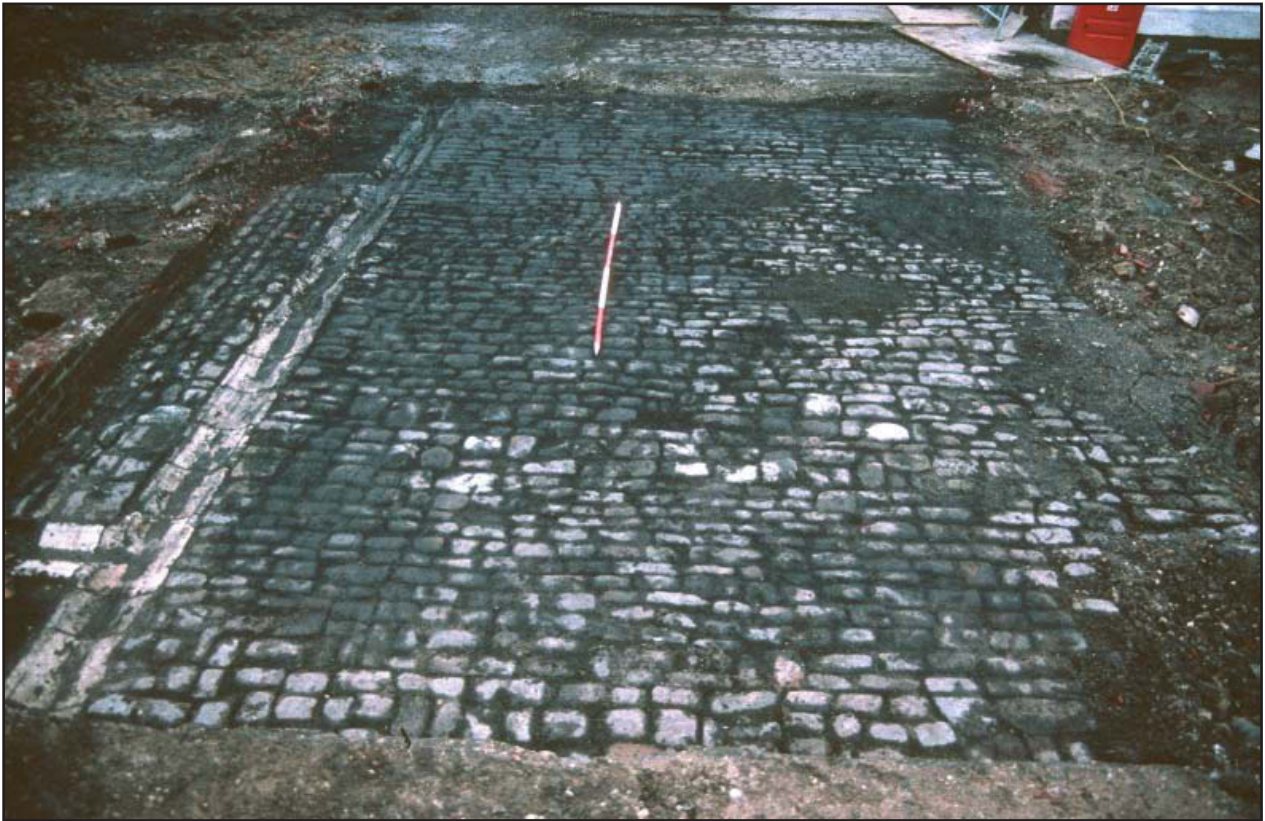
Plate 6: Cobbled surface 1023 in area of ambulance shed. Looking north with drains to the west of the shot

- 3.9.2 The earliest deposit over the whole area was a layer of alluvial clay silt (24), probably the same deposit noted to the north in AAs 4 and 5 and under AA2. The layer was overlain by a 0.05 m layer of yellow sand acting as a bedding deposit for the setting of an extensive surface of granite cobbles (1023) - see Fig. 8 and Plates 6 and 7. The cobbles were rounded on their upper surfaces and had a distinctly polished appearance.

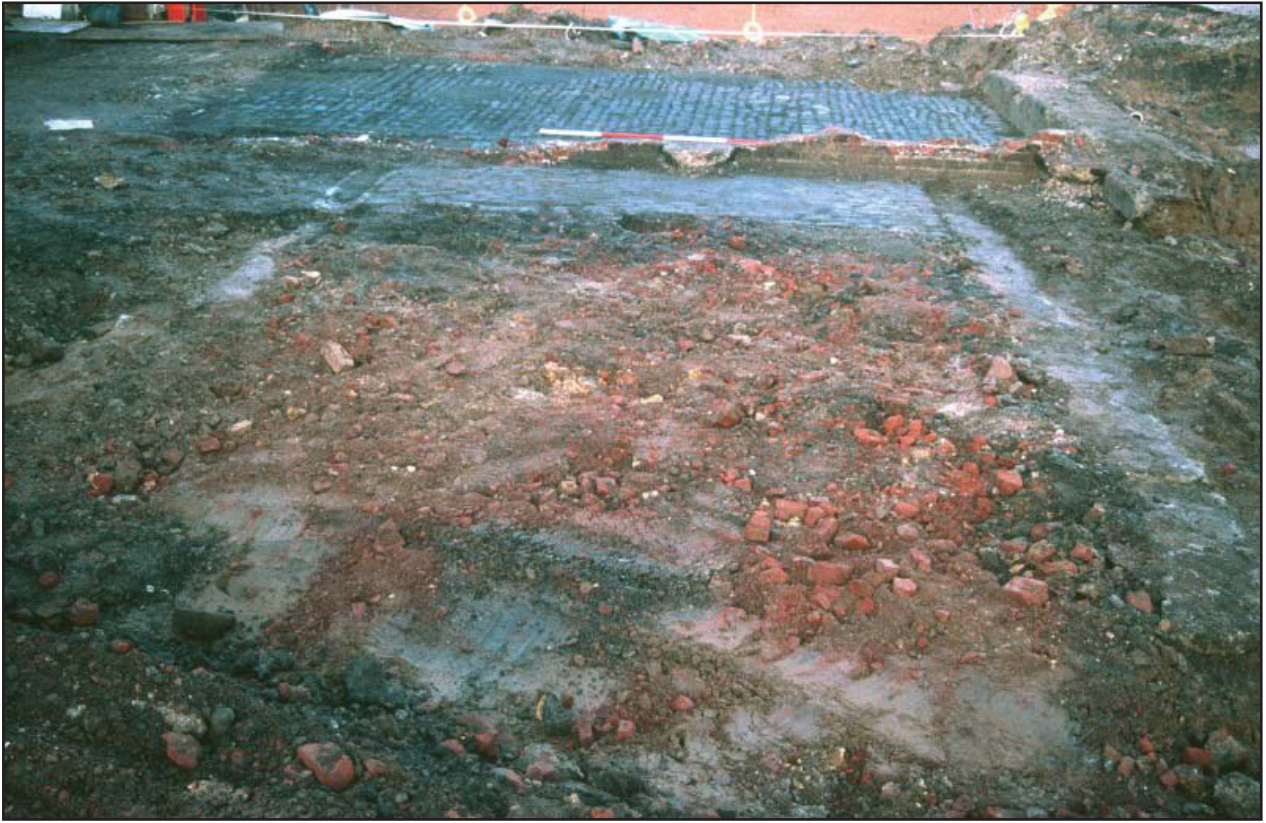
Plate 7: Cobbled surface 1023 looking west, remains of Ambulance Shed in the foreground.

services was an extensive spread of brick rubble (1024) occupying an area of *c* 4 m by 4 m (Plate 7). No evidence of *in situ* walls or other standing structures was noted. The rubble lay on the site of the former Ambulance Shed, which would appear to have been erected on shallow foundations and demolished with the remains left *in situ* prior to being sealed by the present tarmac surface.

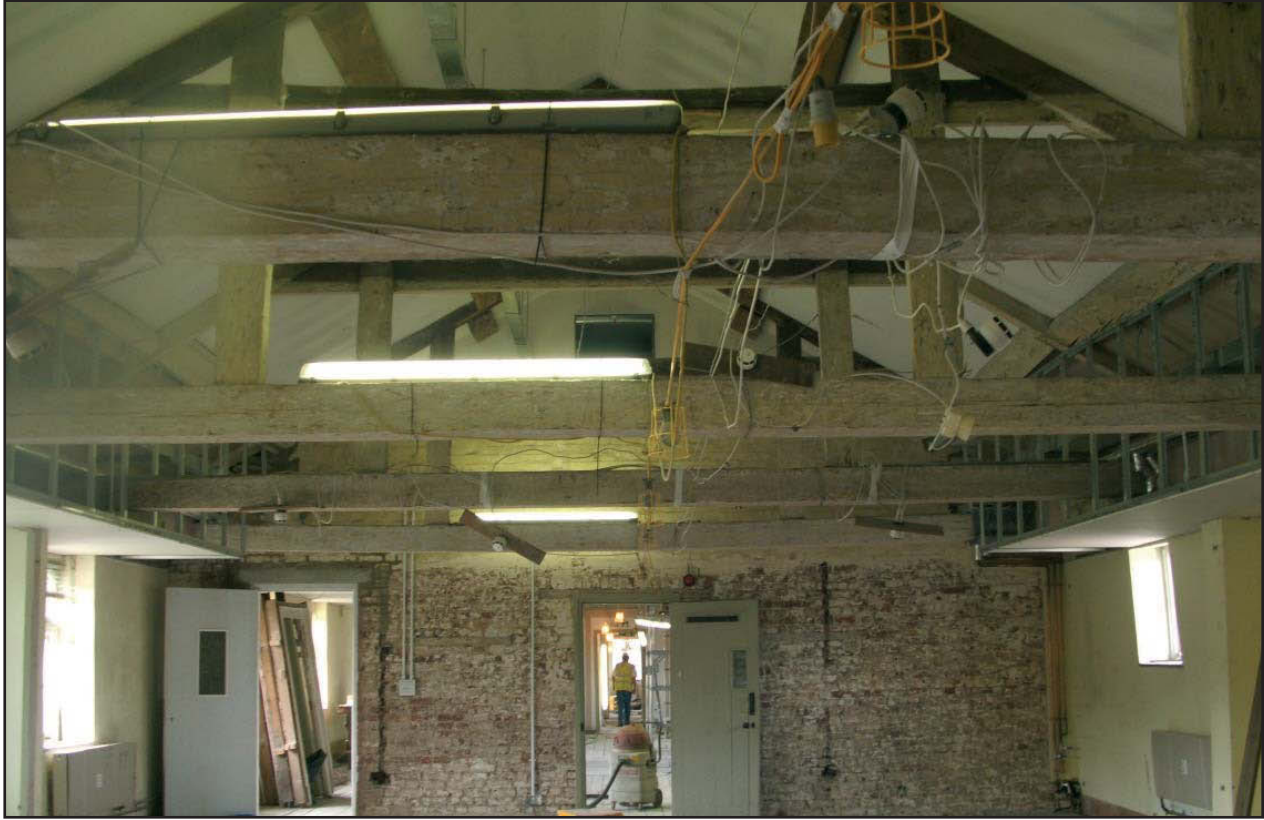
Plate 8: General view of east barrack room looking west

- 4.4.15 In the centre of the block are two large barrack rooms divided from each other by a later brick wall which was exposed during the works. After the removal of the 1980s partitions the two large barrack rooms were found to be largely intact and (apart from the steel floor reinforcement columns coming up from the floor below) the 20th century work appeared to have had little impact on the historic fabric (Plate 8).
- 4.4.16 The barrack rooms extend across the full width of the block. Most of the plasterwork in the rooms is relatively modern and was not removed during the current works so the historic fabric of the walls, excepting the central dividing wall, was not exposed.

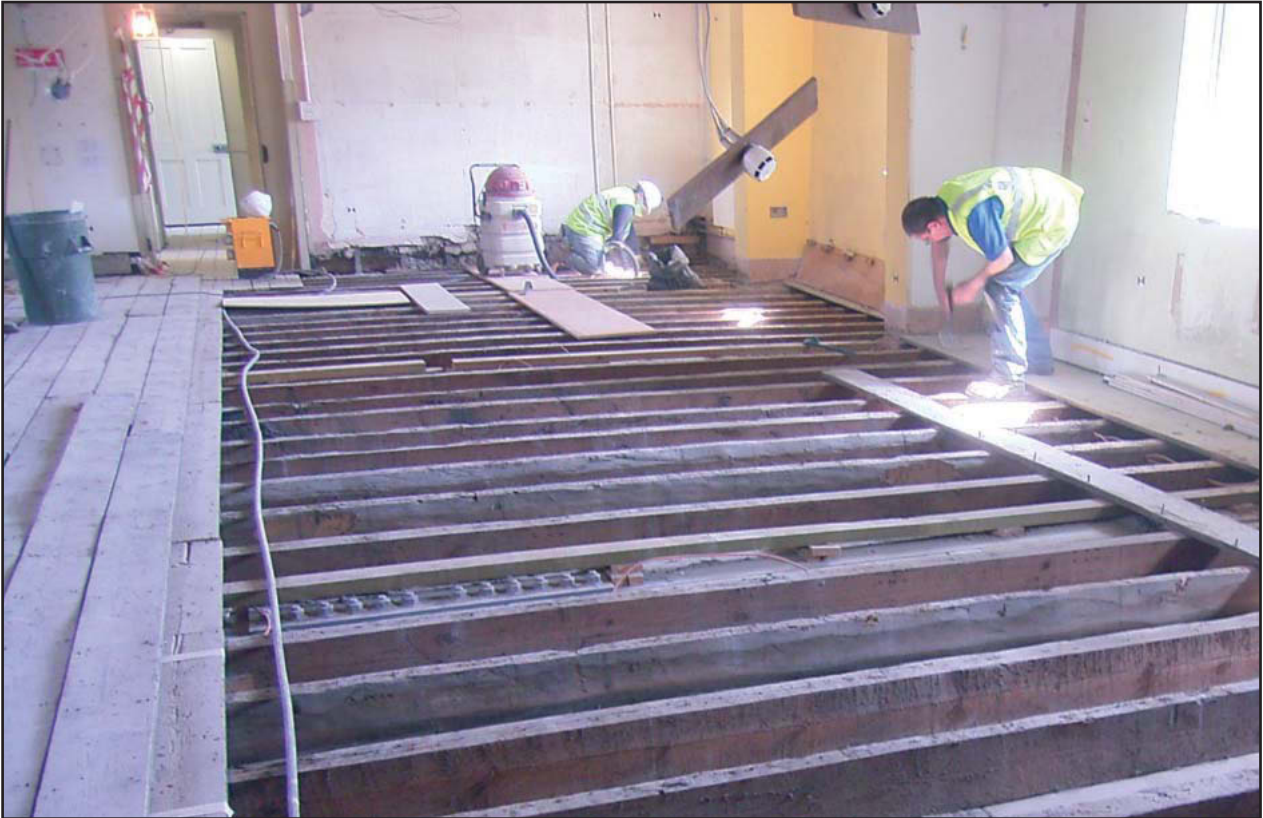
Plate 9: First floor joists on south side of east barrack room

- 4.4.30 The timber common joists exposed on the south side of the east room were of softwood and appeared to be mostly early (probably primary) timbers and later replacements (Plate 9). There were 30 transverse timber joists in situ and three transverse steel girders inserted in the 1980s which had replaced three of the earlier timber joists.

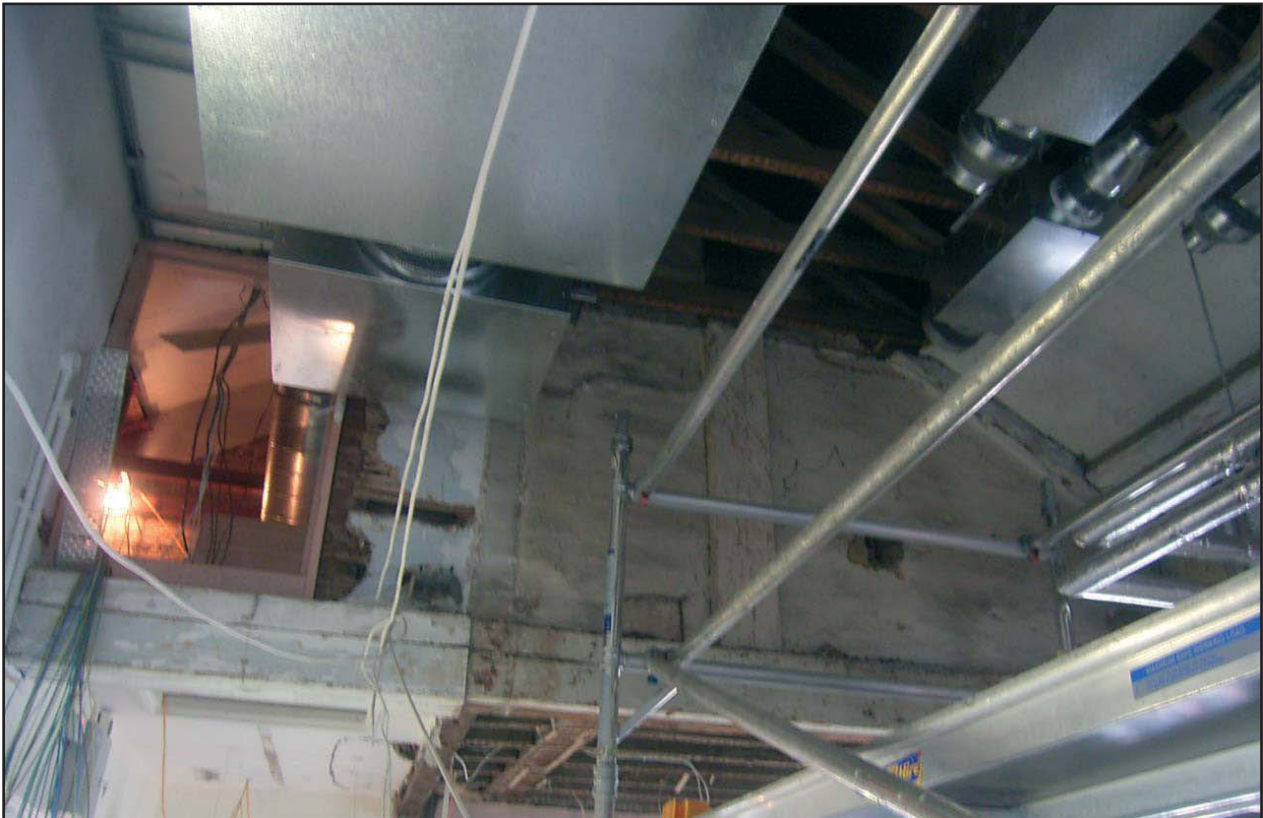
Plate 10: East elevation of closed truss (truss 2) with primary stairwell ceiling joists behind

- 4.4.62 As mentioned above, there were ceiling joists at tie beam level between truss two and the brick partition to the west. The upper portion of truss two above the tie was closed with extra studs and lath and plaster which was in a partly decayed condition with patches of plaster missing revealing broken laths and studs beneath. On the east side of truss two there was a ceiling at collar level, most of the lath and plaster had been removed here revealing the collar rafters. The tie beam of truss three had mortises as though for ceiling joists along both faces (see Figs 19 & 20) but there were no corresponding mortises in the east side of the truss two tie and the truss three mortises facing truss two contained the same paint as covered that side of the tie beam. The mortises on the east side of truss three were within the faint ghosts of former joists and faced later inserted partitions which were plastered. Thus if former joists had spanned to this partition which is only a late 19th century insertion the evidence was concealed. The former joists had not spanned to truss four prior to the partition being inserted as there were no mortises in the west face of the truss four tie beam. This rather suggests that the truss three tie beam was reused from elsewhere.
