Hampton Court Palace  
Richmond  
London  
Clare Learning  
Centre Project

**Archaeological Watching Brief  
and Building Recording Report**

**Oxford Archaeology**

**Document Title:** Hampton Court Palace, Richmond, London. Clore Learning Centre Project

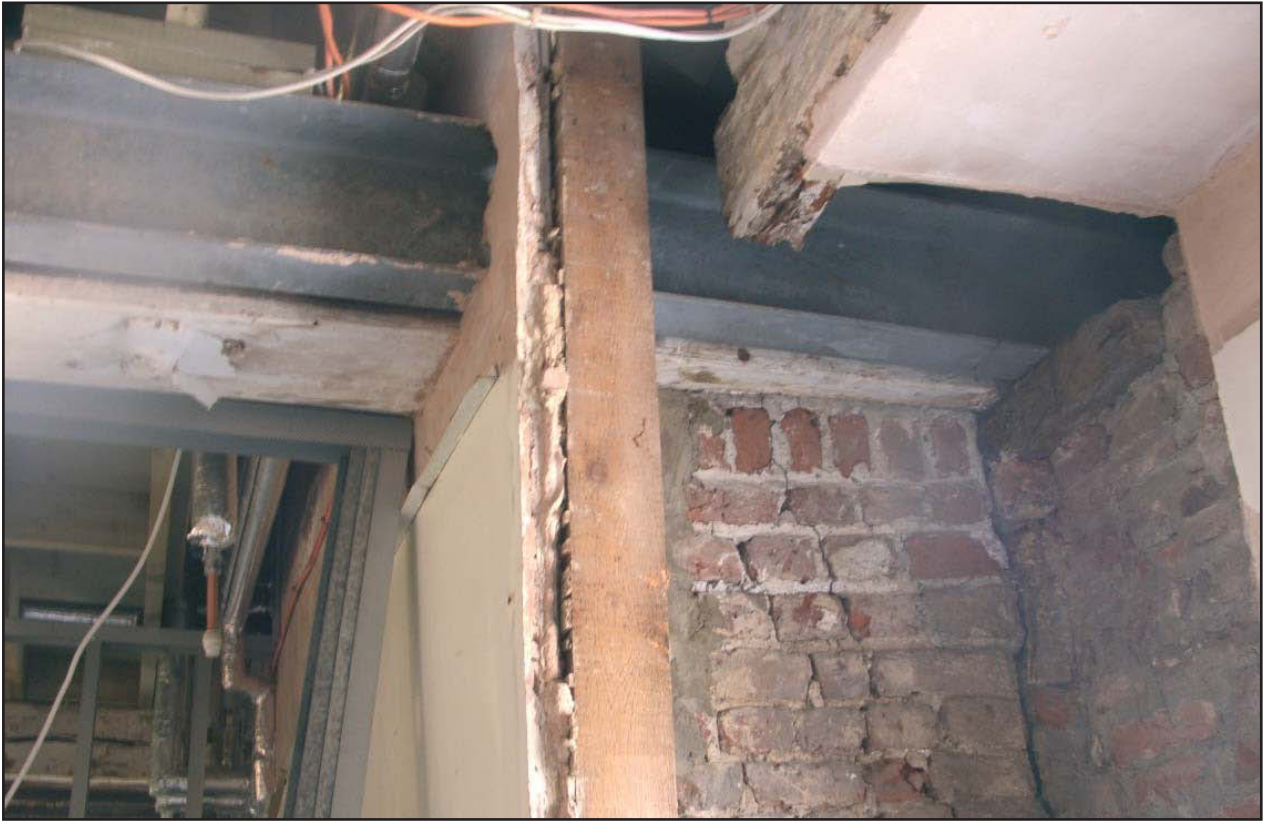
Plate 11: Exposed brickwork of chimney breast (centre right) and inner face of exterior north wall (extreme right)

- 4.4.48 The bricks in the chimney breast are handmade bricks of low quality with no skintlings and are therefore probably place bricks and do not figure at all in the brick typology. They are quite weathered and cracked in places which suggests they may either be reused from an earlier building or may have been left over or rejected from the original construction of the barrack block and then used a few years later when an additional fireplace was required. The bricks were primarily bonded with a soft creamy yellow coloured lime mortar. The upper three courses of bricks below the tie beam of truss three have been re-pointed later with a harder grey white lime mortar.

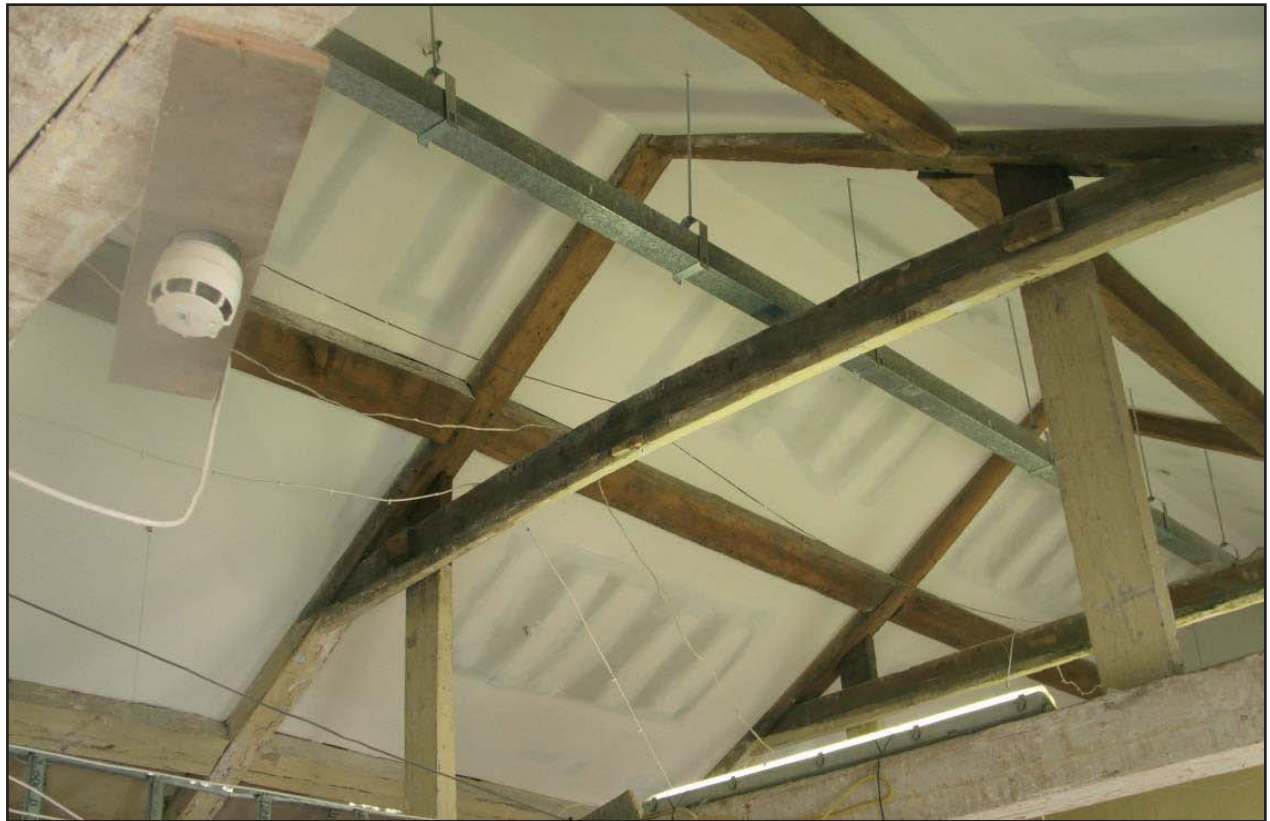
Plate 12: Typical open roof truss (west face of truss 11)

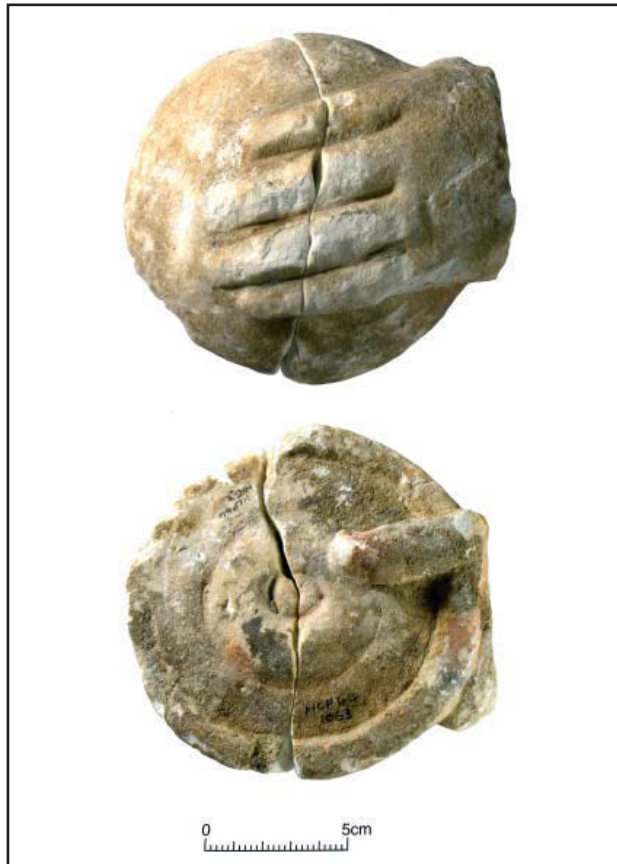
Plate 13: Statuary hand, context 1063

- 5.1.41 *Statuary:* The statuary hand has a thumb on top holding a hemispherical vessel, with a lid or top. The top or lid is slightly domed and has a low circular feature in the centre. It is possibly a lamp. It is made of a white marble. L 115mm; D of vessel 110mm. Context 1063. The statue cannot be closely dated from the surviving fragment. The location from which the find was recovered - by the barracks - suggests that it was redeposited. The barracks are utilitarian buildings without decorative features. However there are gardens nearby from which a fragment of statue could have come (see Plate 13 for detail).

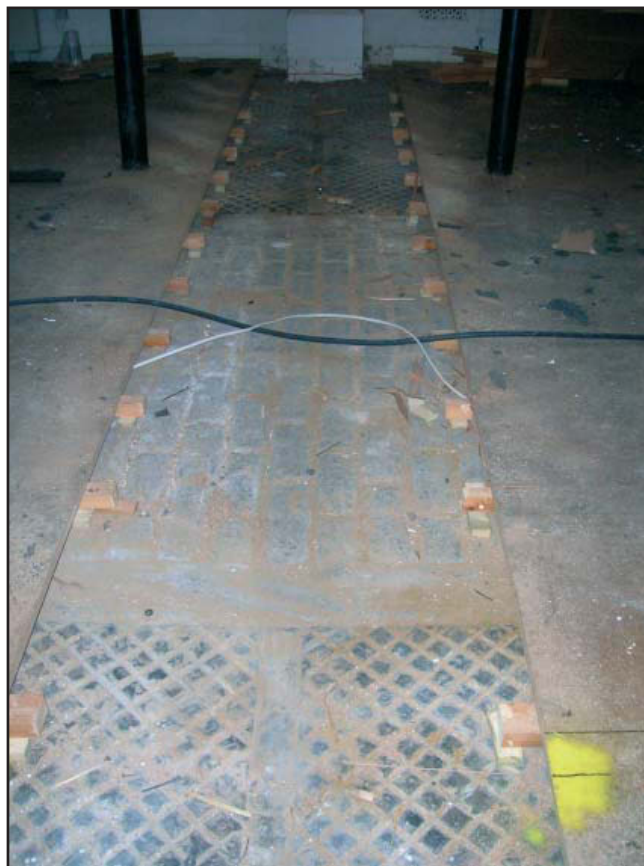
Plate 14: Stable floor view NE, see figure 26

- 4.3.3 Areas of the floor surfaces that were accessible at the east end of the ground floor were recorded during the works and the survey drawings and notes will form part of the site archives. The eastern three bays were recorded plus a couple of strips further west and the east part of the central area between the large doors (see Fig. 26).

- 4.3.4 Most of the floor seen east of the entrance bays consisted of an axial 2 m wide central walkway of granite setts between the iron columns with a 0.2 m wide band of setts either side recessed 0.01 m for drainage. The horse stalls to either side were paved with dark ceramic pavoir bricks laid at 45° to the walls; each brick was divided with v-section incisions into eight small squares thus creating a diamond pattern grid to aid grip and drainage. There was also a line of sets recessed by 0.01m for drainage down the centre of each stall (see Plates 14, 15). The east half of the entrance bay surveyed was paved entirely with the grid-cut black pavoirs. These floor surfaces appear to be 19th century in date and may relate to the major late-19th century refurbishment, but could be from earlier in the century.

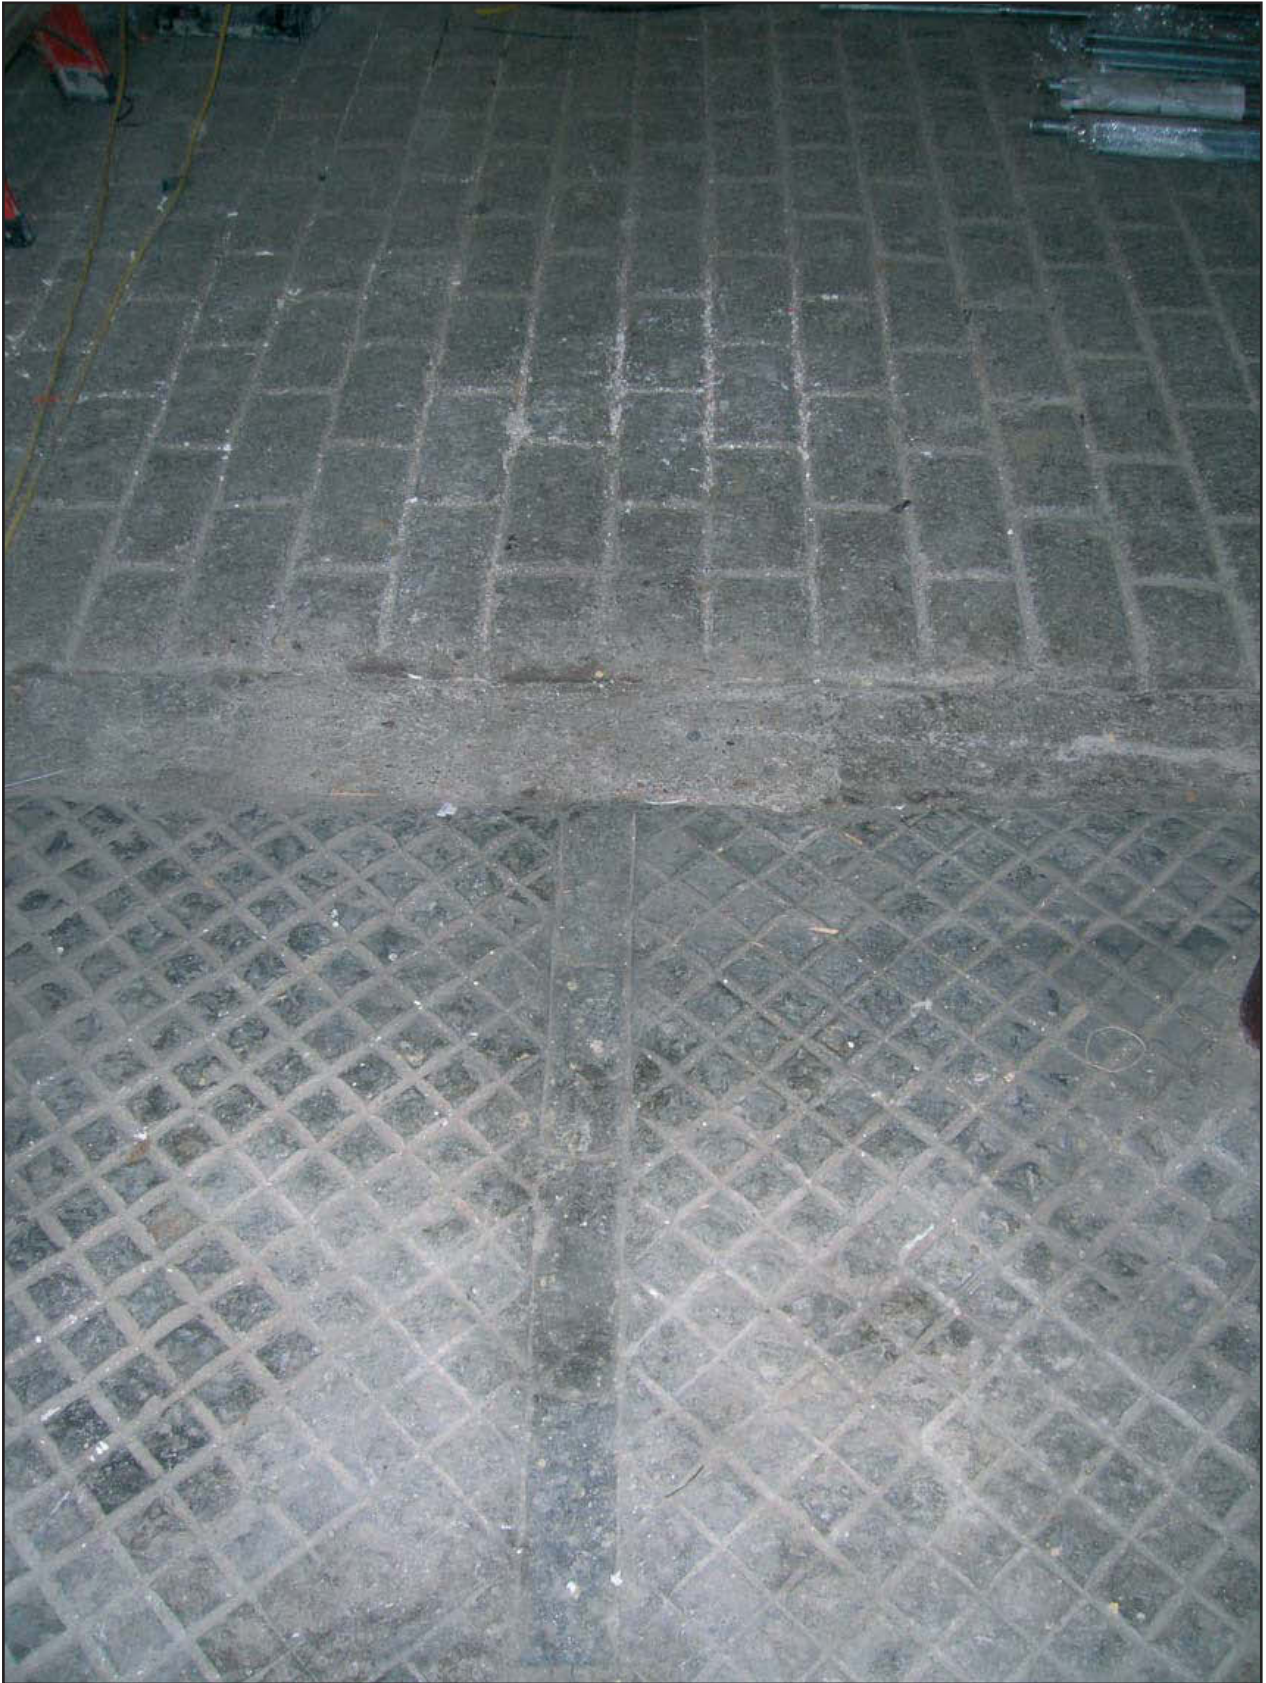
Plate 15: Stable floor view S, see figure 26
