Osney Mill Mill Lane Oxford

Archaeological Watching Brief Report

June 2008

Document Title: Osney Mill, Mill Lane, Oxford

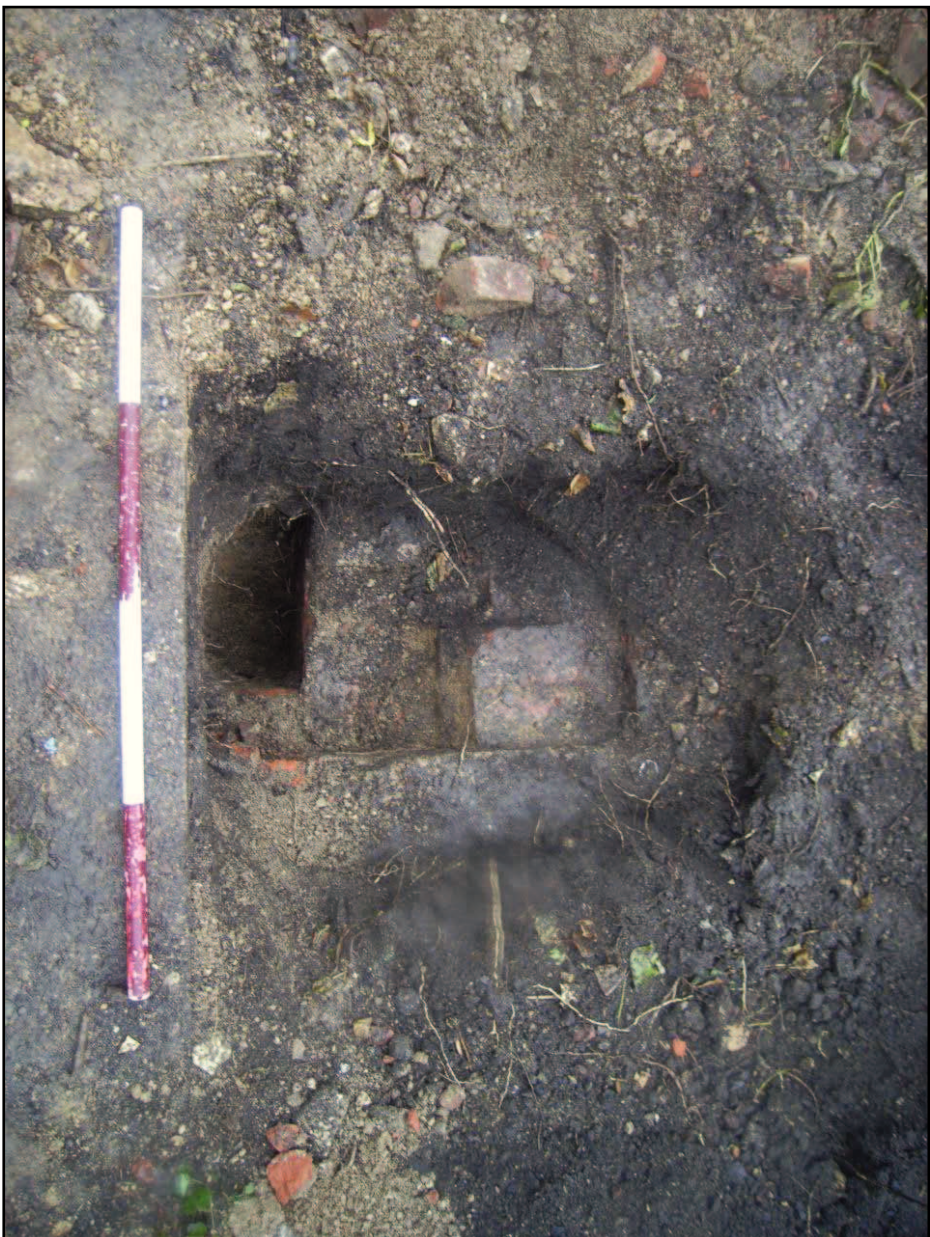
Plate 2 : Test pit 2

- 3.1.5 This was located on the southern edge of a demolished two-storey brick building, and measured approximately 1 m square.
- 3.1.6 A standing brick wall (21) constructed using machine made bricks measuring 0.22m by 0.102 m by 0.072 m laid using English Stretcher bond defined the northern edge of the pit (Fig. 3, Section 2, Fig. 4, Plate 2). A second wall (22) running parallel with wall (21) 0.4 m to the south of similar construction was encountered during the course of excavation. Filling the space between these two walls was a very dark grey sandy silt (25). This was encountered at a depth of 0.2 m below the current ground level and was excavated to a depth of 1.2 m below ground level without determining its full depth.

- 3.1.7 Laid directly onto deposit 25 and running over the top of Wall 22 was a brick floor (24). This was built using frogless bricks measuring 0.225 m by 0.105 m by 0.072 m. Overlying this floor and butting up to wall 21 was a 0.1 m deep layer of very dark grey-brown silt loam (23), an accumulation of leaf mould and organic debris.

- 4.1.2 The presence of the 19th-century brick walls (21) and (22) (dated by brick size) suggests that this area has been heavily disturbed. While Wall 21 appears to respect the alignment of the standing medieval building, no evidence for any earlier foundations was observed. As in Pit 1 the walls and the brick floor (24) probably relate to the 19th-century industrial use of the site.

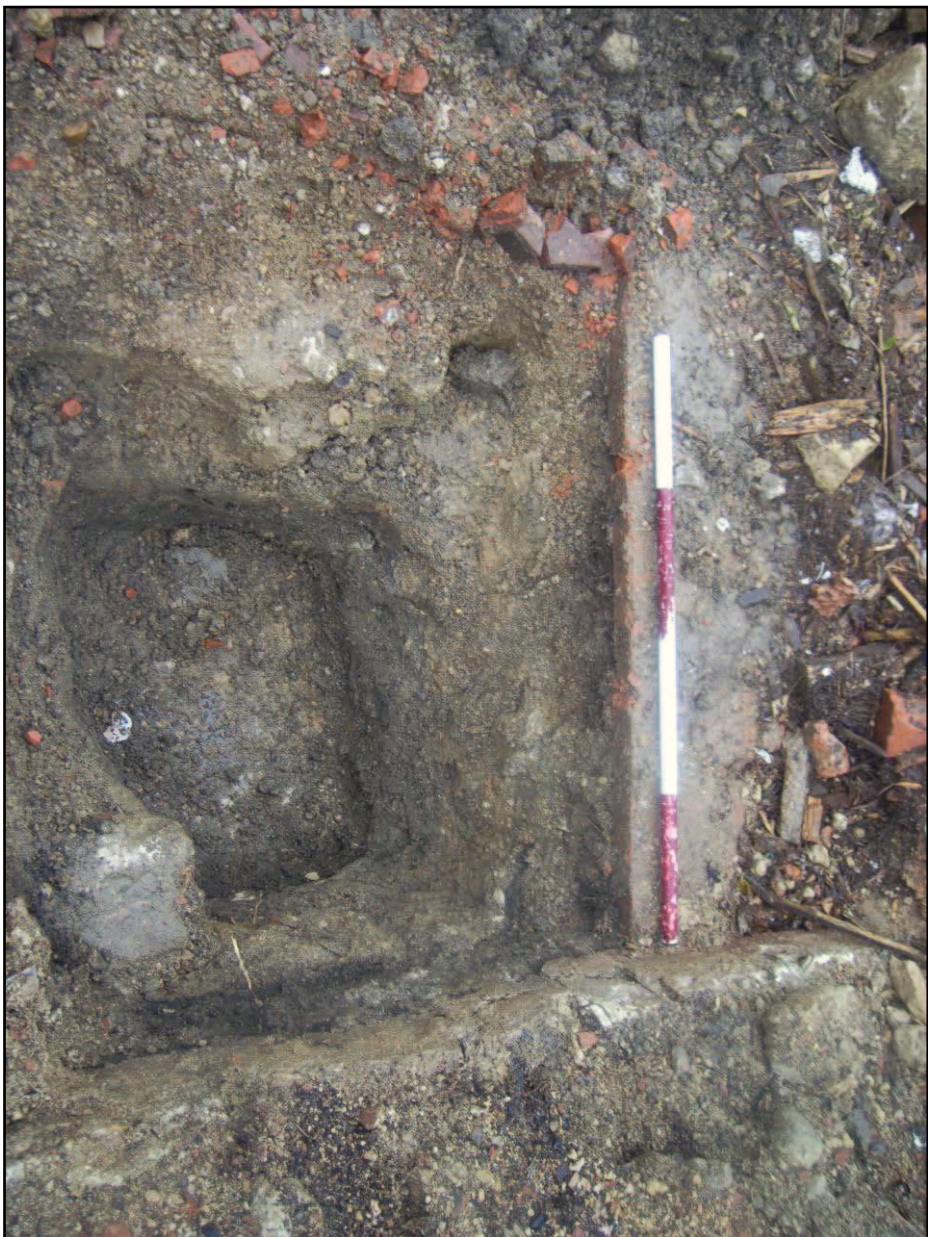
Plate 1 : Test pit 1

3.1.2 A stone floor composed of rounded limestone blocks (15) was encountered at a depth of 0.7 m below the current ground level (Fig. 3, Section 1, Fig. 4, Plate 1). This feature butted up to the limestone block constructed wall (16) and may be contemporary.

3.1.3 The floor was overlaid by a 0.35 m deep layer of grey-brown silt (14). This deposit produced fragments of stone and also fragments of pottery. Laid directly upon this layer was a second stone floor (13). This was constructed using blocks of limestone measuring approximately 0.3 m by 0.25 m by 0.2 m with only the top face levelled and the rest as quarried. The surface of the floor was very smooth and polished indicating a high degree of wear.

3.1.4 Overlying this floor was a layer of dark grey-brown clay silt (12) measuring between 0.07 m and 0.12 m in depth. this deposit formed a bed for the brick floor (11). This was constructed using frogless machine-made bricks measuring 0.225 m by 0.105 m by 0.072m laid using a simple overlapping pattern and no bonding material.

- 4.1.1 Exposed within this pit was the base of a limestone constructed wall (16) which had been used as the foundations for the brick walls of the demolished out building. The stone floor (15) exposed in the base of the pit is probably associated with this wall. No direct evidence for the date of construction of these features was observed during the course of the excavation, however Layer 14 which contained fragments of 18th and 19th century pottery lay directly over Floor 15. The absence of any intervening deposits containing earlier dating evidence may indicate that both the floor and the stone wall are post-medieval in date (possibly reusing stone recovered from the abbey buildings). The later stone floor (13), Layer 12 and the brick floor (11) are all 19th-century or later, and probably relate to the later industrial use of the site.

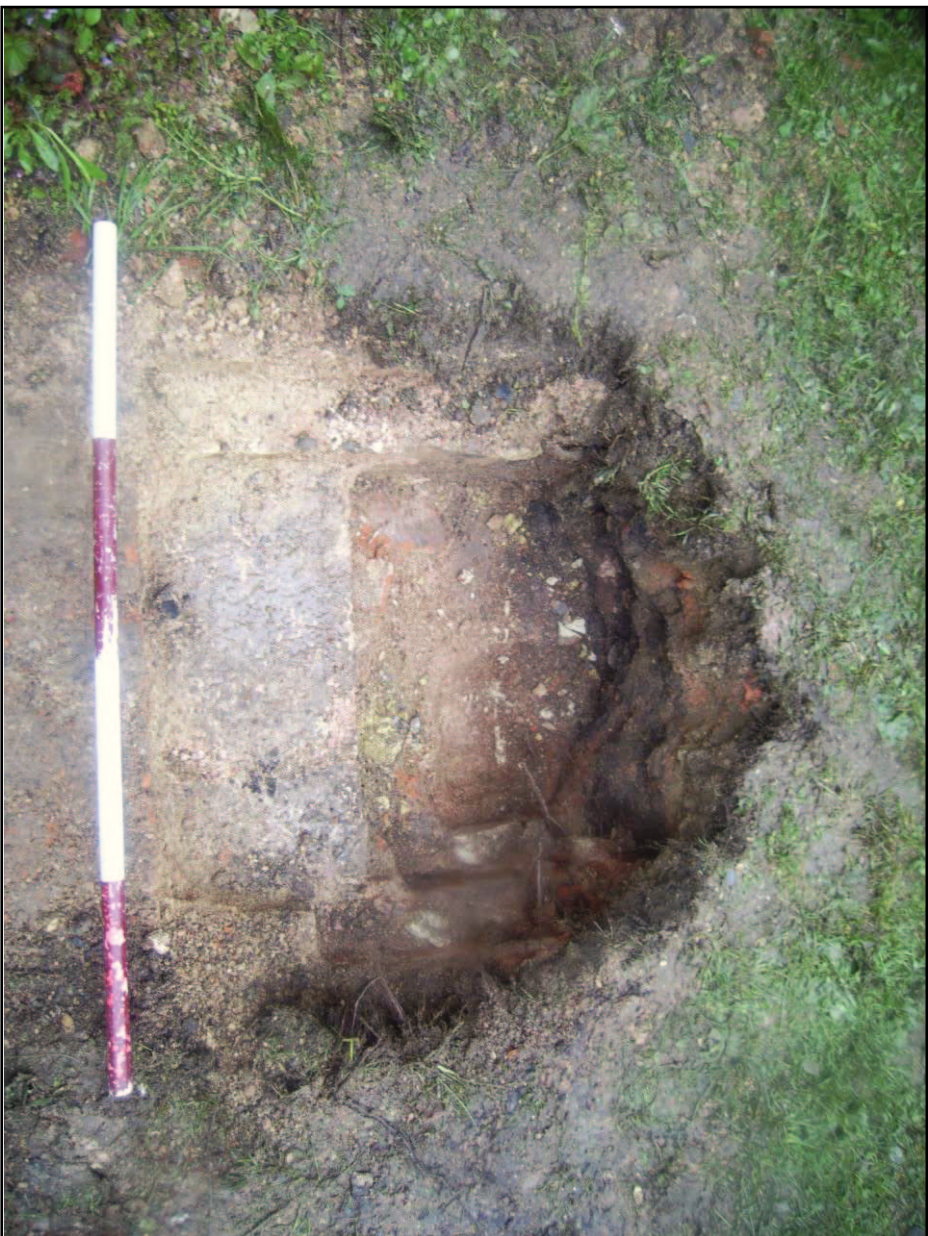
Plate 4 : Test pit 4

- 3.1.12 The top of a demolished south-east to north-west aligned wall (44) was encountered during the excavation of the test pit 0.1 m below the current ground level (Fig. 3, Section 4, Fig. 4, Plate 4). The alignment showed it to be a continuation of the west wall of the standing building and probably originally extending to meet the brick frontage added onto the northern wall of the medieval range. Butting up to the western side of this wall was a brick built foundation plinth (43). Built using machine made bricks laid using cement mortar excavation showed it to be 0.48 m wide and at least 6 courses of bricks deep. examination of the bricks when removed showed signs of heating and burning on some of the bricks.

- 3.1.13 Butting up against this feature was a layer of black gritty silt (42). This deposit appeared to have a clinker and ash content consistent with the evidence of burning, possibly suggesting a hearth.

- 3.1.14 Butting up to the western side of wall 44 was a layer of concrete 0.15 m deep (45), which was left in situ. Overlying concrete 45, walls 43 and 44 and layer 42 was a 0.1 m deep layer of grey-brown clay silt (41), an accumulation of leaf mould and flood deposits.

- 4.1.7 This pit was located on the projected alignment of the west wall of the standing medieval building, although no evidence for the continuation of the building was exposed. There is the probability that the building material, including the foundations, had been robbed out leaving no positive evidence. The construction of the 19th-century brick wall (44) on the same alignment would have disturbed or destroyed any evidence of a robber trench.
- 4.1.8 The brick-built structure (43) probably represents the base of a hearth or fireplace; its substantial construction would have allowed it to support the weight of a chimney stack. The presence of the clinker within deposit (42) would support this conclusion.

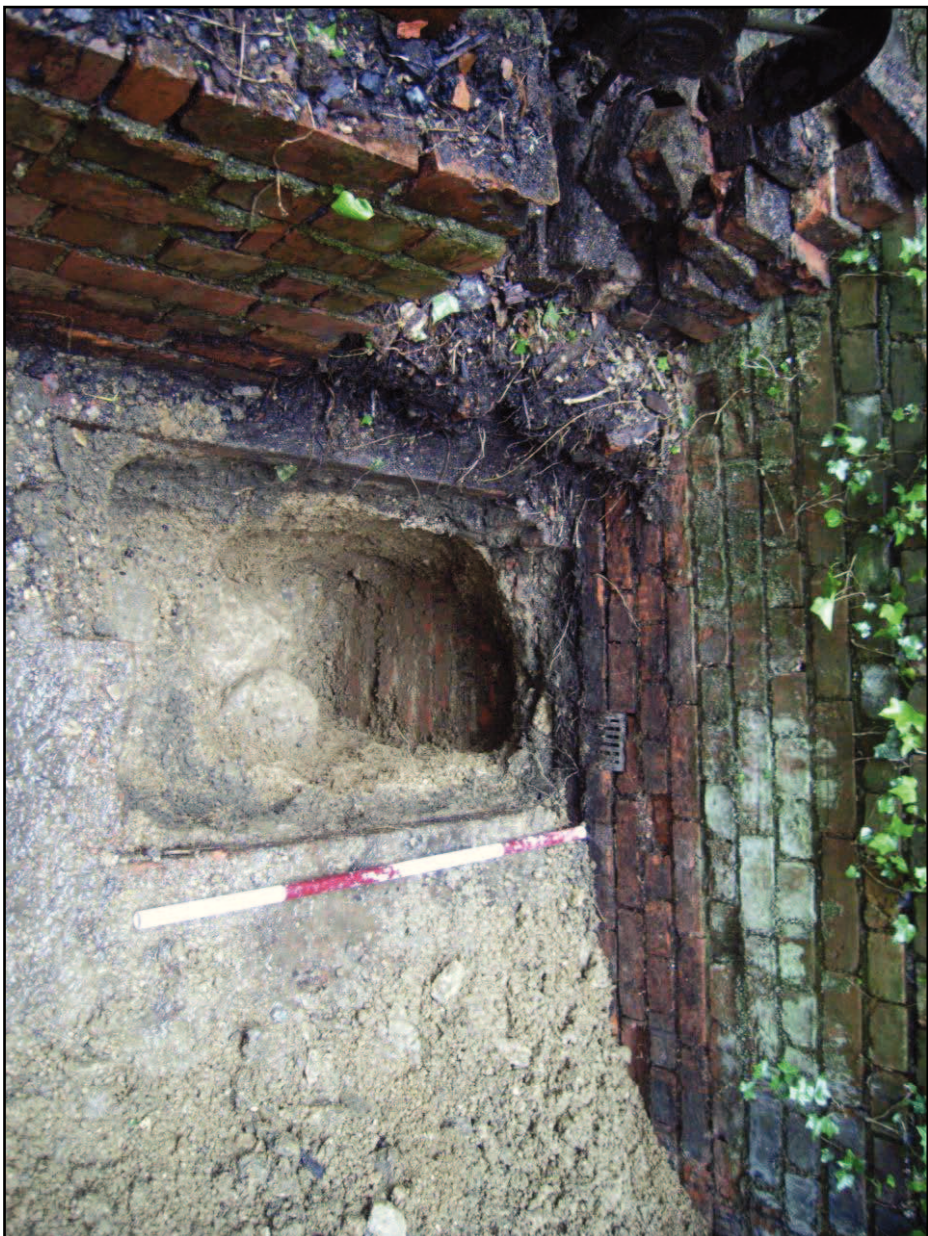
Plate 3 : Test pit 3

- 3.1.8 This was located against the inside of the eastern wall of the main mill building, on the opposite side of the wall to the mill race channel (Fig. 3, Section 3, Fig. 4, Plate 3)

- 3.1.9 The eastern wall of the mill building (37) formed the eastern edge of the pit. Butting up to this wall at a depth of 1.5 m below the original floor level of the mill was a layer of large limestone boulders (38). This was constructed using as-quarried rocks laid adjacent to each other with no bonding material. Overlying this was a 1.1 m deep layer of imported yellow oolitic gravel (36). This was overlaid by a 0.15 m deep layer of dark grey-brown clay silt (35). Lying directly upon this deposit was a bed of lime mortar forming a base for the brick floor (34), built using machine made bricks measuring 0.22 m by 0.105 m by 0.072 m.

- 3.1.10 Cutting the eastern edge of this floor was a foundation trench (33), 0.2 m wide and 0.22 m deep and running parallel to Wall 37. This was filled by a weak lime concrete (32) forming the foundations for Wall 31, a brick built wall 9 courses high and a single bricks length wide, butting up against Wall 37. This formed a ledge supporting a later inserted wooden floor. Butting up to Wall 31 and overlying Floor 34 was a layer of black leaf mould and demolition debris (39), between 0.3 m and 0.5 m in depth.

- 4.1.3 This Pit exposed details of the initial construction of the main 19th-century mill building, together with later alterations.
- 4.1.4 Neither the foundations or base of the eastern external wall (37) were observed. The layer of limestone boulders (38) butting up to this wall were probably placed as a drainage layer to enable rising ground/flood water to drain quickly from the inside of the building when the river was in spate. The layer of gravel (36) has been imported both to raise the internal level of the building above the water table and also to aid drainage of any water ingress. The brick floor (34) probably represents the original floor level of the mill.

- 4.1.5 The brick stub wall (32) and (33) is part of a later refitting of the mill with a raised suspended wooden floor being inserted into the building. This work seems to be contemporary with the insertion of the substantial brick machinery plinths (not illustrated) still to be seen in the main mill building and is probably late 19th or early 20th-century in date.
