Magdalen College, Oxford

Winter Common Room

Archaeological Watching Brief Report

3rd April 2019

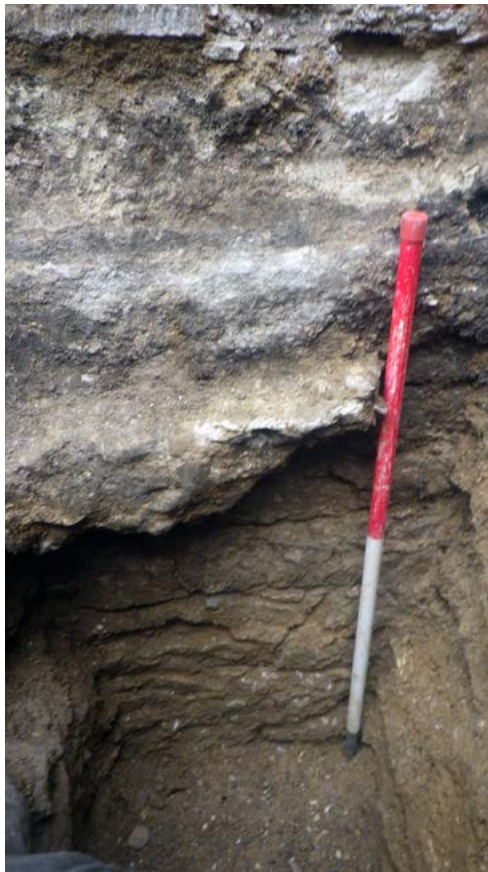
Plate 1: Wall 103, section 100. 1m scale

5.4.1 The earliest feature in TP1 was a medieval structure 103 which was at least 0.95m high with an upper-most height of 57.23m OD (400mm b.g.l). The structure, probably a former upstanding wall of which the eastern face was revealed, was built in roughly coarsed and worked rectangular, but relatively thin and small limestone blocks measuring on average 90 x 50 x 30mm in size and bonded with a yellowish brown sandy-silt mortar.

6.3.3 The limestone wall, 103, in TP1 has a distinctly different appearance to any other stone structure at the site. Its' use of thin limestone blocks is very reminiscent of 12th – 13th century structures excavated at Longwall Quad (OA, forthcoming), as well as many other Oxford sites (e.g Postmaster Hall, Merton Street). If medieval, it is very significant as it would probably represent a survival of internal structural fabric relating to the Infirmary of the Hospital of St John the Baptist. The wall/foundation, 6, observed in the WB in the Music Room Store (OA, 2009) is on a similar alignment and may represent the western side of the same structure as 103 but further to the north. It should also be borne in mind that the building above this foundation was originally constructed in the 17th century, and structure 100 may relate to this

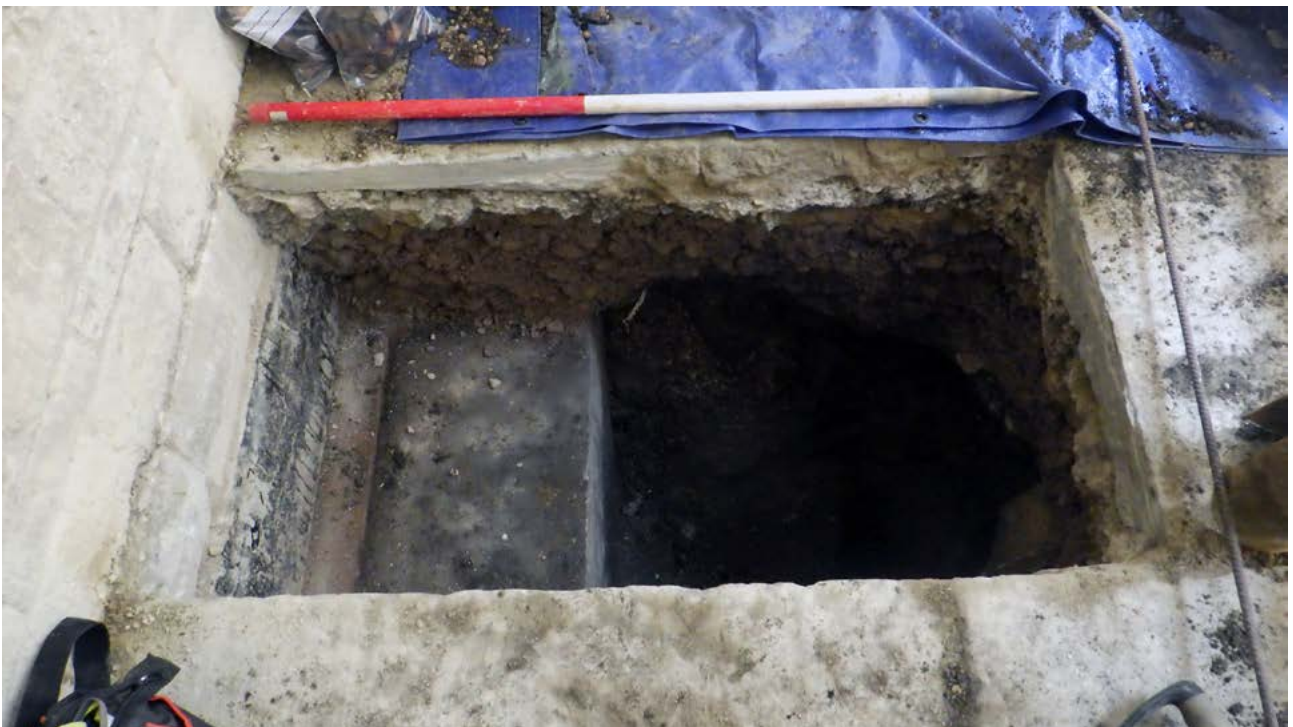
Plate 2: Section 200. 1m scale

5.5.1 TP2 was primarily taken up with a two-stepped offset concrete foundation 205 for the current wall 200 on the eastern side of the Maintenance Yard. The lower step at 56.57m OD was 0.58m wide and at least 0.40m deep whilst the upper step at 57.04m OD was 0.47m wide and 0.56m high. The construction cut 206 for these foundations was not exposed within the confines of the trench. The construction cut backfill 204 over the lower step was a mixed stone rubble deposit with frequent animal bones, charcoal and oyster shells and general rubbish including crisp packets dating to the mid 1980's.

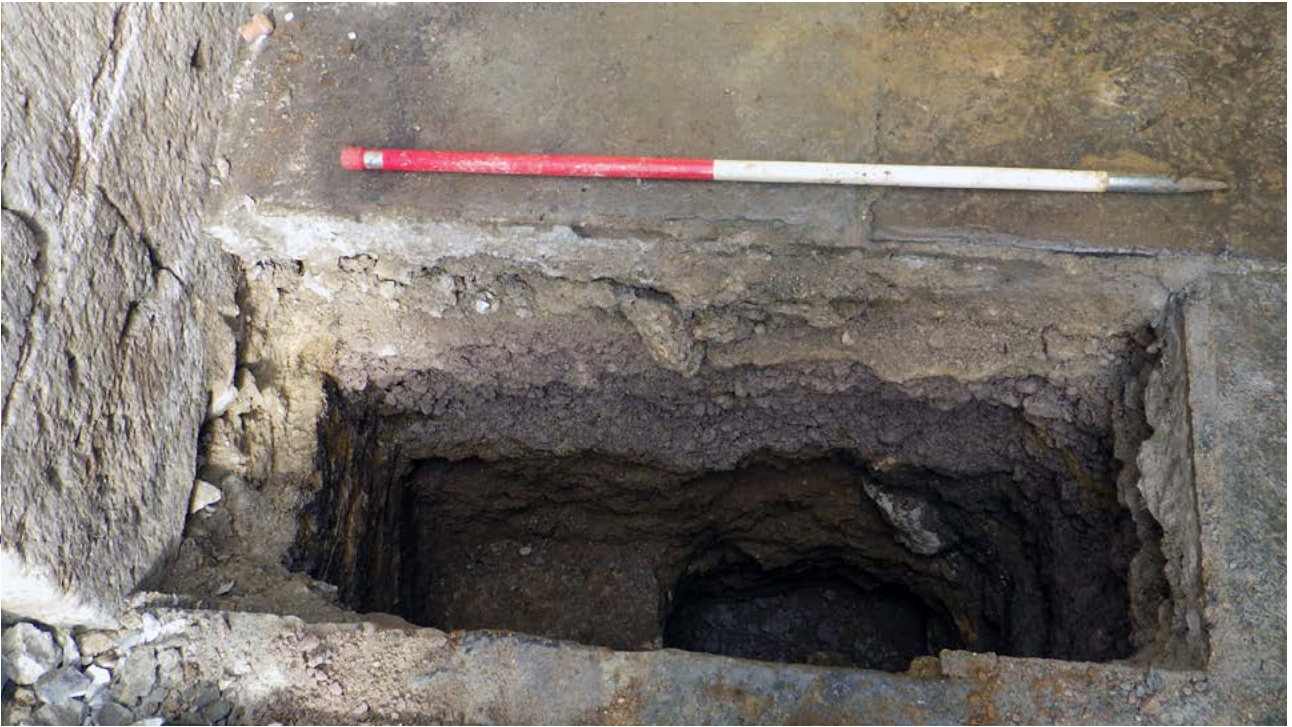
Plate 3: Section 300. 1m scale

5.6.3 Layer 306, was a dark brownish-grey clayey silt containing limestone pieces. It possibly abutted 307, or was cut by a 'trench-built' construction cut for 307 which was not visible. The upper horizon to 306 was equal to the top of foundation 307. Layer 305 overlay foundation 307 and deposit 306, and comprised a reddish brown coarse sandy silt with moderate limestone inclusions.

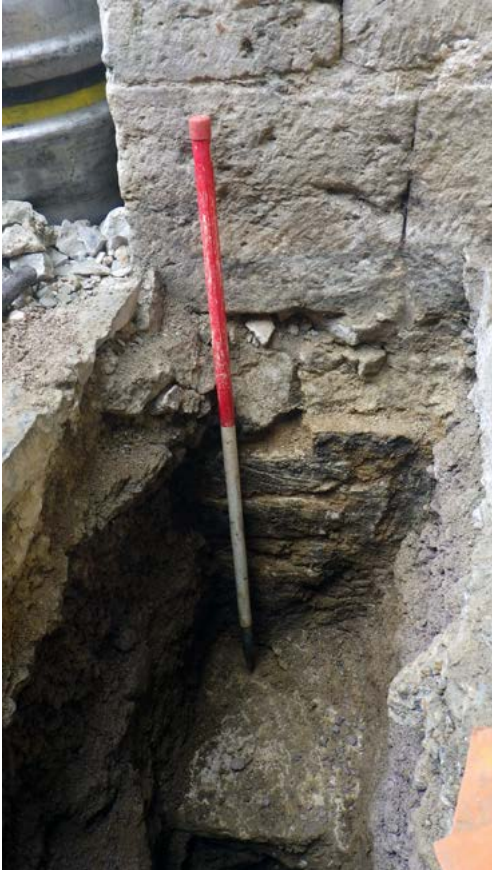
Plate 4: Wall 303. 1m scale

5.6.2 The earliest archaeology in TP3 was an off-set limestone foundation, 307, for overlying foundation, 308. Foundation 307 was recorded at 56.79m OD, and extended beyond the face of 308 by 0.45m. Three courses of well-shaped limestone blocks measuring 0.35m high were seen (but this probably extended below the base of the trial pit). Built upon 307 was 308 which was at least 0.55m high with an upper height of 57.49m OD, it was constructed in a similar way to 307 with its face almost directly aligned with the above elevation of the current buttress. Both elements to the buttress foundation were constructed of poorly coarsed hewn
