# St Ebbe's Church Drainage Works

## Oxford

### Archaeological Watching Brief Report

June 2020

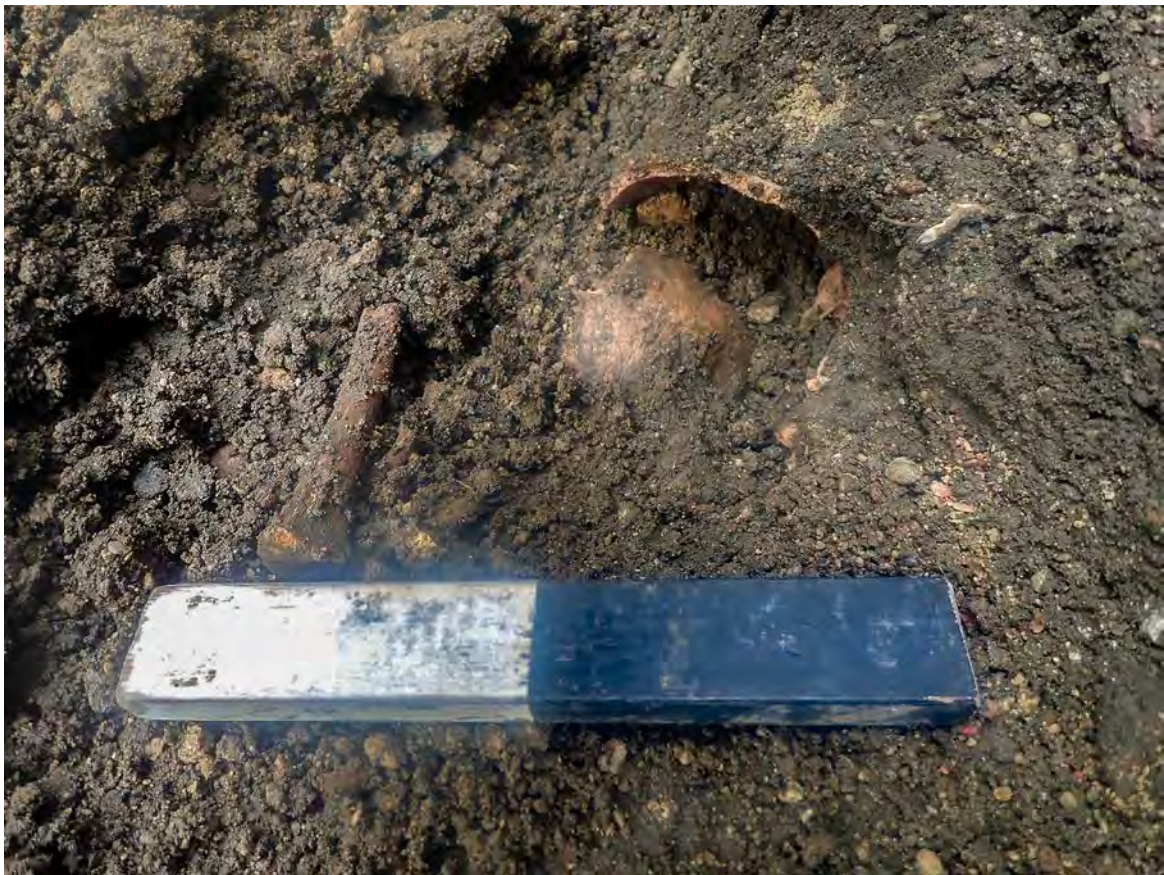
Plate 2: Human remains

- 3.1.3 The human remains (3) were located within the cemetery soil (5) and appeared to be disarticulated. This was a concentration consisting of a skull, part of a radius, vertebrae and small miscellaneous fragments. All remains were recorded *in situ* and reburied.

2.3.3 Where disarticulated human remains were seen they were left *in situ* and re-covered with soil. Discussions between the contractor and archaeologist ensured a revised path for the new drainage allowing for no further impact upon the human remains present.
