The Provost's Garden Wall, The Queen's College, Oxford

Historic Wall Recording

The Provost's Garden Wall, Queens Lane

Built Heritage Recording

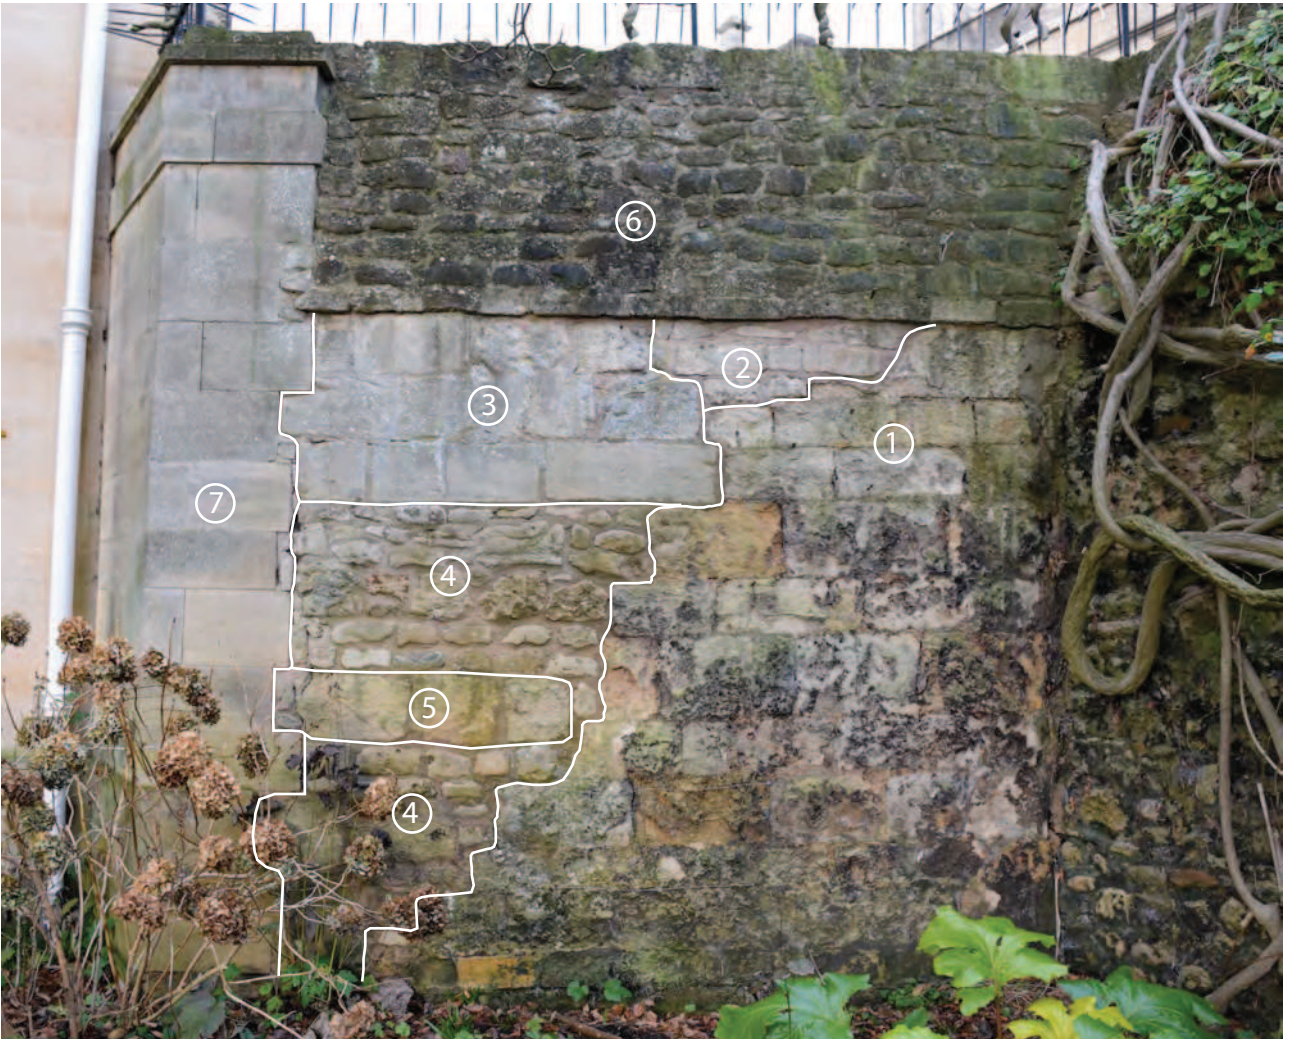
Figure 3: East face of wall showing phasing (see section 3 of text)

- 3.3.1 The east face of the wall comprises the following distinct sections (see Figures 3):
- 3.3.2 **[1]** this section appears to represent the main primary face of the wall probably constructed in the mid 18th century. It is formed from a relatively soft limestone (probably from the Headington quarries) and is heavily weathered in parts. The faces of many of the stones are blackened from pollution and in many areas are coming away from the main stone behind. The stonework is dressed and laid in regular courses with a soft lime mortar. The stone blocks are between 28 cm and 22 cm tall and although they vary in length they are generally c.40-60 cm long. The character of this section of wall is different to the main, adjacent east-to-west wall which fronts Queens Lane as it is formed from larger stones and at the junction between the two it appears that the south-westerly kinked wall abuts the main street-front wall. It may be that the wall originally continued right along Queens Lane and that the opening was created within it to allow access to the rear service yard.

- 3.3.3 **[2]** This is a small area of infill or patched repair formed from smaller stones than [1] and bonded with a relatively smooth salmon-coloured cement mortar. The larger stones measure c.30 cm by 10 cm while the smaller ones measure c.15 cm x 10 cm. This repair may be of the same date as other repairs (eg 4-5)

- 3.3.4 **[3]** This is a regular patch of coursed, dressed stone and although its character is quite different from the other areas of secondary repair (2, 4, 5) it is possible that it is from the same phase as them. It appears to use the same smooth cement mortar as the other areas of re-facing. The stones are large measuring from 23 by c.60 cm to c.30 x 23 cm.

- 3.3.5 **[4]** This context has two sections with each one formed from relatively small stones grouped together to form sections of similar stones. This context is partially coursed and it appears to be formed from stones similar to the sloped cap [6].

- 3.3.6 **[5]** This context is within [4] and is probably contemporary with it but it is formed from much larger stones with a different character. There are three stone blocks in this context measuring c. 25 cm tall by c.25-36 cm wide. It is possible that the blocks could be reused stones from the primary wall [1] but the coursing is different to that of the primary wall.

- 3.3.7 **[6]** The top of the wall is formed from a shallow sloping cap of roughly coursed and roughly squared stone. The character of the stone varies in different areas and there is likely to be areas of repair or rebuilding but the nature of the stonework means that it is difficult to identify these with certainty.

- 3.3.8 **[7]** Regular ashlar stonework constructed in c.1958-60 when the adjacent Provost's Lodging was added. This wall would have been constructed to cap the truncated section of NE-SW wall when it was shortened.
