Cannop Foundry  
Cinderford  
Gloucestershire

**Historic Building Survey**

**Document Title:** Cannop Foundry, Cinderford, Gloucestershire : Level II Building Recording

# Cannop Foundry, Valley Road, Cinderford, Gloucestershire

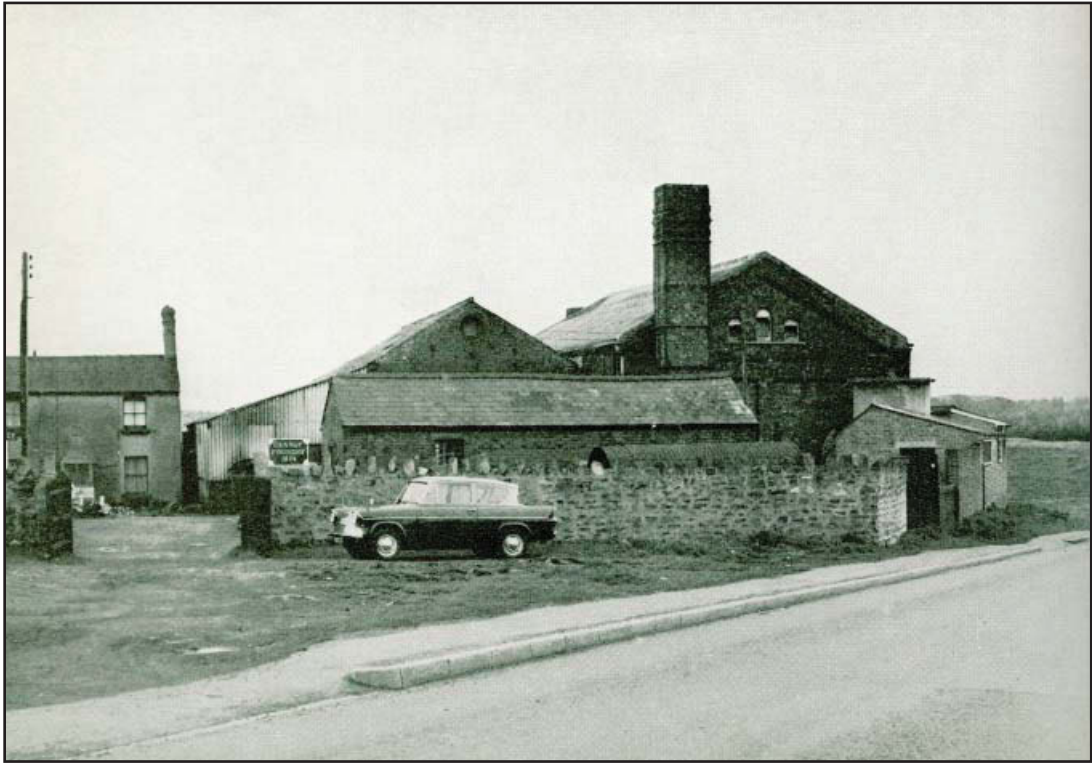
Plate 1: Cannop Foundry c. 1960

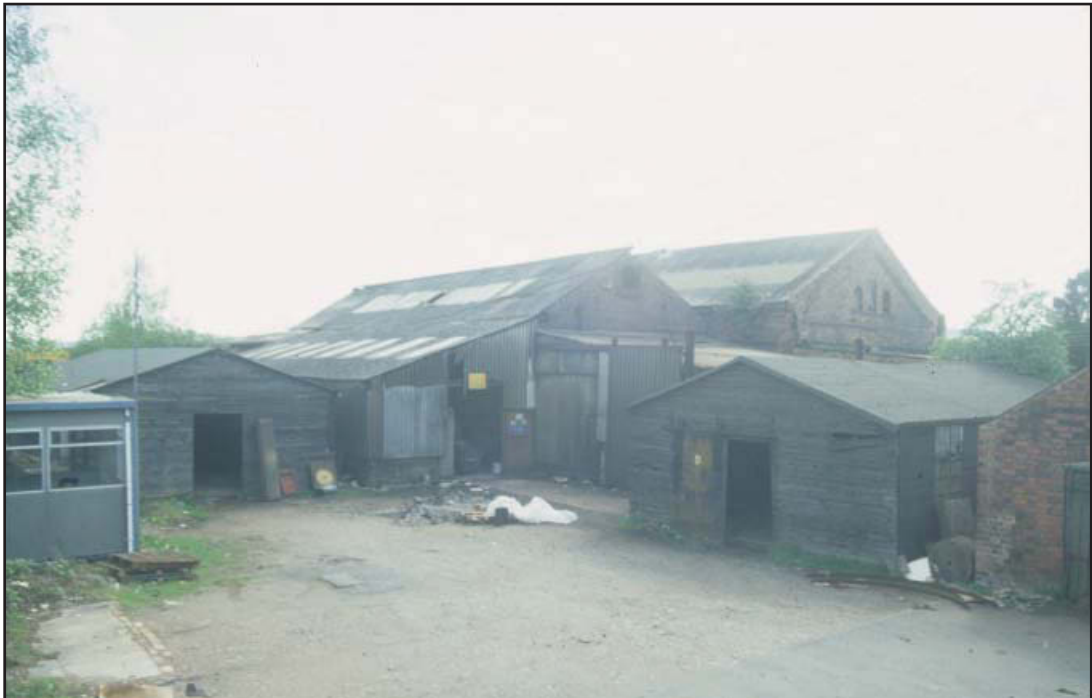
Plate 2: North end of foundry, showing buildings 1, 3, 5, 6 and 7

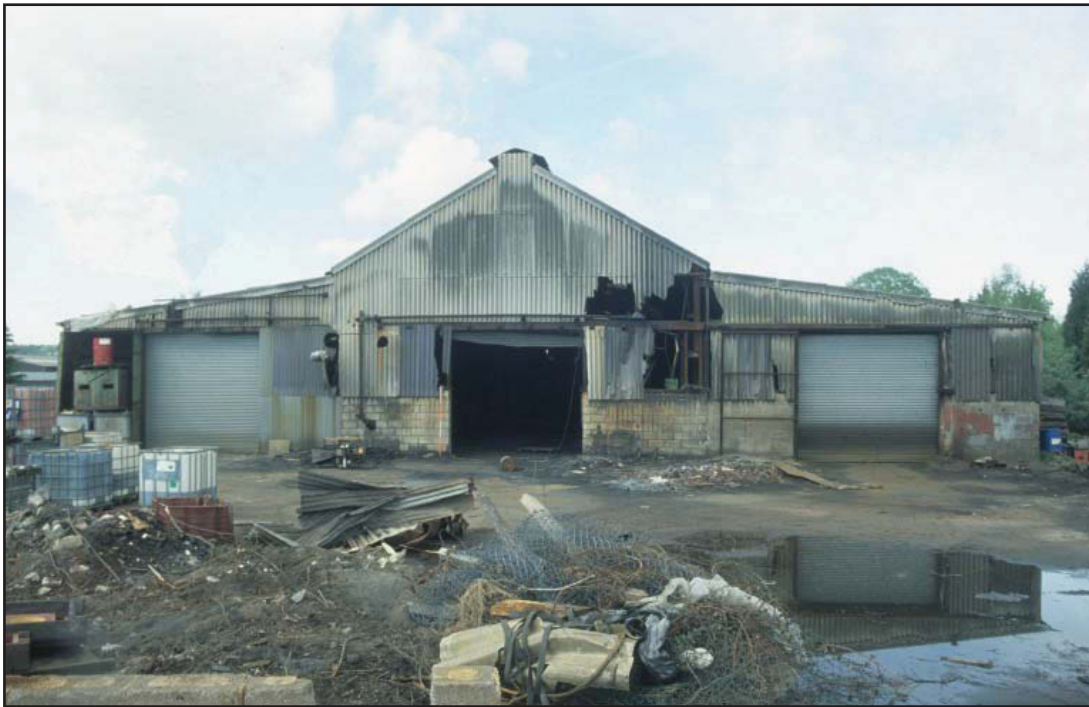
Plate 3: South end of foundry, showing extension 3, 4 and 5

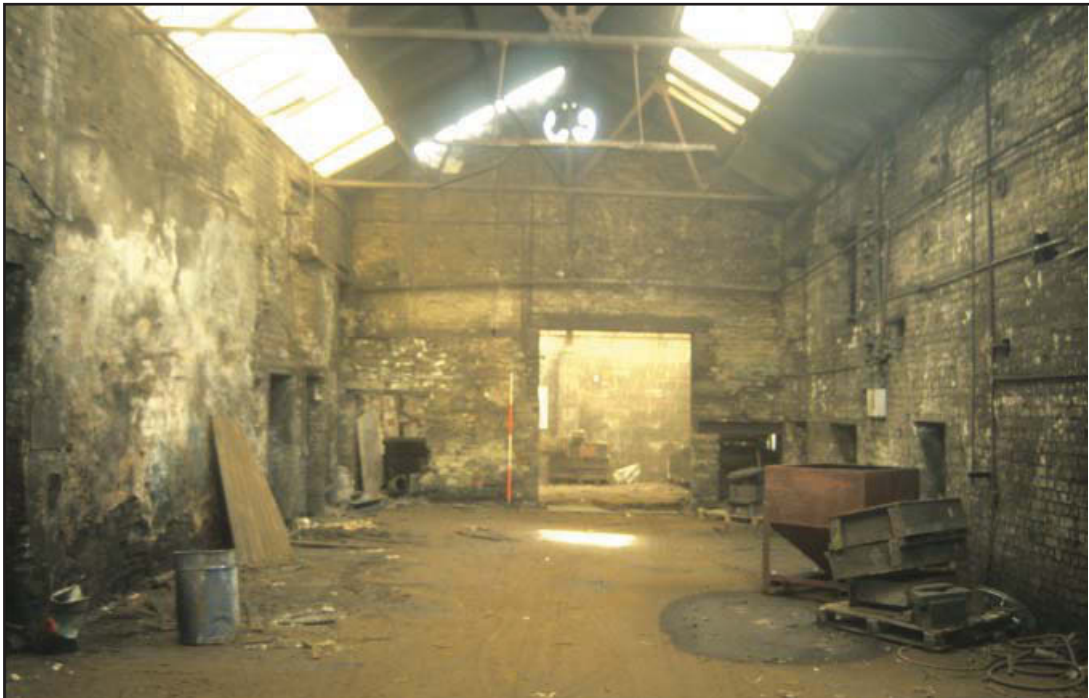
**Description:** Long rectangular building with extensions 1, 2 and 3 attached to the north, east and south faces respectively. The bottom 3 m height of the west wall and the south and north gables was constructed using roughly coursed squared sandstone blocks bonded with lime mortar. The eastern wall and the remaining height of the west wall and the gable ends were constructed in brick using English stretcher bond and lime mortar, the bricks measuring 0.236 m x 0.115 m x 0.086 m. The eastern brick wall has 3 original window openings and 2 doorways still visible on the ground floor, while the west wall has 3 small doorways and a larger doorway visible within the stonework. Both the west and east wall had small square windows visible in the upper half of the walls.

The current roof is constructed using steel framing supporting corrugated asbestos sheeting suggesting that the building may have been reroofed during the lifetime. The floor within the building is composed of concrete and is clear and level. There is a large inserted doorway in the north gable leading Extension 1 and a second inserted doorway in the south gable leading into Extension 3.

Plate 4: Building 6, interior

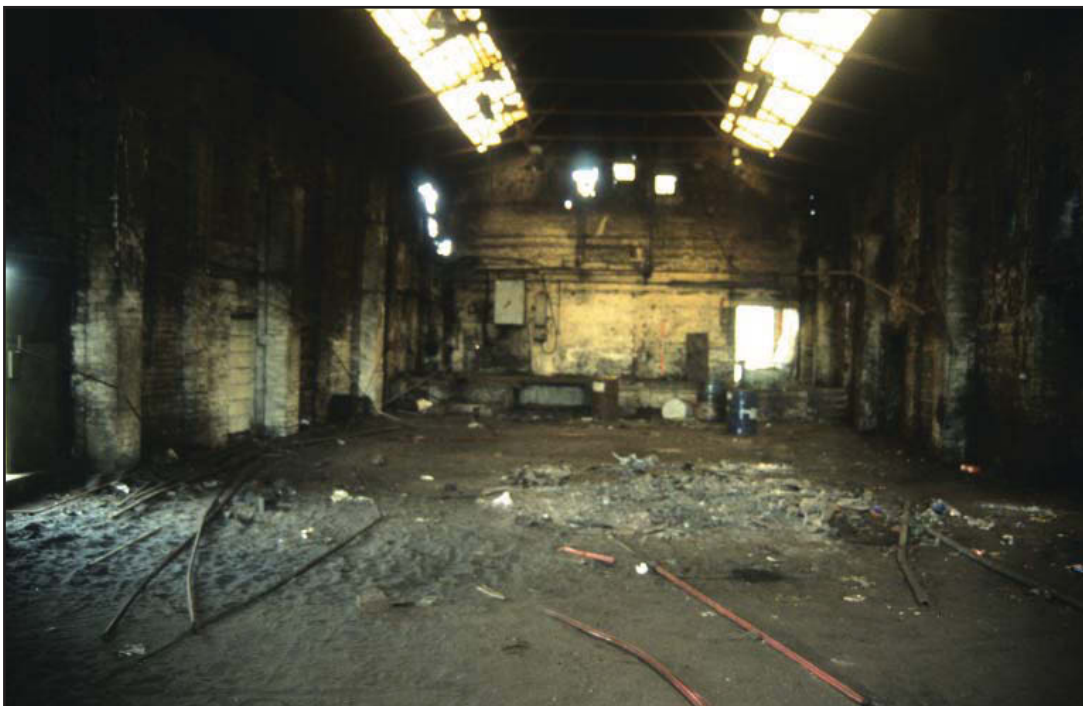
**Description:** Long rectangular building built adjacent to the western side of Building 6 (leaving an approximate 1 m gap between the 2 buildings). The walls were divided into 4 bays and were constructed of plain red brick measuring 0.237 m x 0.113 m x 0.076 m laid in English stretcher bond. Later work has inserted extra brick piers/buttresses in the centre of each bay which run from floor to the eaves. The end gables were also constructed using plain red brick laid in English stretcher bond, but with blue engineering brick embellishment including parapets along the top edge of the gable. The ground floor of the building was constructed using concrete with a raised platform built along the northern end of the building. The base of the walls contain two large doorways located towards the southern end of the building and 2 smaller doorways located towards the northern end. The southern gable wall has been severely rebuilt leaving a large opening, almost the width of the building, leading into Extension 4 while the northern gable has had a small doorway inserted into the north-east corner leading into Extension 7. Within the upper part of the west and east walls a total of 20 round topped windows each side (5 to each bay) are visible, although all windows had been bricked up at the time of recording (although the blocking appears to have happened during the lifetime of the foundry rather than recently suggested by the fact that the later inserted brick piers run over the central window in each bay.). The doorways in the eastern wall of the building correspond with those in the western wall of Building 6. The gap between the two buildings has been blocked either side, and above, these doorways leaving 1.5 m long passageways running between the buildings.

The roof is constructed using angle iron trusses and ties covered with corrugated asbestos sheeting. The roof profile continues into Extension 4 suggesting that the building had been reroofed during the construction of Extension 4.

During the removal of the internal metal fittings of the foundry for scrap the north-west corner of this building had been damaged leaving the top of the wall leaning outwards and a large crack in the face of the gable.

Plate 5: Building 7, interior

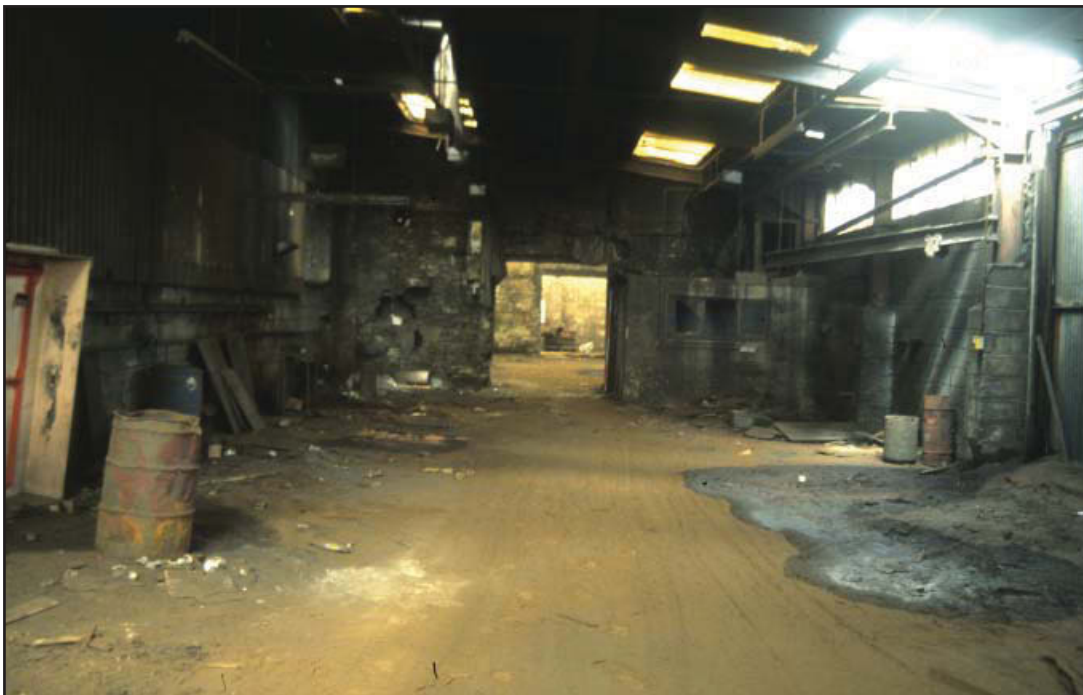
**Description:** A modern steel framed building butting up to the southern gable of Building 6 and constructed onto the side of Extension 4. The walls are constructed using concrete breeze blocks and the roof is a single pitch constructed of asbestos sheeting over steel bracing. The floor of the building is concrete. Constructed within the north-eastern corner of the extension is a single storey wooden framed room 3 m x 3 m. This has a single door in its western side and windows in its southern side overlooking the interior of extension. A large opening has been inserted into the south gable of Building 6 to allow access with fork lift trucks, while in the southern end of the extension a roller door has been fitted.

**Significance:** The presence of large amounts of grinding debris and notices regarding the safety of grinding wheels suggest that this extension was used as a “fettling” floor, ie, for removal of the castings from the moulds and “fettling” (cleaning the casting sprue, flash and any remaining sand from the castings) the finished castings.

Plate 6: Extension 3, interior

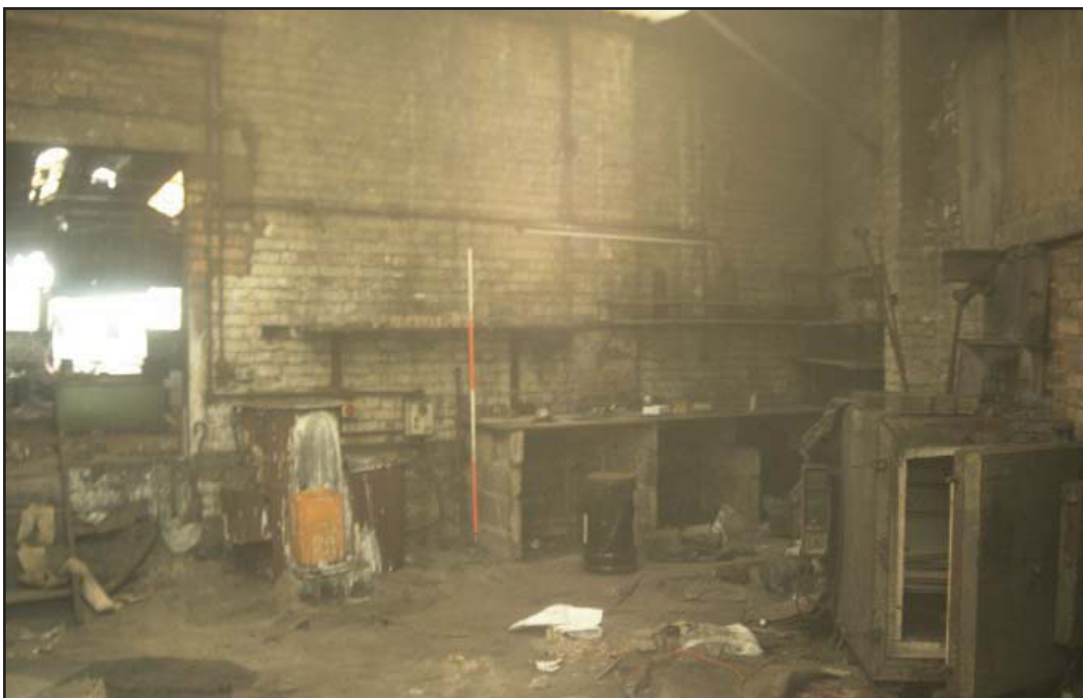
**Description:** An irregularly shaped single storey structure butting up to the northern gable of Building 7. The east and west walls are a single brick skin of plain red bricks measuring 0.218 m x 103 m x 65 m, laid using flemish bond and lime mortar. The north wall is almost wholly taken up with a pair of large doors constructed using corrugated iron over a steel frame. The roof is single pitched and uses a mixture of corrugated asbestos sheeting and clear plastic.

The interior of the structure is a single level of concrete floor with a set of steps leading up to a doorway in the south-east corner of the extension which leads onto the raised platform at the northern end of Building 7. There are a series of benches built up against the north wall of Building 7 together with a large mixer which may have been used for mixing moulding sand. The presence of a storage area for CO<sub>2</sub> bottles (used to fix the moulding sand) suggests that this area may have been used for the preparation of sand moulds.

Plate 7: Interior of extension 7, showing moulding benches

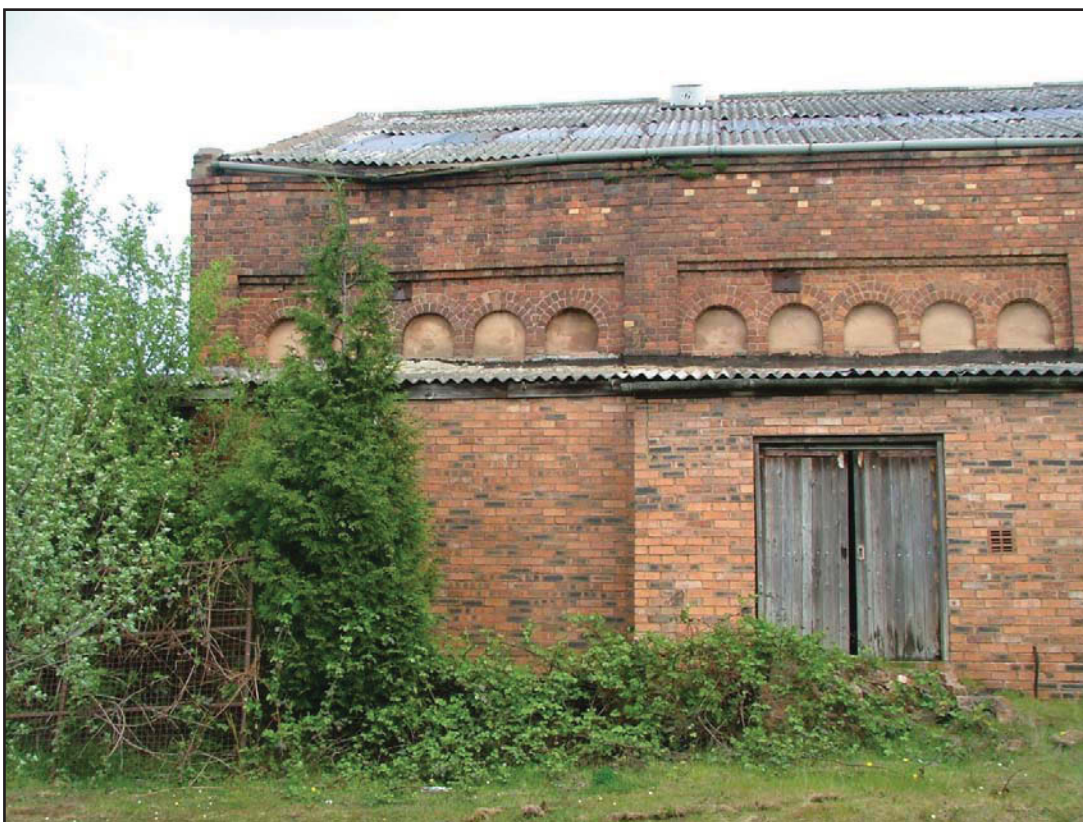
**Significance:** This building probably dates from the original use of the site as a gasworks, the presence of the row of windows along the tops of the walls may have been to allow the heat and gases from the banks of ovens to pass out. The desk based assessment showed that this building was constructed as a Retort House in 1911.

Plate 8: North-western end of building 7, showing round topped windows
