Clapham Park Regeneration Lambeth London

Archaeological Evaluation Report

October 2007

Client: Clapham Park Homes

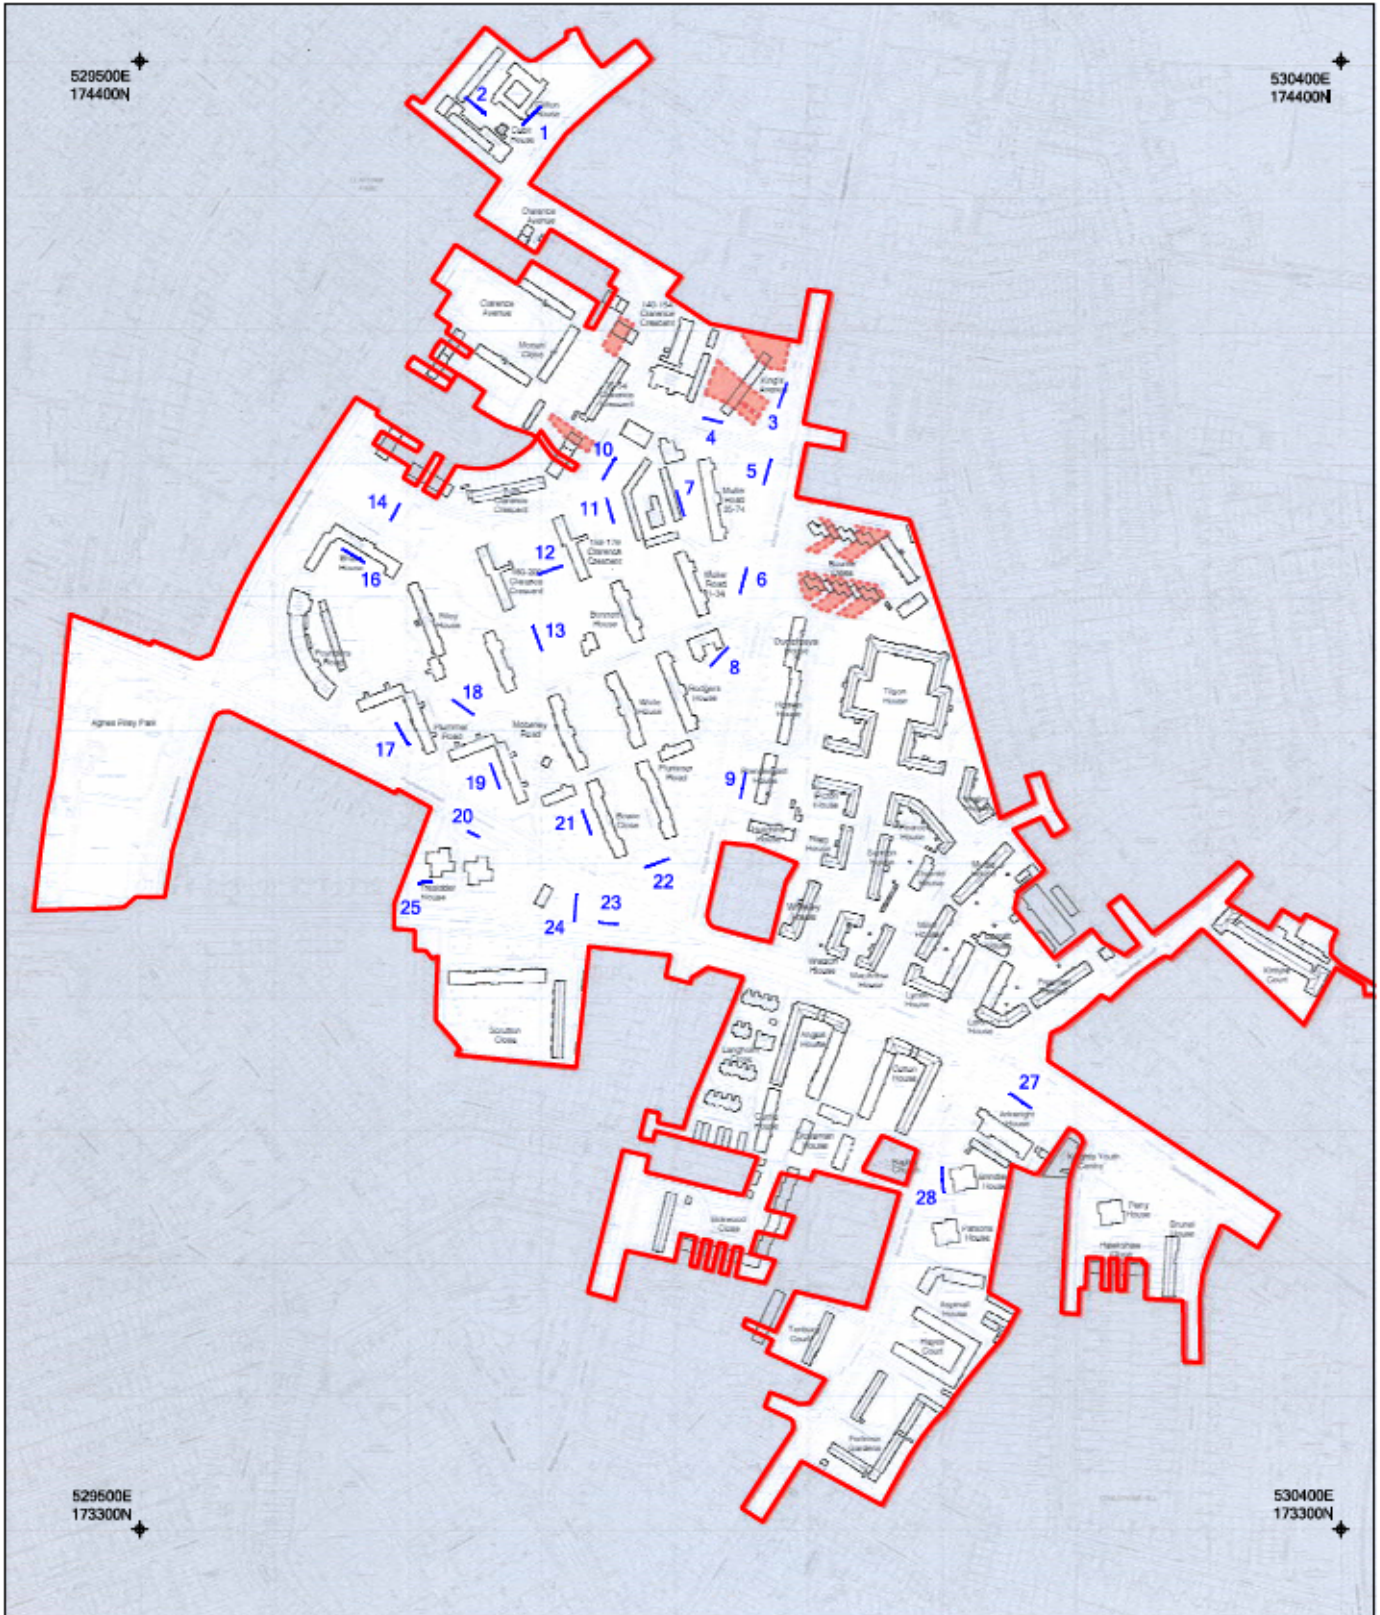
CAK 07 Clapham Park Regeneration	
Drawing No.	CA1
Date printed	07 Sep 2007
Drawing title	Figure 2: Trench location plan

- 3.1.1 The evaluation consisted of 26 trenches measuring *c* 20 m x 1.8 m. Originally 29 trenches were proposed, but due to access problems three trenches were abandoned (Trenches 15, 26 and 29); some trenches were also shortened (Fig. 2). The overburden was removed under close archaeological supervision by a 360° mechanical excavator fitted with a toothless bucket. Excavation ceased at the top of the highest archaeological horizon or the level of the natural geology, whichever was reached first.

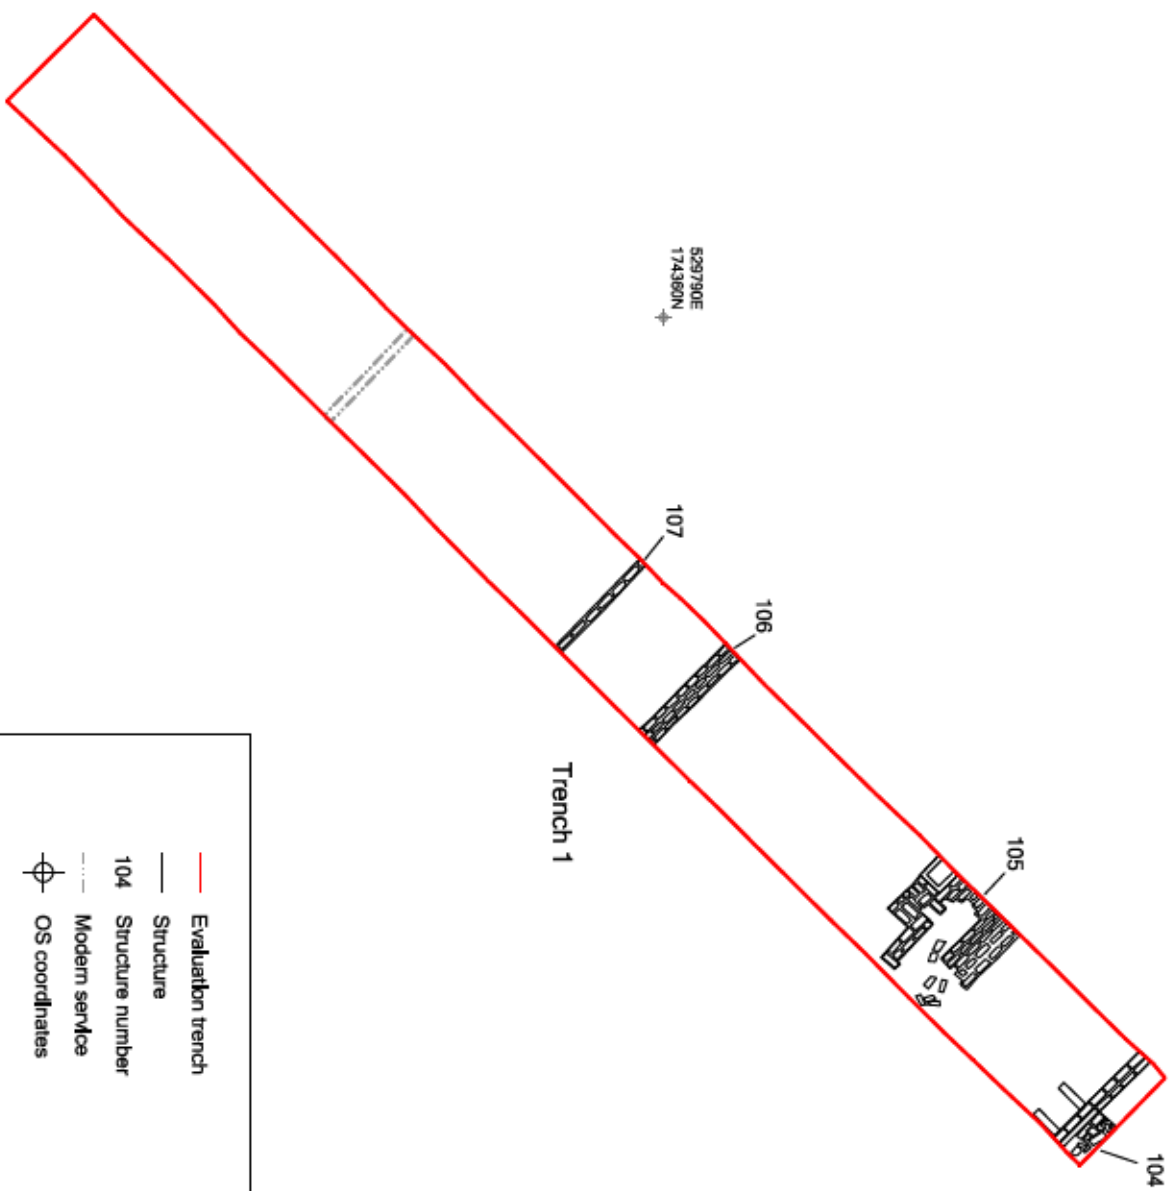
CAK 07	
Clapham Park Regeneration	
Drawing No.	CA1
Date printed	07 Sep 2007
Drawing title	Figure 3: Trench 1

- 5.1.1 Trench 1 was aligned NE-SW and natural clay was revealed c 1 m below ground level (BGL). A brick-built cellar structure was revealed measuring over 8 m wide and c 1.5 m deep. The cellar was constructed from walls (104 and 106) measuring 0.35 m wide and constructed from 19th-century yellow stock bricks, laid in an English Bond and each measuring 230 mm x 100 mm x 70 mm. The interior face of wall 104, to the north, was rendered with green plaster and cast iron bars were set into the wall. Traces of yellow plaster were evident on wall 106. In the centre of the cellar was the base of a brick chimney, measuring 1.5 m wide. A cast iron oven was set into the chimney base (Plate 1), and ceramic tiles were also evident. Wall 107 was located to the south of wall 106 and measured 0.2 m wide and 0.7 m deep. It was overlain by a concrete surface, which also abutted wall 106.

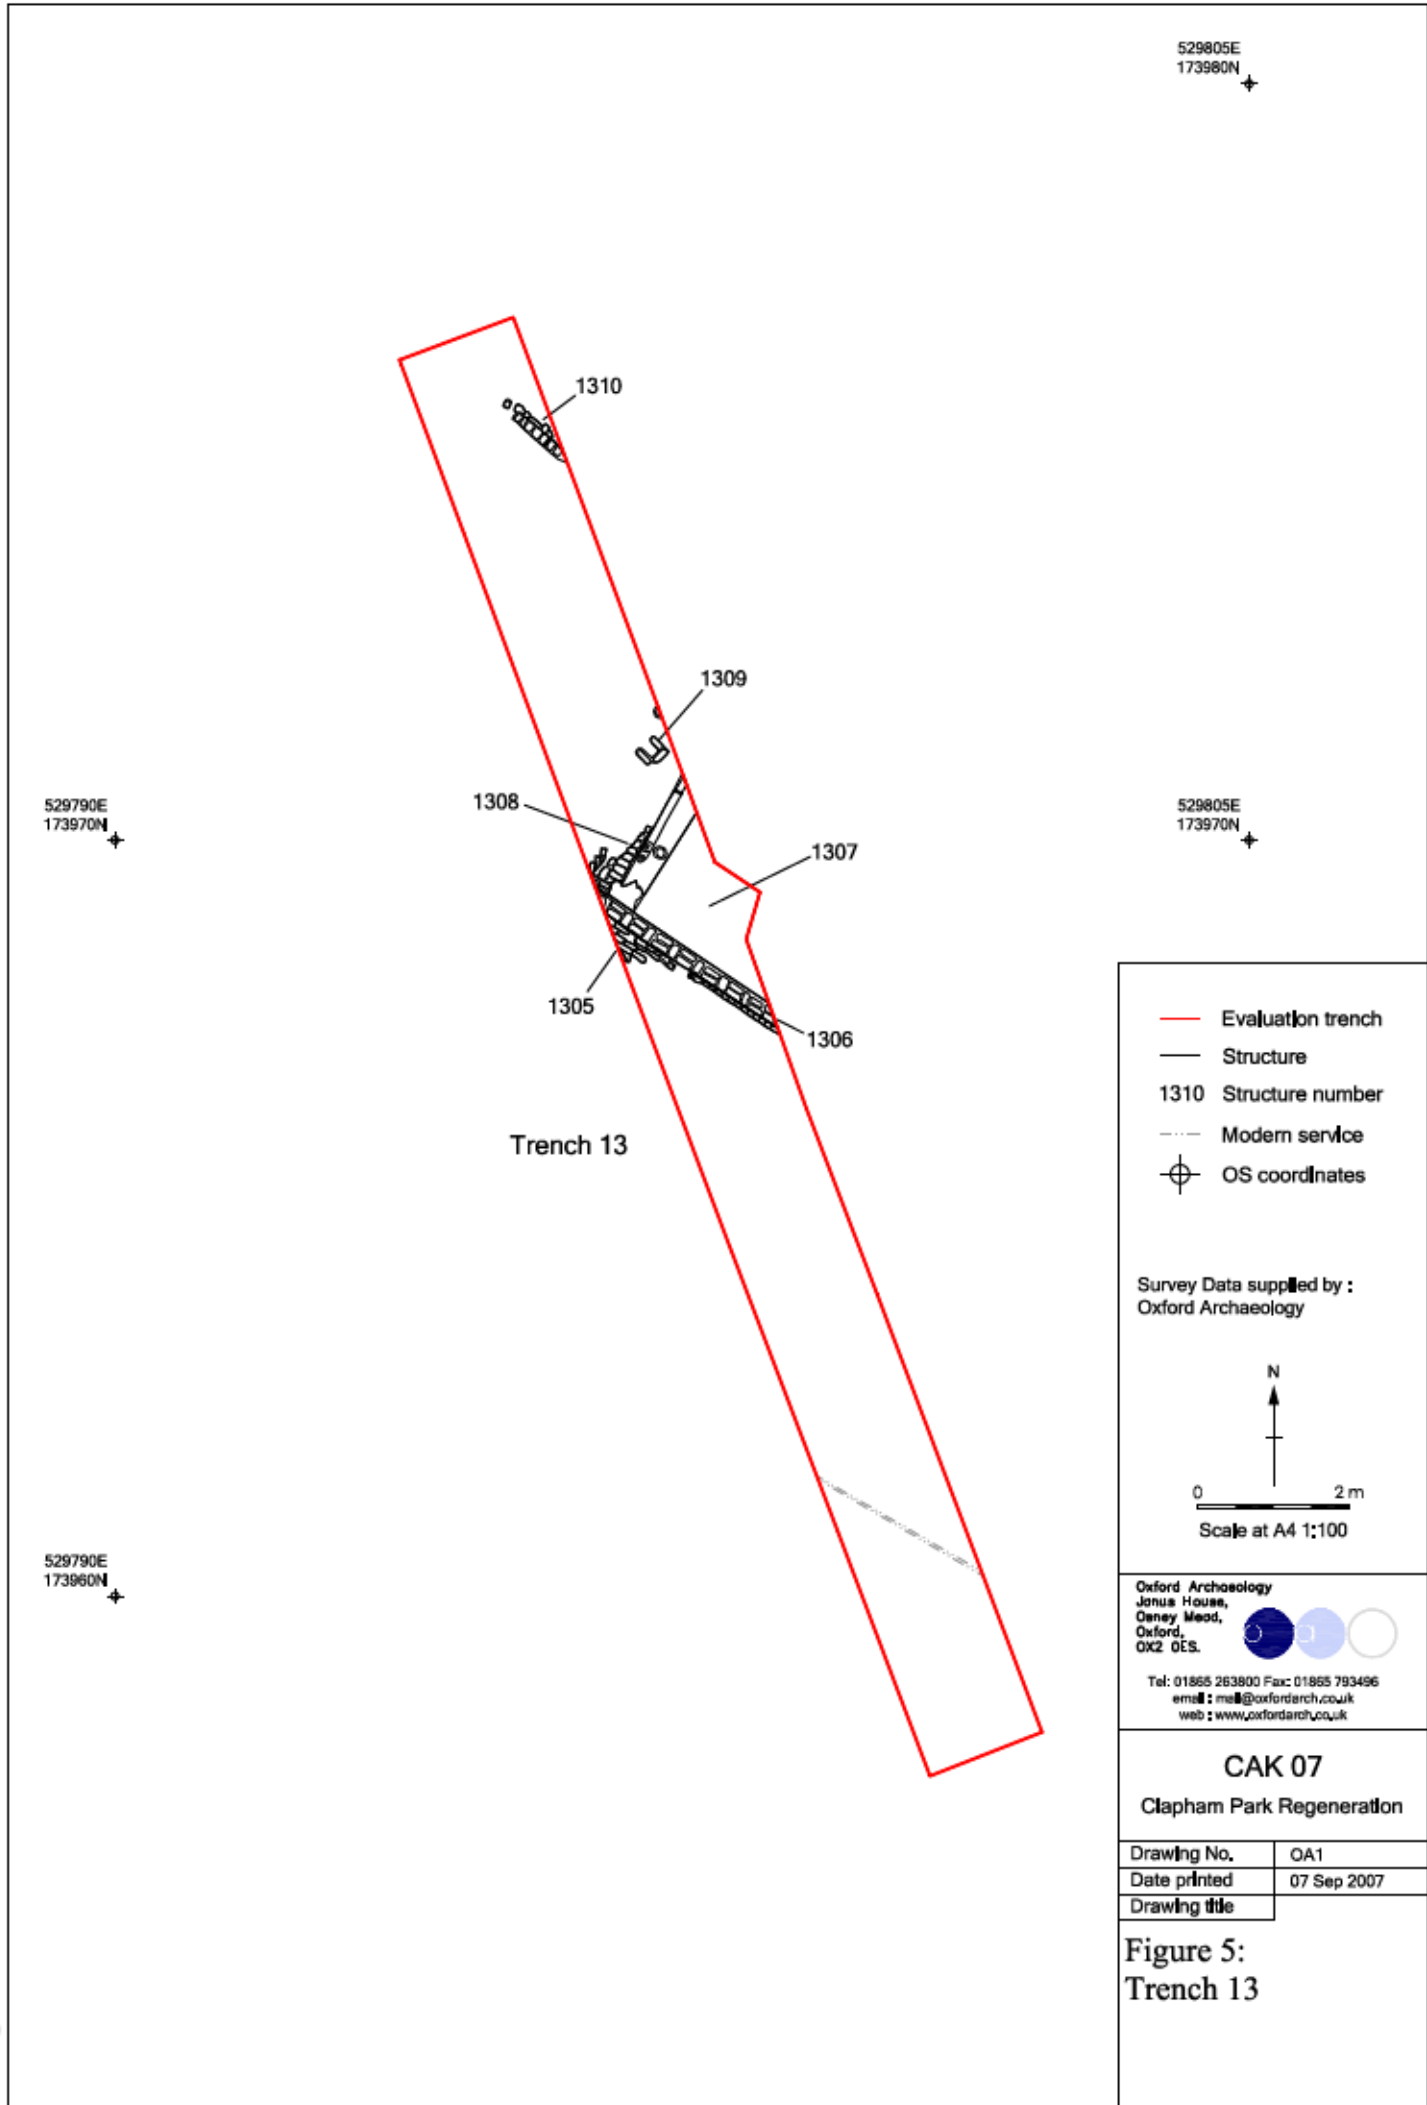
Figure 5:
Trench 13

- 5.1.4 Natural geology was revealed 0.8 m BGL and was cut by the foundations for a 19th-century structure with a sunken room. Two NW-SE aligned parallel walls (1306 and 1310) were revealed. They were 0.25 m wide and 0.3 m high and constructed from yellow stock bricks measuring 230 mm x 100 mm x 70 mm. A similarly constructed NE-SW aligned wall (1308) abutted the northern side of wall 1305 and was abutted by an iron gas pipe. A concrete surface (1307) abutted walls 1306 and 1308, and a fragment of a glass ink bottle was recovered from the deposit.

- 5.1.5 A surface (1305) constructed from bricks measuring 150 mm x 100 mm x 45 mm was revealed to the south of wall 1306 and was revealed 0.3 m BGL. This may have formed part of a ground floor room or external pathway. A brick-built soakaway (1309) measuring 0.4 m wide was revealed to the north of wall 1308. The deposits were overlain by a demolition dump (1303 - not illustrated) that contained several late 19th-century or early 20th-century glass bottles and pottery sherds.

6.2.2 The structural remains seen in Trench 13 formed part of a group of outbuildings within the grounds of Clarence House, the remains of which were identified in Trench 16. The curved brick surface revealed in Trench 22 may form part of an oval path seen on the 1875 OS plan, to the rear of the most easterly property fronting Queen's Road (Fig. 14).

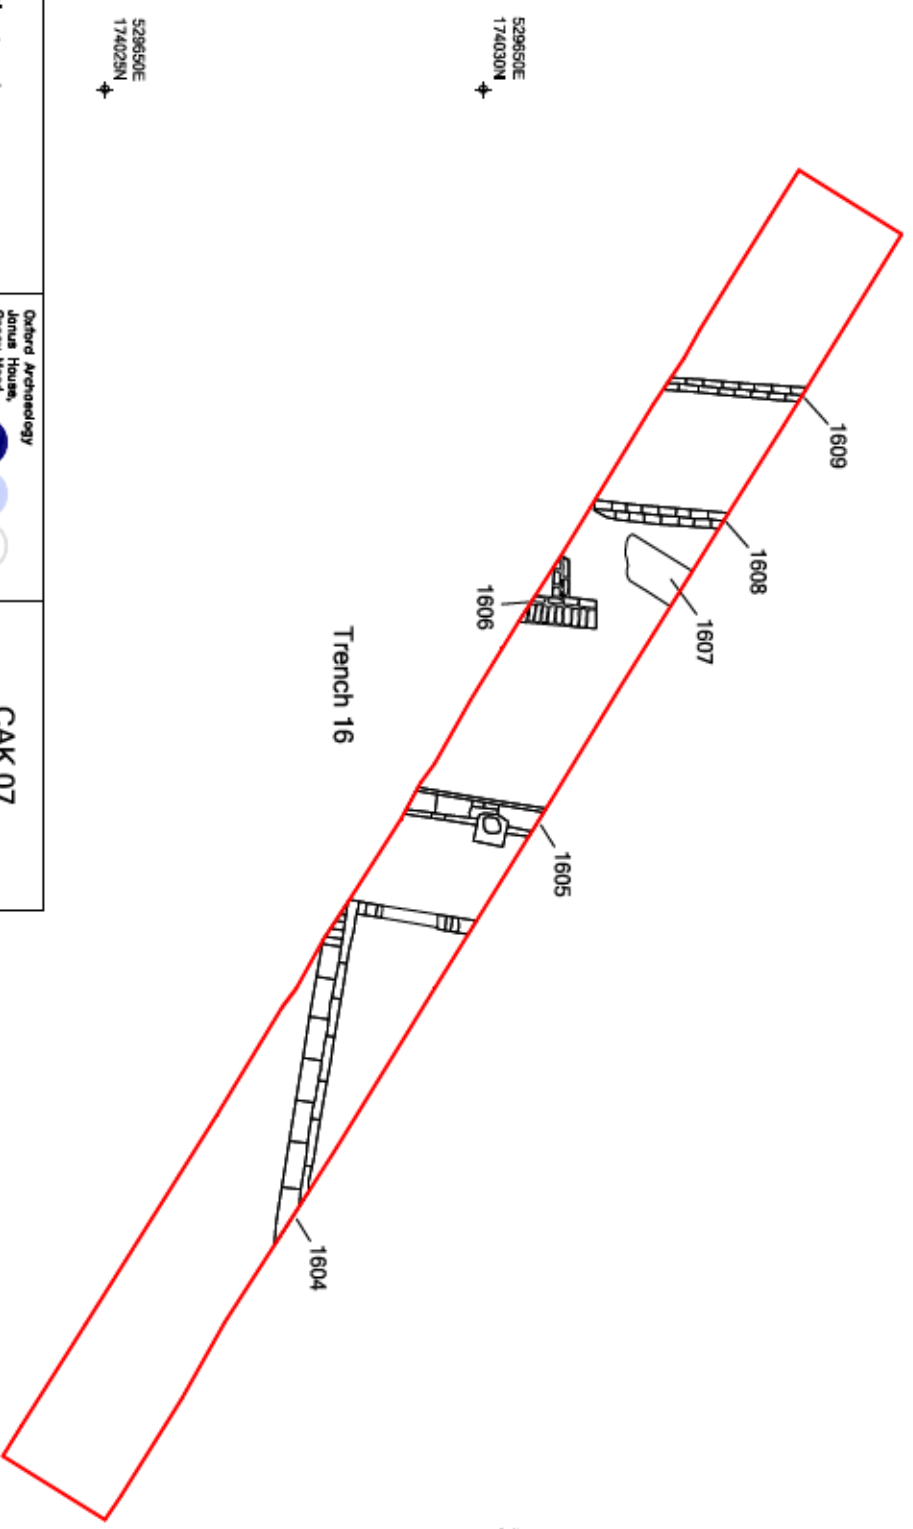
Figure 6:
Trench 16

- 5.1.6 Natural geology was revealed 0.8 m BGL and was cut by the foundations for a sunken room or cellar, constructed from 19th-century yellow stock bricks. The SE corner of a room (1604) was revealed in the east of the trench. The walls were 0.2 m high and 0.25 m wide and the internal faces were lined with slate tiles, measuring 520 mm x 250 mm x 3 mm.

- 5.1.7 A similarly constructed wall (1605) was revealed to the west of 1604. This was 0.45 m wide and 0.3 m high and also slate lined. It had a ceramic drain set into it and may have formed an internal wall of the cellar.

- 5.1.8 To the west of wall 1605 were N-S aligned walls 1606 and 1608, they were of similar construction to 1605 but not slate lined. The walls were 0.25 m to 0.45 m wide and 0.3 m deep. Wall 1608 was overlain by a green mortar surface that was overlain by a large sandstone block (1607); the block may have formed part of a stairway or an entrance.

- 5.1.9 The footings of a dividing wall (1609) were revealed to the east of 1608, which was probably associated with the overlying structure. It was only 0.5 m BGL and was constructed using Portland cement.

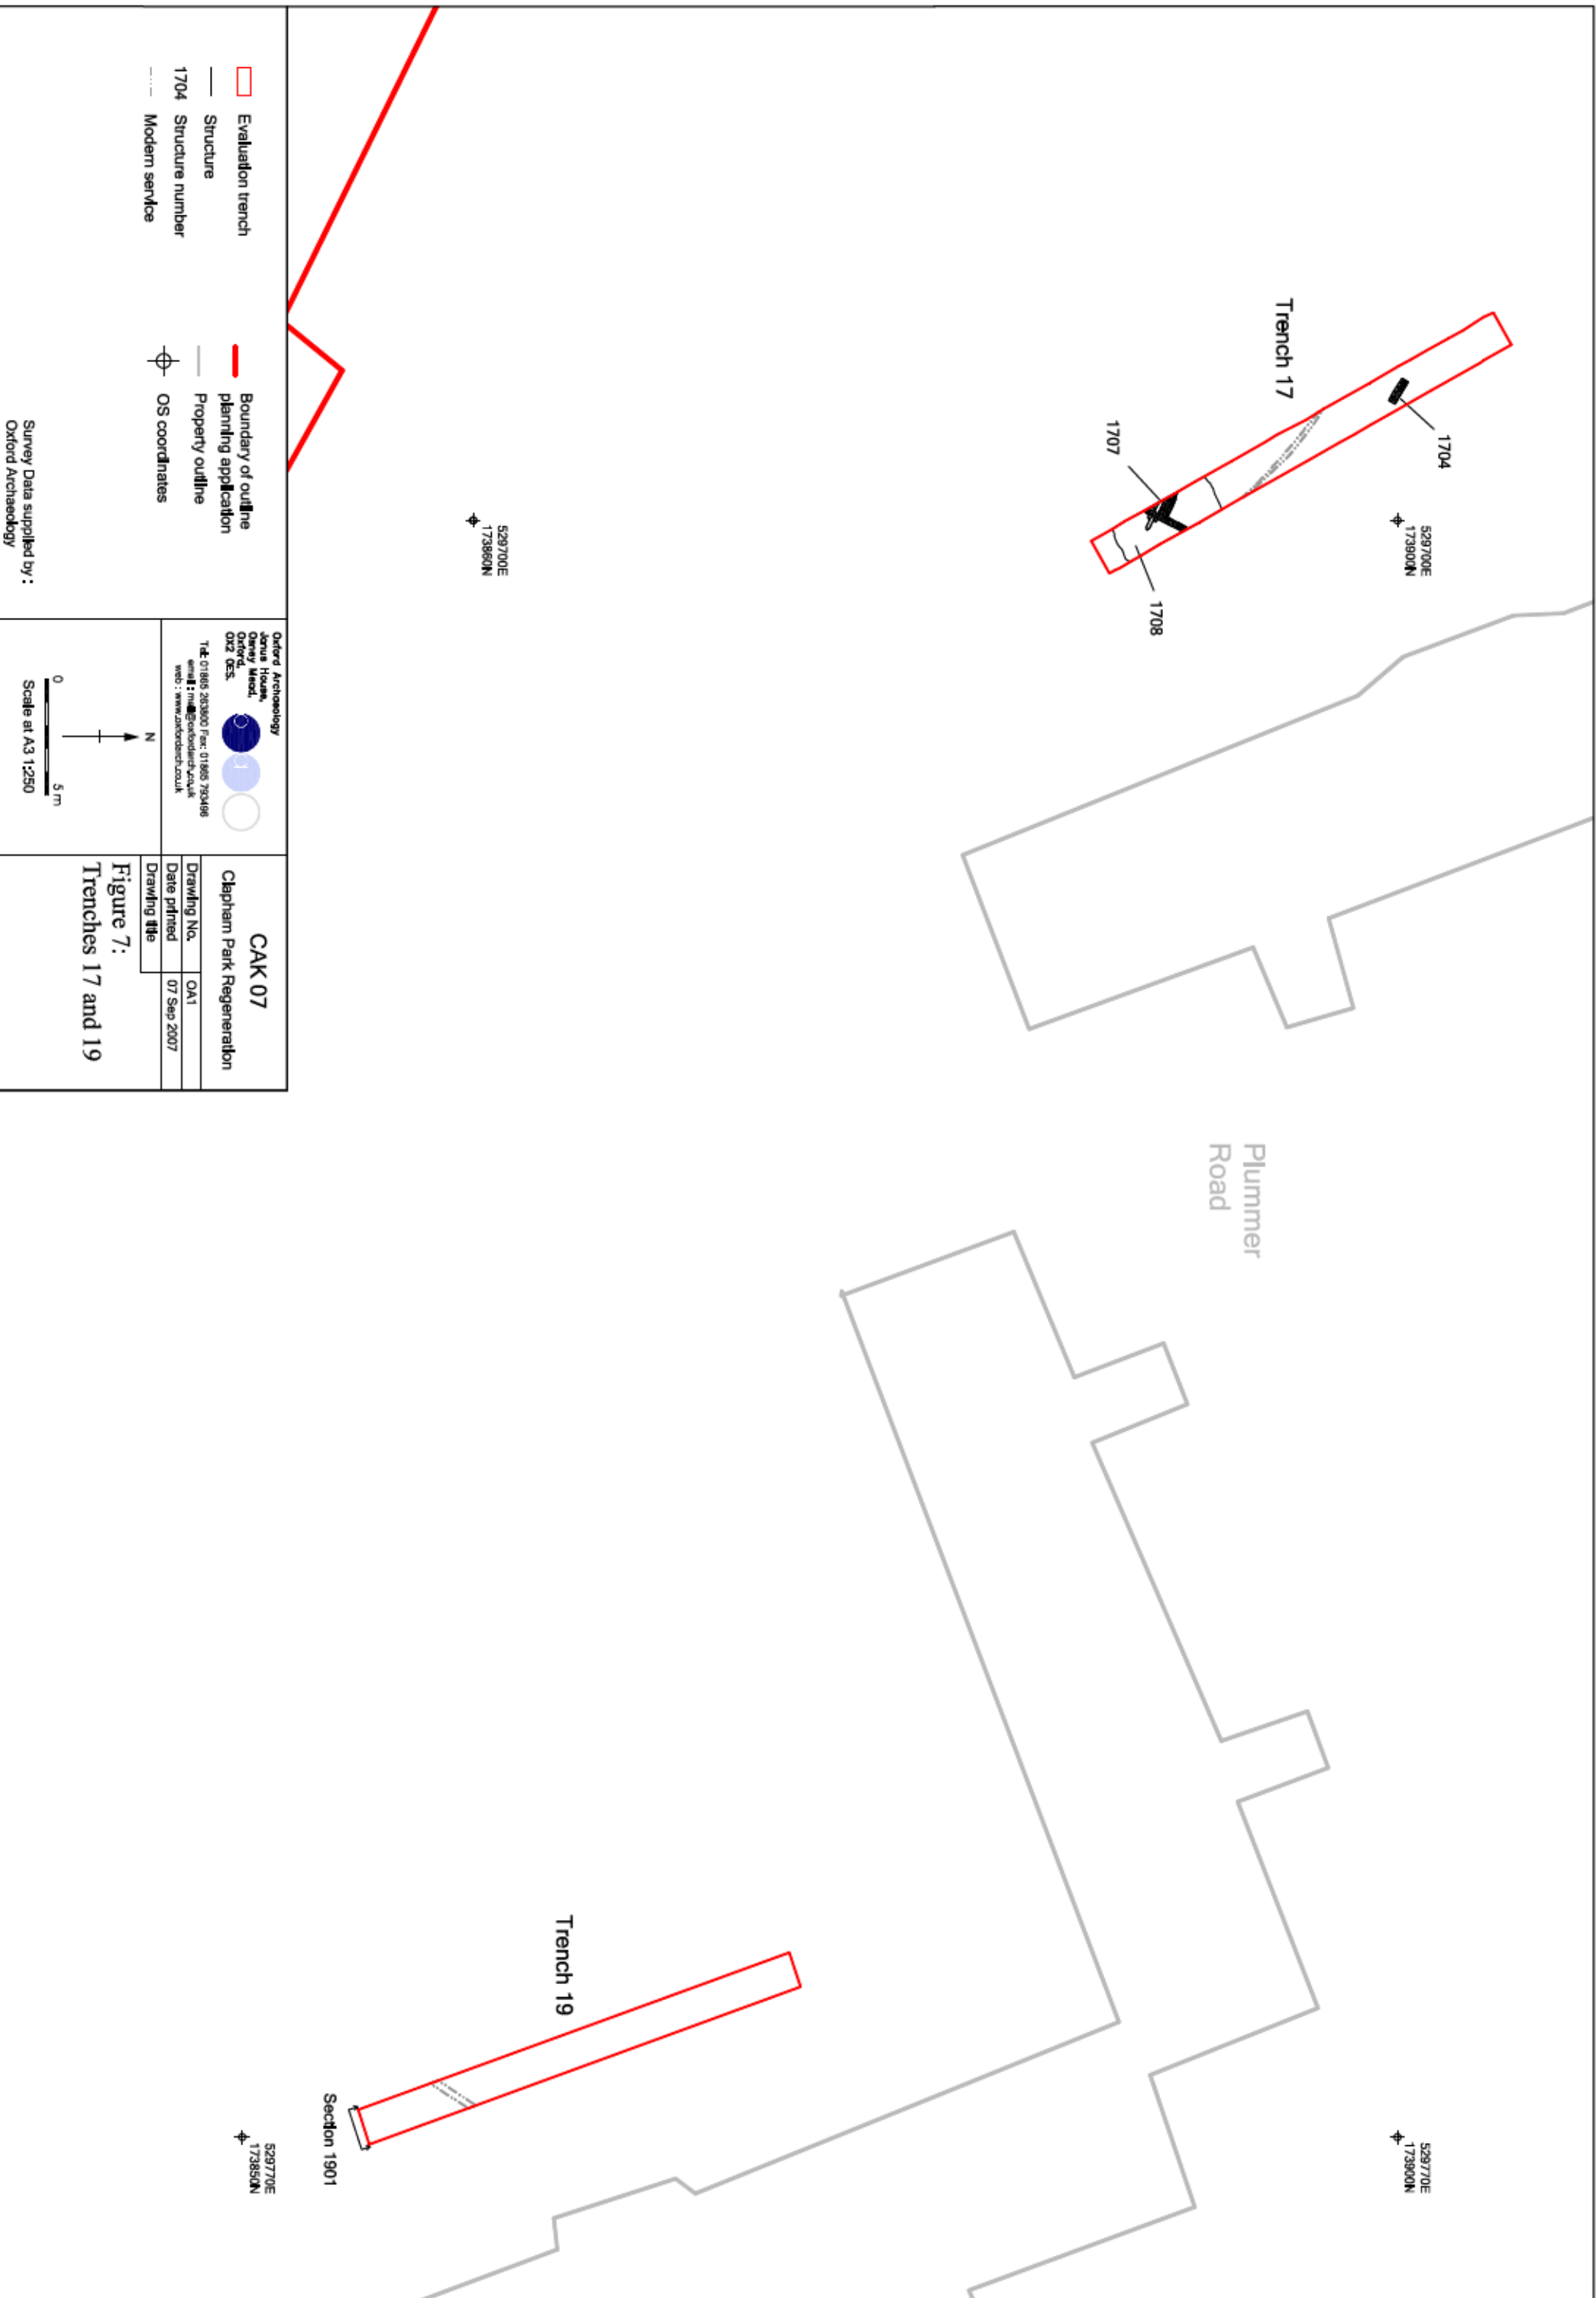
CAK 07	
Clapham Park Regeneration	
Drawing No.	OAI
Date printed	07 Sep 2007
Drawing title	Figure 7: Trenches 17 and 19

- 5.1.10 Natural geology was revealed 0.8 m BGL and was cut by the SE corner of a cellar room in the southern end of Trench 17 (1707). The cellar walls were constructed from 19th-century yellow stock bricks and measured 0.25 m wide and 0.2 m high. A ceramic drain was set into the southern wall, and the walls were abutted by a concrete surface (1708).
- 5.1.11 A similarly constructed NW-SE aligned wall (1704) was seen in the north of the trench, which measured 0.34 m wide and 0.14 m high. This may have represented the northern wall of the 19th-century property.
- 5.1.12 A similarly constructed wall (1905) was revealed in section at the southern end of Trench 19 (Fig. 8 - Section 1901). A relieving arch was present and the wall was abutted by silty sand (1906) that filled a probable construction trench. The wall may have formed the western edge of a 19th-century property.

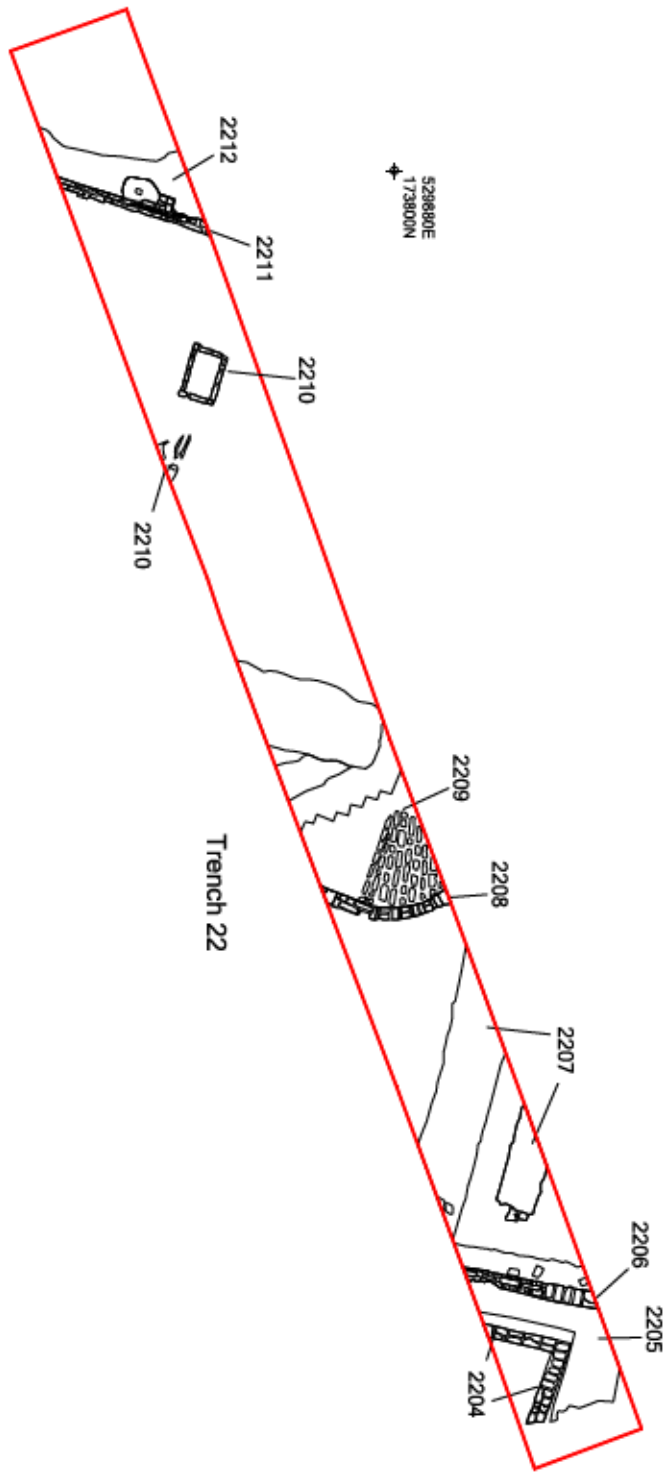
CAK 07	
Clapham Park Regeneration	
Drawing No.	CA1
Date printed	10 Sep 2007
Drawing title	Figure 9: Trench 22

- 5.1.13 Natural geology was revealed 0.6 m BGL, and the northern corner of a brick-built structure (2204) was revealed in the eastern end of Trench 22. The walls were constructed from 19th-century yellow stock bricks and measured 0.25 m wide and 0.2 m high. The walls were overlain by a concrete foundation (2205) for a similarly constructed N-S aligned wall (2206). A similar wall (2211 and 2212) was also revealed at the western end of the trench.

- 5.1.14 To the west of 2206 was a curved wall (2208) constructed from 19th-century yellow stock bricks. The wall measured 0.23 m wide and was abutted by a floor surface (2209), constructed from similar bricks and tiles measuring 140 mm x 140 mm x 80 mm (Plate 3). The floor surface was located 0.7 m BGL, and it may be that it formed part of a garden path. A brick-built soakaway (2210) was revealed to the west, measuring 0.75 m by 0.5 m.

- 5.1.15 Two concrete footings (2207) for 20th-century walls were revealed in the east of the trench, and may have represented development of the 19th century structure.

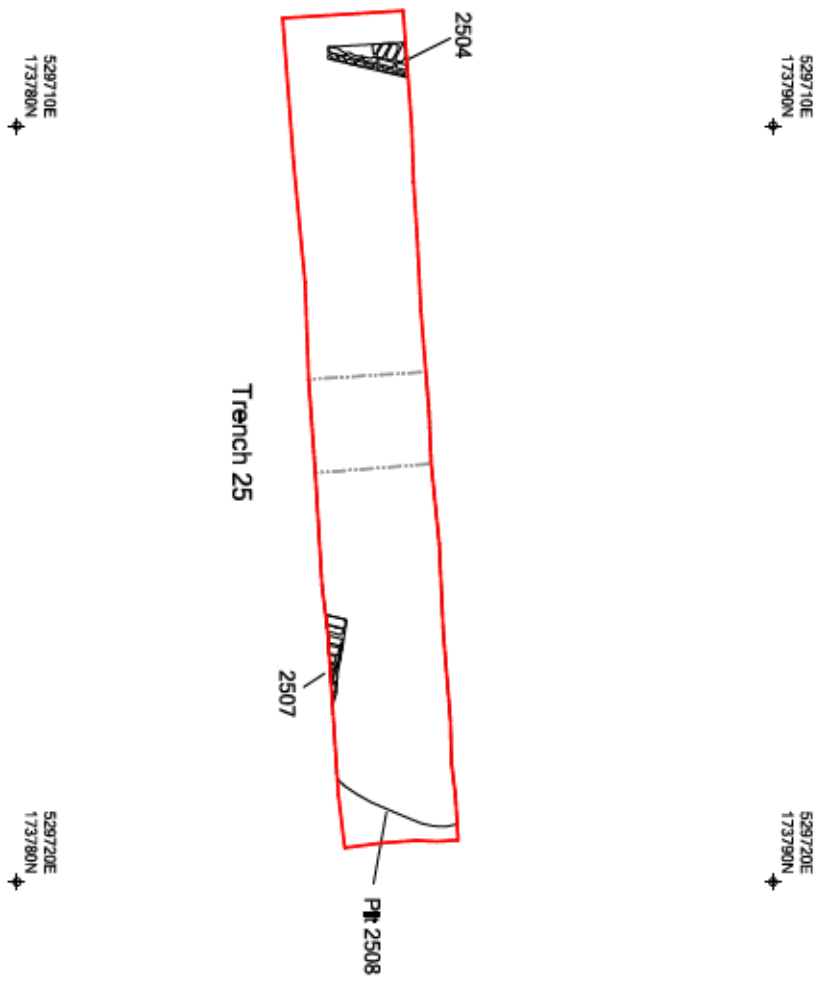
CAK 07	
Clapham Park Regeneration	
Drawing No.	CA1
Date printed	07 Sep 2007
Drawing title	Figure 10: Trench 25

- 5.1.17 Natural geology was revealed 1.5 m BGL and was cut by N-S aligned 19th-century yellow stock brick wall (2504), measuring 0.4 m wide and 0.16 m high. A pit (2508) was observed in the west of the trench, which was over 1 m deep and filled with rubblely clay (2509). The pit fill appeared to be cut by a trench for a W-E aligned wall (2507), measuring 0.2 m wide and 0.4 m high.

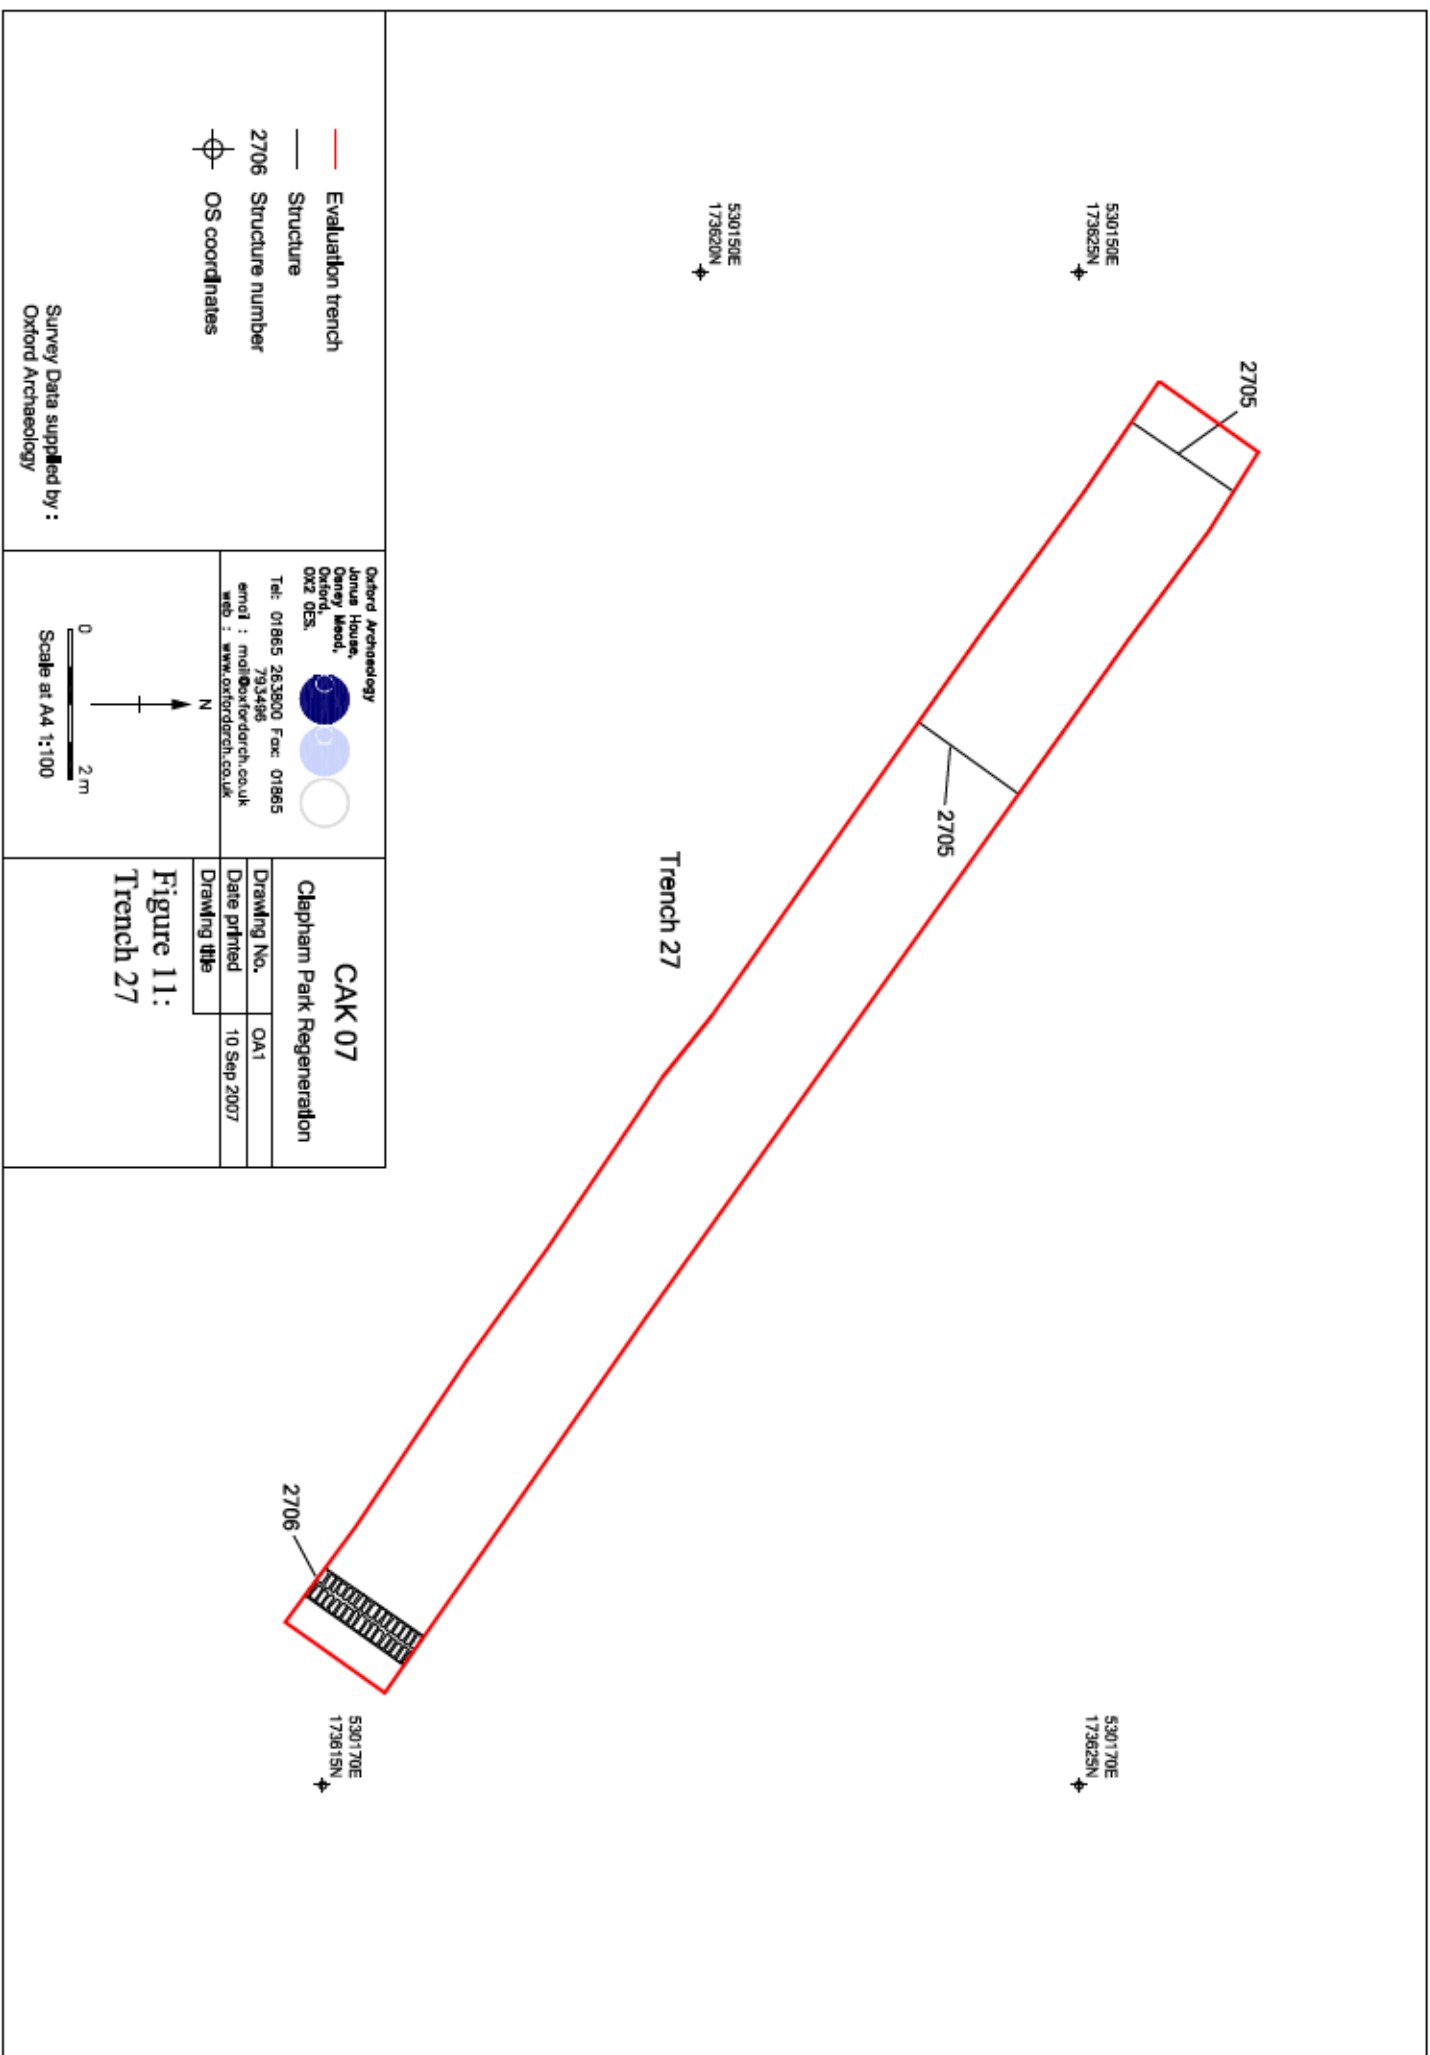
Figure 11:
Trench 27

- 5.1.18 The natural geology was revealed 0.6 m BGL, and in Trench 27 was cut by a 5 m

wide trench (2705) for a disturbed 19th-century yellow stock brick wall (2704), possibly forming the footprint of a cellar (Fig. 12 - section 2701). The trench had been backfilled with sandy silt (2708). A similarly constructed NE-SW aligned wall (2706) was revealed at the eastern end of the trench.

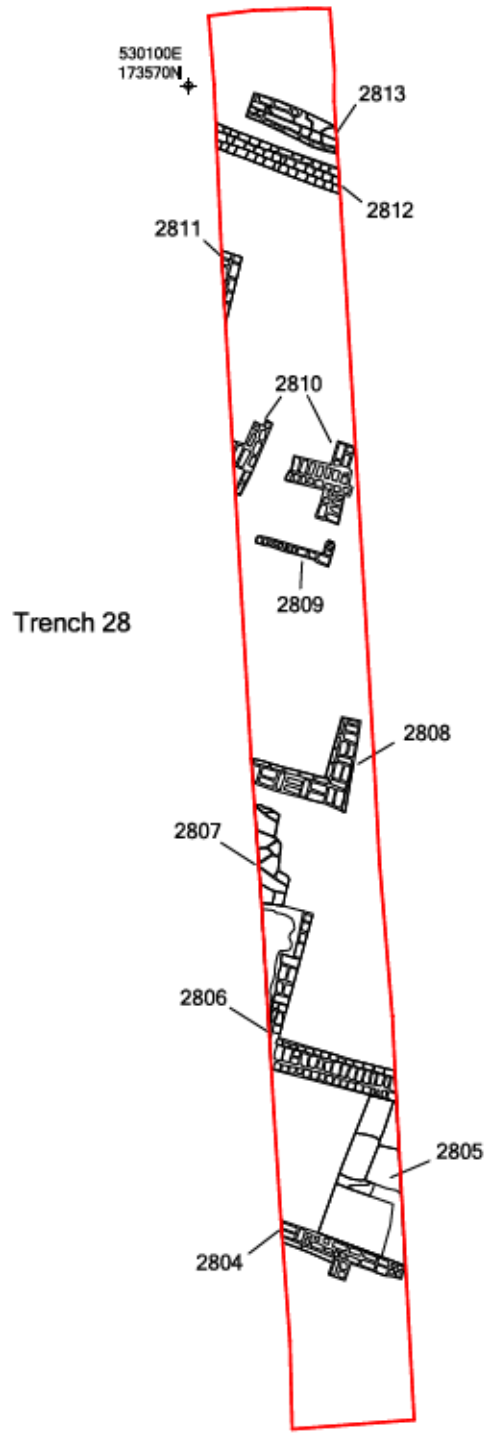
Figure 13:
 Trench 28

- 5.1.19 The remains of a house floor plan were revealed in Trench 28 (Fig. 13 and Plate 4), comprising seven NNE-SSW and WNW-ESE aligned 19th-century yellow stock brick walls (2804, 2806 and 2808-2812). The walls measured between 0.15 m and 0.4 m wide and 0.35 m high. Walls 2806 and 2812 may have formed the southern and northern limits of the structure respectively, and wall 2810 may have formed the base of a chimney at the southern edge of a room. A brick drain lined with slate (2813) was recorded to the north of wall 2812.
- 5.1.20 A floor constructed from concrete slabs (2805) was revealed 0.15 m BGL and abutted walls 2804 and 2806; it may have formed an external corridor. A second concrete floor (2807) overlay walls 2806 and 2808.
