Clapham Park Regeneration Lambeth London

Archaeological Evaluation Report

October 2007

Client: Clapham Park Homes

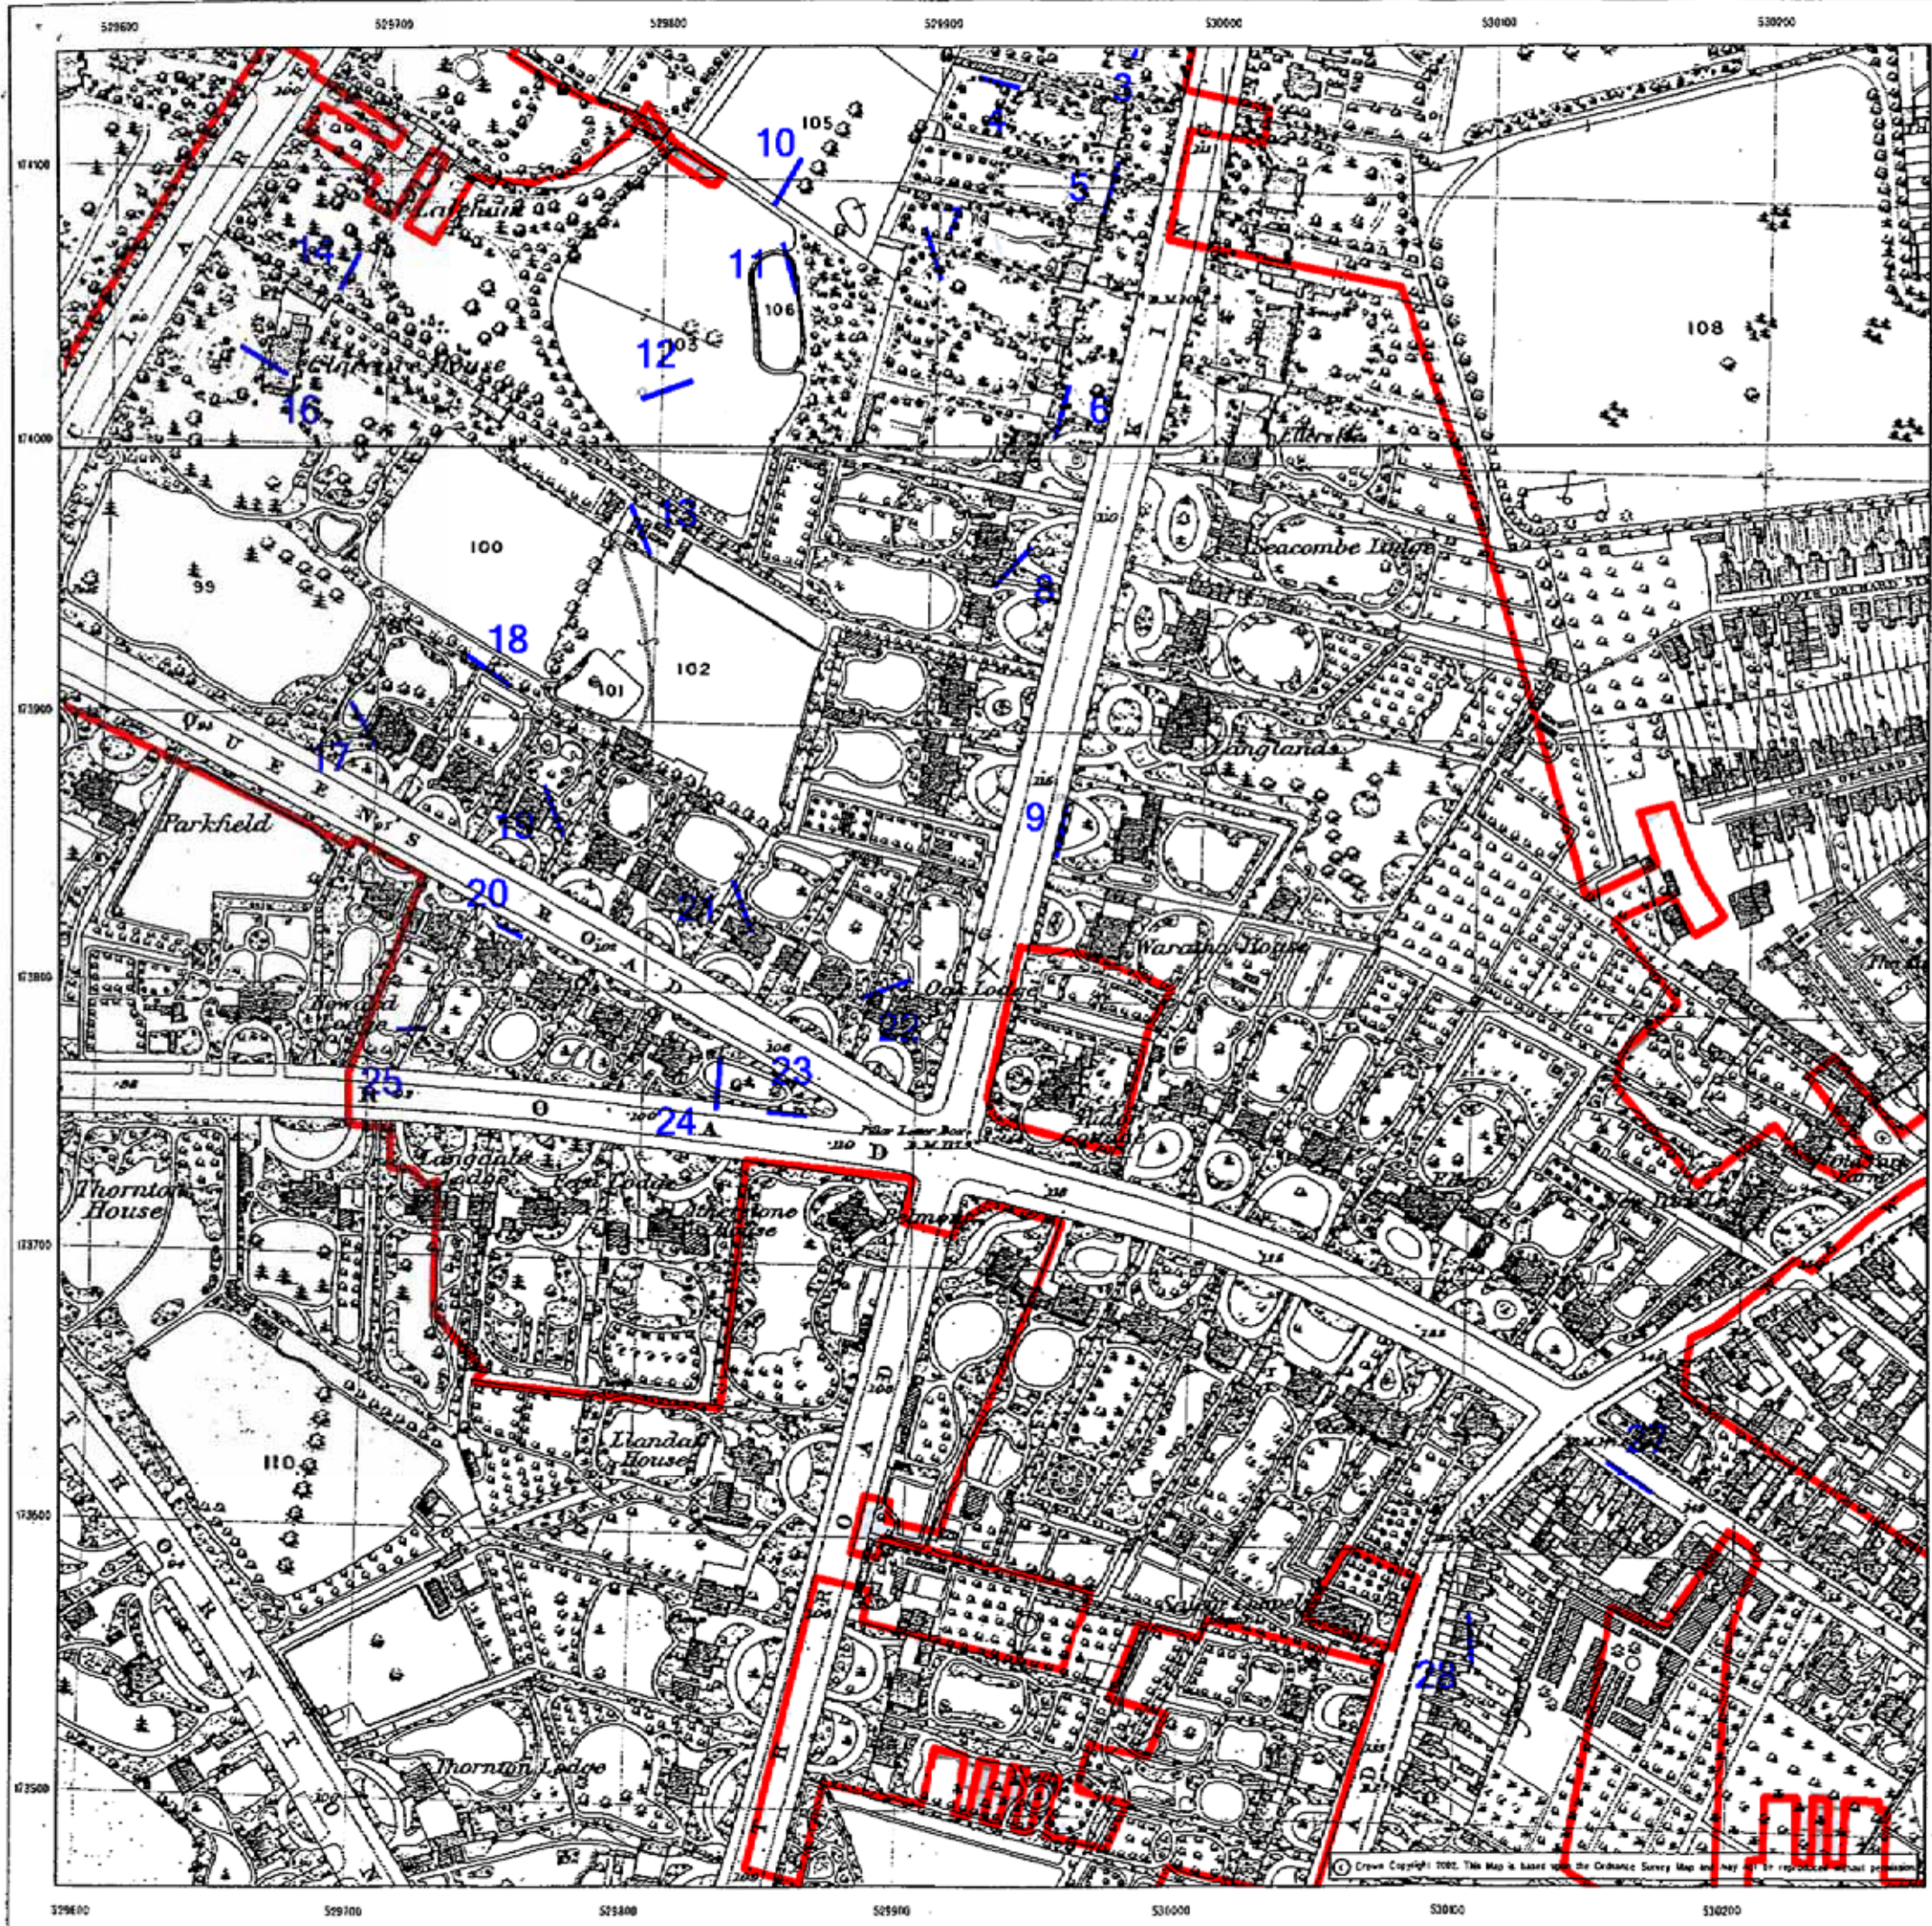
Figure 14: Trench locations in relation to 1874 and 1875 OS plans

6.2.2 The structural remains seen in Trench 13 formed part of a group of outbuildings within the grounds of Clarence House, the remains of which were identified in Trench 16. The curved brick surface revealed in Trench 22 may form part of an oval path seen on the 1875 OS plan, to the rear of the most easterly property fronting Queen's Road (Fig. 14).

6.2.3 The findings do not significantly increase our understanding of the 19th-century estate. The late 19th-century plans of Clapham Park clearly show the layout of the properties and gardens, and some of those properties are still standing today.

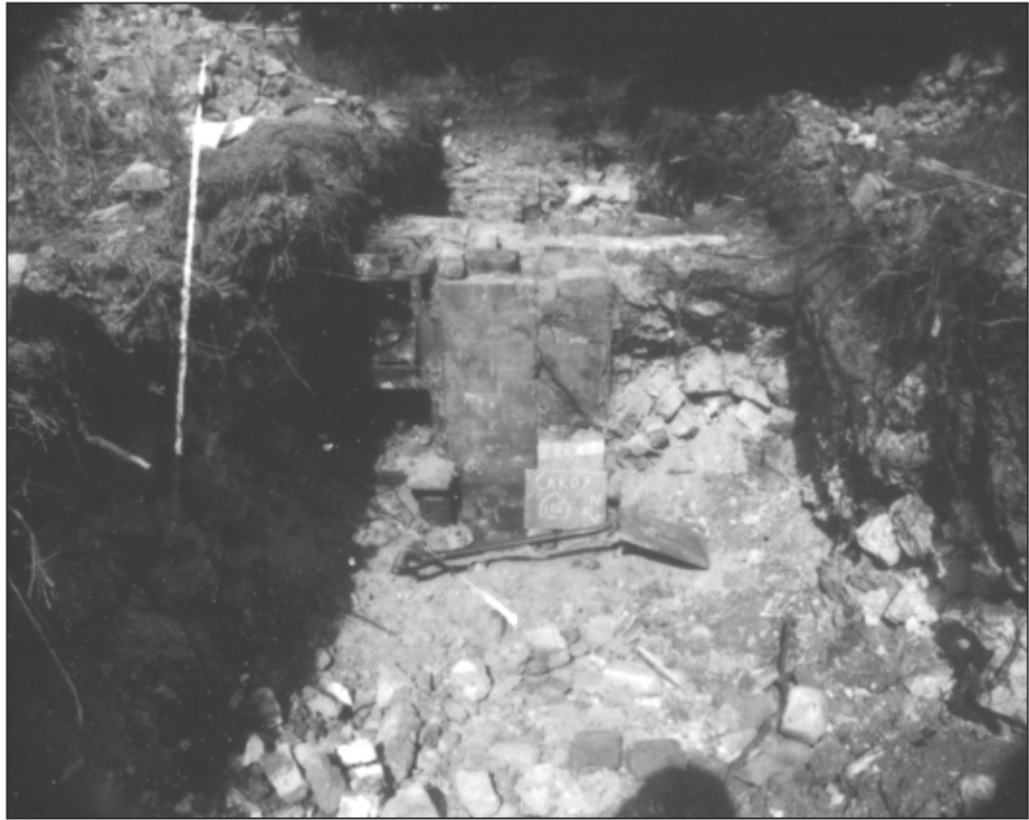
- 5.1.1 Trench 1 was aligned NE-SW and natural clay was revealed c 1 m below ground level (BGL). A brick-built cellar structure was revealed measuring over 8 m wide and c 1.5 m deep. The cellar was constructed from walls (104 and 106) measuring 0.35 m wide and constructed from 19th-century yellow stock bricks, laid in an English Bond and each measuring 230 mm x 100 mm x 70 mm. The interior face of wall 104, to the north, was rendered with green plaster and cast iron bars were set into the wall. Traces of yellow plaster were evident on wall 106. In the centre of the cellar was the base of a brick chimney, measuring 1.5 m wide. A cast iron oven was set into the chimney base (Plate 1), and ceramic tiles were also evident. Wall 107 was located to the south of wall 106 and measured 0.2 m wide and 0.7 m deep. It was overlain by a concrete surface, which also abutted wall 106.

Plate 1: Trench 1, cellar and oven - looking NE

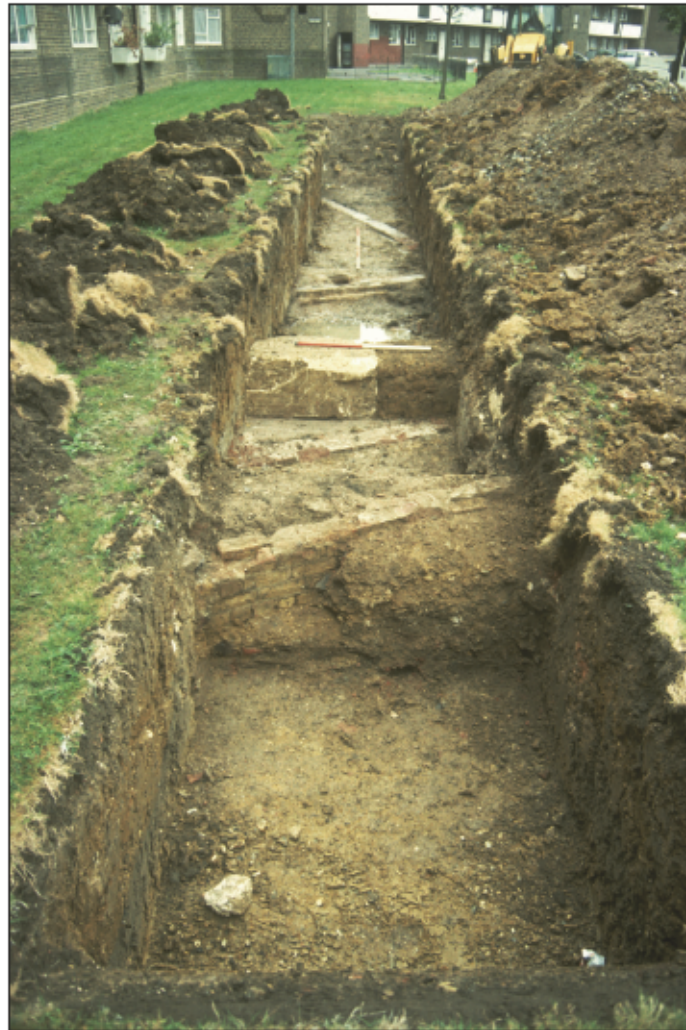
- 5.1.6 Natural geology was revealed 0.8 m BGL and was cut by the foundations for a sunken room or cellar, constructed from 19th-century yellow stock bricks. The SE corner of a room (1604) was revealed in the east of the trench. The walls were 0.2 m high and 0.25 m wide and the internal faces were lined with slate tiles, measuring 520 mm x 250 mm x 3 mm.

Plate 2: Trench 16, sunken room looking east

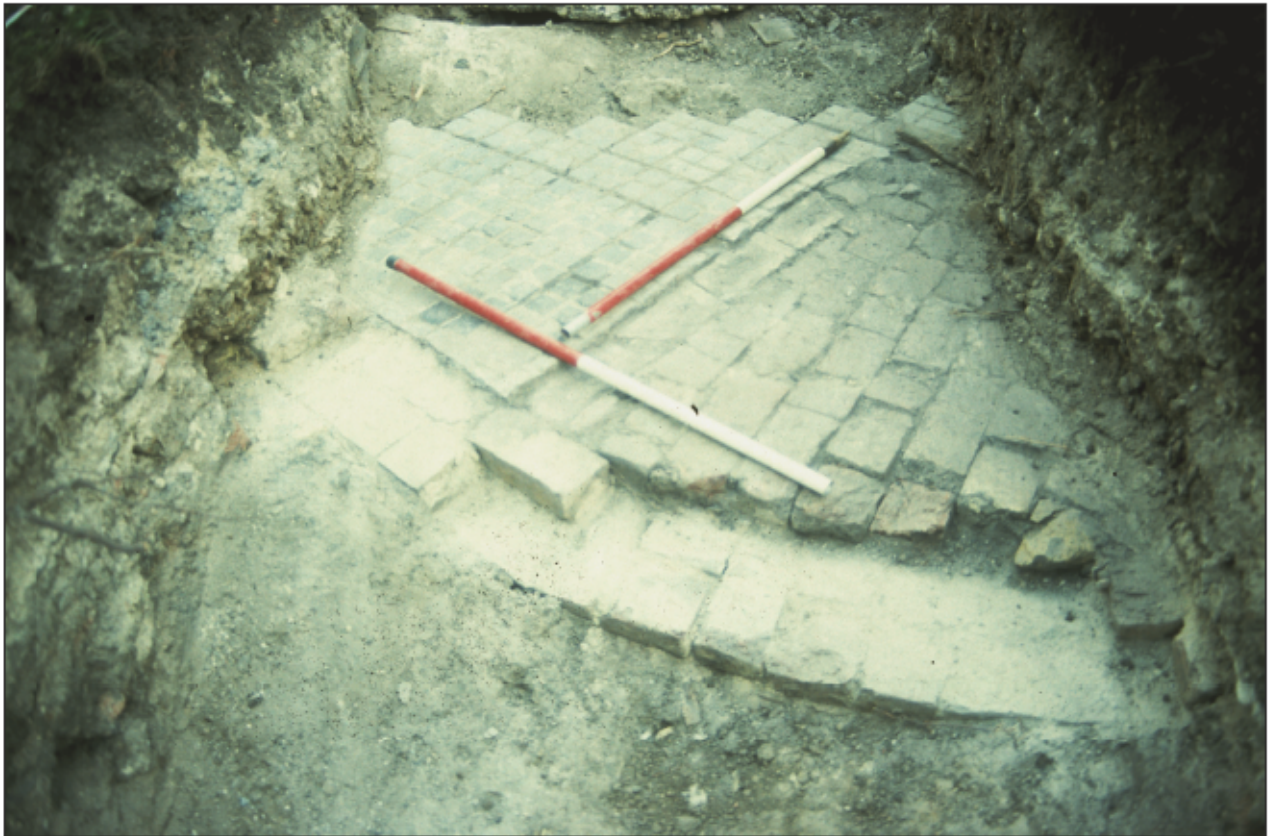
- 5.1.14 To the west of 2206 was a curved wall (2208) constructed from 19th-century yellow stock bricks. The wall measured 0.23 m wide and was abutted by a floor surface (2209), constructed from similar bricks and tiles measuring 140 mm x 140 mm x 80 mm (Plate 3). The floor surface was located 0.7 m BGL, and it may be that it formed part of a garden path. A brick-built soakaway (2210) was revealed to the west, measuring 0.75 m by 0.5 m.

Plate 3: Trench 22, wall 2208 and surface 2209 - looking SW

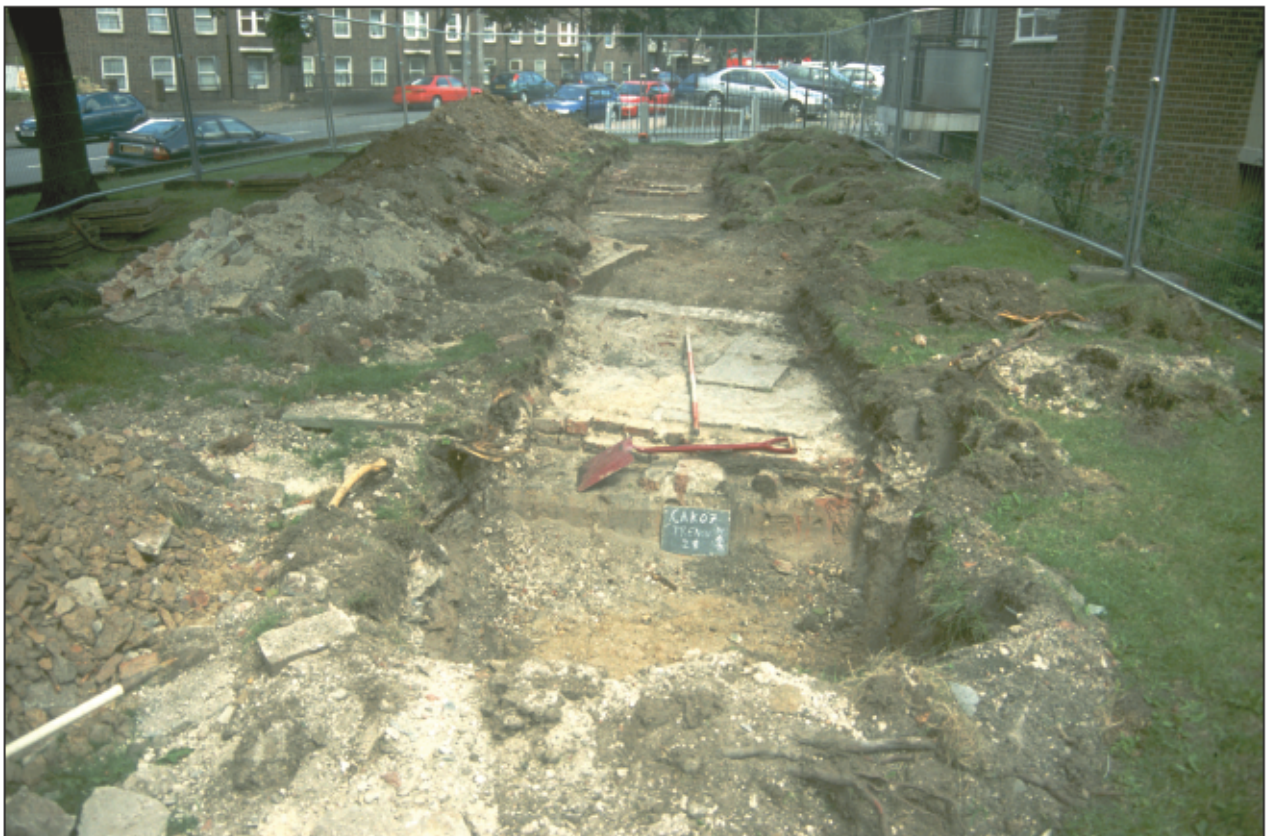
- 5.1.19 The remains of a house floor plan were revealed in Trench 28 (Fig. 13 and Plate 4), comprising seven NNE-SSW and WNW-ESE aligned 19th-century yellow stock brick walls (2804, 2806 and 2808-2812). The walls measured between 0.15 m and 0.4 m wide and 0.35 m high. Walls 2806 and 2812 may have formed the southern and northern limits of the structure respectively, and wall 2810 may have formed the base of a chimney at the southern edge of a room. A brick drain lined with slate (2813) was recorded to the north of wall 2812.
- 5.1.20 A floor constructed from concrete slabs (2805) was revealed 0.15 m BGL and abutted walls 2804 and 2806; it may have formed an external corridor. A second concrete floor (2807) overlay walls 2806 and 2808.

Plate 4: Trench 28, structural walls and surfaces - looking north
