Former Sandwell College  
Woden Road  
Wednesbury  
West Midlands

**Archaeological Evaluation Report**

**Oxford Archaeology**

November 2004

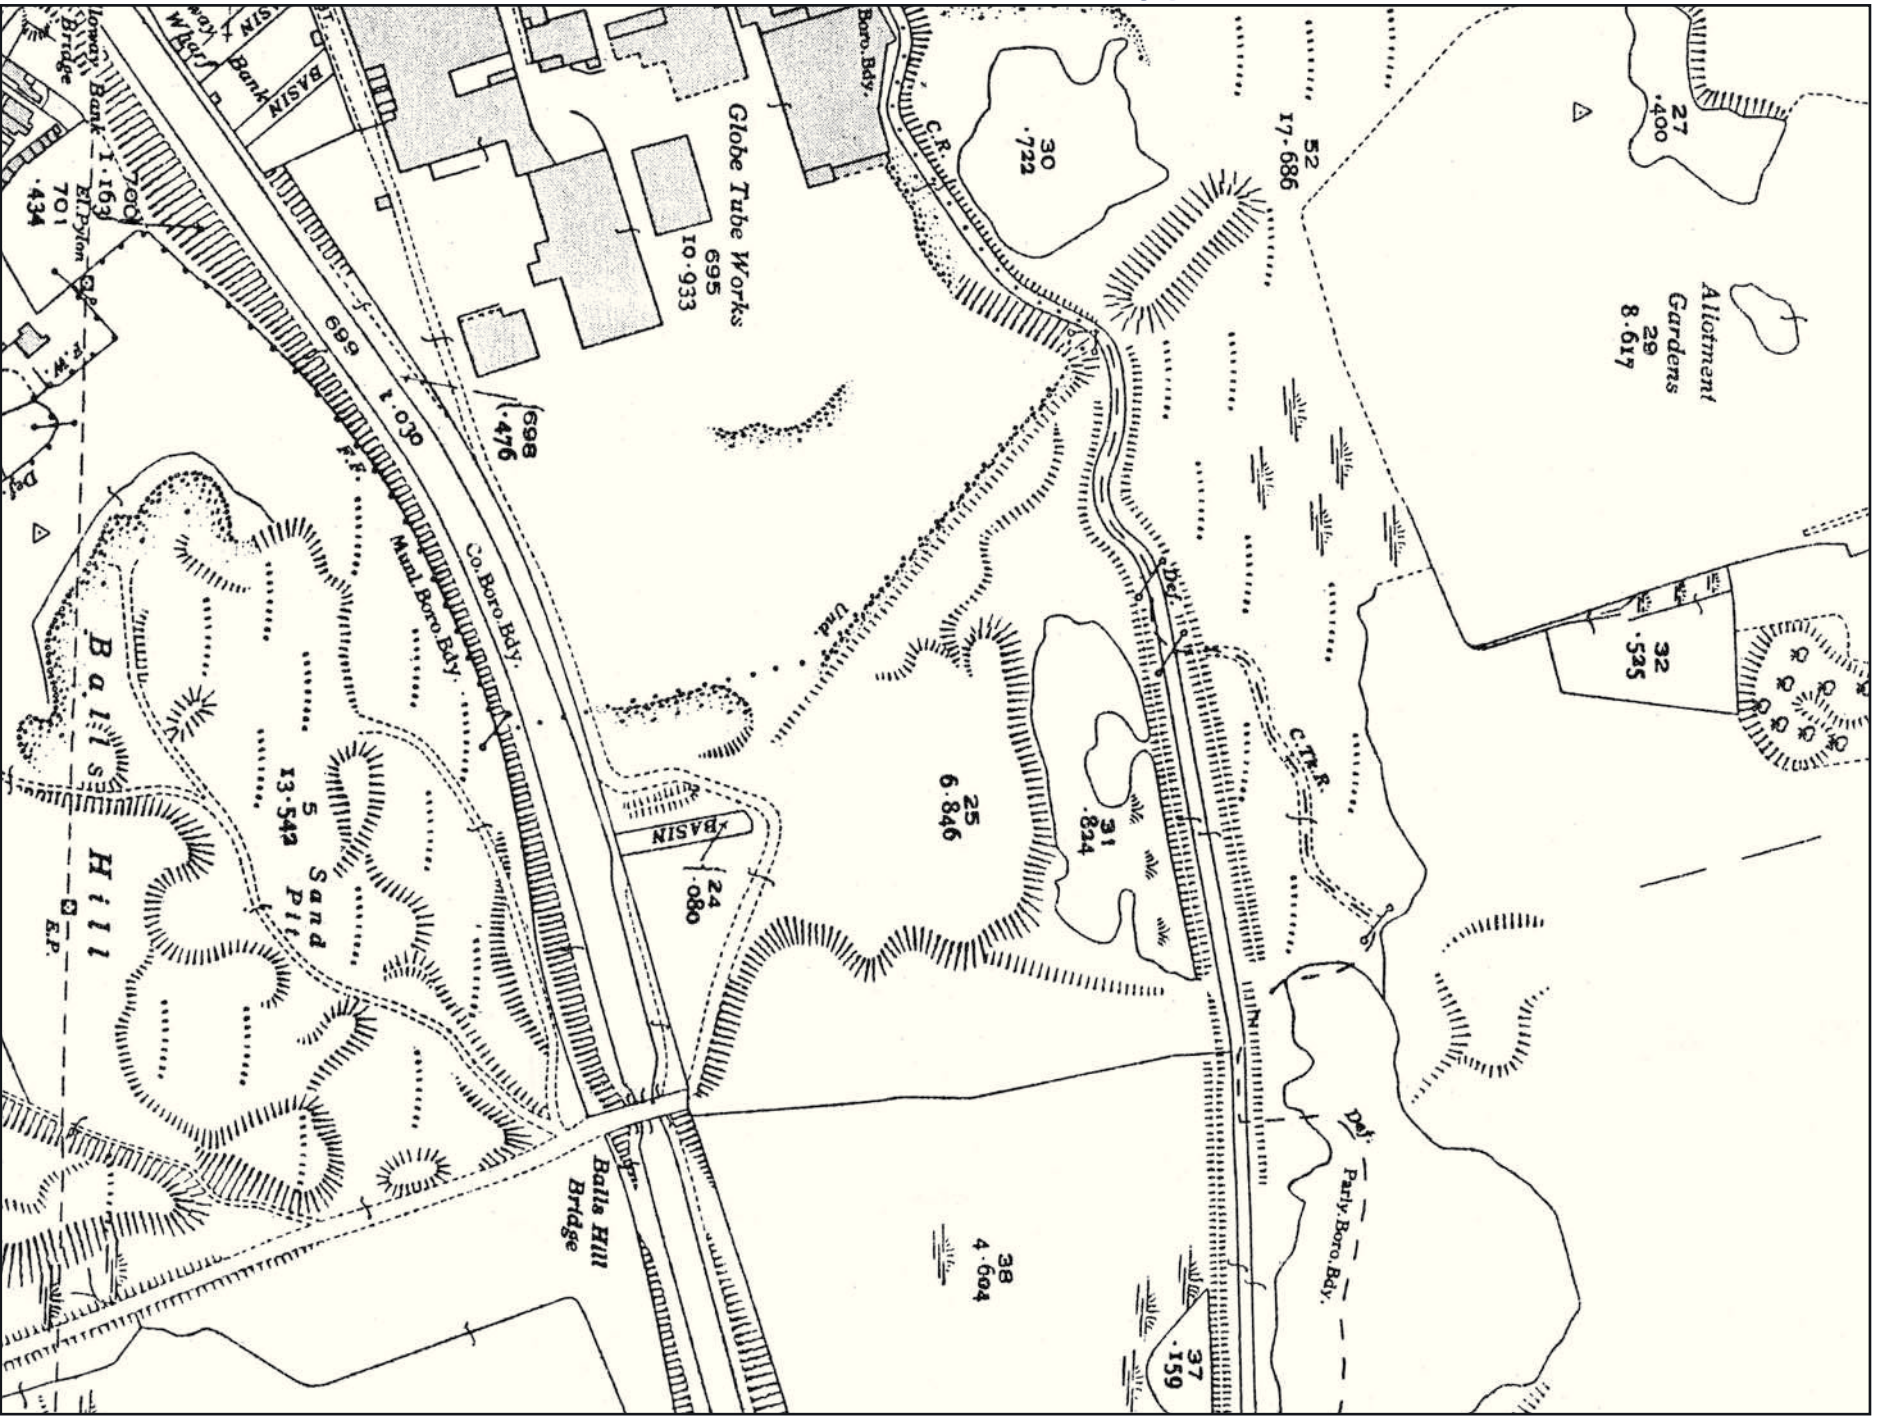
Figure 2: OS map of 1938

1.3.4 Historic maps depict the site of the college as being used for coal mining and later sand pits in the Victorian period and early part of the 20th century. In 1890 the site lay due east of the Globe Tube Works and was the site of a large clay pit. Sand pits are depicted south of the site on Balls Hill, where there was also a colliery. By 1903 coal shafts are shown on the site and by the time of maps dated 1919 and 1938 (Fig. 2) there were further clay pits and coal shafts. By 1965 the site appears as an array of steeply sloping earthworks, which appear to have been levelled by the early 1970s, when the college is mapped for the first time (AIG Consultants Ltd, 2003).

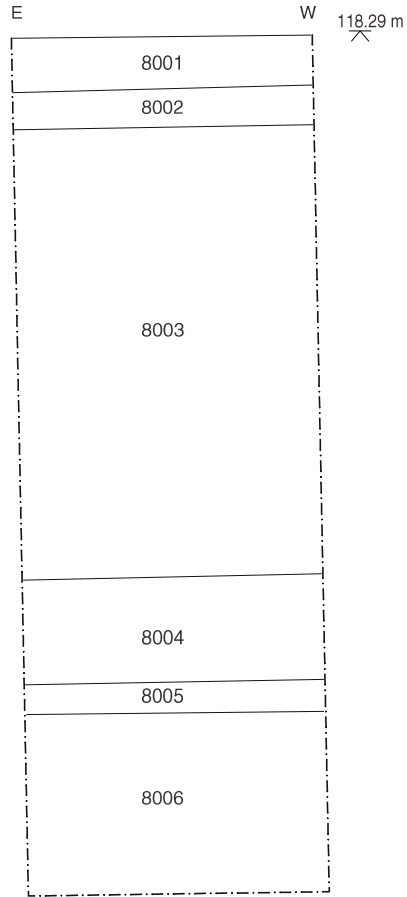
Figure 4: North facing section through trench 8

- 6.2.1 These trenches were located on the north-east side of the River Thame and were all aligned roughly east-west. They were machined to a depth of 1.2 m with test pits excavated at either end of the trenches to an average depth of 2.5 m. All three trenches revealed natural alluvium at an average depth of 2.7 m. In Trench 7 this was overlain by a possible natural sub-soil (7008) at a depth of 2.55 m. This was, in turn, overlain by made ground to the surface of each trench.

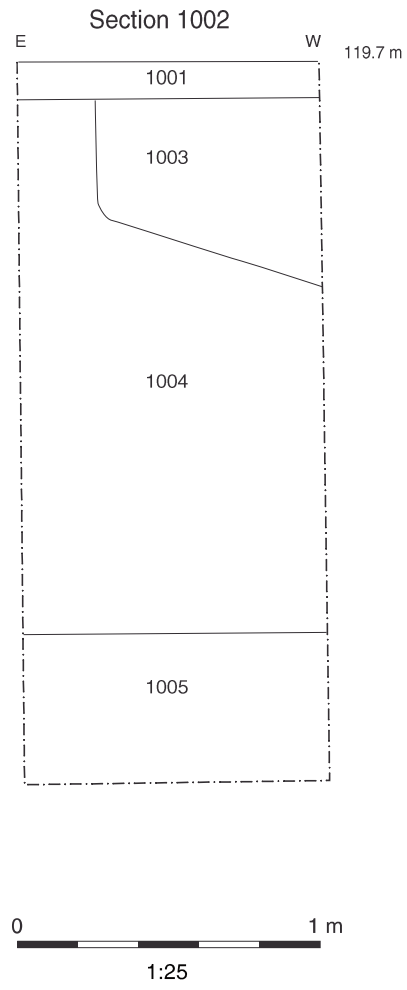
Figure 5: South facing section at east end of Trench 10

- 6.2.2 These trenches were located along the south-west side of the river, and were aligned approximately east-west. They were machined to a depth of 1.2 m, with test pits excavated at either end to an average depth of 2.5 m. All four trenches all revealed a grey silty clay, thought to be either colluvium or re-deposited natural, at an average depth of 116.7 m OD. In all trenches this was overlain by made ground, which was overlain by topsoil to an average depth of 0.2 m. The trenches did not contain any features of archaeological significance.

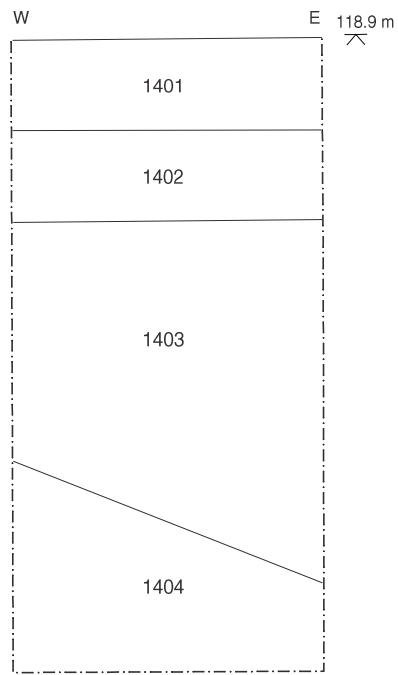
Figure 6: South facing section at west end of Trench 14

- 6.2.3 These trenches were located towards the centre of the site, and were aligned east-west. They were excavated to a depth of 1.2 m and test pits were opened at each end to an average depth of 2.5 m. Trenches 12 and 14 encountered the water table at 116.2 m OD and 116.3 m OD respectively. Here natural gravel was revealed and in both cases this was overlain by made ground, in turn was overlain by topsoil to an average depth of 0.25 m. Trench 18 was excavated to a depth of 2.4 m and revealed only made ground/landfill deposits.

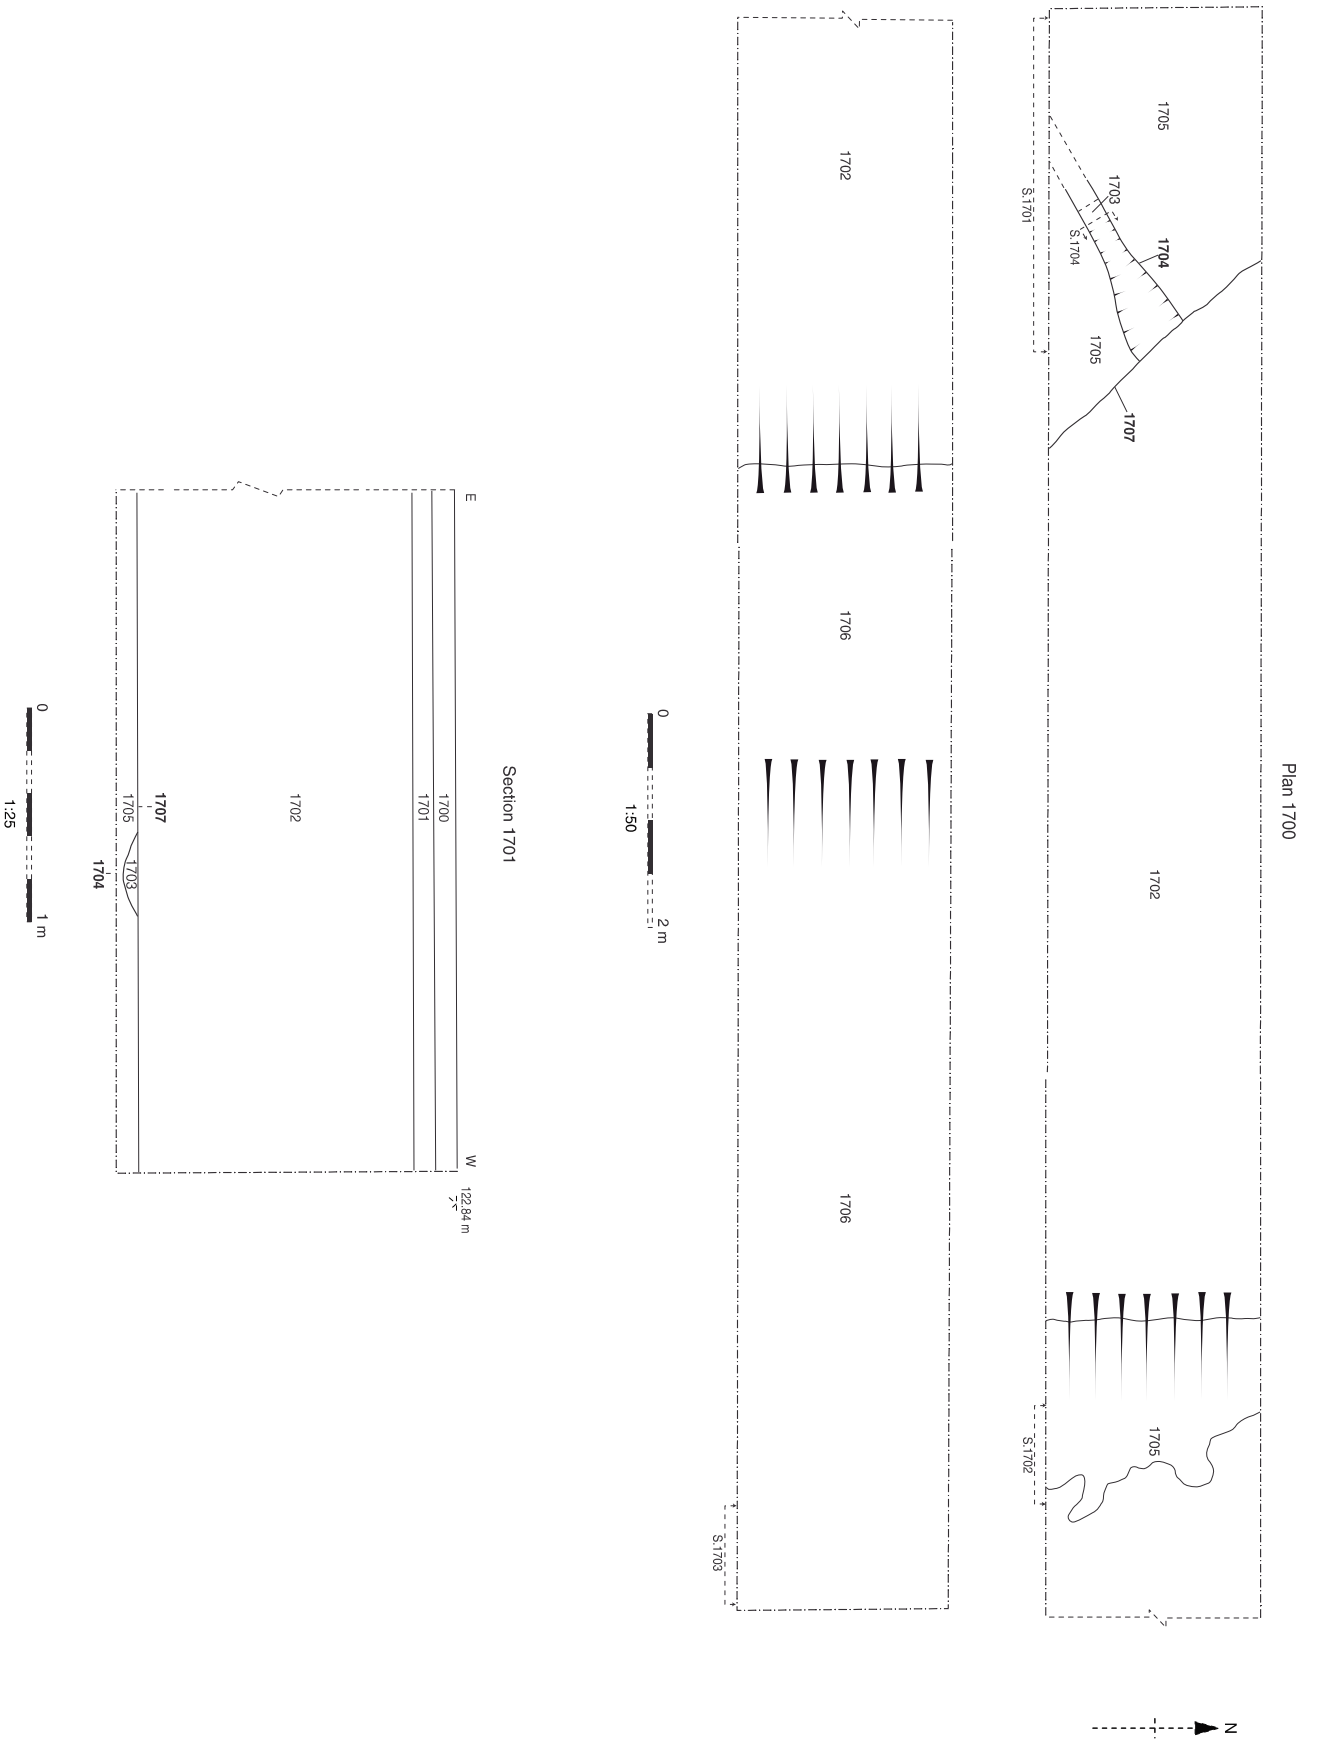
Figure 7: Plan of Trench 17; north facing section west end of Trench 17

- 5.1.2 Where there was survival of the original land-surface, it generally comprised brick-earth overlain by natural subsoil.
- 5.1.3 Only one trench (Trench 17) contained archaeological features or deposits. This was located towards the centre of the site. However, the feature identified within this trench contained no finds and is thought to be post-medieval in date.

- 6.2.5 Trench 17 lay to the centre of site, and was aligned east-west. It was machined to a depth of 1.2 m with a test pit excavated at the east end to a depth of 2.5 m. A small feature, possibly a gully (1704) was revealed at the west end of the trench cut into what was thought to be natural clay at a depth of 121.54 m OD. However, due to similar deposits appearing elsewhere on site, it was thought that this is a post-medieval feature cut into re-deposited natural. At the west end Trench 17 was excavated to a depth of 120.7 m OD without revealing natural deposits.

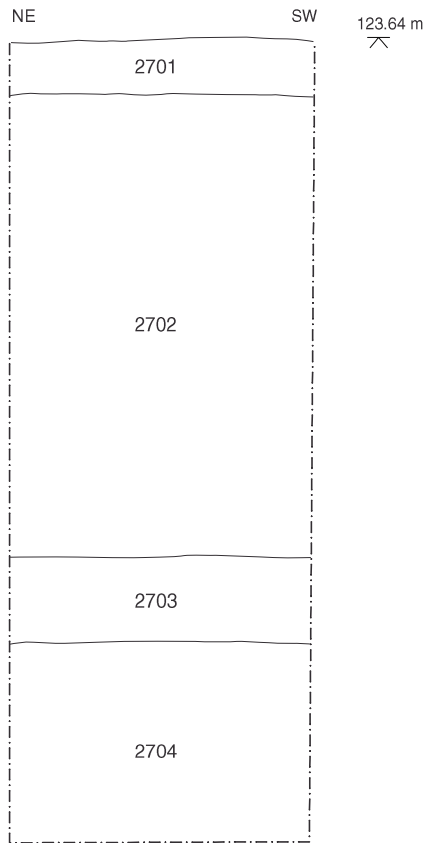
Figure 8: South facing section through north-east end of Trench 27

- 6.2.6 These trenches have been grouped together due to the fact that they all revealed natural brick-earth at a relatively shallow depth, thus displaying some potential for the survival of archaeological remains. Trench 27 was located at the far south-west end of site and was aligned north-east/south-west. Further trenches (27a and 27b) were excavated at right angles to its south-west end and centre respectively. Within Trench 27 natural brick-earth was revealed at the north at 120.31 m OD, rising to a depth of 121.75 m OD at the SW end. Trench 27a revealed natural brick-earth at its north-west end at depth of 122.2 m OD, rising to 121.13 m OD at the south-east end. Trench 27b measured 10 m in length and revealed natural brick-earth at a depth of

121.1 m OD. In all these trenches the natural brick-earth was overlain by made ground/landfill and then topsoil to an average depth of 0.2 m.
