De Montalt Mill Combe Down Bath

Archaeological Evaluation Report

February 2006

Client: Classico-Rural Ltd

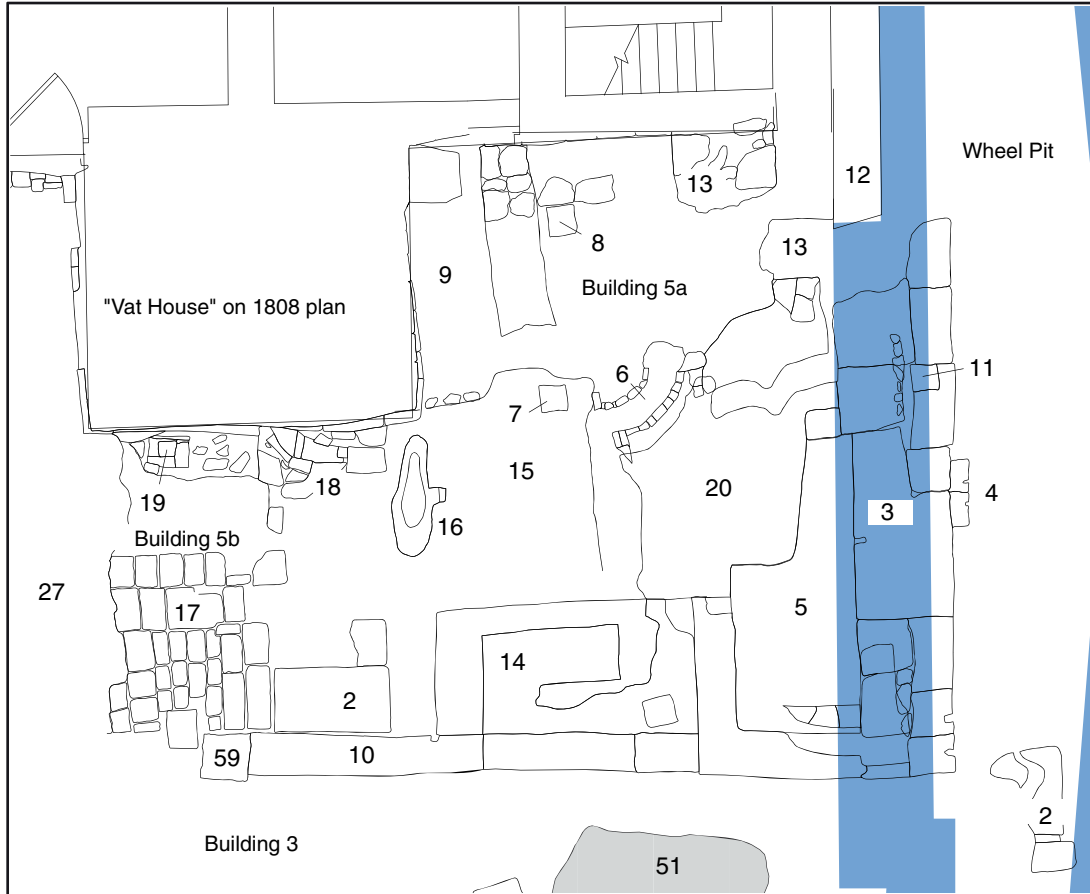
Figure 4: Detail of Buildings 5a and 5b

Key	
	Wheel pit (from historical sources)
	Area outline (as in figure 3)
9	Wall described as temporary in 1808. The boiler was probably sited between 9 and 13
6	Part of the boiler ducting
14	Thought to be the site of the steam engine itself
16	Small shaft leading to the void under 15

- 4.1.4 **Phase 2:** Phase 2 comprises the elements added and augmentations made to facilitate the addition of the Steam engine in 1808. Towards the centre of 5a a red brick curvilinear structure (6), a rectangular depression (14), a flue-like vertical hole in the floor masonry leading to an underground chamber (16), and two floor surfaces (15 and 20) were noted (Fig. 4). This arrangement is thought to reflect the addition of the Boulton and Watt steam engine in 1808, as indicated in a drawing from Boulton and Watt showing the proposed installation, dated May 1808 (Fig. 11). However, the proposal drawings do not match what was found. The question is discussed below. Context 6 comprised two curvilinear arrangements of red brick and contained some highly oxidised clay. It probably constitutes the remains of a flue coming from the boiler. To its south, a rectangular depression (14) sunk into the floor surface with a second smaller rectangular depression in its centre, is probably where the machine mount for the steam

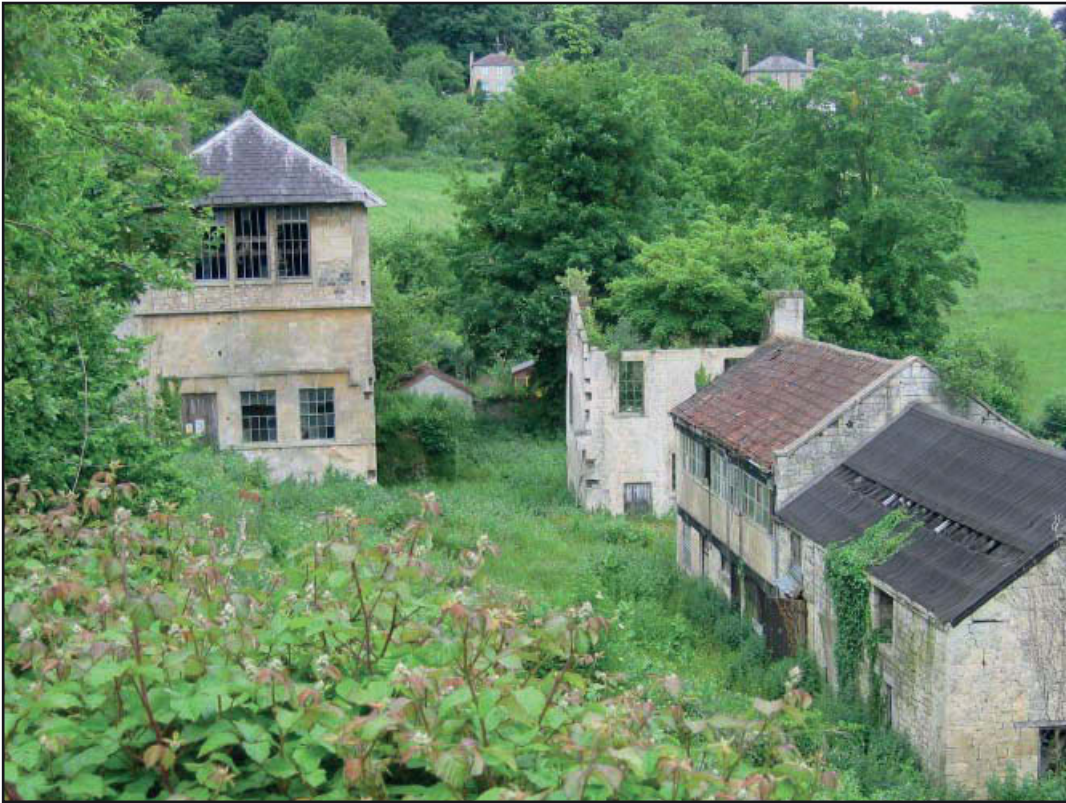
Plate 1: General view of mill from west with Building 2 to left rear and roofless Building 4 to right rear. The low range bottom right is Building 1, subject of a separate report

- 5.2.10 What is clear is that one continuous structure was erected between Building 3/4 and 2 by 1852 and that this probably incorporated 5a, 5b and 5c. 5a would have had its monoslope roof replaced by the flat one represented by the continuous run of joist pockets. If 5b & c were single storey buildings predating this change then they gained a storey. The two storey west elevation of Building 5 is clearly indicated by the remains of masonry dogging on Buildings 2 and 4 and the remains of a first floor window with a stone cill at the junction with Building 4 (plate 1).

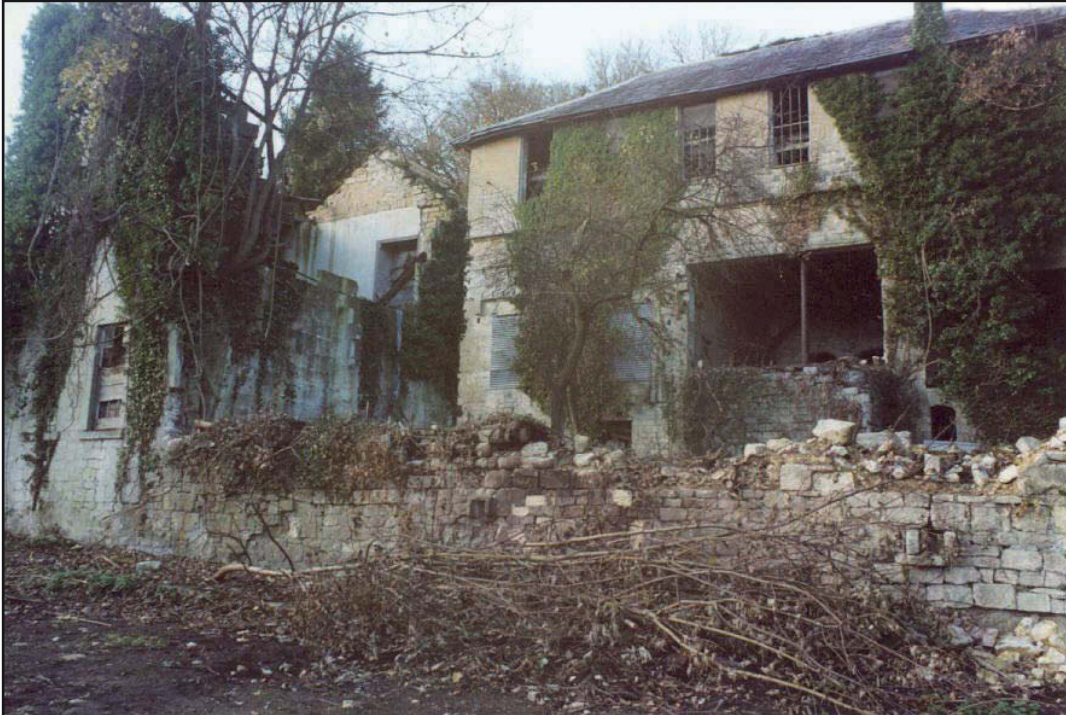
Plate 2: View from south with the platform of Building 3 in foreground (Building 4 to left) and Building 2 in the background

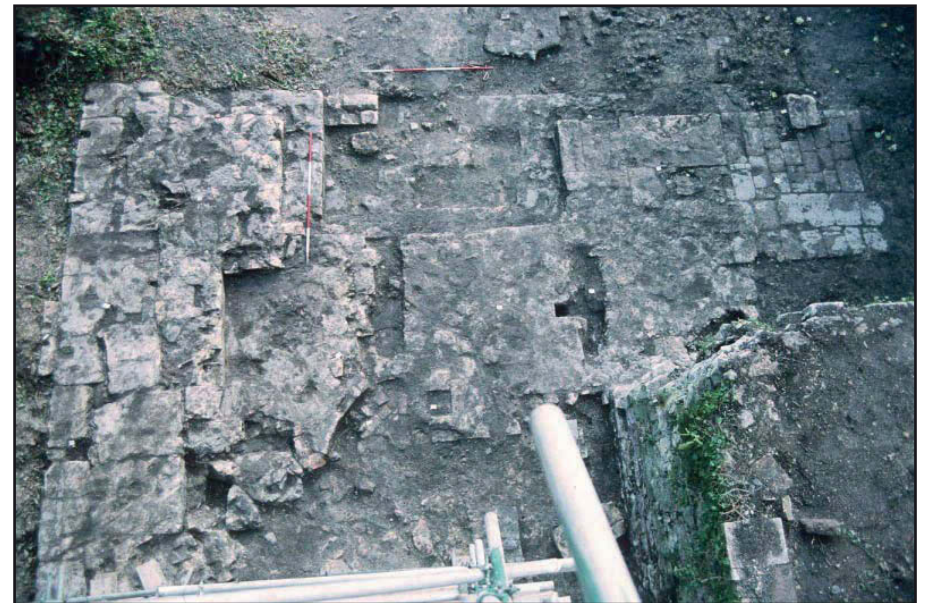
Plate 4: Building 5a and 5b seen from above and north. Building 5b to right of picture

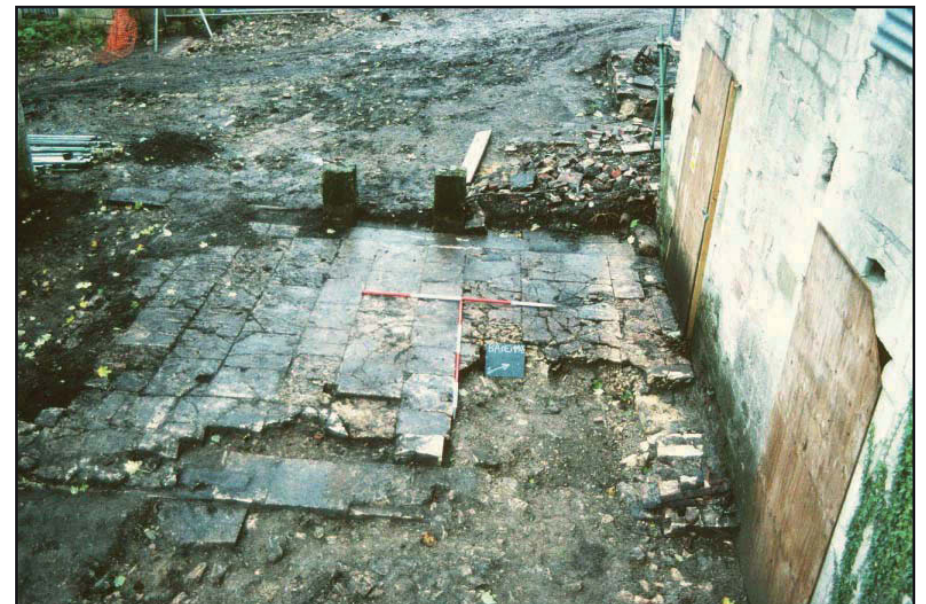
Plate 5: Building 5c seen from the east

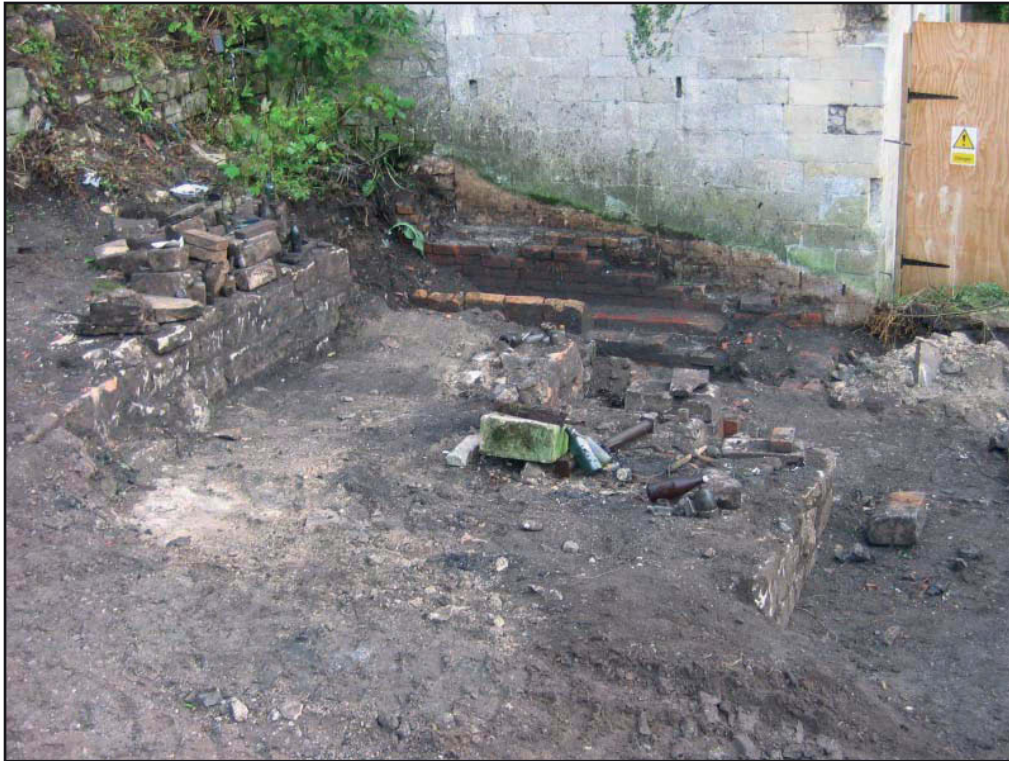
Plate 6: Structure 1 seen from the west. The stone walls and robbed floors of the terracing are evident in the foreground and the brick steam cabinet base in the background. The pre-excitation ground surface is still shown by the mark on the wall of Building 2 in the background

- 5.5.1 The brick and firebrick construction in Structure 1 and the abundance of burning products in the adjacent stone built element make it clear that a hot process was going on here. A structure is shown on the 1886 OS map in this position and not in 1852. A likely date for its construction would be the establishment of Whitaker's cabinet works here in 1875.

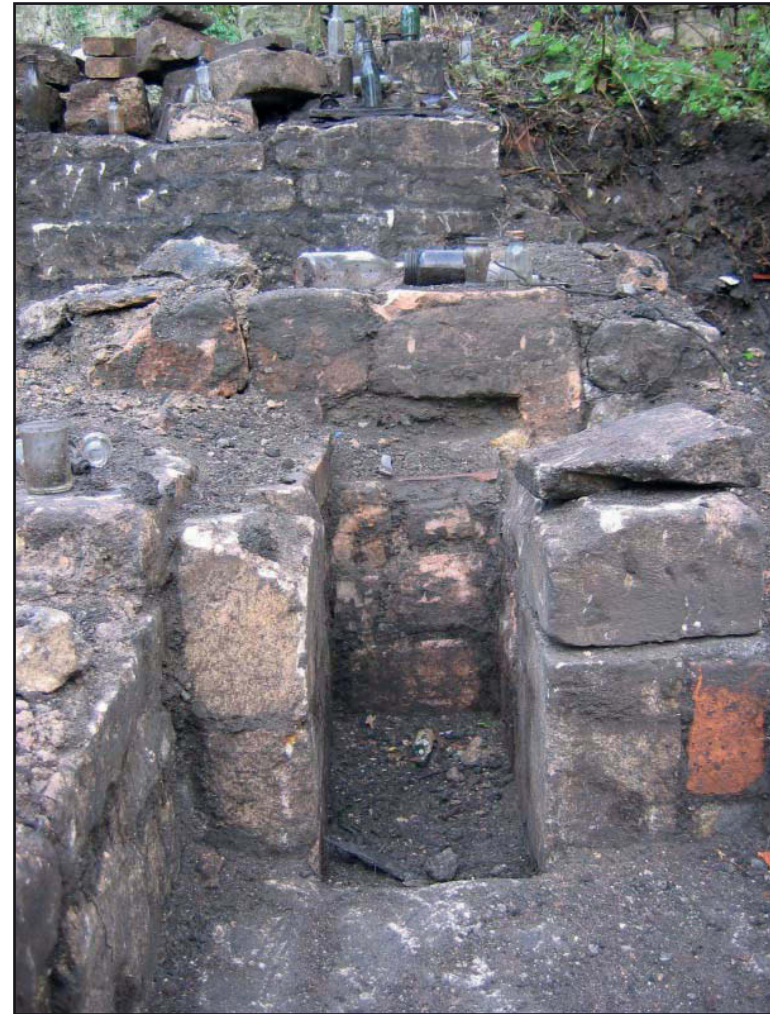
Plate 7: Context 3, the slot in Structure 1 lowest terrace. This also shows the structural interlocking of the brick and stone parts of the structure. Note the pink heat discolouration of the stones at the rear of context 3

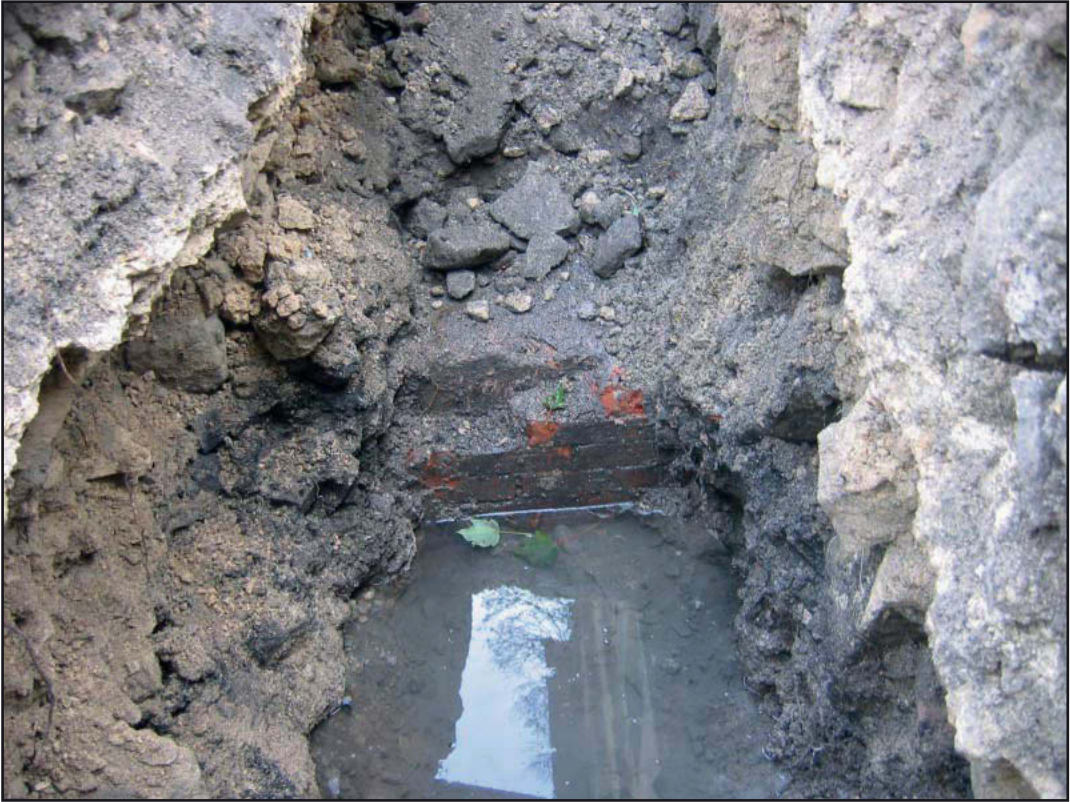
Plate 8: The brick culvert in Trench 1a seen from the south, just after discovery. Note the strong ledge formed by layer 129, the mortar layer between rubble fills 127 and 128

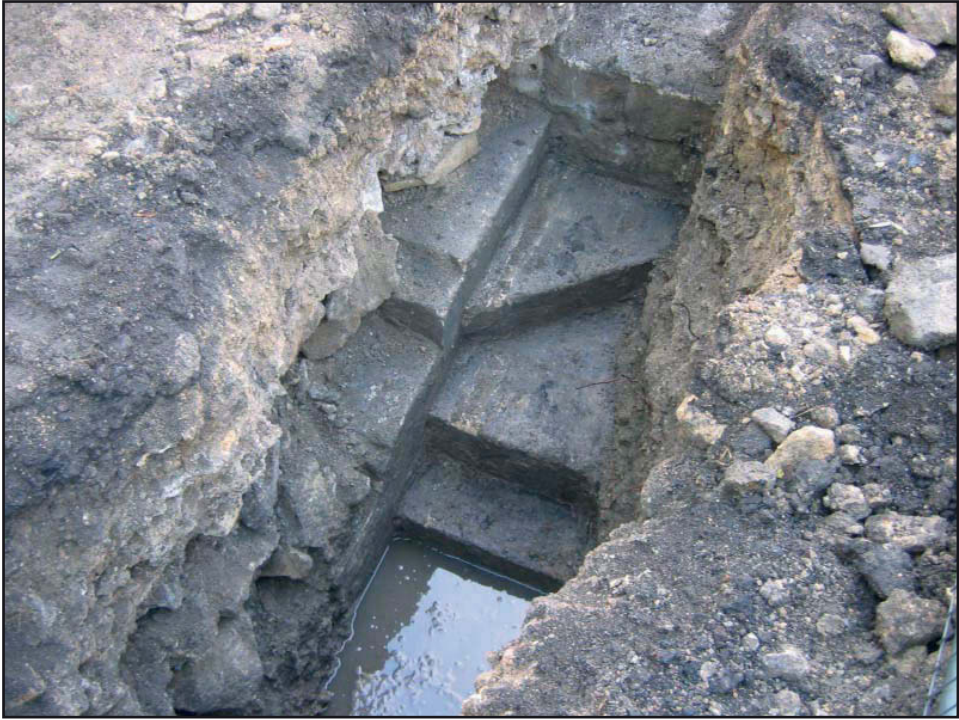
Plate 9: The stone steps down to the "western cellar" seen from the north in Trench 1b. Wall 124 to top of picture

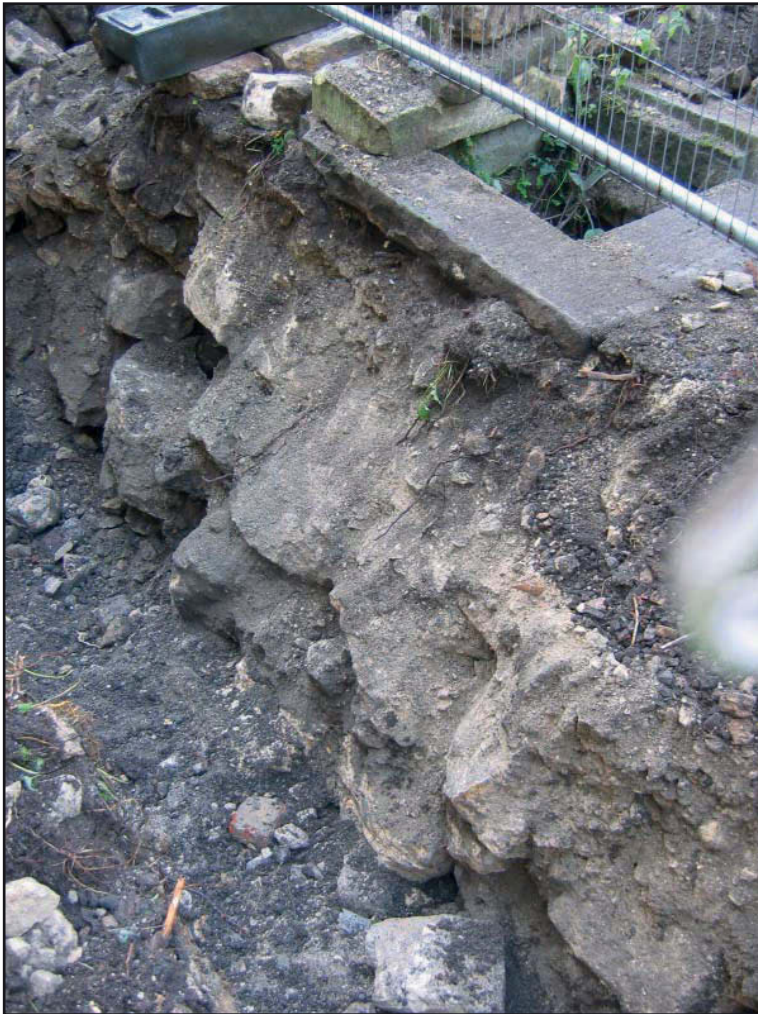
Plate 10: The west side of Trench 1b, showing the water tank's robbed (?) east side and the pennant framed manhole, 133

- 4.3.7 There were more structures to the south and west of the cellar, however. A pennant-stone-framed manhole survived at ground level immediately west of the centre of Trench 1b (133) and this gave limited visual access to an ashlar-built, cellar-like room, with a segmental, ashlar-vaulted roof (134). This was also inspected via two holes where stones were missing (Plate 11). This enabled its internal width to be measured, at 1.28 m, and one end to be identified, 6.3 m from the south external face of the western cellar wall (Fig. 5). The northern limit could not be ascertained.

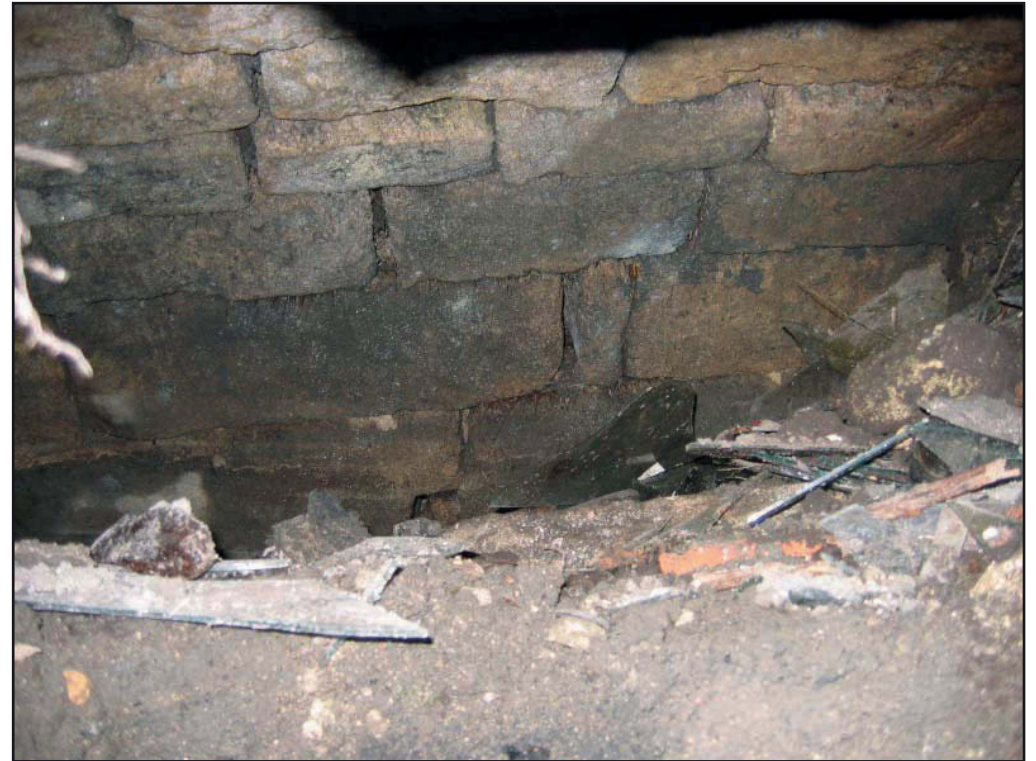
Plate 11: Interior of the water tank next to Trench 1b seen through a void in the side wall, showing it almost full of rubble and rubbish
