# Taunton's College Hill Lane Southampton

Targeted Excavation and Building Recording Report

**Document Title:** Taunton's College, Hill Lane, Southampton

**Document Type:** Building Recording Report

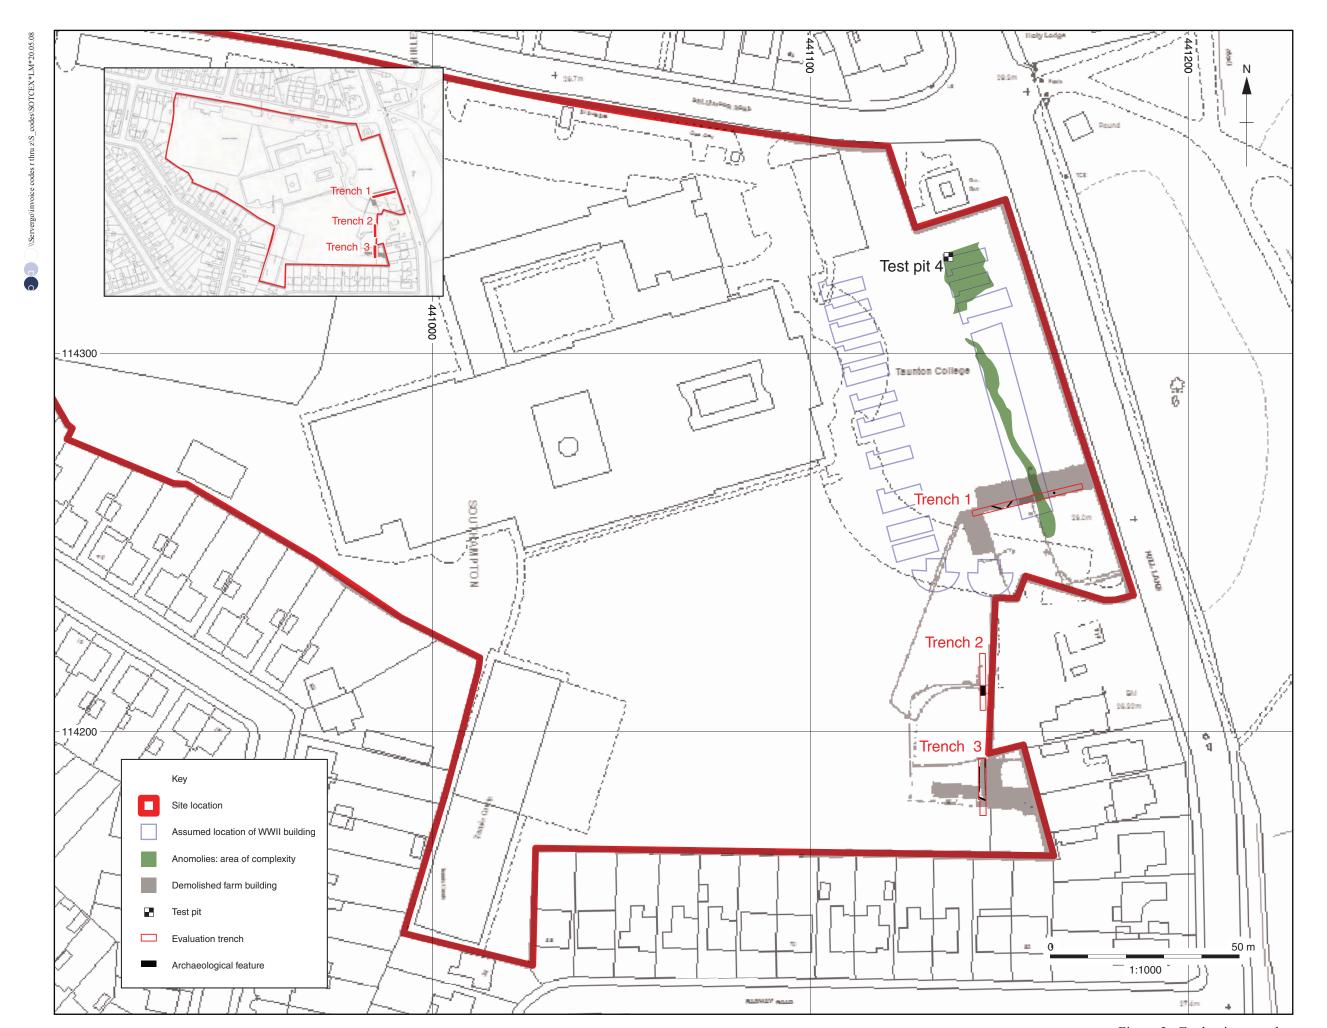
Figure 2: Evaluation trenches

Figure 3: Detail of trenches

- 7.1 Trench 1 (See Fig.2 and 3)
- 7.1.1 Trench 1 was located on the grassed area to the east of the main entrance. It was aligned east-west and measured 30 m by 1.5 m. Natural brick earth (105) was revealed 0.6 m below ground level at a height of 26.80 m OD.

- 7.2 Trench 2 (See Fig.2 and 3)
- 7.2.1 Trench 2 was located to the east side of the college sports pitch adjacent to the eastern boundary of the college. The trench was orientated north-south and measured 15 m long by 1.5 m wide.
