Apprentice Store De Montalt Mill Combe Down Bath

Archaeological Evaluation and Watching Brief Report

June 2006

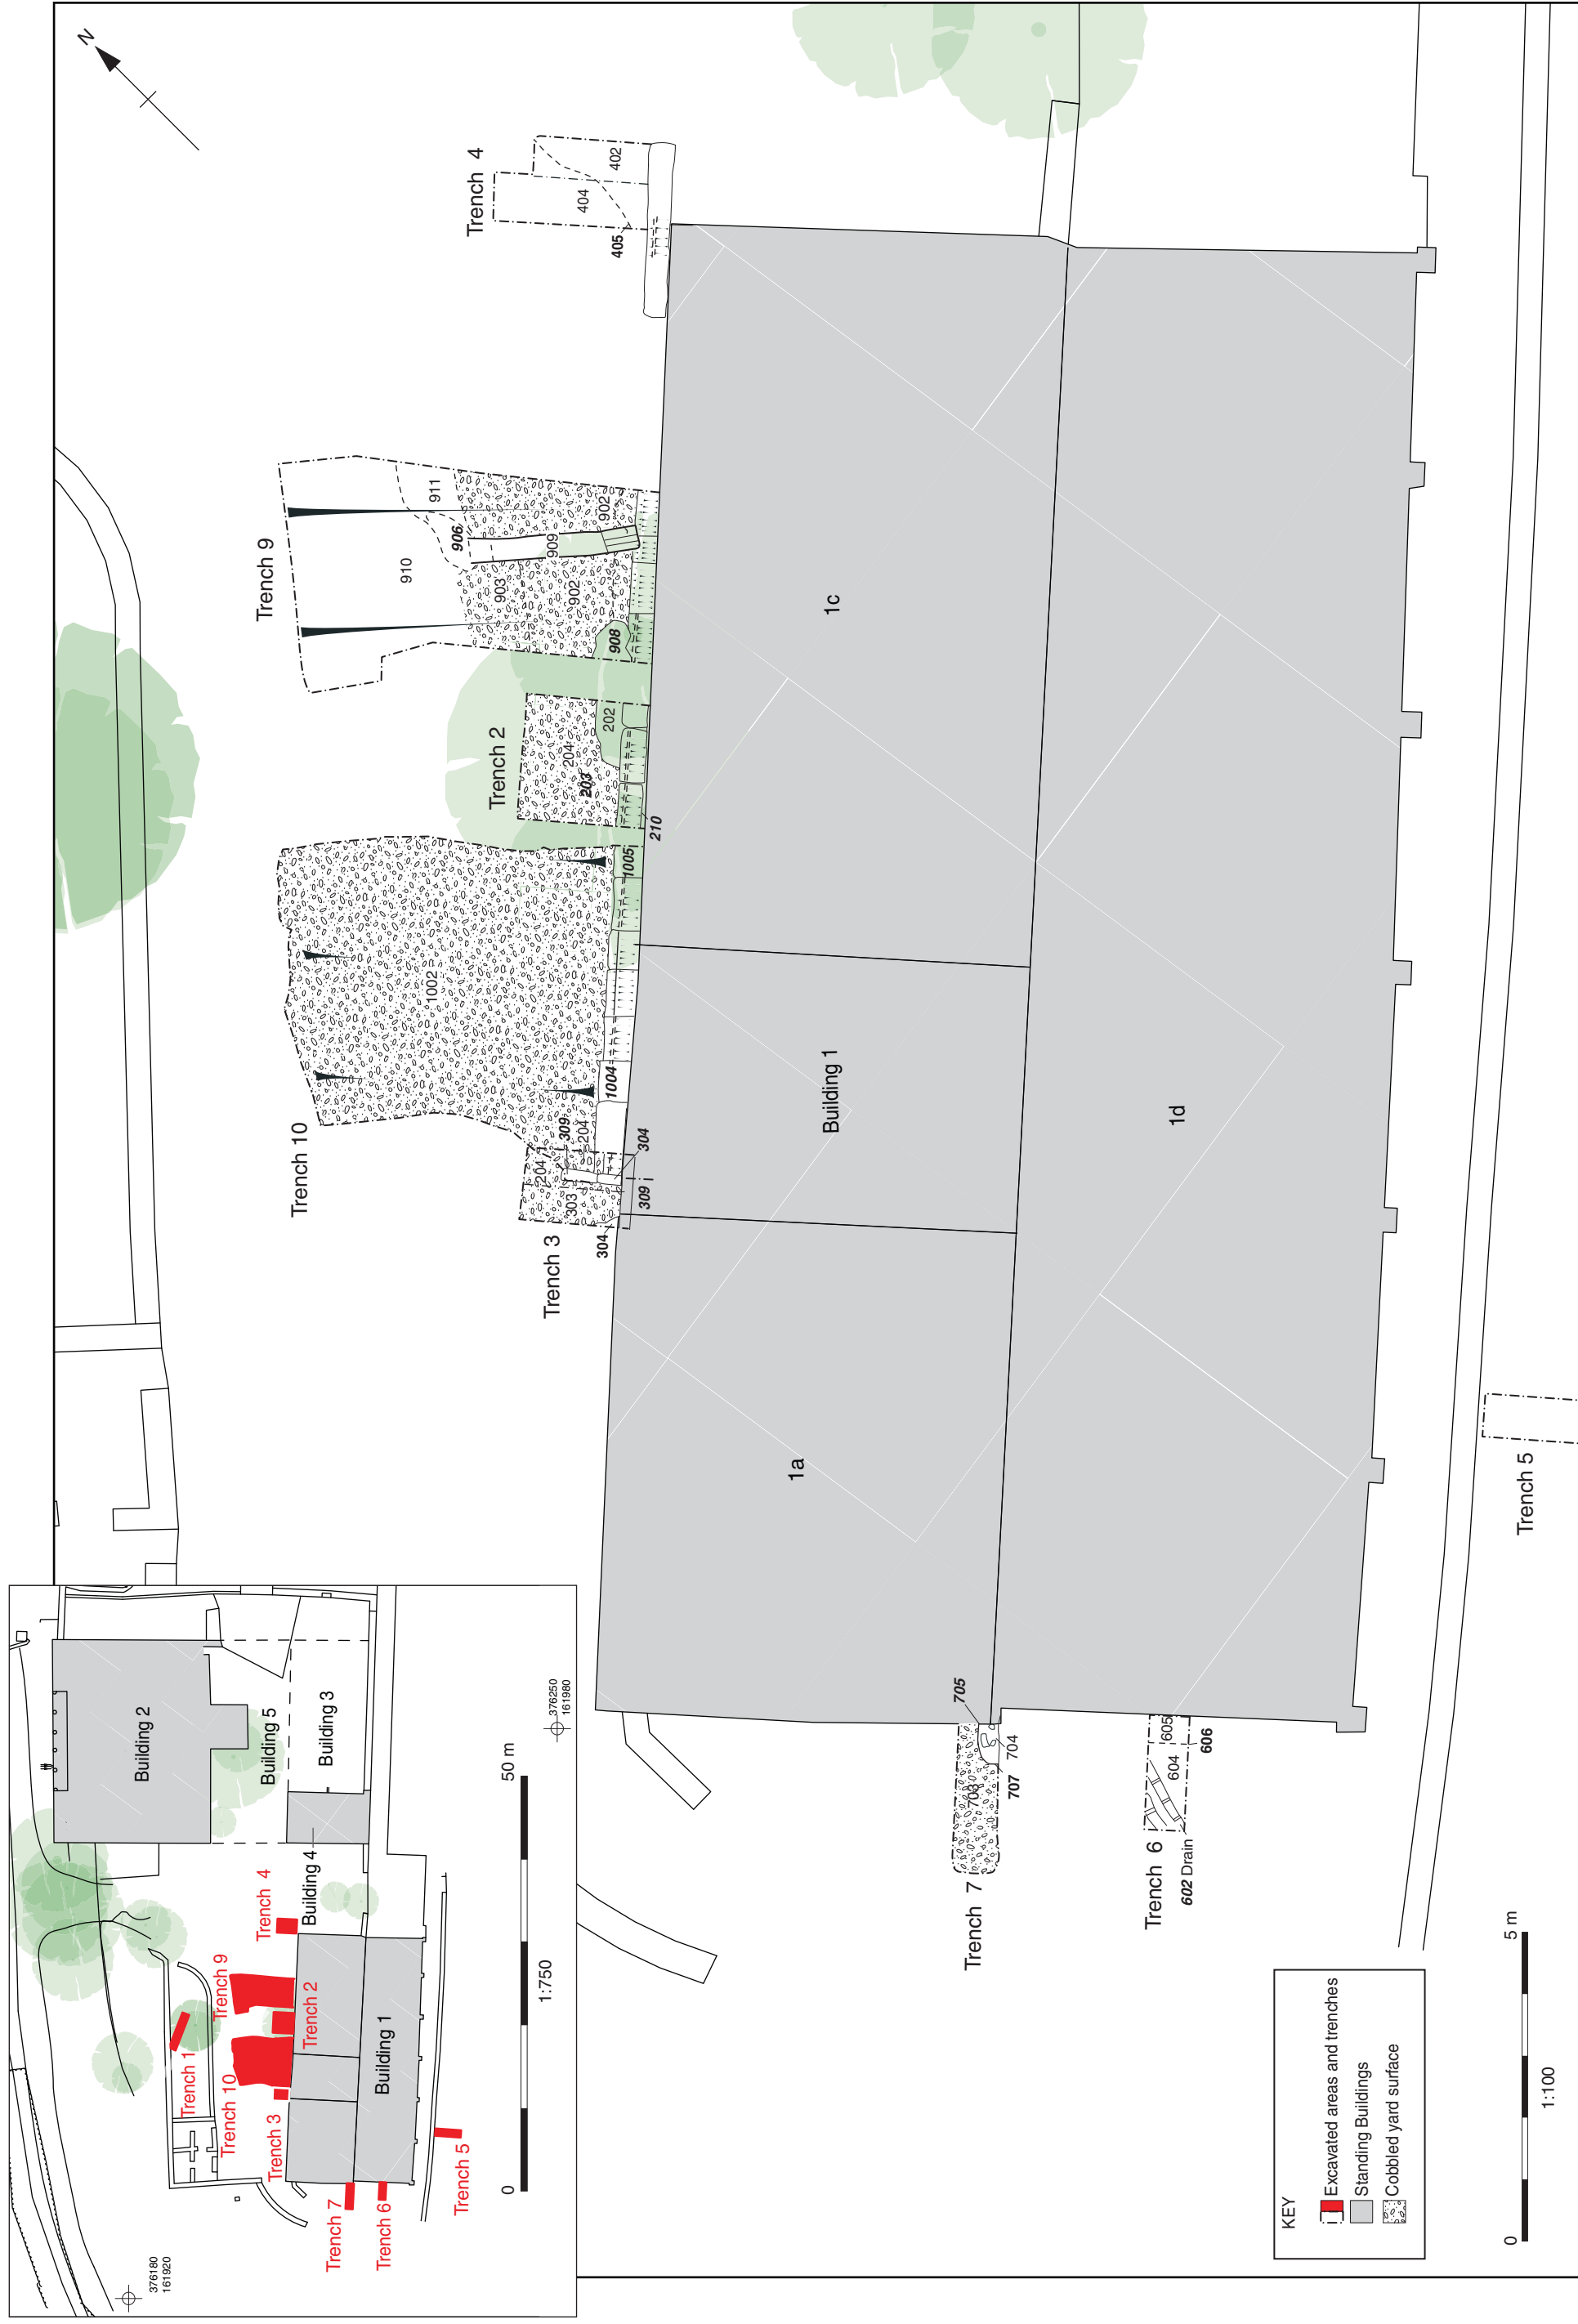
Figure 2: Site plan of De Montalt Mill, Combe Down, Bath
 (based on a survey by H.J. Rees & Company Ltd, Chartered Land Surveyors)

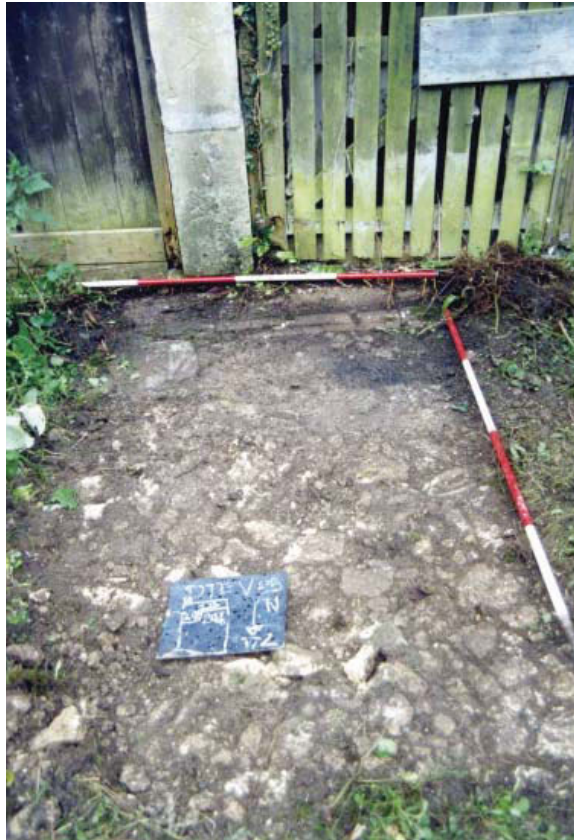
- detail against the retaining wall of the south terrace near to Trench 5.
- 2.2.2 Where archaeological remains were encountered in excavation, the machining was stopped to allow recording. This occurred specifically in Trenches 2, 3, 4 and 7 (e.g. Pl. 1). After recording, the machine excavation continued.

Plate 1: Trench 2 before excavation, showing cobbled surface 204

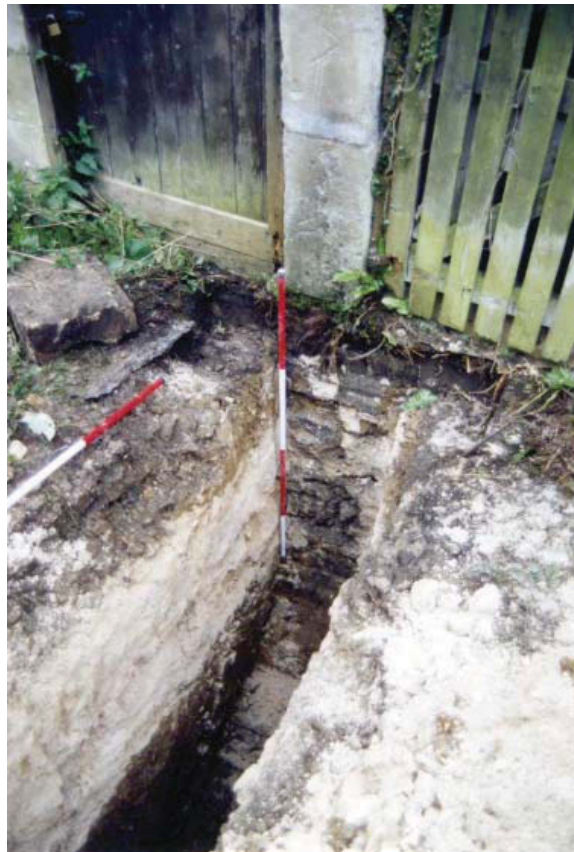
- 3.1.4. On the north of the building these natural subsoils were capped with a dump of greyish white crushed lime stone (103, 206, 305 and 406). This was as much as 1.1 m thick in Tr 2 (Fig. 4 & Plate 2), only 400mm in Tr. 1 and 600mm in Tr. 3 (Fig. 4). It was also about 1 m thick in Tr. 4, but was cut away by a large pit or scoop (405).

- 3.1.5. This seems to represent a deliberate dump of quarry waste to form the foundations for

the yard north of Building 1. It seems to post-date the construction of the footings of Building 1a and b but is cut through by the footings of Building 1c. This is consonant with the phasing of these buildings (see Davenport 2001 and OA 2006b). The present cobbled yard surface is secondary, however, the original perhaps being the quarry waste.

Plate 2: Trench 2 excavated, showing footings of Building 1c and quarry waste make-up, 206

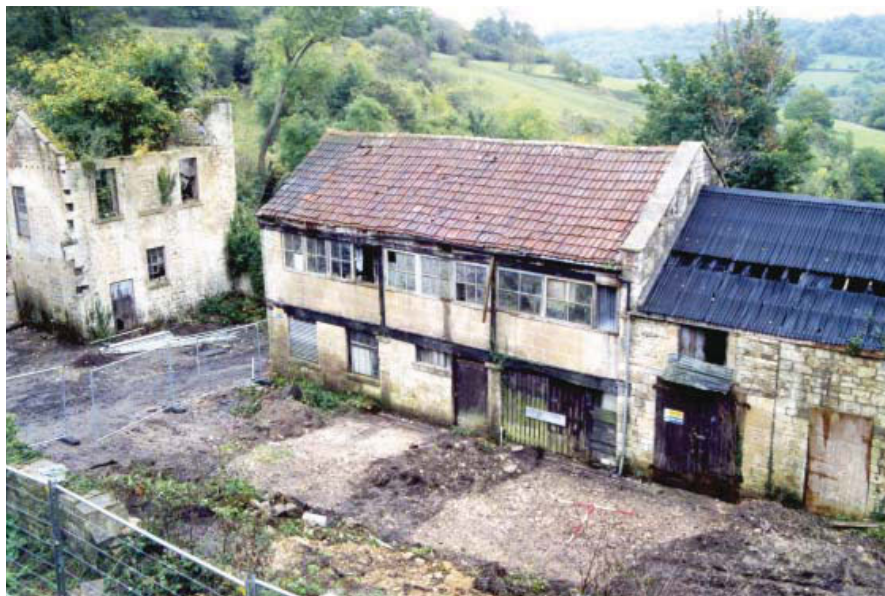
- 3.1.9. Two areas in front of the Apprentice Store were cleared by machine down to the top of the cobbled surface (Tr. 9 and Tr. 10; Fig. 3 and Plate 3). The cobbling was contemporary with the gutters and therefore postdated the construction of Building 1c and was in use contemporary with the other elements of Building 1.

Plate 3: Trenches 9 and 10 from the north west

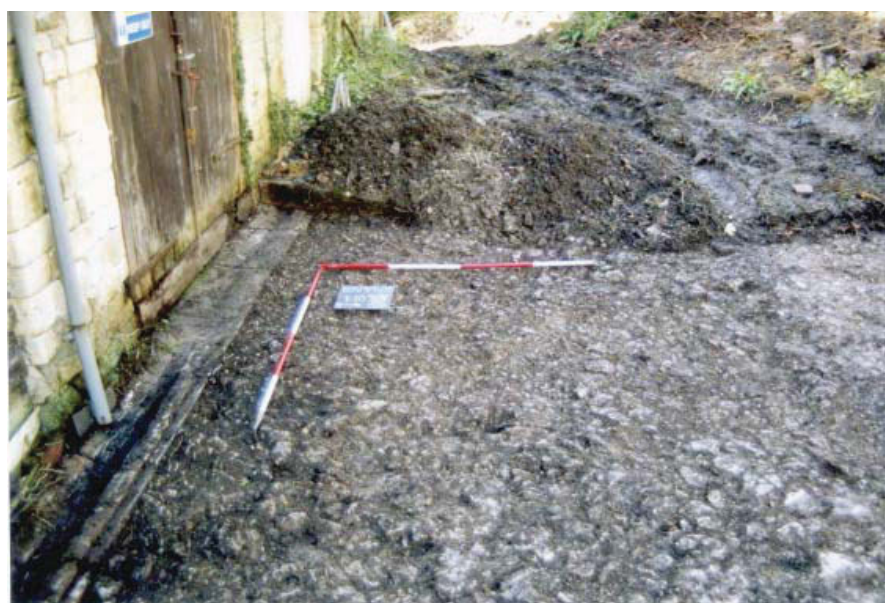
- 3.1.6. The yard was a roughly laid thickness of cobbles set in a grey brown silty sandy matrix which is merely the result of dirt infiltrating during use (204, 303, 402, 703, Pl. 4). It was separated from the north wall of Building 1 by a gutter made from single blocks of Pennant sandstone (203, 403). This gutter continued about two metres across the yard east of Building 1 but did not appear on the west side of the building.

- 3.1.7. The gutter was quite worn in front of the double doors of Building 1b, resulting from the passage of carts or waggons (Plate 4). The wear was not concentrated where wheel ruts might have been expected, suggesting a lot of foot or animal passage in addition.

Plate 4: Trench 10 from the east showing wear in gutter in front of wagon store and quality of cobbling

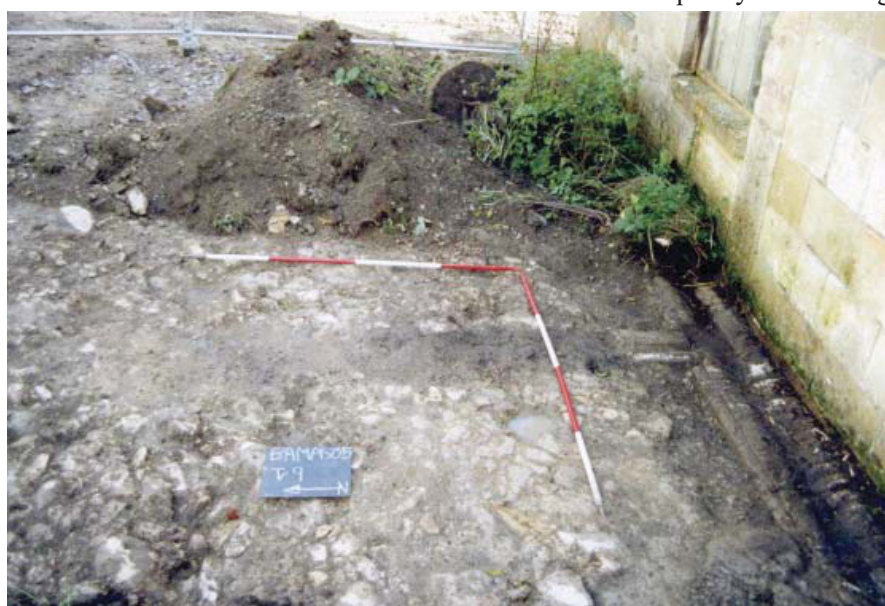
- 3.1.8. A gutter of similar design ran north-south across the yard joining this gutter in Tr.9 (904, Fig. 3, Plate 5). It was robbed out for most of its length. The gutter 203 etc did not continue beyond the western edge of Tr. 10. Here it is blocked by 304, the stone slabs marking the east end of a raised, paved platform in front of Building 1a. The gutter may have run around it. In any case it this platform seems to be contemporary with Building 1a and therefore pre-dates the gutter and cobbling.

Plate 5: Trench 9 from the west showing robbed out course of gutter 904 and its junction with gutter 403
