The Octagon Chapel and Moon and Sixpence Yard Milsom Street Bath

An Architectural and Archaeological Assessment

Oxford Archaeology

September 2005

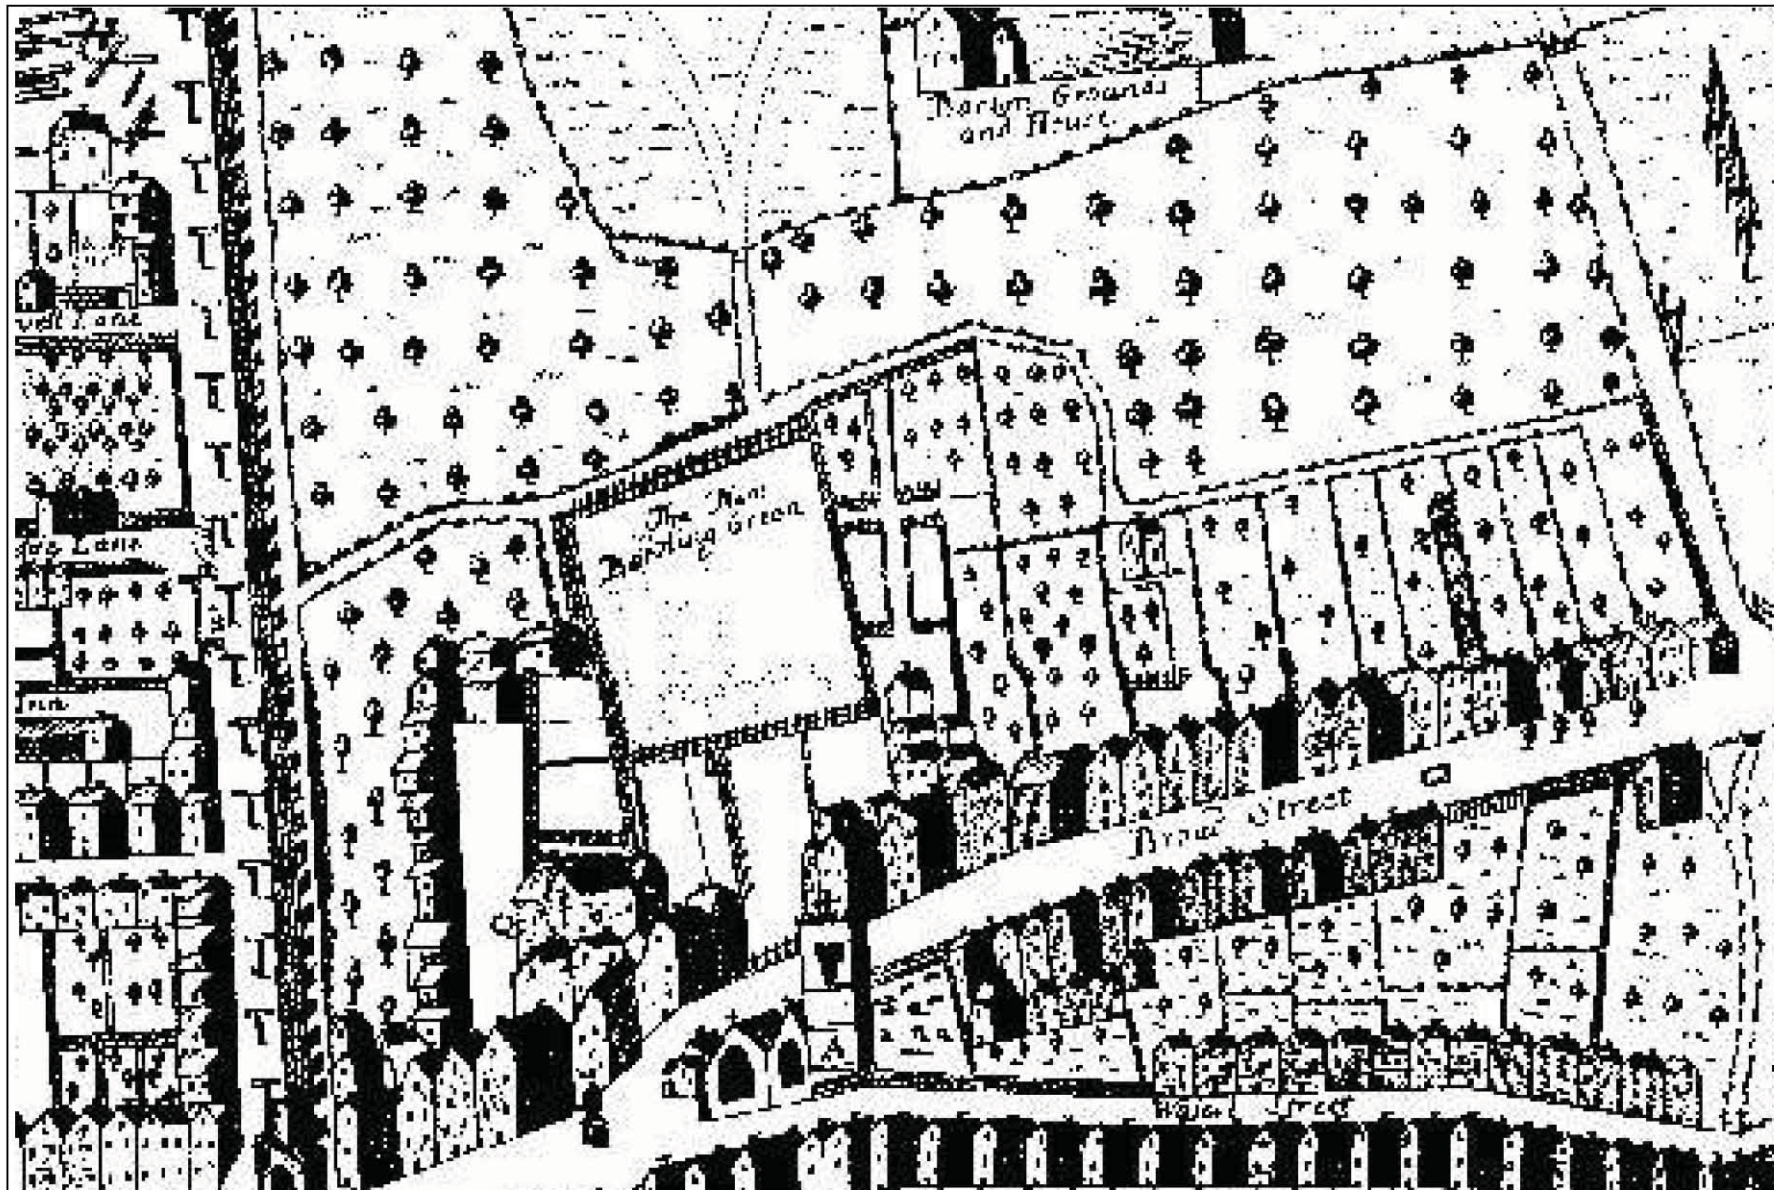
Figure 7. Detail from the Gilmore map of 1694. The bowling green is shown and Green Street was laid out from the gap between the houses opposite the church. The Octagon Chapel was built just north (right) of it. Interestingly, what appears to be the site of Moon and Sixpence Yard is built up even then (bottom right of the bowling green).

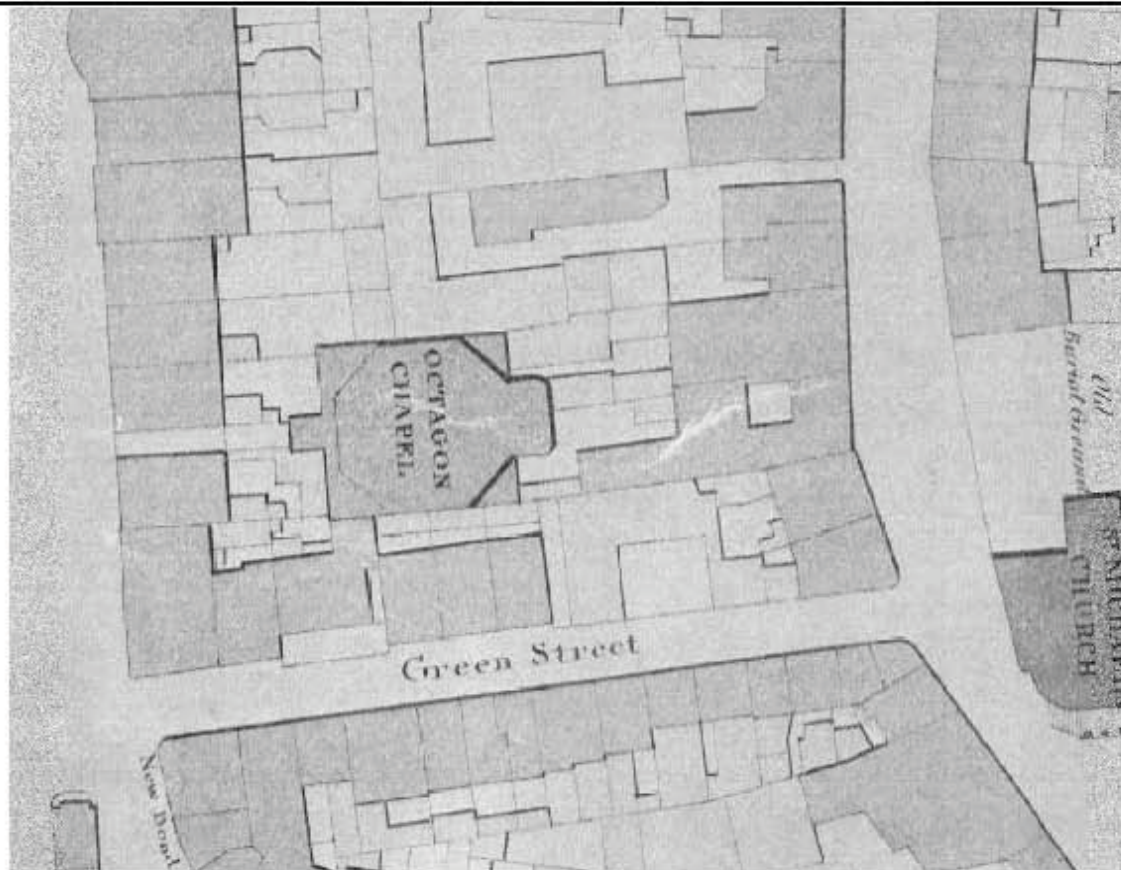
Figure 9. Part of the 1818 survey of the Parish of St Michael, by Manners. He distinguishes the main habitable buildings from lower outbuildings and service wings. The pattern of building shown here hardly changes until the 1970s. Note that his conventions imply that the Milsom Street corridor to the chapel was only one storey high, but that the vestibule was two, the organ recess being over it.

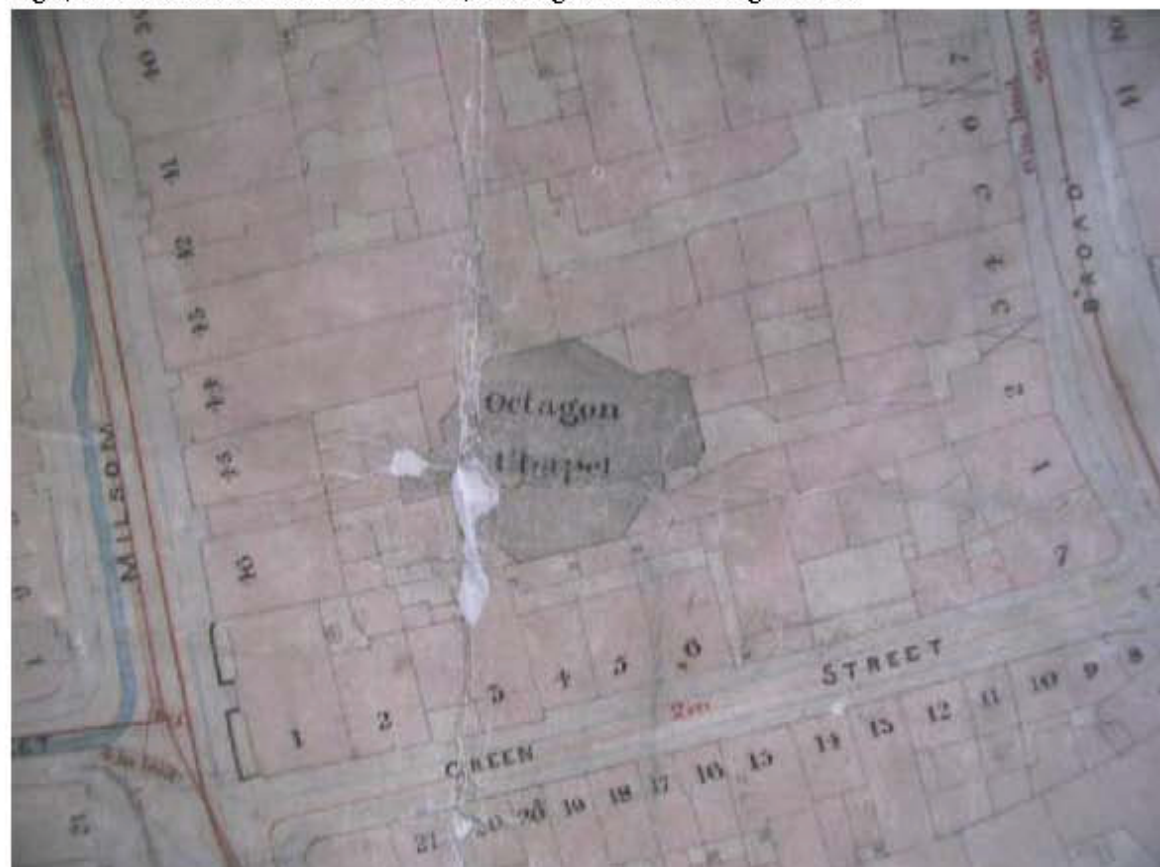
Figure 10. Cotterell's large scale survey of 1853. Very slight changes to the outbuildings can be seen but little else has altered in plan.

giving access also to doors into the vaults under the south east apse. The route is shown clearly on the Cotterell and Spackman survey of 1853 (fig 10 and fig 15).

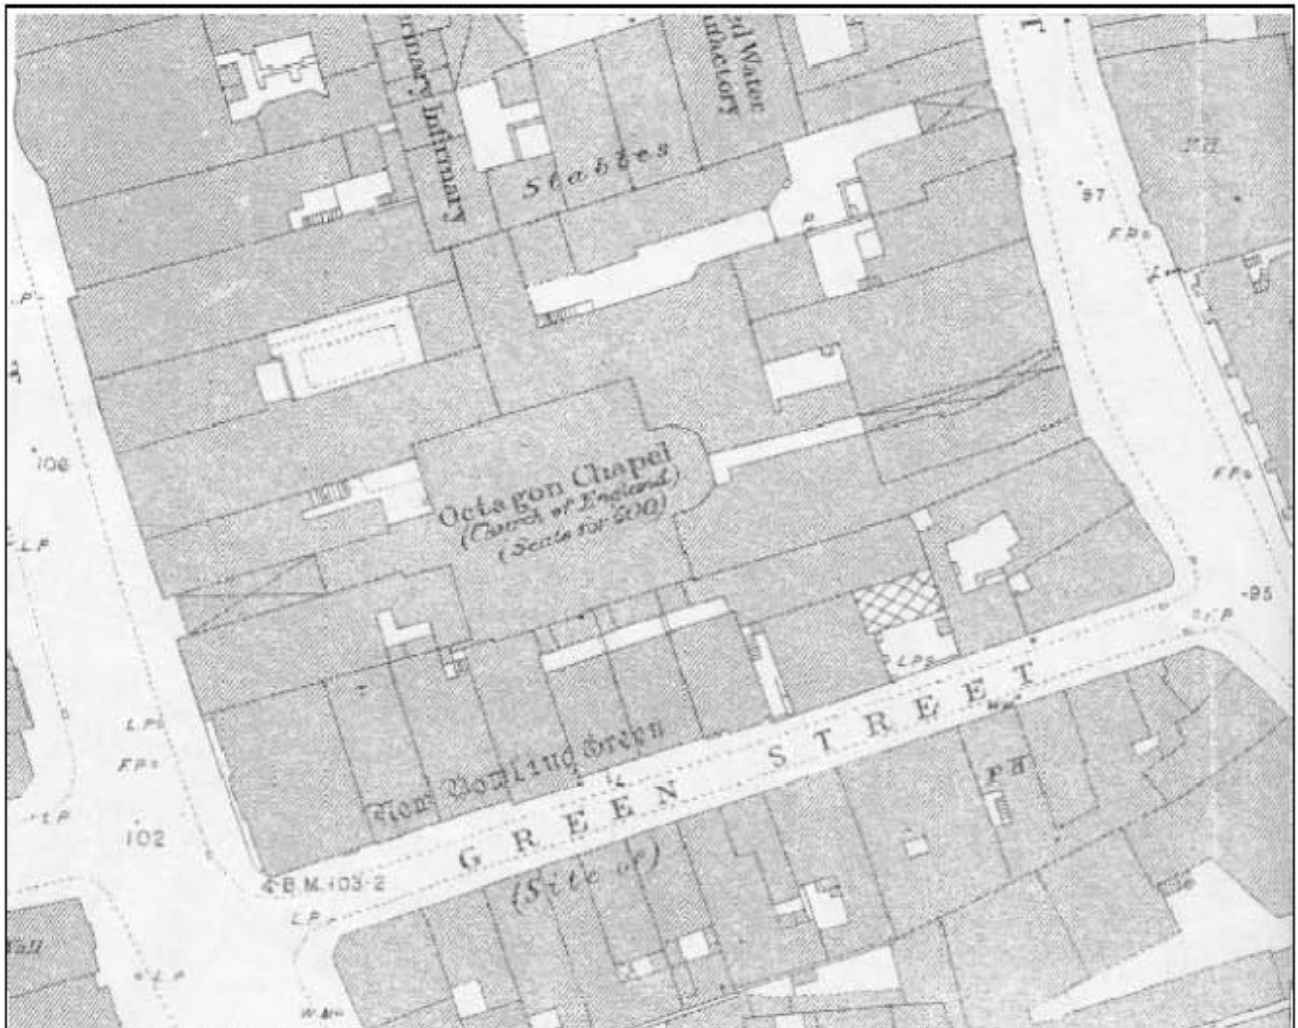
Figure 11. The Ordnance survey 1:500 map of Bath. Detail of the study area. The open fronted shed added after 1853 is visible just below the “s” of stables”. Note altered vaults access and the full width approach to the chapel from Milsom Street. Moon and Sixpence Yard is full of buildings

- 3.2.3 By 1886 (OS map that year - fig 11 and fig 15) this access was completely reorganized and straightened out. It appears that 2 Broad Street was rebuilt completely by that year and the rear yard built over south of the new access route. The details are shown differently in the 1886 map and the 1901 lease. The former bends the alignments a little too much. The building shown is not the present one. However, the masonry ashlar wall which forms the north wall of the ground floor of the cinema, behind the concrete screen wall, has blocked windows, and must be part of the rear north wall of the building shown in 1886. Fragments of this wall probably also still form part of the south wall of the staircase in 2, Broad Street. The rest of this wall dating from 1921 is built of brick.

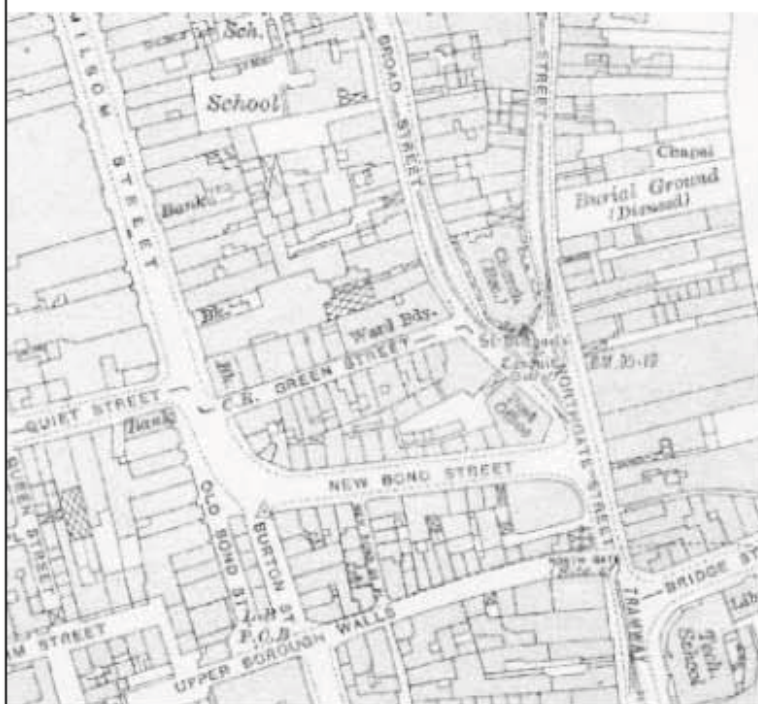
Figure 12. The 1902-4 map shows no changes from the 1886 except for the glass roof over the rear of 2, Broad Street, which does not seem to have existed. The 1930 one reproduced here postdates the rebuilding of no 2, Broad Street in 1921, but still shows the new showroom with the glass roof of 1902. It is probably a mis-planning of the glass roofed building immediately south of the plot in the 1886 map.

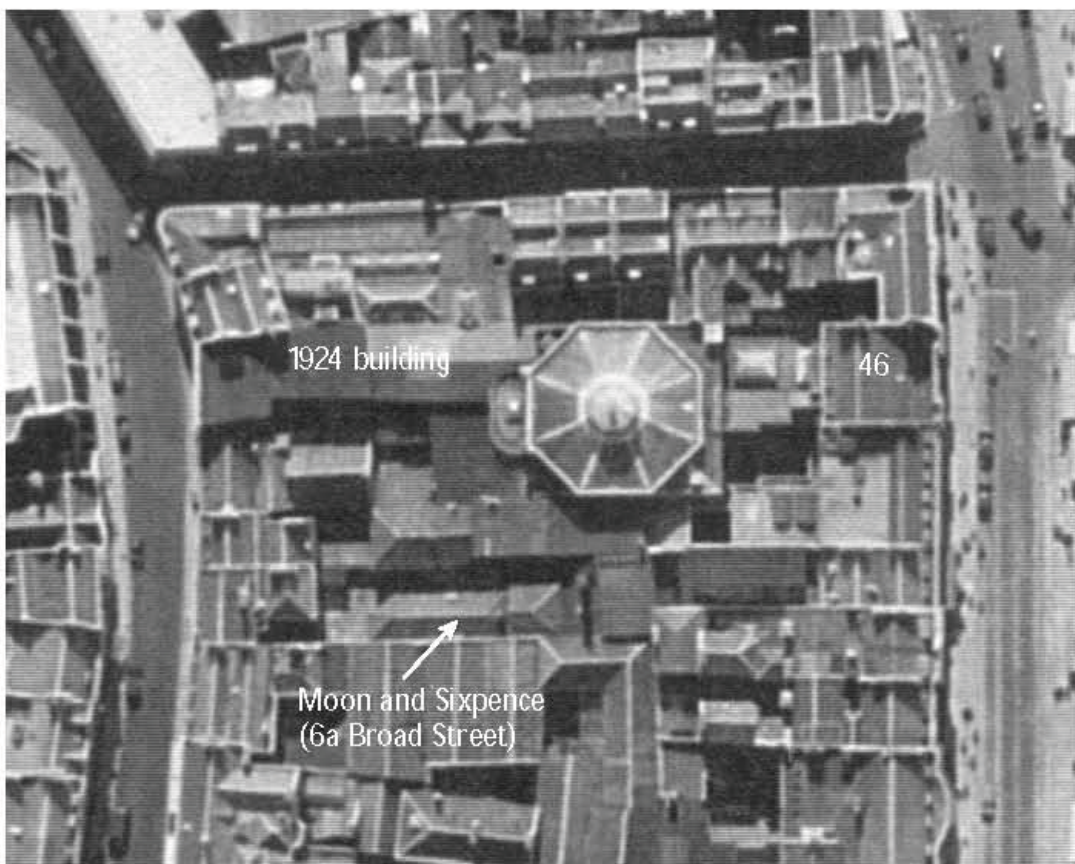
Figure 14. Enlarged detail from an aerial photograph of the area around the Octagon in 1947. It shows how packed with sheds the Moon and Sixpence Yard was. The flat-roofed ones are probably twentieth century rebuilds or alterations.

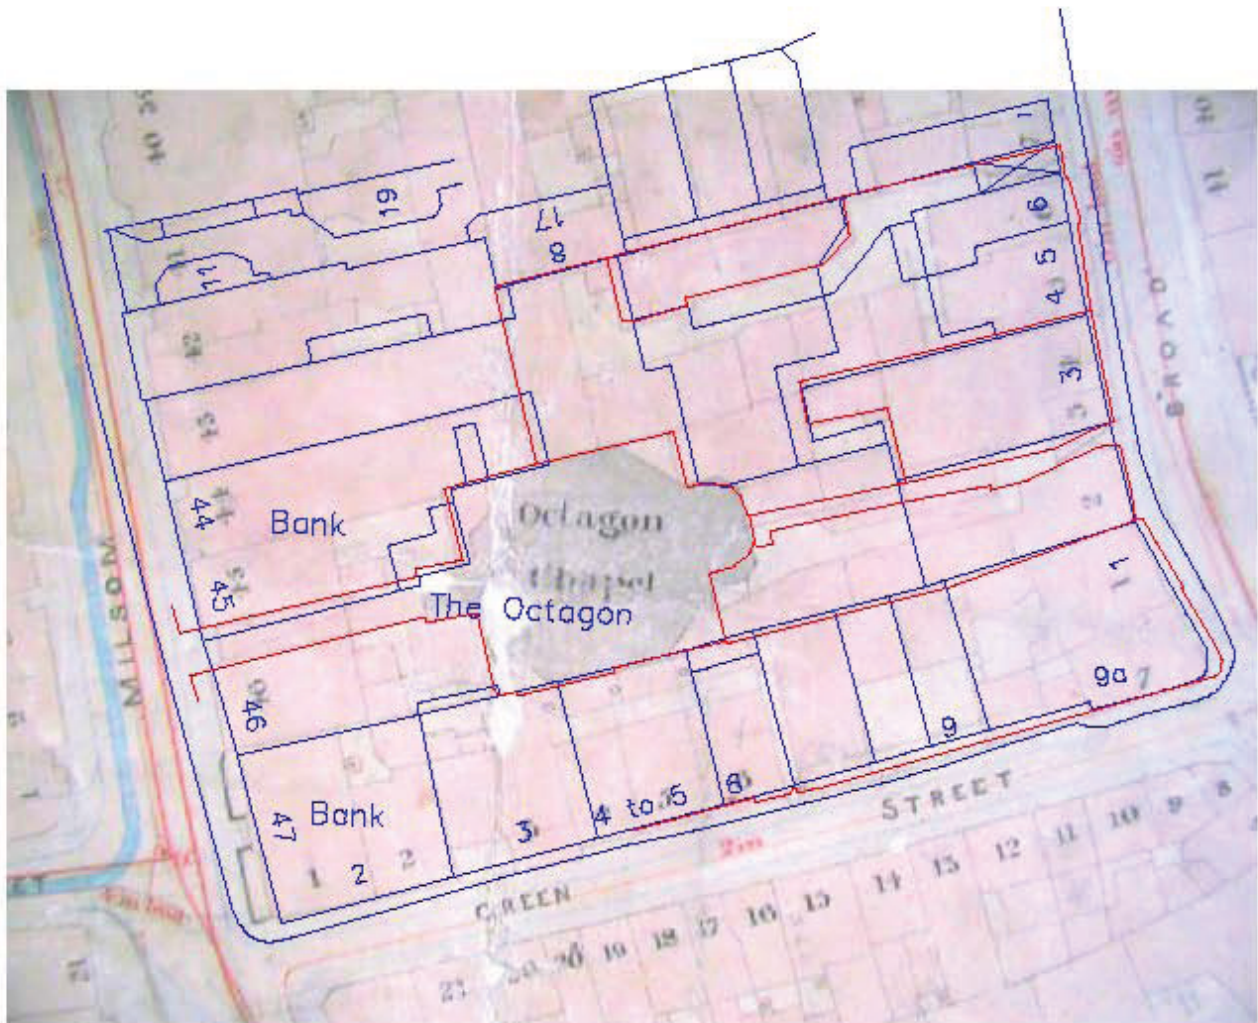
Figure 15. The 1886 property boundaries of 2 and 3, Broad Street in 1886 (in red line) superimposed on the 1853 Cotterell Survey, showing the alterations between those years, mainly the rationalisation of the vaults passage. This suggests that the southern boundary of no. 3 must have been rebuilt. While comparison with the 1901 lease plan suggests that the 1886 mapping is not quite accurate here they both show a realignment of the southern boundary of no 3, Broad Street. It was rebuilt on this new line in 1921. Curiously the modern OS, inaccurately, has reverted to Cotterell's line (blue lines).
