The Octagon Chapel and Moon and Sixpence Yard Broadstreet Bath

Archaeological Watching Brief Report

**The Octagon Chapel and Moon and Sixpence Yard,
Broad Street, Bath,
Bath and North East Somerset**

ARCHAEOLOGICAL WATCHING BRIEF REPORT

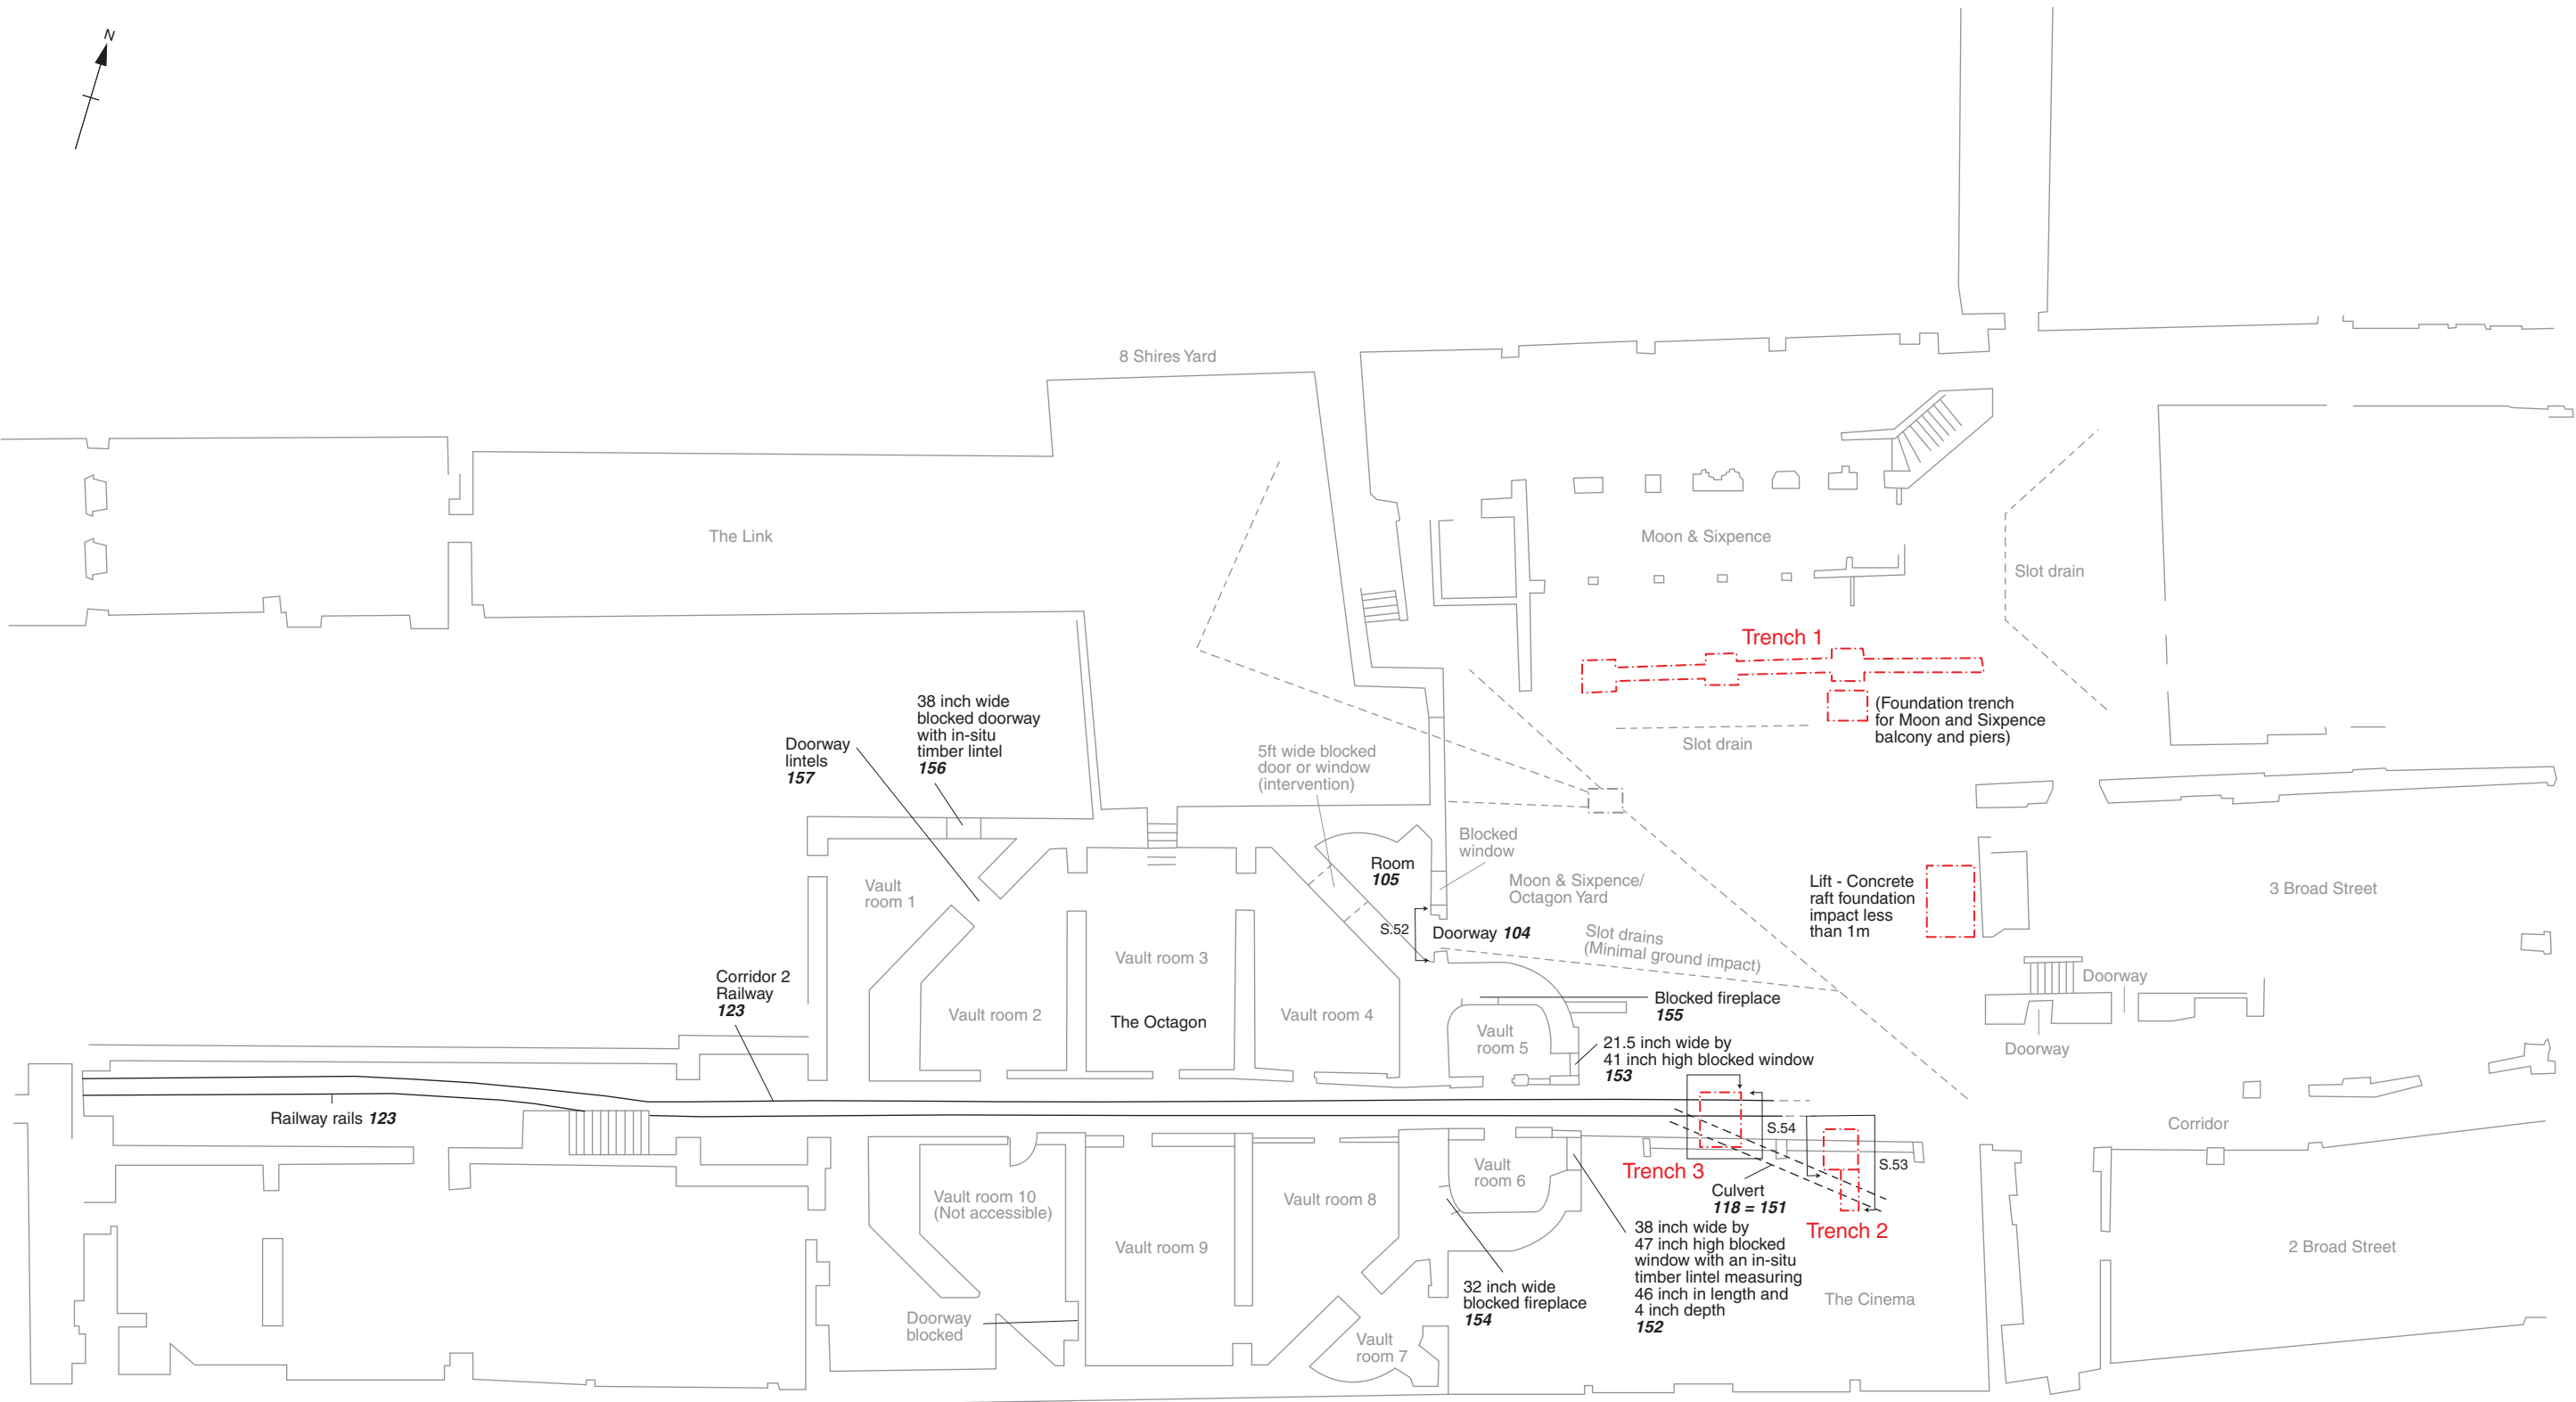
Figure 2: The Octagon chapel building and trench plan

- 4.1.1 The trench was located to the east of the Octagon Chapel within the Moon and Sixpence Yard, close to the southern extent of the Moon and Sixpence restaurant, and was excavated by the principle contractors to form part of the foundations for the Moon and Sixpence restaurant renovation. The trench measured 12 m in length, had an average width of 0.5 m and an average depth of 1.1 m.

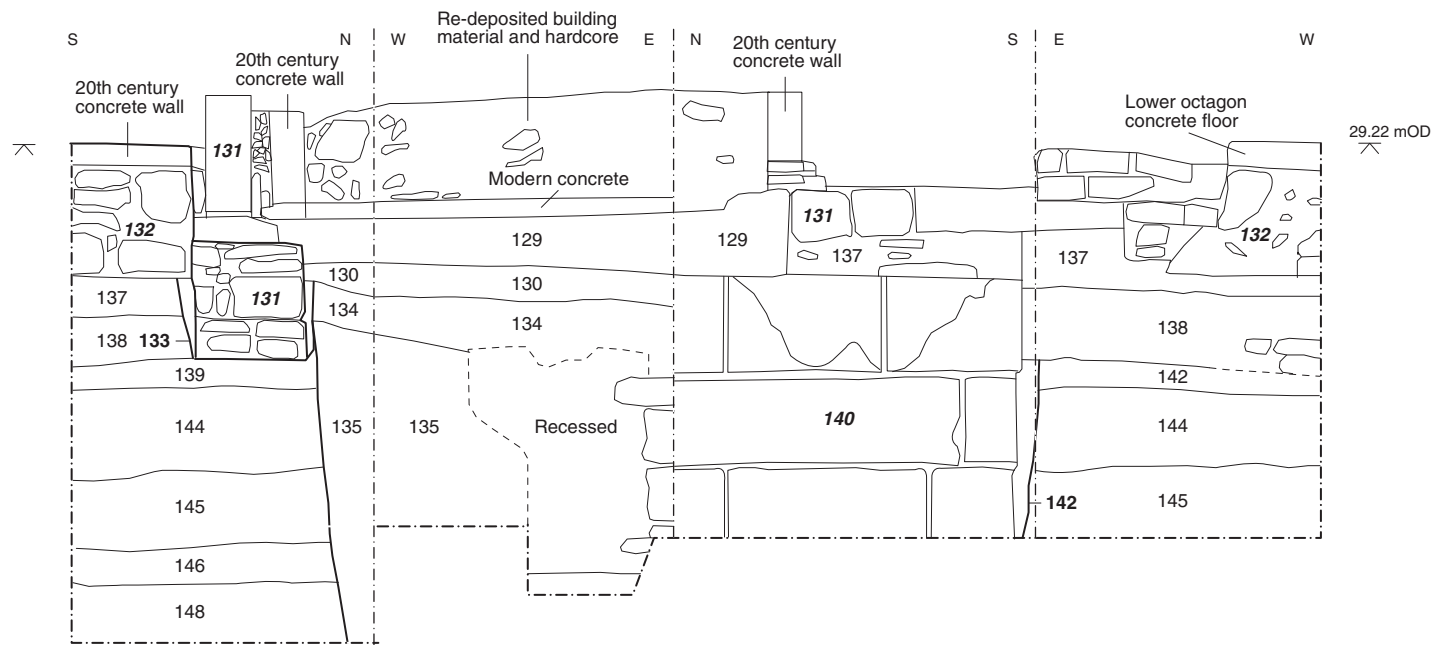
Figure 3: Trench 2, Section 53

- 4.1.4 The earliest deposit encountered within the trench was a possibly natural layer of tenacious yellowish white clay (148) which was excavated to a depth of 0.22 m; or an imported very clean deposit of made ground. The deposit was overlain by a 0.08 m deep layer of mid brown silt clay with charcoal fleck inclusions (147) which has been interpreted as the weathered deposit described above. Layer (147) was overlain by a similar 0.22 m deep deposit of mid orange brown silt clay which may represent an alluvial deposit or clean layer of imported made ground (146). Overlying this was a 0.26 m deep layer (145) of dark brown silt clay loam (as seen in Trench 1) with a large part of the matrix consisting of mixed charcoal. The layer probably represents an medieval occupation layer or topsoil although no finds were recovered to date the context. The layer was overlain by a 0.28 m deep layer of mid greyish brown silt clay loam (144) with several lenses of material, suggestive of a gradual formation process.

- 4.1.5 Deposit 144 was overlain by two layers attributable to the same deposit, (139) and (143). The layer was 0.10 m deep throughout and consisted of a tenacious, mottled light and mid brown silty clay with frequent mortar and lime flecking. The layer represents an imported make-up layer. Layers (139) and (143) were both cut by a 0.90 m deep and narrow construction trench for the construction of Structure (140) at their northern limits, and were also cut by the construction cut (150) for Culvert/Drain (151) at their southern limits.

- 4.1.8 The structure (140) had four courses of Oolitic Limestone ashlar blocks and survived to a height of 1.22 m, with a width of 1.08 m. The blocks (measuring 370 mm x 290 mm x 380 mm) were laid directly on a natural layer (148) at the base of the construction trench (Plate 2). The blocks had been squared and finished/smoothed with a masons drag and were bonded in thin bedding joints with a compact, light-mid grey lime mortar with charcoal fleck inclusions. The structure has characteristics of 18th century build and may have formed the foundation of a much larger structure that has subsequently been truncated.

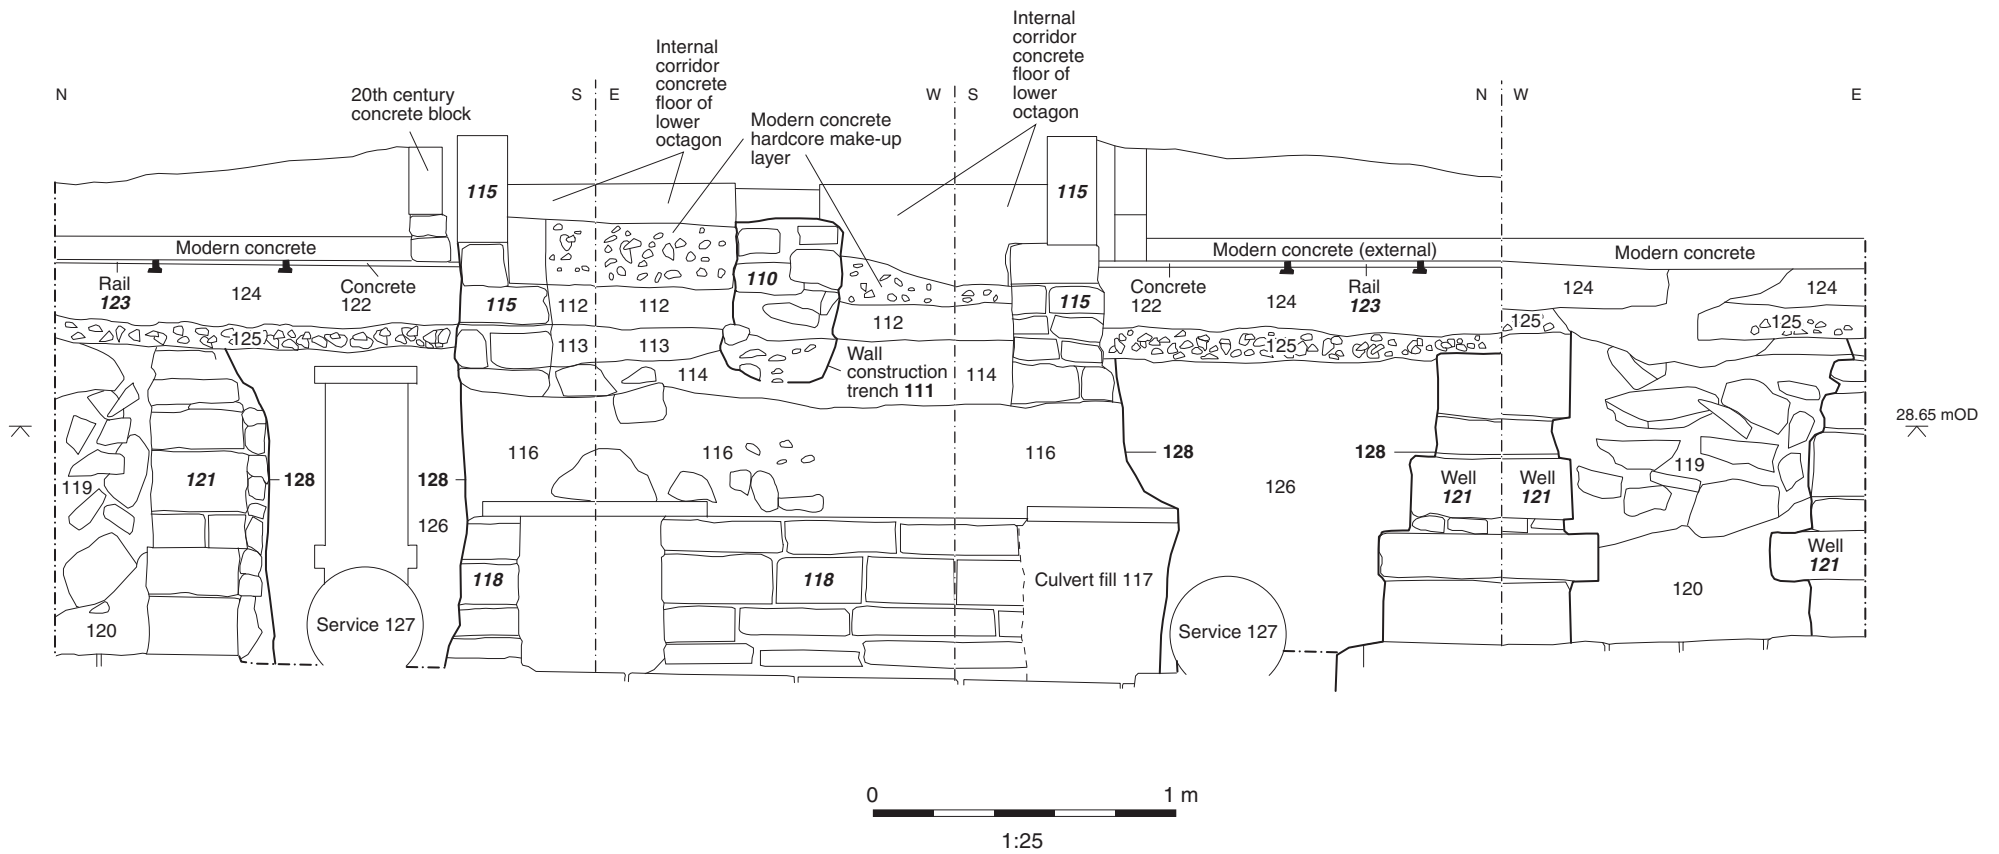
Figure 4: Trench 3, Section 54

- 4.1.14 The earliest features that were encountered within the trench were a well (121) and culvert (118), both the structures have been largely truncated by the 20th century service drain cut (128); which is the same feature as (136) located in Trench 2.

- 4.1.15 Well structure (121) was located within the northern and eastern corner of the trench and was constructed in at least seven visible level courses of randomly placed Pennant Sandstone (measuring 300 mm in length and 230 mm in width and 170 mm depth). The sandstone does not appear to have been bonded with any conventional mortar and has been packed with clay throughout the exposed structure. The well was filled with at least two layers. The lowest fill (120) had a minimal depth of 0.16 m and was a friable, light grey clayey silt with mortar flecking throughout. This was overlain by the uppermost fill (121) which was a loose dark grey clayey silt and sandstone rubble, derived from the demolished upper section the well. Fill (121) was subsequently overlain by a 0.12 m deep layer of limestone aggregate make-up (125), representing the same deposit as layer (130) in Trench 2. This was the make-up layer for concrete surface (124).

- 4.1.18 The culvert/drain construction cut was not visible within the trench and was overlain by a 0.42 m deep layer of tenacious, mid brown mixed clay and garden soil deposit (116), similar to that noted within the construction trench noted within Trench 2. This was overlain by a 0.22 m deep layer of friable, mid greyish brown clay silt loam which was a re-deposited garden soil 114.

- 4.1.19 Soil layer 114 had been cut by the construction trench (111) for Wall (110) and probably by the construction of Wall (115) although the actual construction cut was not visible. Wall (110) represented the foundation of a previously demolished wall and survives to a height of 0.64 m, with a width of 0.34 m. It was constructed of randomly placed Pennant sandstone (measuring 180 mm x 90 mm x 80 mm) and Oolitic Limestone rubble (measuring 170 mm x 110 mm x 70 mm) and bonded with a compact, mid grey lime mortar. The wall is attributable to the early 19th century and probably a contemporary build to Wall foundation (115).

- 4.1.20 Wall (115) comprised a buried foundation and upper exposed level. The foundation survived to a height of 0.54 m with a width of 0.38 m, and was constructed with randomly placed Pennant sandstone and Oolitic Limestone rubble and was bonded with a compact, mid grey lime mortar. The upper part of the wall was constructed of Oolitic Limestone ashlar blocks and survived to a single course, and a height of 0.40 m. The wall was orientated east-west and represents the same build as wall (131) within Trench 2.

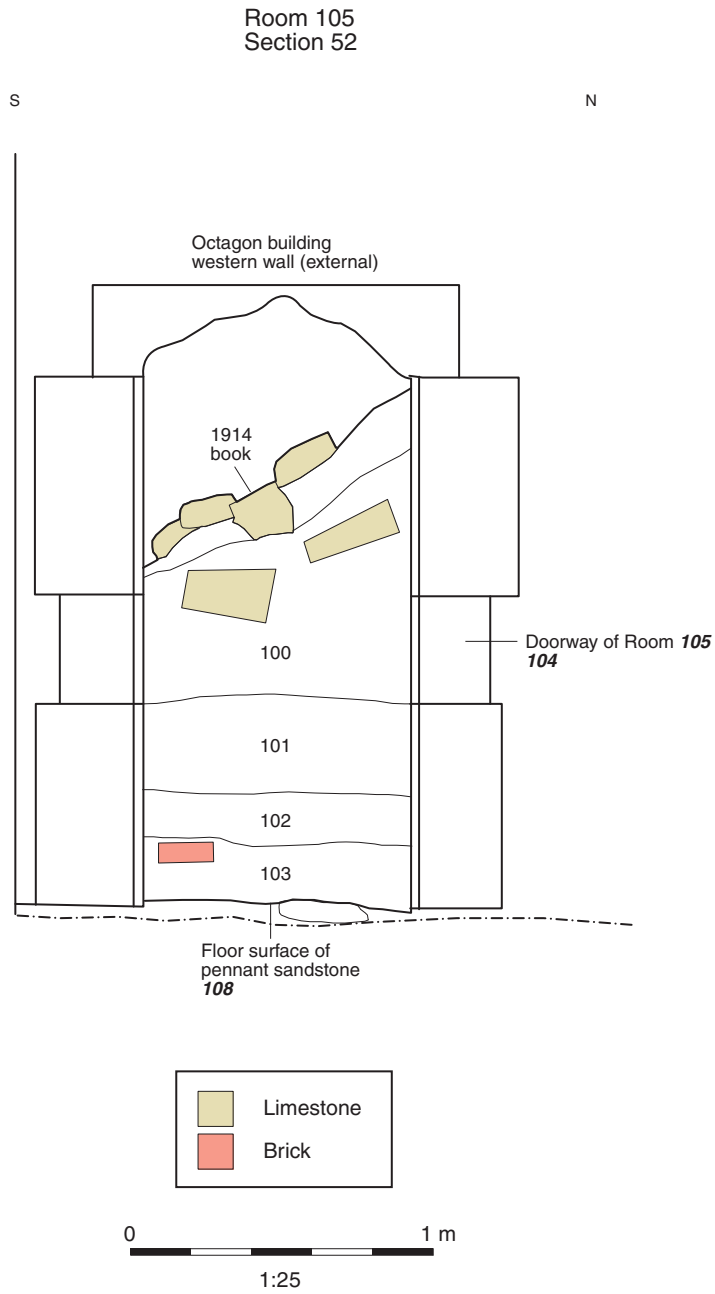
Figure 5: Room 105, Section 52

- 4.1.24 The room measures 4.8 m in length along its principle wall, measures 2.6 m in width, and the north-western wall has a rounded profile. The room would have originally been accessible through an internal doorway to Vault Room 4, which has subsequently been blocked, and by an external doorway (104) opening onto the Moon and Sixpence Yard. Room 105 was located beneath a side room on the Octagon Chapel ground floor with a single fireplace. The floor plan of Room 105 mirrors the plan of Vault Room 7 on the south-eastern side of the chapel building and both appear to have been linked to the floor above by flues.

- 4.1.28 Structure 107 was abutted by several layers of mixed sand, clinker and rubble that were all deposited throughout the limits of Room 105. The earliest of these was a 0.22 m deep layer of loose light grey ash and clinker waste (103), possibly attributable to farriers waste associated with the structure 107. Overlying this was a 0.18 m deep layer of light brownish grey silt clay and mortar (102). This was sealed by a 0.32 m to 0.46 m deep layer of dark brown and black clay sand (101). Layers 101 and 102 are probably attributable to farrier's waste. Several iron farriers tools were recovered from either layer 101 or layer 102, and included three individual tongs, one for holding round, one for forming or bending and the third of a more general type. Also recovered were a rasp file and part of what could be part of an iron

- 4.1.30 Overlying the farriers waste deposits was a 1.10 m deep layer (100) of mid-dark greyish brown ash, clinker waste and mixed rubble. Fragments of brick and limestone rubble and squared blocks of Oolitic limestone blocks were noted throughout. An incomplete newspaper published by the 'Wilts Chronicle & Herald', and dated to May 17th 1926 was recovered from on top of the layer.

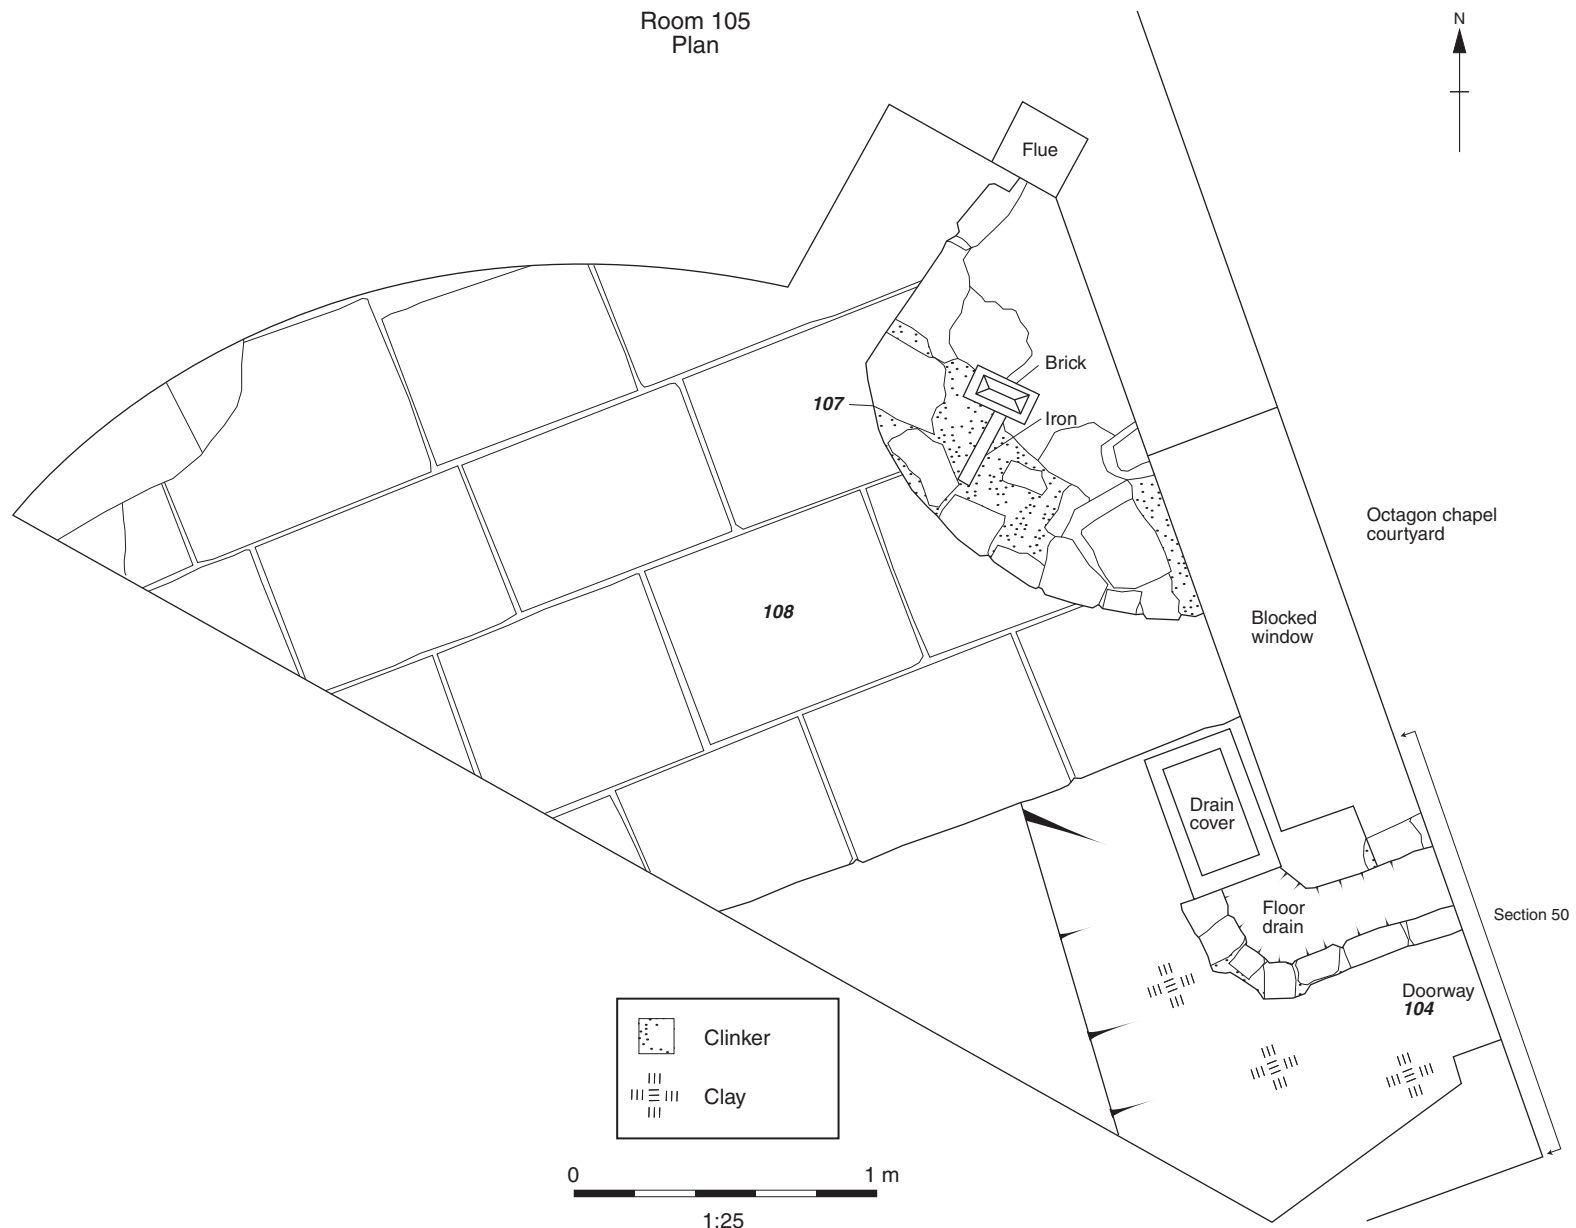
Figure 6: Room 105, Plan 50

- 4.1.25 The earliest feature located in the room was a 0.20 m wide and 0.26 m deep drain constructed with and lined with roughly hewn limestone. A Pennant sandstone drain inspection cover, measuring 0.50 m by 0.30 m, was also located (Fig. 6). The drain was located beneath the external doorway (104) and fed into an east-west orientated length of drain which was discovered 15 m to the east within the Moon and Sixpence Yard. Overlying the drain was a well constructed flagstone floor of Pennant sandstone, bonded with a mixture of mid grey lime mortar and brown clay. The flagstones had an average size of 0.76 m by 0.30 m. An area of the flagstone floor in the entrance to the room had subsequently been removed prior to the investigation and revealed the floor make-up layer of mixed grey lime mortar and brown clay. The Pennant sandstone floor and drain are thought to be original features attributable to the primary Octagon Chapel construction.

- 4.1.26 A semi-circular structure (107), located in the north-eastern corner of Room 105, was constructed upon the flagstone floor. The structure measured 1.60 m in length, 0.80 m in width and had a height of 0.82 m. The structure was constructed in five courses of roughly hewn and squared Pennant sandstone (measuring 220mm x 110 mm x 70 mm) bonded with a compact mid grey lime mortar containing large flecks of charcoal and lime throughout. A single red brick (measuring 225mm x 105 mm x 70 mm) and an associated iron strip were also noted within the upper surviving course of the structure, but are thought to have no specific function as it was clear that the upper part of the structure has been truncated.

- 4.1.27 The structure is thought to be associated with a secondary use for Room 105, possibly by a farrier, in the 19th century and is thought to be a farrier's working bench.

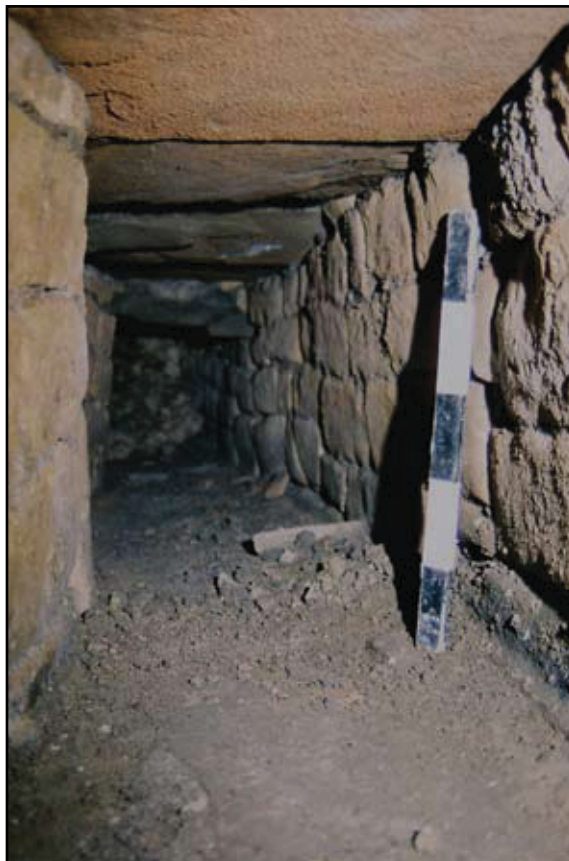
- 4.1.6 Culvert/Drain (151) (Plate 1) was uncovered in the southern extent of Trench 2 when the trench was subsequently extended and was orientated WNW-ESE (Fig 2). Its construction trench was approximately 1.0 m in depth and at most 0.10 m in width

and extended above the level at which the Culvert had been laid; it had been filled with mixed clay and a garden soil deposit (149). The visible part of the Culvert had an internal width of 0.48 m and a height of 0.50 m. The sides of the culvert were constructed in fairly level courses of randomly placed and roughly squared Oolitic Limestone blocks (measuring 4600 mm x 100 mm and 360 mm x 160 mm). The base and top of the culvert were constructed/capped with Pennant sandstone slabs (measuring 740 mm in length and 50 mm in depth). The structure was bonded throughout with a compact mid grey lime mortar with charcoal flecking.

- 4.1.7 The drain had collapsed in several places and had a minimum length of 12 m. It was seen to extend towards the west and noted within Trench 3 (118), and also seen to extend eastwards beyond the limits of excavation in the direction of Broad Street. The culvert has a similar mortar type to that used in Wall (140) and was probably constructed in the 18th century.

Plate 1: Trench 2 Culvert (151) looking south-east

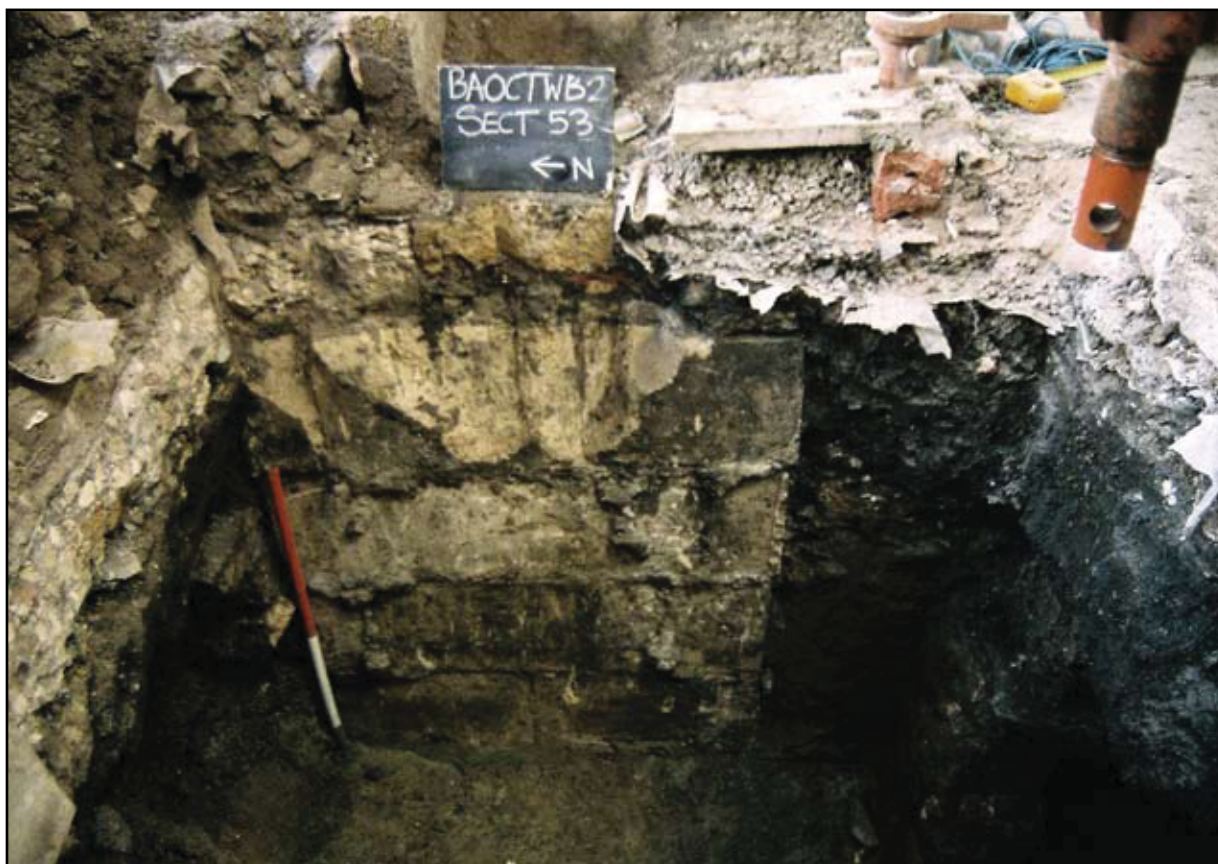
Plate 2: Trench 2 west facing Section 53 Wall (140)

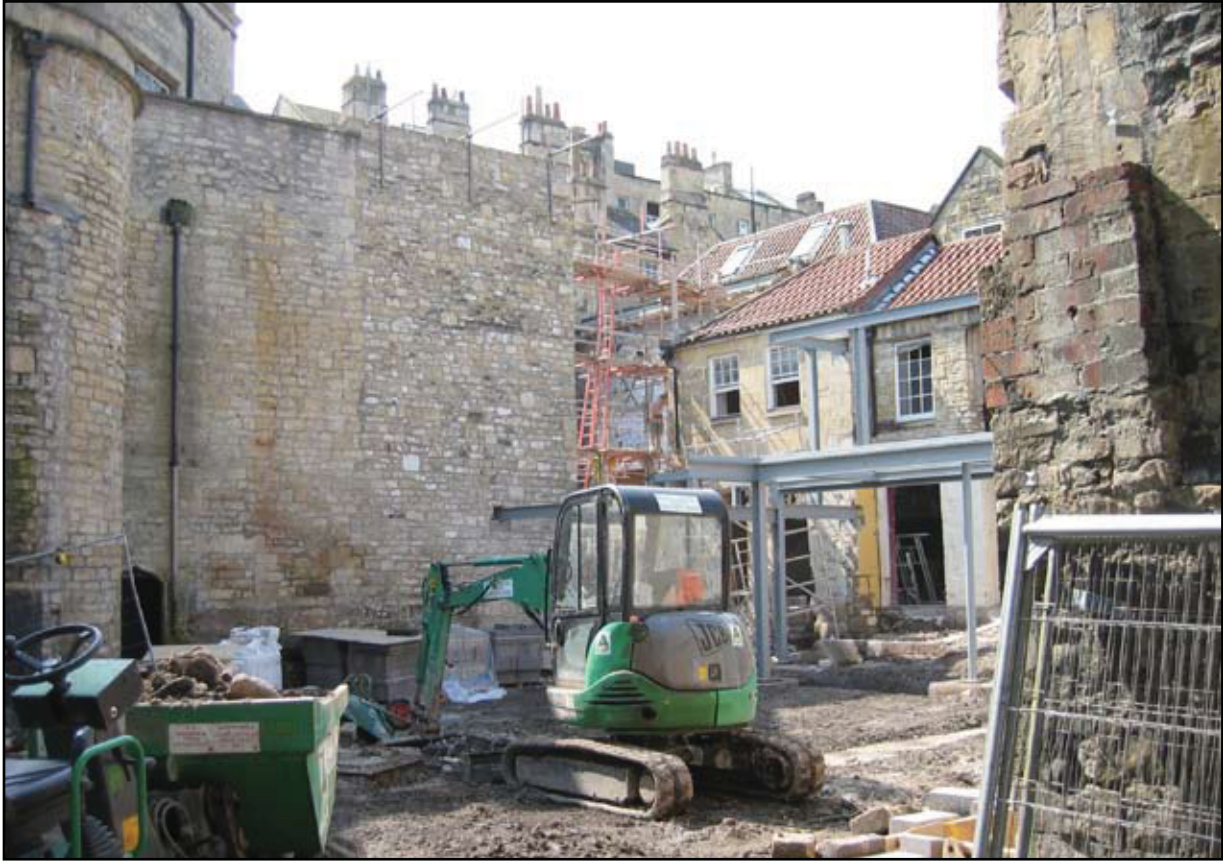
Plate 3: Western wall of Octagon Chapel and blocked Doorway (104) looking north-west

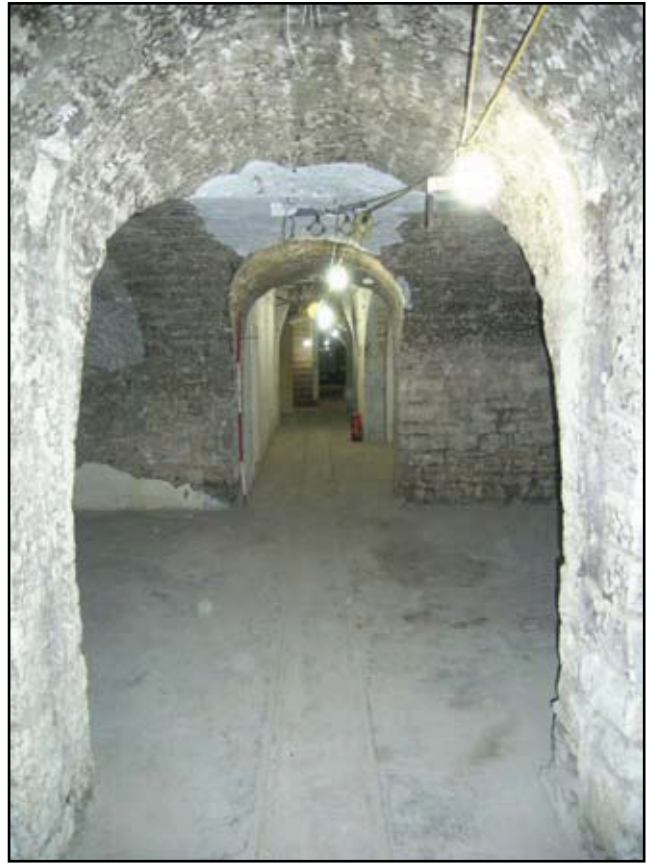
- 4.1.16 The concrete floor may have formed the foundation for or be contemporary with a set of tramway rails (123) that had been set in the top of the layer. The tramway rails were 0.025 m (one inch) wide with a gauge of 0.40m (16 inches) and ran the length of the Corridor in the Octagon Chapel basement (Fig. 2). The rails remain exposed within the Octagon Chapel basement and have been overlain by modern concrete to the east of Trench 3 towards Broad Street.

- 4.1.34 The corridor was marked out on various lease plans, with access from the northern side of No.2 Broad Street. It is shown as a dog-leg access on the Cotterell and Sparkman survey of 1853, and would appear to have been straightened out by the 1886, as noted on the OS map of that year (BAT 2005, Fig 10 & 11). The narrow and straight tramway (123) was probably introduced after this period. (Plate 6).

Plate 6: Octagon Vaults corridor and Tramway (123)
looking towards Milsom Street

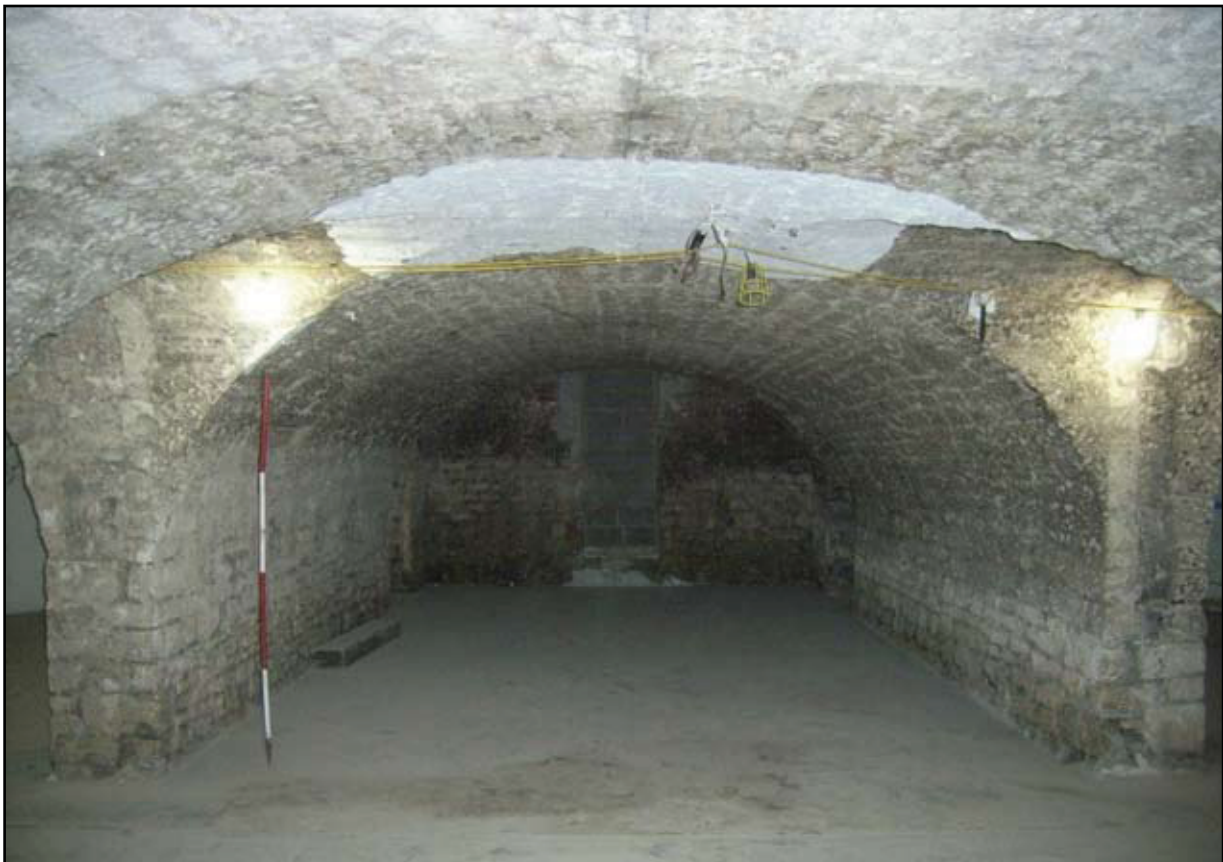
4.1.38 Vault Room 3 (Plate 7) is located on the northern side of the central corridor and would have been walled off from the corridor except by a central doorway. It is linked to Vault Room 4 by an open doorway at the eastern side. No architectural features of note were noted within this room.

Plate 7: Octagon Vault Room 3 looking north-west

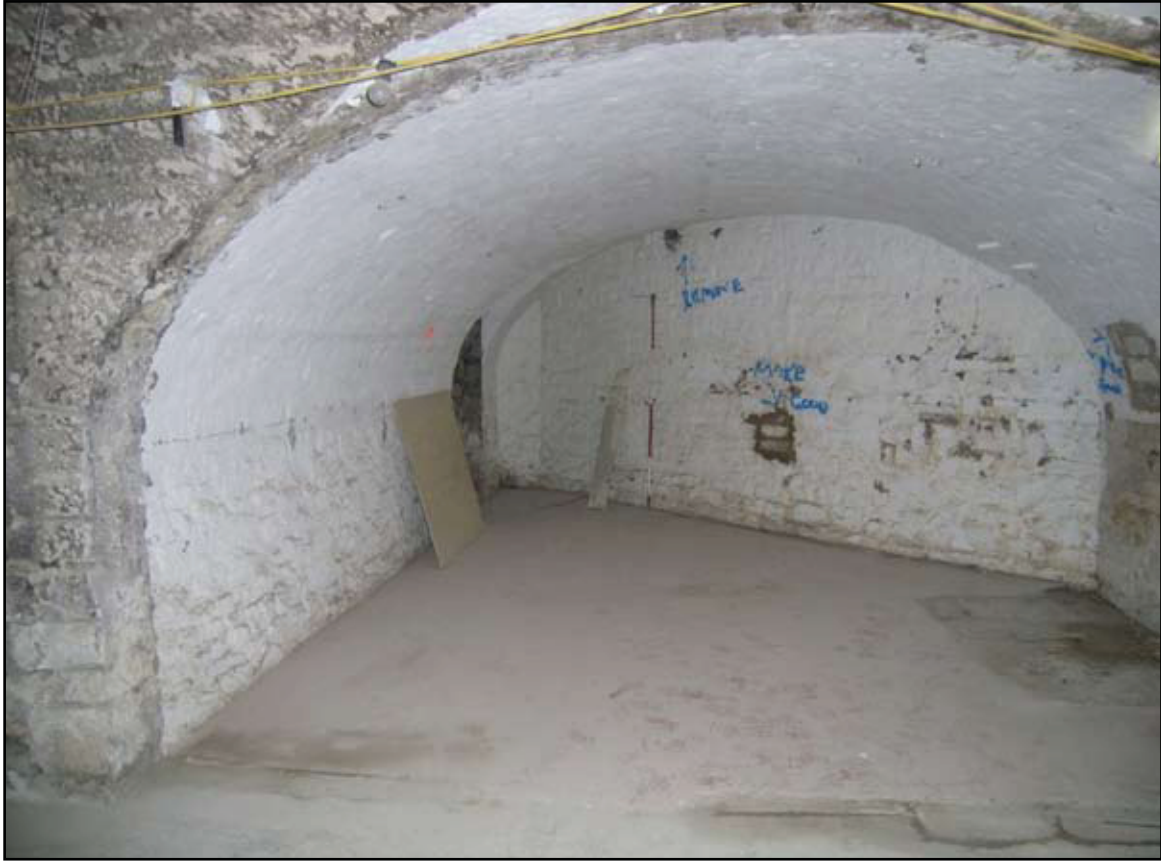
4.1.39 Vault Room 4 (Plate 8) is located on the northern side of the central corridor and would have been walled off from the corridor except by a central doorway. The room is linked to Vault Room 5 by an open doorway on the western side. A possible blocked doorway to Room 105 in the eastern wall face is noted and the room arrangement would have duplicated that of Vault Rooms 6 and 7 on the southern side of the Octagon Chapel. No other features of merit were noted within this room.

Plate 8: Octagon Vault Room 4 looking north-west

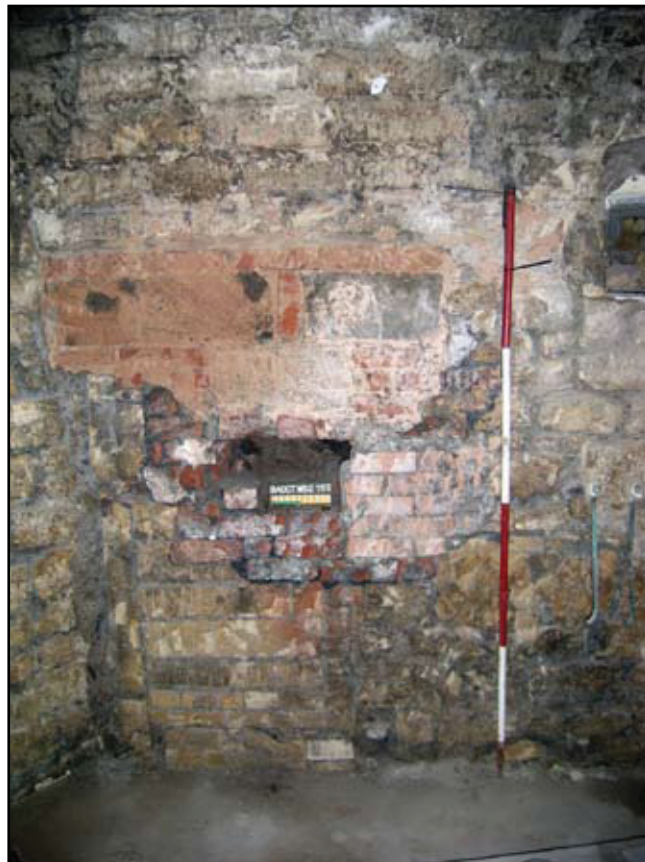
4.1.41 A blocked Fireplace (155) was also noted in the northern wall and measured 0.50 m in height and had a width of 0.48 m. The blocking consisted of what look like 19th century bricks held in a compact, mid grey lime mortar (Plate 9).

Plate 9: Octagon Vault Room 5 Blocked Fireplace (155)

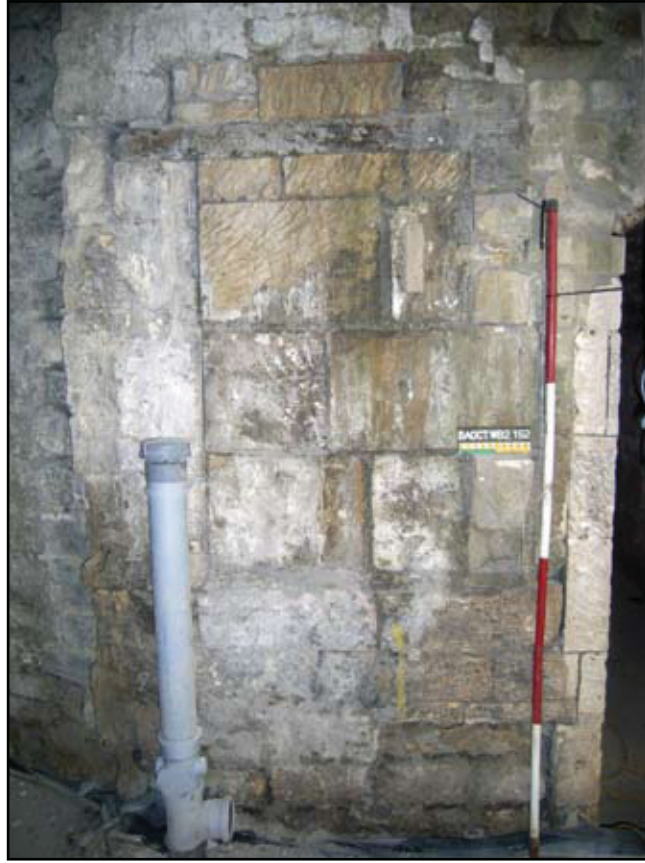
4.1.42 Vault Room 6 is located on the southern side of the central corridor and is linked by a single open doorway on the northern side. A blocked window (152) is noted within

the eastern wall which would have opened onto the Moon and Sixpence Yard, it measured 1.20 m in height and was 0.97 m in width. It had been blocked with Oolitic Limestone (Plate 10).

Plate 10: Octagon Vault Room 5 Blocked Window (152)

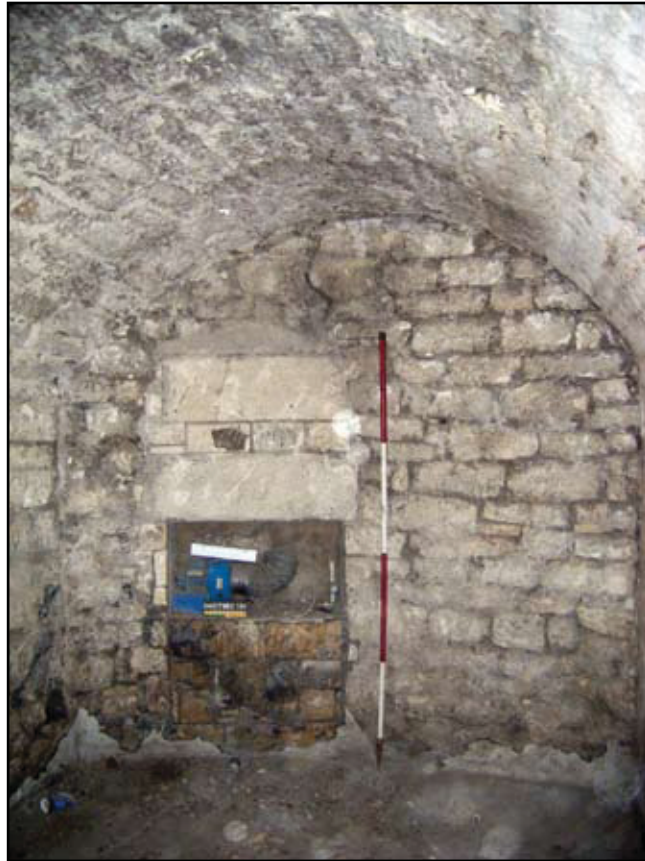
- 4.1.43 A blocked Fireplace (154) was also noted in the northern wall and measured 1.20 m in height and had a width of 0.81 m. The blocking consisted of Oolitic Limestone blocks which had been finished/smoothed with a masons drag and had had a modern water or heating pump installed in the recess (Plate 11).

Plate 11: Octagon Vault Room 6 Blocked Fireplace (154)
