South Hill Park Bracknell Berkshire

Archaeological Watching Brief Report

February 2009

ARCHAEOLOGICAL WATCHING BRIEF REPORT

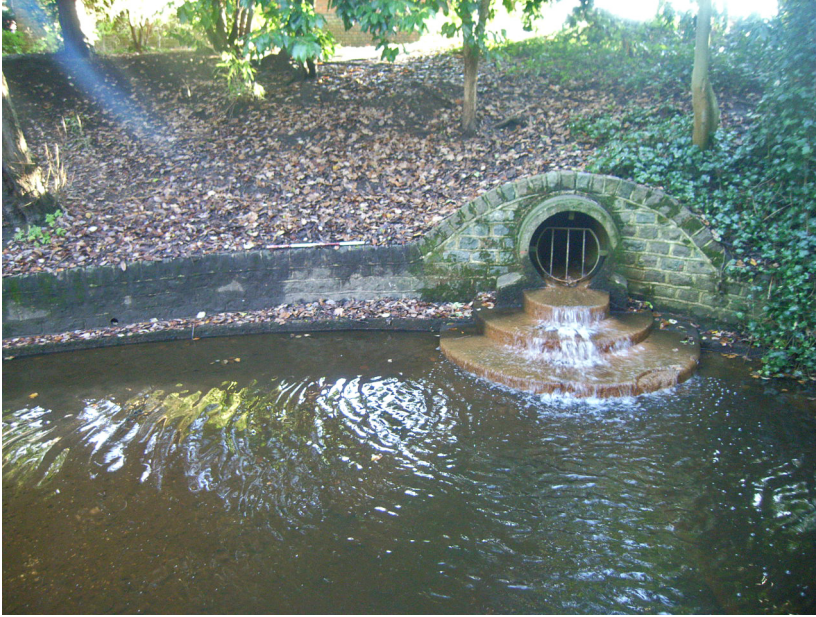
- 3.1.8 The masonry comprising the inlet to the southern lake was composed of a stone wall enclosing the southern end of the lake, with a concrete pipe projecting out of its southern extent (Plate 1).

- 3.1.9 The stone wall was built using dressed sandstone blocks measuring on average 0.25 m x 0.18 m x 0.15 m. The wall consisted of 4 courses. The bottom 3 courses were laid using Flemish bonding, while the upper course was laid using the blocks on edge and running the width of the wall, the total height measuring 0.62 m. This was constructed on a concrete foundation which projected 0.2 m in front of the wall.

Plate 1: Southern lake inlet and wall

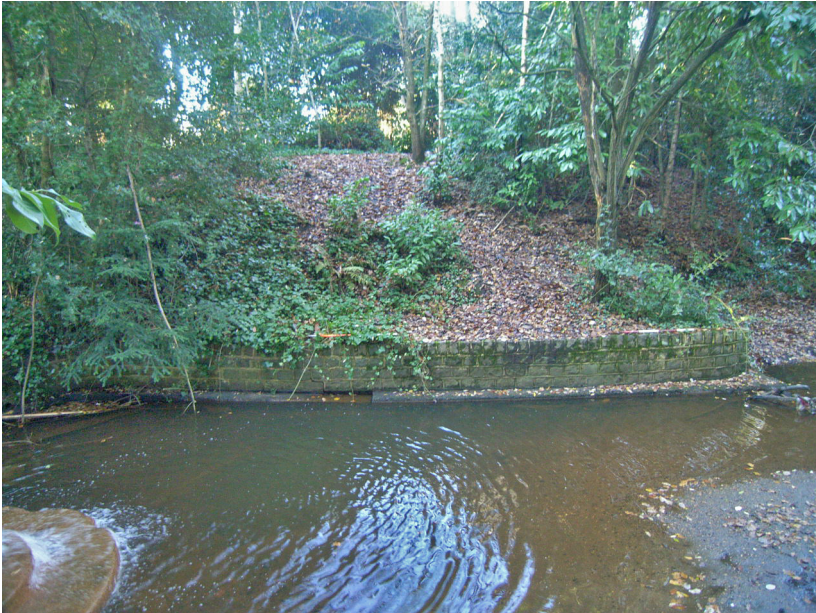
- 3.1.10 Because of silting it was impossible to determine the thickness of the concrete foundations.
- 3.1.11 The south wall ran round all three sides of the southern end of the lake. The wall flanking the west side was only 13.2 m long (Plate 2) while the wall on the eastern side was in excess of 70 m long. All construction seems to have been part of the same phase of work with a similar style of construction and materials being used throughout.

- 3.1.12 The wall is in a generally good state of repair, however within a 3 m long stretch of wall along the western edge of the lake, the concrete footing has partially subsided (possibly in the silts forming the sides of the lake) leaving the stone wall unsupported (Plate 2).

Plate 2: West wall of Southern inlet, showing subsidence
