# Slough Bottom Farm Saunderton Buckinghamshire

## Archaeological Watching Brief Report

# Slough Bottom Farm, Saunderton, Buckinghamshire

## *ARCHAEOLOGICAL WATCHING BRIEF REPORT*

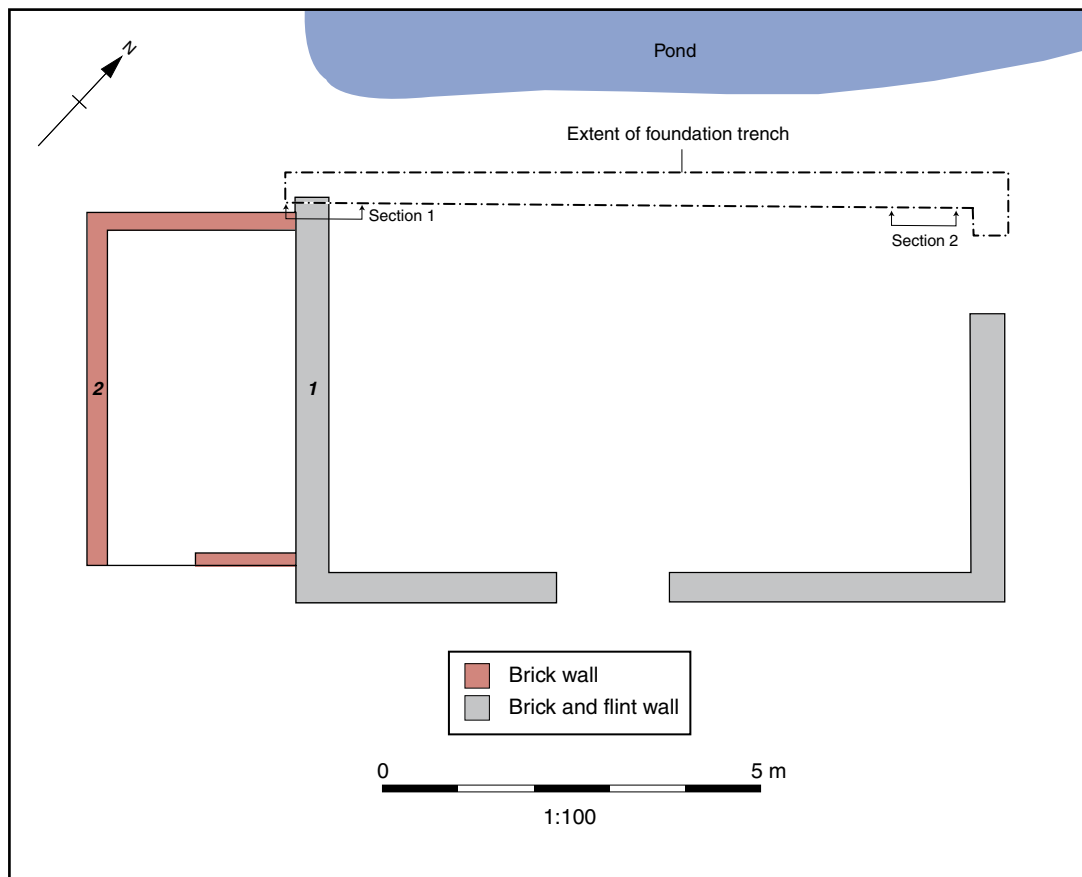
Figure 3: Trenching plan

- 2.2.1 The watching brief was conducted as an archaeological presence during the excavation of new foundation trench. series of periodic visits to examine intrusive works and excavations as development work proceeded. These works included the excavation of a new foundation trench for the north wall of the building. The excavated areas were closely examined for any features and the spoil was examined in order to collect dating evidence.
- 2.2.2 A plan of the extent of any excavations was maintained (Fig. 3) at a scale of 1:100 and sections of exposed features and sample sections showing the stratigraphy were drawn at a scale of 1:20. All excavated features were photographed using digital photography, colour slide and black and white print film. A general photographic record of the work was also made. Recording followed procedures detailed in the *OA Field Manual* (ed. D Wilkinson, 1992).
