New Boundary Wall
St Mary's Church
Banbury

**Archaeological
Watching Brief Report**

Document Title: New Boundary Wall, St Mary's Church Banbury,
Oxfordshire

Document Type: Watching Brief

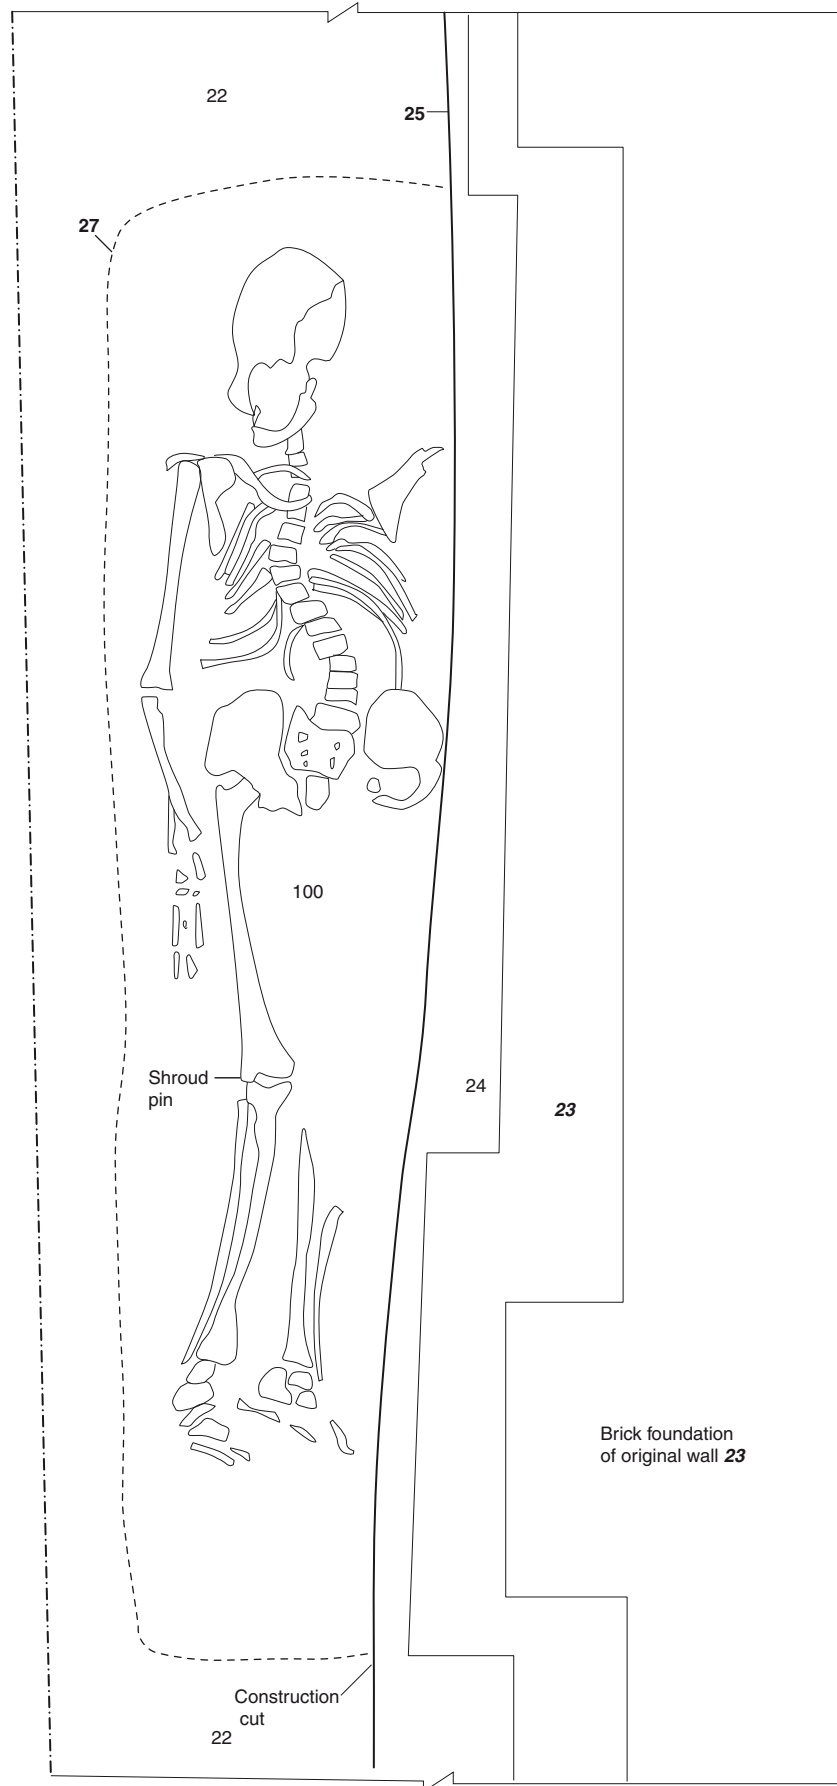
Figure 3: Burial 100

- 3.1.3 Also cutting layer 18 was a 1.9 m long by estimated 0.6 m wide grave cut (27) (Fig. 3, not shown in section). This contained a skeleton of an adult male (100), also aged approximately 45 years who displayed scoliosis of the spine, probable rickets and symptoms of Pagets disease on his skull. The left arm and left femur had been truncated by a later foundation cut (25), but were recovered from the backfill of the foundation trench. The grave was backfilled with a yellow-brown silt clay (26) which contained fragments of post-medieval brick, possibly 17th-century in date.

Plan 2
Skeleton 100

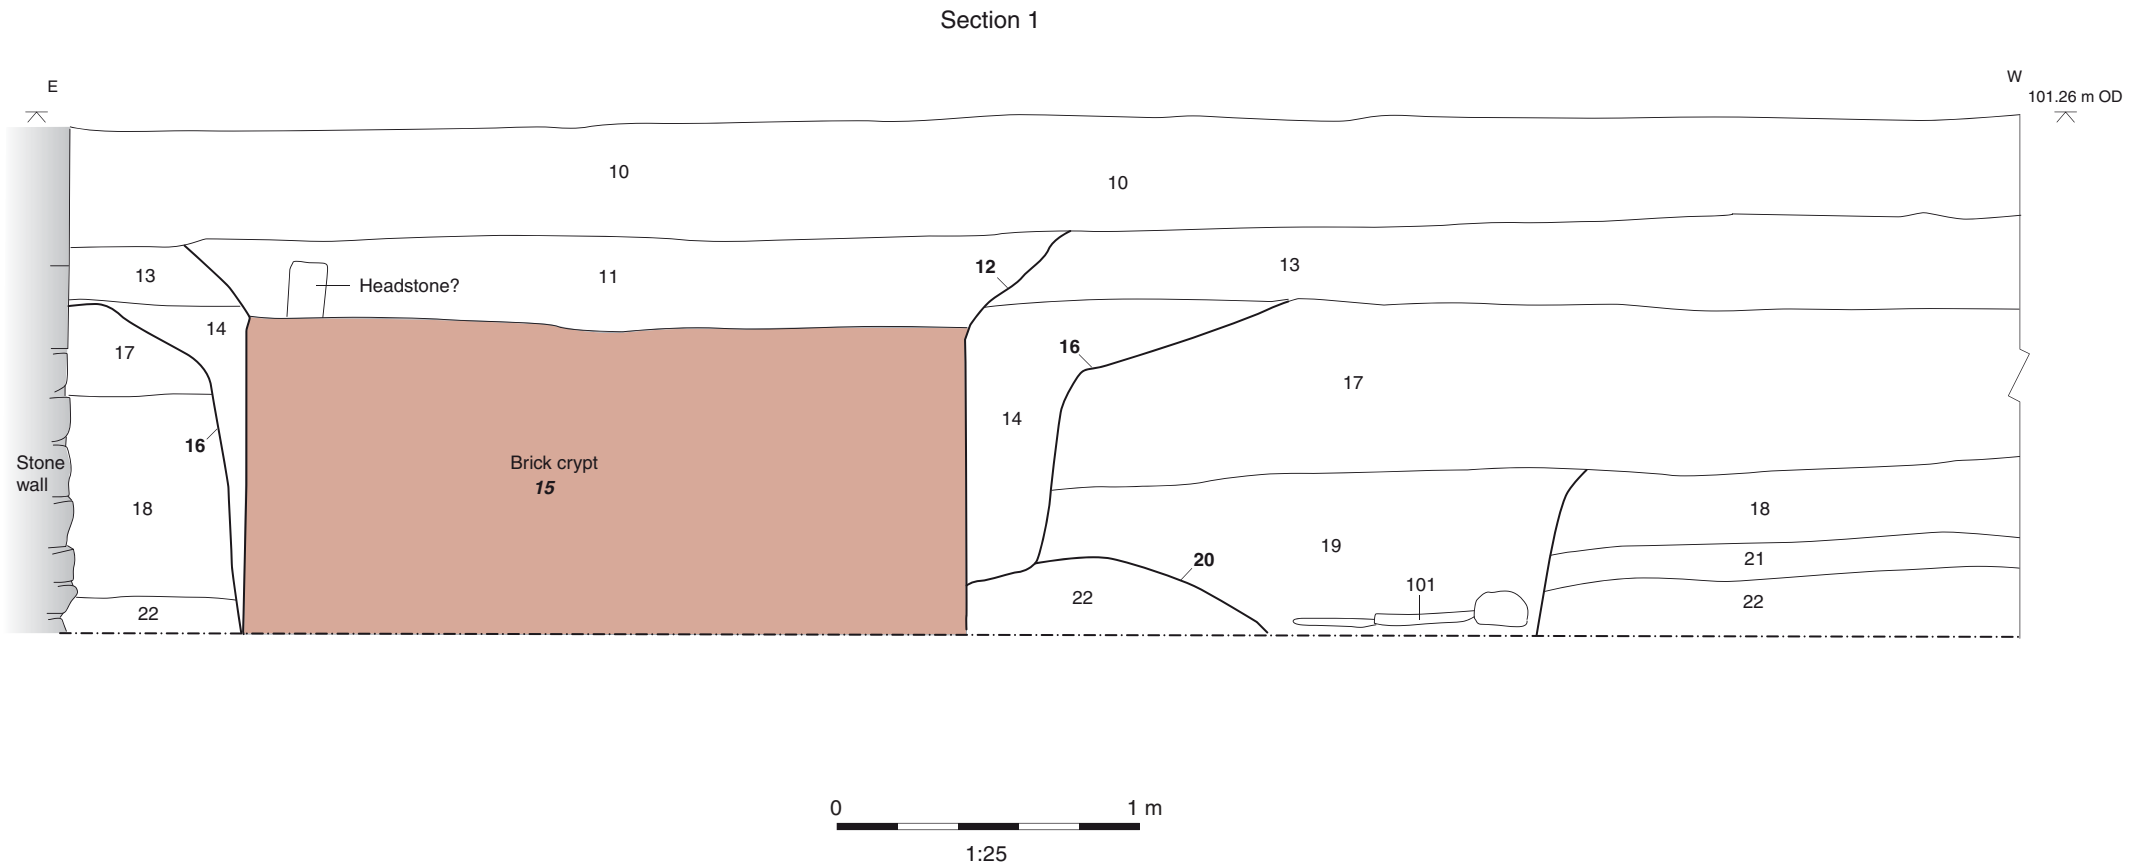
Figure 4: Section 1

- 3.1.1 The underlying natural, a yellow-brown silt clay with lias inclusions (22) was encountered at a depth of 1.5 m below the current ground level of the churchyard (Fig. 4, Section 1). At the western end of the excavation this was overlaid by a 0.12 m deep layer of dark grey clay silt (21) containing lens of yellow and blue grey clay suggesting a layer of disturbed ground. Overlying this and running the full length of the section was a layer of grey-brown clay silt (18) measuring between 0.3 m and 0.65 m in depth. The layer contained inclusions of yellow-brown clay and charcoal flecking and probably represents an earlier phase of churchyard soil.

- 3.1.2 Cutting this deposit was a 0.55 m deep flat-bottomed cut estimated at approximately 1.8 m long (20). This was filled with a yellow-brown silt clay (19) which sealed an adult male skeleton (101) who was aged roughly 45 years old at the time of depth.

- 3.1.4 The graves were sealed by a layer of dark yellow-brown silt clay (17) measuring between 0.3 m and 0.6 m in depth. This deposit ran the full length of the section and contained charcoal flecking, abraded brick fragments and yellow clay inclusions suggesting that it is a second phase of churchyard soil. This layer was cut by a 2.6 m long cut (16) with very steeply sloping sides whose depth was in excess of 1.1 m. Built within this excavation was a rectangular brick-built structure 2.3 m long, over 1.1 m in height and with 0.6 m width exposed in plan (15). This was built using hand-made unfrosted bricks measuring 0.225 m by 0.105 m by 0.063 m and lime mortar. This structure represents a family vault or shaft burial. Examination of the church records showed that it contained the bodies of Thomas Abbots and Keziah Abbots who died on the 12th January 1824 and 28th April 1828 respectively. Observed within the section on the top of the brickwork was a small stone round topped object, possibly a headstone, but no inscription was visible. The space between the vault and cut 16 was backfilled with a yellow-brown silt clay (14) containing small fragments of brick and blue-grey clay inclusions.

- 3.1.5 Overlying layer 17 and the backfill of cut 16 was a 0.2 m deep layer of grey-brown clay silt loam (13) containing abraded brick fragments and charcoal flecking. This probably represents another phase of churchyard soil. Cutting this layer was a steeply sloping excavation (12) leading directly on to the top of the brick vault 15. This event may have occurred when the body of Keziah Abbots was interred in the vault or

possibly when a monument which may have stood on the brickwork was removed. This void was filled by a dark yellow-brown clay silt (11).

3.1.6 Sealing this intrusion and running the full length of the section was a 0.35 m deep layer of dark grey silt clay loam (10) containing brick fragments and bottle glass. This represents the last phase of churchyard soil.

3.1.7 This was cut by the east-west running foundation trench (25) which also truncated the left hand side of skeleton 100. Built within this trench was a brick retaining/boundary wall (23) composed of 14 courses of 19th-century machine made bricks topped with limestone coping stones and iron railings. This was keyed into the earlier stone retaining wall bounding London Yard.

4.1.2 This showed that there were 4 distinct phases of churchyard soil observable, layers 10, 13, 17 and 18. The probable 17th-century burials 20 and 27 cut layer 18 suggesting that it predates the 17th-century and may be medieval in origin, although no dating evidence was recovered to confirm this.

4.1.3 Layer 17 sealed the probable 17th-century graves and was cut by the early 19th-century shaft burial (15) suggesting that it dates to the 18th-and 19th-centuries. Layer 13 overlies 15 and is probably late 19th-century in origin. Layer 10 represents the current churchyard soil.
