St Aldates Resurfacing Oxford Oxfordshire

Archaeological Watching Brief Report

Road Resurfacing, St Aldates (A420), Oxford

ARCHAEOLOGICAL WATCHING BRIEF REPORT

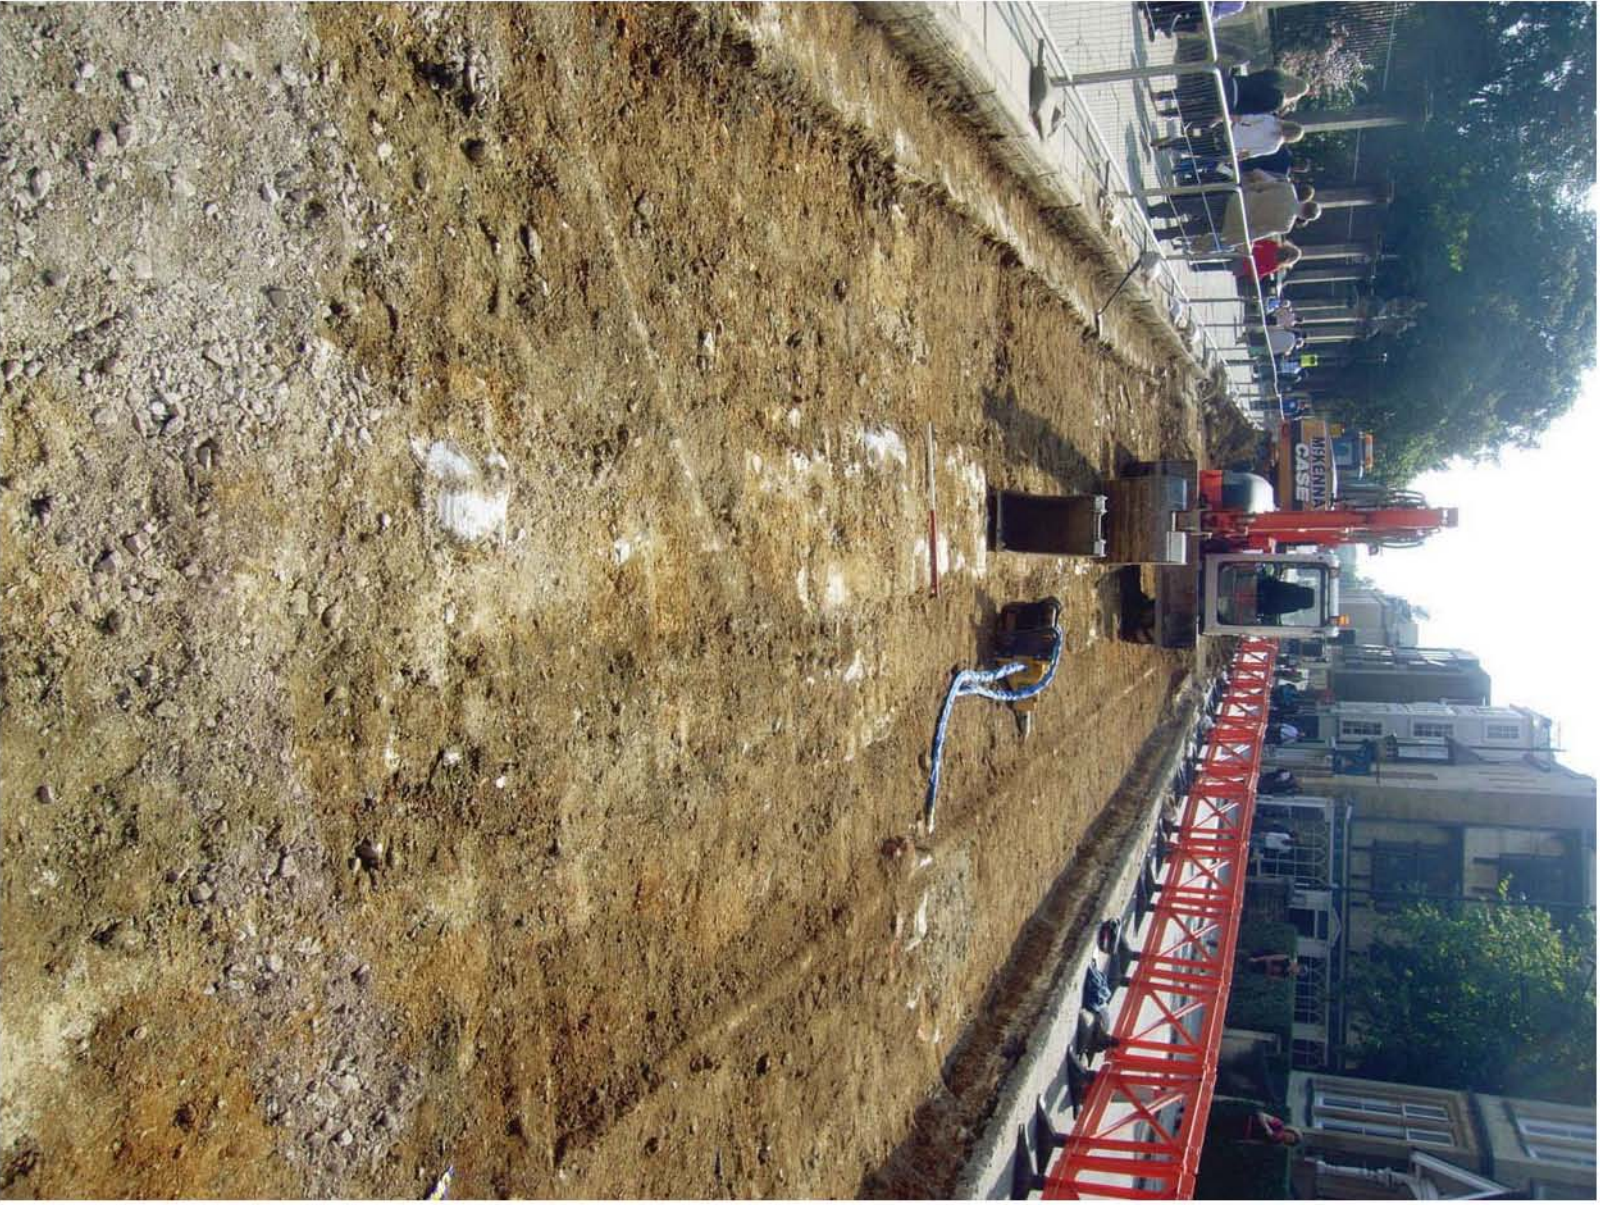
Plate 1 : Truncated base of Wall 12 as exposed

- 3.1.11 Visible in the surface of this deposit was a the top of a truncated stone wall (12), running roughly parallel to the edge of the road, 2 m west of the kerb (Fig. 4 and Plate.1). This measured 0.85 m wide and was constructed using roughly dressed stone blocks for the external faces and a rubble core, bonded with lime mortar.

- 3.1.12 The northern extent of the wall started approximately level with the south-west corner of the Christchurch main building and ran 74 m southwards before turning eastwards and running towards the entrance into Christchurch College gardens.

- 3.1.13 This structure appears to respect the college boundary and probably is the truncated remains of the precinct wall, possibly reduced to allow the road to be widened. A void was visible in the wall at its northern end, however it was felt that this was due to the removal of a modern intrusion rather than part of its original construction.

- 4.1.2 The truncated base of the stone wall 12 marks the original boundary wall of Christchurch. No evidence was observed to establish a relationship between this wall, the Saxon town wall in Brewers Street and the Saxon/medieval Southgate.
