Network Rail

West Coast Mainline Upgrade

Staffordshire: Tamworth to Lichfield

Archaeological Evaluation Report

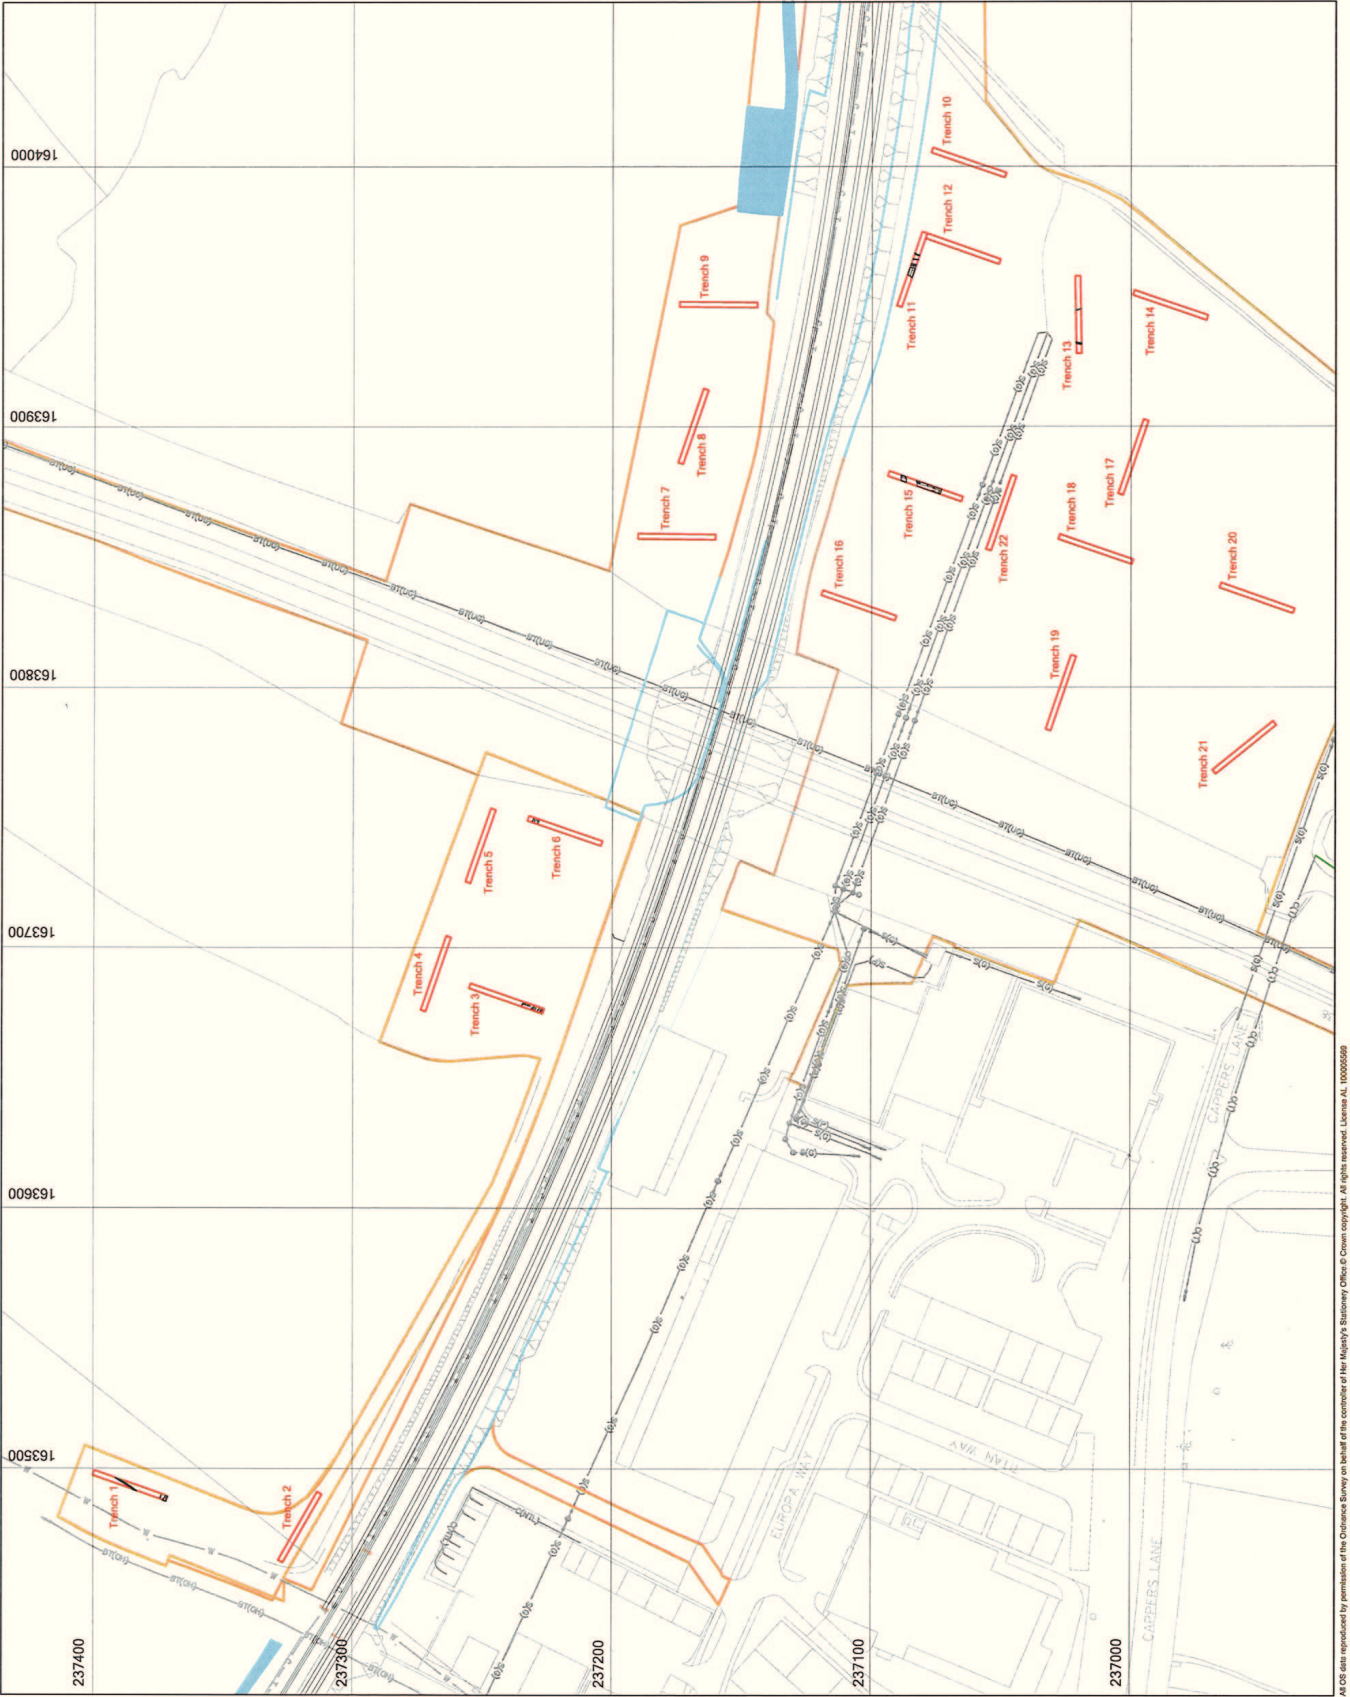
Figure 2: Trench locations

3.1.1 The evaluation consisted of twenty one trenches across three main areas (Fig. 2).

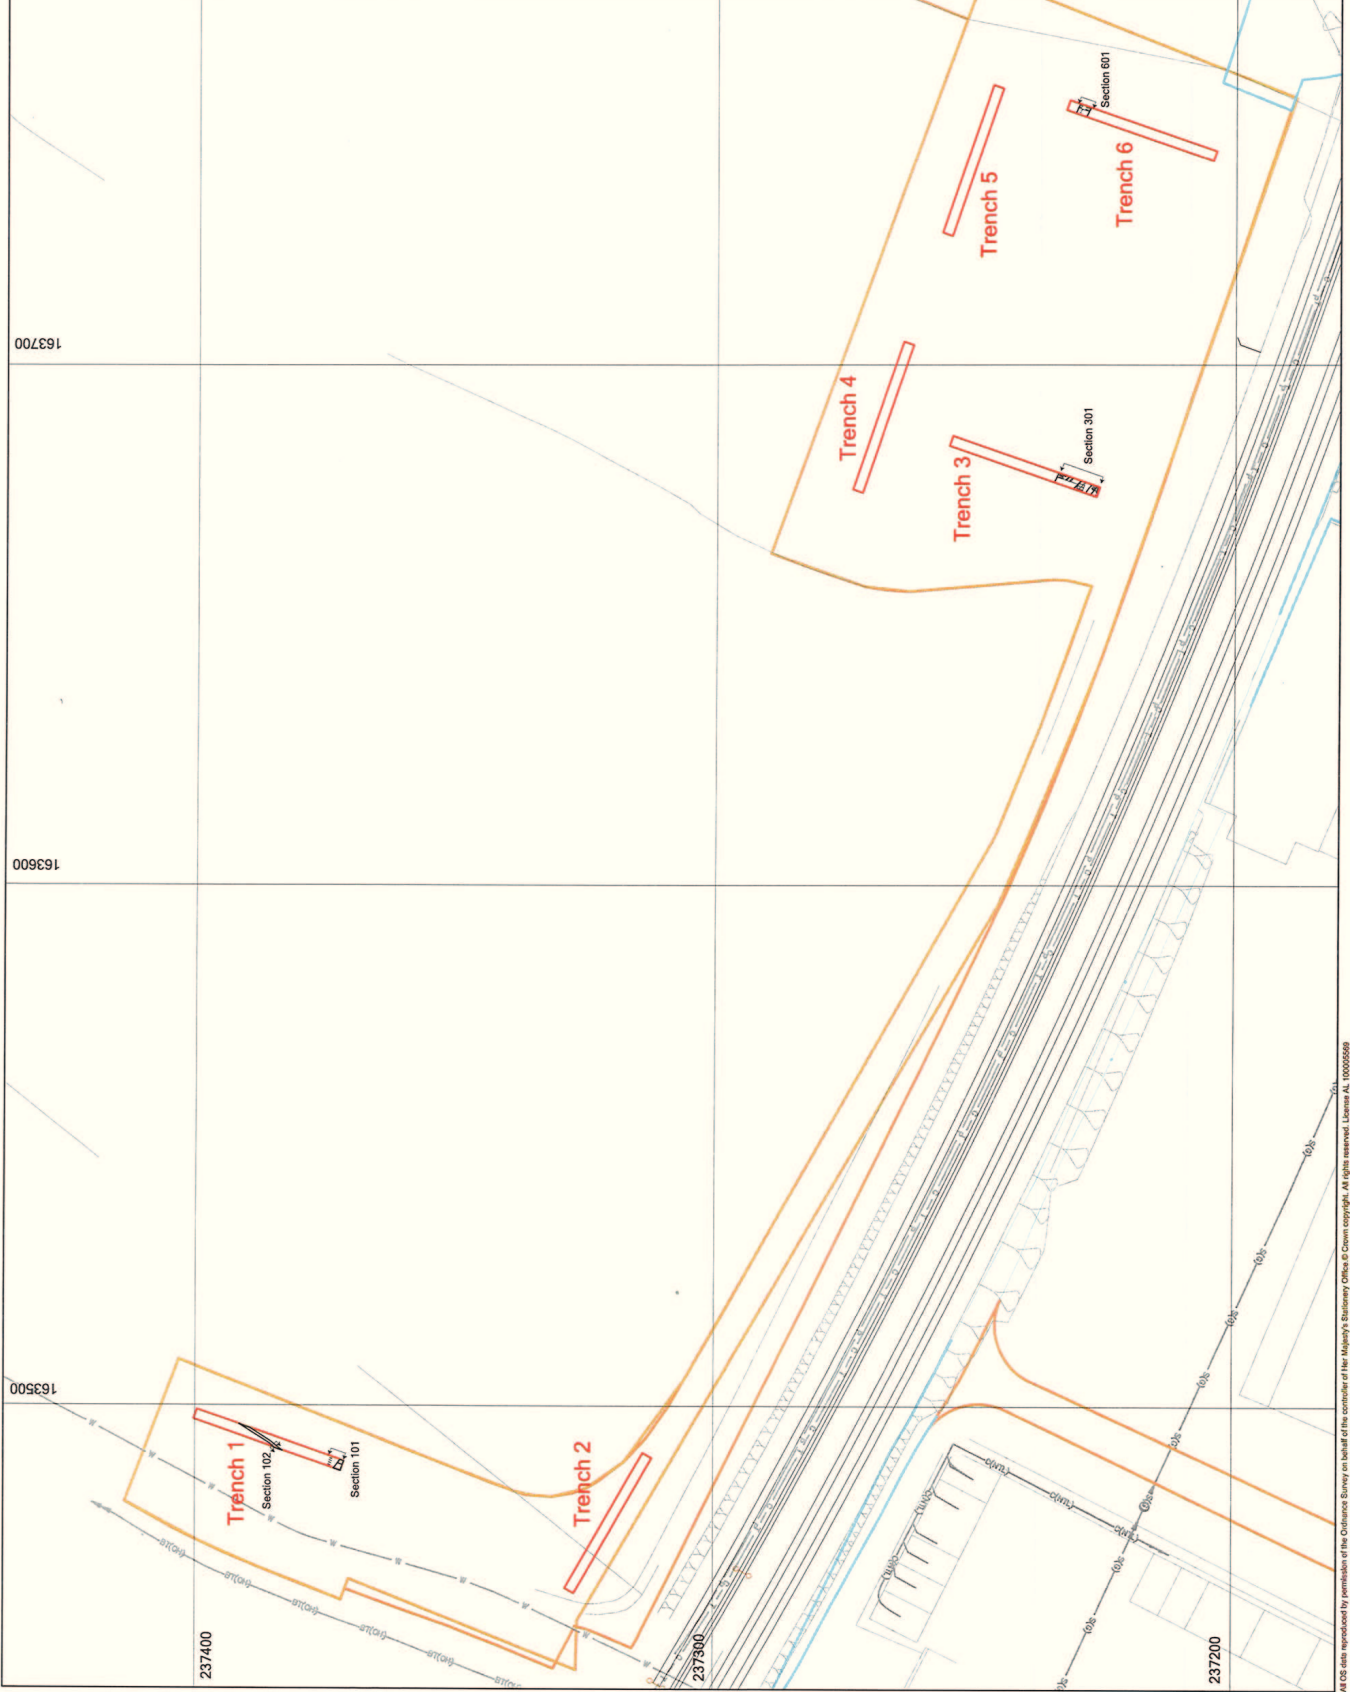
Figure 3: Northern area

4.2.1 Ditches or other linear features were found within trenches 1, 3, 4, 6, 7, 8, 10, 13 and 15. Probable modern features were also found within Trenches 12, 15 and 21. A plot of these features is shown on (Figs 3 and 4).

5.1.2 Trench 1 revealed two features, ditch (106) and a probable shallow land-drain (112) (Figs 3 and 5).

- 5.1.7 The mid yellow sand natural (313) was observed at between 69.07 and 69.61 m aOD. Trench 3 contained three main features: a broad ditch (311), which was re-cut later by ditch (306), and a smaller possible hedge-line (315) (Figs 3 and 5).

- 5.1.14 The mid yellow sand natural (313) was observed at between 69.07 and 69.61 m aOD
- 5.1.15 A WNW - ESE aligned ditch (607) cut the underlying natural pale brownish yellow sand natural (601) within the southern end of Trench 6, (Figs 3 and 5).

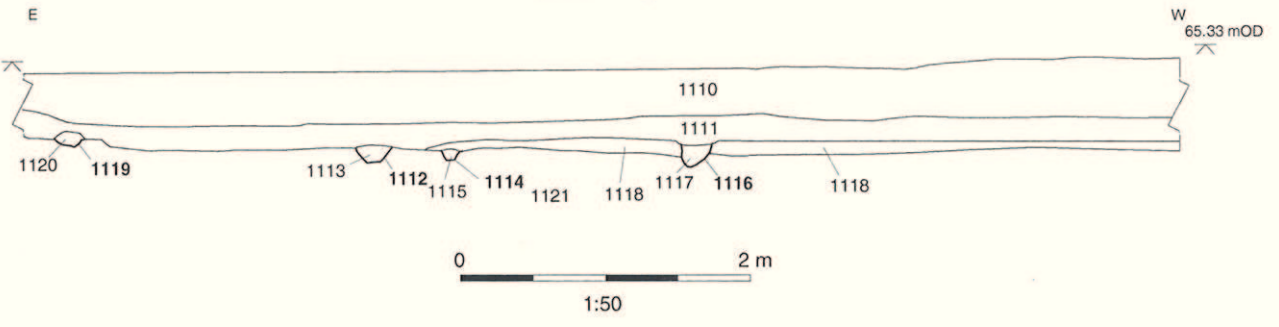
Trench 11 Section 1100

- 5.1.30 Within Trench 11 the underlying natural (1111) consisted of a pale brownish yellow silty sand with patches of reddish brown sandy clay observed at between 64.94 and 65.2 m aOD (Figs 4 and 6).

- 5.1.31 Within the middle of the trench several small shallow linears ((1110), (1112), (1114), (1116) and (1119)) cut the underlying natural. These shallow linears were all aligned roughly north-south and were filled by dark reddish brown silty clay. They were typically either 'U' shaped or rounded in profile and measured between 0.08 m deep by 0.18 m wide and 0.18 m deep by 0.26 m wide. Within the middle of the trench, two of these features (1114) and (1116) were overlain by a broad shallow spread of dark greyish brown silty sand (1119), that was up to 0.13 m thick.

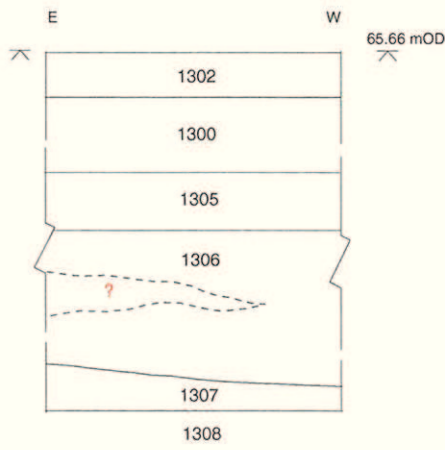
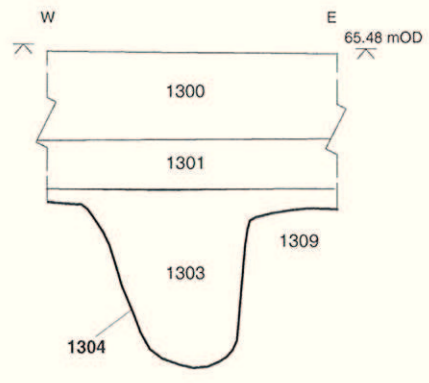
Trench 13 Section 1300

- 5.1.35 The natural appears to be truncated within the middle and western end of the trench by a broad concave cut (1310) that is at least 20 m wide. The eastern side of this cut sloped down at approximately 30°, its western side was shallower and sloped at approximately 5°. At its deepest point the cut was approximately 0.8 deep. A ceramic land-drain was revealed at the eastern side of the cut and appeared to be overlain by the fills of (1310): a 0.12 m thick layer of pale yellow sand (1307) and up to 0.54 m of dark brown sandy loam (1306).

- 5.1.36 Within the eastern end of the trench and away from cut (1310), a single ditch cut (1304) the natural from a depth of 0.46 m beneath the present topsoil. The ditch was 'U' shaped in profile and measured 0.6 m wide by 0.5 m deep. it was filled by a brown sandy silt (1301).

- 5.1.34 Within trench 13 the underlying natural (1309) varied from greyish brown sandy gravels to grey brown clay and orange sand with depth and was observed at c 65.02 m aOD (Figs 4 and 6).

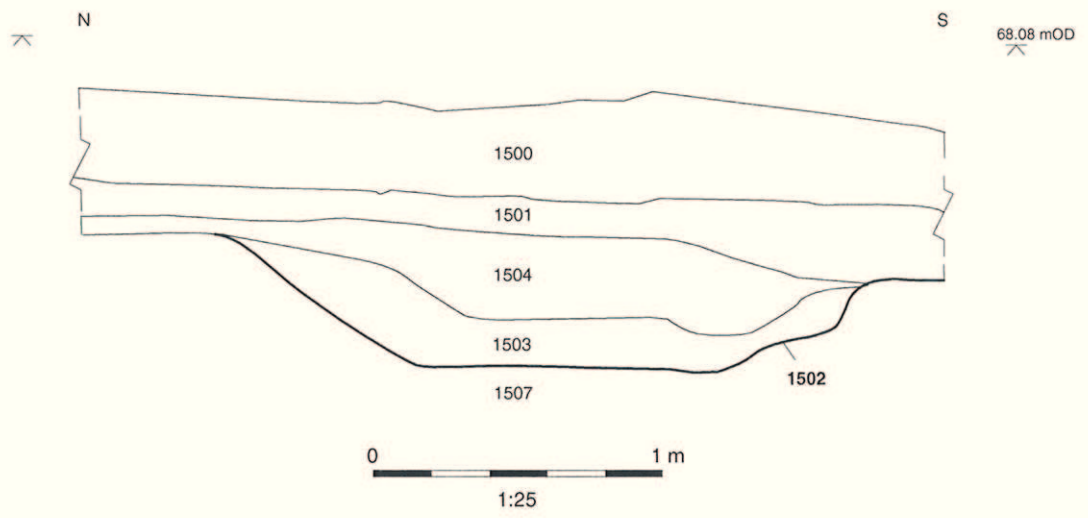
Trench 15 Section 1500

- 5.1.41 A single east-west aligned ditch (1502) cut the natural at the northern end of the trench. The ditch had concave sides, a flat base and measured 0.4 m deep by 2.2 m wide. It was filled by a 0.28 m thick, dark greyish brown silty sand, primary fill (1503) which was overlain by a reddish brown silty sand (1504) 0.19m thick.

- 5.1.40 The underlying natural within Trench 15 (1507) consisted of a pale orange yellow silty sand (1507) and was observed at between 65.92 and 67.54 m aOD (Figs 4 and 6).
