# Parterre Gardens Witley Court Great Witley Worcestershire

## Archaeological Evaluation

**Witley Court Gardens**  
Great Witley, Worcestershire

*ARCHAEOLOGICAL EVALUATION REPORT*

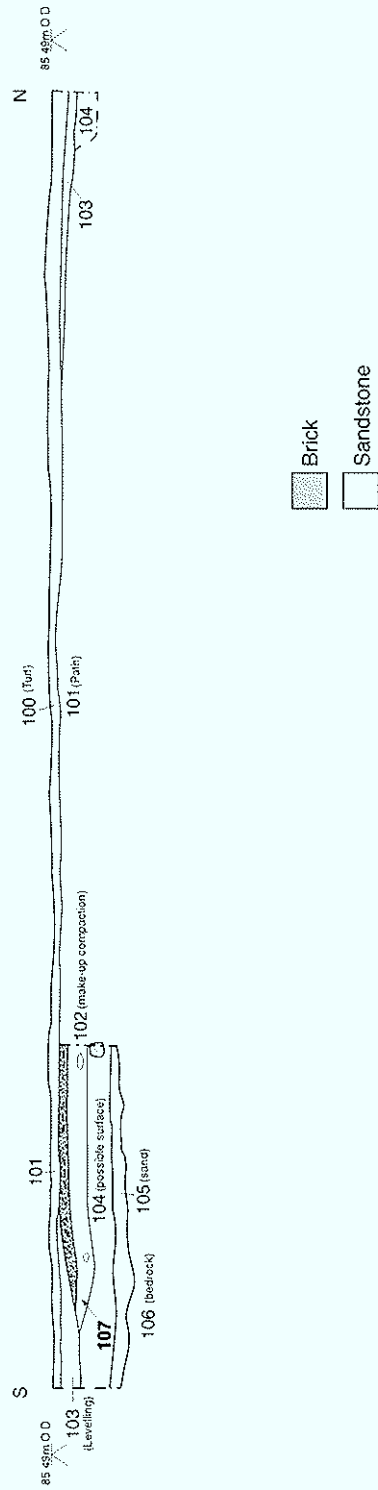
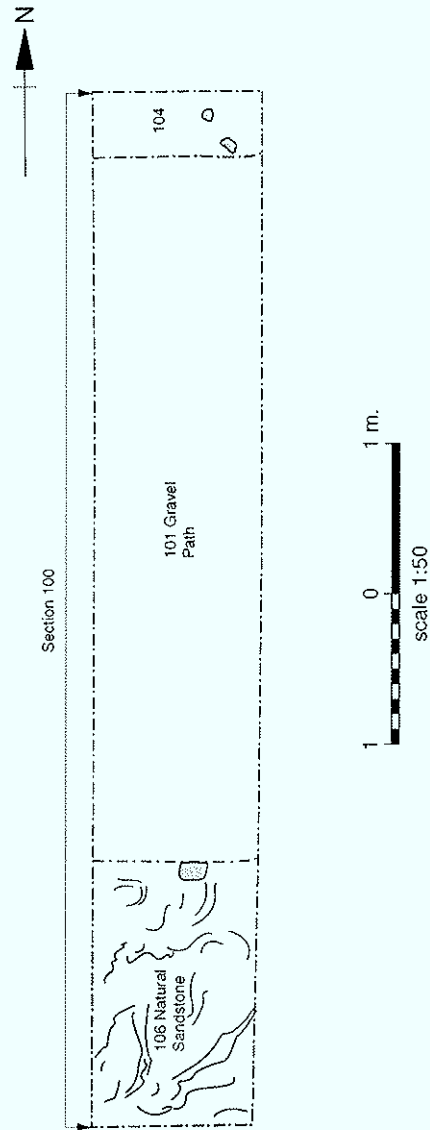
Fig 3: Trench 1: Plan and Section.

### 5.1 Trench 1: Pathway in South Parterre (Fig. 3)

- 5.1.1 Bedrock (106) was located within a sondage at the southern end of Trench 1 at a level of 85.07 m OD. This was weathered sandstone sloping gently to the south.

- 5.1.2 Overlying the bedrock deposit was the sand layer 105. This was a layer c.0.1 m thick with a <3% charcoal content. Several small sherds of 18th/19<sup>th</sup>-century ceramic were recovered from this deposit. This was overlain by layer 104, a very compacted mixture of sand and fragmented sandstone. This deposit was c.0.2 m thick and had inclusions consisting of 10% charcoal and <3% ceramic building material.

- 5.1.3 Layer 104 was cut by context 107, a construction cut for the 19<sup>th</sup>-century parterre pathways. This was c.0.2 m deep with an approximate width of 6.20 m and was aligned east-west. This cut was filled by 102, a layer of red/brown compacted sand and gravel c 0.20 m thick. This provided the make-up for the surface remnant of the path 101. This layer showed a slight camber in profile and included imported flint gravel. This deposit was c 0.06 thick.

- 5.1.4 These layers were overlain by deposit 103 which was a topsoil levelling layer of light brown sandy loam c 0.11 m thick which levels out the camber of the path at both sides. The final deposit in the Trench 1 sequence was the turf level of 100.

- 6.2.1 Whilst examining the condition of the pathway make-up layers within Trench 1, it was clear that the integrity of the pathway was in-fact very stable and in good condition. A slot dug through the path on its southern edge revealed compacted make-up levels (102) sitting within an apparent cut for the feature which truncated earlier levels which possibly relate to a pre-Nesfield pathway running east-west along the northern edge of Repton's landscaped deer park of the 18th century. This of course is only an interpretation of the levels investigated within the area defined by Trench 1, but it may point to an earlier access route or walkway along the eastern side of the manor.

- 6.2.2 The condition of the pathway make-up and surviving surfaces do mean that less consolidation will be necessary to enable the eventual reinstatement of this garden feature.

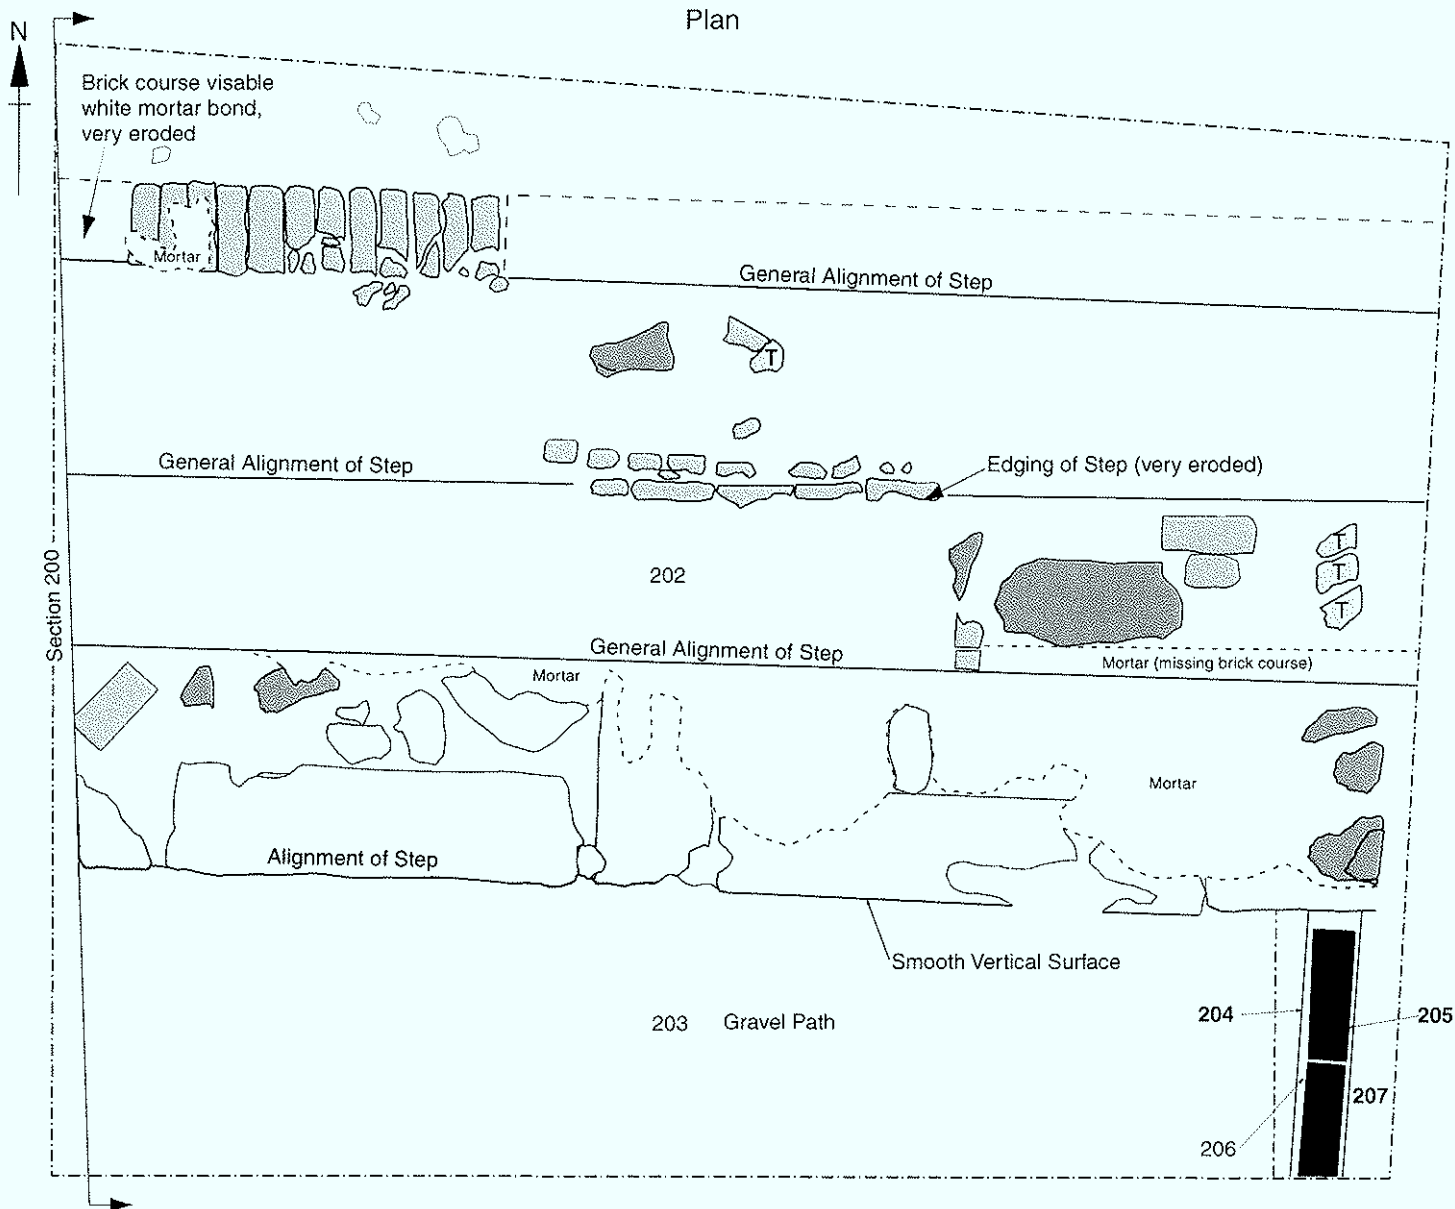
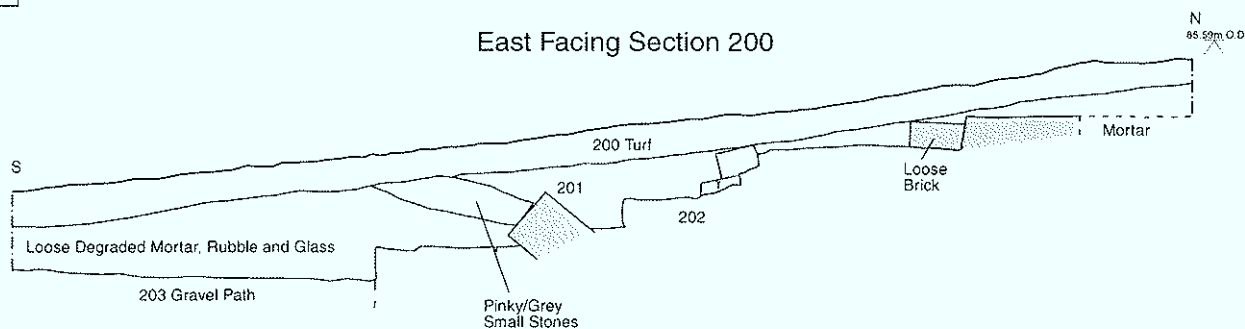
Fig 4: Trench 2: Plan and Section.

### 5.2 Trench 2: Steps S12 in South Parterre (Fig. 4)

- 5.2.1 The earliest context located within this trench was the foundation for the steps S12. These foundations were mostly constructed from red un-frogged brick (0.24 x 0.14 x 0.09 m) with two large sandstone blocks measuring 0.30 m by 1 m with an unknown depth. The foundation consists of four steps falling to the south with some residual white lime mortar evident on the surface of each step (presumably from the bonding of the removed limestone block treads). The brick foundations incorporated into the structure include several apparently random pieces of re-used roof slate. The bonding material for the main foundation structure was a sandy mortar.

- 5.2.2 The next deposit in the sequence for Trench 2 was the make-up deposit 207. This was a compacted sand layer with <1% charcoal inclusions with a depth of >0.15 m. This deposit was cut by context 204, a north-south linear feature with a flat base and steep sloping sides c 0.20m wide and 0.15 m deep. This was the cut for the ceramic drain 205 which had an external diameter of 0.14 m. The drain cut was filled by deposit 206 which also overlay the drain itself. This was a moderately compact sandy clay deposit c.0.15 m thick. The gravel path surface 203 overlay these deposits as a contemporary surface level. This was c.0.08 m thick and was of a similar make-up to deposit 101 in Trench 1.

- 5.2.3 Layer 201 Overlay the foundation steps and the pathway alike. This was a layer of dump material including glass slag, brick/tile fragments and iron nails. This deposit was c.0.20 m thick and contained c.30% ash debris; it was overlain by a thin, poor quality turf layer c.0.12m thick.

- 6.2.3 The sections of step foundations examined within Trenches 2 and 3 (S12 and S3 respectively), showed an overall stable condition with fairly limited consolidation necessary for their re-use in the reinstatement of the Parterre terrace steps. The excavation of the S3 steps was particularly interesting due to the existence of two possible construction phases with the primary phase of 302 incorporating the square brick sockets. These may have been used for upright banister style features along the western edge of the step sequence (presumably these were mirrored on the eastern side of these foundations). The straight joint created by the junction between 302 (east section of foundation S3) and 311 points directly to an additional section to the western edge of the original foundation, thereby widening out the line of steps (312 was issued as an overall structure group number relating these two phases). It would therefore be of interest to examine the steps to the north of these (S2) for some correlation between the development of the construction design of these stepped landscape features. However due to the limestone steps still remaining in-situ at the S2 location, this comparison of foundation architecture will be impossible to undertake through excavation.

- 6.2.4 Whilst examining the integrity of the remaining fabric of the foundations to the garden steps, this was a good opportunity for a detailed examination of the overlying deposits. The deposit 201 (Trench 2) contained large amounts of ashy material and vitrified glass. This was interesting from the view as to where this glass originated. Trench 2 was located immediately south of the east wing of the main house, and it

may be that the glass found within deposit 201 was in fact related to the fire in 1937. This may also explain the amount of ashy material within this layer as the inside of the house was swept clean of debris. It may be another possibility that this glass was actually residual slag from either on-site glass manufacture, (which was not uncommon on estates such as Witley during the 19th century) or imported material from outside Witley Court.

- 6.2.5 As this deposit overlay the foundation steps, it can be determined that the layer was deposited post removal of the limestone dressed steps during the post-war years. This suggests that the deposit was deliberately laid as a levelling layer by the Department of the Environment during the 1970s.

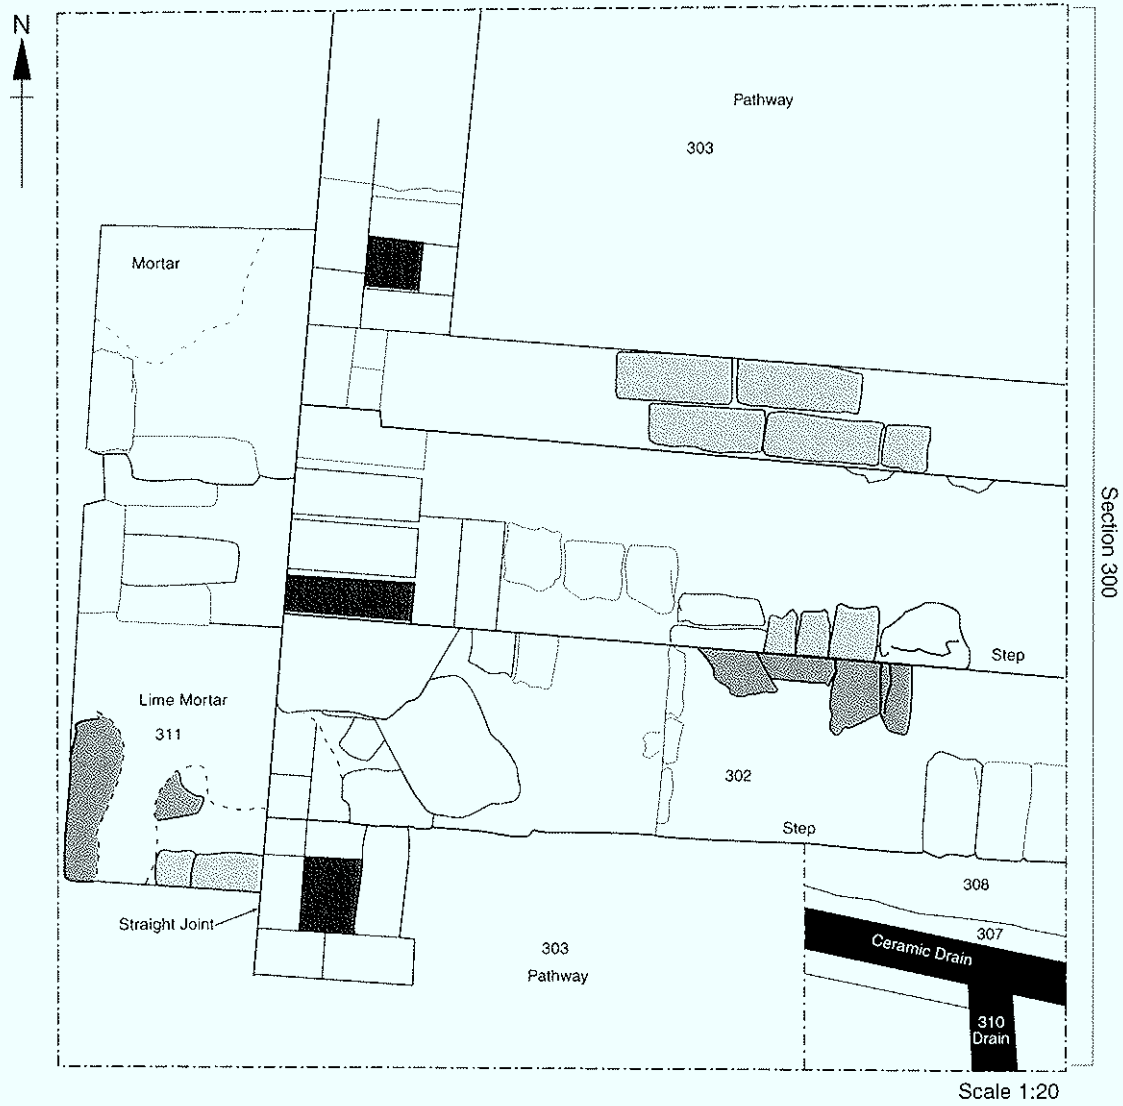
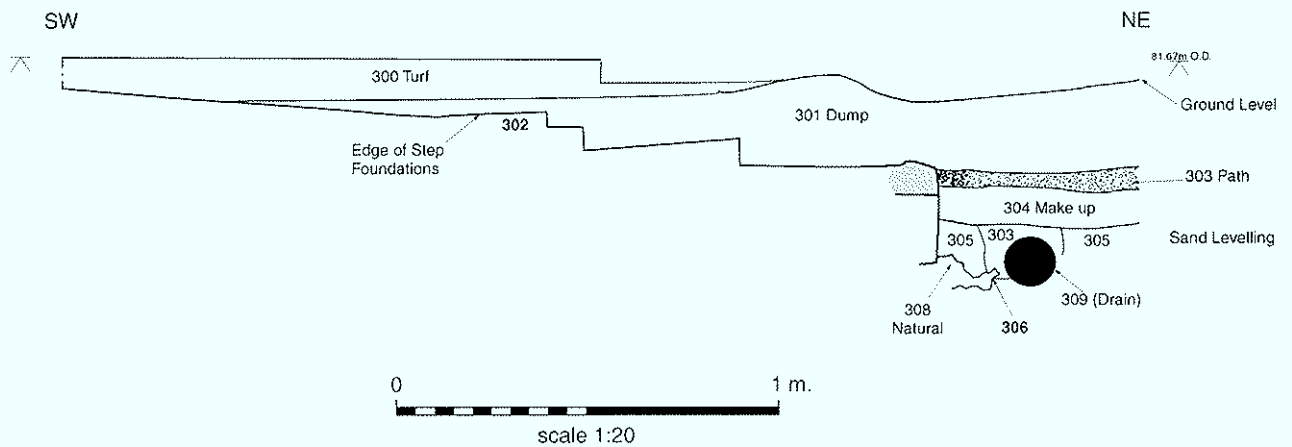
Fig 5: Trench 3: Plan and Section.

### 5.3 Trench 3: Path and Steps S3 in East Parterre (Fig 5)

5.3.1 Natural sandstone (308) was located at c.81.07 m OD. This was overlain by structure 312, the foundation to steps S3. This structure was split into two separate contexts (302 and 311). The first, 302 was c.2.20 m wide (exposed) and was constructed of brick, incorporating two square vertical sockets (one on the upper step, one on the lowest third step). These were located at the western end of the steps and were c.0.30 m by 0.30 m with an internal square socket of c.0.20 by 0.20 m. The bricks within the structure were 0.24 x 0.14 x 0.09 m with no strict bonding pattern, in a sandy mortar bonding material and with inclusions of sand stone and re-used roof slate within the build of the structure. This was flanked on its western edge by 311, an apparently later structural addition of the foundation widening out the steps to align perfectly with S2 to the north. This was constructed from the same materials, with both foundation segments showing trace residual deposits of a white lime mortar over the surface of some of the brickwork.

5.3.2 The foundation was abutted by a deposit of moderately compacted sand (305) which had a <1% charcoal content with some small brick/tile fragments also evident. This layer was 0.10 m thick and lay directly over the sandstone bedrock 308. This deposit was cut by 306, an east-west drainage construction cut measuring 0.18 m wide and 0.16 m deep with a flat base and steep sloping sides. This contained the ceramic drain 309 which had an external diameter of c.0.14 m and an internal diameter of c.0.11 m. This drain was covered by the fill 307, a moderately compact red/brown sandy clay c.0.16 m thick. Ceramic drain 310 was aligned north-south and had the same dimensions, form and fabric as 309. The association between the two drains was not clear.

5.3.3 These were overlain by the deposit 304, a moderately compacted red/brown sand c.0.10 m thick with <5% flint gravel and <3% brick/tile inclusions; it was overlain by 303, a moderately compacted sand and gravel mix c 0.06 m thick.

5.3.4 The path and foundation was overlain by the dump deposit 301, a loose grey black sandy material with <5% charcoal and <5% brick/tile inclusions c.0.20 m thick. Structural glass fragments and iron nails were recovered from this deposit. Layer 301 was overlain by 300, friable turf/topsoil layer with <2% charcoal inclusions and a thickness of 0.10 m.

- 6.2.6 The deposit 301, which overlay structure 312 (Trench 3) was found to contain a large amount of broken structural glass. The thickness of the glass ranged between c.2 and 4 cm which corresponded to the thickness of both kinds of glass (window panels and roof) used in the conservatory/orangery building c.60m to the north of Trench 3. With the two dump deposits described in Trenches 2 and 3, it does appear that a lot of the debris material from within the derelict house was re-deposited over the grounds as levelling material across the parterre gardens.
