# Parterre Gardens Witley Court Great Witley Worcestershire

## Technical Report Volume II

**Document Type:** Archaeological Investigation Report

**Witley Court, Worcestershire  
The Parterre Gardens**

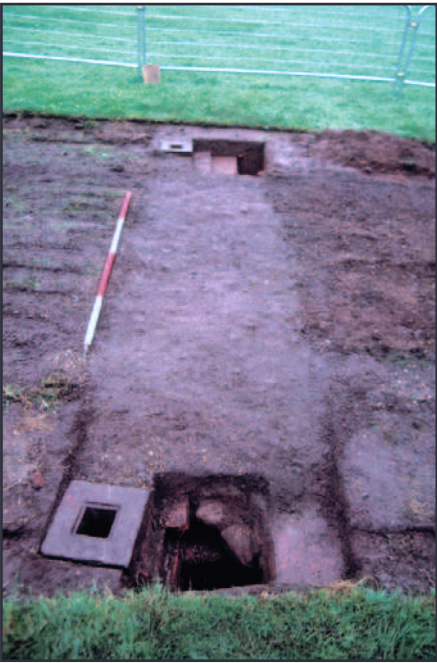
Plate 13 - Trench 10, excavation to expose extent of path and examine drainage. Looking east.

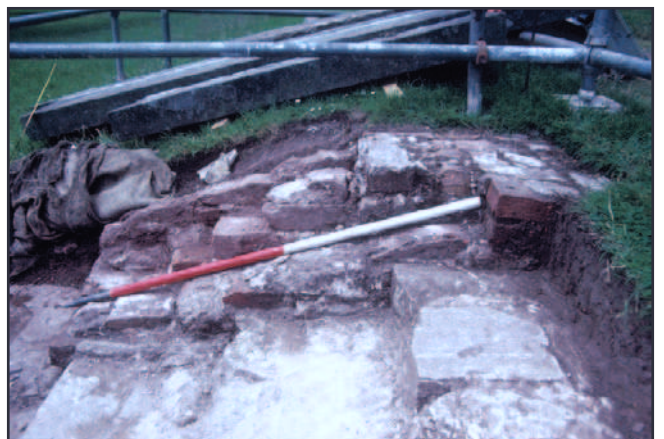
Plate 18 - Trench 7, surviving stringer of steps S2. Looking west.

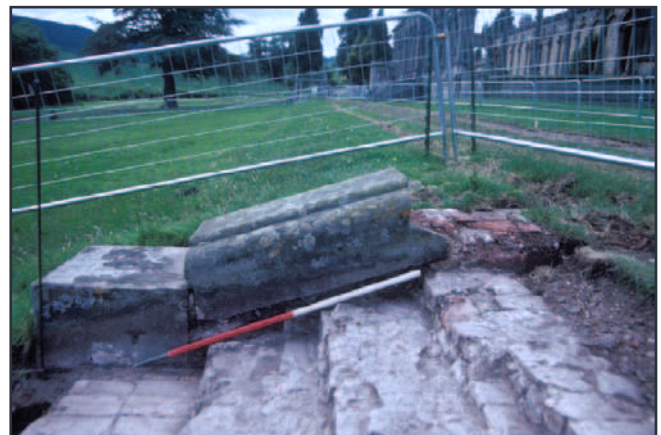
Plate 24 - Trench 5, detail of surviving stringer S4. Looking west.

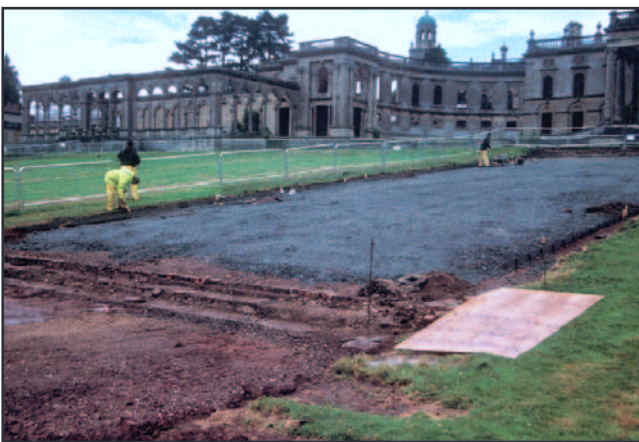
Plate 29 - Trench 6, surviving step foundations S5 with central path being prepared for re-surfacing. Looking north west.

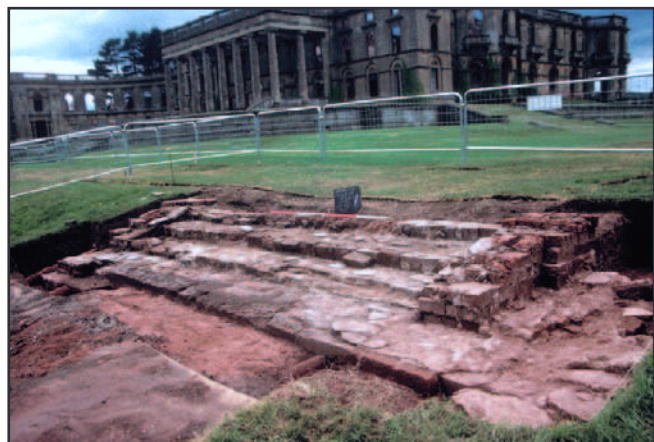
Plate 30 - Trench 17, excavation of step foundations S12. Looking north west.

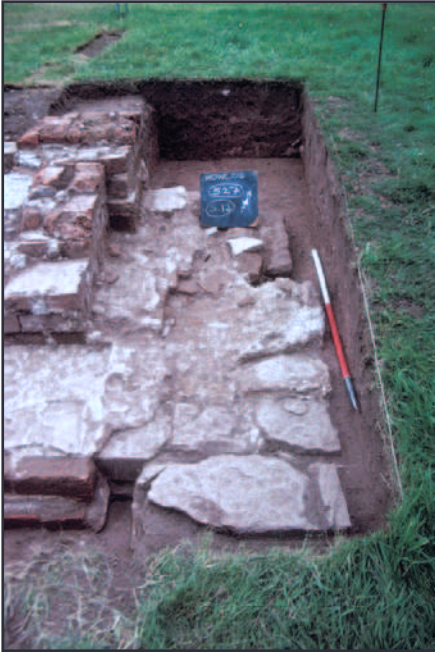
Plate 31 - Trench 17, wall footing 527 exposed beneath step foundations S12. Looking north.

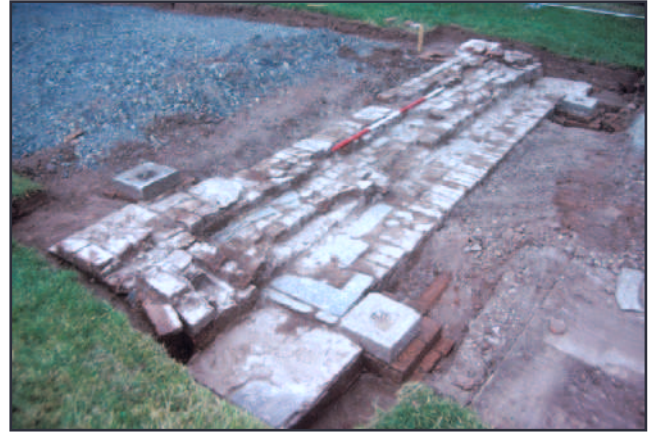
Plate 32 - Trench 16, excavation of step foundations S6. Looking north east.

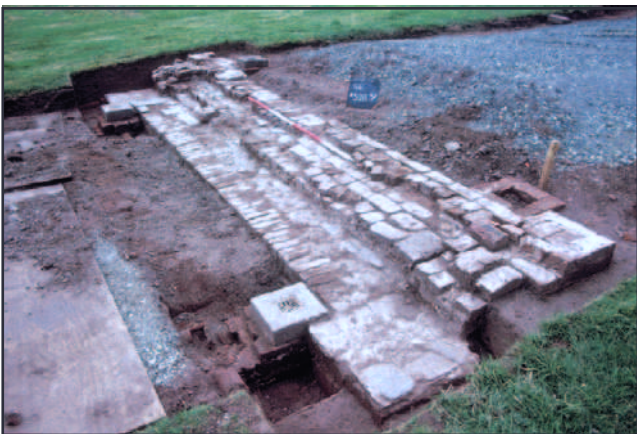
Plate 33 - Trench 16, excavation of step foundations S6. Looking north west.

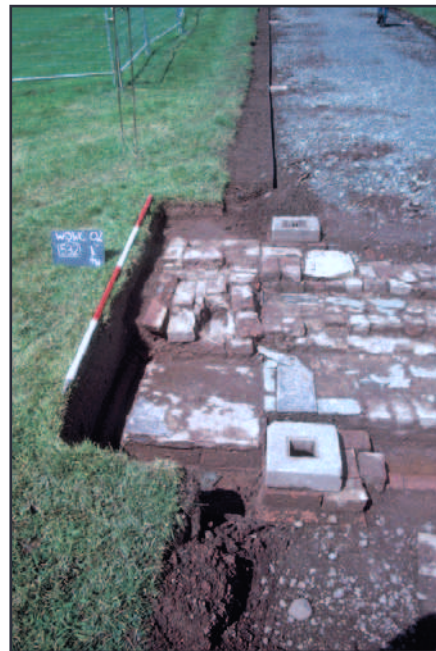
Plate 34 - Trench 16, detail of surviving stringer of steps S6. Looking north.

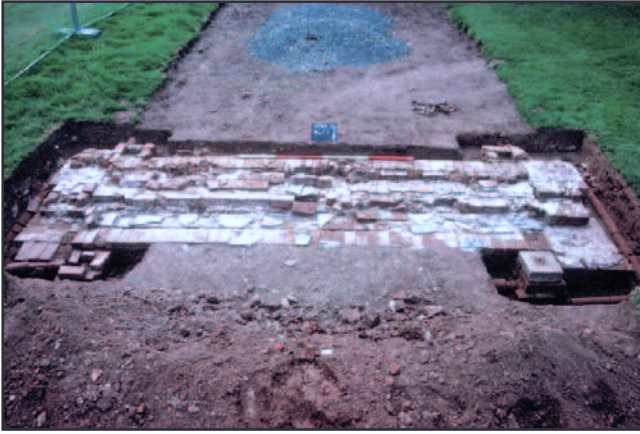
Plate 37 - Trench 22, excavation of step foundations S31. Looking south.

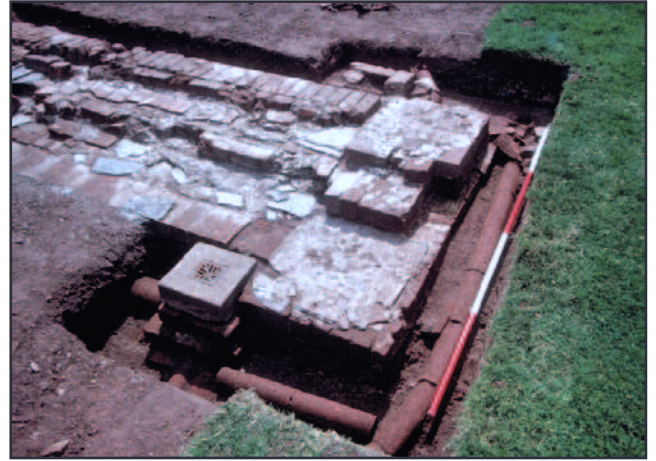
Plate 38 - Trench 22, detail of surviving stringer and drainage of steps S31. Looking south.

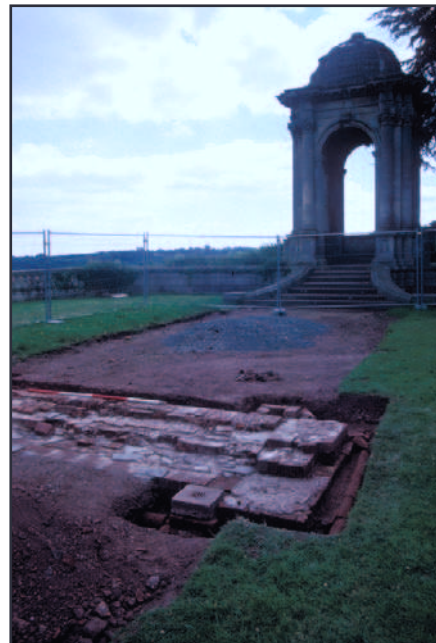
Plate 40 - Trench 22, excavated step foundations S31 with south eastern Temple in background. Looking south.

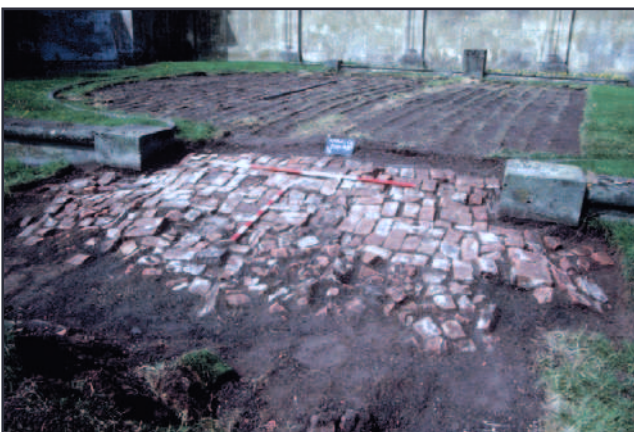
Plate 41 - Trench 15, brick constructed ramp exposed overlying step foundations S1. Looking north.

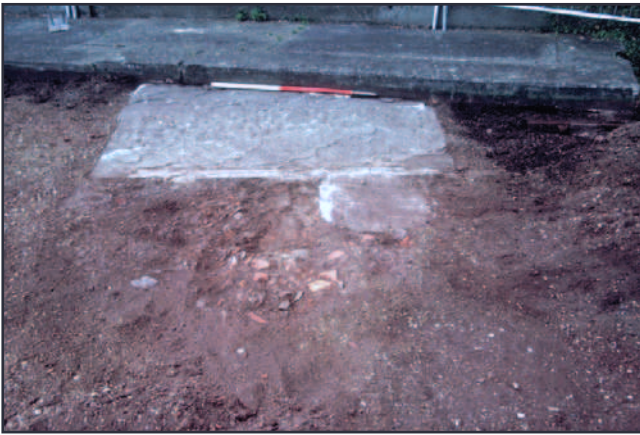
Plate 43 - Trench 20, top of fountain tunnels exposed. Looking west.

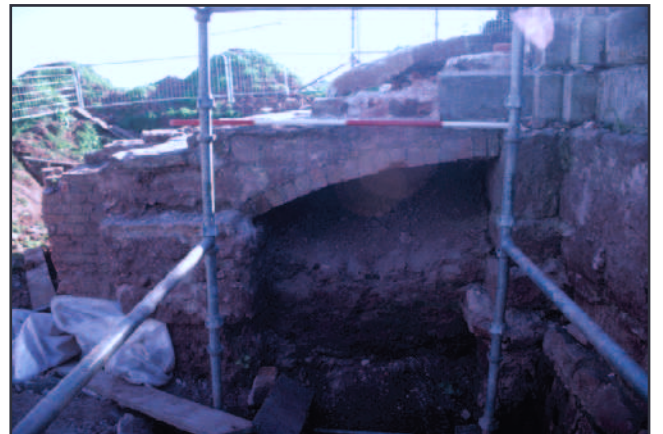
Plate 64 - Trench 20, arched foundation of steps S7 above fountain tunnel. Looking south.

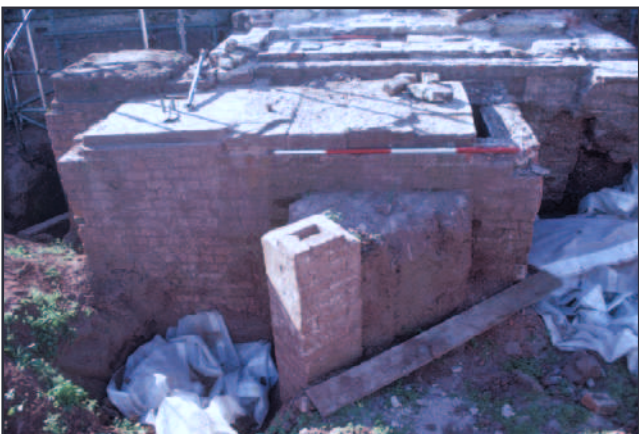
Plate 65 - Trench 20, detail of tunnel entrance structures. Looking west.
