Henley Baptist Church
55-57 Market Place
Henley-on-Thames
Oxfordshire

**Archaeological
Watching Brief Report**

April 2010

**Henley Baptist Church,
55-57 Market Place,
Henley,
Oxfordshire**

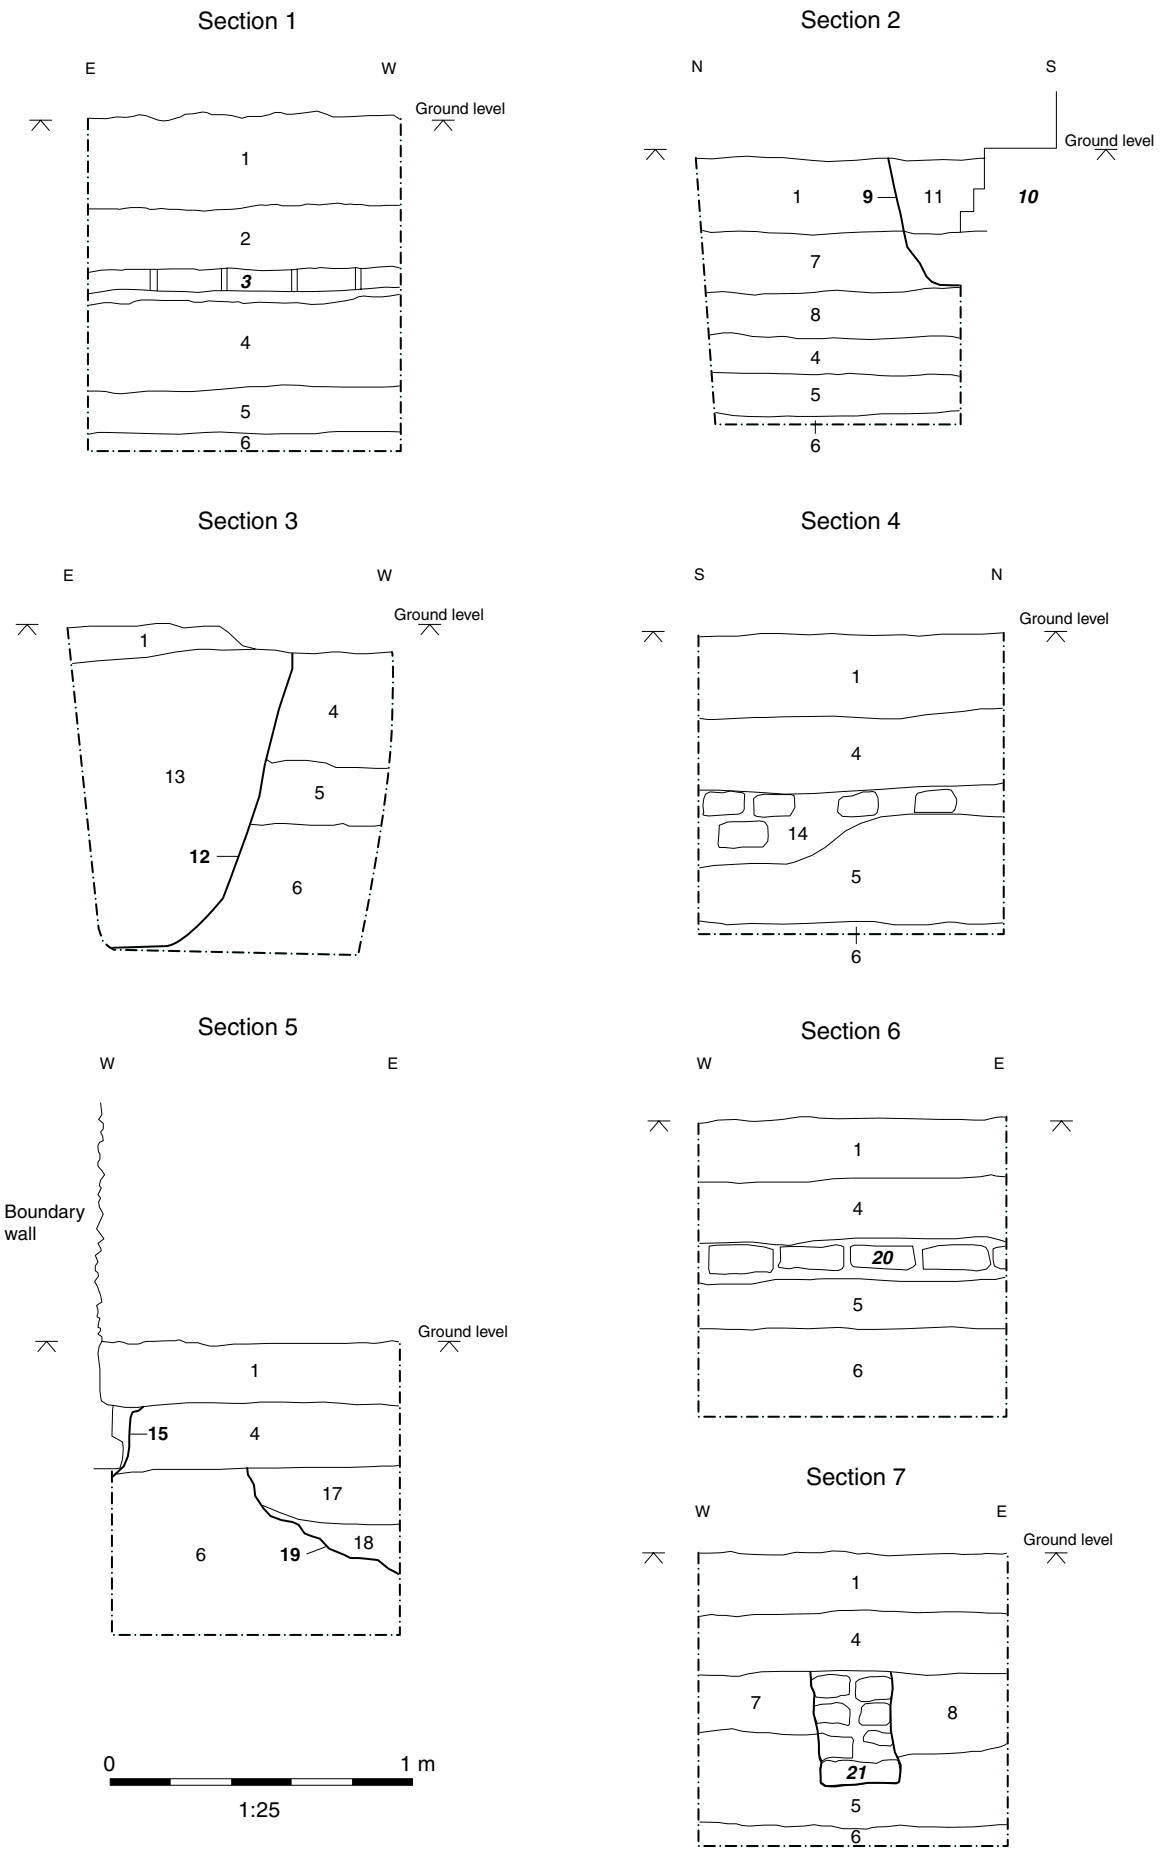
Figure 3: Sections

- 1.1.15 The undisturbed natural, an orange-brown clay silt (6) was encountered at a depth of 0.95 m below the current ground level (Fig. 3, Section 1).

- 1.1.16 Overlying this was a 0.15 m deep layer of brown clay silt containing many pebbles (5). This was overlaid by a 0.5 m deep layer of light brown clay silt (4). Built directly upon this layer was a brick floor (3) constructed of a mixture of two types of hand moulded bricks measuring 0.22 m x 0.106 m x 0.06 m and 0.231 m x 0.11 m x 0.07 m respectively. The bricks were laid on a bed of lime mortar. This surface was overlaid by a 0.2 m deep layer of demolition debris including bricks and corrugated iron sheeting (2). A 0.3 m deep layer of dark brown silt loam containing bricks and corroded iron objects (1) completed the section.

- 1.1.17 This was located adjacent to the rear (southern) boundary wall and was excavated to a depth of 1.1 m below the existing ground level.
- 1.1.18 The underlying natural clay (6) was encountered at a depth of 0.85 m below the current ground level. This was sealed by a 0.14 m deep continuation of layer 5. Overlying this was a 0.15 m deep layer of light brown clay silt, a continuation of layer 4. This layer was overlaid by a layer of light red-brown silt clay loam, 0.15 m deep (8). This layer contained fragments of brick and mortar flecking and probably represents a demolition layer. Overlying layer 8 was a 0.2 m deep layer of dark grey-brown silt loam (7), a probable layer of worked soil. This was sealed by a 0.25 m deep continuation of Layer 1. Cutting Layer 1 was a 0.5 m deep foundation trench (9). Built into this trench was a concrete footing supporting the brick and flint boundary wall (10). The remainder of the trench had been backfilled with loose dark brown sandy silt (11).

- 1.1.19 This was located along the eastern edge of the new building, and was excavated to a depth of up to 1.1 m below the current ground level.
- 1.1.20 The natural (6) was encountered at a depth of 0.6 m below ground level. This was overlaid with a 0.2 m deep continuation of the earlier worked soil (5). This was sealed by a 0.35 m deep layer of light brown clay silt, a probable continuation of layer 4. Cutting this deposit was a steep sided cut (12), 1 m deep and over 0.8 m in width. This was filled by a grey-brown silt clay (13) containing numerous broken bricks. Sealing this was a 0.1 m deep layer of dark brown silt loam, a continuation of layer

1.1.21 This was located on the inside corner of the new build, measured 0.9 m square and was excavated to a depth of 1.1 m. The natural, (6), was encountered at a depth of 1 m below the level of the current ground level. This was overlaid by a continuation of layer 5, up to 0.35 m in depth. Built on top of this deposit was a brick surface (14). This was constructed using hand moulded bricks 0.23 m x 0.11 m x 0.07 m in size bonded with lime mortar. Overlying this was a 0.25 m deep layer of light brown clay silt, a continuation of layer 4. Sealing this was the present day topsoil (1) 0.3 m in depth.

1.1.23 The underlying natural was encountered at a depth of 0.4 m. This was cut by a small pit, 0.4 m deep and approximately 1 m in diameter (19). The base of this feature was filled by a 0.2 m deep layer of broken brick in a grey-brown silt matrix (18). Overlying this was a 0.2 m deep layer of light grey-brown clay silt containing chalk and lime mortar flecking (17). The pit was sealed by the layer of light brown clay silt (4), 0.25 m deep. This deposit was cut by the 0.25 m deep linear vertical sided foundation trench (15). Built within this cut was the 2 m high western boundary wall (16), constructed using dressed flint blocks bound with a lime mortar. This wall had been repaired using hand moulded brick.

1.1.26 The natural (6) was encountered at 0.6 m below the current ground level. This was overlaid by a continuation of layer 5, 0.15 m in depth. Built directly on top of this deposit was a single layer of bricks (20) laid on a lime mortar bed running north-south across the width of the pit. The hand moulded bricks measured 0.23 m x 0.11 m x 0.07 m. This feature was aligned with the rear door of the church. Sealing this feature was a 0.2 m deep continuation of layer 4. Overlying this was a 0.2 m deep continuation of the modern topsoil (1).

1.1.28 The red-brown natural clay (6) was encountered at a depth of 0.85 m below the current ground level. Overlying this was a continuation of layer 5, which was 0.35 m deep. Cut into this deposit was a 0.28 m wide by 0.2 m foundation (22), which ran north-south into approximately the centre of the pit. Built within the cut was a stub

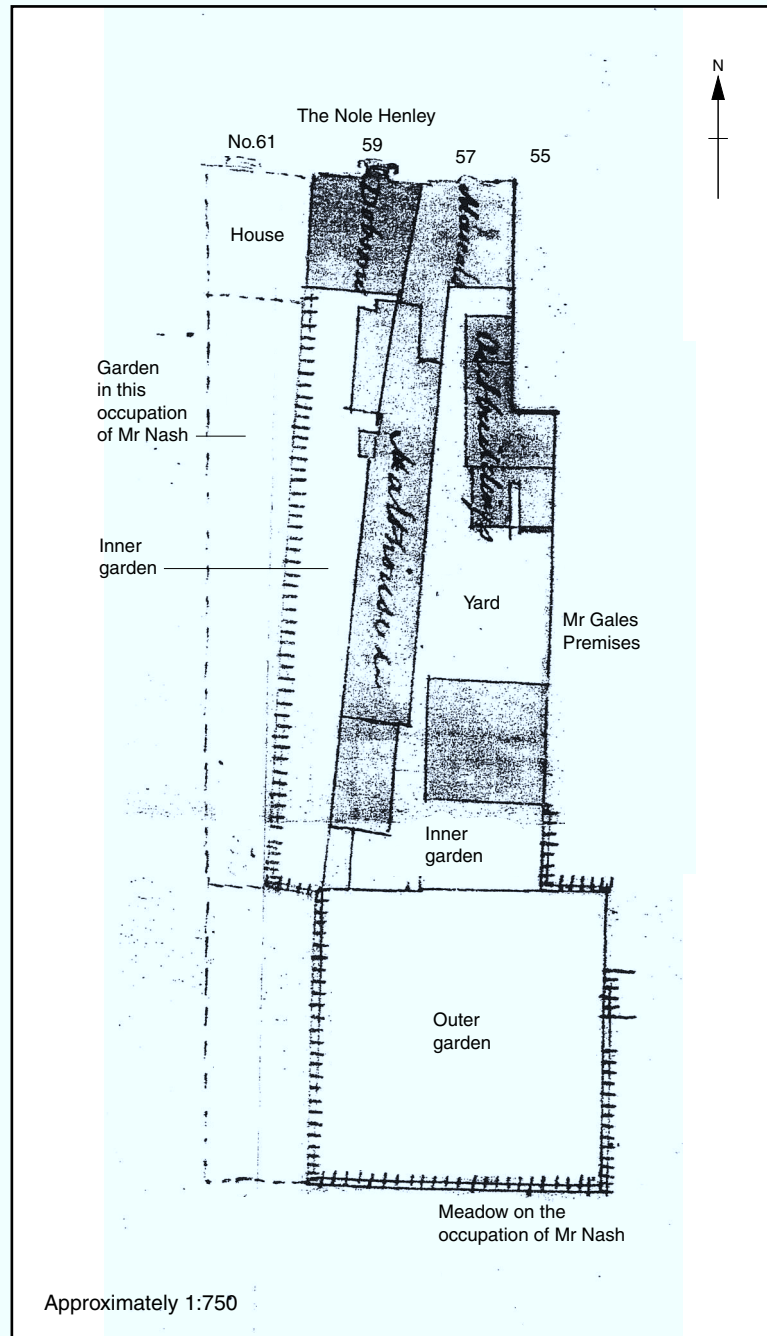
Figure 4: 1826 plan of site

- 1.1.38 The 1826 map (Fig. 4) accompanying the leasing contract from T and R Tyrell to William Dobson shows a long building (labelled as a “malthouse”) running down the length of the western edge of the site, from the rear of the original house up to the end of the timber framed building (still standing on site). This building (scaling from the present day dimensions of the site) was approximately 31.7 m long by 4.6 m wide.

- 1.1.39 The construction of the malthouse is unknown. If this structure had been of brick construction the number of foundation pads dug alongside the western boundary wall should have impacted on the foundations, or at least the robber trench if these had been grubbed out. The absence of this evidence suggests that it may have been a wooden structure, possibly resting on pads (either brick or stone) which were subsequently removed. It is possible that Pit 19 may represent one of these robbed out pads.

- 1.1.40 Straddling the present day southern boundary of the site is an un-labelled building approximately 9.2 m square. The north-west corner of the site is occupied by an “L” shaped building, measuring 11.2 m by 8.1 m, enclosing the yard of no 55. Butting up to the rear of this structure are two out buildings.

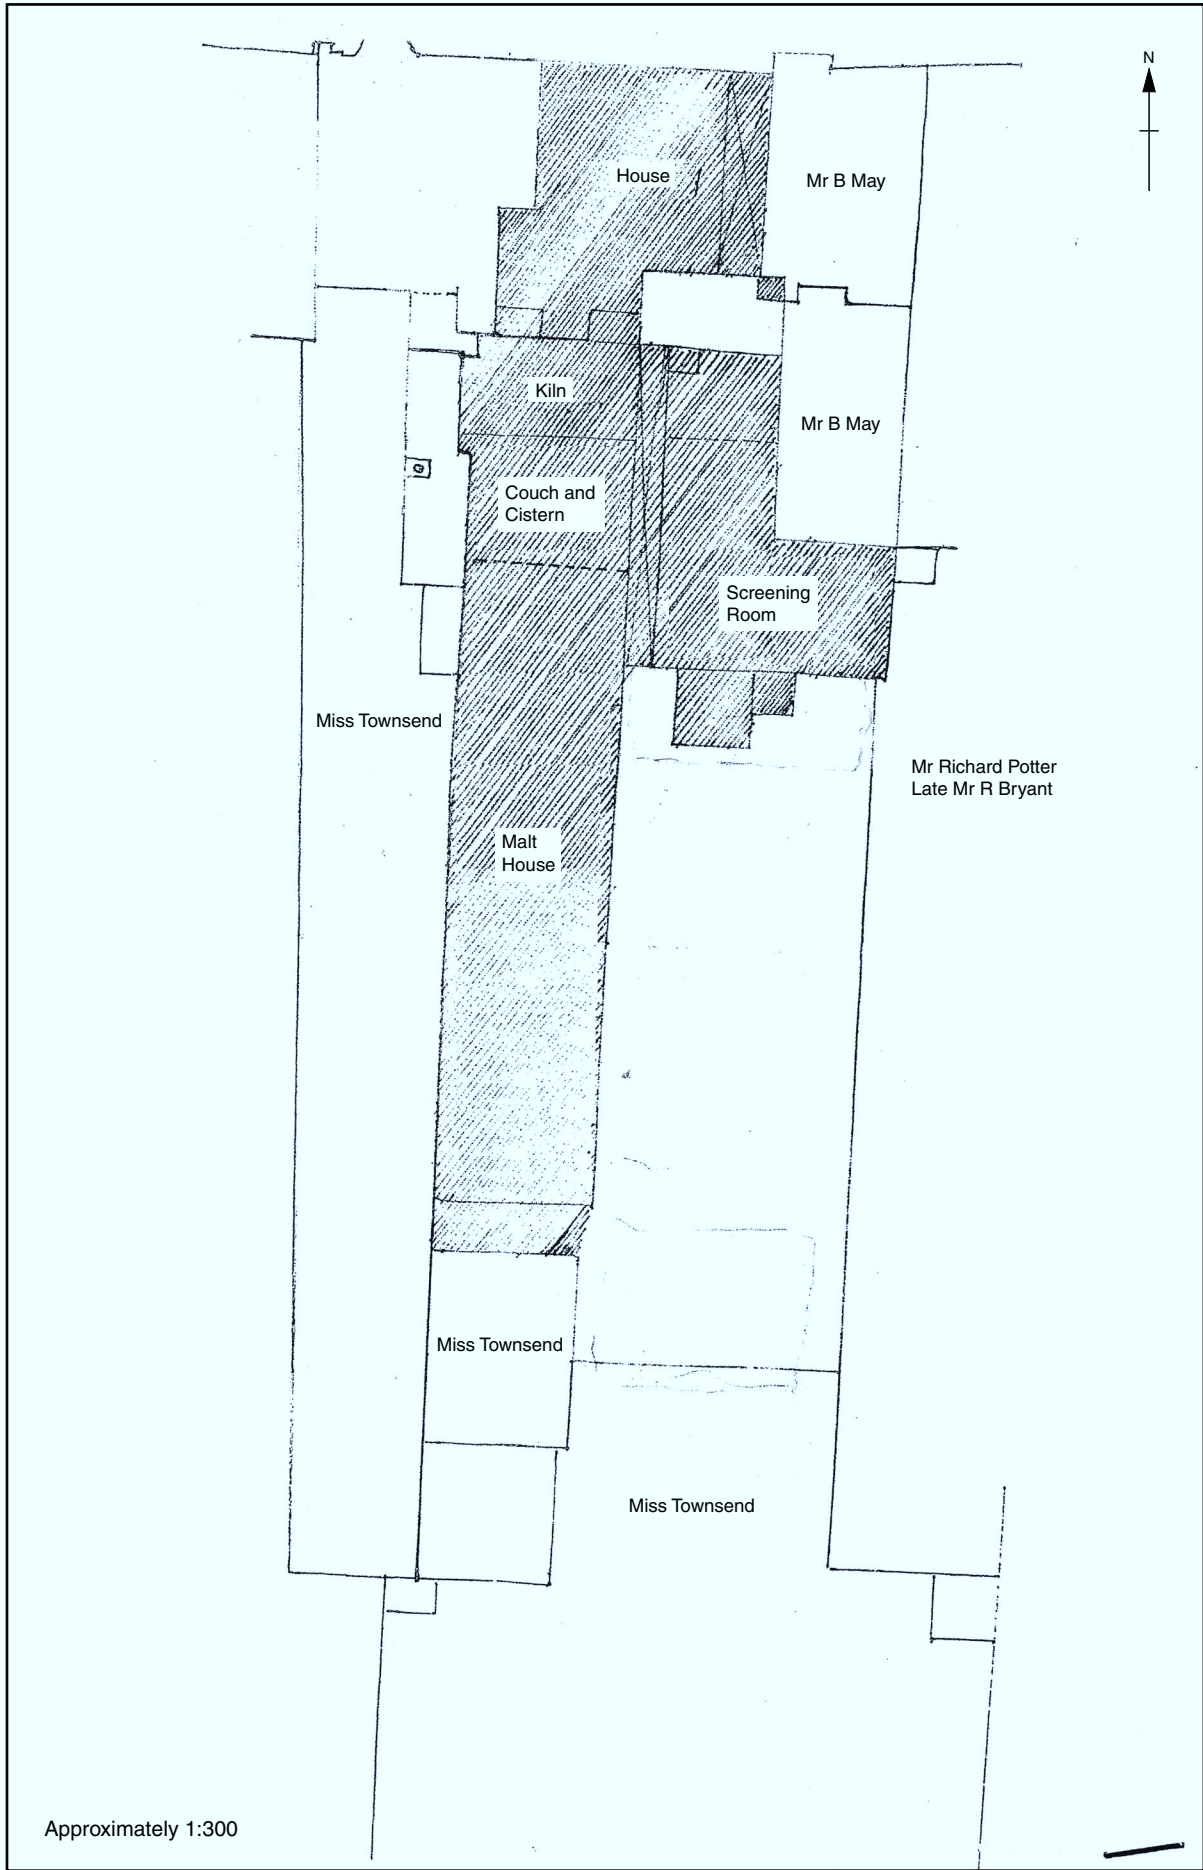
Figure 5: 1877 plan of site

- 1.1.42 By 1877 when the site was conveyed from J. Sharp to Samuel Gestase for the sum of £590 (Fig. 5), the square building has disappeared and the present day southern boundary has been established. The malthouse is still in place, and the function of the outbuildings attached to the house has been defined. It is probable that the kiln used for drying the grain and stopping the malting process would have been built of brick and would have been of two storey construction. The building containing the cistern (a large stone tank used to steep the barley) and the couch (a flat area where the wet barley was stored until it germinated) may have been of either brick or wood framed construction. The “L” shaped building’s function is shown as a “screening room”, where the malt was sieved to remove the grain shoots from the malt, and would have been fed directly from the kiln. The two outbuildings butting up to the rear of this building have been replaced by two smaller constructions centrally placed against the

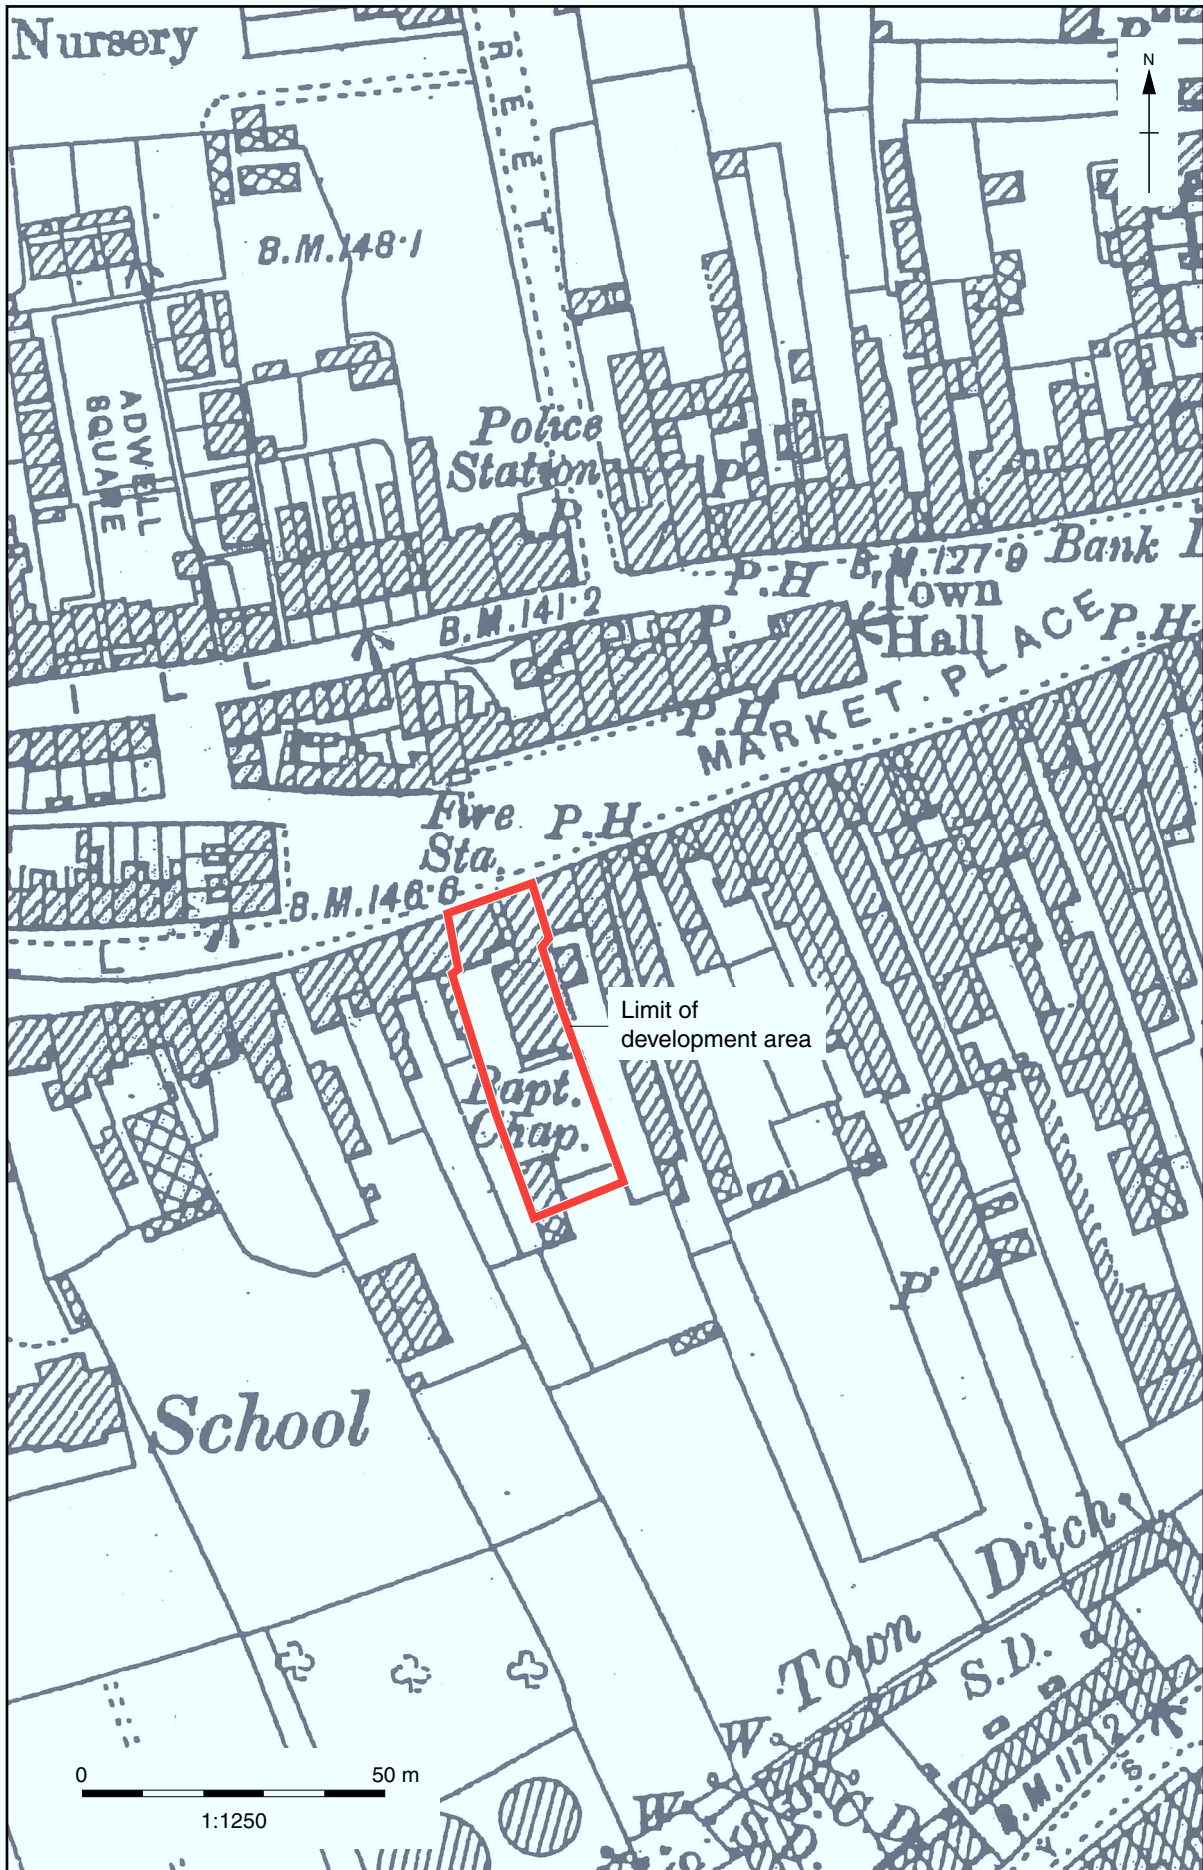
Figure 6: Ordnance Survey 2nd Edition of 1925

- 1.1.43 By the time of the 2nd Edition OS survey of 1925 (Fig.6) The malt house, along with the couch, cistern and kiln has gone and the screening room has been replaced by the church building, which also covers the back yard of no 55. This probably happened soon after the site was acquired by the Baptist church in 1879.

- 1.1.44 A comparison of the church building's footprint with the previous map shows that the new building was larger than the screening room and the earlier outbuildings removing the potential for determining their construction. The well, 24 and wellhouse, 25, appear to be associated with the church and butt up to the rear wall of the church. It is possible that they were demolished when mains water became available.
