# Flood Alleviation Scheme Ascott-under- Wychwood Oxfordshire

## Archaeological Watching Brief Report

**Document Title:** Flood Alleviation Scheme, Rear of 36 Shipton Road,  
Ascott-under-Wychwood, Oxfordshire

**Document Type:** Watching Brief

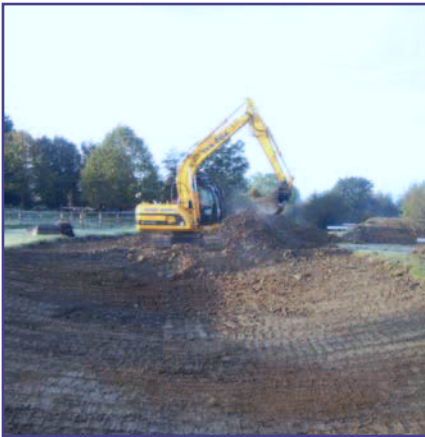
Front cover: Excavation of the swale
