Archaeology West - Contract No. C254
Archaeological Excavation at Tottenham Court Road North
 Interim Report

Document Number: C254-OXF-W-RGN-N105-50002
 (Draft Document No. OAG16188.R11)

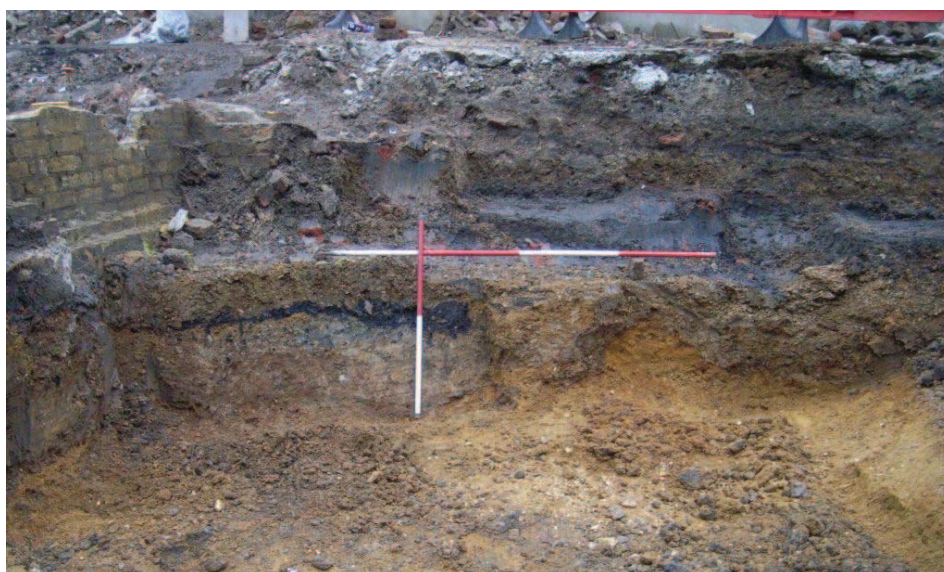
- 2.1.5 **Phase 1 Early to Mid-Seventeenth Century:** The quarry pits were difficult to define since they had been partially obscured by the much later deep truncations of Victorian and modern features, namely 5005, 5038, 5038 and 5044. Where the quarrying was visible the interface was somewhat uneven and irregular (Plate 1), perhaps indicative of a more continual, piecemeal extraction occurring over an open area, rather than an organised and discriminating approach. The main quarrying interface (5341, 5342 and 5329) was seen to occupy an area aligned roughly east-to-west across the northern part of the site, with a southern extent seen in the south-east corner. There were indications of other cuts/interfaces (5274), suggesting an open area with several active quarries.

Plate 1: Uneven nature of the quarrying, looking west

- 2.1.6 The backfills of the quarrying were generally orange sands and gravels with mixed pale brown clay and occasional sooty lenses (eg 5314). These deposits are characteristic of the surrounding natural and suggest that some of the backfilled material was being re-deposited. Within the backfill the presence of post-medieval finds in these deposits was a relative rarity but the dateable elements found (5268) seem to indicate an early 17th-century date for the infilling. This included a fragment of relatively high status, polychrome tin glaze tile, possibly Dutch in origin. Further analysis may elucidate whether the complete assemblage dates to the same period. If it does this will provide the earliest evidence of activity on the site. The documentary evidence from ratebooks and leases can only show occupation as far back as 1694, although earlier activity is certain.

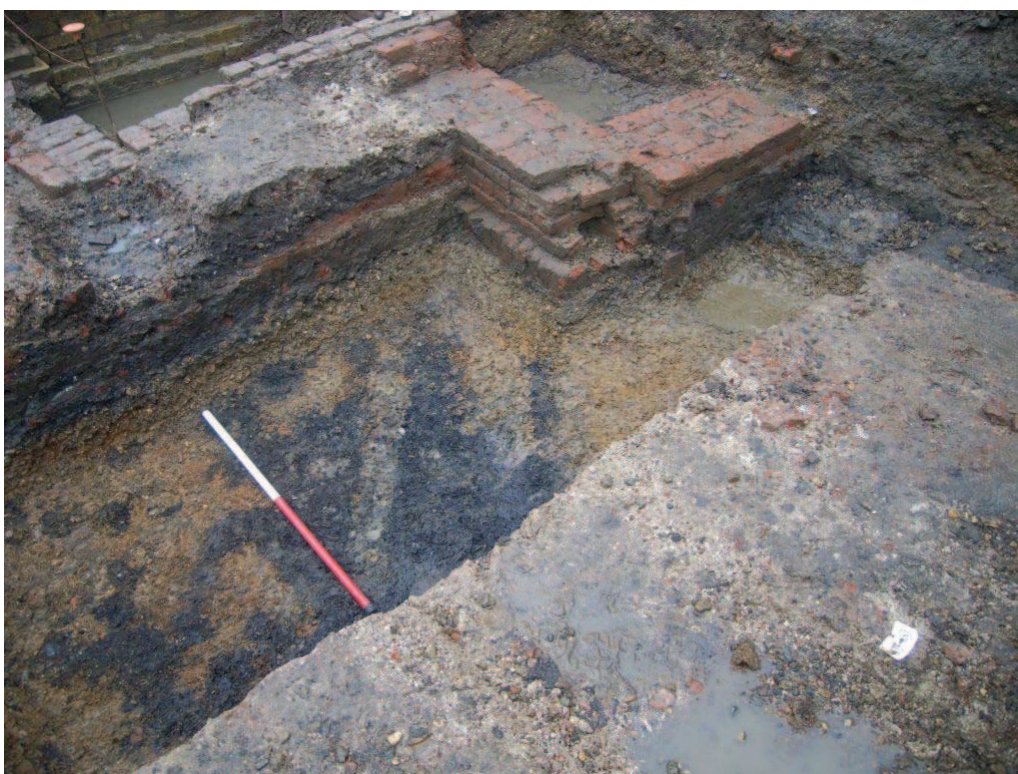
- 2.1.7 **Phase 2 Late Seventeenth Century:** On the western side of the site, the quarrying was sealed by a deliberate, widespread deposit of compacted clayey gravel, seen as contexts 5162, 5110 and 5247, amongst others. Beneath this layer was evidence of wheel ruts which could be related either to the quarrying and its backfilling, or possibly the actual transport and compaction of the sealing gravel layer (Plate 2). Overlying the gravel layer was a thin horizon of black sooty trample (5158) onto which the foundation course of the earliest red brick building was constructed.

Plate 2: Evidence of wheel ruts in surfaces prior to the construction of buildings in the 17th century, looking south-west

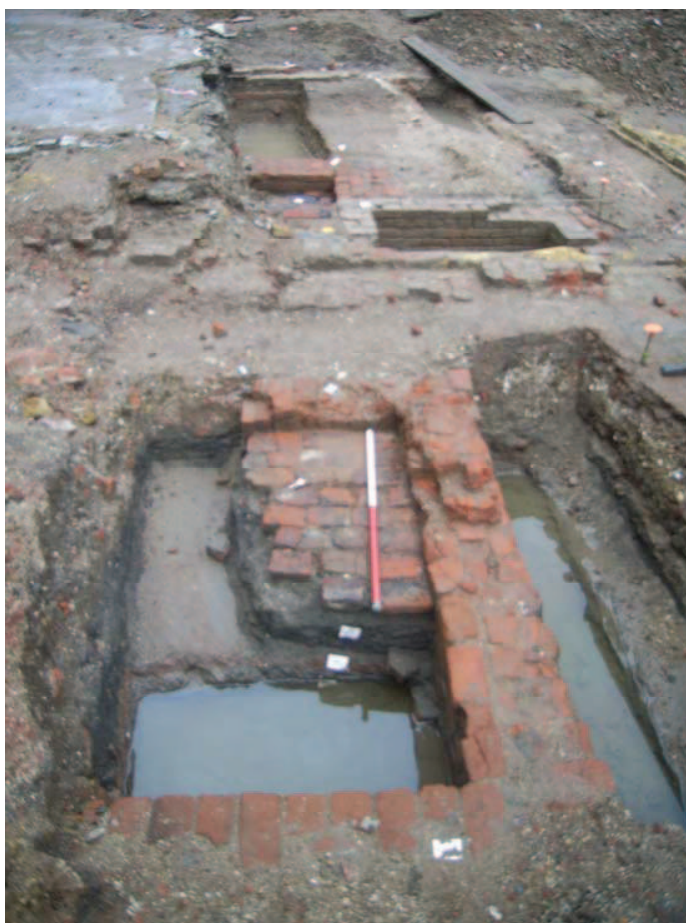
- 2.1.8 The remains of the brick building located in the trial pit investigation (624=626) were uncovered again (5009) and the expanded excavation area allowed the northern extent of surviving remains to be identified (5217, Plate 3). There were two identifiable phases. The first was the construction of the main, weight-bearing wall (5009 and 5217), which was seen to be aligned north to south, and returned westwards at the southern end, as seen in test pit 624. This wall was constructed of hand-made, unfrosted bricks. Its coursing was somewhat arbitrary but appeared to be a mixture of English and Flemish stretcher bonds. The wall was supported by a single soldier course of brick. The wall had at its time of construction probably extended further than the 5.75m length seen in the excavation, but had been truncated by cut 5136. Possibly at the same time as cut 5136 was dug, inner partition walls (5016 and 5284=627) were erected, and it is with this later phase that a brick floor (5010=621) was associated.

Plate 3: Brick building dating to the 17th century, looking north

The structure first seen in Test Pit 6 was revisited and the initial conclusions were confirmed. In addition it was proven that the building was substantially larger than previously recorded, extending to over 5.75m in length. The wall found was identified as the eastern, rear wall of the building, and, although there were later abutting walls extending to the west, these were seen to have been truncated, immediately adjacent to the western limit of excavations. This is probably a result of the truncation of deep foundation of later buildings along Great Chapel Street. The full analysis of the associated finds assemblages will give a clearer picture of the use of the premises but it appears to be primarily domestic.

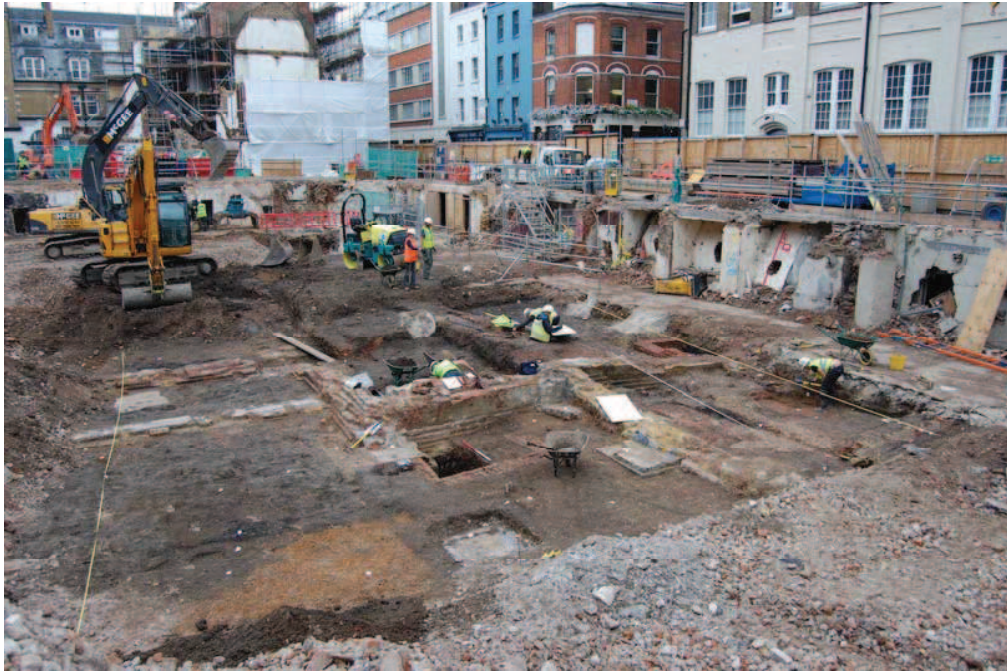
- 2.1.14 **Phase 4 The Victorian to Modern periods:** A series of walls belonging to buildings of this period were constructed of the distinctive yellow London Stock bricks (5005, 5038 and 5038, Plate 4). This phase of activity saw both the truncation of earlier features and the adaptation of earlier walls, namely 5201, which was incorporated into the newer buildings. The walls seen in the excavation correspond well with those shown on the 1896 and 1916 editions of the OS mapping, but suggest that there may be some subtle sub-phases. The corresponding Post Office directory for 1896 lists a dairy amongst the properties along Great Chapel Street, as does the 1915 edition. Although further documentary research is required, it is possible that the slate-lined walls seen in this phase could have been part of a cold storage room, as seen elsewhere in the area (*Interim Statement for Targeted Watching Brief conducted on 12 Goslett Yard, Museum of London Archaeology (MOLA)*).

Plate 4: General view of site, including later Victorian walls, looking south-west
