KINGSLEY COTTAGE, RED LION LANE, NANTWICH, CHESHIRE

Archaeological Watching Brief

Oxford Archaeology North

October 2008

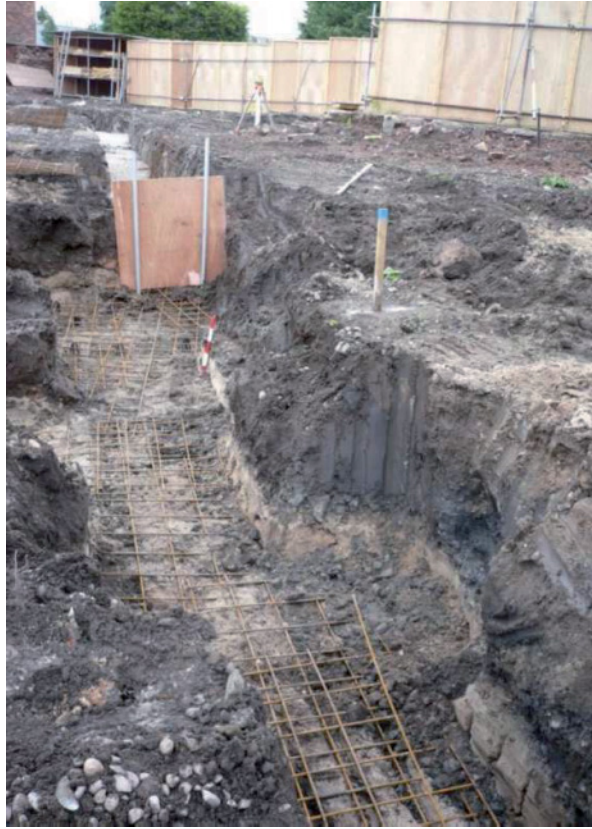
Plate 1: Roman road 119 in north-facing section with construction work ongoing

3.2.2 **Roman features:** the earliest identified archaeological remains included metal surface **119**, which was initially observed for a length of c 17m in the north-facing sections of the most south-westerly foundation trenches (Fig 3; Plate 1), before a wider area was exposed to the south within an archaeological sondage. Surface **119** was patchy in places and clearly had been truncated to a greater or lesser extent across much of its length (Plates 2 and 3), whilst its intermittent disturbance by piles and the use of a toothed bucket did not aid its initial identification. At the western end of the sondage the road was severely truncated by activity associated with Kingsley Cottage, and survived only as a thin band of make-up material, whilst the more easterly portion was truncated by later cut **124** (Plate 4); no further evidence of the surface was identified in those foundation trenches to the east. Although the full width of the road was not seen in plan, there was sufficient evidence to suggest that it was orientated north-west/south-east, following a natural slope in the alluvium from 36.3m OD in the west to 37.1m OD in the east. The surviving surface, **119**, up to

0.3m thick, comprised sub-rounded and sub-angular gravel and stones up to approximately 0.1m across, within a grey gleyed sandy matrix. It appeared to have been laid directly onto the natural sand, **103**, with the larger stones generally at the top. No finds were recovered from below the road surface, but Roman artefacts, including pottery and a fragment of lead, were all recovered during the cleaning of the road surface (recovery context **120**).

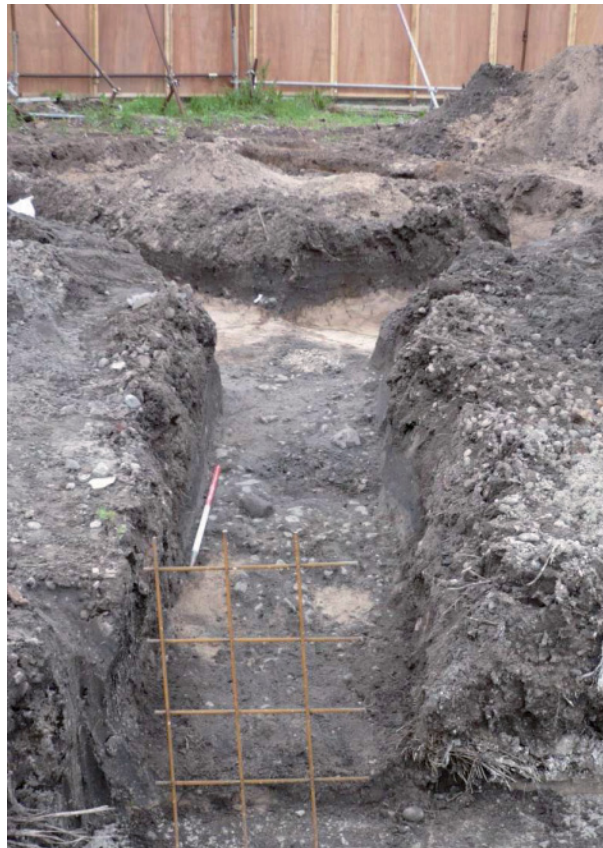
Plate 2: West-facing shot of road 119 in plan with modern cut 124 in foreground; 1m scale

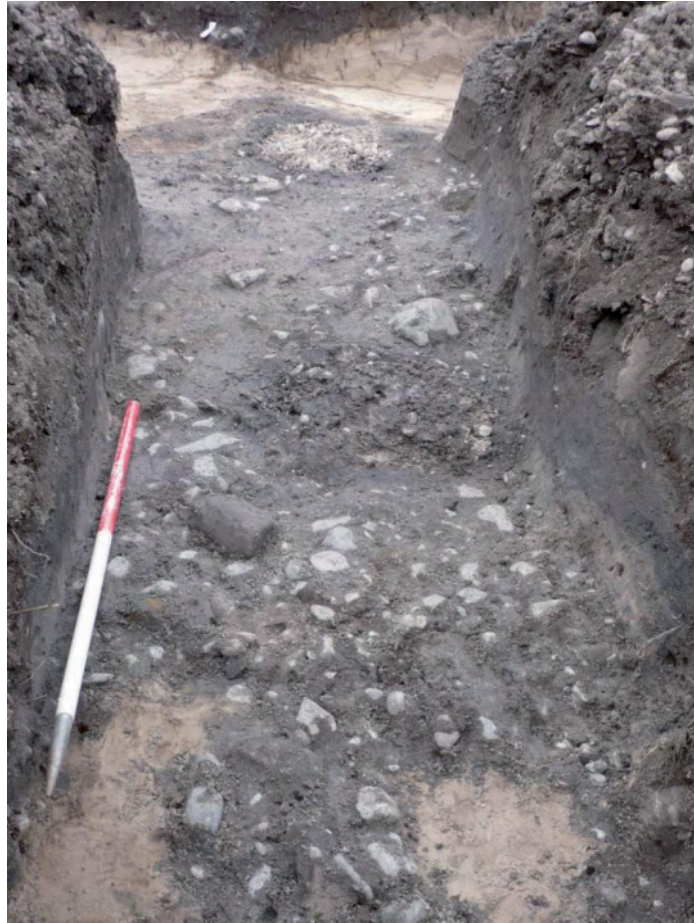
Plate 3: Roman road 119 in plan; 1m scale

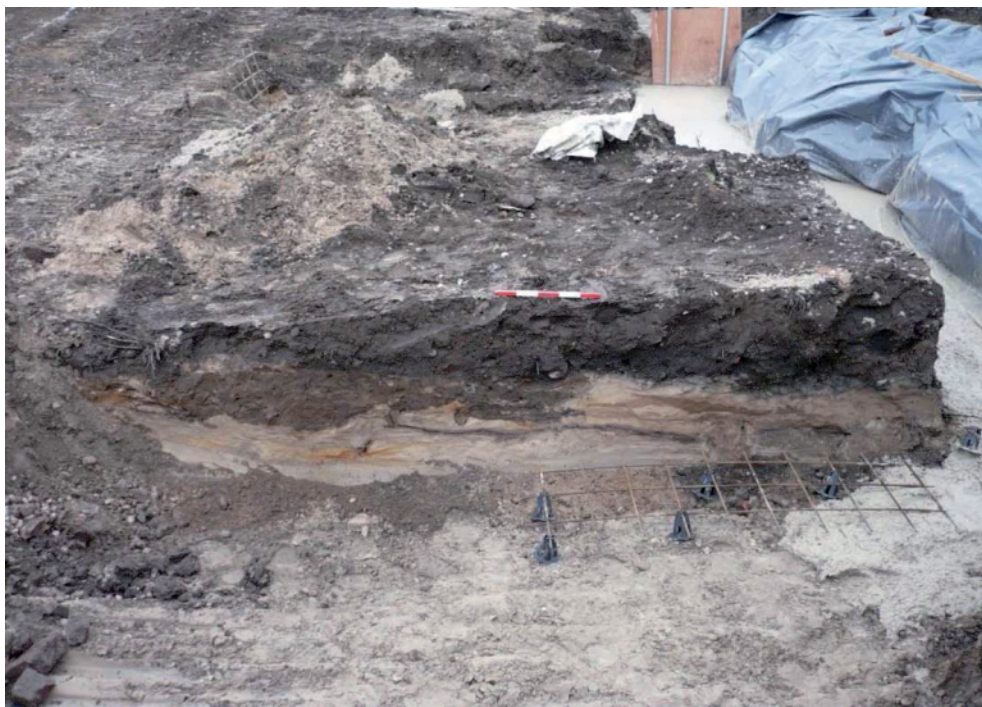
Plate 4: West-facing section showing linear feature 128 and road 119 truncated by modern cut 124; 0.5m scale

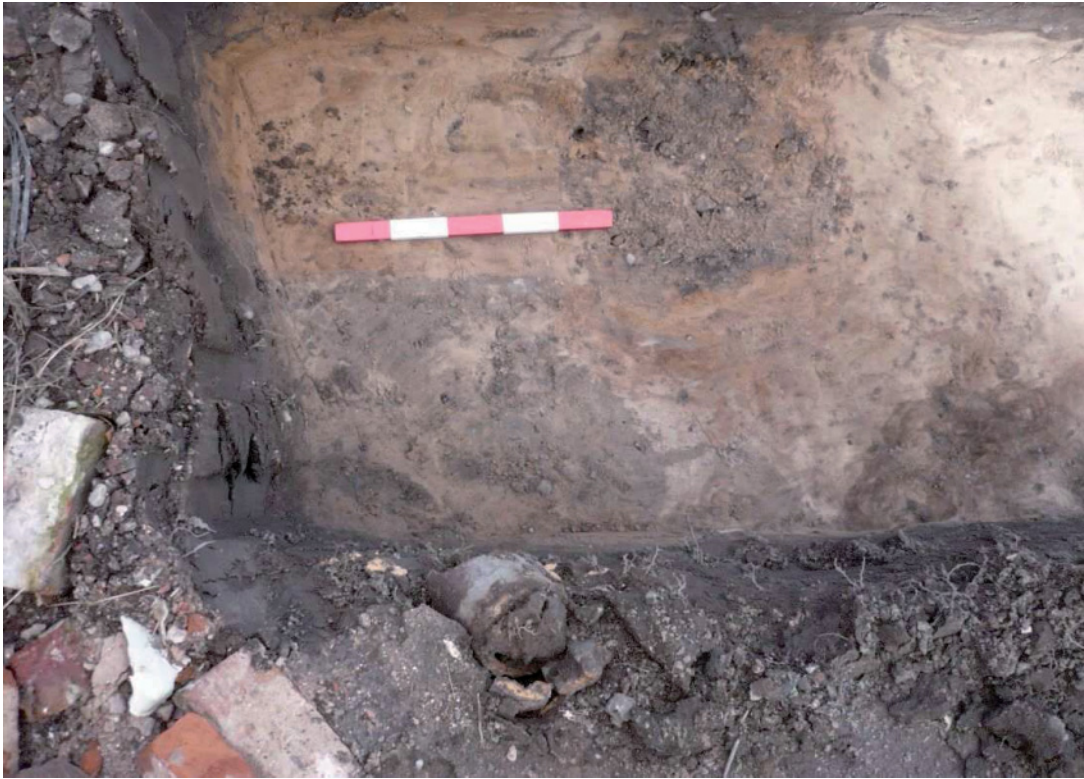
Plate 5: Pit 131 in plan; 0.5m scale

- 3.2.3 Pit **131** was identified within the most south-westerly foundation trench, extending beyond the southern and western limits of excavation (Plates 5 and 6). In section the pit could be seen to contain several fills, of which fill **136** appeared to have accumulated at a very steep angle, indicative of deliberate, albeit perhaps gradual, filling rather than natural silting. The final fill, **132**, perhaps represented a more rapid backfilling and contained a quantity of second-century pottery. Road **119**, pit **131** and alluvium **103** at the western end of the site, were sealed by two successive fairly localised sandy overburden deposits, **121** and **122** (uppermost), both of which produced artefact assemblages of solely Roman date, including a coin from layer **121**.

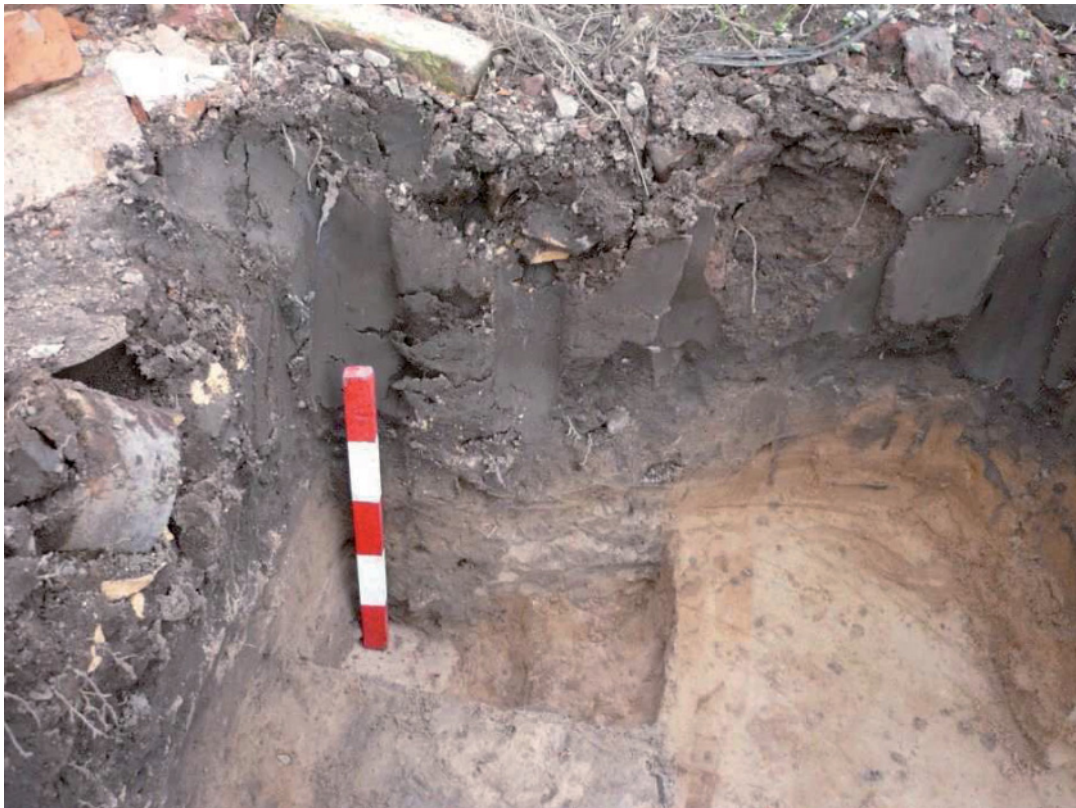
Plate 6: North-facing section of 131; 0.5m in scale

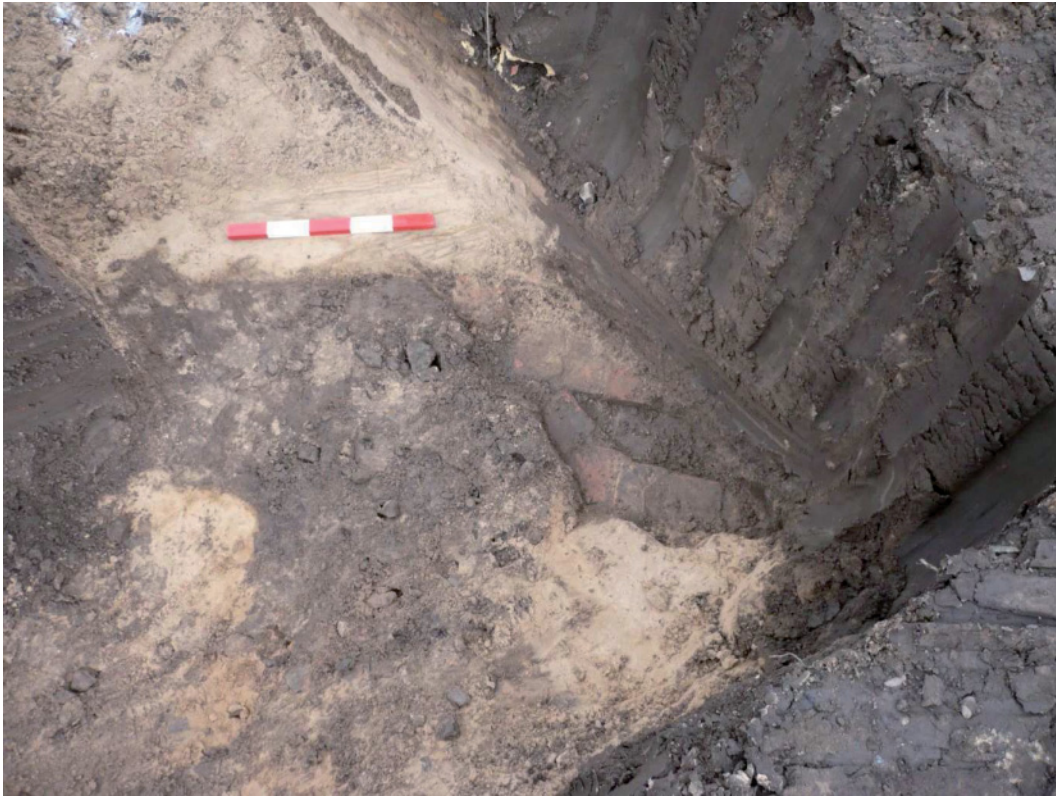
Plate 7: Drain 112; 0.5m scale

- 3.2.4 **Other features:** observation of the foundation trenches within the southern part of the site identified a number of truncated and rather discontinuous archaeological features (contexts **107** to **118**), all likely to relate to the post-medieval settlement activity on the site (Plate 7). Structural remains comprised a small stub of roughly east/west aligned wall **109**, and, similarly aligned, L-shaped wall **110**, which had been robbed-out and backfilled with material containing Roman and seventeenth- to eighteenth-century pottery. Linear features **117 = 126** and **128** would appear to represent narrow ditches on a similar alignment, their fills, **118** and **127**, respectively, containing small assemblages of eighteenth- to nineteenth-century pottery and occasional residual Roman material. Handmade brick-lined drain **112** was observed in section at several points in the north-eastern foundations, and may have fed into ditch **117 = 126**, although any conjunction of these features lay outside of the foundation trenches. Several pits were also identified, including pit **134** within the western-most foundation trench; the only artefact to derive from this 0.35m deep by 0.8m wide feature was a single sherd of abraded Roman pottery, which may well have been residual. Otherwise, the earliest post-medieval pit, **113**, contained eighteenth-century and residual Roman pottery, and had been clipped by pit **115**, itself likely to date to the nineteenth century on the basis of the finds from fill **116**. Pit **107**, at the south-eastern end of the foundations, measured 2.7m across, but the finds from fill **108** implied that it was rather modern in date.

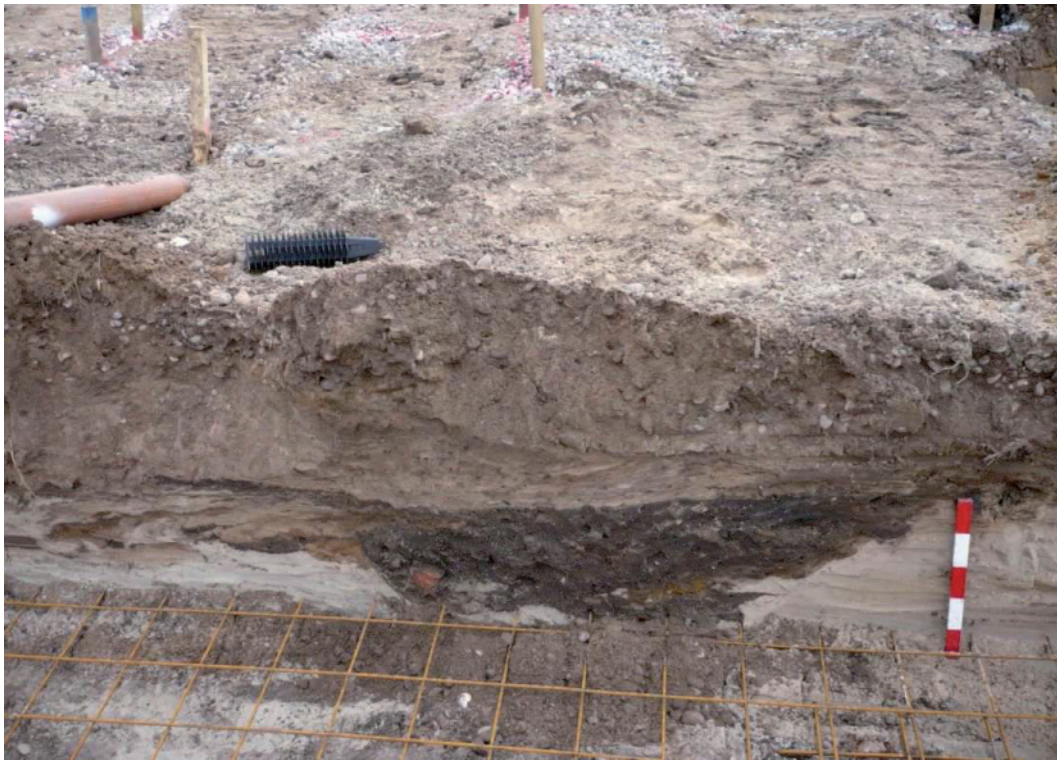
Plate 8: West-facing section showing re-deposited subsoil 101 after earlier ground clearance works truncated features; 0.5m scale

3.2.1 **Site strip:** although the majority of the site strip was undertaken without archaeological supervision, these results from the monitored areas are likely to be representative of the site as a whole. Observations demonstrated that, beneath topsoil **100**, there was a considerable depth of demolition debris across much of the site (deposit **104**, for example), presumably arising from the demolition of those buildings that formerly had occupied the site; that within the eastern part of the site was particularly contaminated and was not investigated closely. Within the southern part of the site, demolition debris and modern refuse appeared to have been incorporated with a considerable volume of bovine waste material (context **125**), deposited together within 10m by 8m cut **124**. Removal of these modern deposits revealed an extensive sandy interface/subsoil layer, **101**, up to c 0.5m thick and containing occasional charcoal and cultural material, mostly of post-medieval or modern date, but occasionally Roman. Subsoil **101** in turn sealed a series of alluvial deposits, the uppermost a 0.5m depth of banded light grey sands, **103**, followed by a layer of coarse sand **106**, which became increasingly silty with depth. All of the identified archaeological features were found to cut sand **103**.
