# Bradford Lane, Nether Alderley, CHESHIRE

## Documentary Research, Walkover Survey and Watching Brief

**Oxford Archaeology North**

**United Utilities**

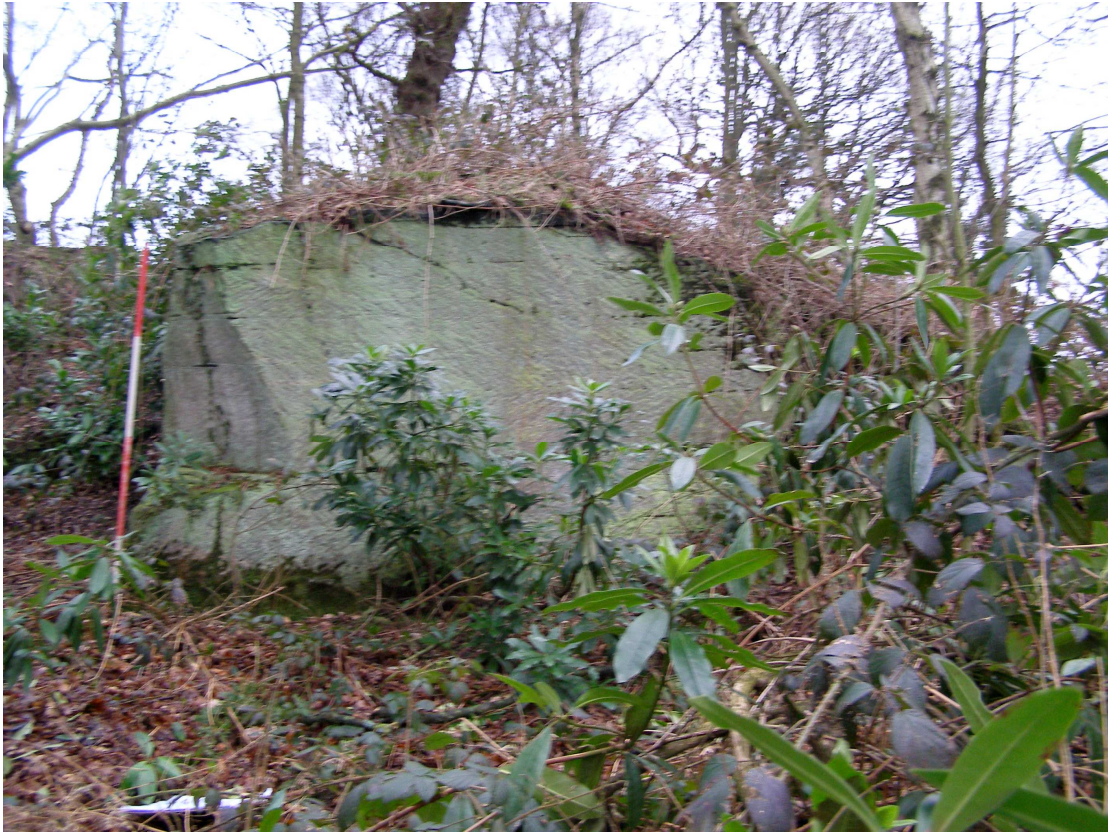
Plate 1: Part of sandstone quarry (Site 06)

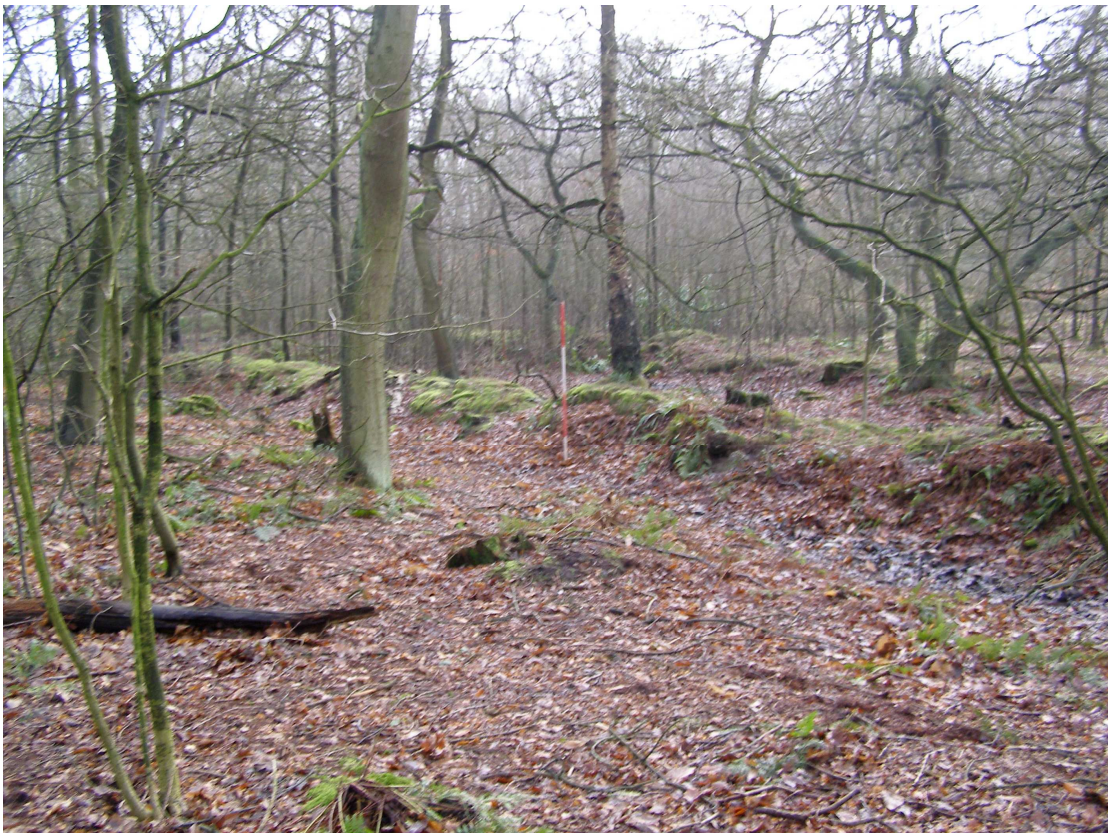
- 4.2.5 **Miscellaneous Sites:** Cow Lane (Site **09**) is located across the top of Finlow Hill Wood, nearly adjacent to Macclesfield road. The site survives as two parallel banks with a hollow-way in-between.

Plate 2: Cow Lane (Site 09) showing two upstanding banks.

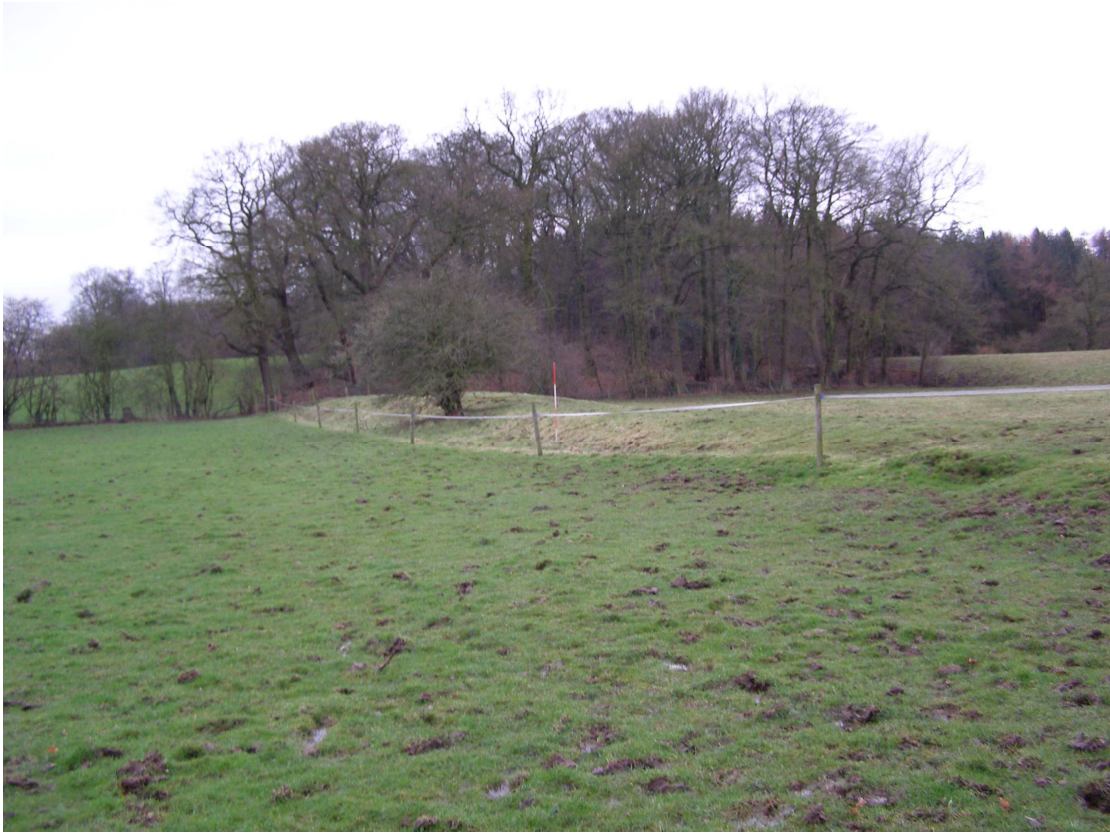
Plate 3: Large bank that was a field boundary (Site 18).
