Old Vicarage Moulsford Oxfordshire

Archaeological Watching Brief Report

February 2010

Document Type: Archaeological Watching Brief Report

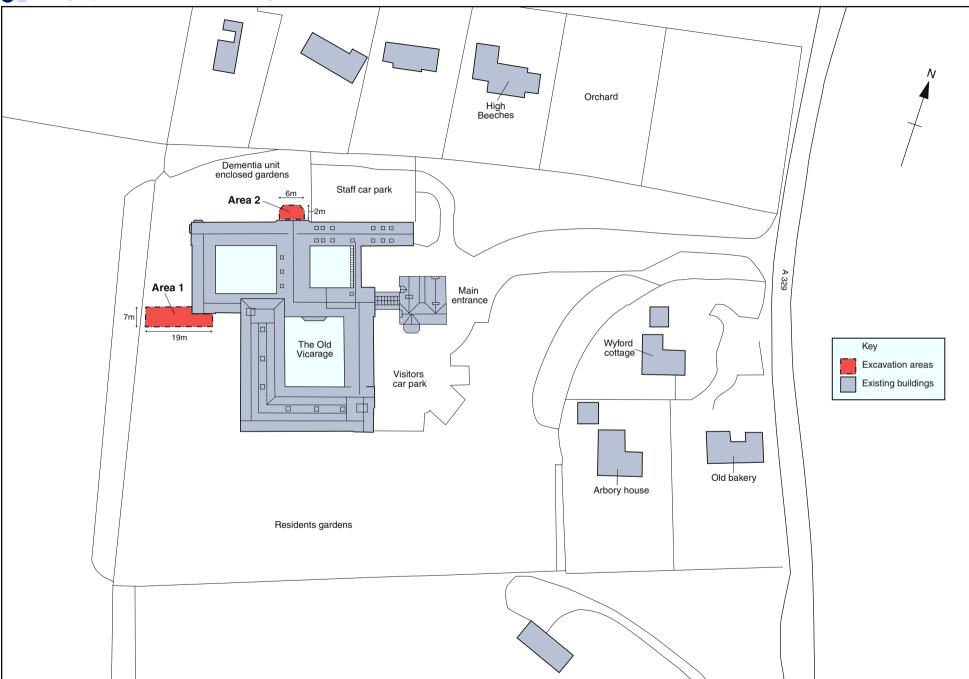
Figure 2: Location of areas 1 and 2

- 2.2.2 Two areas, Areas 1 and 2 (Fig. 2), were excavated to an average depth of 0.40 m below ground surface level within the proposed footprints of the new extensions as well as foundation and service trenches. Area 1 was at the western end/rear of the Old Vicarage and covered an area of 19 m x 10 m. Area 2 was at the northern end/side of the Old Vicarage and covered an area of 6m x 6 m. A JCB Site Master 3CX and a small dumper/ tipper were used by the contractors in the ground reductions.

- 3.1.1 Area 1 (Figs 2 and 3) was situated at the western end and to the rear of the care home. It was a 19 m x 10 m trench excavated to a depth of 0.40 m below the ground surface level and was reduced to accommodate footings for a new extension to the existing building.

- 3.1.5 Area 2 (Figs. 2 and 3) was situated against the northern end side of the care home. It measured 6 m x 6 m and was excavated to a depth of approximately 0.40 m below the ground surface level. A 0.60 m wide and 0.60 m deep trench was dug around the entire footprint of the area to accommodate the foundations of the new building.

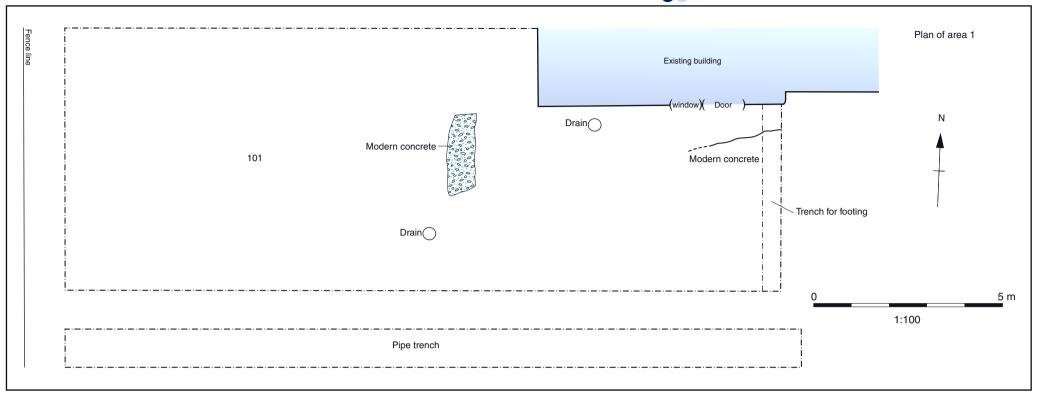
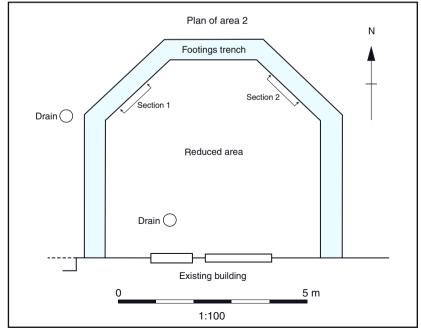
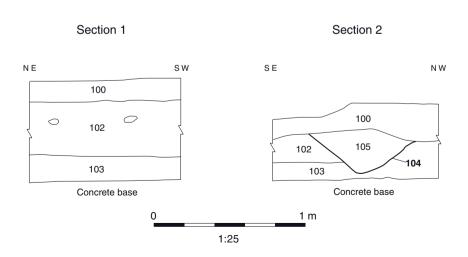
Figure 3: Plans of area 1 and 2 and sections

- 3.1.6 Area 2 was reduced through 0.15 m of topsoil (100) and into a layer of what appeared to be a landscaping/levelling deposit (102). This deposit was a friable, brown silt at a depth of 0.26 m with <1% sub angular stone and brick fragment inclusions (Fig 3 and Plate 1) and was probably part if the landscaping if the gardens after the existing extensions to the care home were constructed. Deposit 102 lay over a pale yellow/brown silty sand deposit (103), as in Area 1. It was only seen in the section of the foundation trench.

- 3.1.7 A possible pit-like feature (104; Fig. 3, Plate 2) was seen in the north-east facing section of the foundation trench; it contained modern brick fragments and was therefore modern in date. It was 0.60 m wide and 0.26 m deep and contained a hard brown silty deposit (105) with stone and brick fragment inclusions. It may have been associated with the construction of the extensions to the vicarage.
