# MILLER BRIDGE, KENDAL, CUMBRIA

## Watching Brief

**Oxford Archaeology North**

September 2008

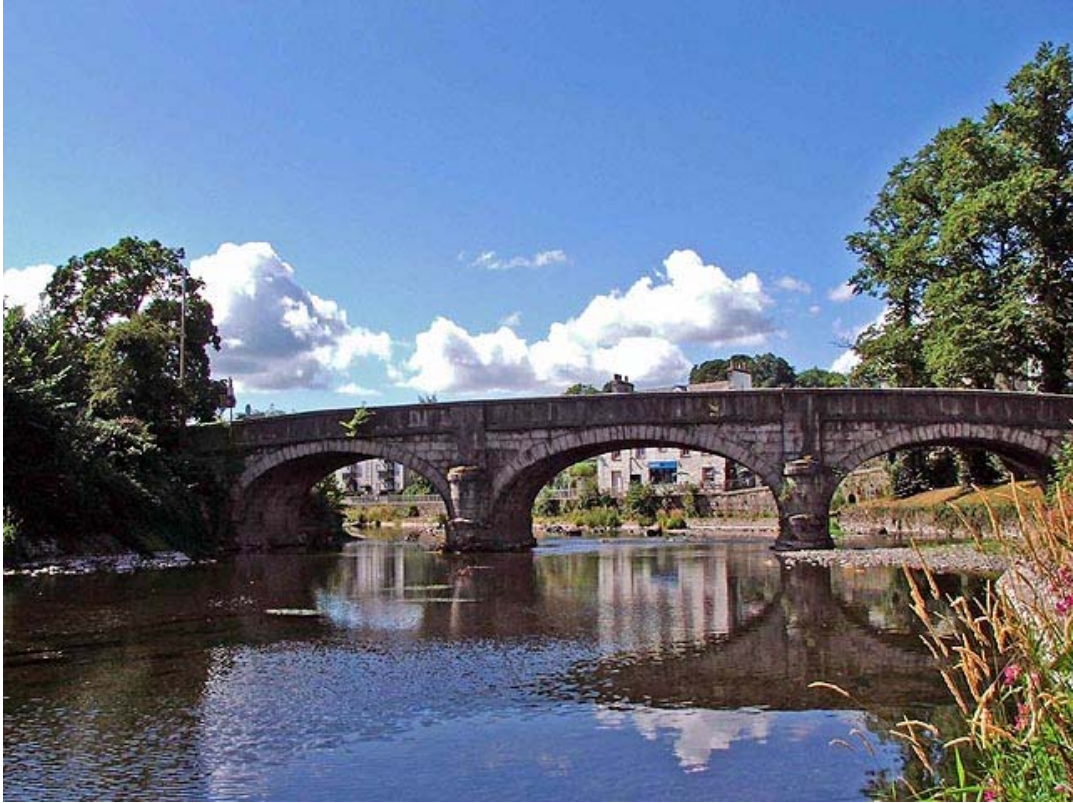
Plate 1: General view of the north side of Miller Bridge

- 3.4.1 The bridge, which is a Scheduled Monument (443) and which is included within the Cumbrian Sites and Monuments Record (SMR 5454), is constructed using grey limestone with three basket voussoir arches, and sturdy piers featuring rounded cutwaters (Plate 1). Its chamfered string course and parapet have voussoirs with V joints, whilst a date stone on the centre of the south side records a date of construction as 1818 (MDCCCXVIII) (Plate 2). It is now an integral part of Kendal's one-way system, and provides access over the River Kent to the southbound carriageway of the A65.
