St Cross Church Oxford

Historic Buildings Recording

December 2009

Client: Balliol College, Oxford

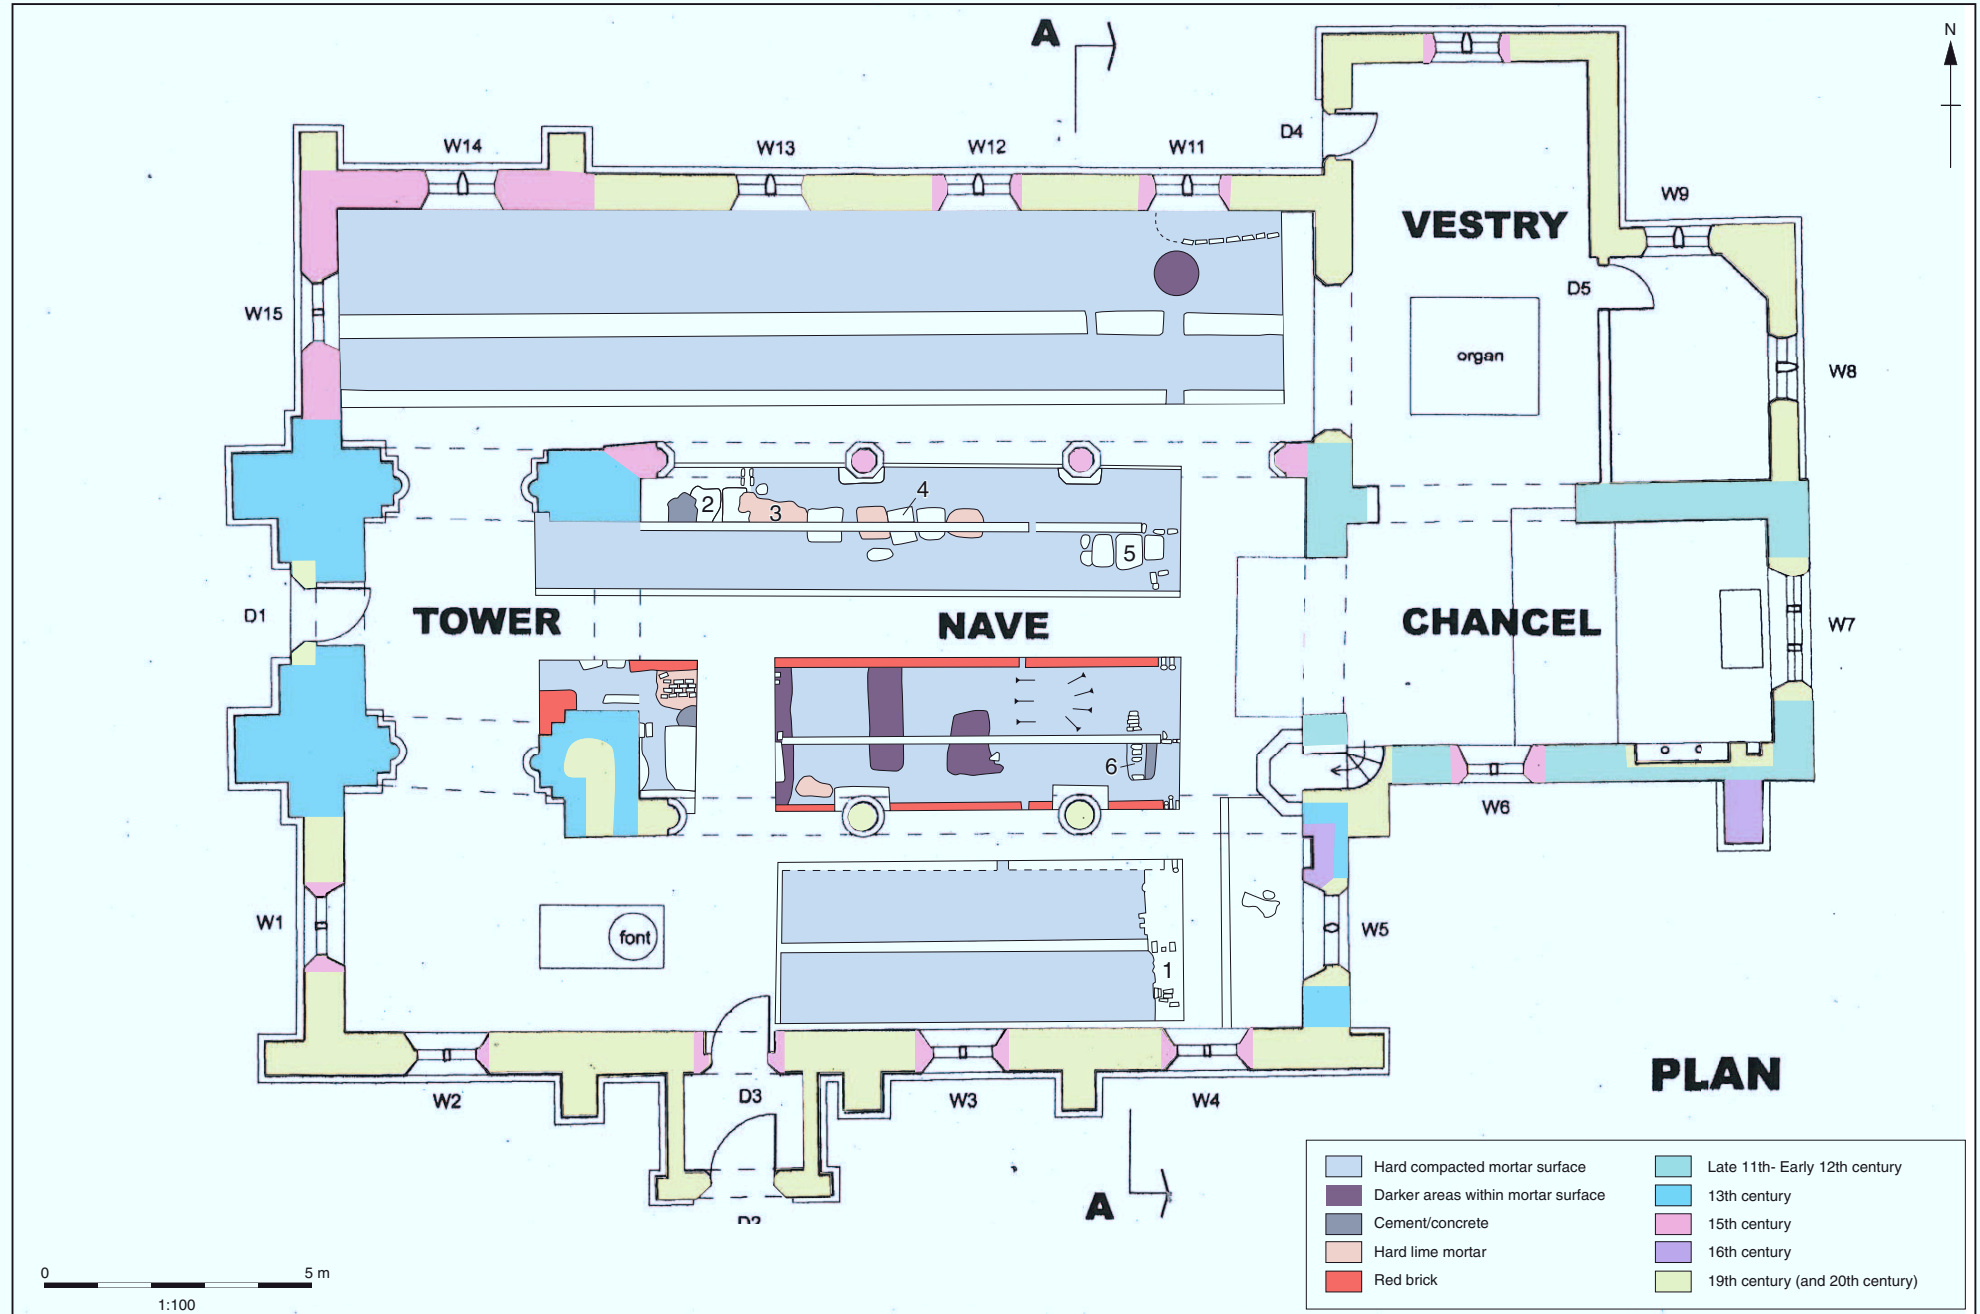
Figure 2: Phasing plan of St Cross Church

3.2.2 There are six areas in total exposed by the pew removal within the church (fig. 2). All of the north aisle has been cleared and most of the south aisle to the east of the south porch. The nave has been entirely cleared except for the central aisle and a small causeway running north south towards the west end of the south side. There is another small opening directly east of the south aisle clearance, under the pulpit.

- 4.1.1 The foundations for the new archive units will comprise concrete rafts at a maximum depth of 300 mm below the existing floor level, on permanent shuttering. Levels were taken throughout the cleared areas, using the stone paving in the nave as datum to measure potential impact of the development on areas of archaeological interest.

- 4.1.2 The north aisle reached a depth of 490mm at the east side and raised to approximately 360mm on the west side, creating a suitably deep void for foundations.

- 4.1.3 The exposed surface in the nave however, is much more uneven, particularly within areas of archaeological interest. At the lowest point of the north side, it reached a depth of 310mm where the stone lined burial chamber is located at the east side. Along the centre of the north side however, where archive units will protrude from the north aisle into the nave, it is as shallow as 220mm in places, particularly over inscribed stones, necessitating further clearance before development.

- 4.1.4 The south side of the nave reaches a depth of 410mm in places. Where archive units protrude from the south aisle into the nave, the void is approximately 360mm below datum, although this is quite uneven. There is a stone slab at a level of 190mm towards the west of the south side but this should not be affected by development.
- 4.1.5 Where the possible shaft burial has collapsed at the east side of the south aisle, it reaches a depth of 500mm below datum. However, the rest of the area averages at a level of 240mm necessitating further clearance for foundations.
- 4.1.6 This is necessary to carry out further investigation in the area of the aisle paths.

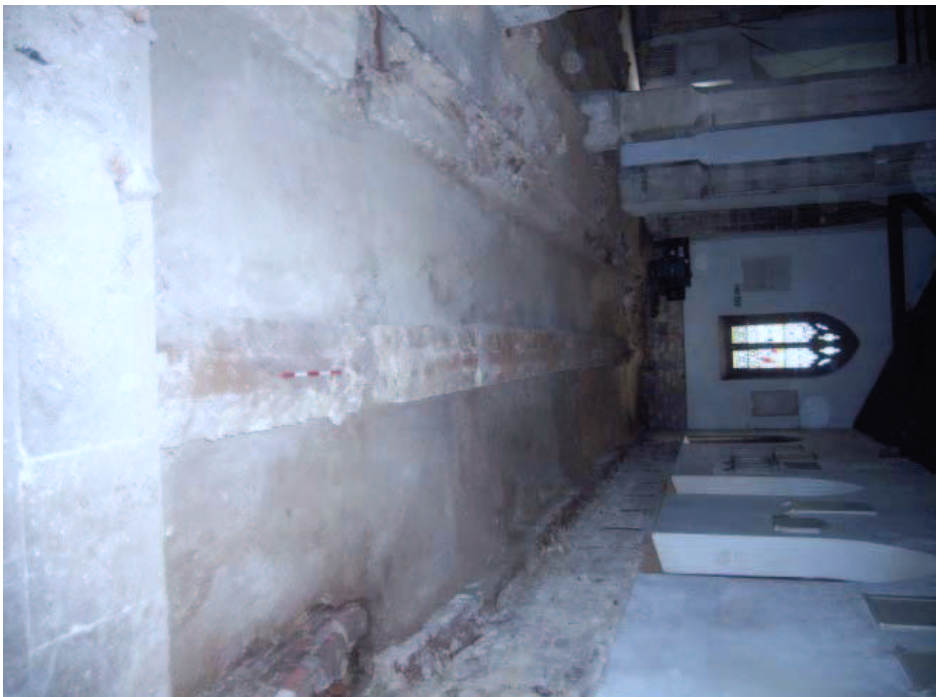
3.3.1 Although the opening in the north aisle is the largest, there are relatively few archaeological features exposed here (plate 1). A sleeper wall of rubble and stone, 430mm wide and 200mm high, with imprints of joists, runs through the centre of the aisle and is truncated for heating pipes at the east end. This is probably of the same phase as the external wall and the south wall of the north aisle (plate 2). At the east end, there is a later brick foundation for a floor and a 19th century red brick heating fixture in the north east corner. There seems to be a dark area immediately south of this, however, it appears to be too small to be a grave cut. Towards the west end, the ground rises and is more uneven indicating possible burials.

Plate 1: North aisle facing west

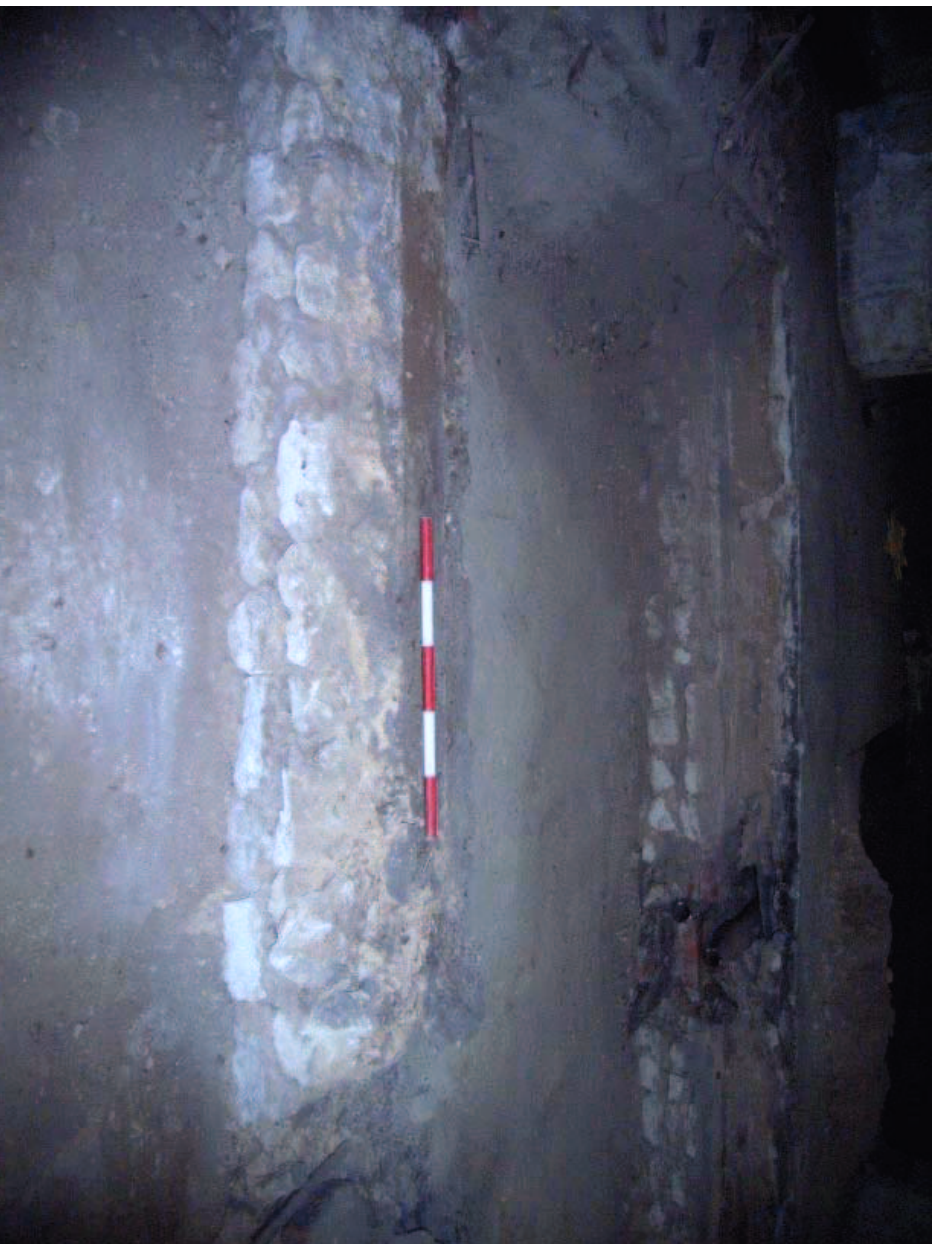
Plate 2: Sleeper wall of north aisle, facing south

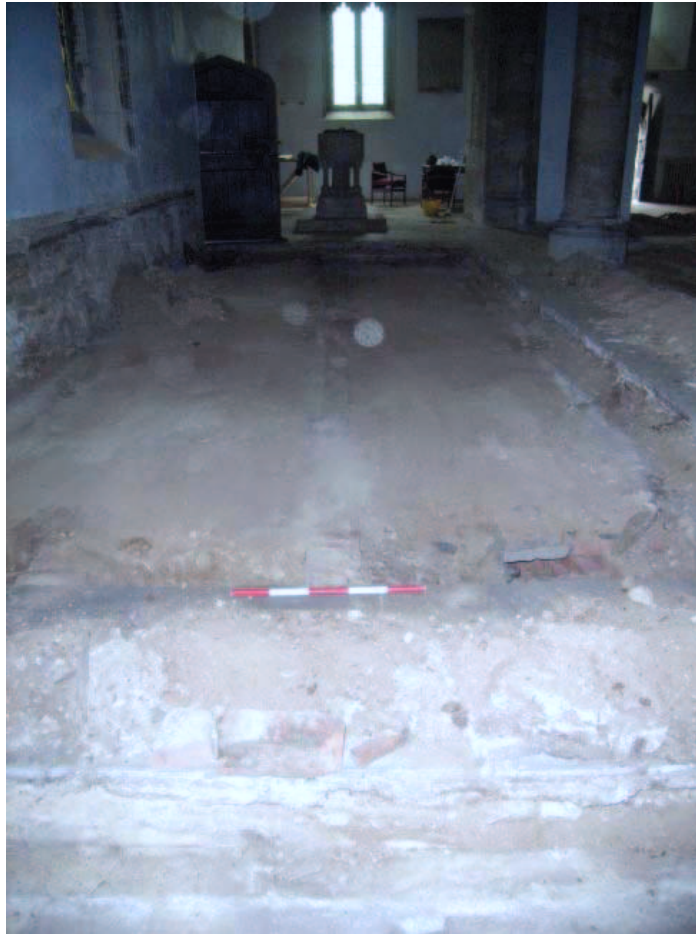
3.4.1 At the eastern end of the south aisle, a collapsed vault structure (no. 1, fig. 2) has been partially exposed which appears to be a shaft grave (plate 3). This is orientated north to south and is c.85 cm wide with some bones visible inside. It is truncated by some red bricks in the centre supporting the stone edge. No more defined burials are visible, although various large fragments of human bone were found throughout the area during brushing back, particularly in the south west corner. This would suggest that the area has been used over time for burials and has been disturbed. The sleeper wall which runs

Plate 3: Possible shaft grave in south aisle

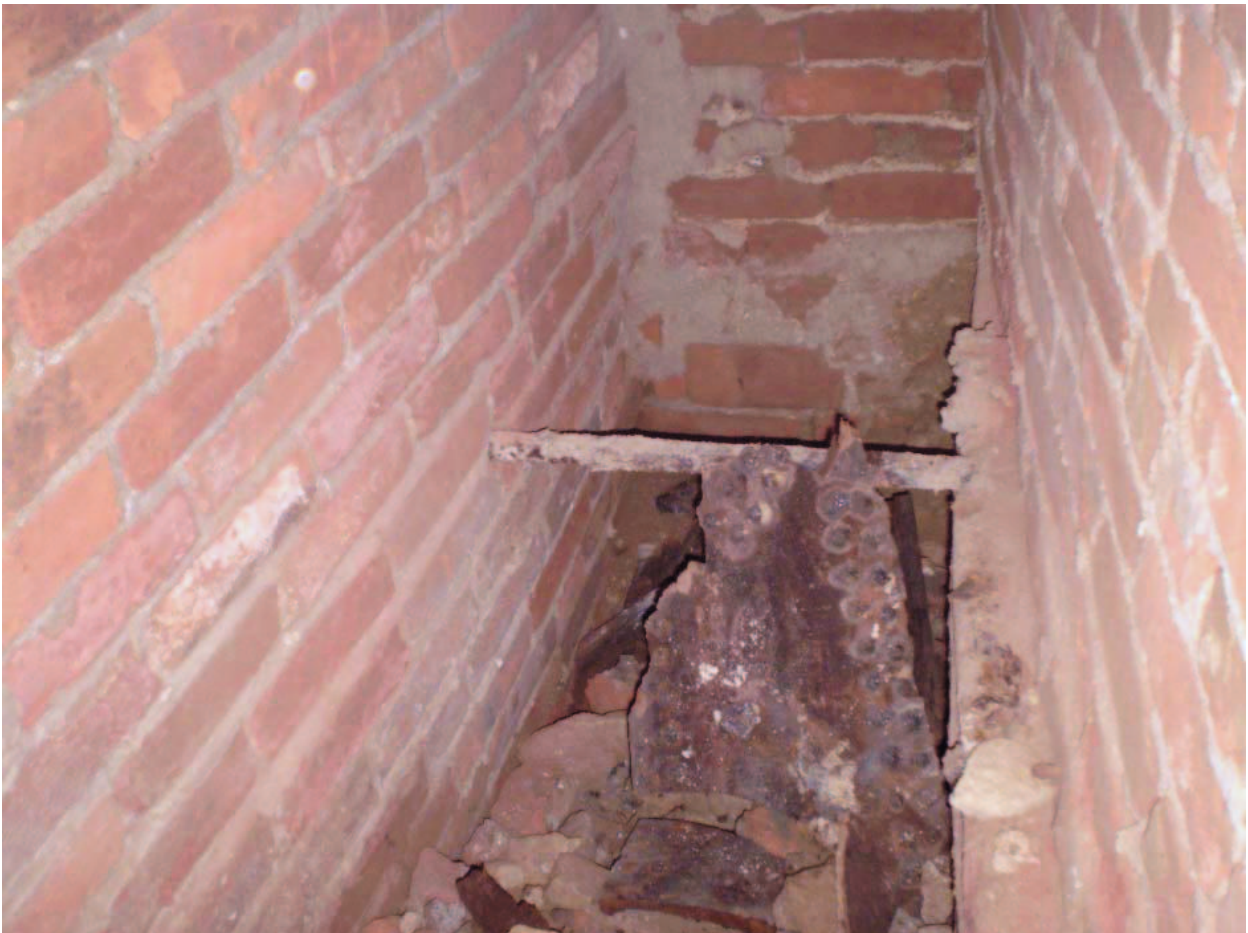
- 3.5.1 Towards the western end of the exposed area on the north side of the nave is a burial vault (no. 2, fig. 2) which has been partially exposed. This is 90cm deep, 2.3 m long (orientated east to west), c.50 cm wide and constructed with 19th or 20th century bricks (plate 4). Towards the eastern end of the grave a bar is visible running across the chamber and approximately 60cm from the base of the chamber. Studs are visible on this bar, indicating that at one time it was upholstered. There would also have been a second bar on which one of the coffins would have rested but this has now disintegrated.

Plate 4: Interior of shaft grave, west end of north side of nave

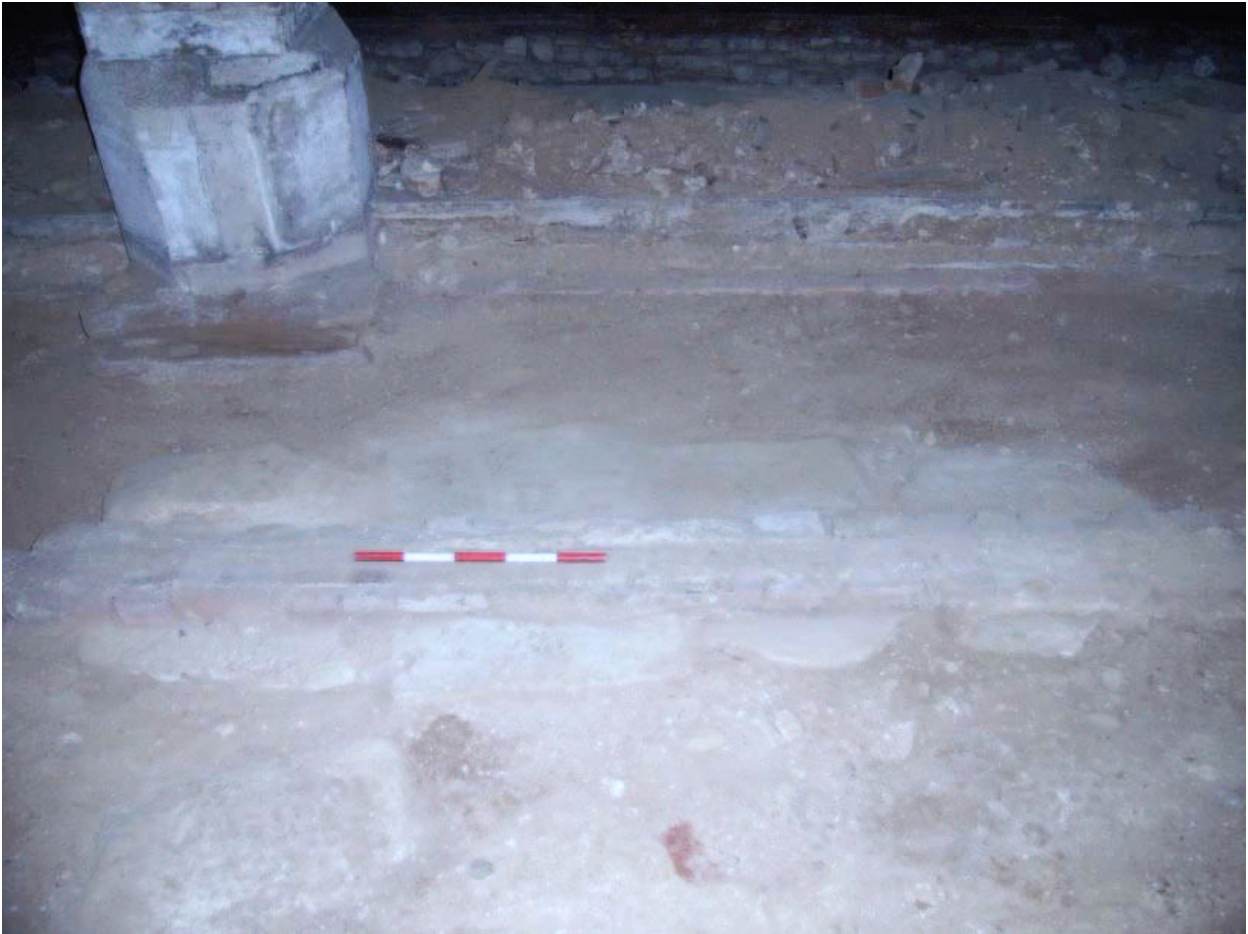
- 3.5.2 There is also evidence of another similar burial vault immediately to the east of the one partially exposed (no. 3, fig. 2). The second vault remains covered so its dimensions and form are currently uncertain. There are also further stone slabs to the east which are less disturbed than other areas of the nave and are suggestive of intact burials or vaults (Plate 5). One of these slabs has an inscription on it. The words "Will Russell who died August 27 170[?] aged 66 years.." are legible (no. 4, fig. 2).

Plate 5: Central slabs in north side of nave, facing north

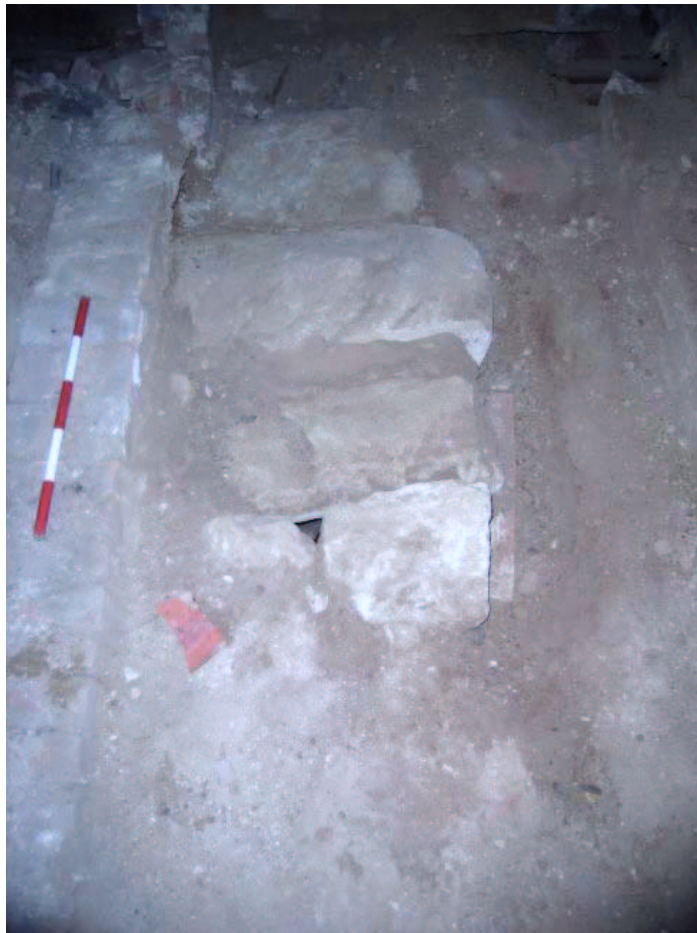
- 3.5.3 At the east end of the north half of the nave, immediately south of the sleeper wall, are three stone slabs covering a burial about 1.75m in length and 0.6m wide (no. 5, fig. 2), orientated east west (Plate 6).

Plate 6: Burial, east end of north side of nave , facing east

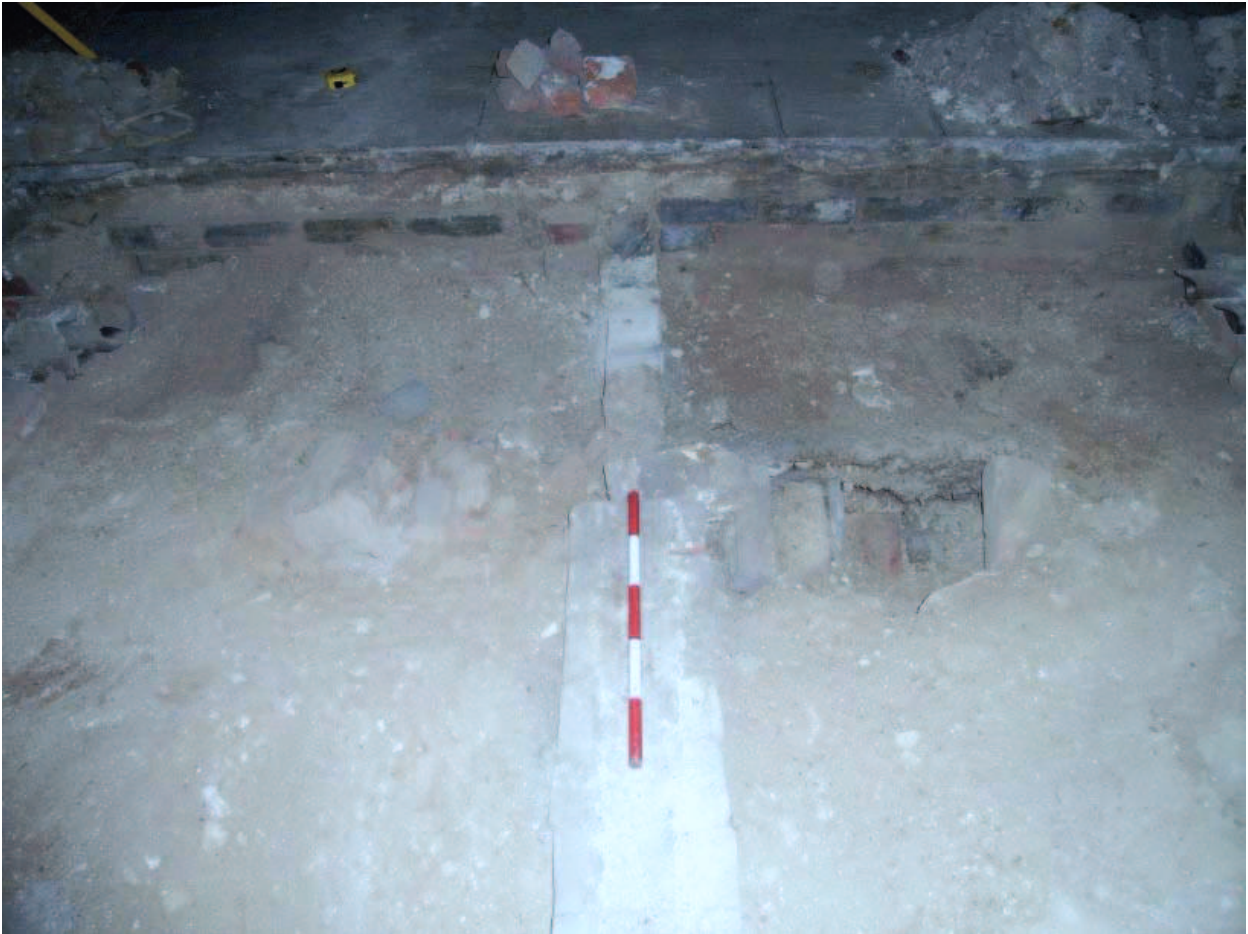
- 3.6.1 There are no clear shaft graves visible in the exposed area in the southern half of the nave but there are several dips and depressions in the eastern half of this area. These are suggestive of possible buried vaults which have partially collapsed. There are also some displaced red bricks and a cavity (Plate 7) at the south end indicating a possible collapsed vault (no. 6, fig. 2). In the centre of the opening, there is a defined dark area, likely a burial, orientated north south. There is another similar, larger dark area 1m west of this (Plate 8). The western half of this area is more consistent and smoother than the east.
- 3.6.2 The opening at the very end of the nave on the west side, just under the south east corner of the tower, features an inscribed slab and what appears to be a partially uncovered red brick vault immediately north of it (Plate 9).

Plate 7: Possible collapsed vault at east end of south side of nave, facing east

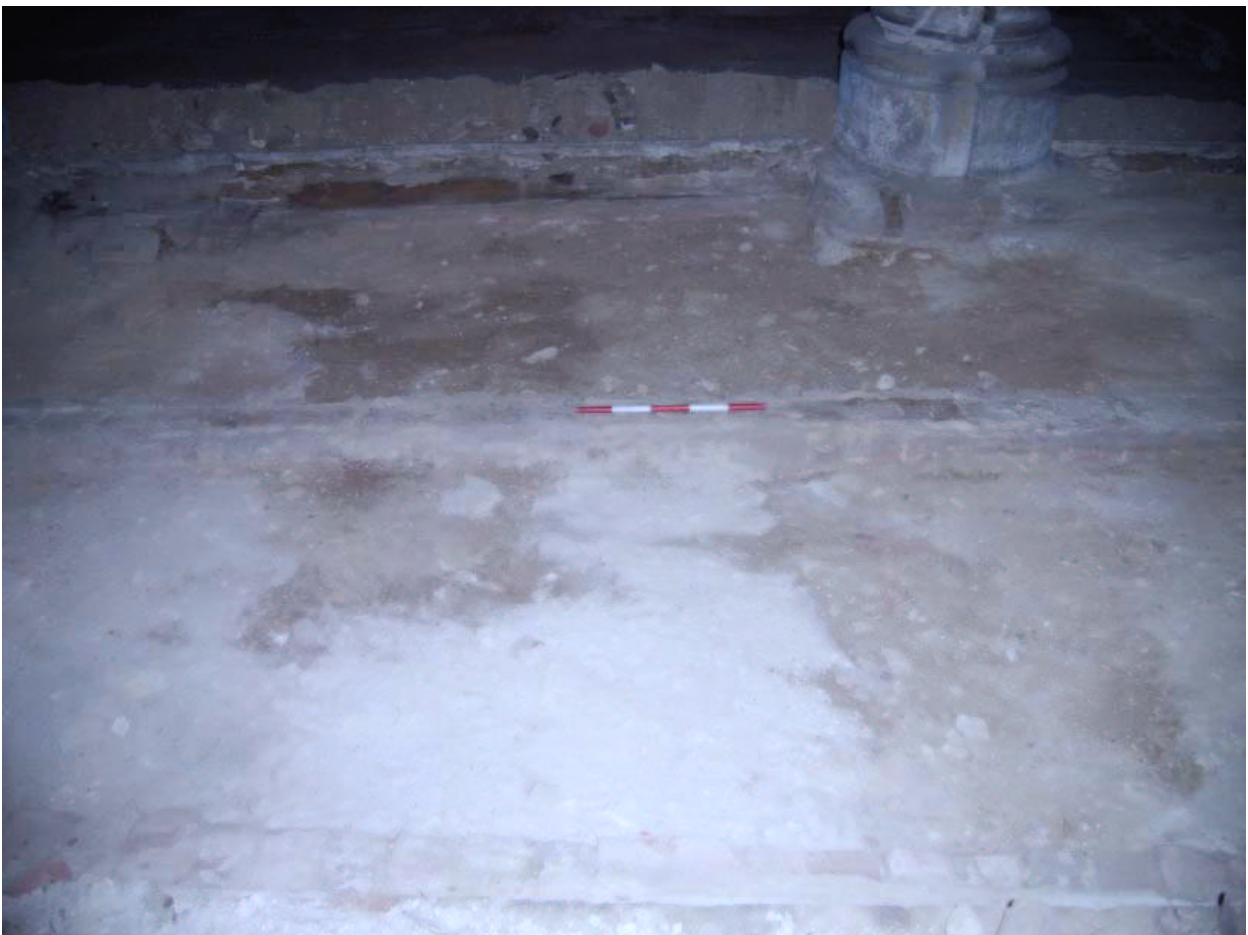
Plate 8: Possible burials in south side of nave, facing south

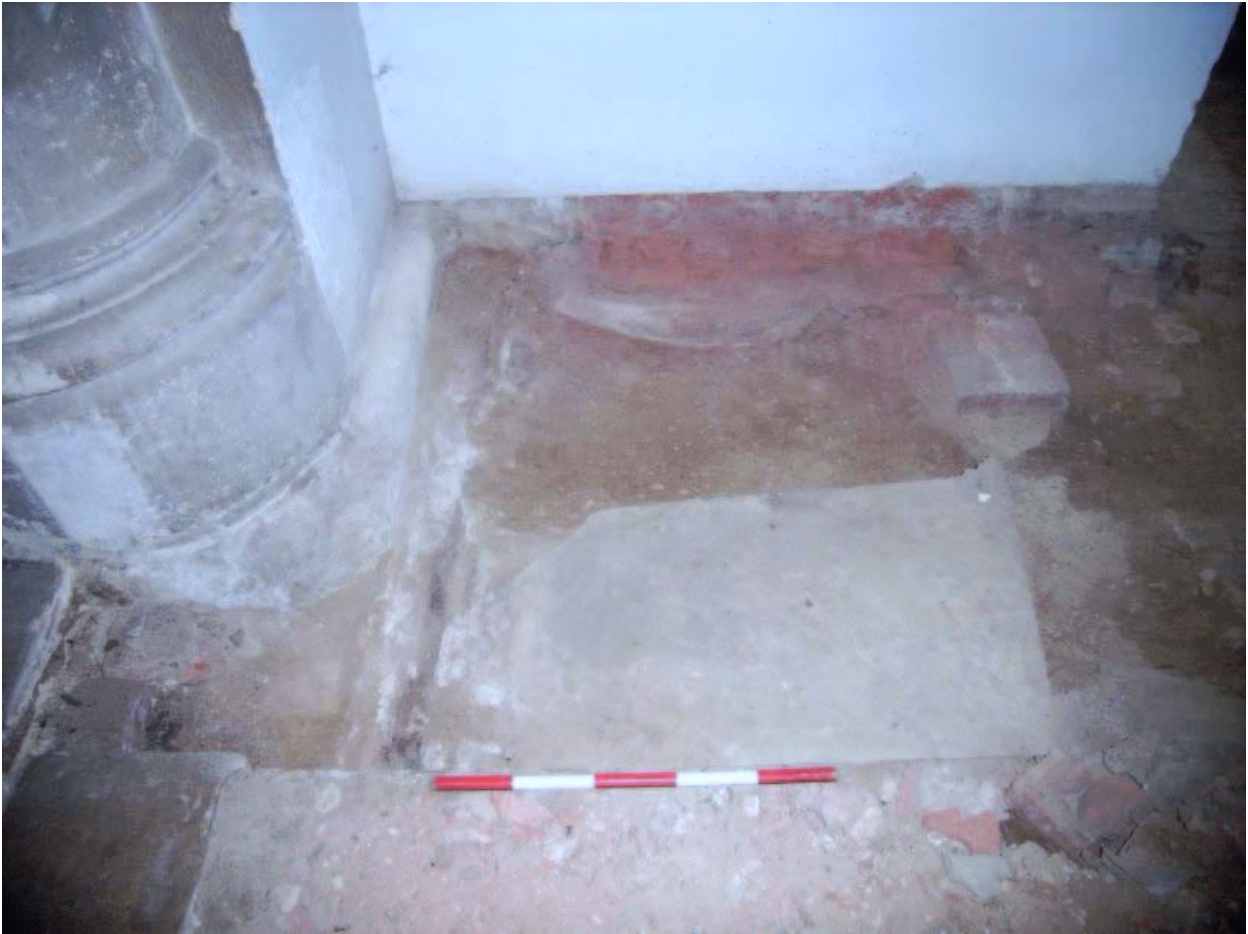
Plate 9: Inscribed slab at west end of south side of nave, facing west

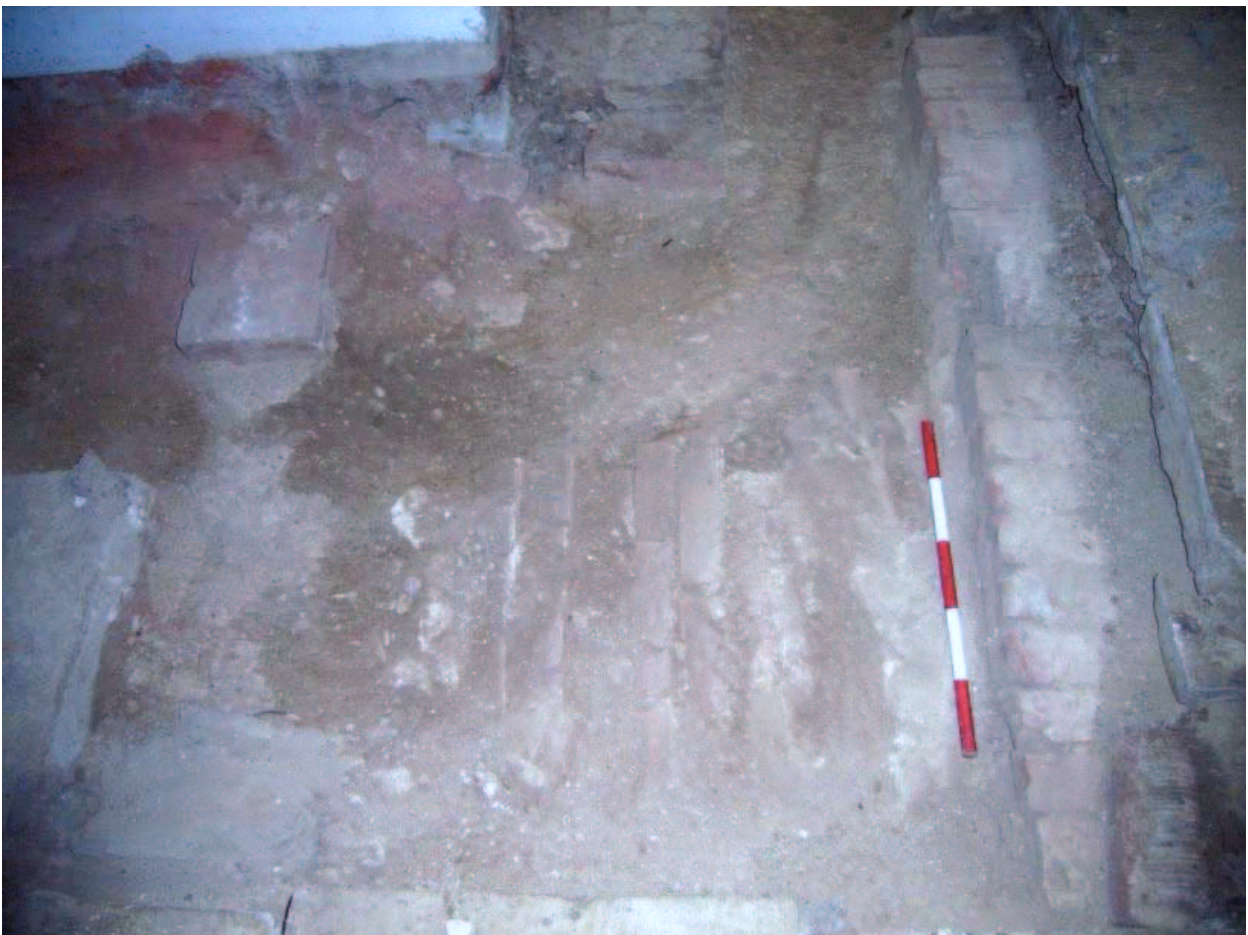
Plate 10: Possible vault at west end of south side of nave, facing west
