President's Lodgings Wall Magdalen College Oxford

**Archaeological
Watching Brief and
Building Recording**

January 2010

Client: Magdalen College

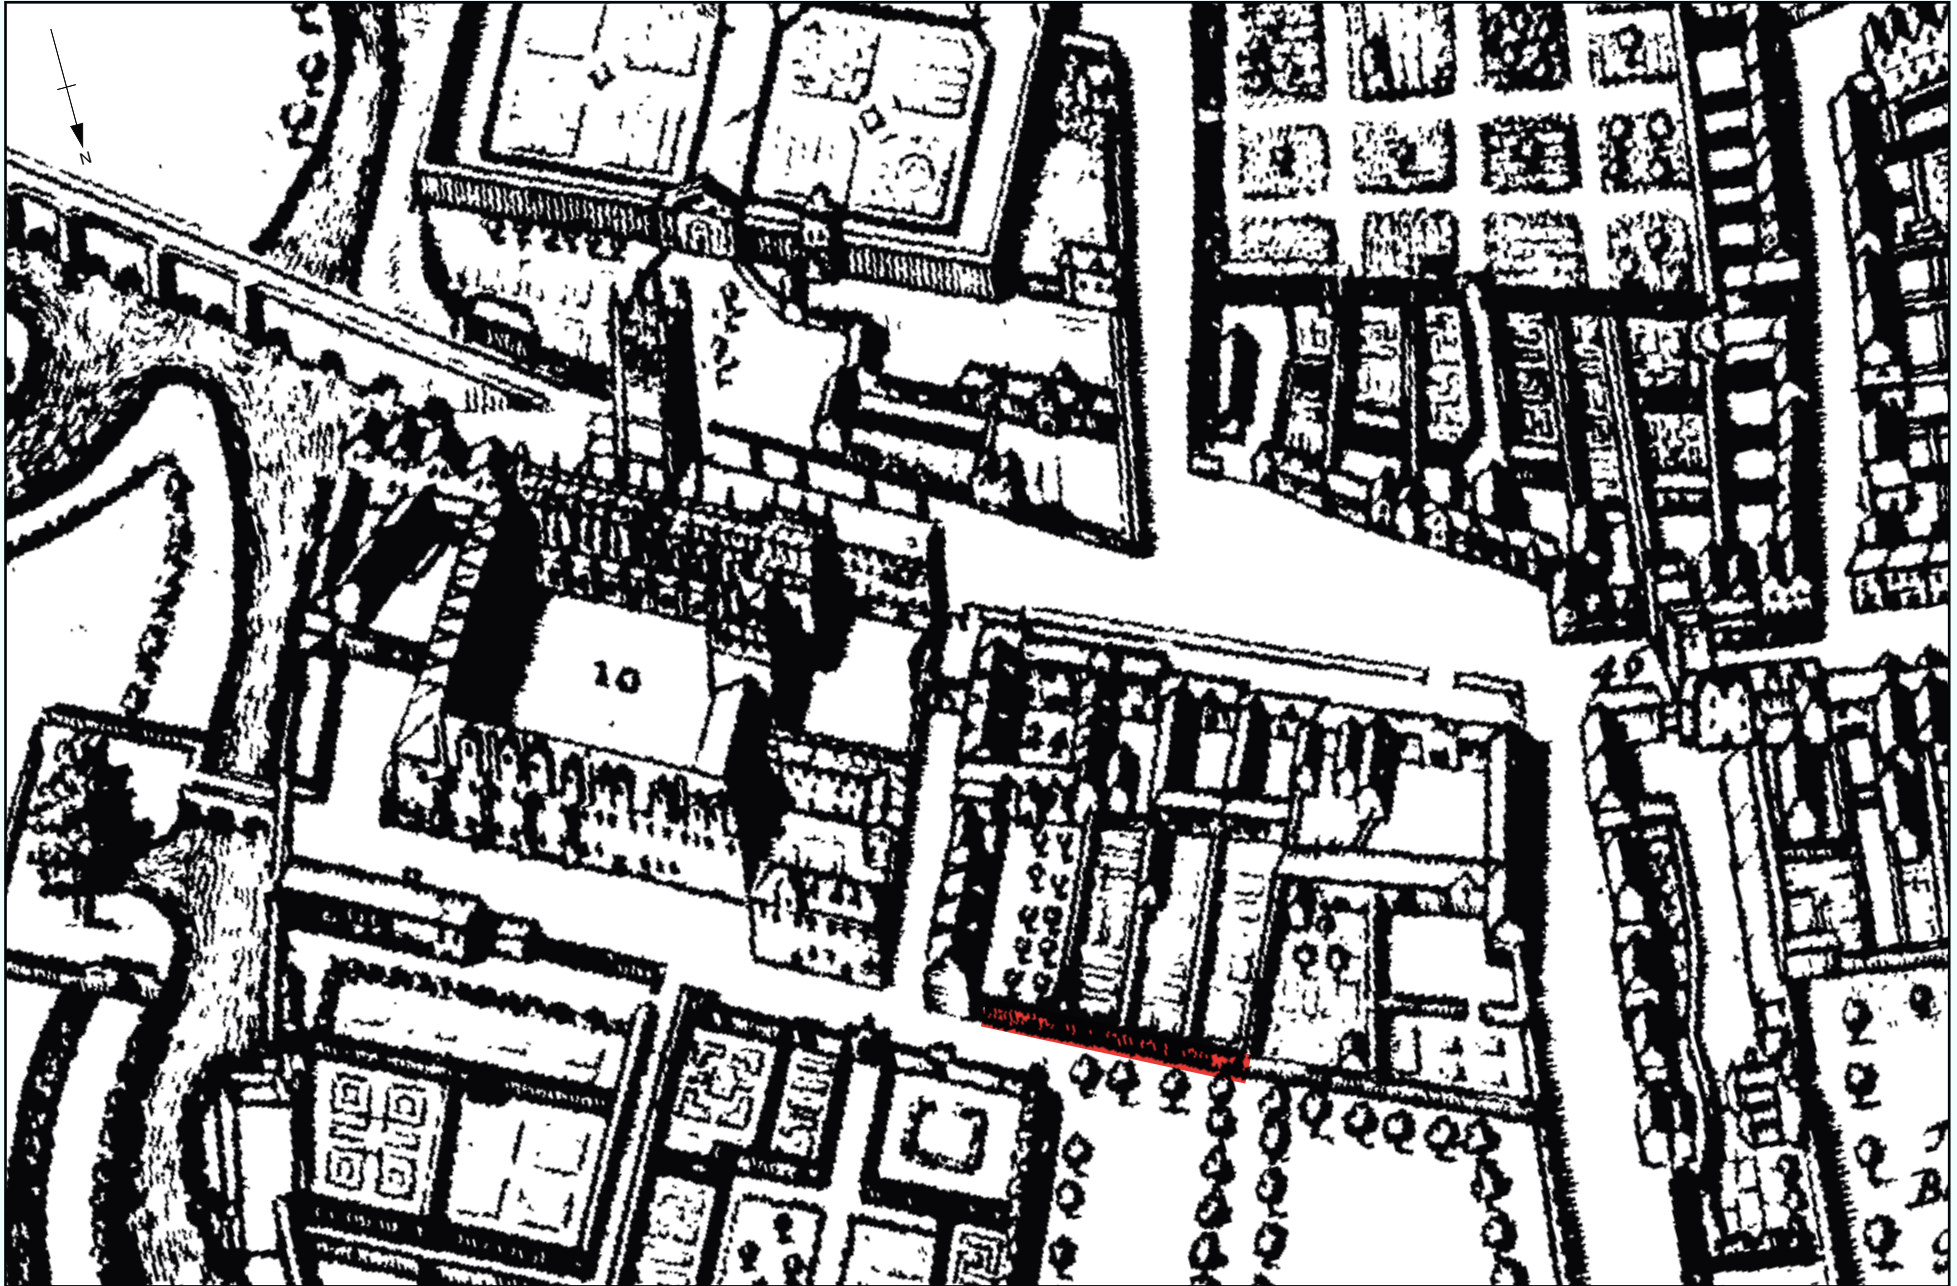
- 2.1.7 It is possible to plot with reasonable confidence the footprint of the current wall on Loggan's map (Figure 4). The map appears to show that in 1675 there was no wall along the eastern quarter of the modern footprint of the wall. At this date this point formed the northern edge of the through-passage between the college and Magdalen Hall/Grammar School. Immediately to the west of this point Loggan's map shows the northern gable end of a north/south orientated range, and this appears to have been aligned with the central section of the modern wall in this study. Loggan's map shows that a boundary wall adjoined the west side of the gable, and this would have aligned with the western section of the modern wall.

Figure 4: Loggan map 1675, Magdalen College; red line indicates probable location of President's Lodging Wall.

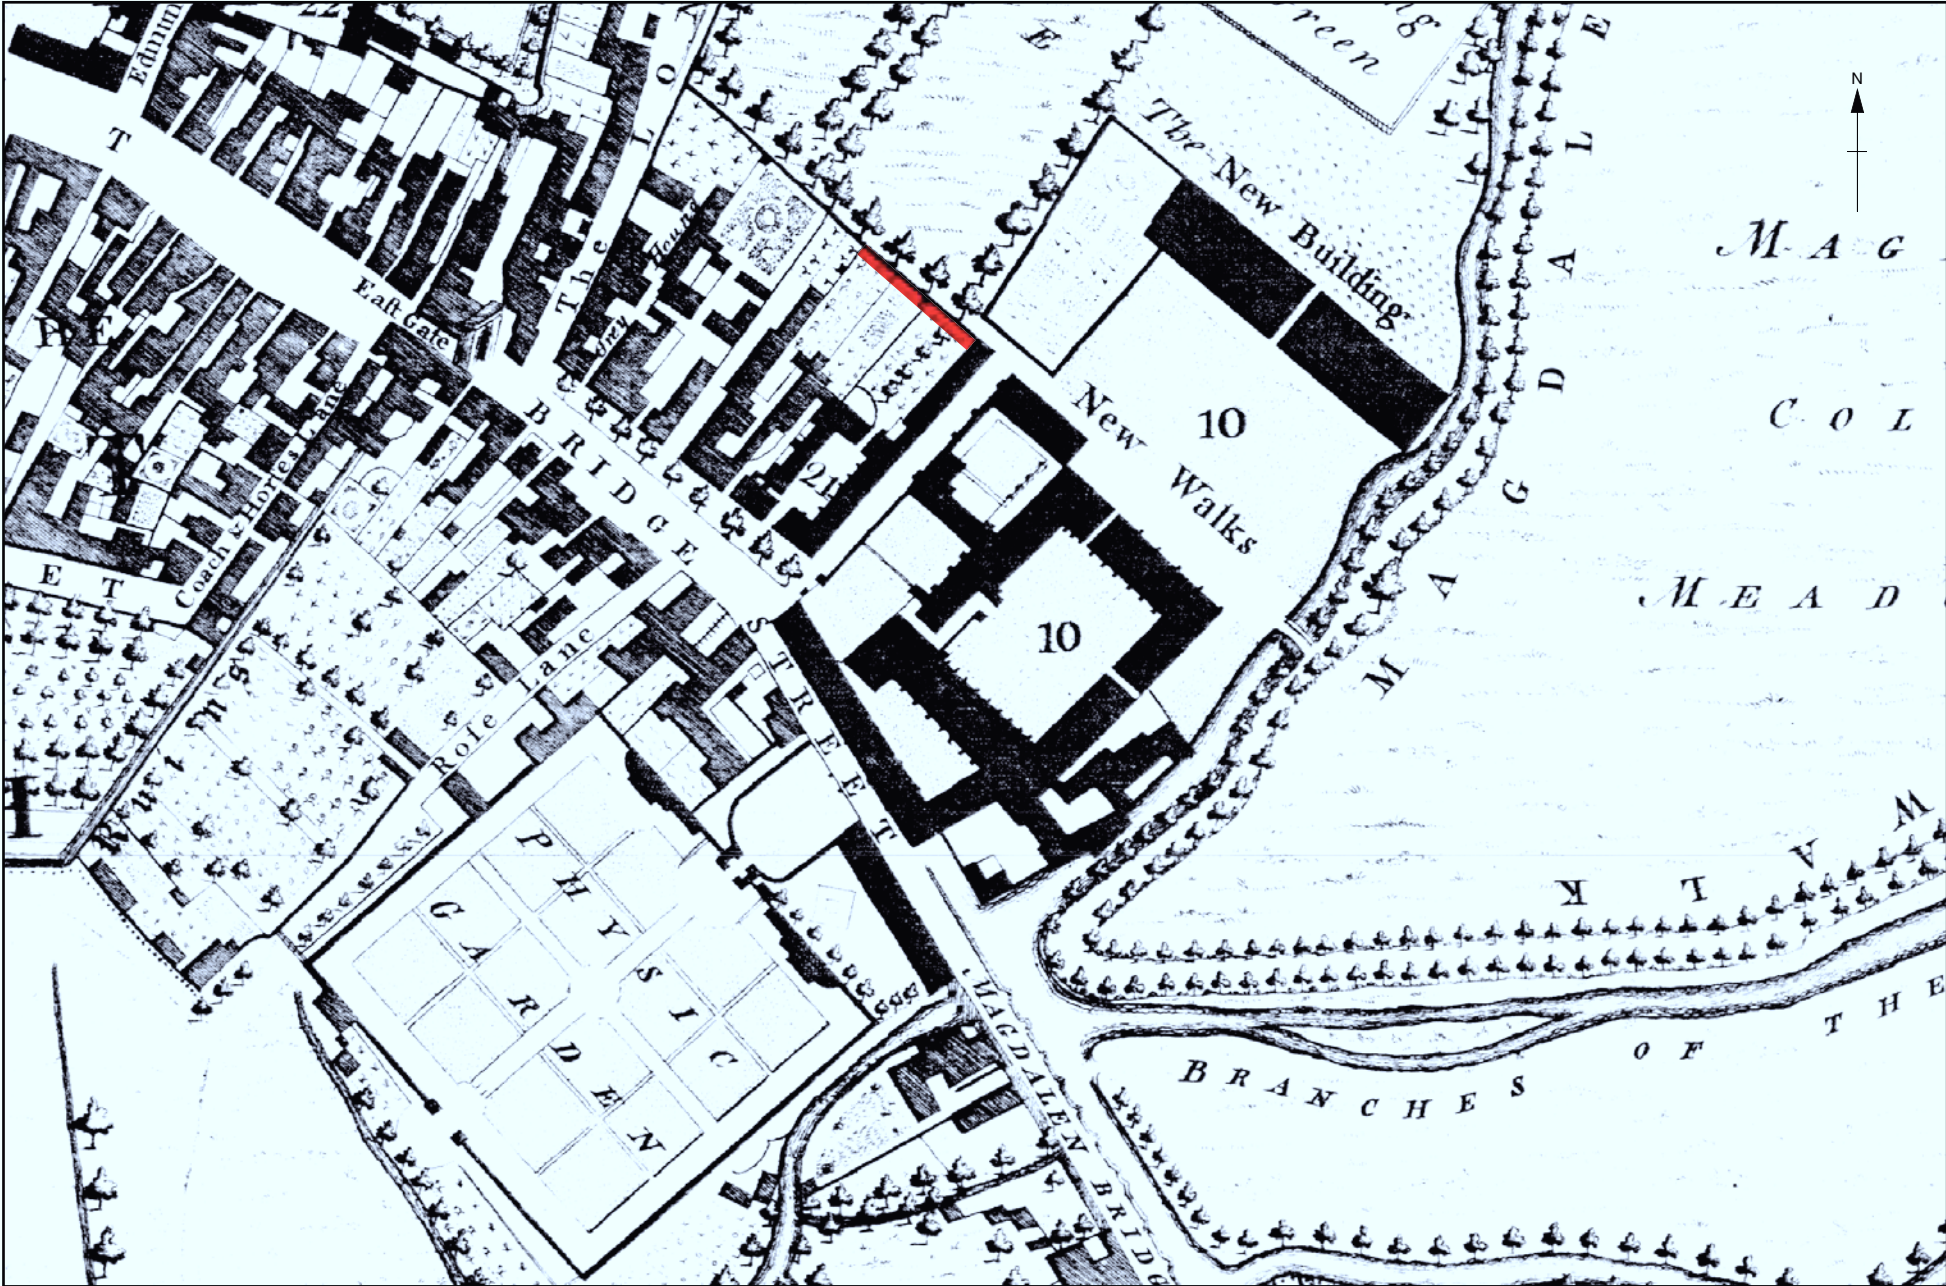
- deer, 1s. 4d.' By the late 18th-century there are regular payments to individuals for looking after and culling the deer.
- 2.1.9 On Isaac Taylor's map of Oxford in 1750 the New Buildings had been built north of the quadrangle and the formal gardens established in the grove have shrunk in size and number. The row of buildings, their courtyards and gardens facing High Street survive almost unchanged. In 1825 the college ordered that the grove be separated from the New Buildings by a sunk fence instead of an iron railing.

Figure 5: Taylor's map of Oxford 1750, showing Magdalen College; red line indicates location of President's Lodging Wall

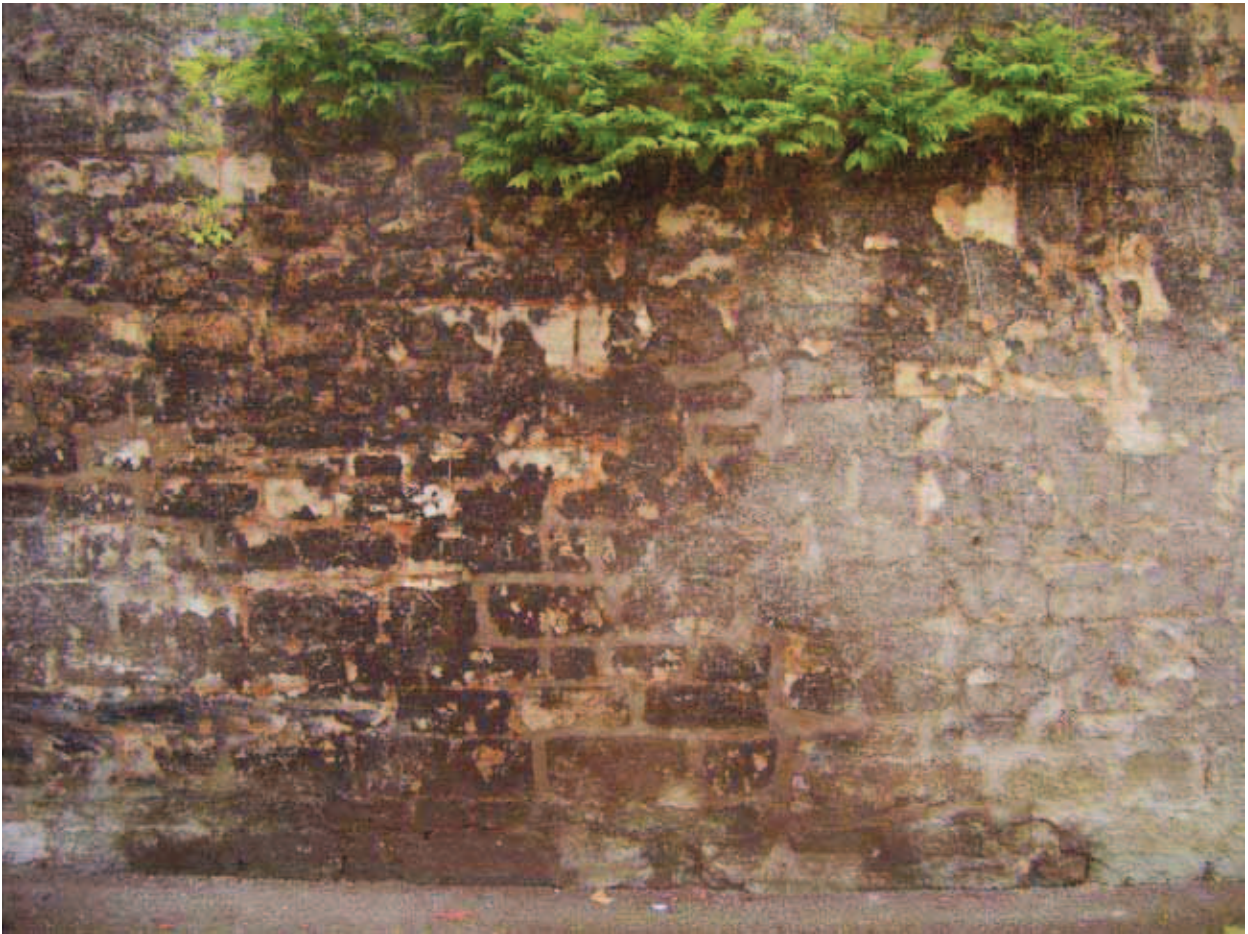
- 3.2.2 There are two steel supports built against the wall towards the west side. These may have been put in place to support the wall (Plate 4).
- 3.2.3 The face of section 2 is obscured by pollution and lichen but most stones appear to be large rectangular dressed stones (Plate 5). Some courses are narrower than others but this seems to be part of the construction rather than an indication of different phasing. However, phasing can be identified in some parts, most notably the latest phase, which is approximately 1m thick along the top (Plate 6). This makes up 5 courses underneath the coping stones and although the stones are smaller they appear to be the same stone as the rest of the wall. It is largely pointed with a modern cement ribbon pointing but is in better condition than the lower masonry. Where cement repointing has fallen off, a distinctive yellow, sandy mortar pointing can be seen.

Plate 5: President's Lodgings Wall, Magdalen College: Coursing on north face, looking south

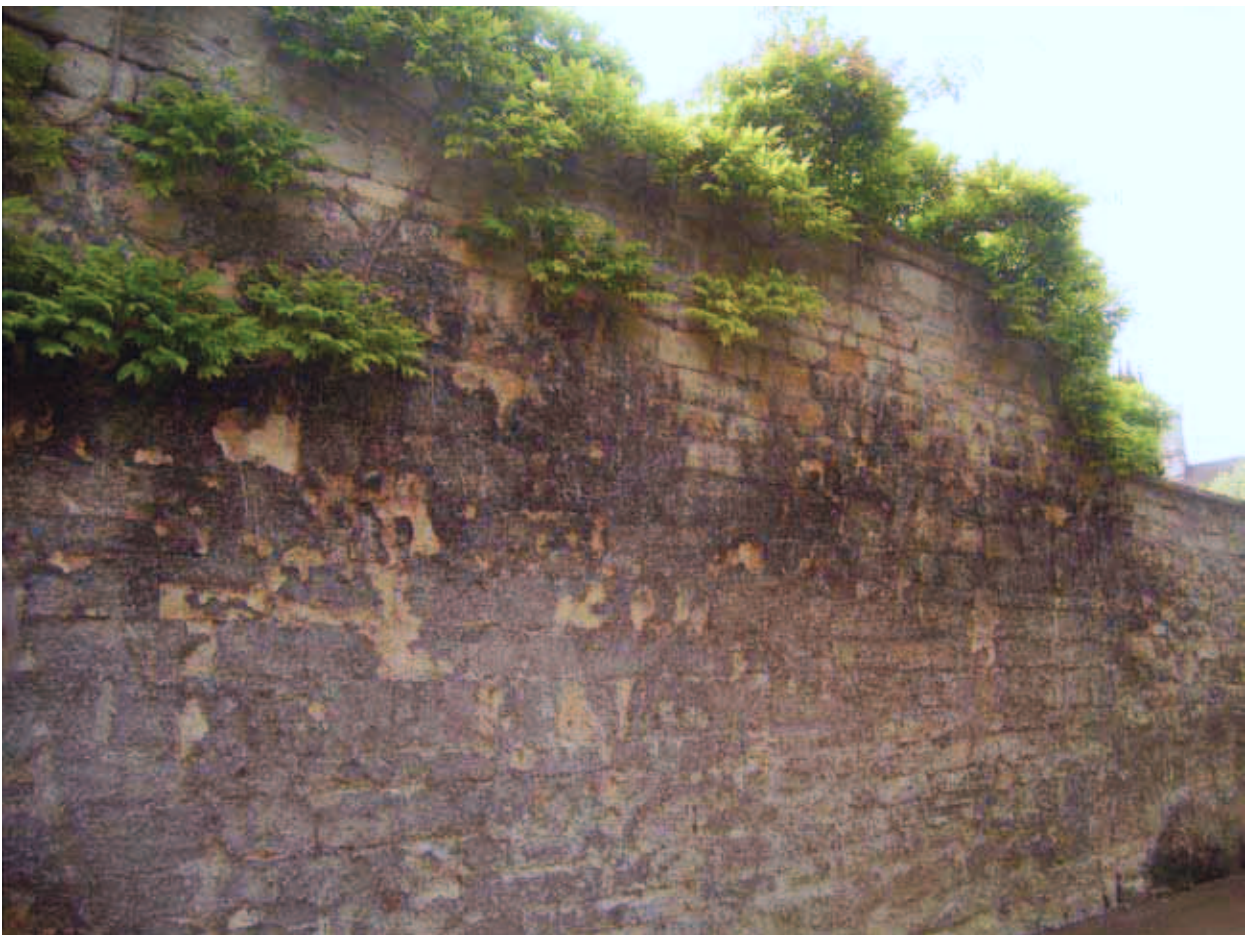
Plate 6: President's Lodgings Wall, Magdalen College: Coursing on north face, looking south west

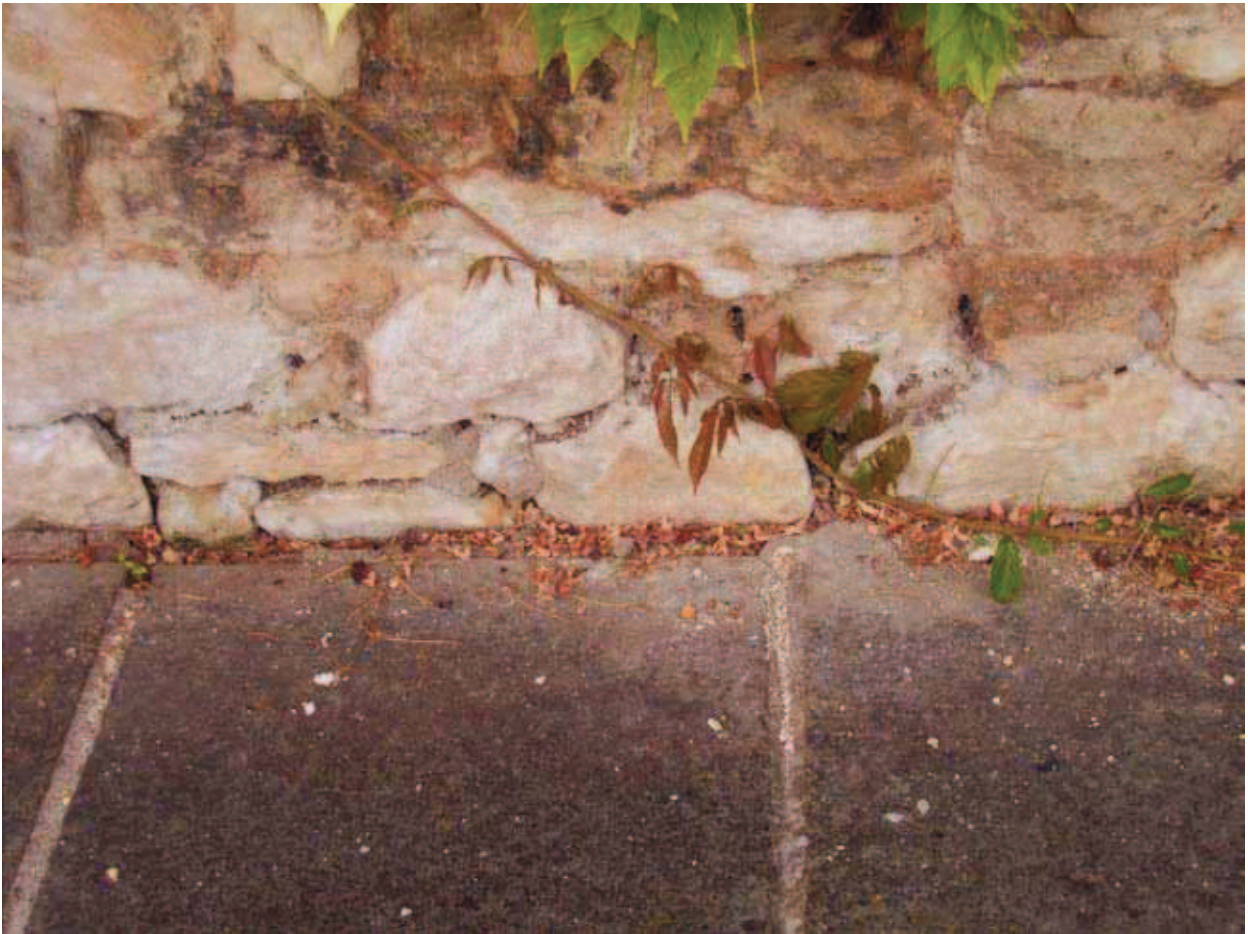
- 3.3.3 Mortar and cement pointing appears to be failing in parts of the wall visible through vegetation. Other areas have been painted with cement. Towards the bottom where the wall meets the garden flower bed, the stone is in very poor condition (Plate 9).

Plate 9: President's Lodgings Wall, Magdalen College: Foot of wall at south side, looking northwards
