East Front Garden Hampton Court Palace

Historic Building Recording

Document Title: East Front Garden Niches, Hampton Court Palace.

Document Type: Building recording and investigation
Issue Number: 1
National Grid Reference: TQ 159 687
]

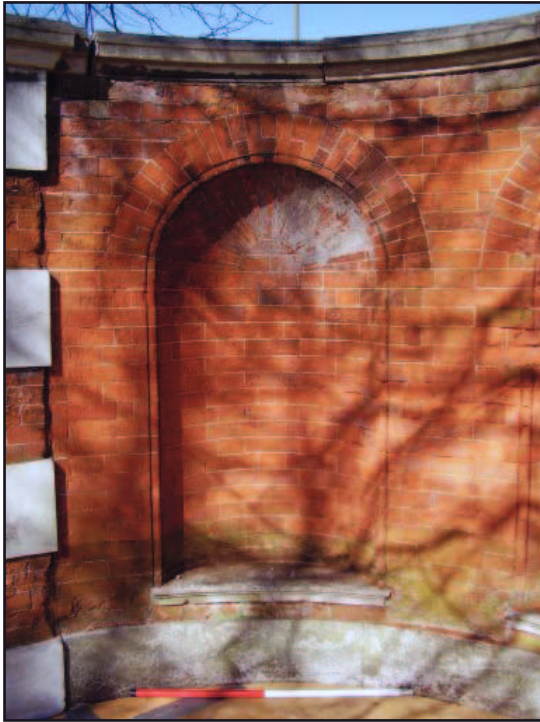
- 3.1.1 The niches which form the main focus of the current study are located in the south side of an east to west orientated wall in the East Front Gardens. The wall forms part of the north boundary of Home Park. and runs parallel to Hampton Court Road. There are three adjacent niches which are located within a single semi-circular recess in the wall (Plates 1-3).

Plate 1: Niche 1

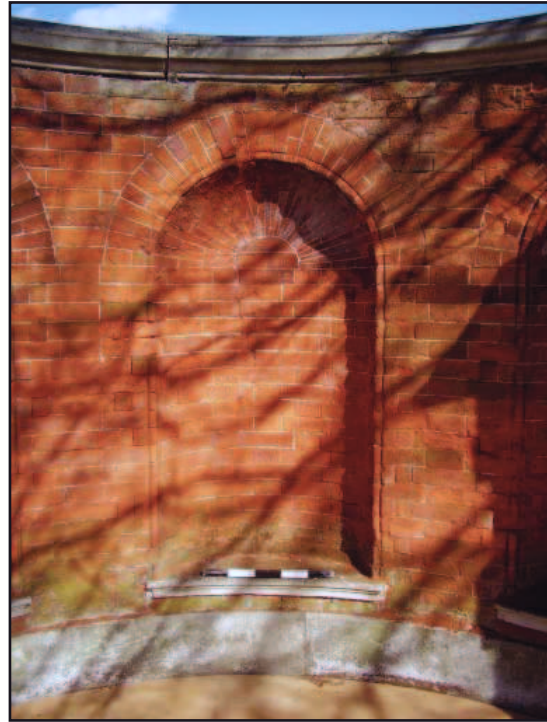
3.1.8 The niches were 31 courses high, and some patches of a slightly different type of brick were noted in niches 2 and 3. These were possibly the result of early 20th century repair work. This repair work showed the use of new red bricks measuring 0.22 x 0.11 x 0.45m, bonded in a light brown mortar with 20% of small inclusions. These were more visible on the outside of the wall than on the inside.

Plate 2: Niche 2

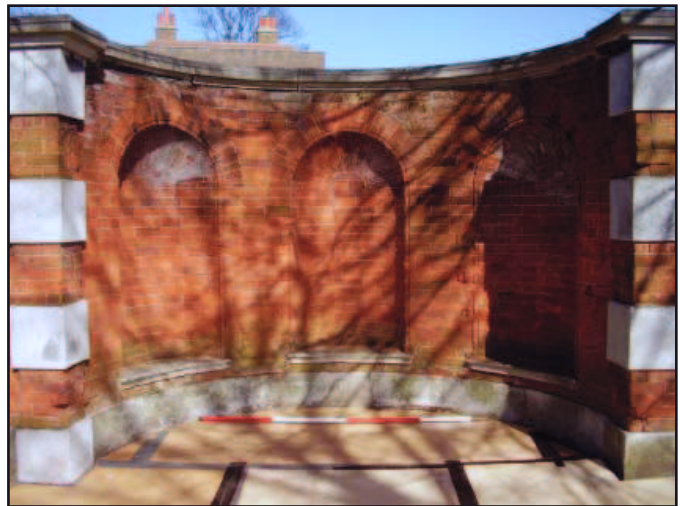
3.1.6 Each niche is c.80 cm wide with a flat base, semi-concave top with very fine gauged brickwork and a semi-circular plan. The niches and surrounding walls are constructed using Flemish bond (Plate 4).

Plate 4: Recess in the wall containing niches
