Weir House Millmead Guildford

Historic Buildings Survey

January 2009

Client: The National Trust

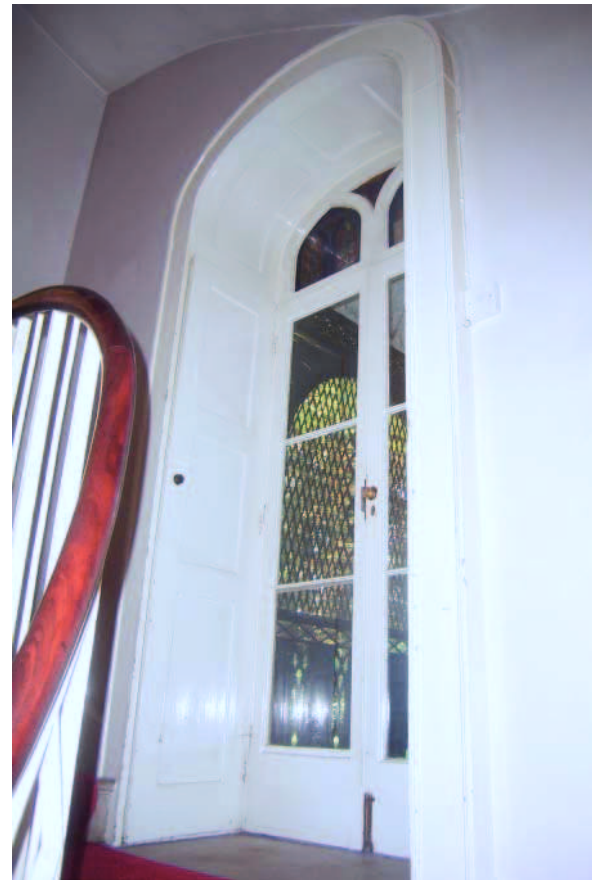
Plate 44: Main entrance at mezzanine level, facing south west

- 4.3.1 The front door to the main house is situated at the west side, on a mezzanine between the ground and first floor (plate 44). It is a stylish, flat-arched doorway with original recessed door case and pocket shutters with shutter knobs. The shutter knobs are the same as those found on the French doors and sash shutters throughout the house (plate 45). The French doors have three panes each, beaded glazing bars and a brass knob. Above the doors is a Gothic style fan light with stained glass (plate 46).

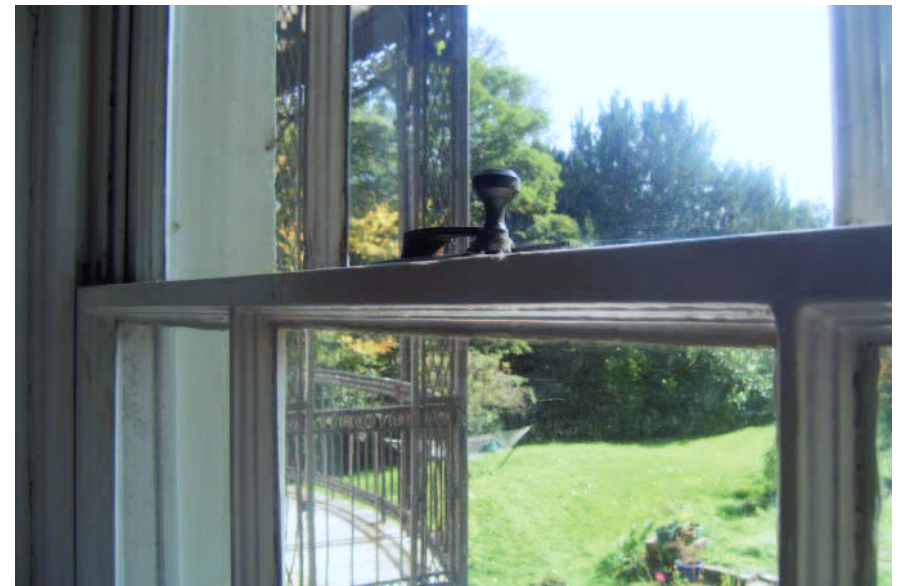
Plate 60: Sash fastener, Bedroom One

- 4.4.8 *Bedroom 1:* Bedroom 1 has the same footprint as the study below it on the ground floor. There is a sash window with nine panes and narrow, moulded glazing bars. The sash fastener is a brass, two lever arm fastener (plate 60). The sash fasteners vary throughout the house indicating that they have been replaced over time. The window case is recessed with pocket shutters and simple corner blocks. There is no window on the curved wall to the west (plate 61). On the exterior of the wall, there is a stone lintel which suggests that a window was blocked and covered with rough cast.

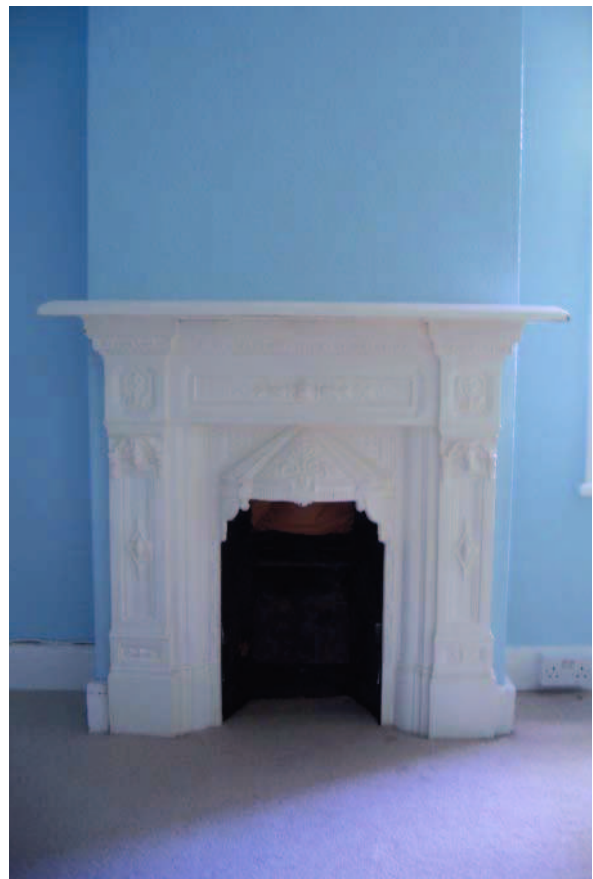
Plate 80: Northend Victorian fireplace, north-east bedroom facing east

- 4.6.4 *North-East Bedroom:* A small bedroom situated in the east gable end of the northern bay, painted blue. In the east wall is a small fanciful Victorian fireplace (plate 80). It is an example of a type of wooden fireplace, mass produced in the late nineteenth century and commonly found in secondary rooms of houses or lower status quarters. It is in good condition and painted white. To the left of the fireplace is a broad, double hung 12-pane sash window with a pan-head sash fastener, horns and a wide moulded frame. The door leading to the hallway in the west wall of the room is a plain 4-panel door with a cast iron lock case and a hardwood knob painted white. It has a narrow moulded frame. The room features a high, plain skirting board and boarded floor.

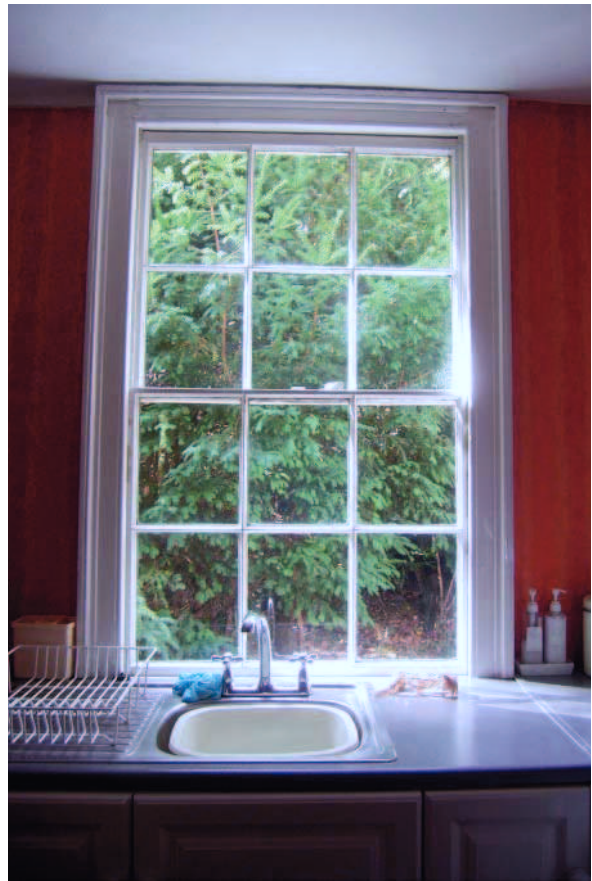
Plate 86: Northend kitchen window, facing west

- 4.6.8 *Kitchen:* The kitchen is situated in the south-west corner of the Northend and features modern kitchen units. In the west wall is a double hung 12-pane sash window with a straight-arm fastener and a wide moulded frame (plate 86). The door to the hallway is missing but in the north-east corner of the room, there is recessed storage space with a plain 4-panel door (plate 87). This is opened with a modern pull handle but there is a plain keyhole with a large black key. The storage space is approximately 1m by 0.5m and features one wooden shelf and a series of hooks underneath. In the left hand side of the north wall is a small recessed cupboard with modern doors. Inside is one wooden shelf. The floor of the kitchen is boarded and there is a high, plain skirting board.

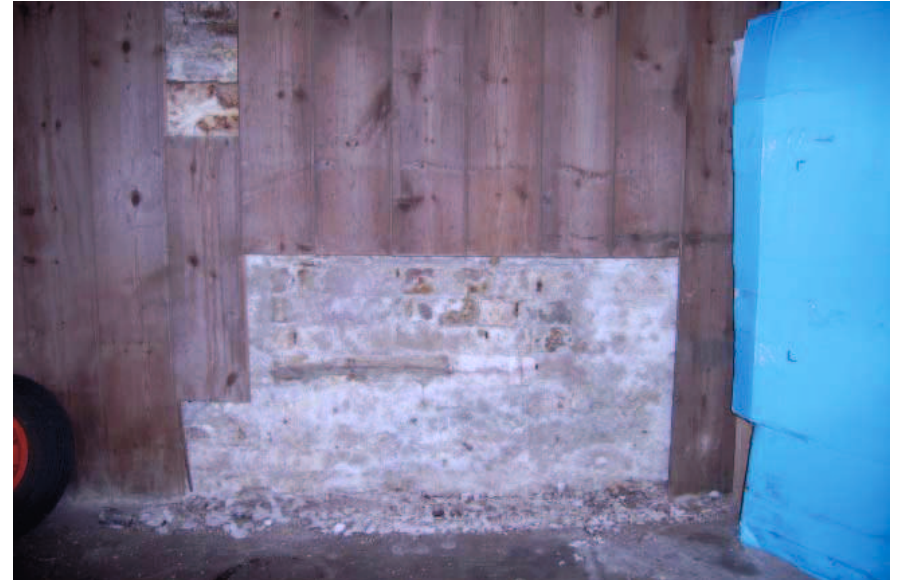
Plate 90: Interior of coach house, visible brickwork in west wall

- 4.7.3 The interior of the coach house is panelled entirely in modern wood (plate 89). Some panelling has been removed on the west wall and the original brickwork is visible (plate 90). There is a boarded door in the south wall providing access to the stable. In the ground there are wooden hatches. These are probably 20th century additions and were used for motor car repair and maintenance.
