Witley Court Gloucestershire The parterre de broderie in the East Parterre

**Post Excavation Assessment
and Project Design**

Witley Court, Worcestershire

The *parterre de broderie* in the East Parterre

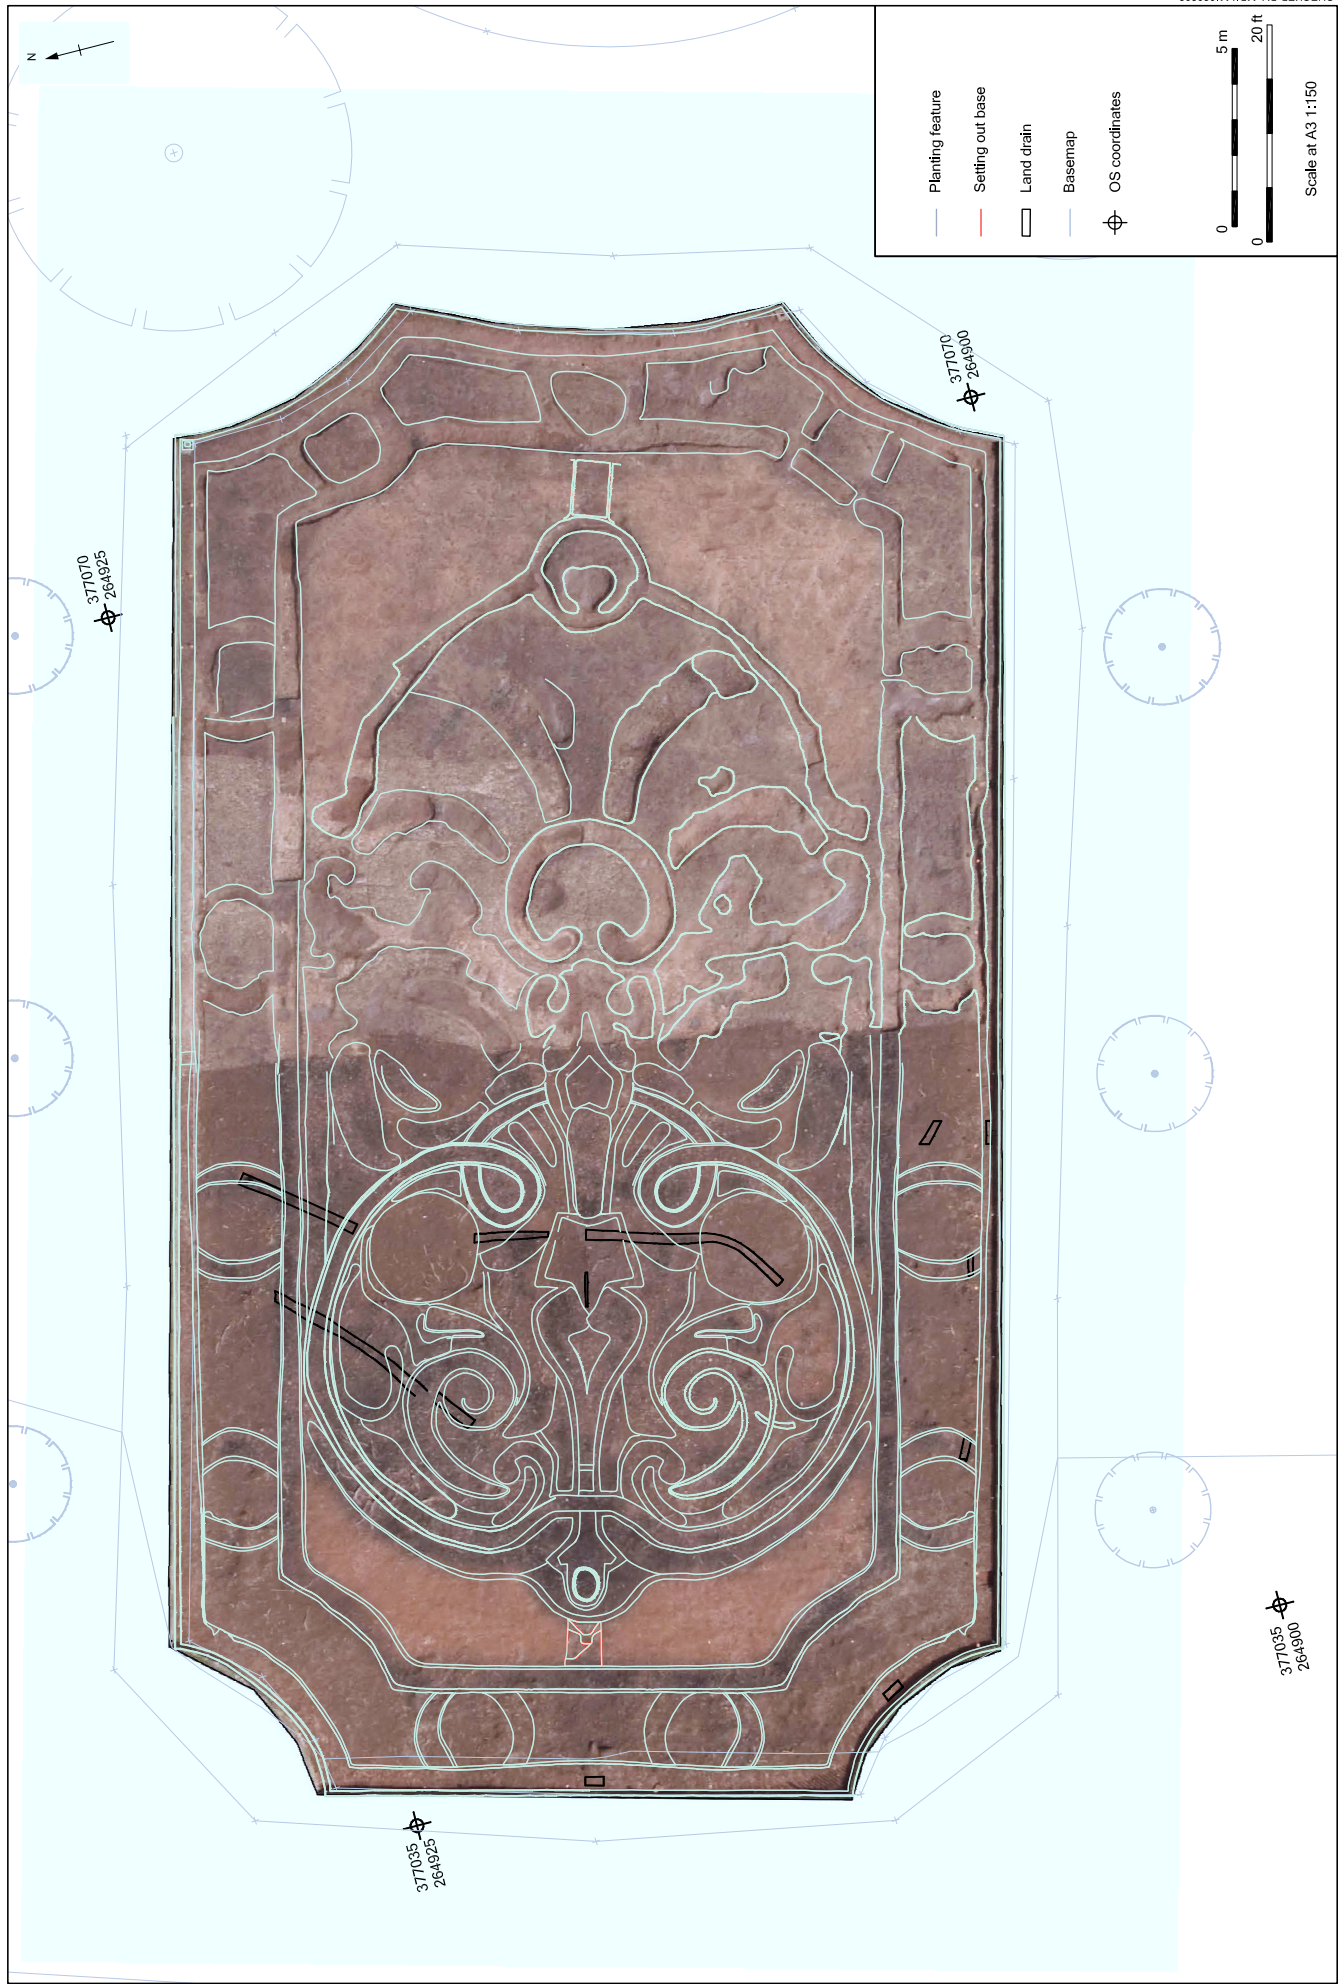
Figure 5: Witley Court East Parterre garden: drainage and other non-design features

- 2.4.3 The principal drainage trenches, running around the edge of the central bed, were backfilled with a mixture of brick rubble, tile and loosely compacted soil. The top of the drain trench was sealed beneath a red-coloured gravel path, which formed part of the decorative border of the parterre.

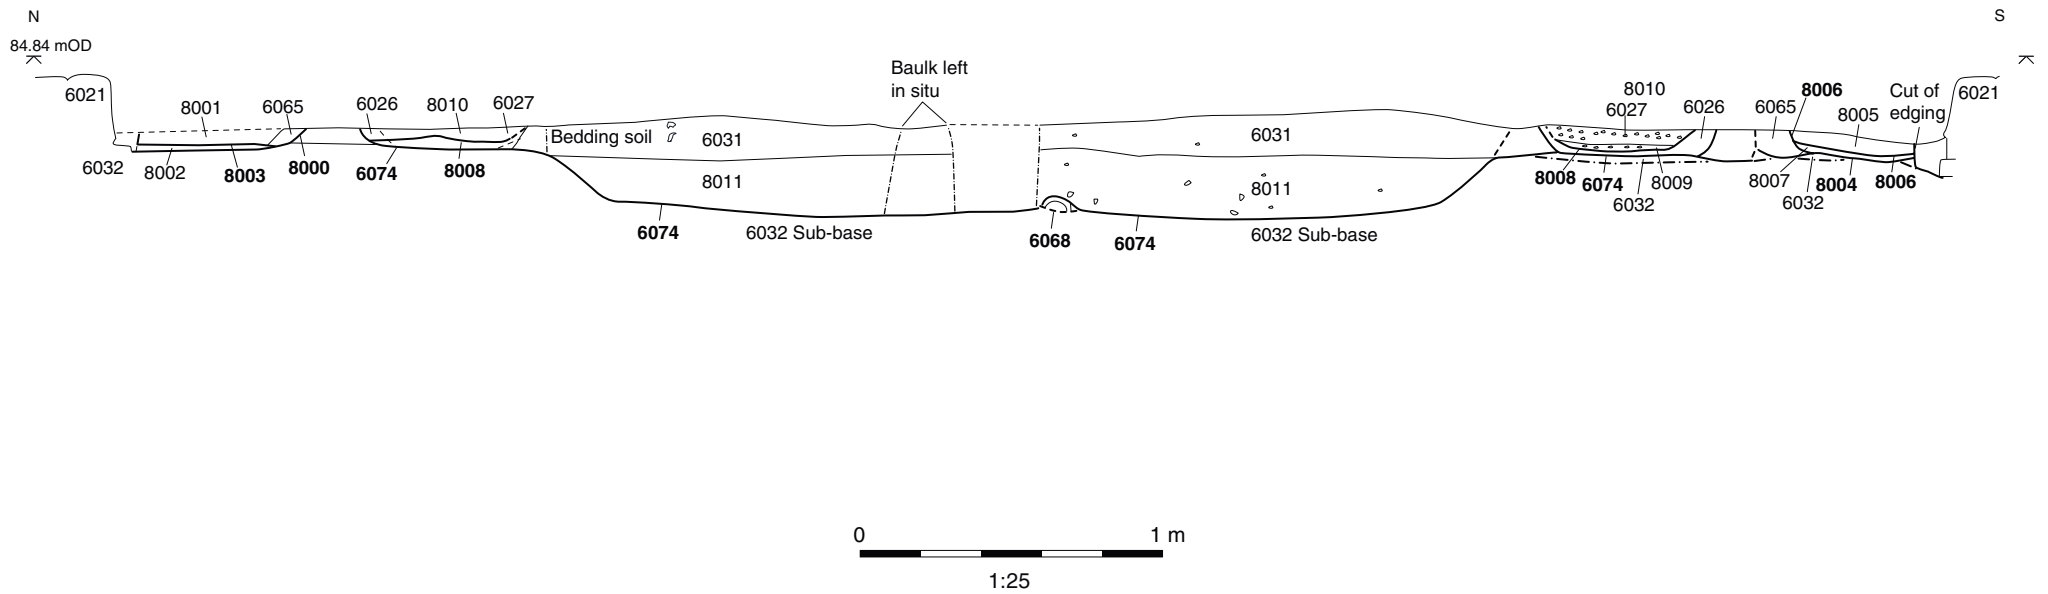
Section 121

Figure 8: Witley Court East Parterre Garden: N-S section through N side bed

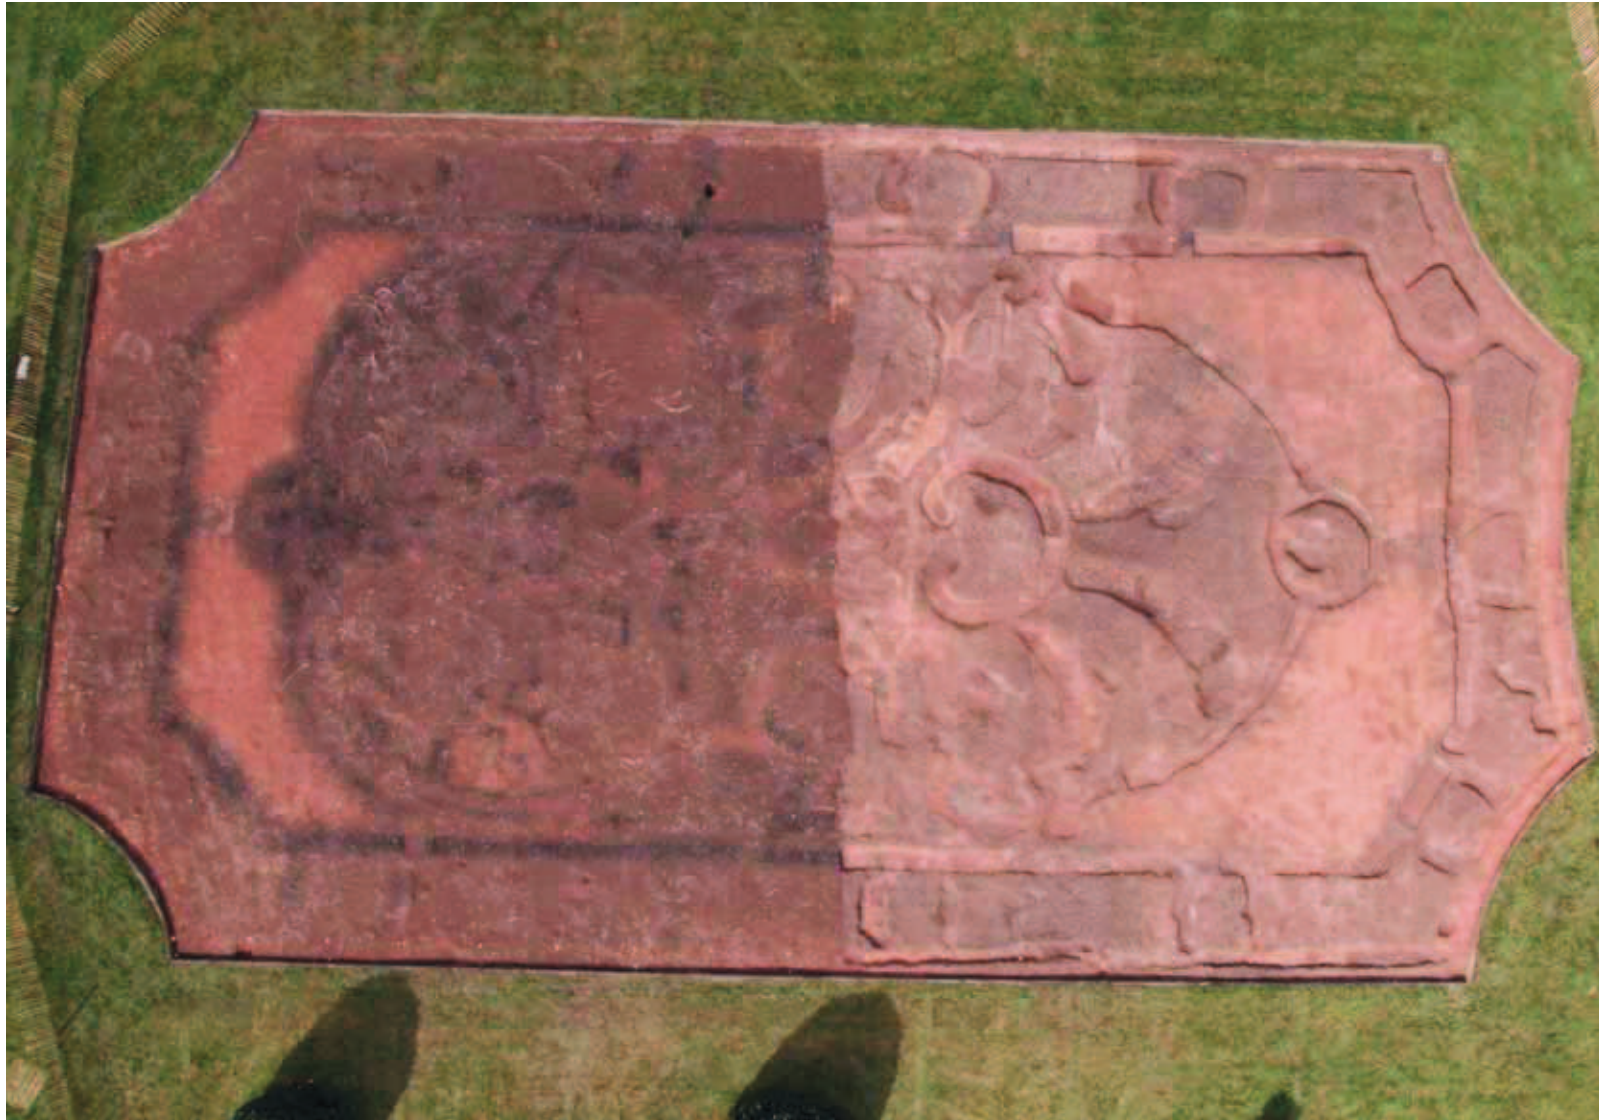
Plate 1: Witley Court East Parterre Garden: Aerial view of centre bed after initial cleaning

- 1.6.3 The central bed of the East Parterre was then carefully hand-cleaned. A series of aerial photographs was taken using a high-definition, remote-controlled digital camera, mounted beneath a tethered balloon. The aerial photography was undertaken by Upper Cut Productions, under supervision of EH Metric Survey Team, who rectified the results. These photographs have been rectified and integrated with the detailed, hand-drawn site plans. The resulting summary CAD drawing covering the central bed, is illustrated as Figure 4. The results are described below.

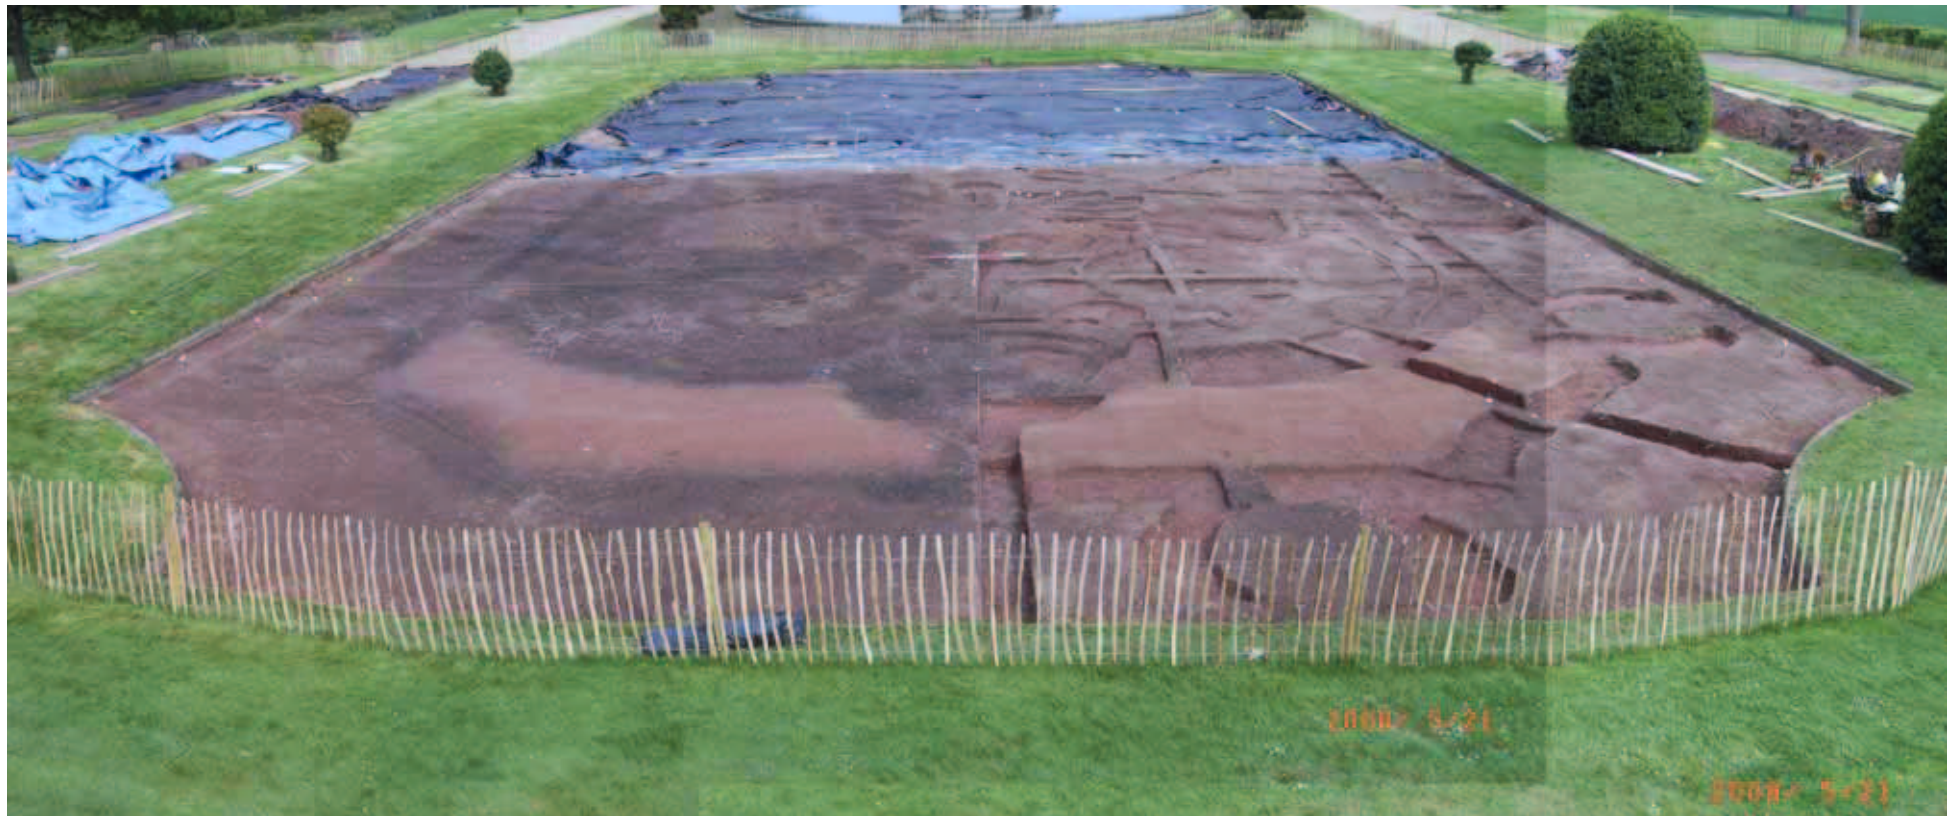
Plate 2: Witley Court East Parterre Garden: Panoramic view of the excavated centre bed (looking east)

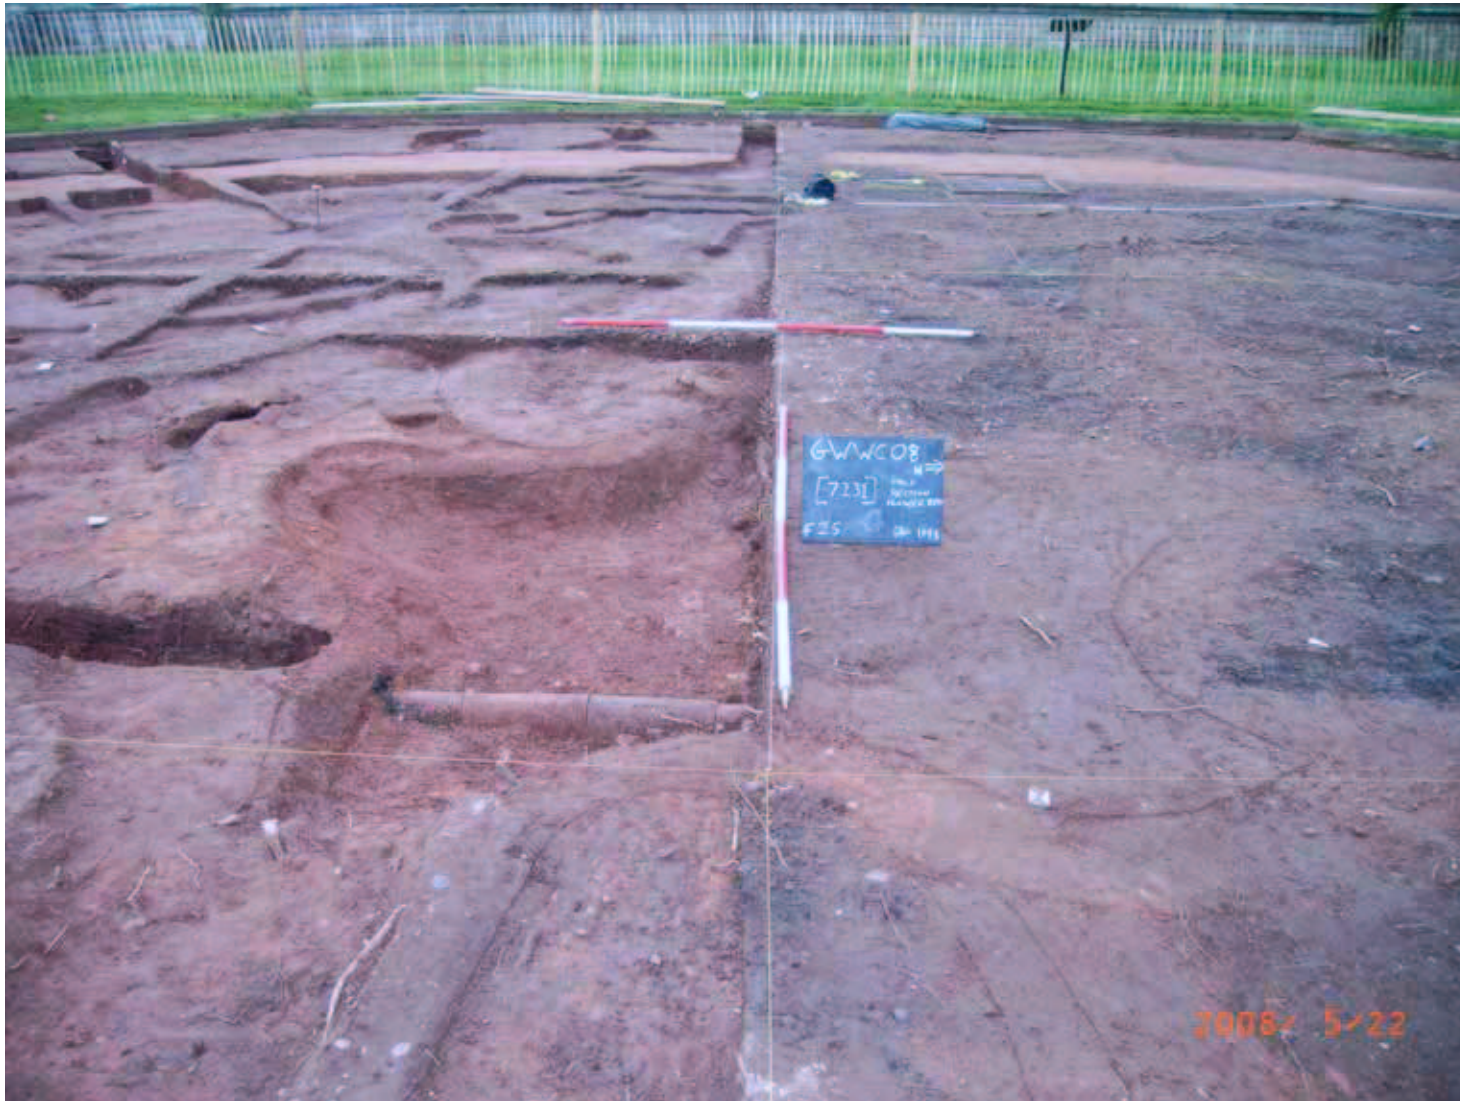
Plate 3: Witley Court East Parterre Garden: View of centre bed features

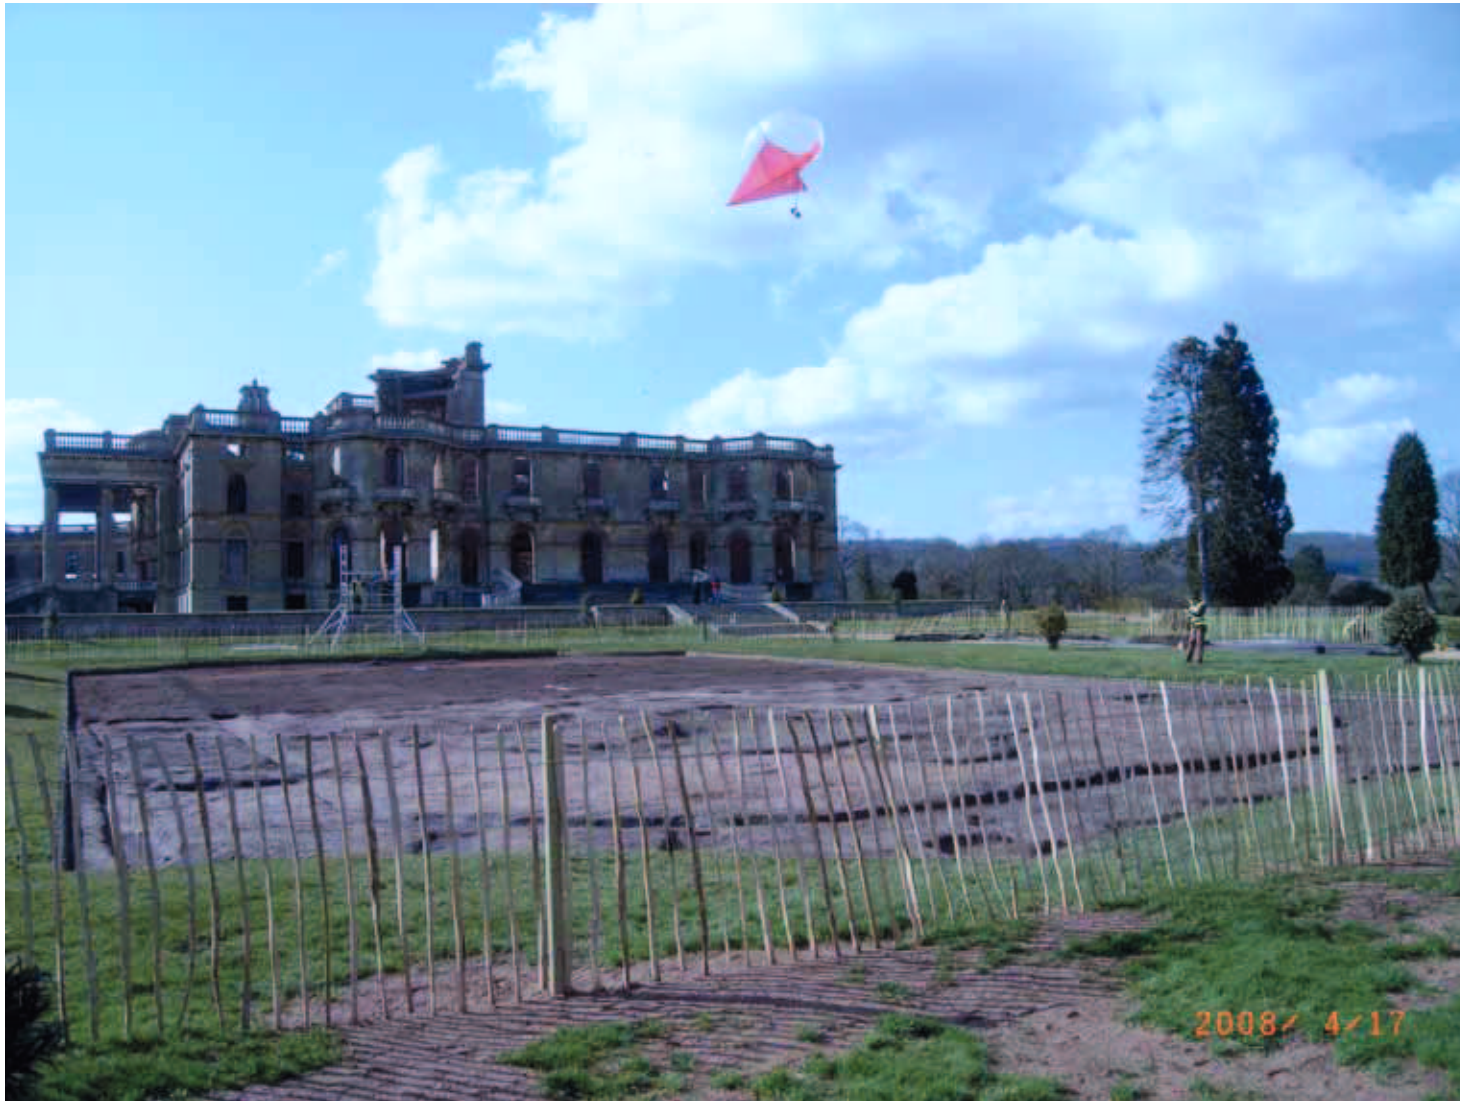
Plate 5: Witley Court East Parterre Garden: A balloon-mounted digital camera, as used to acquire rectified digital photographs

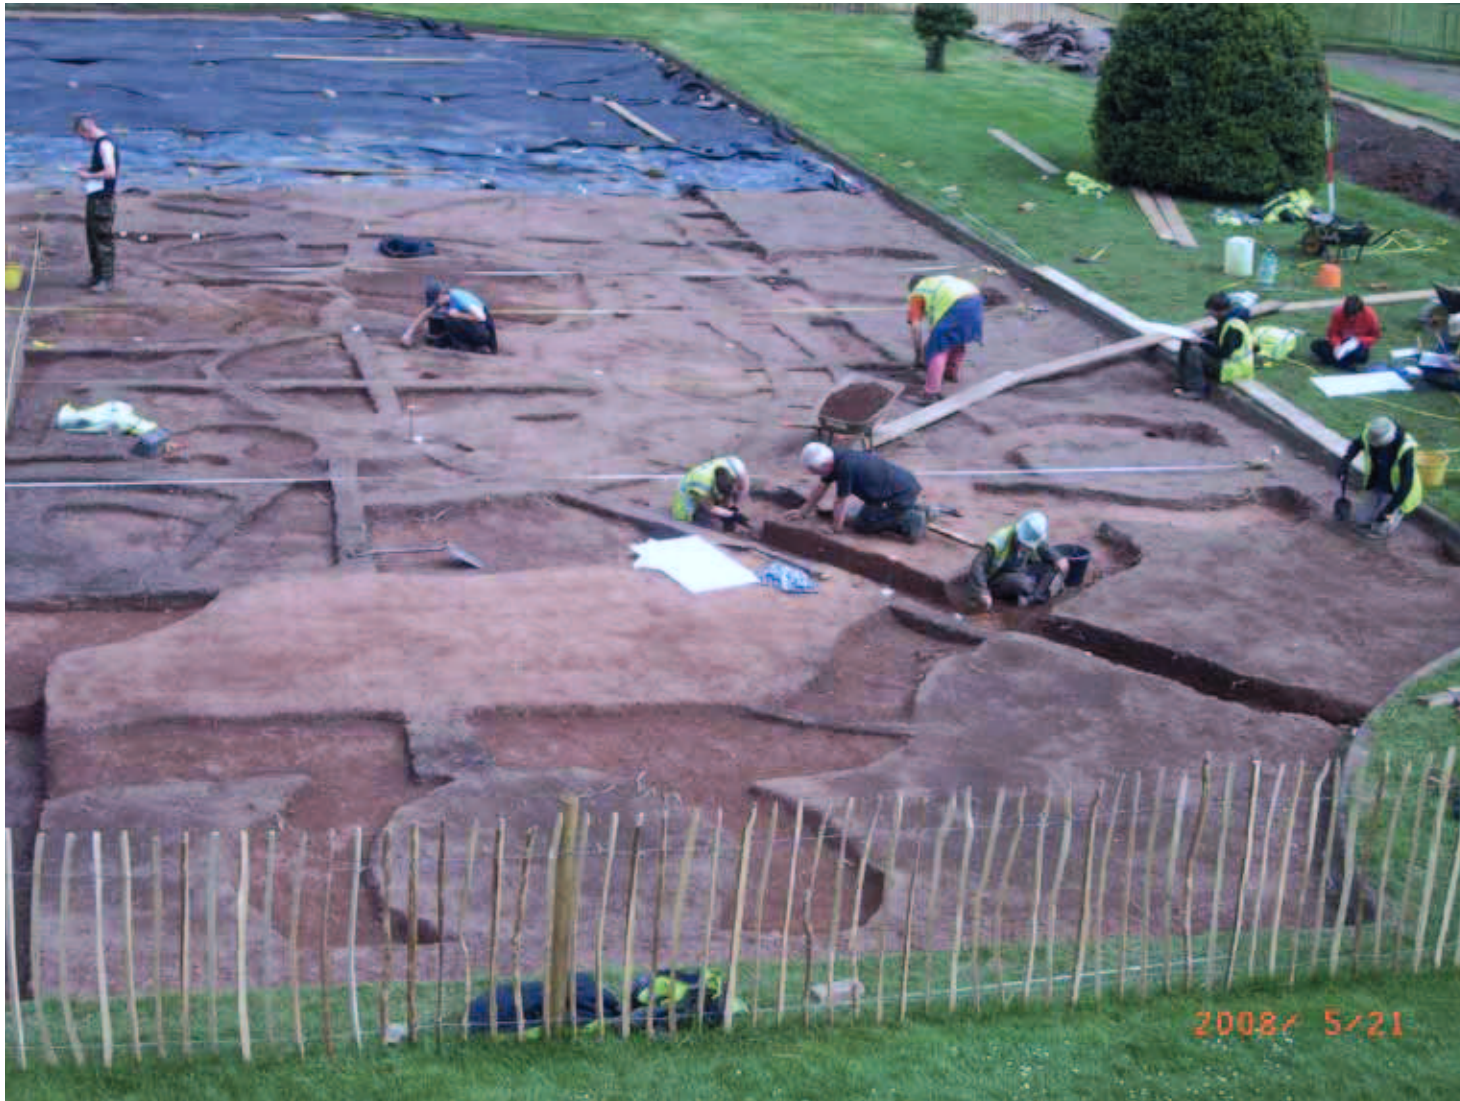
Plate 6: Witley Court East Parterre Garden: The SW corner of the centre bed, under excavation

- 1.6.6 Following the initial cleaning of western end of the East Parterre in 2008 it was decided that detailed excavation of the SW quadrant of the beds would produce the clearest understanding of the surviving garden features. The NW quadrant was disturbed to a significantly greater extent by root action than the SW quadrant. From examination of existing photographs it seemed certain that the overall pattern was originally intended to be symmetrical along its main east-west axis. This was confirmed by reversing the detailed plan of the SW quadrant and overlaying it on the NW quadrant pre-excavation
