East Parterre Gardens  
Investigation  
Witley Court

**Archaeological Excavation Interim**

**Client: English Heritage**

**Witley Court, Worcestershire****The *parterre de broderie* in the East Parterre: Interim report on excavation, recording and analysis, 2006****INTERIM ARCHAEOLOGICAL INVESTIGATIONS REPORT****CONTENTS**

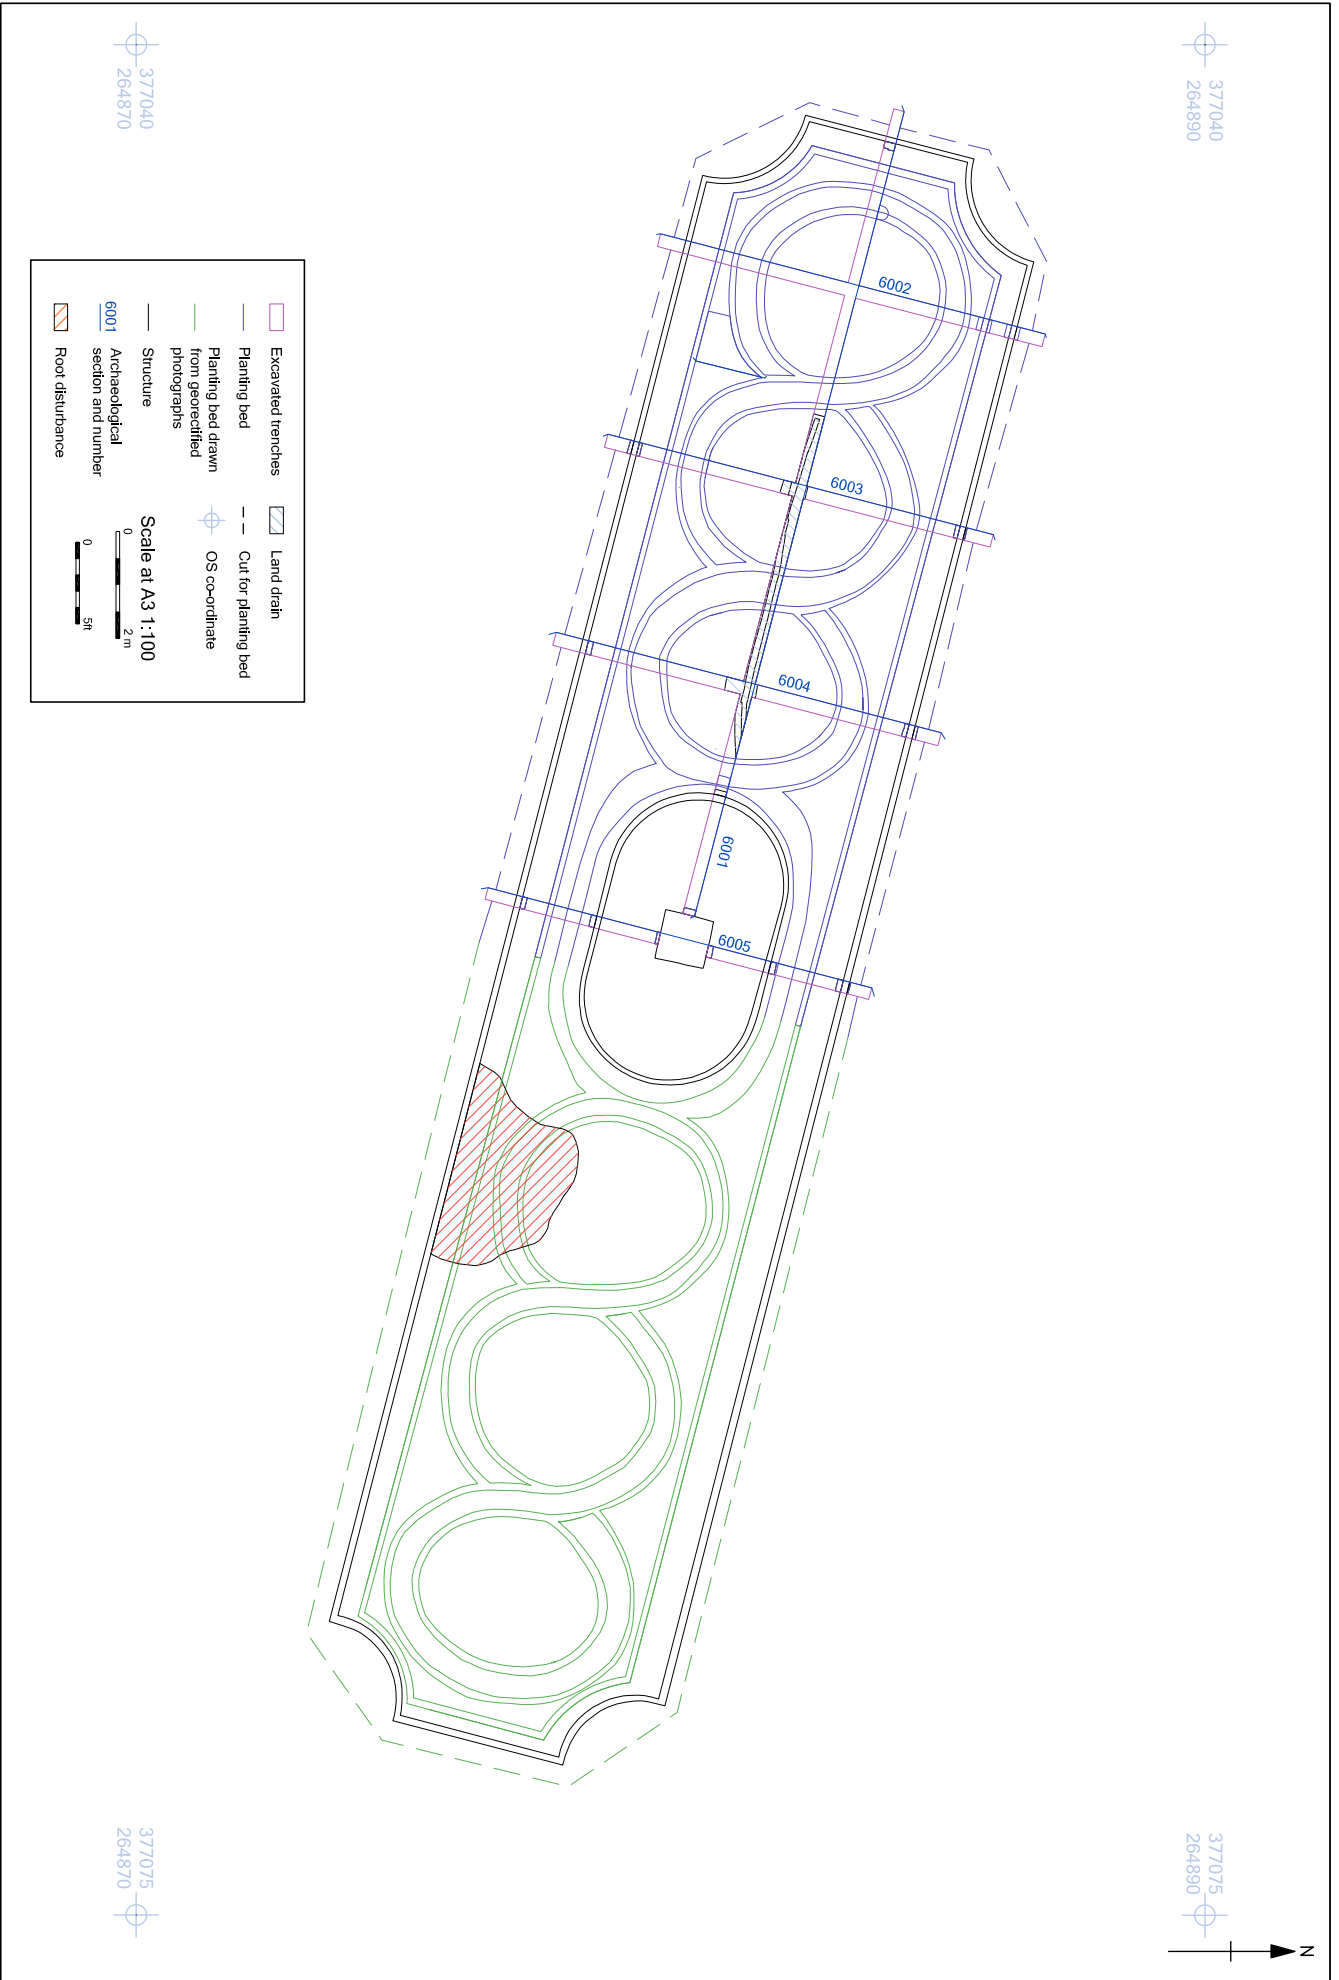
Figure 3: Excavation plan of the south side bed showing the plan of the beds as recorded and locations of recorded sections

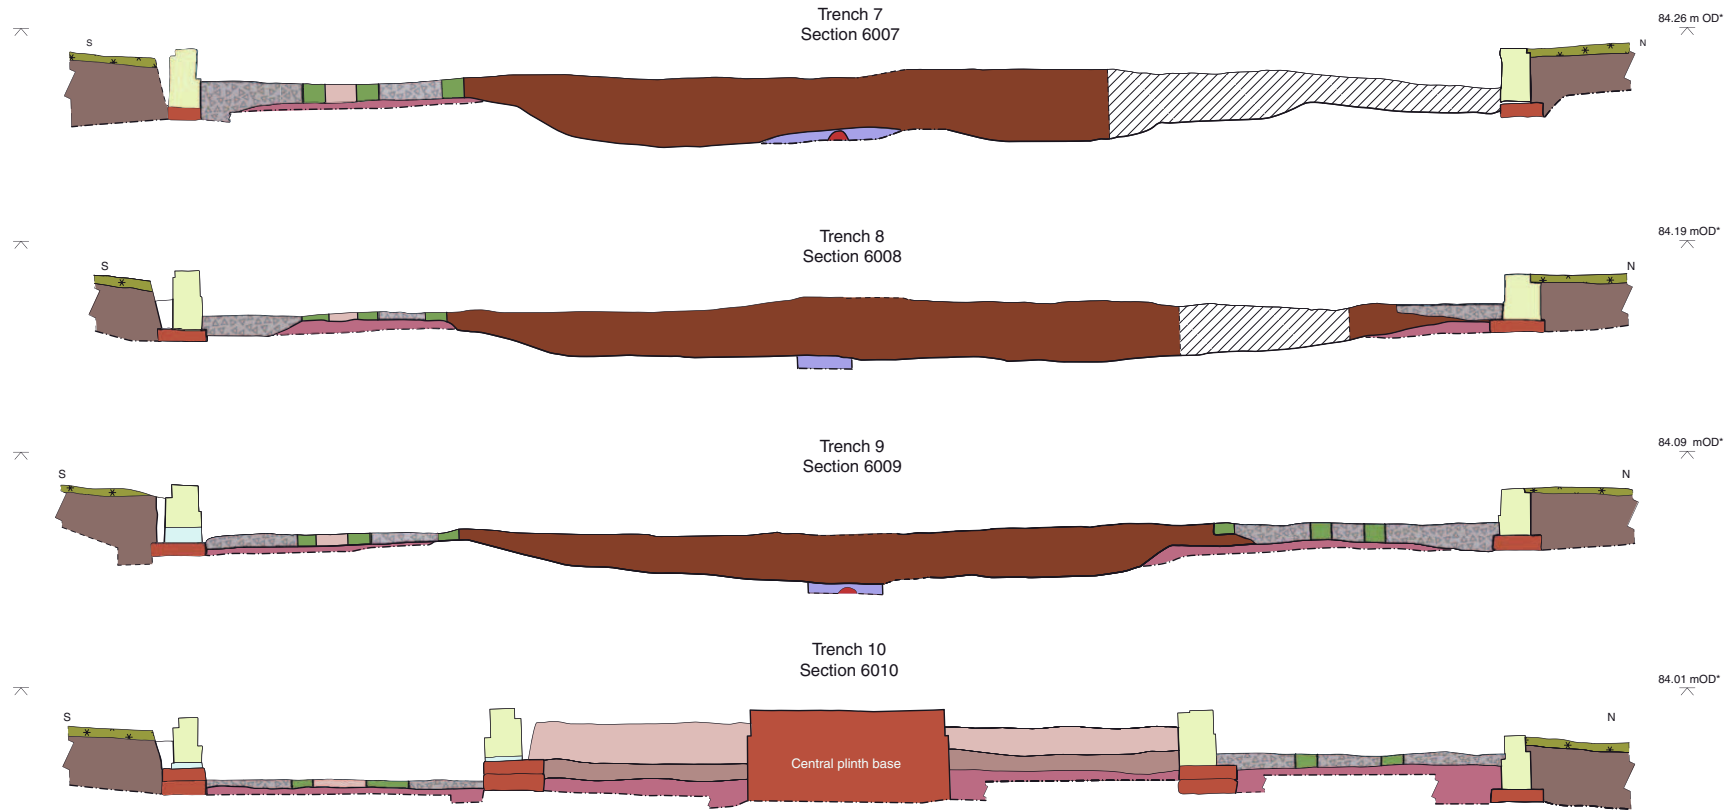
Figure 7: Recorded transverse sections through the north side bed illustrating depth and methods of construction (sections 6007 - 6010)

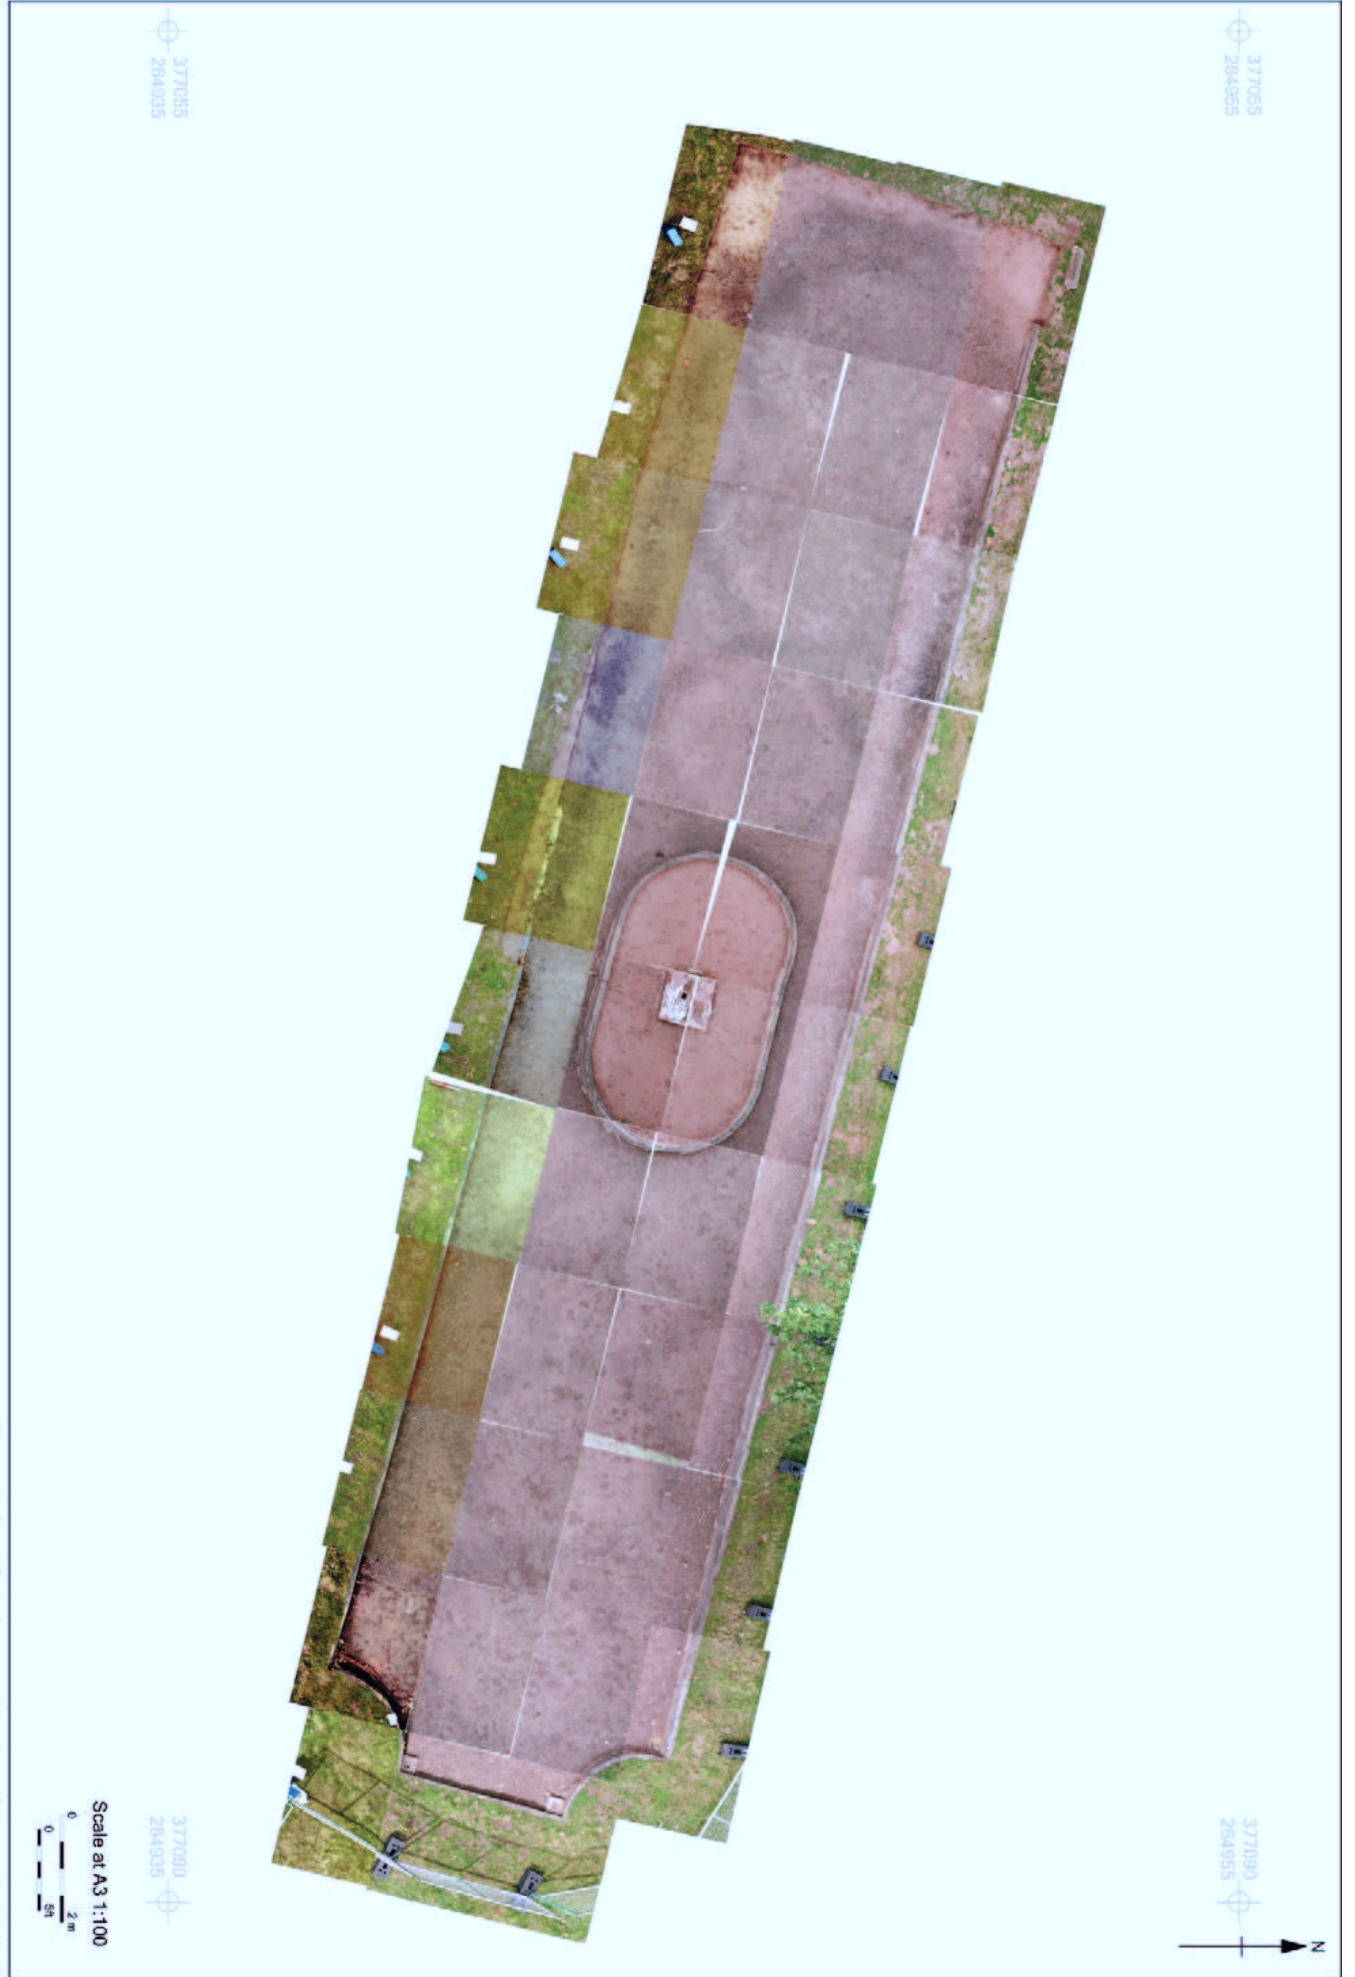
Figure 9: Rectified photographic plan of the north side bed

- 5.3.1 Two rectified photography passes were carried out by Aerial Close-up. The first pass, using analogue photography, was undertaken in September 2006. The second pass, using digital photography, was completed in November 2006. In both cases the light conditions were variable, resulting in patchy colour matching, but the photographs provide an effective record of the overall bed design, albeit with difficulties in interpretation at a detailed level. The photographic records have been rectified and integrated with the detailed, hand-drawn site plans, in the form of a CAD drawing covering all three beds.
