Barn at Cobden Farm
Sabden, Lancashire:
Historic Building Record

Barn at Cobden Farm Sabden, Lancashire: Historic Building Record

The barn at Cobden Farm (NGR: SD 77043650) probably dates to the 18th century but has been heightened, had its roof replaced, and also been extended by the addition of a lean-to shippon in the second half of the 19th century. Historic building recording was carried out in June 2011 for the developers Mr & Mrs Cookson, as a condition of planning consent for the barn's conversion to residential use, and this record includes measured drawings, photographs, and a written description supplemented by the results of historical research.

HISTORIC BUILDING RECORD

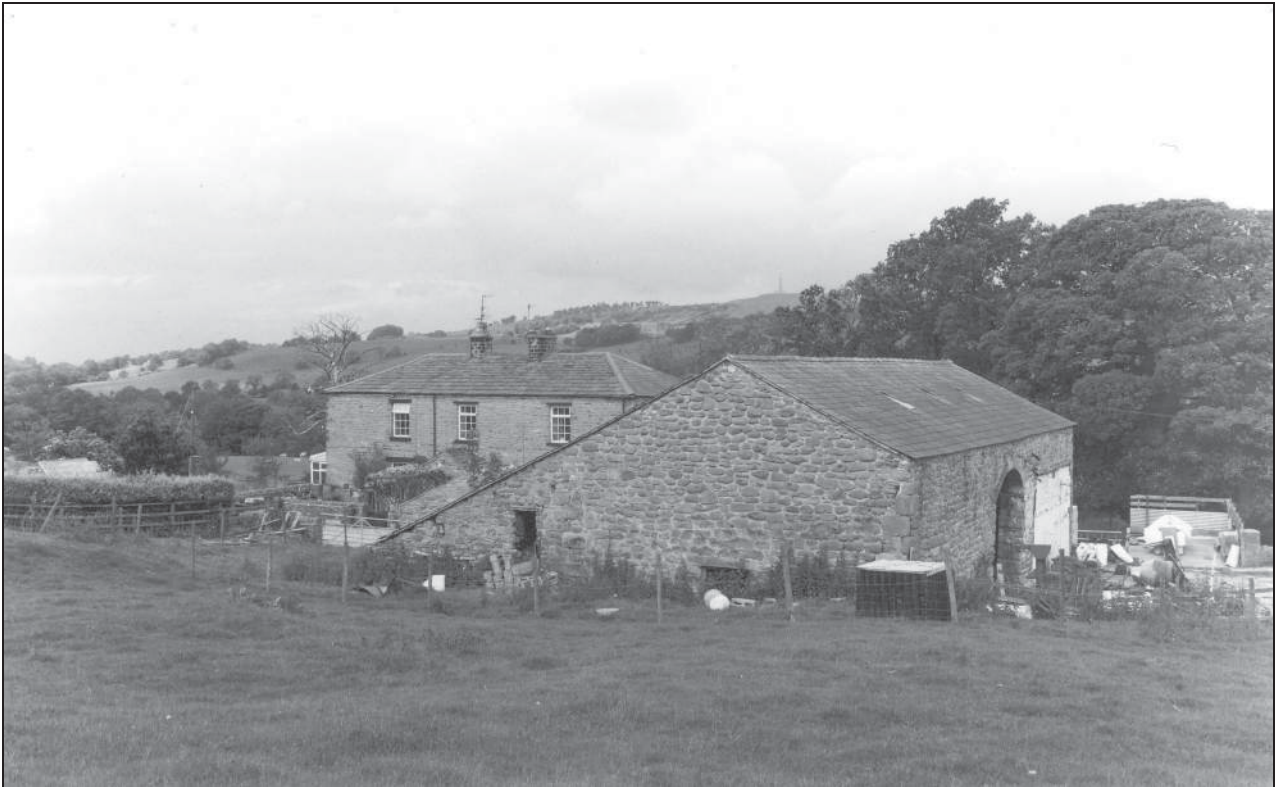
Photo 1: General view of barn and farmhouse, from the east

- 6.1 The barn is built on a levelled area cut into the slope, with its long axis at right angles to the contour, and with its south-east gable set into the rising ground (**1**). Its walls are of local gritty sandstone rubble, laid in rough courses and with roughly squared, edge-laid quoins; otherwise there are very few dressings. The present blue slate roof was relaid in the 20th century, and the original covering would have been local stone slate.

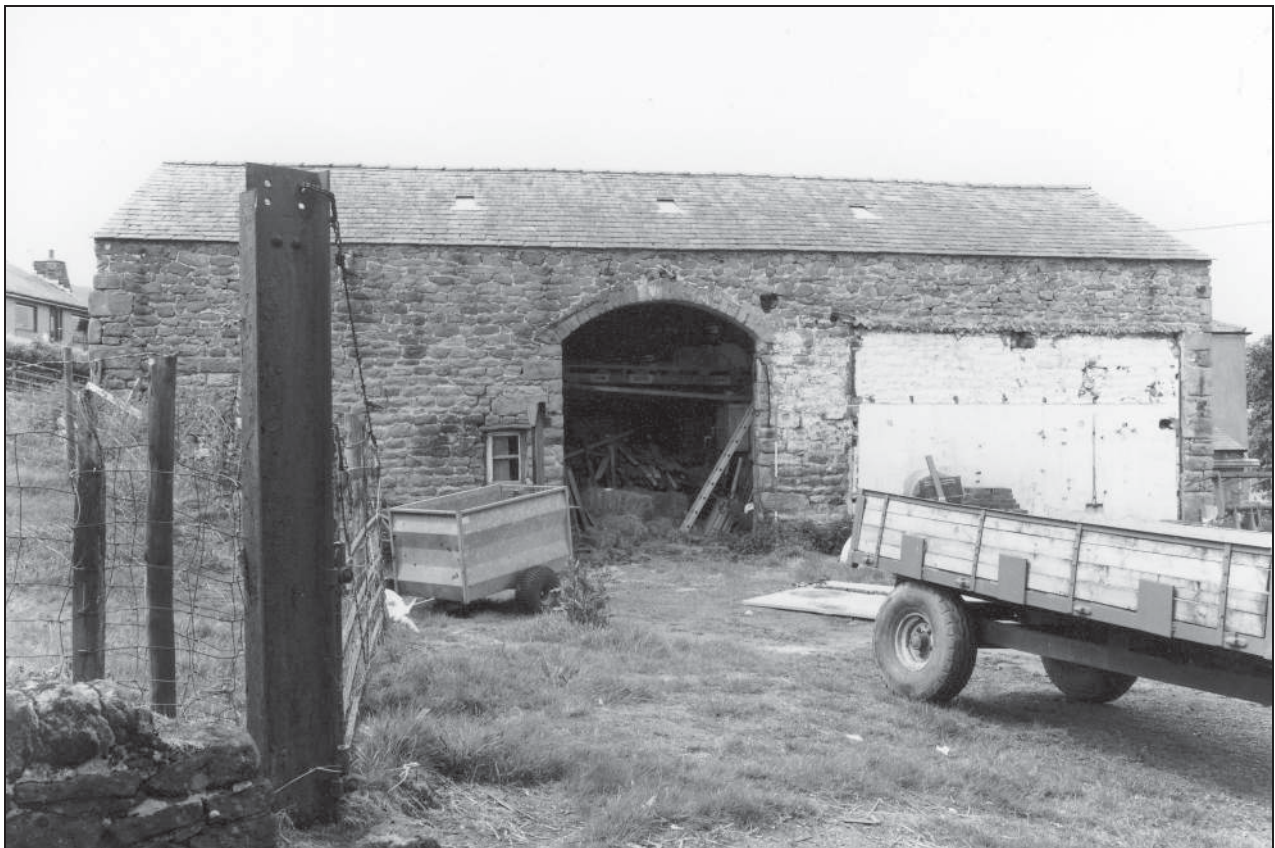
Photo 2: The barn: north-east elevation

- 6.2 The north-east facing elevation contains the main entrance, the tall cart doorway with segmental arch and plain quoined jambs, in which are the remains of iron pintles for hanging the doors. This entrance is set to left of centre (**2-4**). There is evidence that the eaves in this side of the building were previously about 0.5m lower than at present (ie. just above the voussoirs), although this is best seen inside the barn, where there is a clear set-back in the wall face, just below the tie beams (**5**). The other two openings in this elevation are a doorway and window serving the south-east end, and both are rather crude and appear to have been altered: there appears to be a blocked opening just above the doorway (**6**). To the right of the cart entrance a modern lean-to has been demolished, and the whitewash and render there hide much of the wall detail.

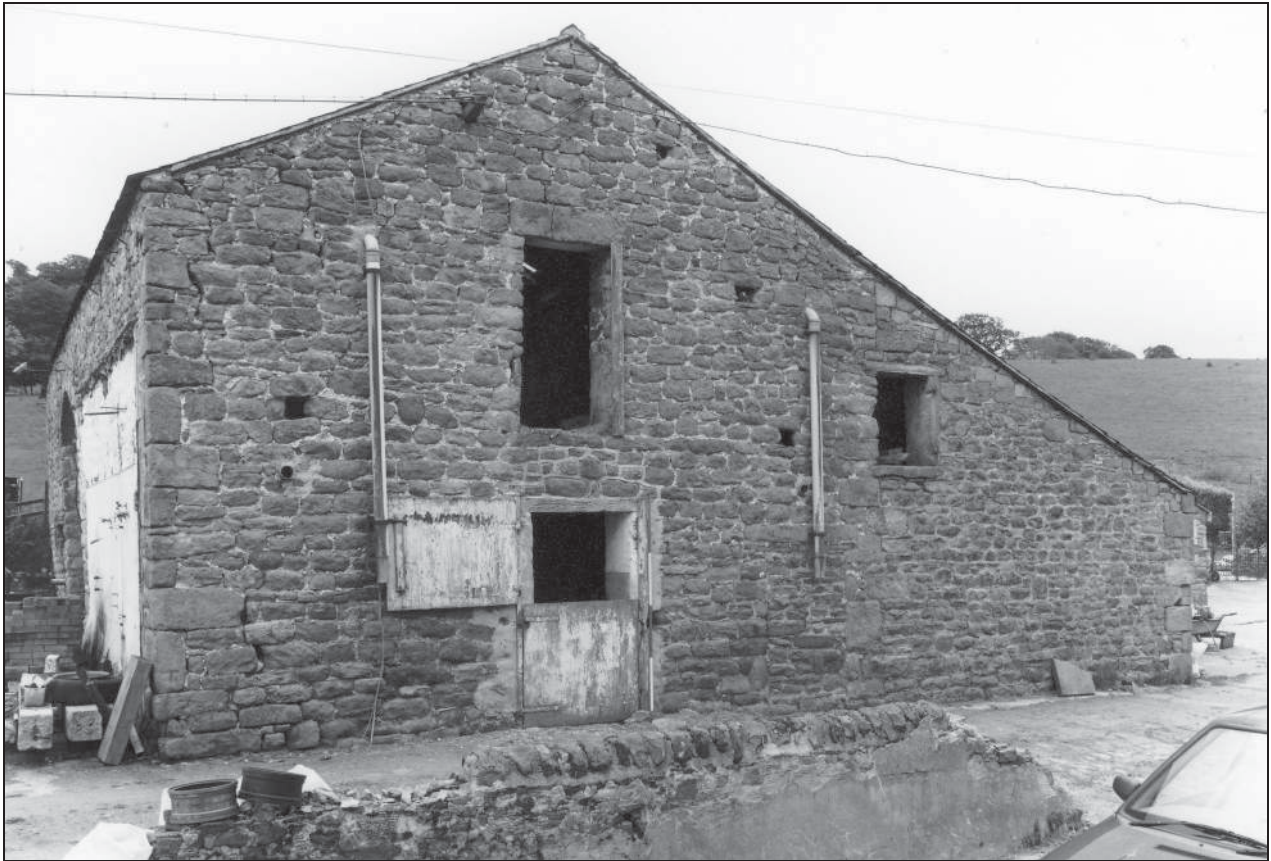
Photo 7: North-west gable

- 6.3 The barn's north-west gable clearly shows that the lean-to shippon was an addition to the barn, and although there is no clear break to show the heightening of the barn, there is a change in the character of the quoins which probably arises from a raising of the eaves (7,8). The present central doorway is either an insertion or an enlargement of an earlier opening, and to the right of it is a smaller, blocked doorway, not matched to the left. The central, first floor doorway has clearly been cut down from a smaller forking hole. At the opposite, south-east end the building is set into the ground, with a low level, inserted window, above which the wall was rebuilt by the present owner, following its collapse (9).

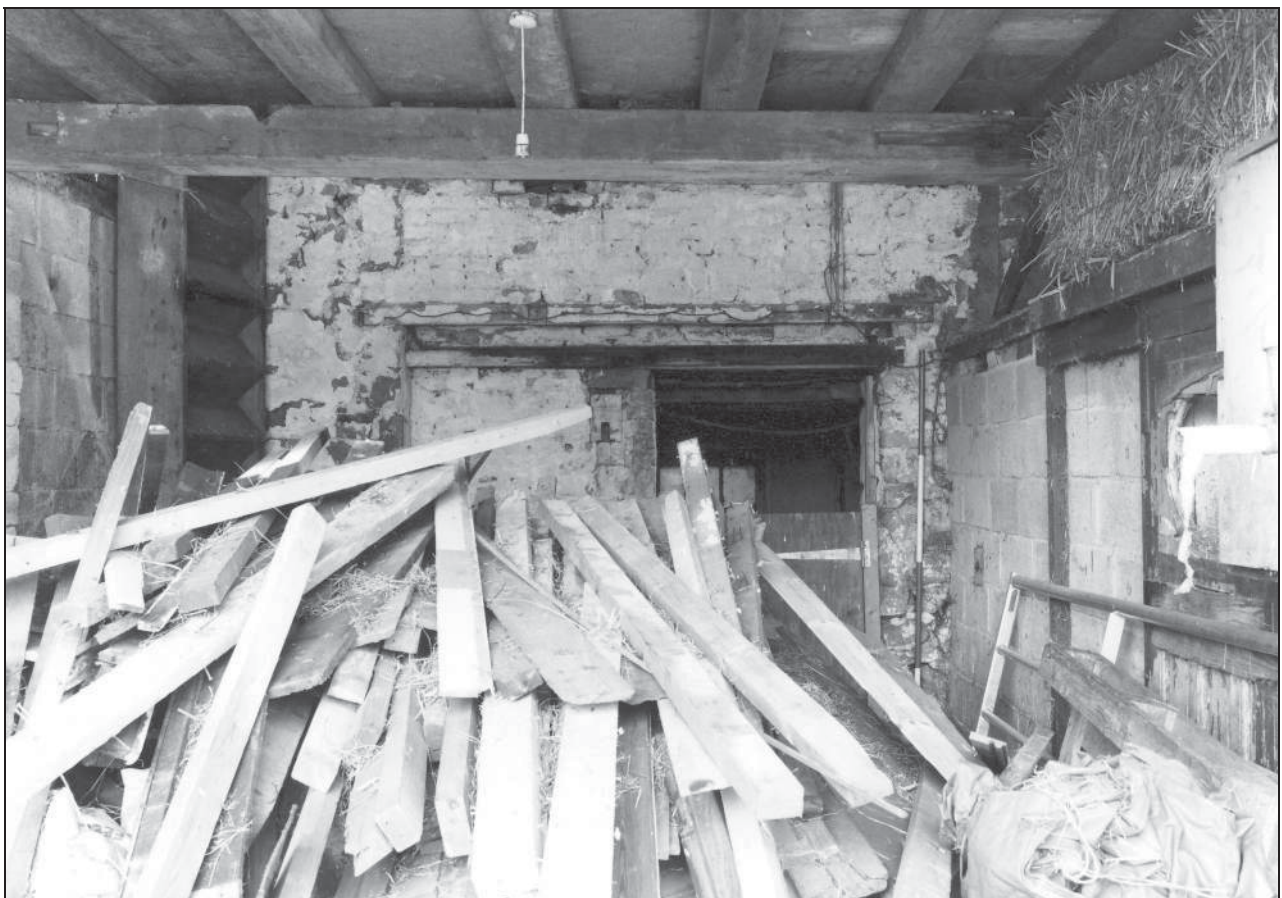
Photo 10: Threshing bay, from the north-east

- 6.4 The addition of the lean-to shippon along the barn's south-west elevation means that this part of the building is now largely hidden, although a former cart entrance opposite the existing north-east one can be seen, reduced to a lower, narrower opening by brickwork (10). Its arch has been lost to rebuilding, which seems to have taken place along the length of the south-west wall. There is also a doorway at the south corner, which appears to have been inserted.

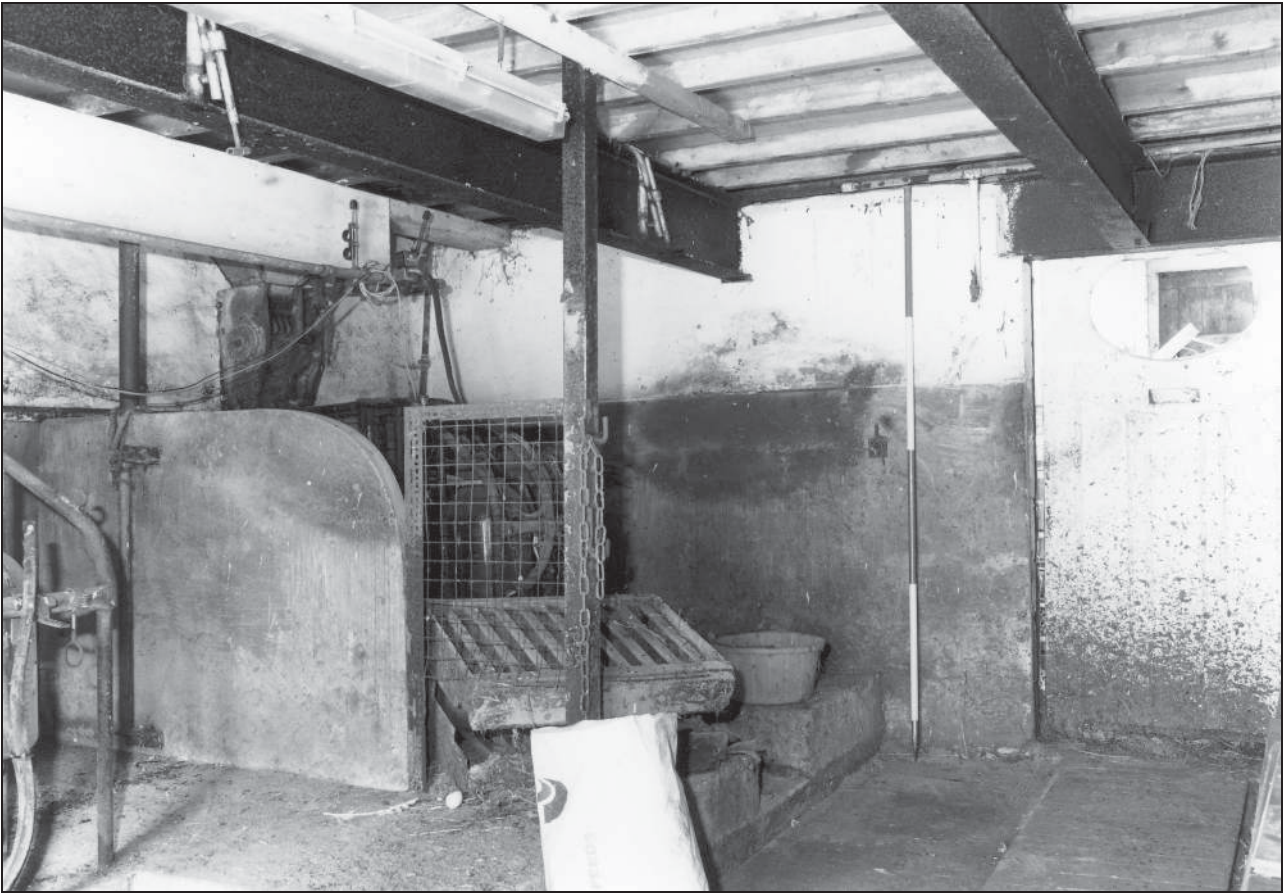
Photo 11: Milking parlour in north-west end of barn

- 6.5 There is little of historic interest within the original barn: on the ground floor, the north-west end has been made into a milking parlour in the mid 20th century (11); previously this was no doubt a shippon, being located at the downhill end of the building, and probably that referred to in the 1896 sales particulars as the "shippen for 6, partitioned off". Breeze block walls divide this and the south-east end of the building from the central threshing bay, reported to have a floor of stone setts, but presently hidden. There is now also a shippon in the south-east end (12,13), with concrete boskin and floor, but it is thought that this was originally a mewstead, ie. simply a storage area open to the roof, as the two doorways are not original. However the two softwood beams overhead show that the concrete boskins replaced two earlier ones of timber, so this area may have been made into a stable or shippon during the 19th century. At loft level there are four softwood trusses, spaced regularly but without regard for the cart entrance, which, together with the observation that the walls have been heightened, suggests that these are not original. The trusses are probably early 19th century, and are of typical bolted king post form, fashioned from square sawn, imported softwood, and bearing joint numbering in the form of Roman numerals at the base of the struts (14-16); most of the purlins have been replaced. It seems likely that when first built the barn was a more typical three or perhaps four bay structure, possibly with oak trusses, although there is no direct evidence for that, and no re-used or discarded oak timbers were observed at the site.

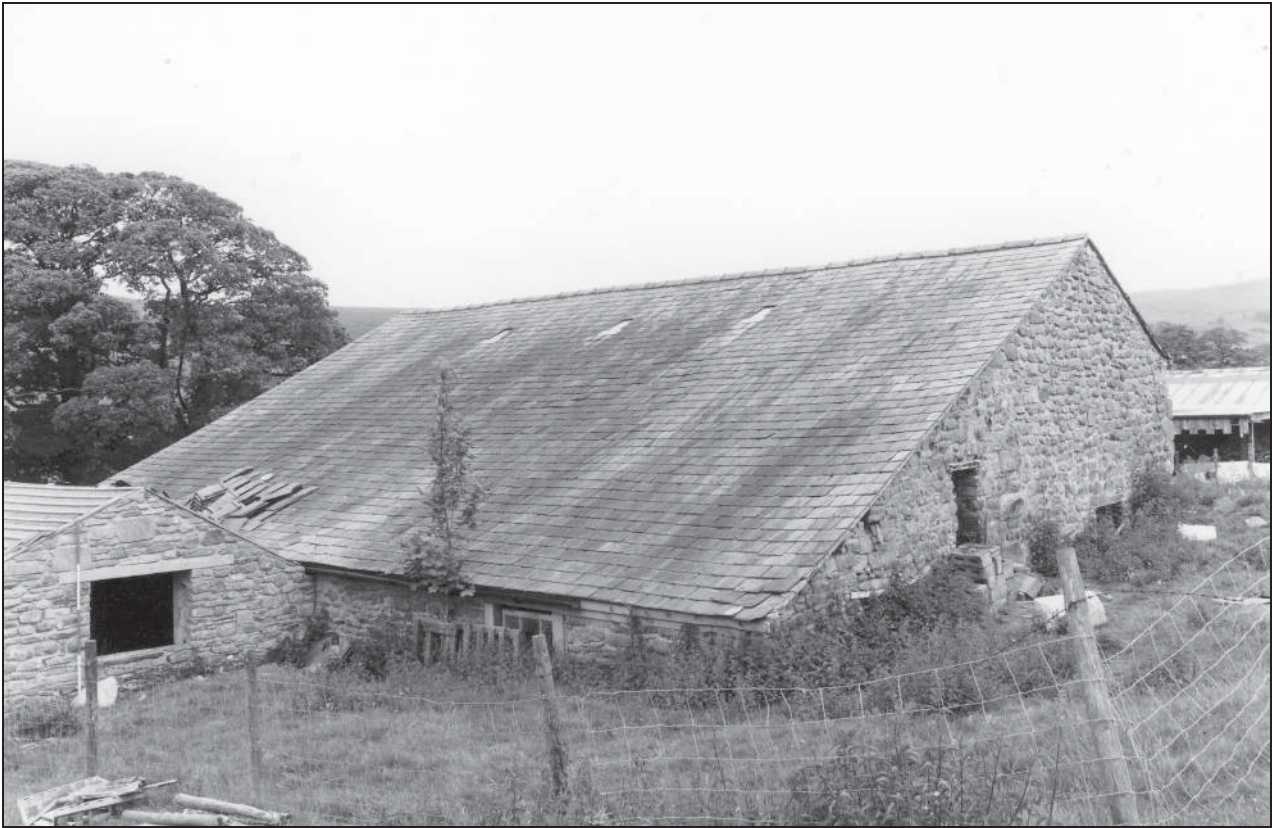
Photo 17: The barn, from the south

- 6.6 The lean-to shippon added in the second half of the 19th century (17,18) is a typical feature of barns in Pennine Lancashire, where dairy farming enjoyed prosperity at that time and herds were expanded in response to increased

demand from growing mill towns. This addition has walling stone very similar to that used in the barn, and quite probably derived from the same quarry in the vicinity, but its dressings are of a better quality, being more finely tooled, and would probably have been bought from a commercial quarry. The extension has two parts: a former two-stall stable at the north-west end, with its own entrance (19), and a larger, twelve-stall shippon, separated from the stable by a masonry wall, and originally with its own entrance, blocked when the adjoining garage was built. Three windows in the long wall light the interior, and these have surrounds similar to those of the doorways, and six-pane timber frames, non-opening, but incorporating ventilation gaps (it is not clear whether these are original or poorly fitting replacements); there is also a more poorly finished window opening in the south-east end, no doubt of later date.

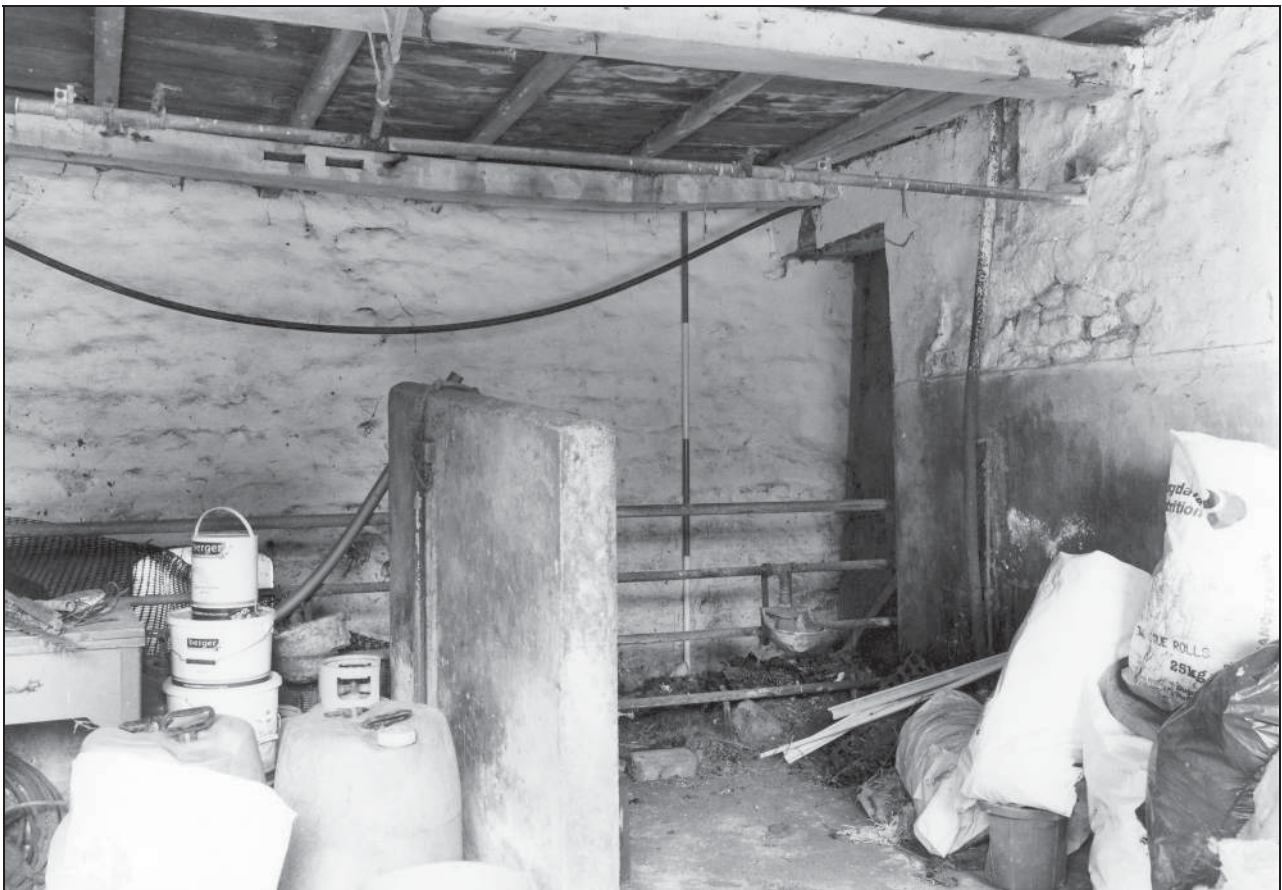
Photo 20: Interior of lean-to shippon, north-west end (former stable)

- 6.7 As with the barn there is little of particular interest inside the lean-to, where the former stable has a concrete boskin showing that it was used for housing cows, (20) and no stalls survive within what was the twelve-stall shippon (21,22). A boarded loft runs throughout the length of the lean-to (23), with forking holes at either end, and would have provided a feed storage area.
