High Moss
Rishworth, West Yorkshire:
Historic Building Record

High Moss Rishworth, West Yorkshire: Historic Building Record

HIGH MOSS, RISHWORTH, WEST YORKSHIRE: HISTORIC BUILDING RECORD

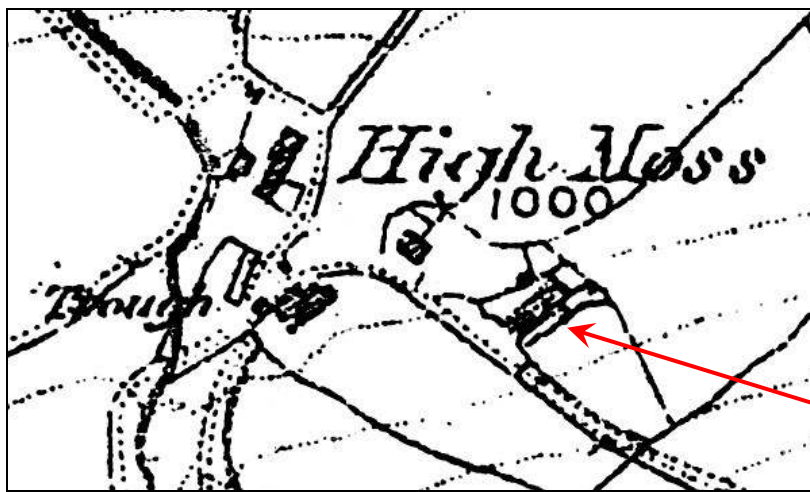
Figure 3: Ordnance Survey 1:10560 map (lower extract enlarged to approx 1:2500)
Published 1854 (surveyed 1848-9); sheet no: Yorkshire 245

- 5.8 No large scale historic maps of the area appear to have been made until the Ordnance Survey's first edition 1:10,560 map, surveyed in 1848-9 (figure 3), which shows High Moss as comprising a cluster of buildings loosely arranged at the foot of the slope, and at the end of the track from Stott Hall, at a site which might have been chosen for its position on the spring line. It is guesswork as to exactly what these buildings were in the 1840s, although the range studied here seems slightly shorter than that standing today. The 1894 1:2500 map (figure 4) shows these more clearly, largely as they now are, but two of the other buildings recorded in the 1840s are no longer shown and must have been demolished. There is also a small building just to the north of the farmhouse range, no longer standing today. Significantly this map also shows an isolated "vent" to the west of the present building, indicating that the culvert which carries water to Ringstone Reservoir to the north-east had been constructed by then, an event which might have occasioned the demolitions mentioned above. Much the same arrangement is also shown in 1907 (figure 5). A modern satellite image is also useful in showing the present site, its surrounding field walls in various states of repair (figure 6).

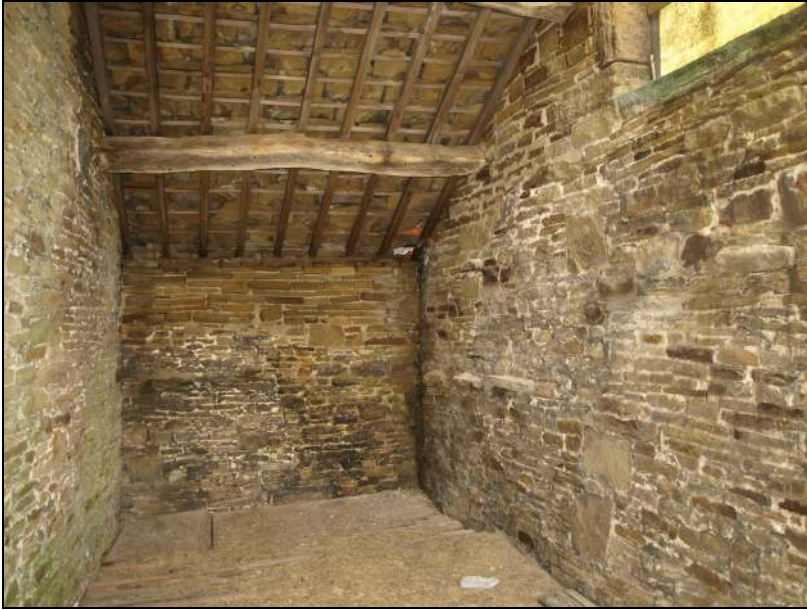
Photo 17: First floor hay loft in north-east end of farmhouse (former shop?)

- 7.4 The arrangements within the former “shop” have been altered by the construction of two new walls on the ground floor, which have themselves been subject to further changes such as the blocking of doorways, but it is striking that this end bay is very poorly lit, there being only a small, possibly inserted window in the gable on the ground floor, though the original arrangement at the rear (where there may have been a taking-in door at first floor level) is not clear, because of modern alterations: this lack of windows suggests that it was used for storage, rather than processing of textiles, so presumably spinning and weaving would have taken place elsewhere within the house. One feature of interest in this area is the survival of an early oak beam, supported by a later wall beneath, which carries the flagstone upper floor in the front part of the building (**15,16**): as the oak beam has redundant joist sockets, it may not be an entirely original arrangement however. The upper floor, now a hay loft with modern plywood floor partly borne on replacement beams, forms a single tall space open to the

roof, with high level forking hole, and oak purlins carrying the present sheet metal roof (17).⁹

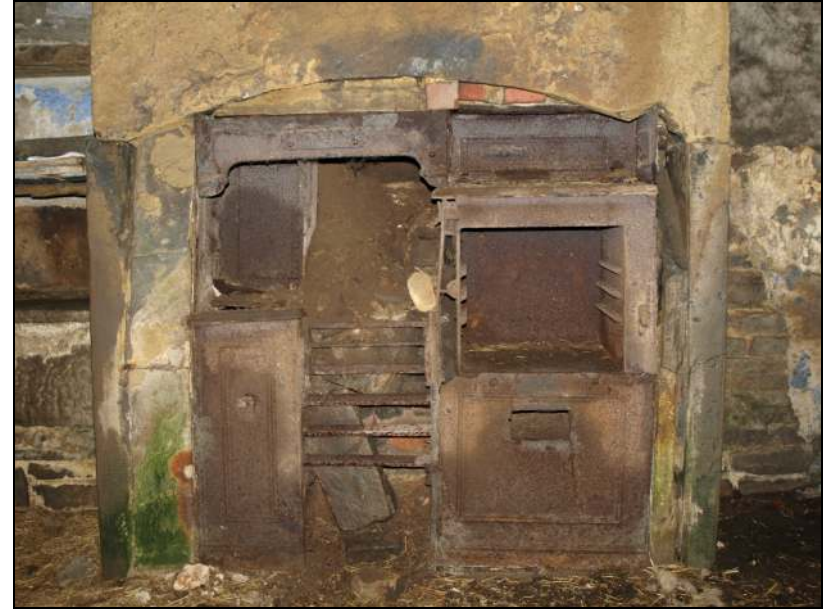
Photo 19: Nineteenth century cooking range in housebody

- 7.5 The cross-wall dividing the shop from the housebody appears largely unaltered, but the original fireplace which is assumed to have backed onto it has been replaced by a nineteenth century cooking range (18,19), leaving no indication of its extent and form of construction (whether stone arched or with timber hood). As the first floor beams have also been replaced with pine beams of a similar date to the range, and the windows to front and rear replaced, neither of these aspects can help understand how the housebody appeared in the seventeenth century, as regards the fireplace and fenestration (20,21). The housebody floor appears to be entirely of flagstones, though most is buried by manure, but it is not known whether this survives from the seventeenth century. The present staircase, now reached from the hearth passage, is also an eighteenth or nineteenth century creation within a later stone wall, and gives independent access to the first floor, which previously would have been reached from another stair either within the housebody or the adjacent parlour. The first floor over the housebody is now also a hay loft open to the roof (22), but would have been a chamber originally (for storage or used for textile working, rather than sleeping), later being made into two rooms, one of them heated by an inserted fireplace, standing next to the inserted flue of the new ground floor fireplace (23). Overhead, the purlins in this part of the building are all of square-sawn pine.

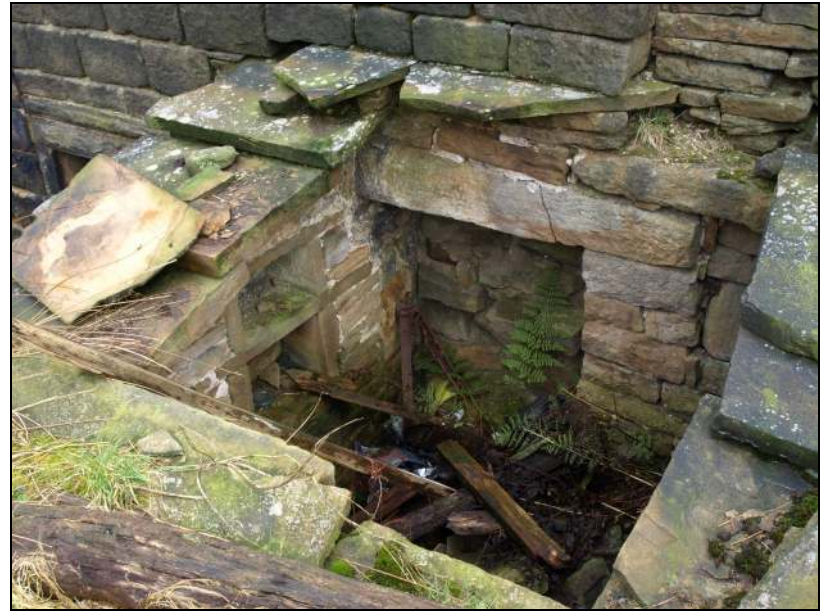
Photo 26: Lean-to pantry to rear of farmhouse, from the north

- 7.7 Another alteration to the house was the addition of the lean-to pantry at the rear, probably in the eighteenth century (26,27). This was reached through an inserted doorway, and comprises a small rectangular room with keep holes to the south-west side and window to the north-east, covered by a flagstone roof. This structure also slights the seventeenth century ground floor window noted in the paragraph above (28).

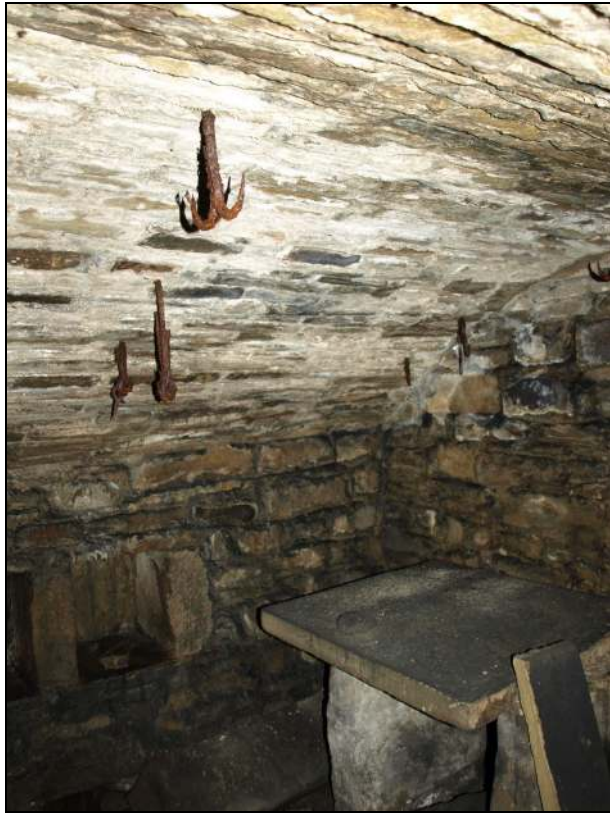
Photo 37: Cellar, below cottage, from the south

- 7.10 The barrel vaulted cellar cannot be entered safely, but can be seen to contain keep-holes in the side walls, a damaged stone bench or sconce, and running water with drain (37). Such cellars were not generally built in houses of this

social level until the mid eighteenth century, so it can be surmised that this was created during an alteration to the 1662 house, but before the late nineteenth century “modernisation” of the cottage.

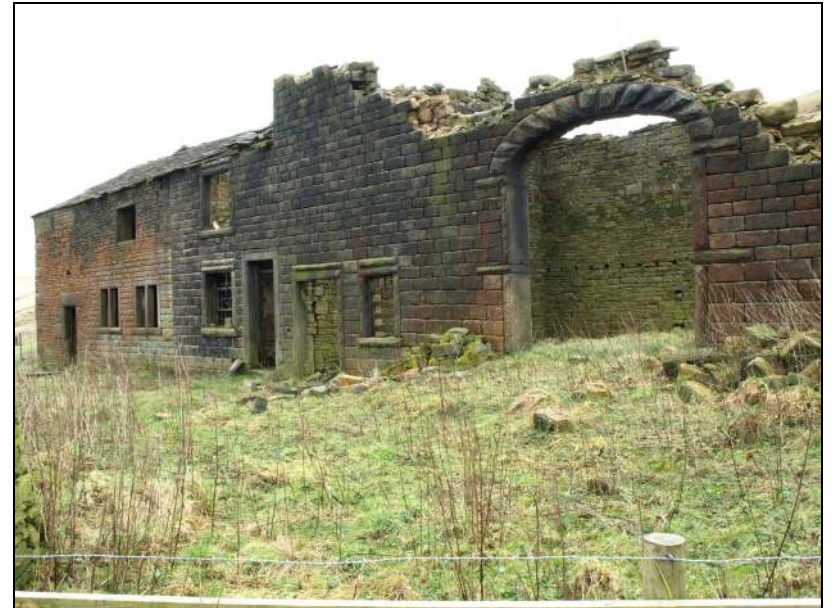
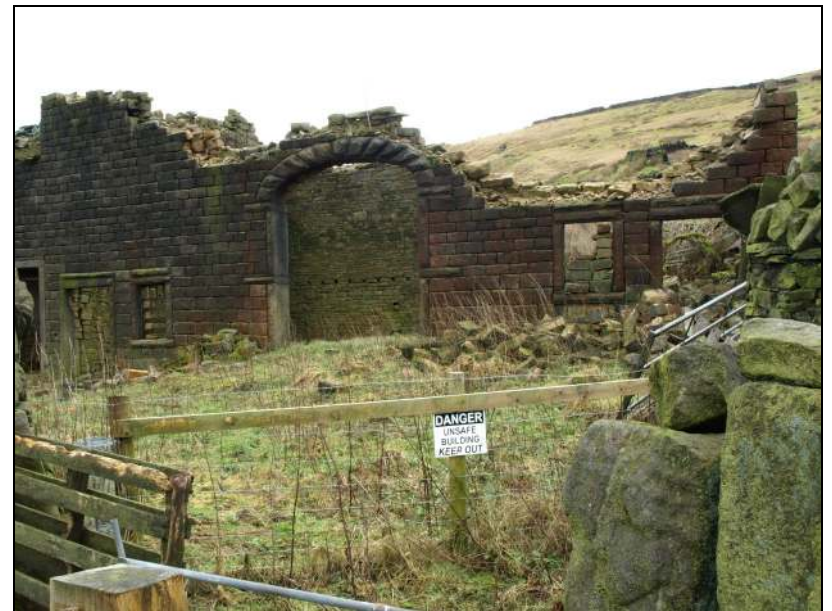
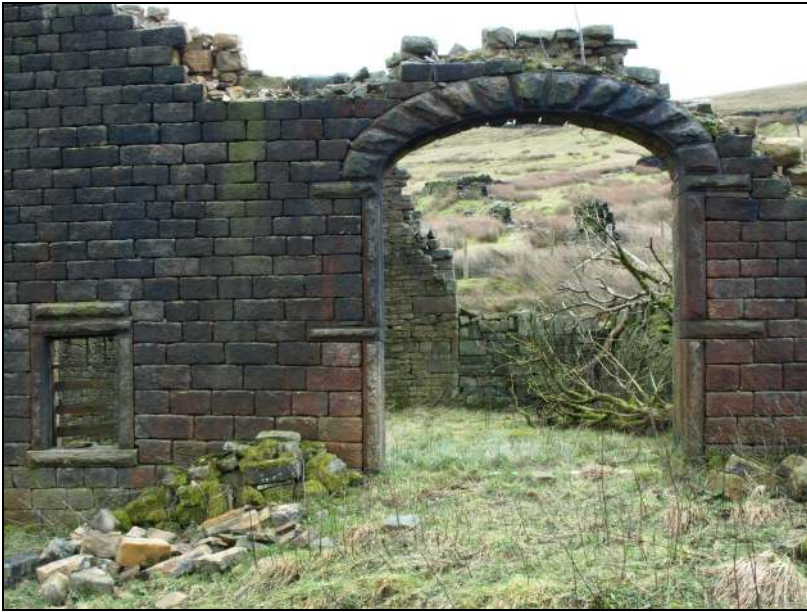
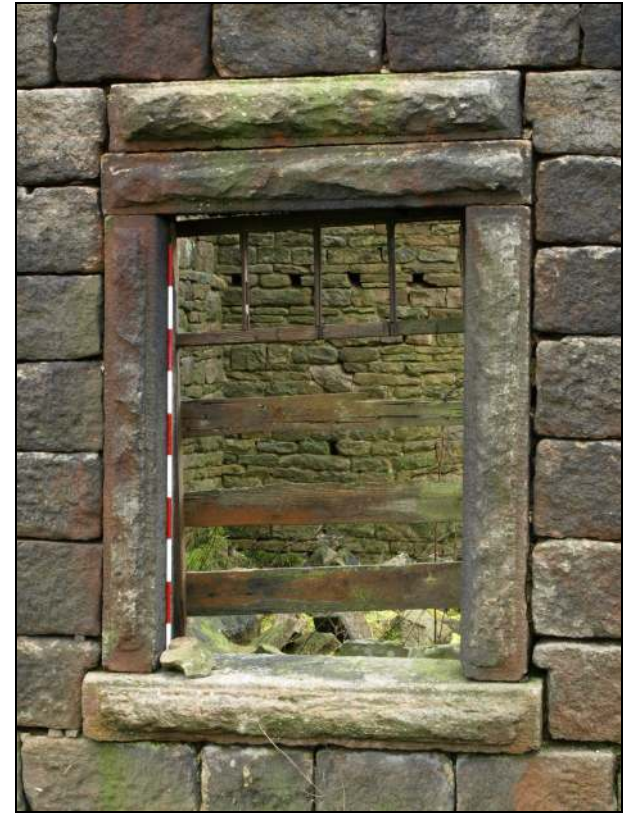
- 7.12 The barn has a wide, central doorway in the front elevation, under a low arch of rock-faced voussoirs, which leads into the central bay. To the left of this, next to the cottage, are the remains of a shippon for tied cows, with a wide doorway and large window adjacent, while to the right is third doorway and adjacent window, though here the walls are more ruinous. The south corner of the building is the least well defined and lies buried in a deep mound of stone derived from the collapsed walls, and extrapolating the surviving wall lines shows that this corner would have been set very close to the adjacent trackway running up the hillside. In the rear wall, the form of the central doorway opposing the wide entrance to the front has been lost, but it appears to have been a narrower opening, probably suitable only for walking an unhitched horse out of the barn (38-41).

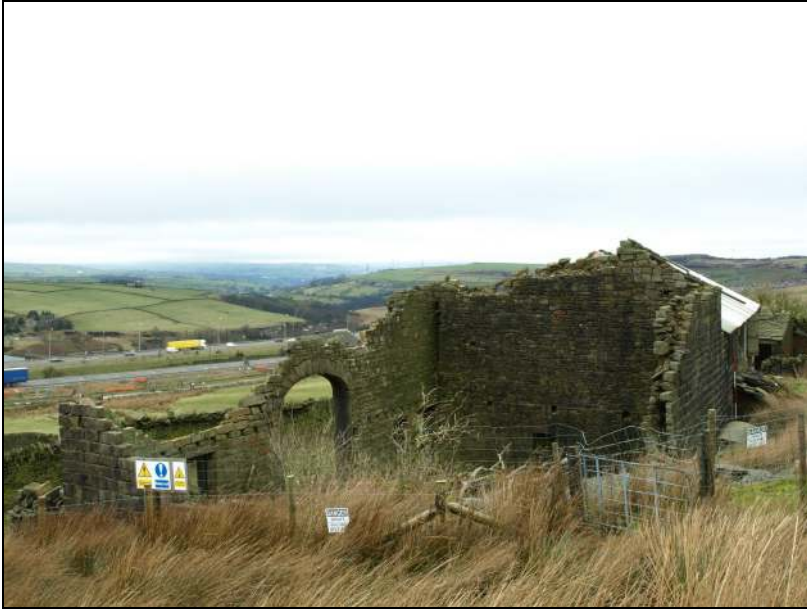
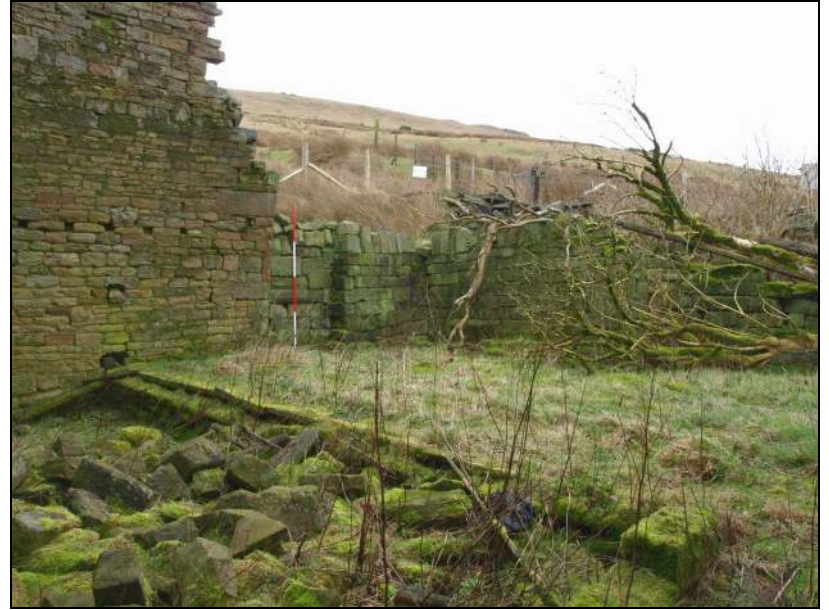
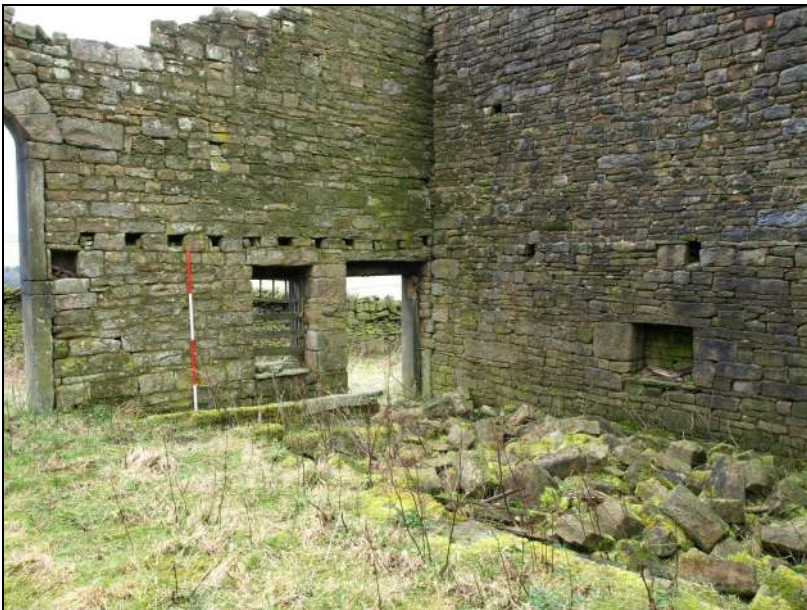
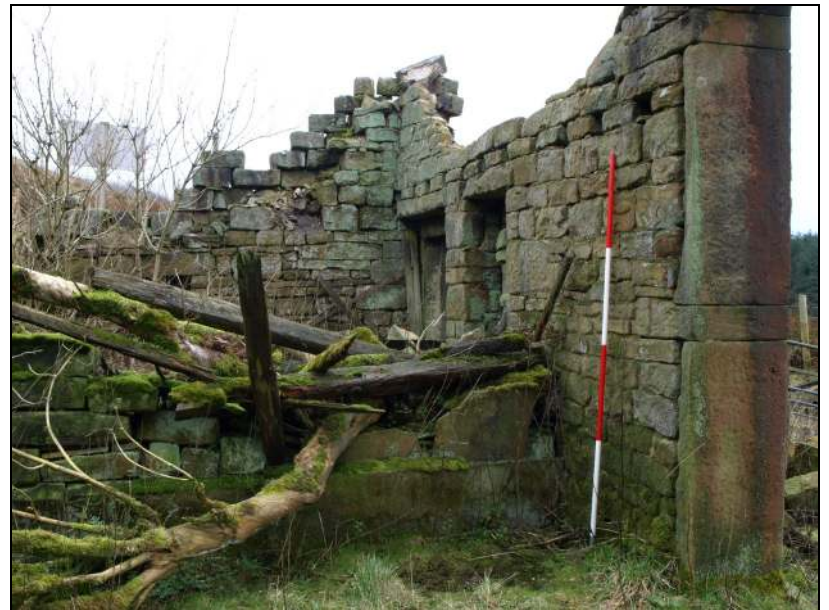
- 7.13 Internal features within the barn include the slightly sunken shippon in the north-east end, containing the remains of machine-cut brick in the low walls which define internal steps up from it, while the central bay has a flagged, though overgrown, floor. A low wall of upright flagstones, not fully visible, forms a division between this and the south-west bay, which may have been a second shippon, or perhaps a stable, but the great depth or rubble here hides any other features. The two outer bays had hay lofts, as the joist sockets in the long walls testify, and generous storage space as the barn roof was some 1.3m higher than that of the house, though only in the cross-wall between the two does it survive to near its original height (42-45).

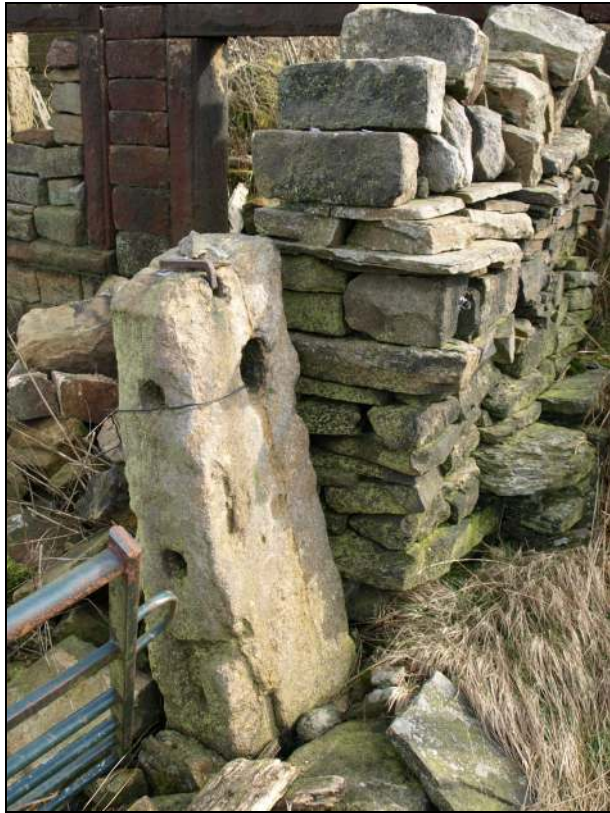
Photo 46: Early gate stoop near west corner of barn

- 7.14 Near the west corner of the barn is an early gate stoop or post, designed for a pole rather than a hinged gate, with L-shaped slots and square hole through, quite possibly seventeenth century (46).
