Trinity Methodist Church
Huddersfield Road, Mirfield, West Yorkshire:
Historic Building Record

October 2012

Historic Building Record

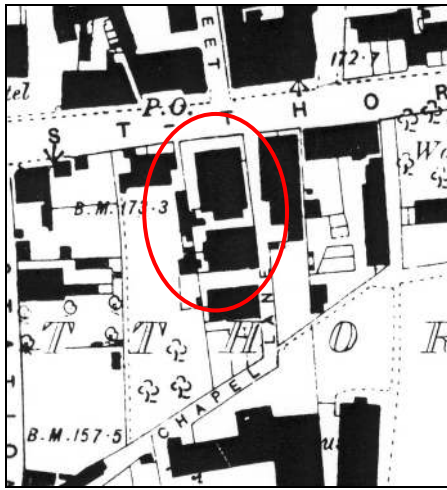
Figure 5: Ordnance Survey 1:2500 map
Published 1893 (surveyed 1888)
Sheet no: Yorkshire, 247.6

Shows the rebuilt chapel and 1861 Sunday school
