Tan House Farm  
Whitley Road, Lower Whitley, West Yorkshire:  
Historic Building Record

April 2012  
NGR: SE 22441 17995  
Historic township: Lower Whitley

### Historic Building Record

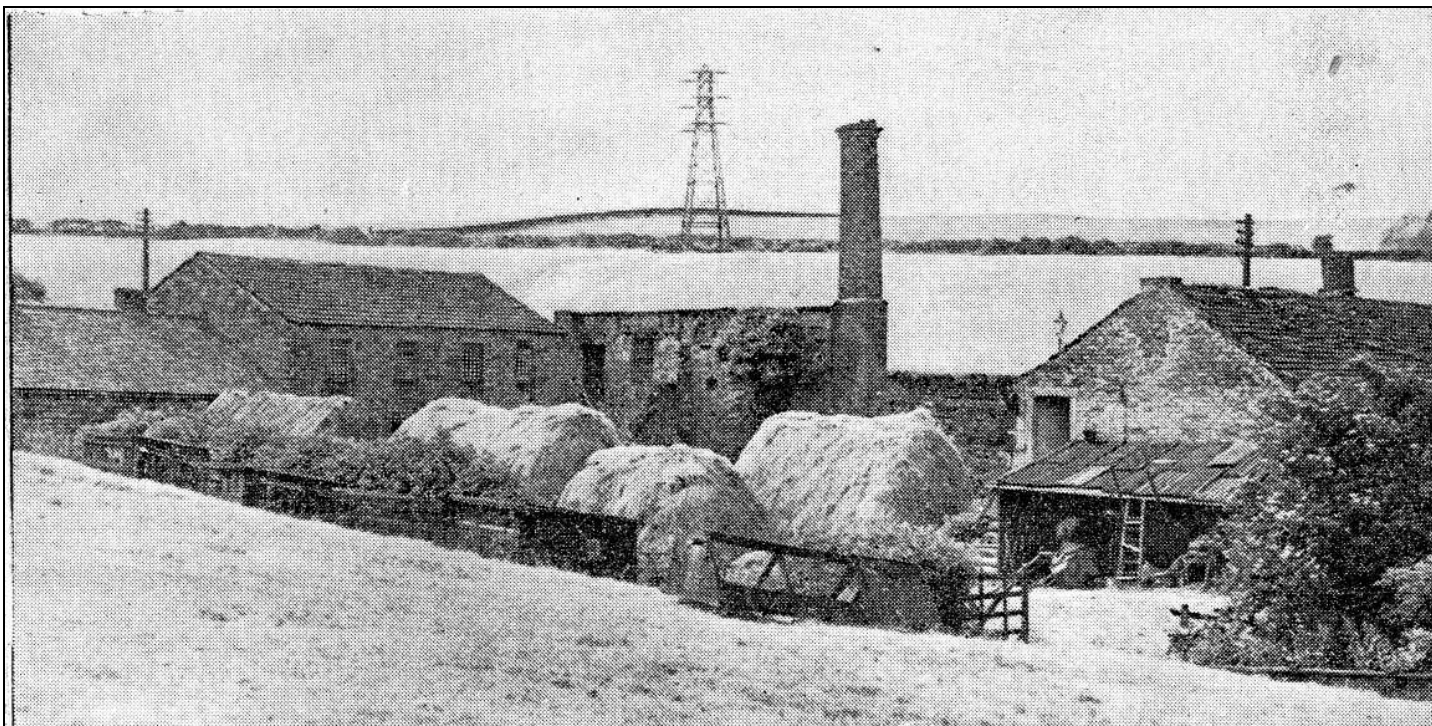
**Figure 11:** Photograph of the tannery from the south-east, 1952  
*Huddersfield Examiner* 19 July 1952

These are the buildings, now used for farm purposes, which were once a tannery. The tall, disused chimney of the tannery still stands, but it does not look out of place and seems to fit into the rural scene quite naturally. When the buildings ceased to be used as a tannery it meant the end of one of the village's few industries.

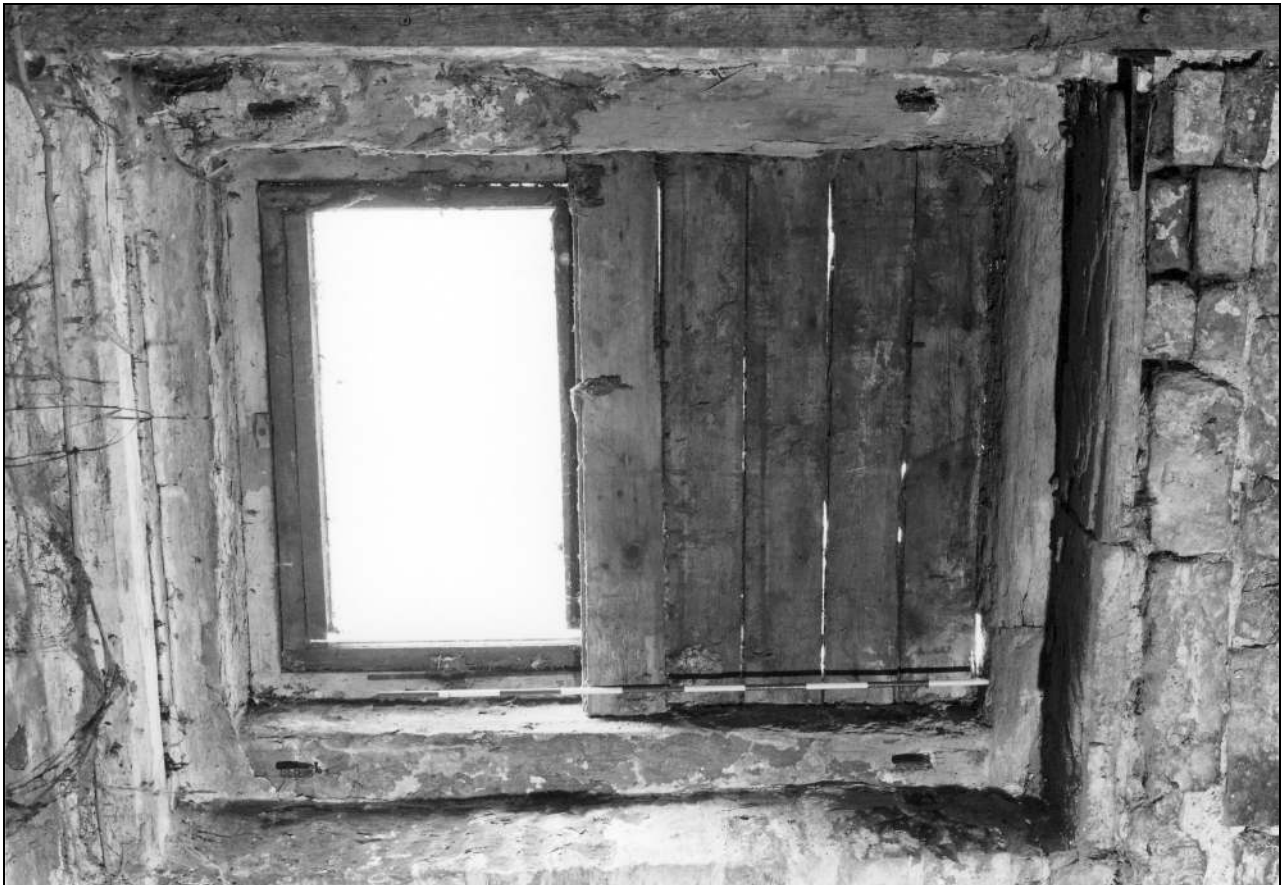
Photo 12: Building 1a: internal detail of window, showing shutter pintles (film 3, frame 11)

- 7.3 The two-storeyed warehouse has walls of coursed local sandstone without quoins, and a stone slate roof (except where replaced with concrete tiles) and stone ridge, and is four bays long, with opposing doorways in the second bay from the south, that in the east side slightly wider than the west doorway, the latter now partly blocked (**8-10**). Otherwise, the long elevations have a regular arrangement of windows to both floors, and all openings have upright, monolithic or tie-stone jambs (**11**). The front entrance has a pair of doors which might be original, but the windows fittings are all modern. Whether or not they were glazed originally is uncertain, and cannot be deduced from the 1952 photograph, but all bear pintles driven in to the inside face of the jambs, for pairs of side-hung

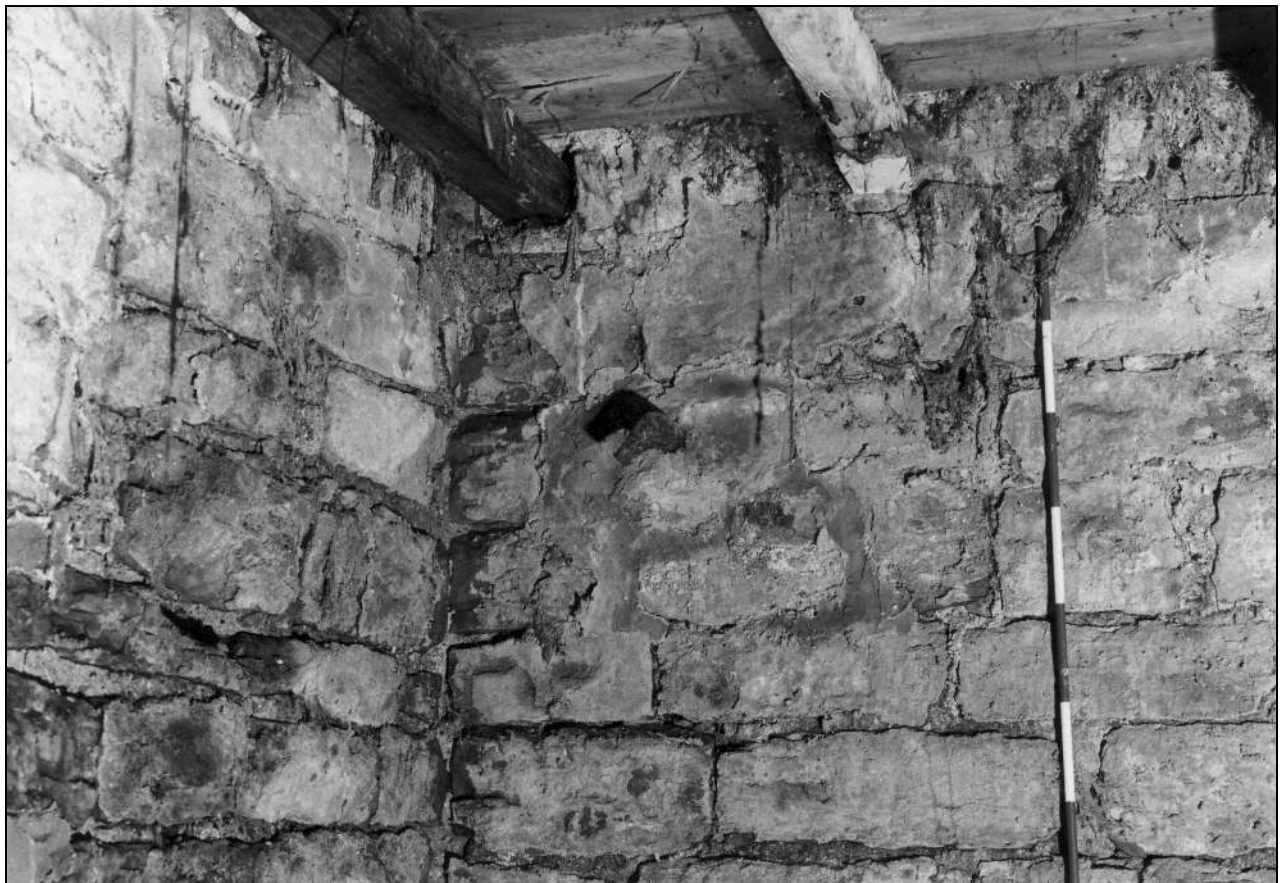
Photo 25: Building 1a: small pipe projecting into north end of ground floor (film 3, frame 10)

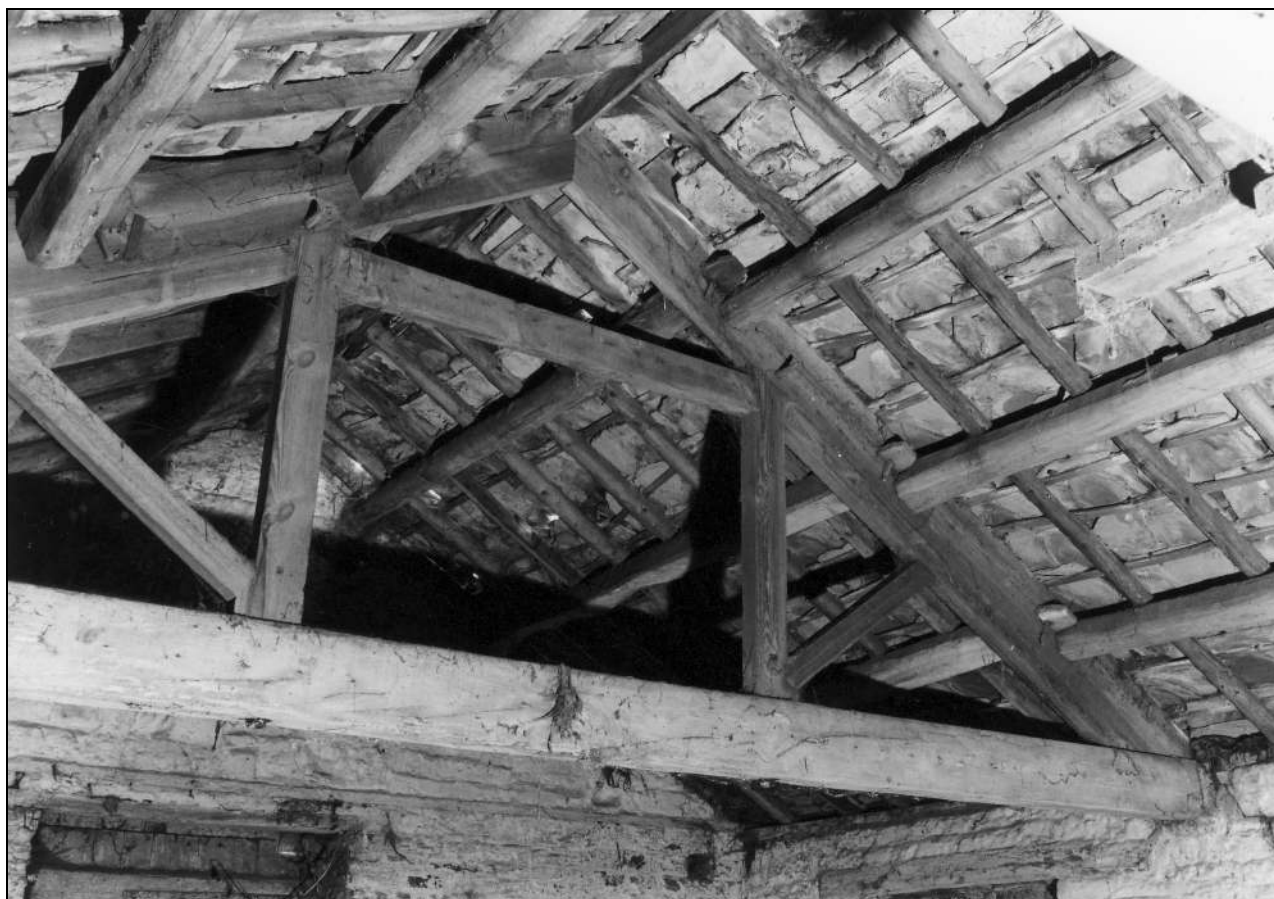
Photo 30: Building 1a: roof truss, from the south-west (film 4, frame 14)

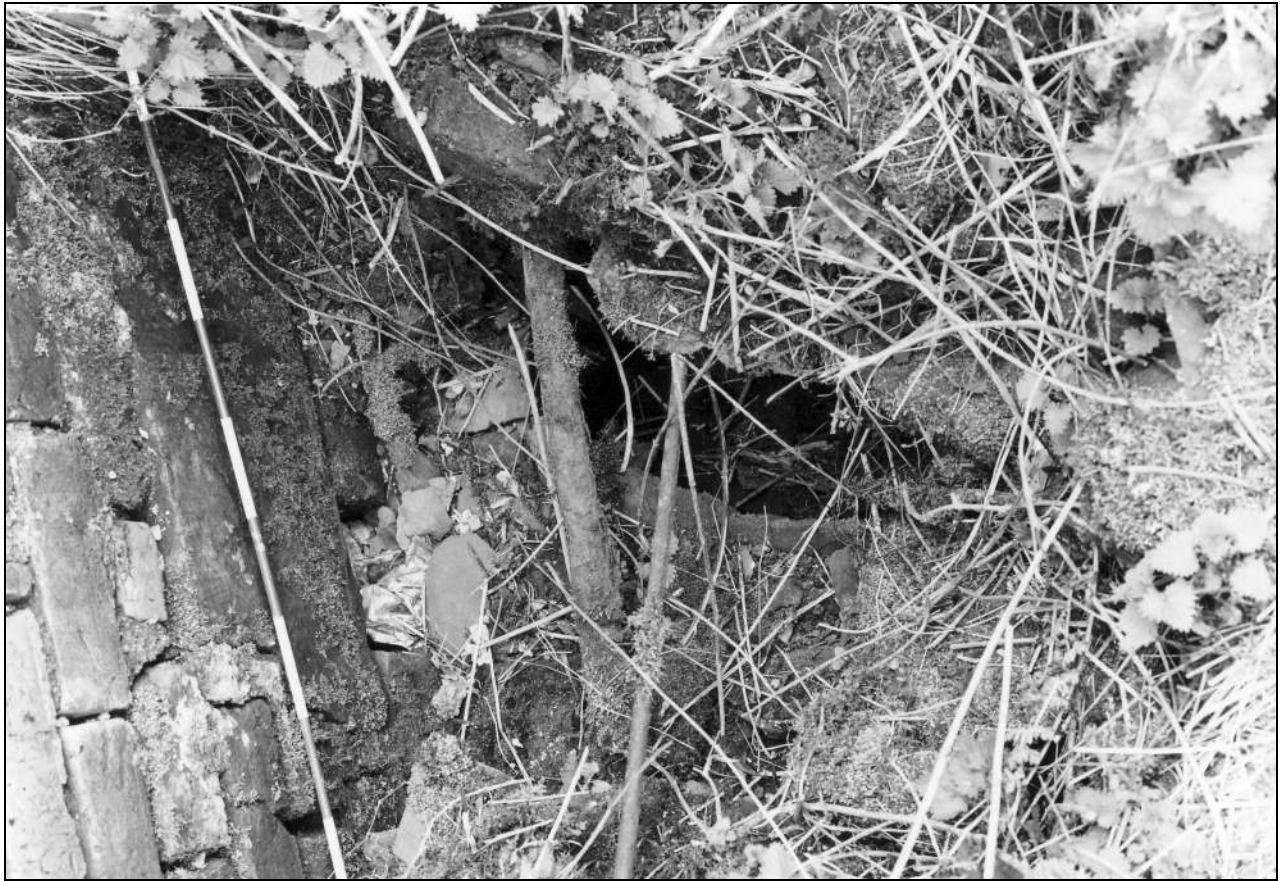
Photo 37: Cast iron water pipe running below south end of building 1b, from the west (film 4, frame 18)

- 7.16 The absence of an obvious water supply for the site has been commented on already, but in addition to the pipe noted as running beneath the south end of building 1b, a narrower bore pipe (0.1m diameter) emerges through the retaining wall south-east of the same building, and appears to have brought a supply into the yard, though it is no doubt later than the earliest, late eighteenth century phase (60).

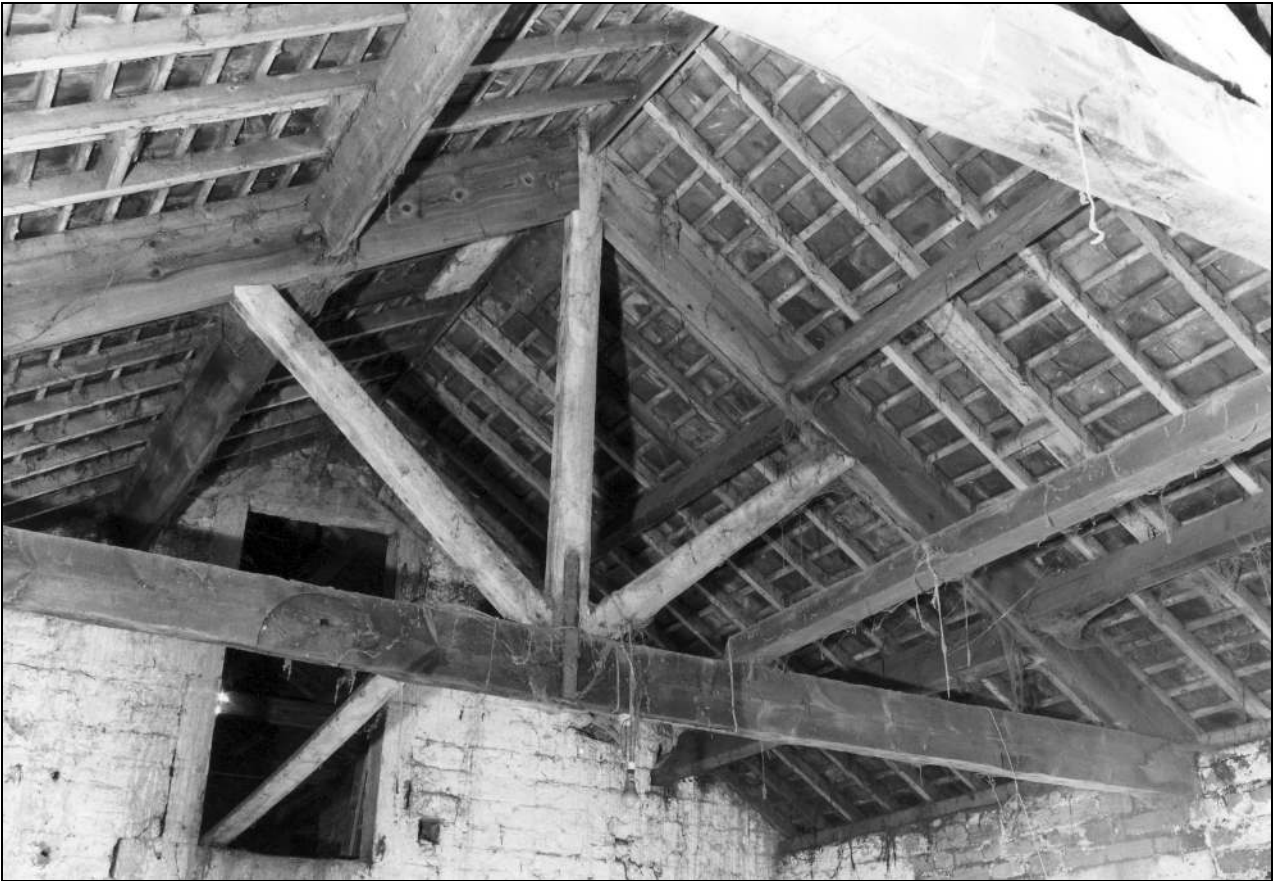
Photo 43: Building 1b: roof truss, from the south-west (film 4, frame 7)

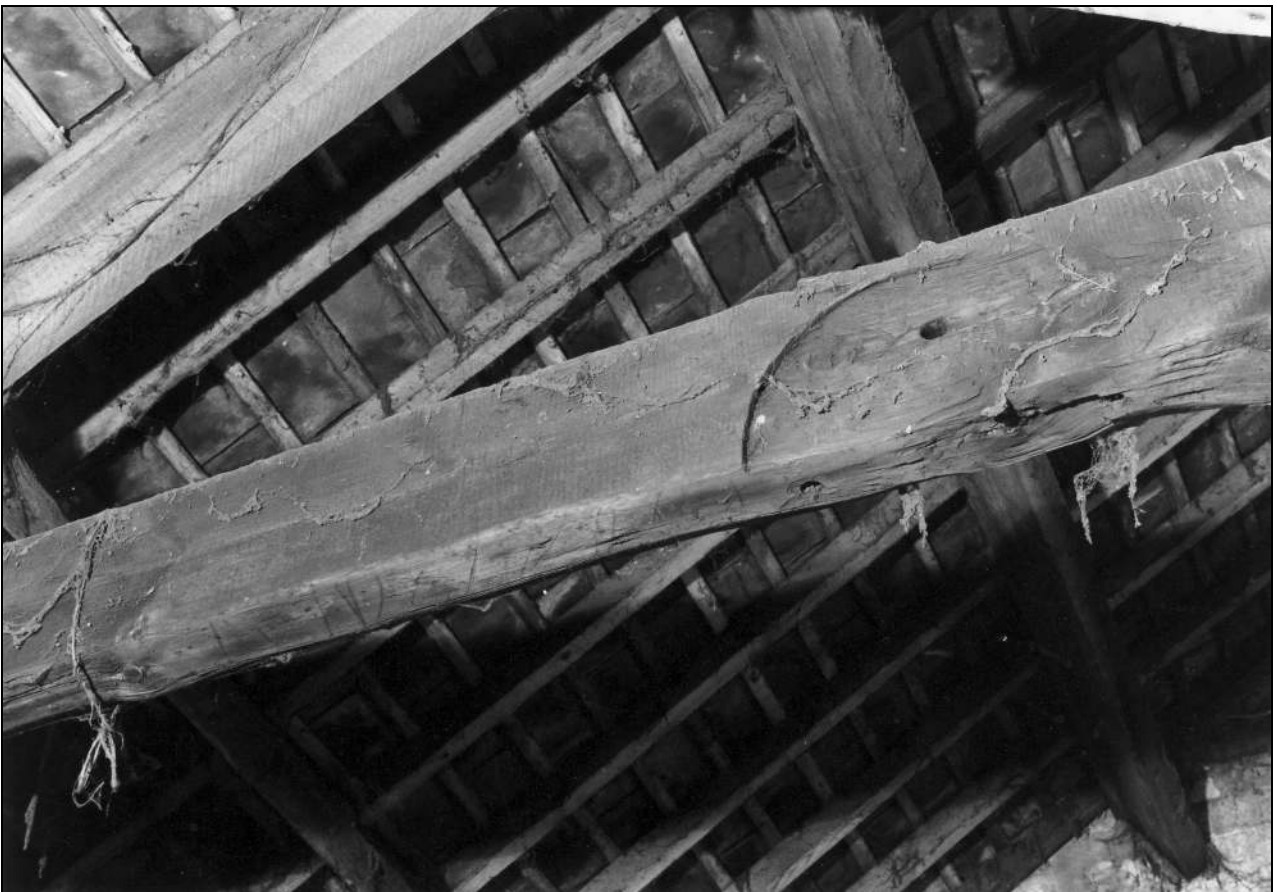
Photo 44: Building 1b: possible location of former line shaft, from the south-east (film 4, frame 8)

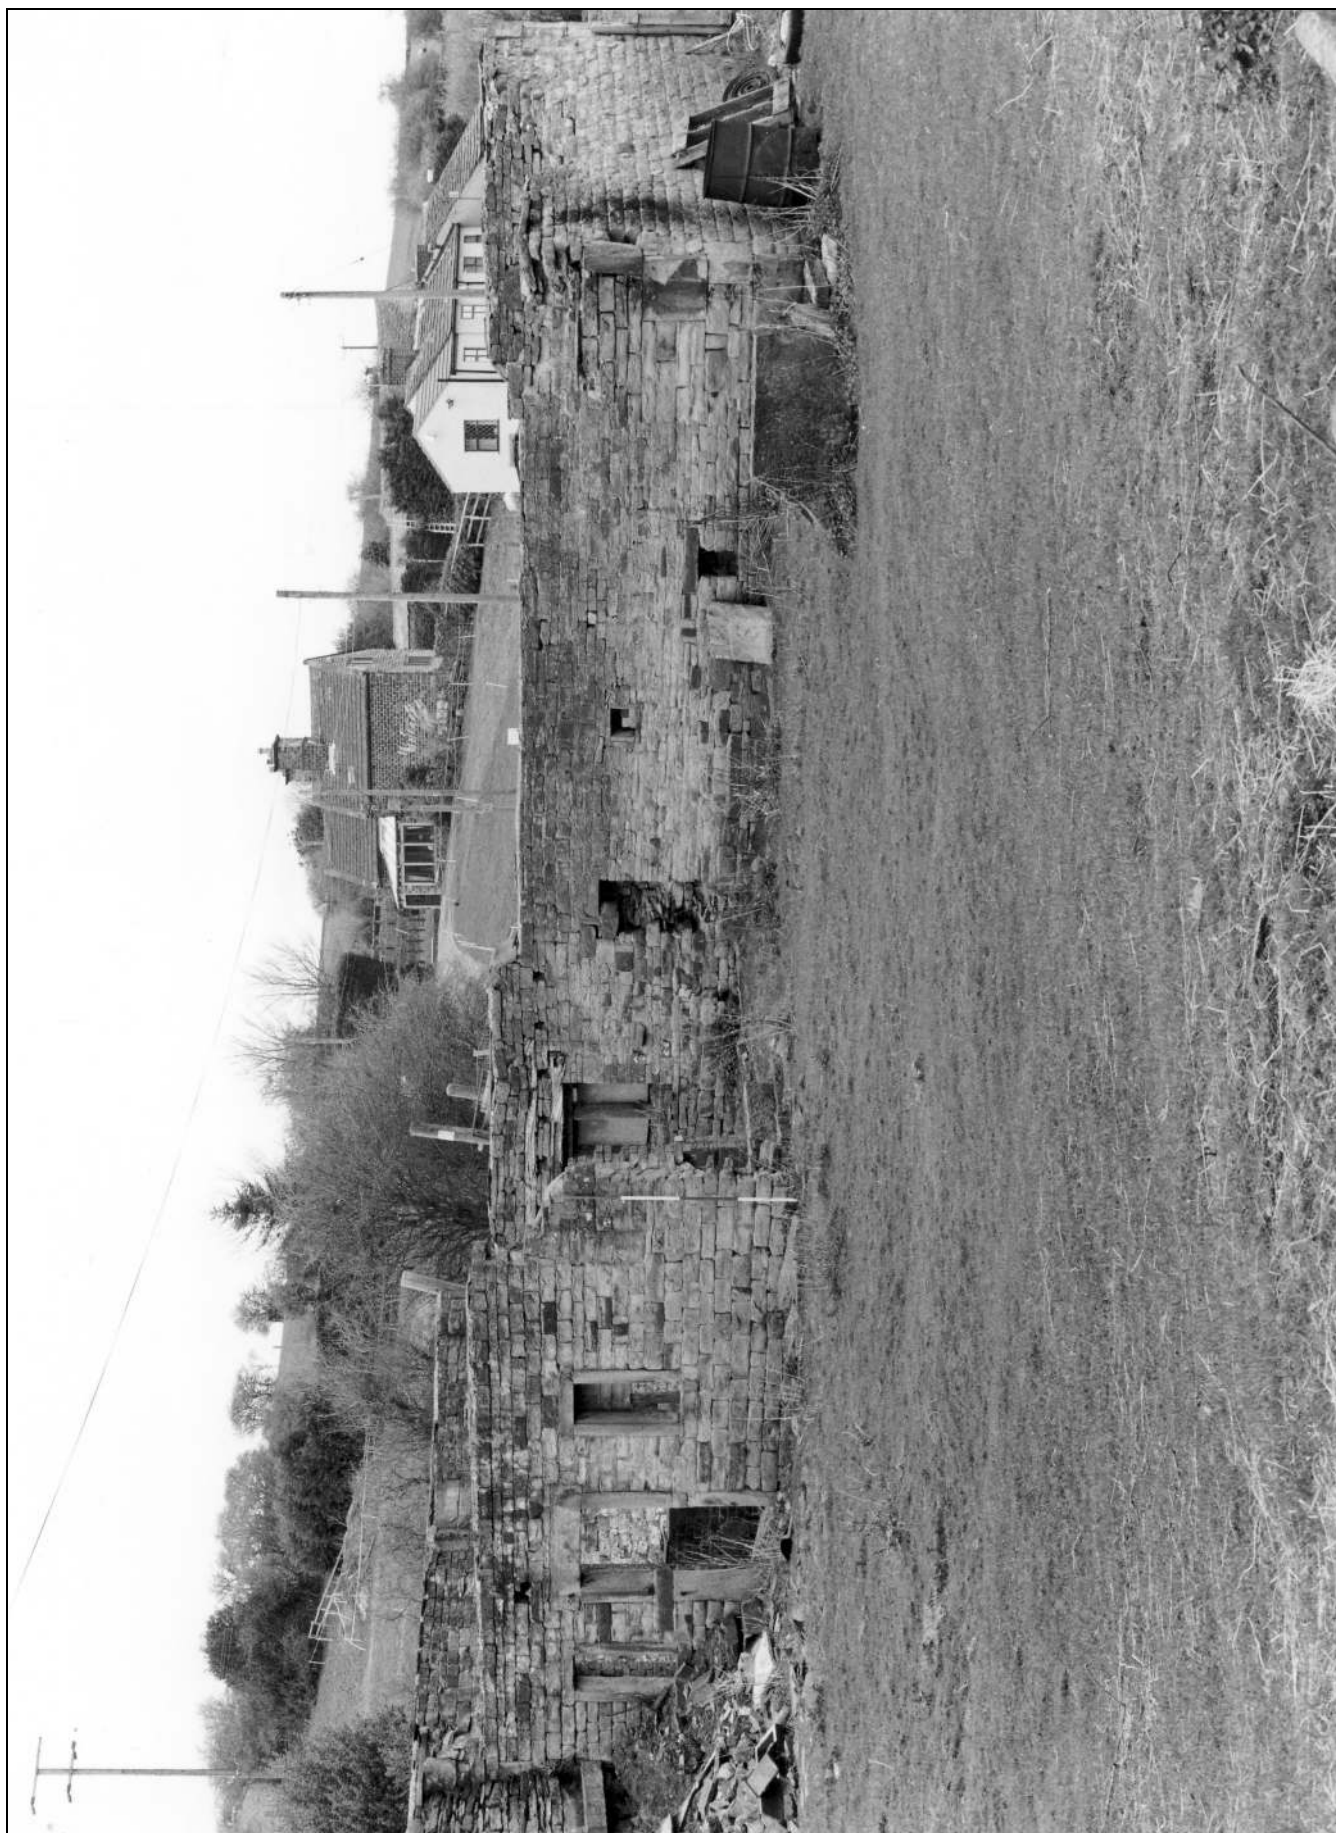
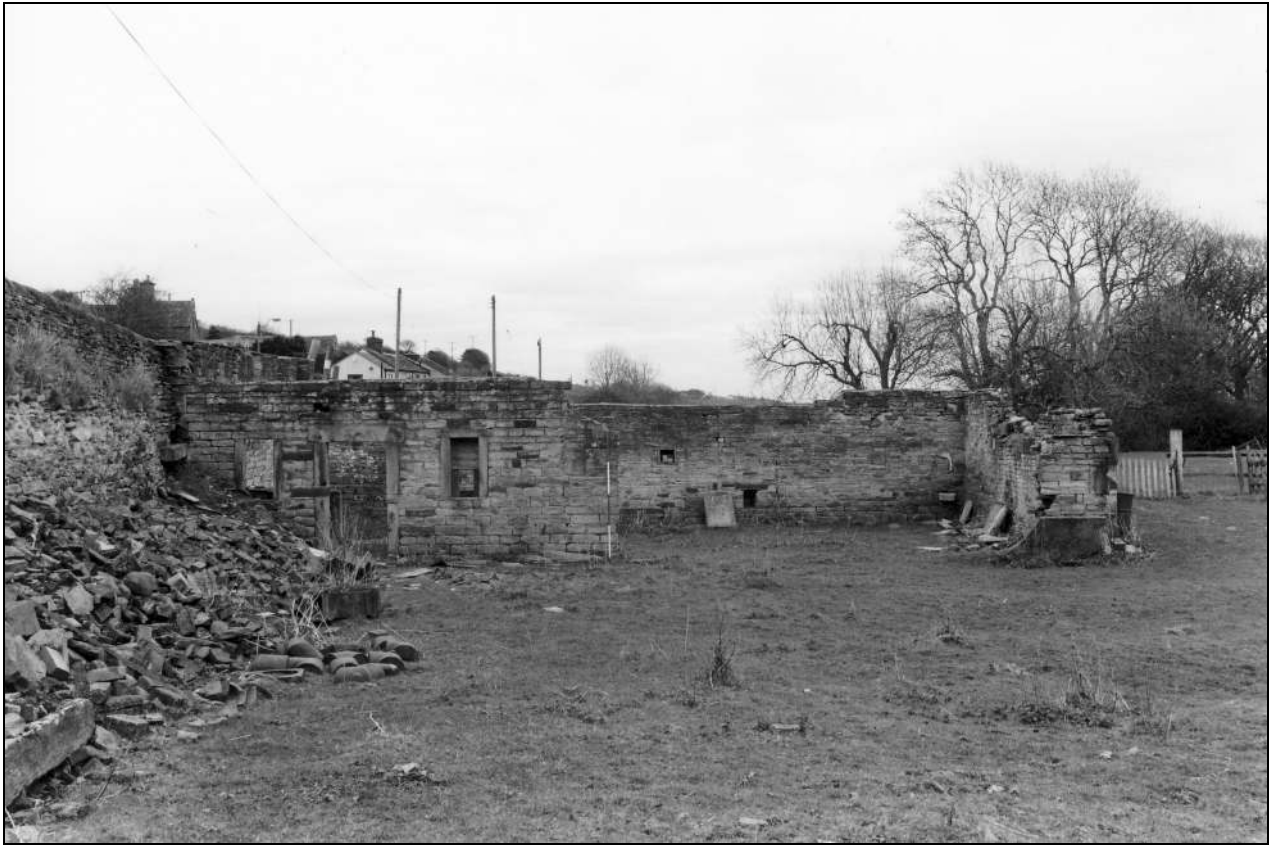
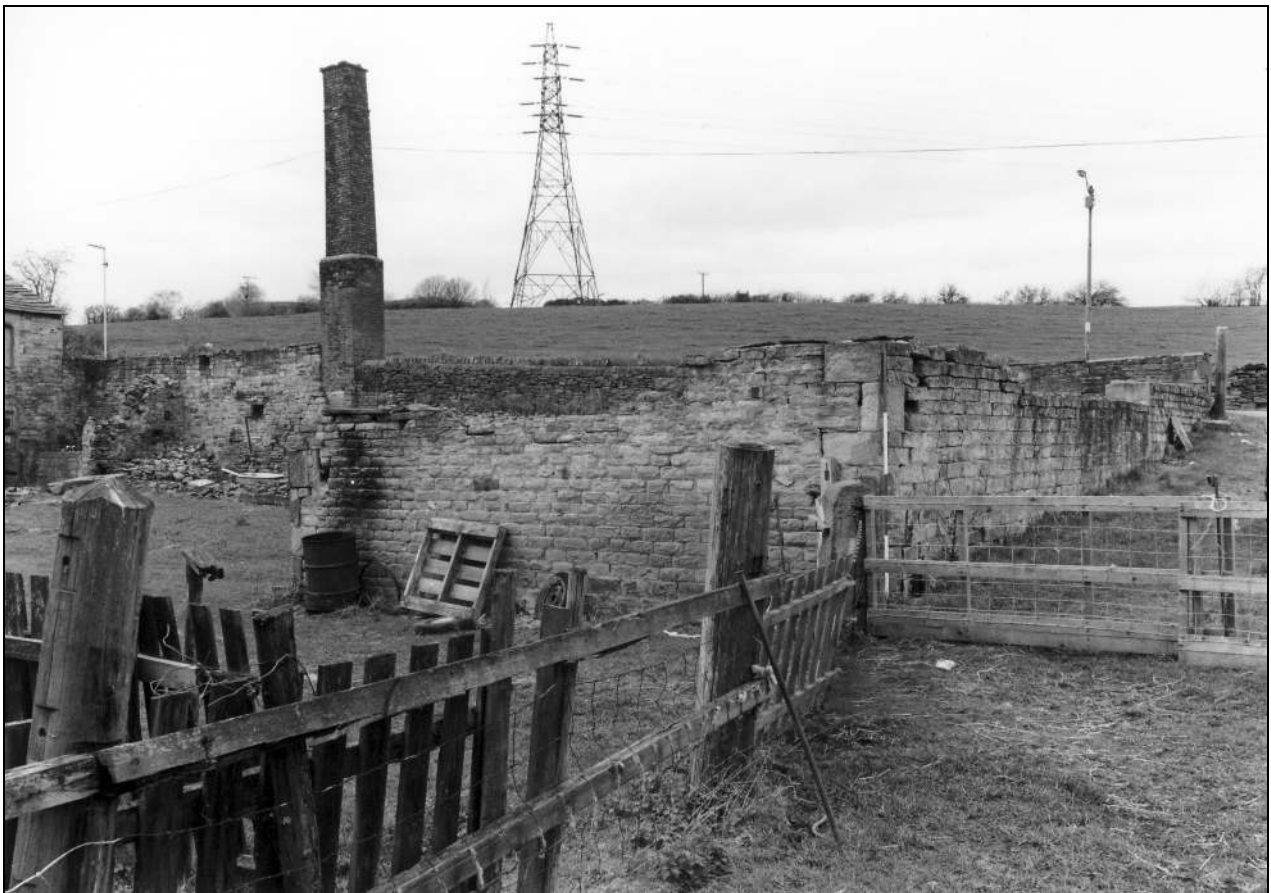
Photo 45: Building 2, from the south-west (film 2, frame 5)

Photo 46: Building 2: west elevation (film 2, frame 6)

Photo 47: Building 2, from the south-east (film 2, frame 16)

- 7.11 The fragmentary remains of the tannery's east range also include two obvious construction phases, with the northern part (2a) the earlier, likely to be broadly contemporary with the late eighteenth century building 1a, with the south end having been added at an unknown date, but certainly before the mid nineteenth century, to go by cartographic evidence. This range is shown as fully roofed and of two storey height in the 1952 photograph, but is reported to have been struck by lightning since, resulting in its largely demolished condition<sup>8</sup> (45-47).

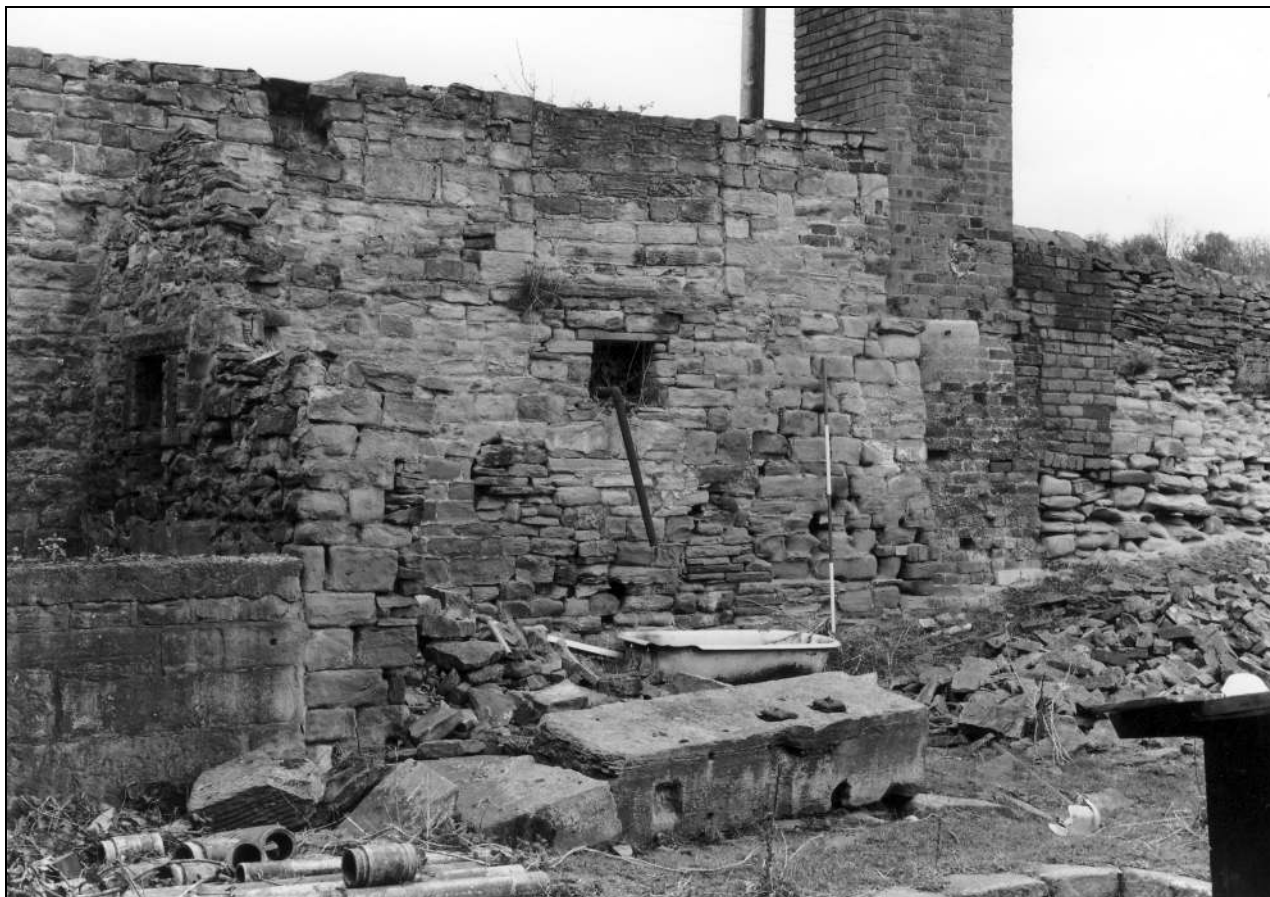
Photo 56: Remains of building (engine house?) at foot of chimney, from the south-west (film 1, frame 18)

case, the engine and boiler house would have stood to the south-west of the chimney, with the structure adjacent perhaps a fuel store. A less likely alternative, given the probable engine bed, is that coal was burned simply to provide heat for drying.

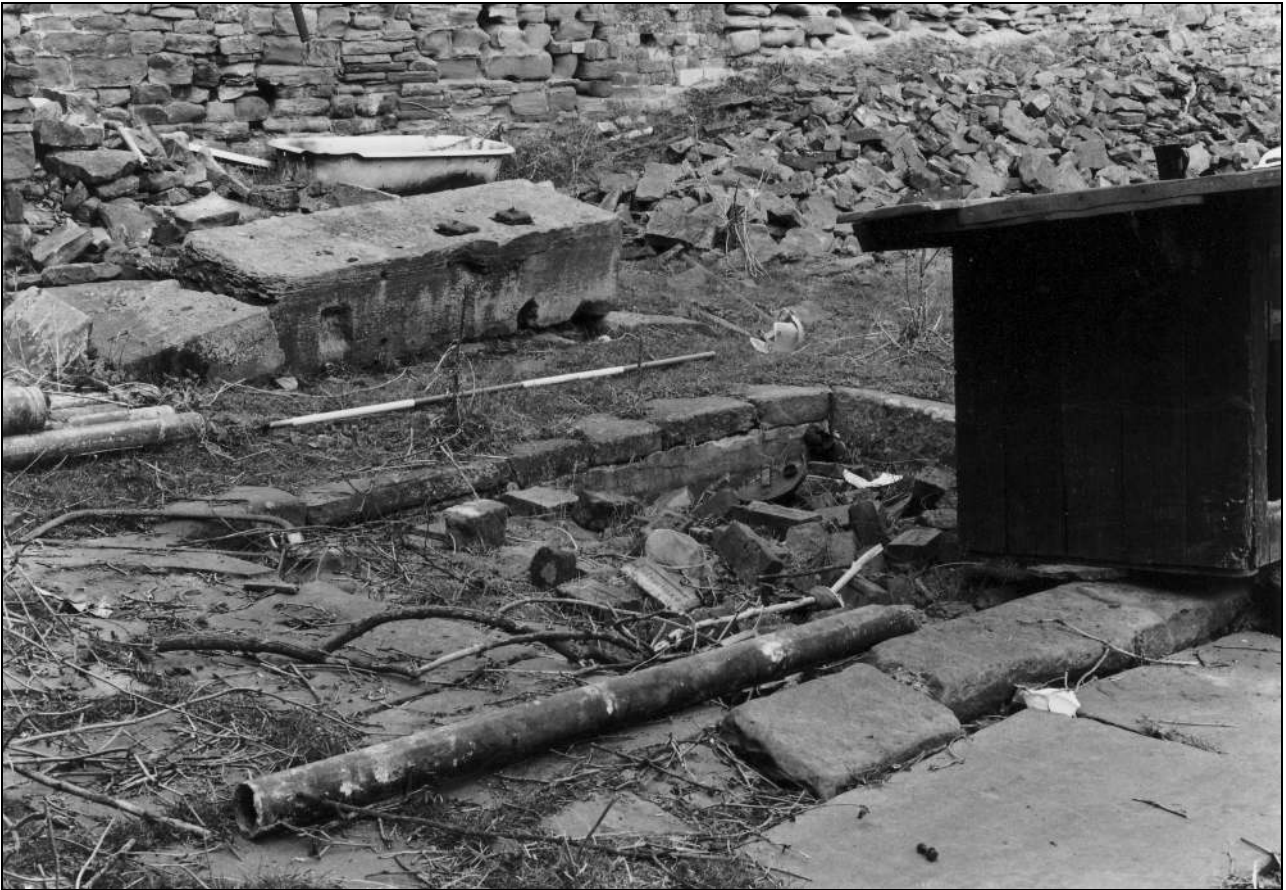
Photo 58: Infilled tanpit and possible engine bed block, from the south-west (film 2, frame 10)

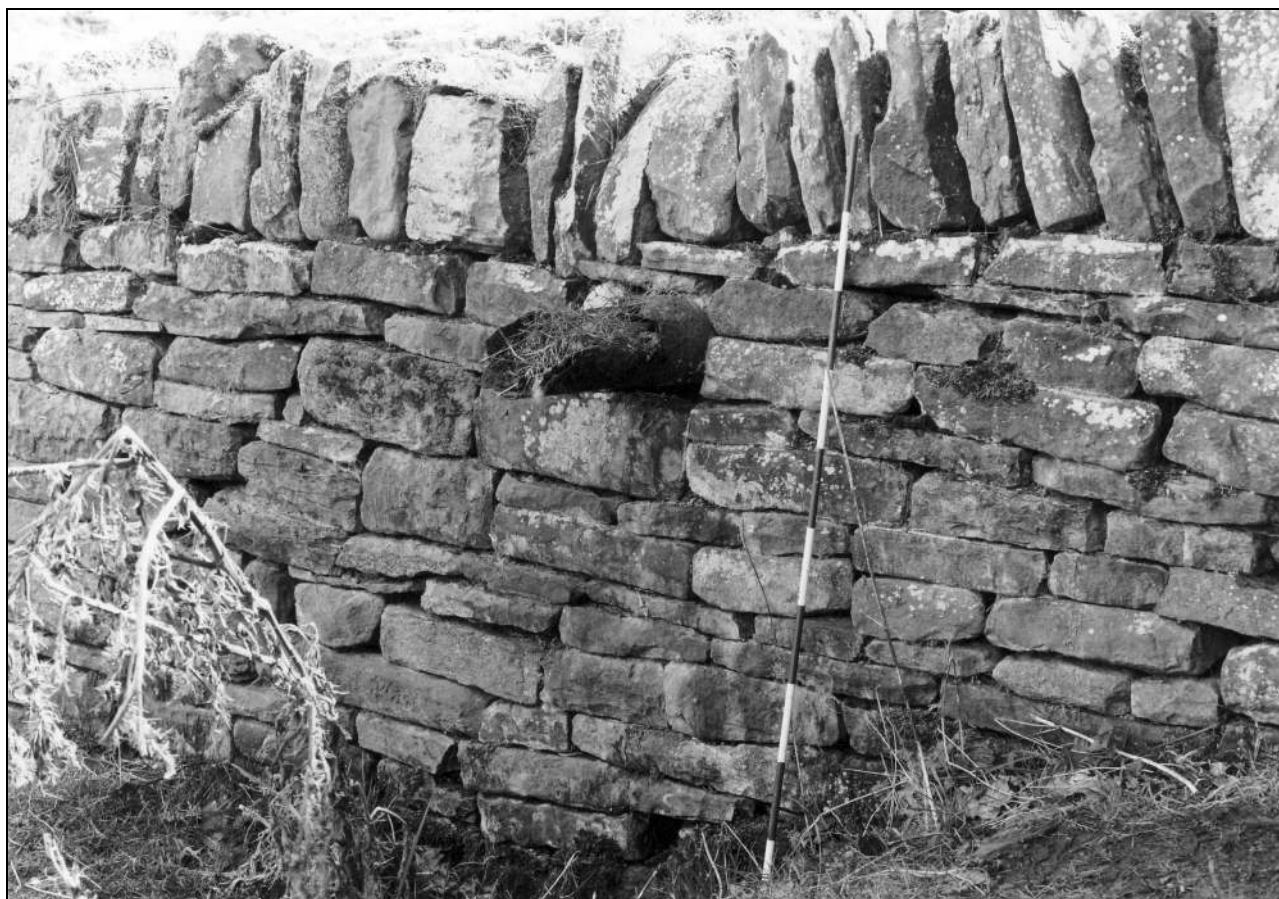
Photo 60: Cast iron water pipe emerging from south retaining wall to east of building 1b, from the north (film 4, frame 17)
