Ivy Bank Mills
Ivy Bank Lane, Haworth, West Yorkshire:
Historic Buildings Record

July 2014
NGR: SE 03410 36760
Historic township: Haworth

STEPHEN HAIGH
Buildings Archaeologist

Historic building recording, primarily photographic, was carried out for K M Norris Ltd (via their agent Prospect Archaeology Ltd) at Ivy Bank Mills, Haworth (NGR: SE 03410 36760), in order to fulfil a condition of conservation area consent for the demolition of most of the surviving buildings. The mills were established in about 1860 for steam-powered worsted spinning and weaving and operated into the late twentieth century, and the principal standing building is a three storey spinning mill, near which is a combined boiler house and warehouse, and small office block. A weaving shed and second warehouse were demolished in 2008-9.

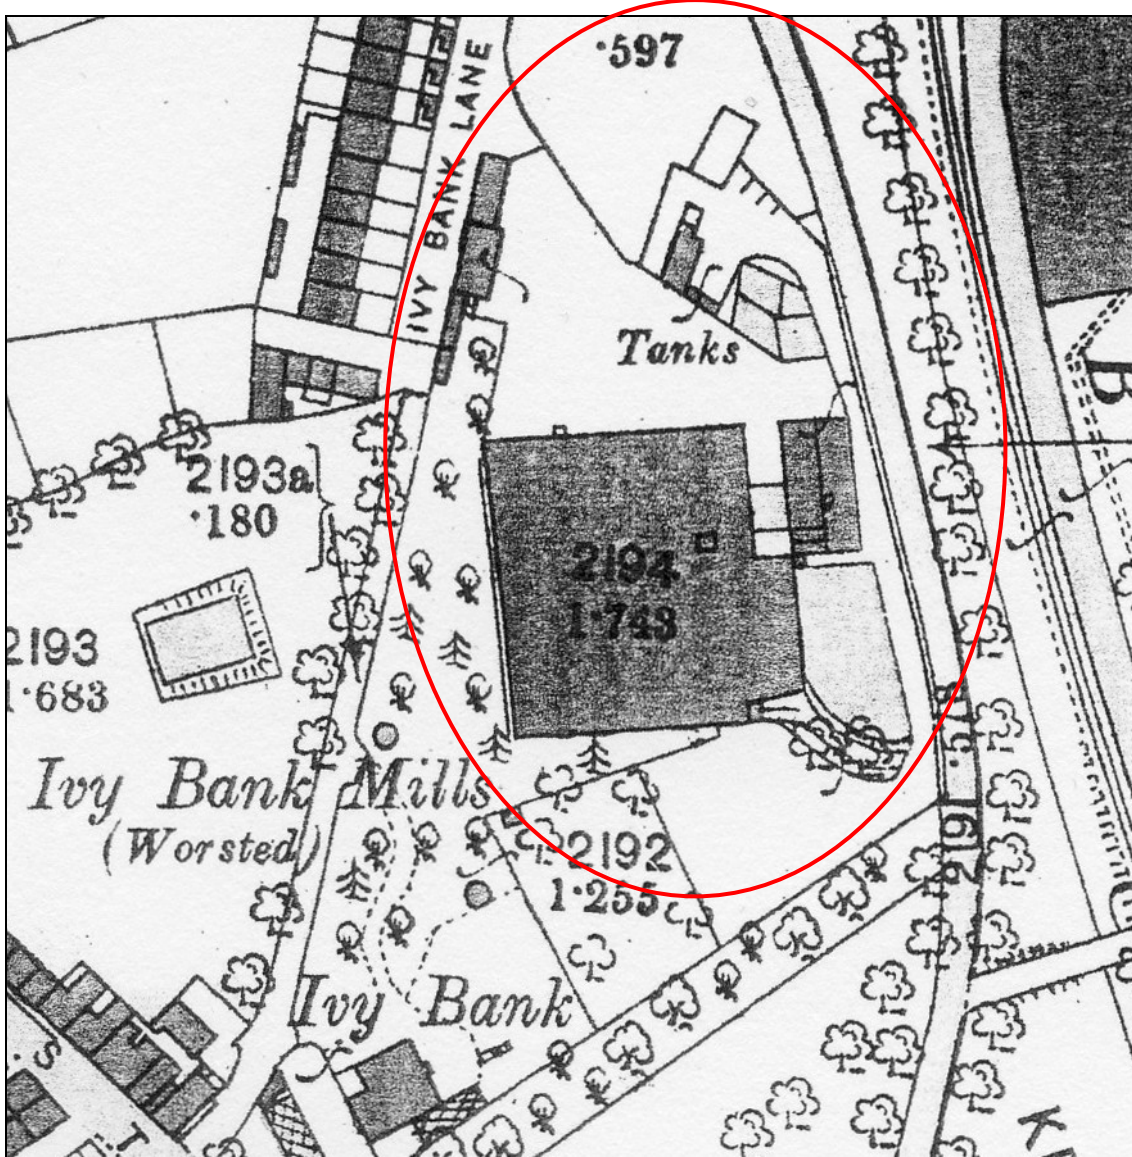
Figure 5: Ordnance Survey 1:2500 map, published 1894 (surveyed 1892)
Sheet no: Yorkshire 200.11
Enlarged to approx 1:1250

- 5.4 The arrangement of buildings at Ivy Bank Mills before depicted by the Ordnance Survey in 1894 (figure 5) is uncertain as no maps or plans are known which might show them. The three storey spinning mill and weaving shed are most likely to have been part of the original configuration, but the former has clear evidence for enlargement to its present size, and one account refers to the building as having been extended in 1885⁵. Another source reports that a warehouse was added in 1870⁶, perhaps that on the west side of the pond. The site’s first source of power is reported as having been a pair of vertical engines (see above), which were replaced in 1888 by a horizontal compound engine, housed in a new room⁷ which can be easily recognised today, although another

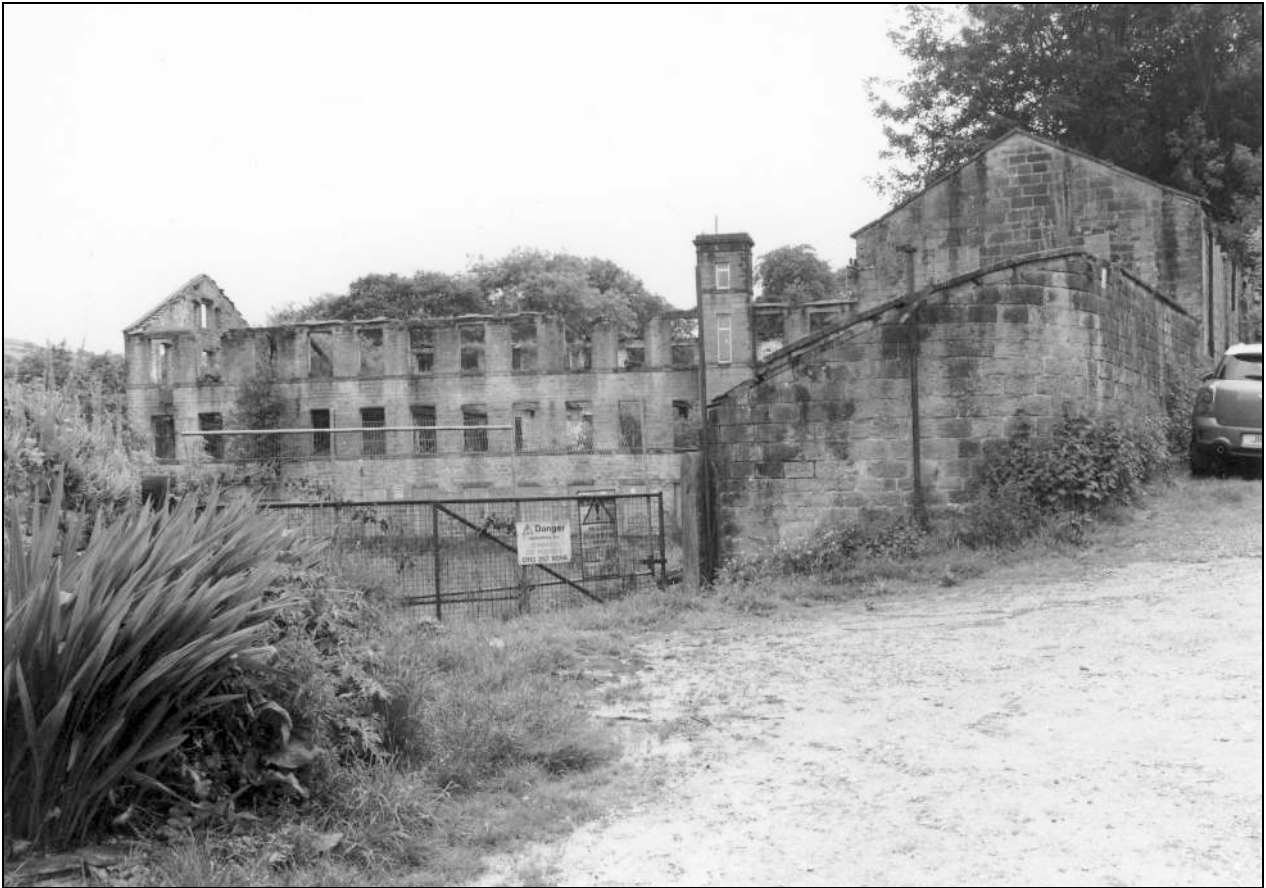
- 7.1 The dominant building at the site, the three storey spinning mill, faces north onto a large level yard, reached via the gateway off Ivy Bank Lane (**1-3**). It presents a largely uniform façade, 17 bays long with the wall being faced with coursed local sandstone, and a regular arrangement of large, plain window openings with sill bands, surmounted by paired, square eaves corbels to support guttering. The projecting lavatory tower (too narrow to have contained the stair), which occupies bay 12, rises above eaves level, where its top storey served the building's attic floor (**4**). It appears to have been added after the building was extended to the west, to judge from a straight joint and subtle change in stonework in the rear, south elevation which aligns with the centre of the tower (**5,6**). There is a second such anomaly in the rear elevation two bays to the west of here, where there is a break in the sill bands, though here the changes in the masonry are otherwise less clear-cut (**7-9**), so quite what this particular change represents is unclear. A few stone slates at the eaves are all that remains of the roof covering, but the RCHME's aerial photographs show ventilation cowls and a continuous roof light to the north of the ridge, and a relatively ornate chimney stack still surmounts the west gable (**10**). An electric hoist crudely inserted through the top floor window of the north elevation near the west end appears to be mid twentieth century (**11**).

Photo 1: General view of the entrance to the site, from Ivy Bank Lane (film 3, frame 18)

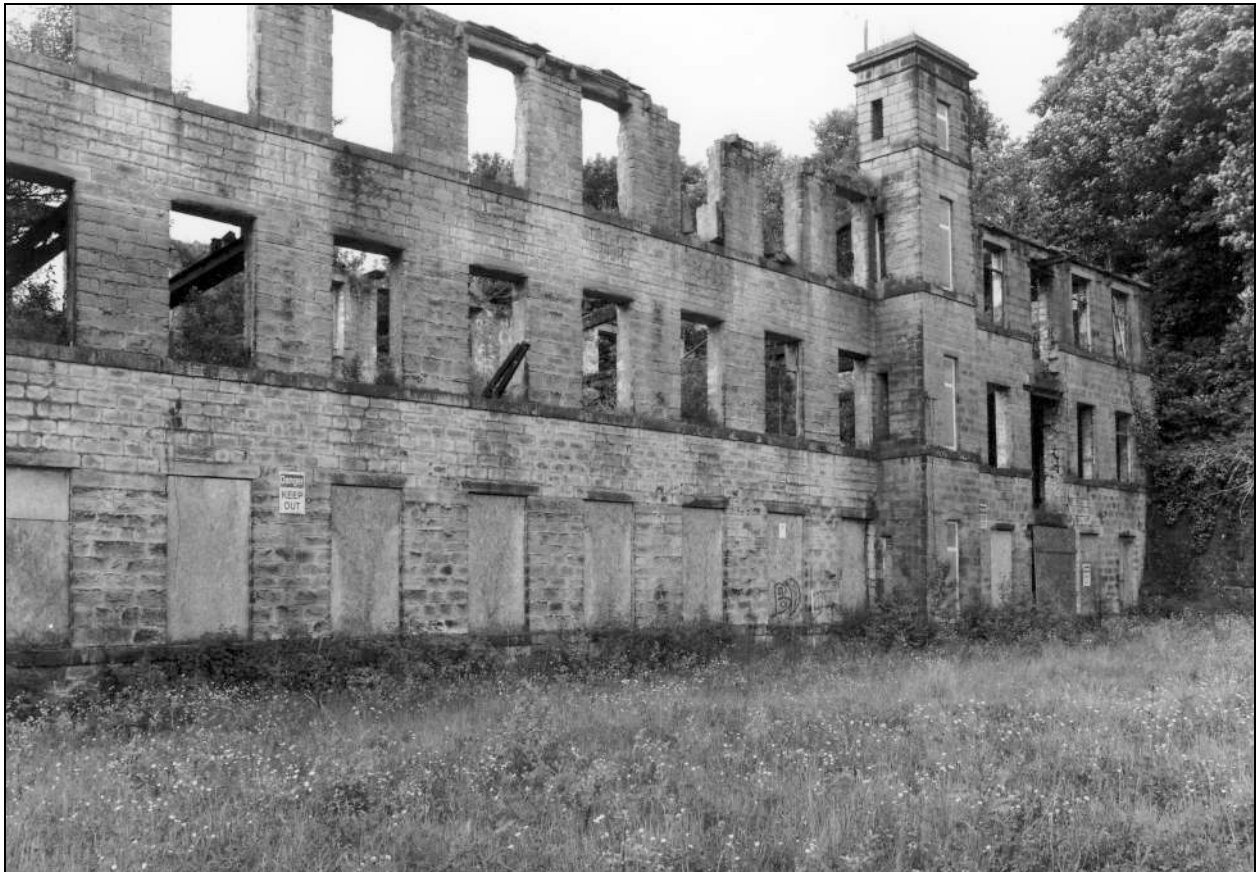
Photo 2: The spinning mill, from the north-east (film 1, frame 4)

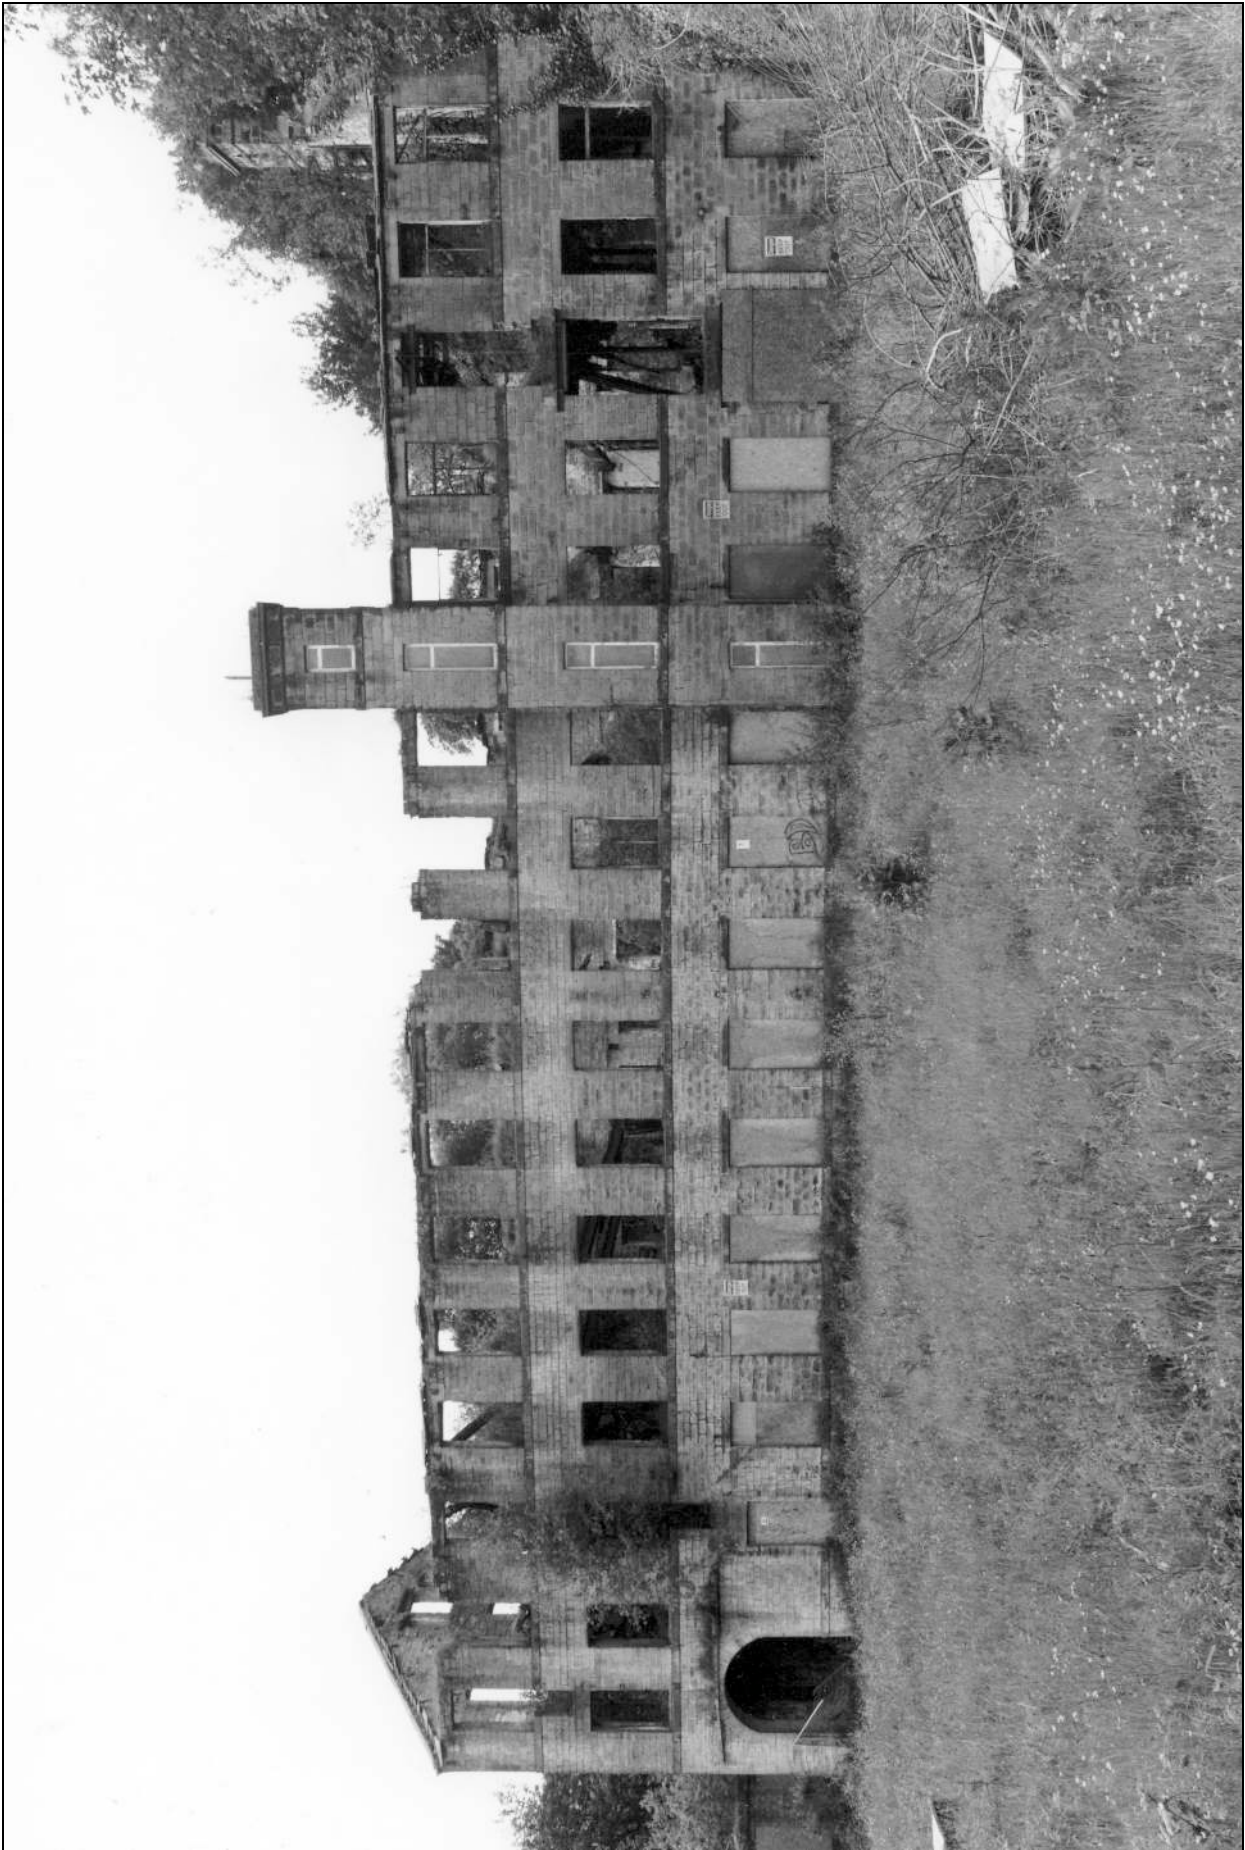
Photo 3: Spinning mill: north elevation (film 1, frame 1)

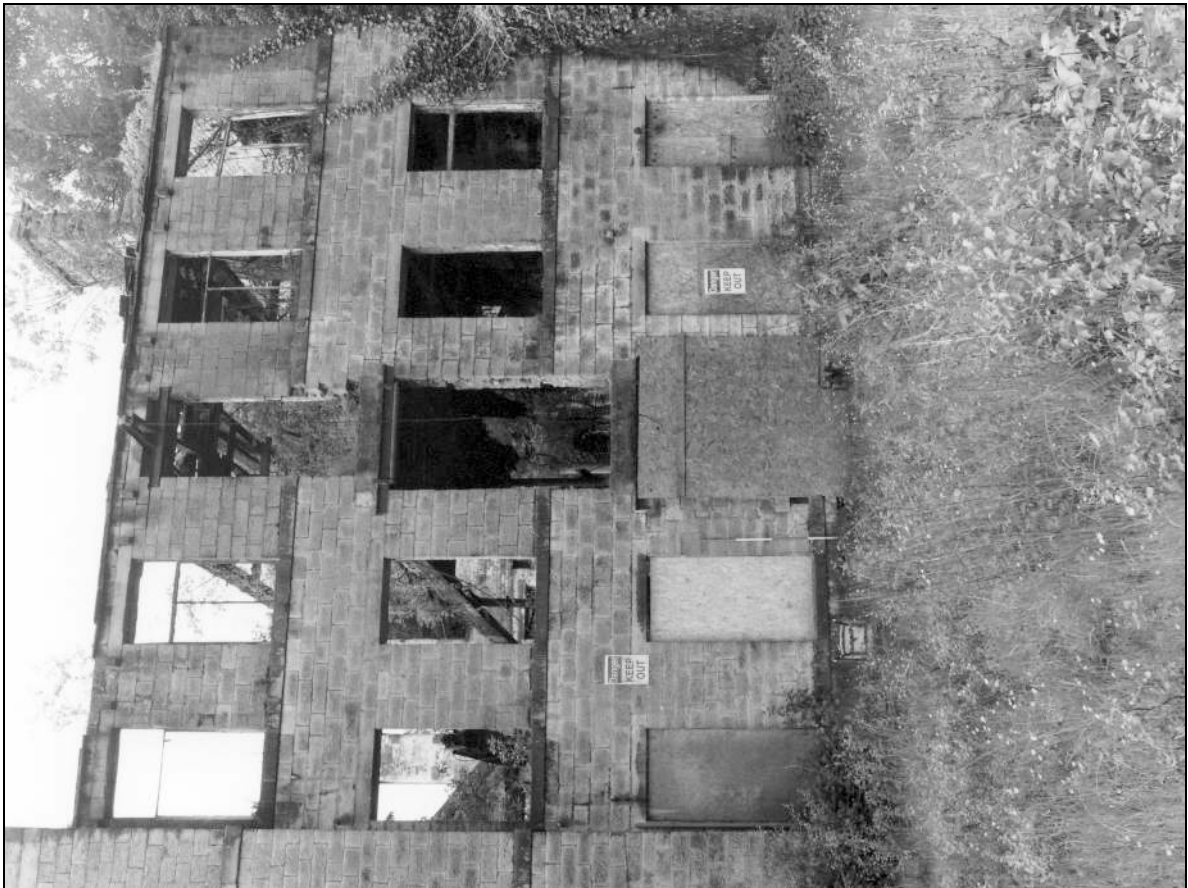
Photo 11: Spinning mill: west end of north elevation, with inserted hoist in central bay (film 1, frame 6)

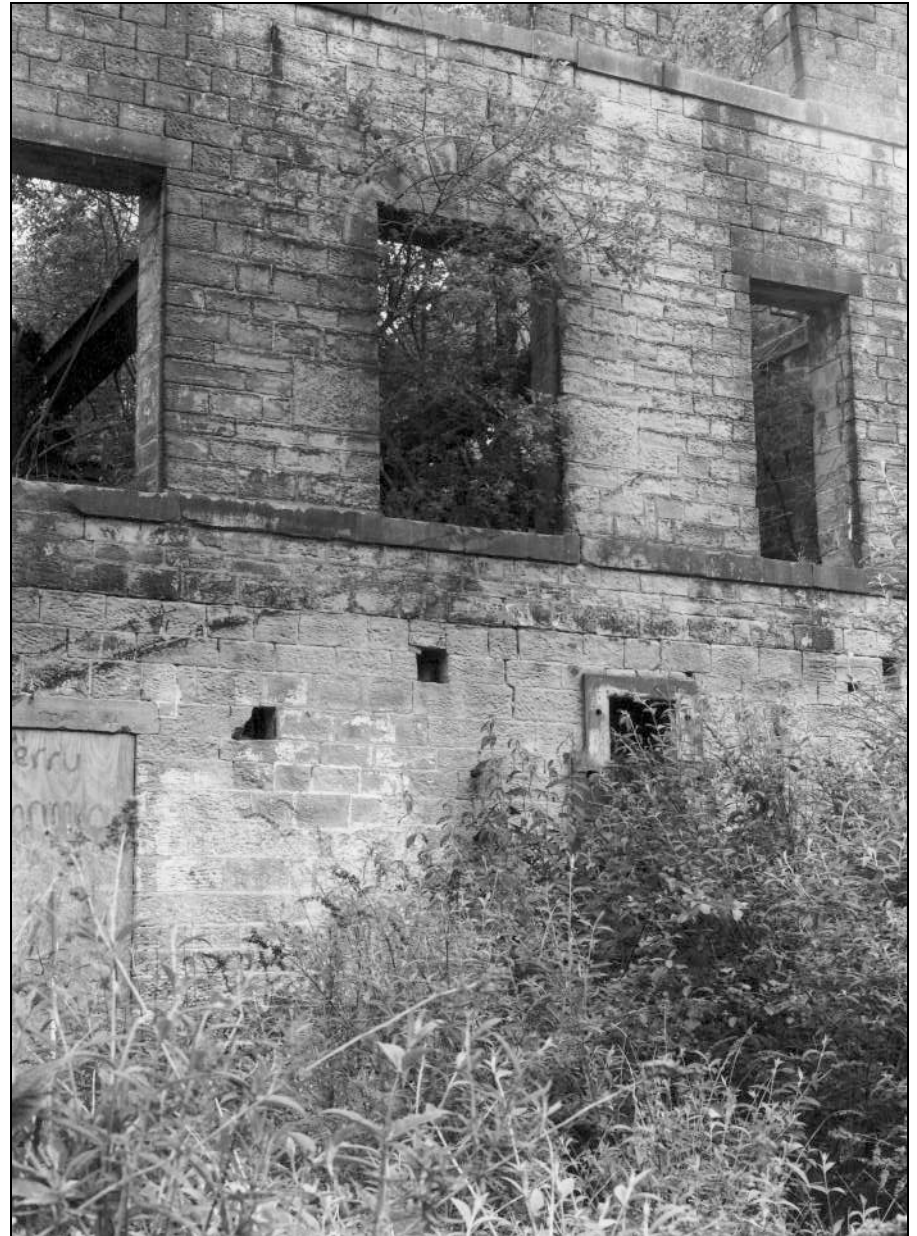
- 7.2 The east end of this building housed the engine, most recently in the ground floor of the end bay, but initially, before the installation of a horizontal engine in 1888, it was located two bays further west, to judge from the presence of a redundant round arch over a window in the south side of the building, very close to the former chimney (**12,13**); the window also has large blocks within the jambs which are unique in the building. This typical indicator of a room for a vertical engine has been slighted by its later adaptation to a rectangular opening, but a large

Photo 13: Spinning mill: window to former vertical engine room, south elevation (film 3, frame 6)

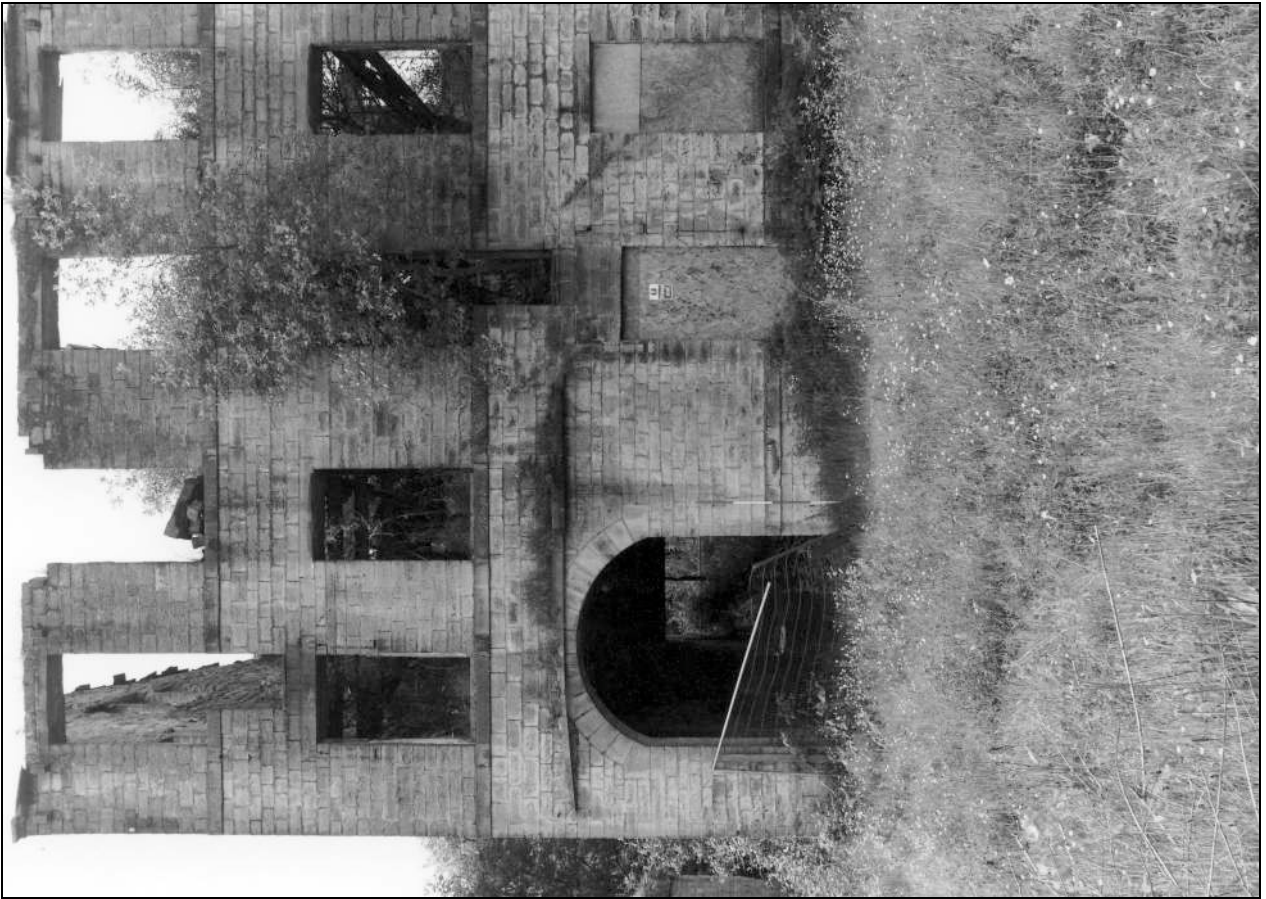
7.3 The present engine room, which was created in 1888 for a horizontal engine, is betrayed by a much larger arched opening in the north side of the building, and then either formed part of the existing mill, or was an addition to it, though there is no straight joint or other obvious sign of the building having been extended eastwards here (14). A steel lintel bridges the matching opening in the south side of the engine room, but perhaps that was also an arch at one time. Inside, remnants of the former glories of this space include a simply moulded plaster dado and matchboarding to the ceiling, and there is also a long steel rail with hoisting eyes attached just below the ceiling, but the floor is later concrete and gives no indication of the engine's arrangement (15,16). However, a number of bearings and other openings in the east gable show something of the power transmission arrangements, though it is difficult to determine whether these relate to the original or a second horizontal engine though to have been installed in the 1900s, a picture made more complicated by the fact that there was formerly a canopy linking the east end of the building with the nearby boiler house (17). The bearings include a large wall box at ground level, over 1m² in size (18,19), above which a former upright shaft can be inferred from the presence of a trap door in the adjacent ceiling, and paired bolts for a transom bracket higher up in the wall. In addition there is a smaller bearing just below the first floor windows (20), and a hatch with remains of an opening shutter, below the second floor windows, which to judge from the oil staining below it, gave access to a shaft for maintenance (21). Paired bolts and a fallen horizontal iron transom bracket within the second floor window suggest there was another vertical shaft up the centre line of the gable inside the mill, to transmit power to the upper floors, not on the same alignment as the very large bearing at ground level, so perhaps of a different phase and relating to a different engine.

Photo 14: Spinning mill: east end of north elevation, with arch to horizontal engine room (film 1, frame 3)

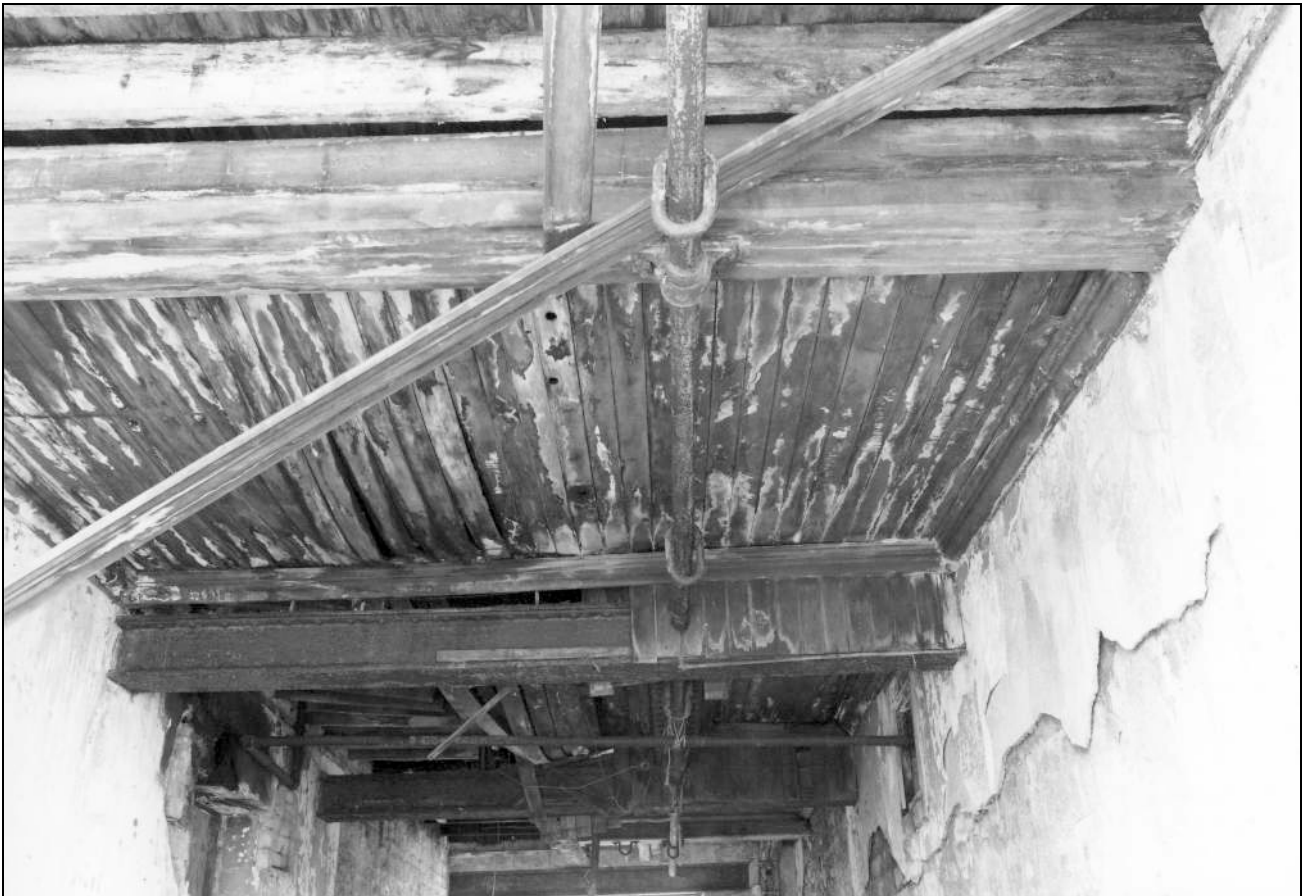
Photo 15: Ceiling over horizontal engine room, from the north (film 1, frame 17)

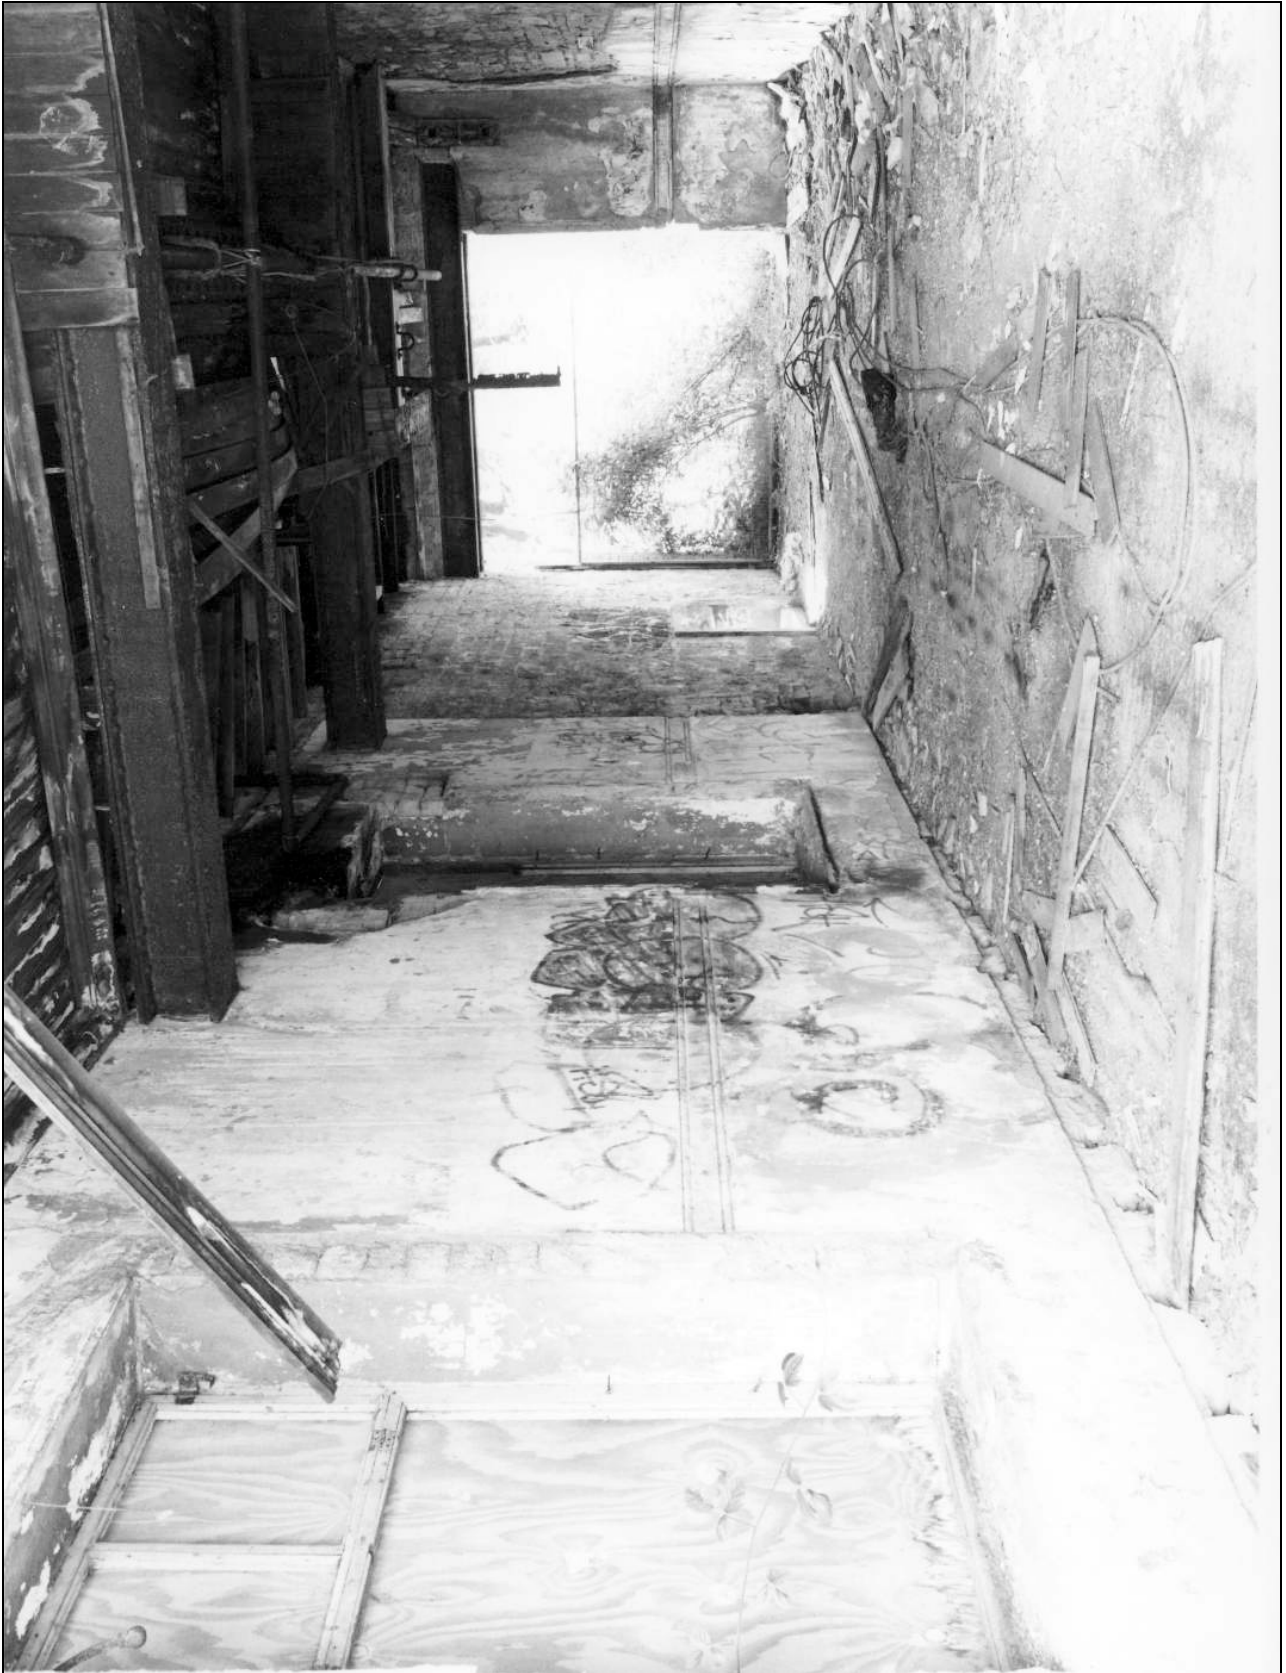
Photo 16: Horizontal engine room, from the north (film 1, frame 16)

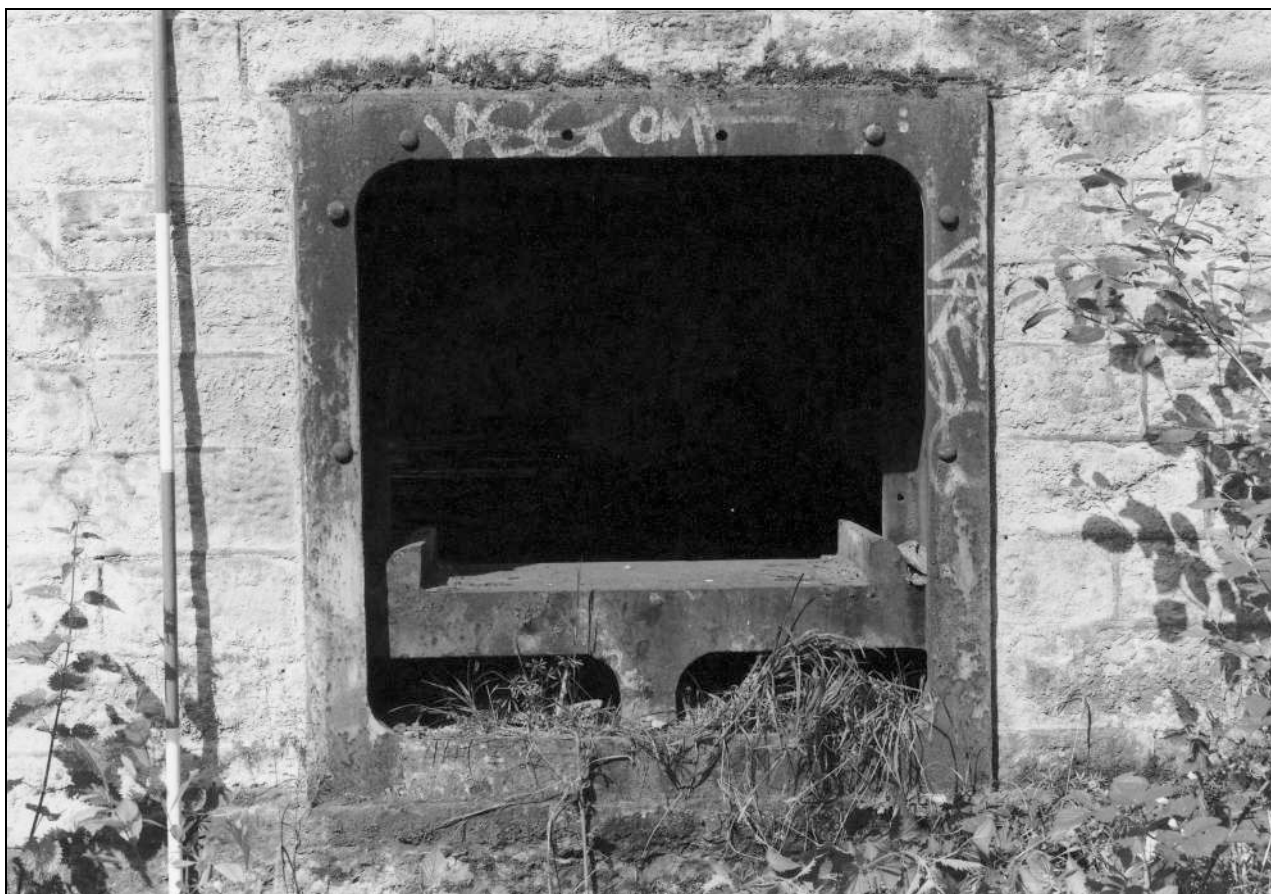
bearing set within the wall below it (hidden by vegetation) may have been the means by which power from it was transmitted into the adjacent weaving shed.

Photo 19: Spinning mill: massive bearing in east (outer) side of engine room (film 2, frame 6)

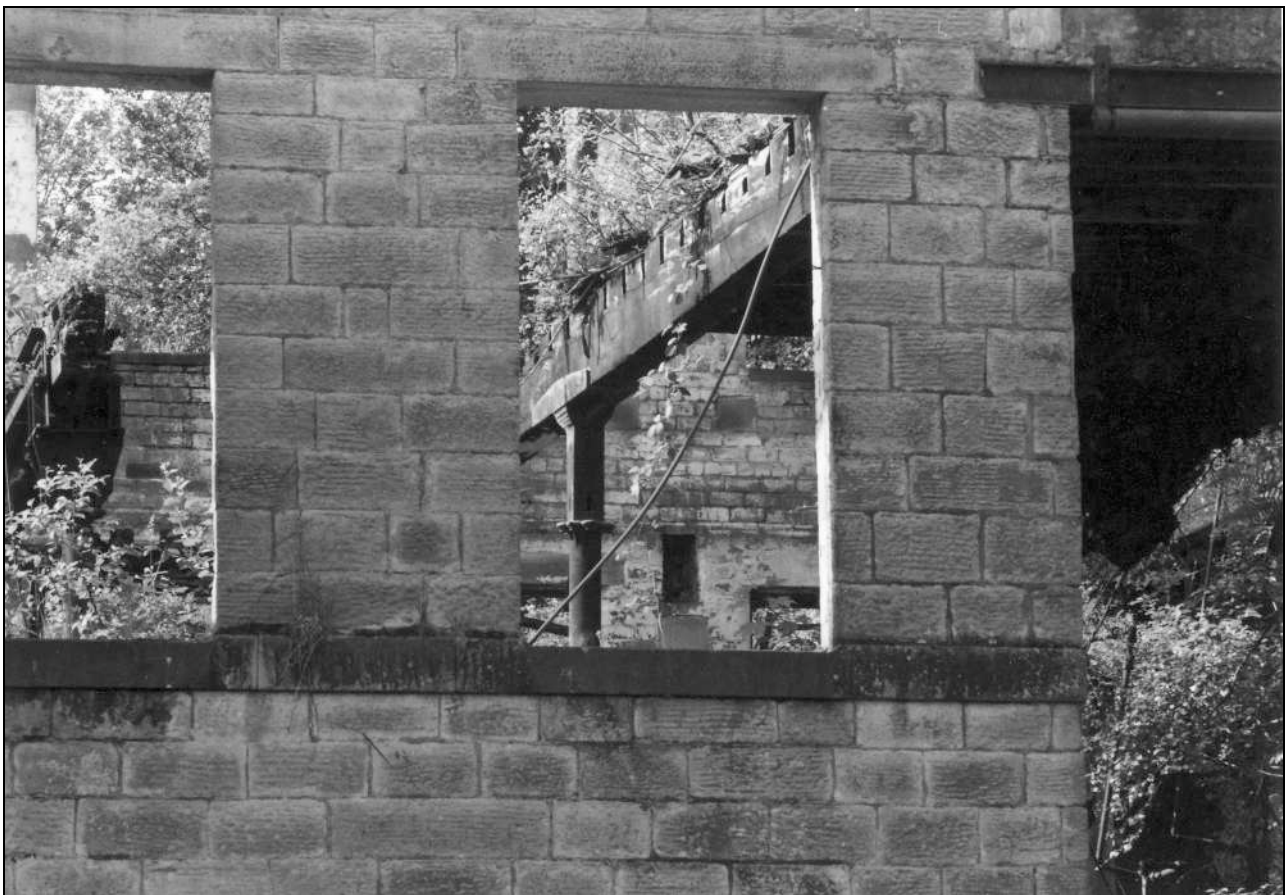
7.4 The arrangements within the rest of the three storey mill cannot now be established: its interior was of timber floors with cast iron columns (22), and there seem to have been no internal masonry walls.

Photo 22: Spinning mill: view through north elevation to interior on first floor, showing cast iron column and timber beam (film 1, frame 7)

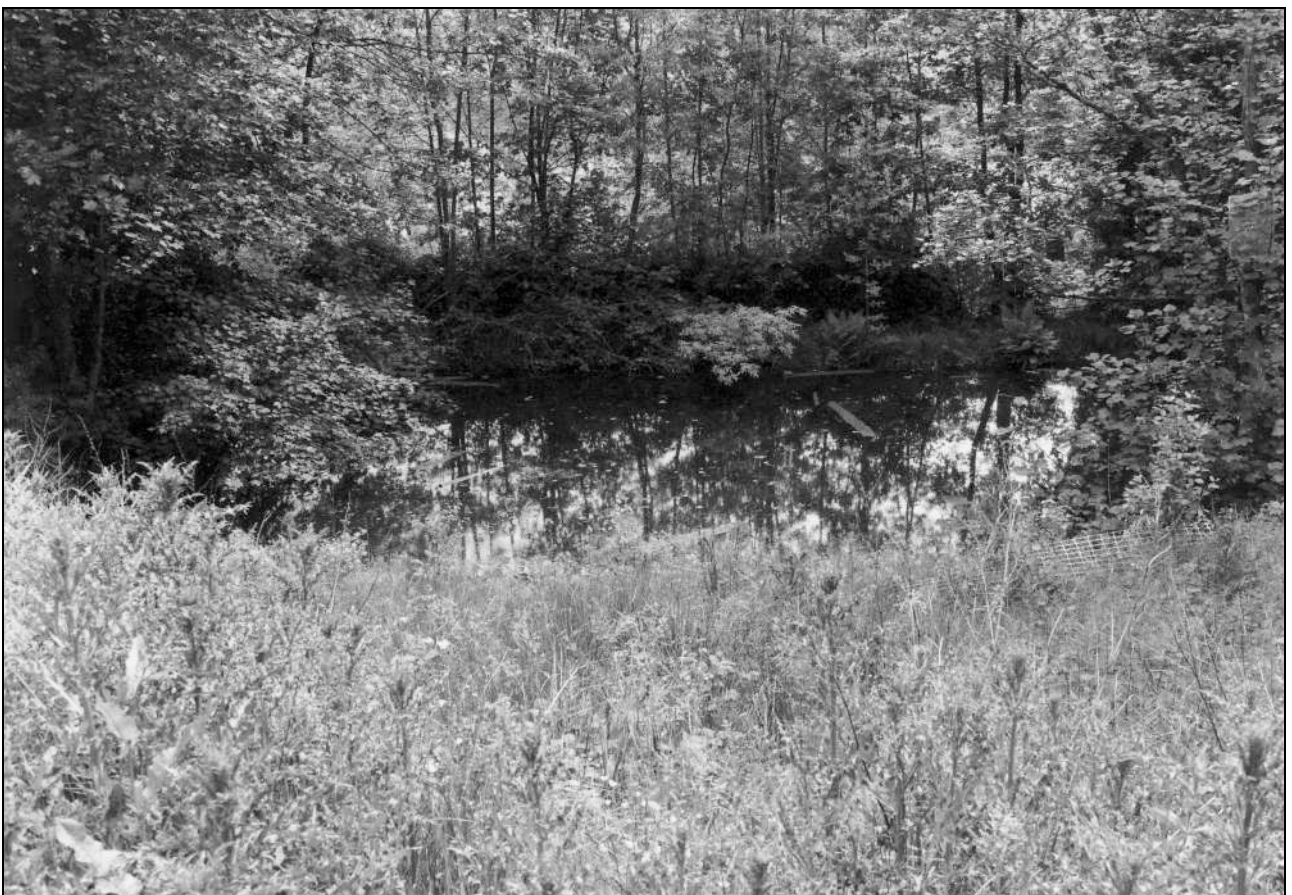
- 7.6 Historic photographs show that the building on the west side of the pond was in broadly similar style to the spinning mill, with an array of large windows, eight bays long and three storeys high, with a roof of stone slate. This is likely to be that referred to as having been added in 1870 by Thomas Bland & Co (see above), but now only three courses of the east elevation remain above ground level, forming the pond's west side (**26,27**).

Photo 26: Mill pond from the west, taken from site of demolished warehouse (film 2, frame 16)

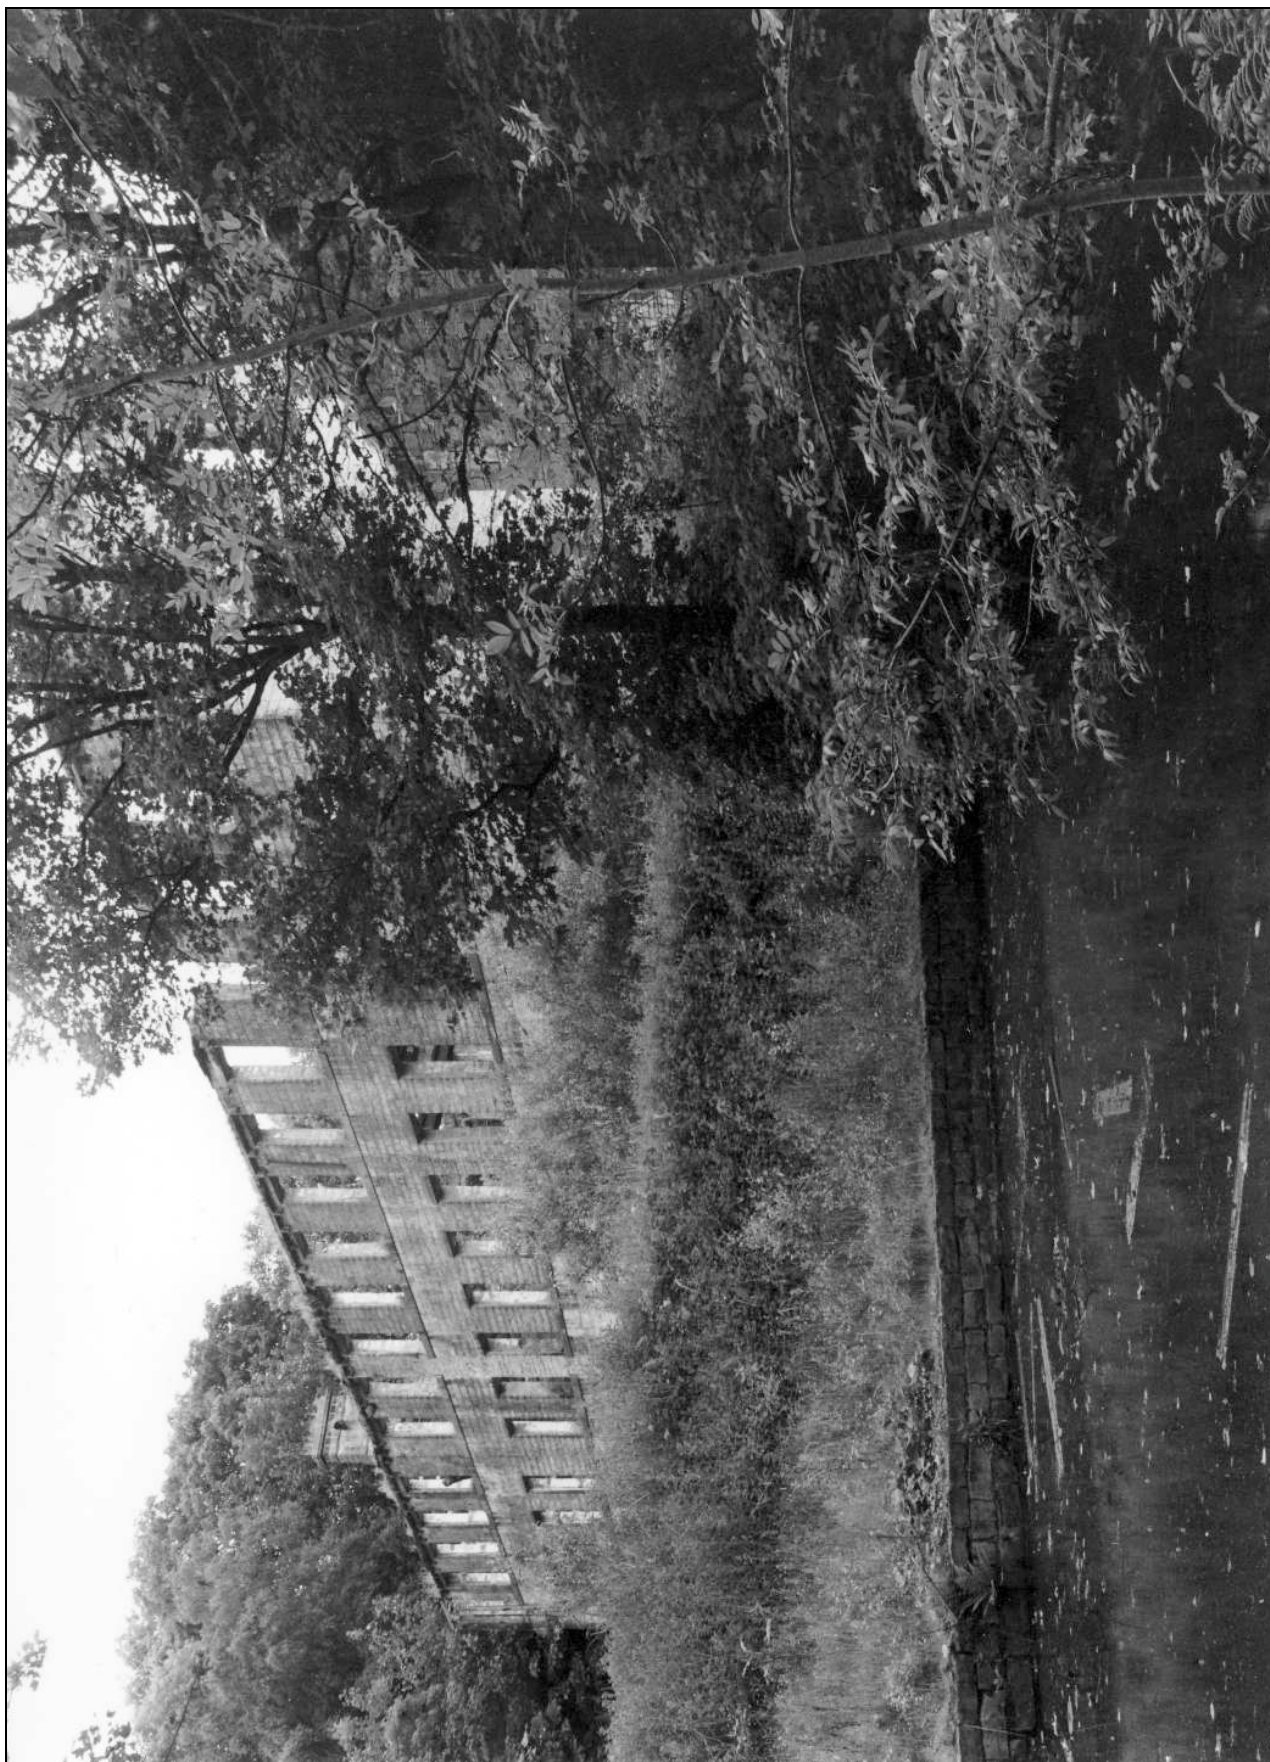
Photo 27: Mill pond, and south side of spinning mill, from the south-east (film 3, frame 13)

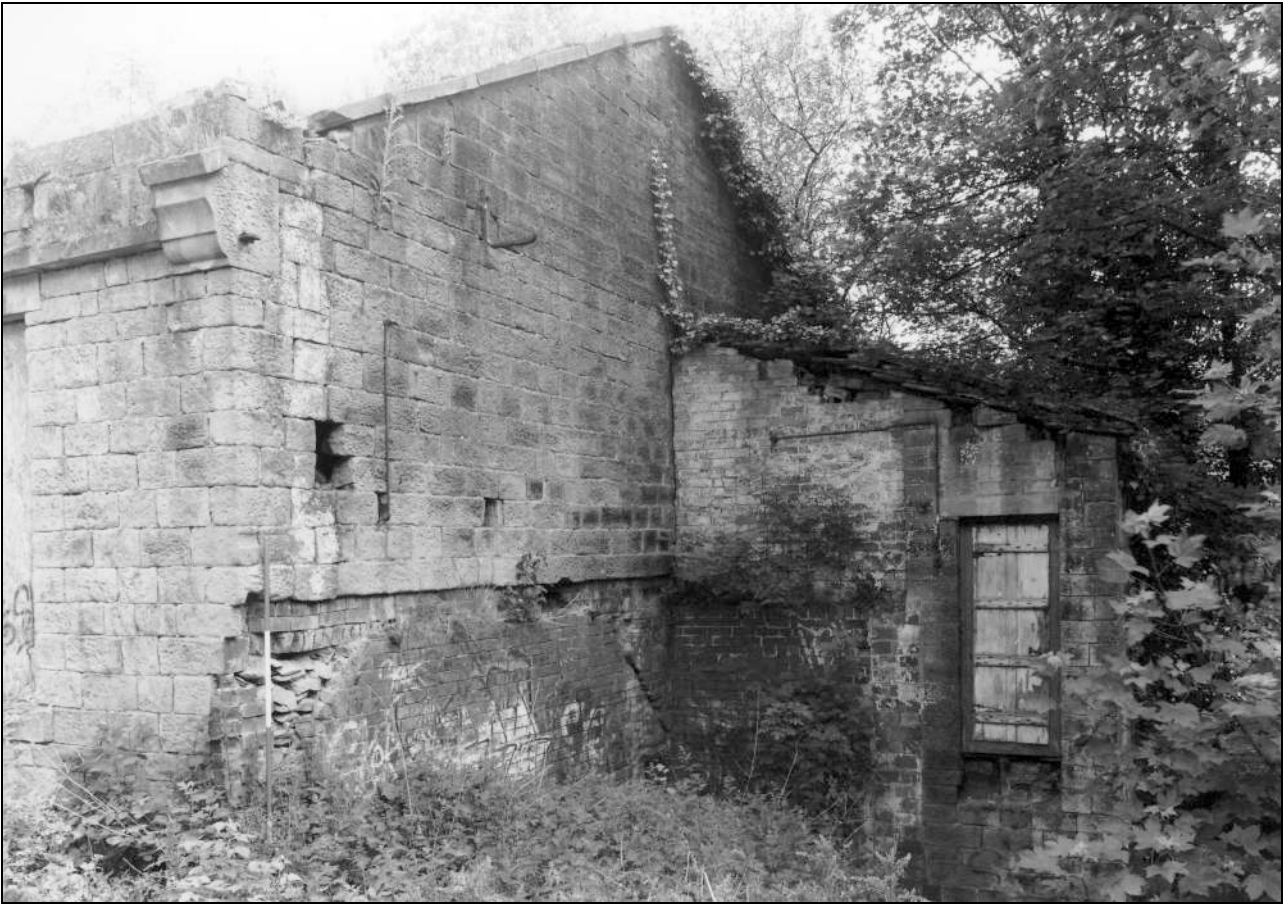
level doorway to an upper floor in the west side, outside the demolished south-west part of the lean-to, which was smaller and lower in height (39,40). The only feature of interest in the latter is a flue opening or similar into the main building, under an iron lintel but with arch over, which was probably connected to the boilers or perhaps to the chimney (41,42). No evidence was observed to indicate the means by which water for the engine and boilers was transmitted to and from the pond, but a man-hole over the outlet exists to the south-east of these lean-tos (43).

Photo 39: Boiler house lean-to (partly demolished), from the south-west (film 2, frame 11)

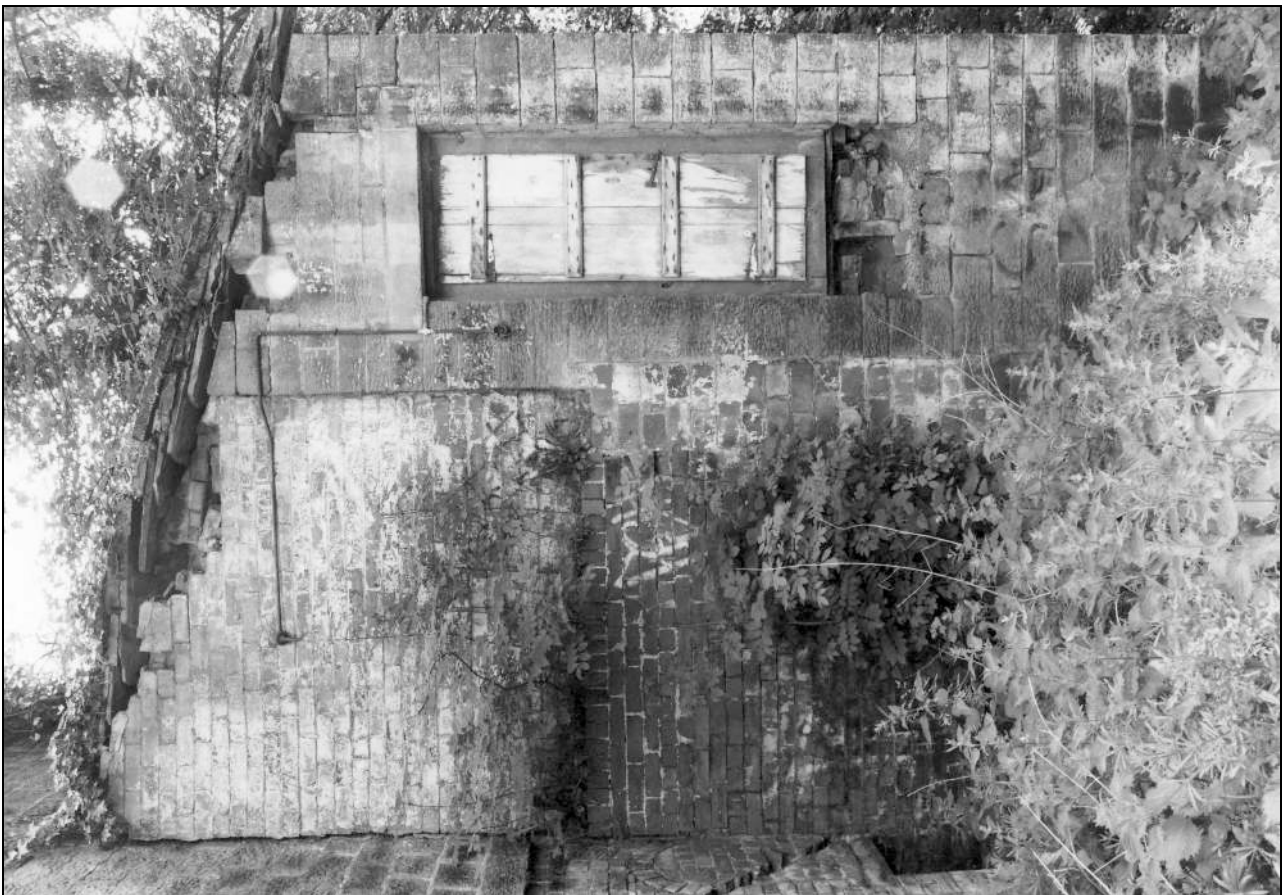
Photo 40: Doorway in west side of boiler house lean-to (film 2, frame 12)
