Ivy Bank Mills
Ivy Bank Lane, Haworth, West Yorkshire:
Historic Buildings Record

July 2014
NGR: SE 03410 36760
Historic township: Haworth

STEPHEN HAIGH
Buildings Archaeologist

Historic building recording, primarily photographic, was carried out for K M Norris Ltd (via their agent Prospect Archaeology Ltd) at Ivy Bank Mills, Haworth (NGR: SE 03410 36760), in order to fulfil a condition of conservation area consent for the demolition of most of the surviving buildings. The mills were established in about 1860 for steam-powered worsted spinning and weaving and operated into the late twentieth century, and the principal standing building is a three storey spinning mill, near which is a combined boiler house and warehouse, and small office block. A weaving shed and second warehouse were demolished in 2008-9.

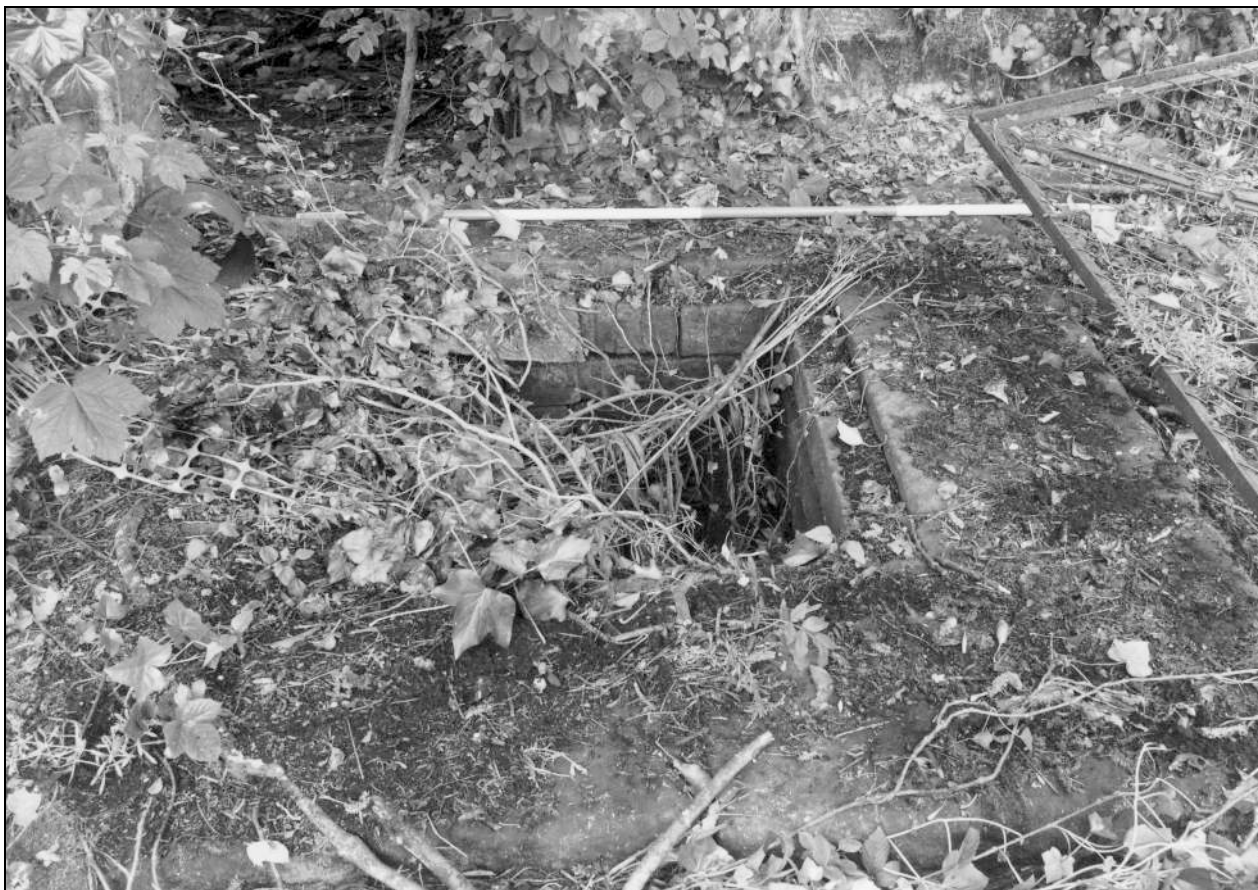
level doorway to an upper floor in the west side, outside the demolished south-west part of the lean-to, which was smaller and lower in height (39,40). The only feature of interest in the latter is a flue opening or similar into the main building, under an iron lintel but with arch over, which was probably connected to the boilers or perhaps to the chimney (41,42). No evidence was observed to indicate the means by which water for the engine and boilers was transmitted to and from the pond, but a man-hole over the outlet exists to the south-east of these lean-tos (43).

Photo 43: Man-hole over culvert forming outfall from mill pond (film 3, frame 12)
