The Amenities Block or Bathhouse  
Central Ironworks, Queen Street South, Huddersfield  
West Yorkshire:  
Historic Building Record

June 2015  
NGR: SE 14591 16171  
Historic township: Huddersfield

## Historic Building Record

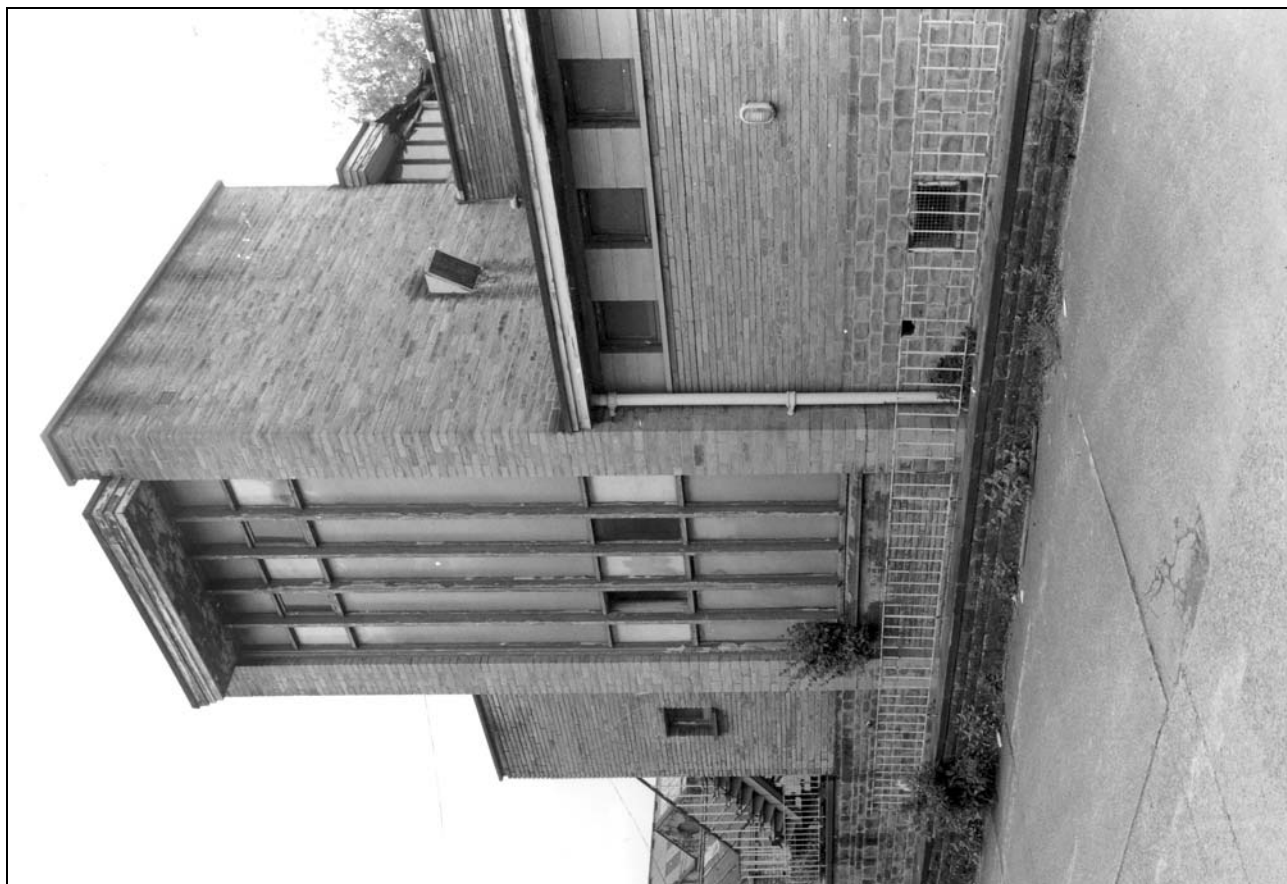
Photo 4: The water tank tower, from the north-east (film 1, frame 18)

- 7.17 The two internal spaces at roof level include the tank room (83), containing two large steel water tanks, of a size necessitated by the surge in demand which presumably accompanied the end of a shift in the foundry. The air extraction duct from the west half of the building also passes through this room, en route to its outlet in the north side. Built on to the south side of the tank room is the “sun lounge”, with south-facing doorway and glazing to the other two sides. It has a fitted wooden bench around three sides, to seat up to about a dozen people, and is unheated. This was a minor but perhaps valued aspect of the Amenities Block which went beyond the statutory requirements, though quite how much it was used remains the subject of speculation.

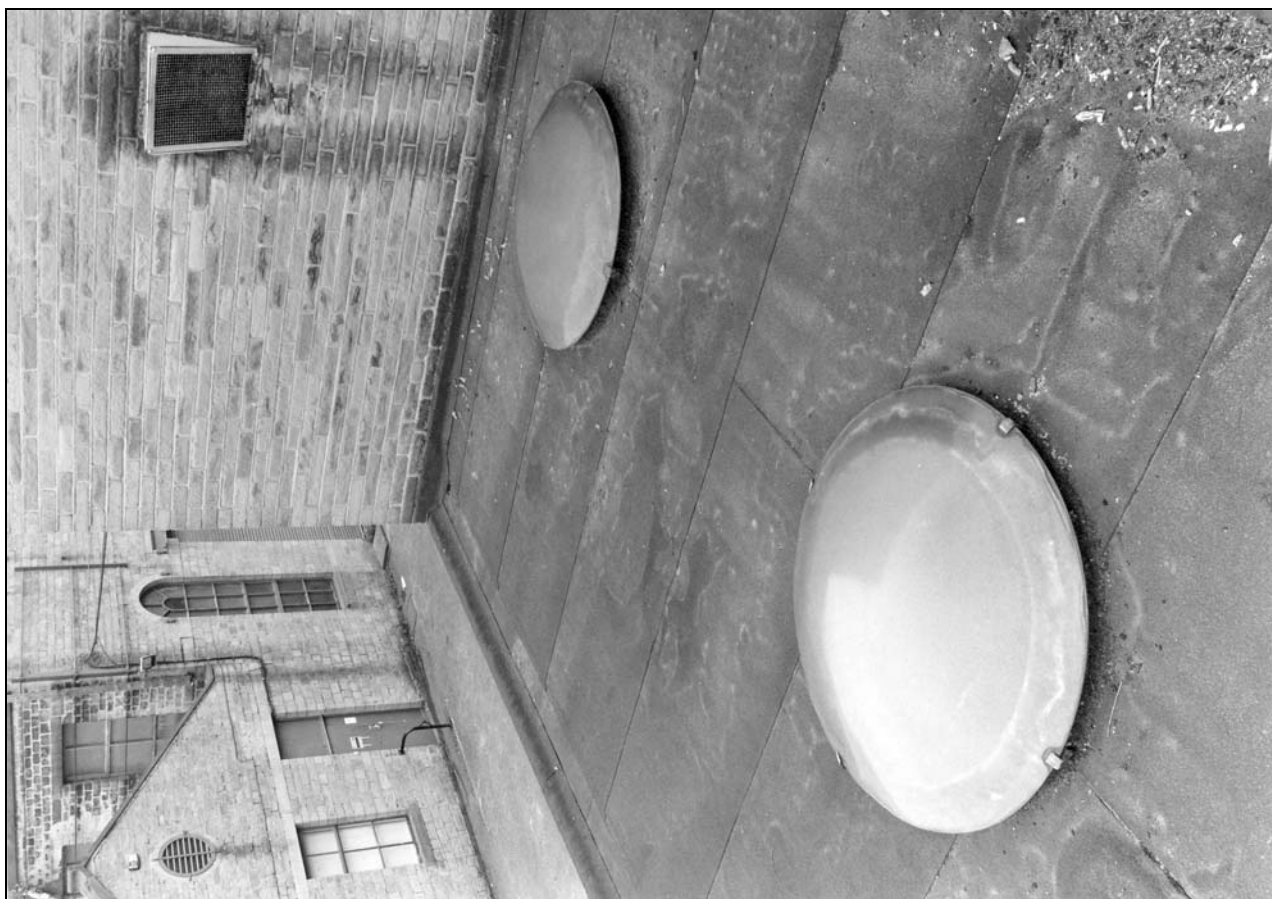
Photo 45: Roof lights over wash-room, and air extraction outlet,  
from the north-west (film 2, frame 15)

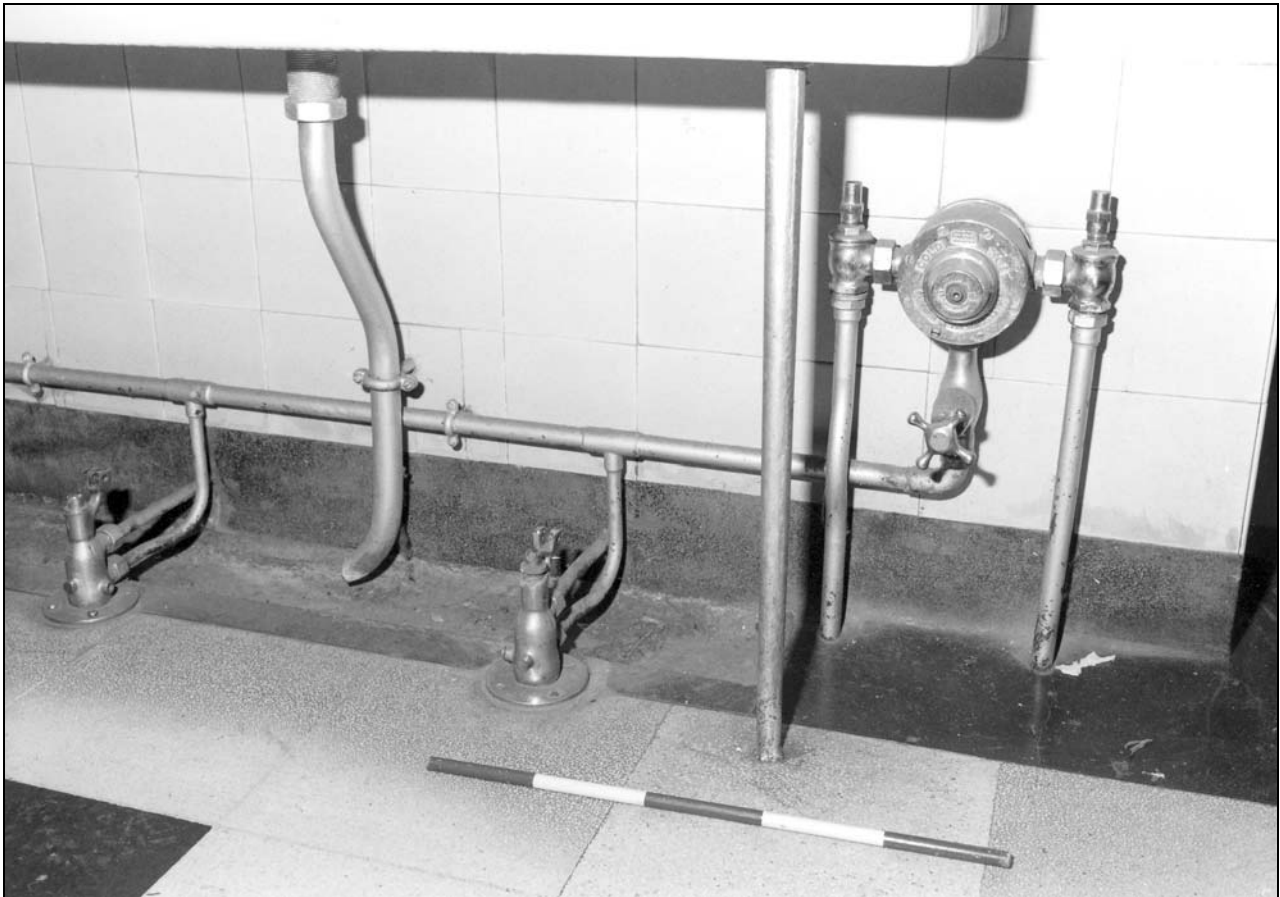
Photo 48: Detail of mixer control and foot-operated taps for wash basin in “washroom” (film 5, frame 9)

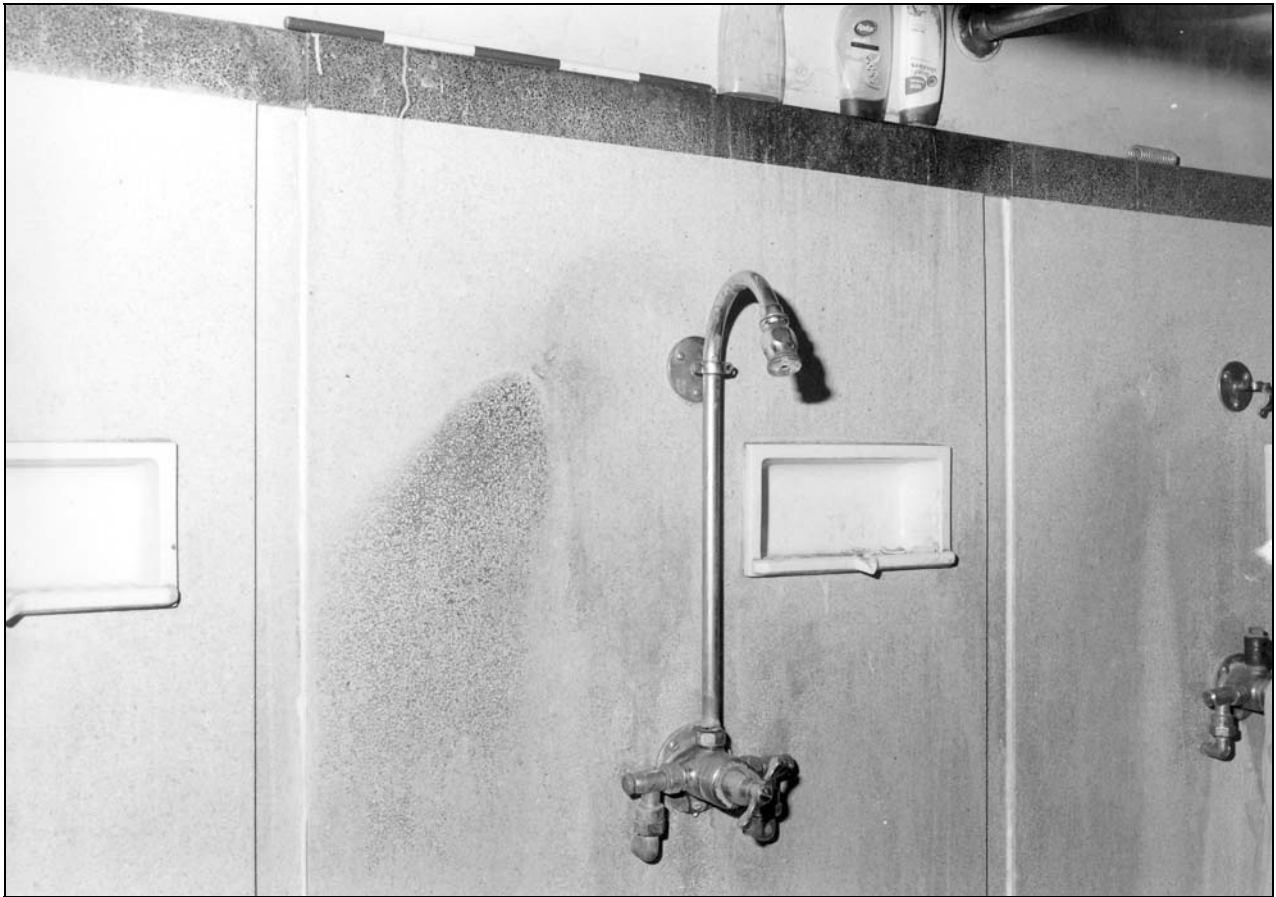
Photo 58: Detail of shower tap and head in open showers (film 6, frame 13)

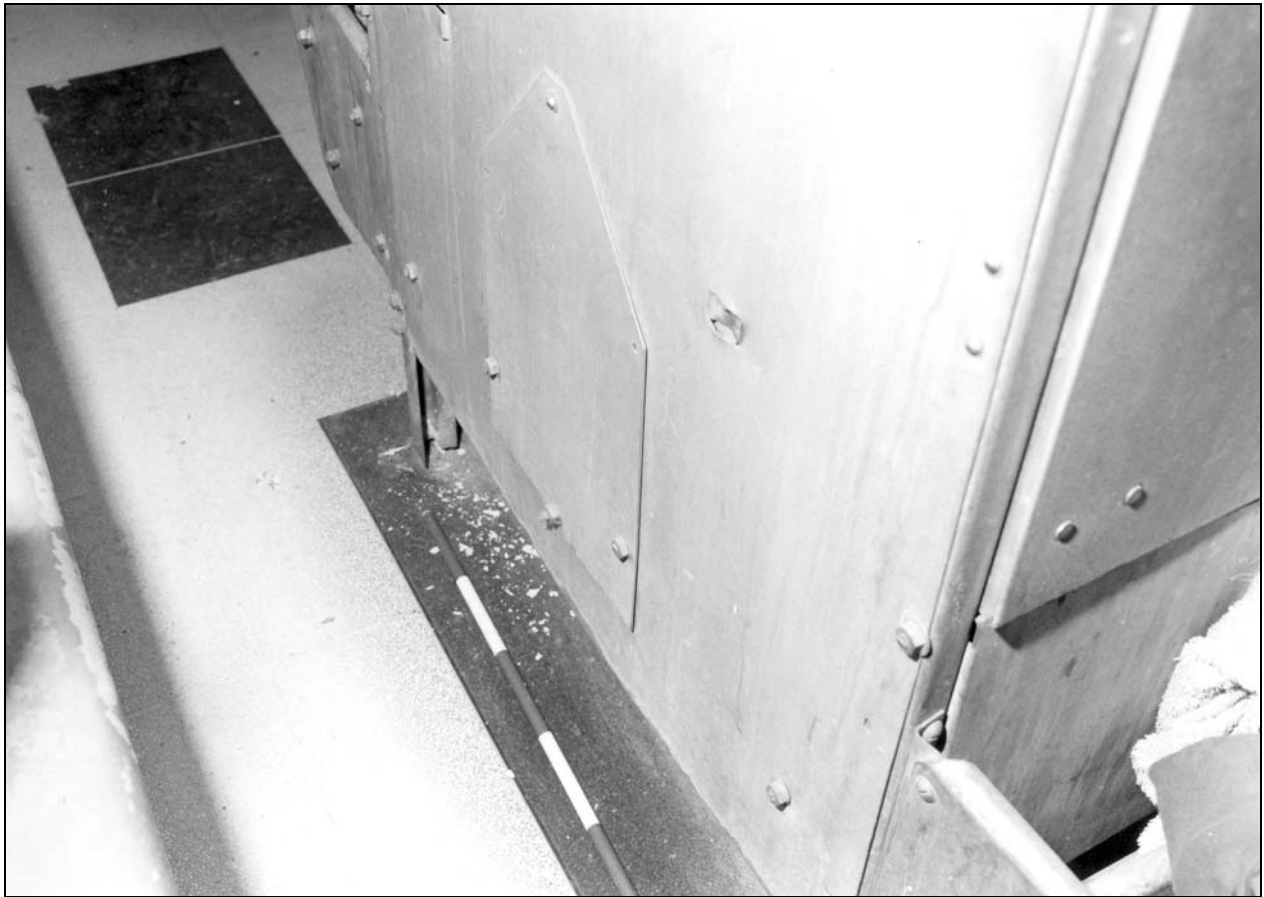
Photo 68: Detail of panel for warm air ducts at end of row of “clean” lockers (film 6, frame 6)

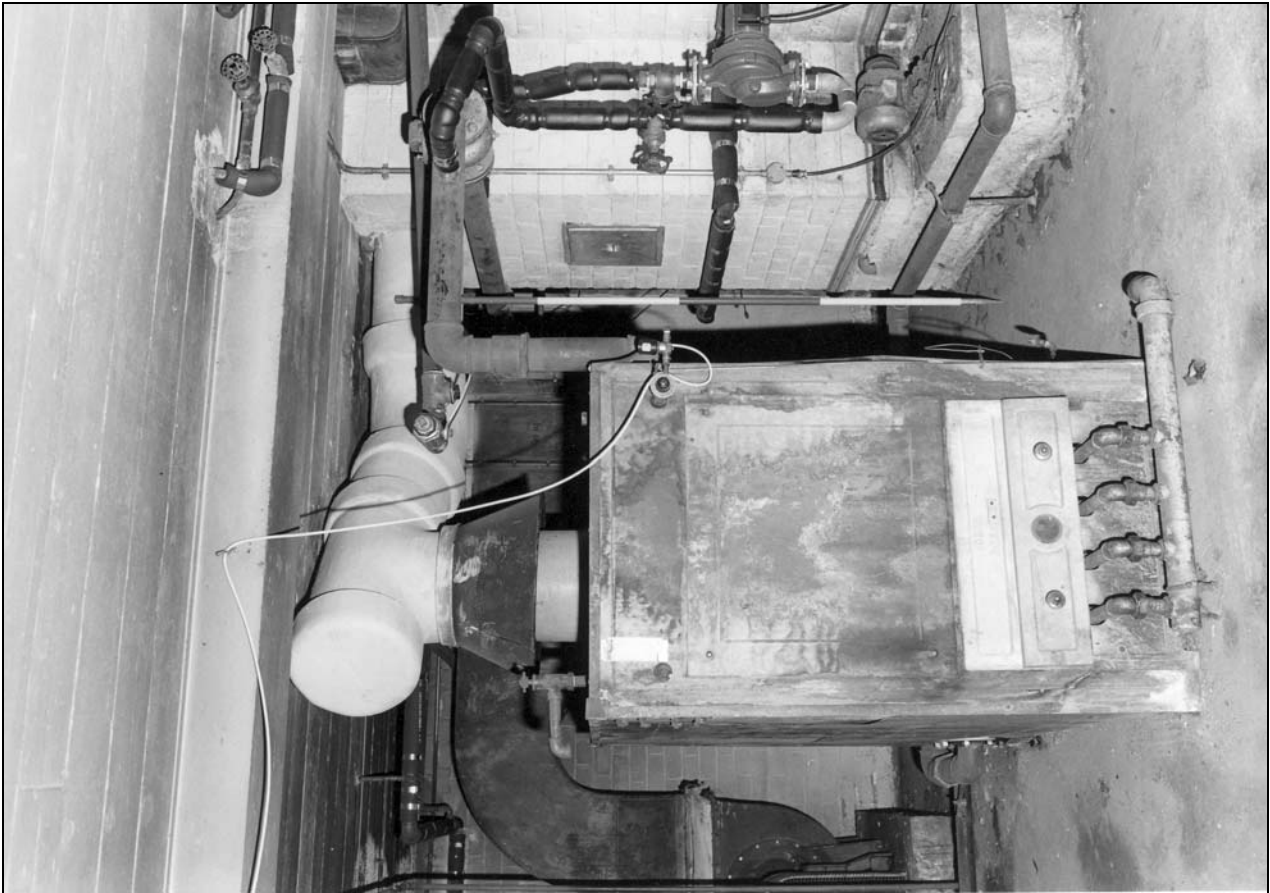
Photo 74: Basement: the gas boiler, from the north (film 1, frame 4)

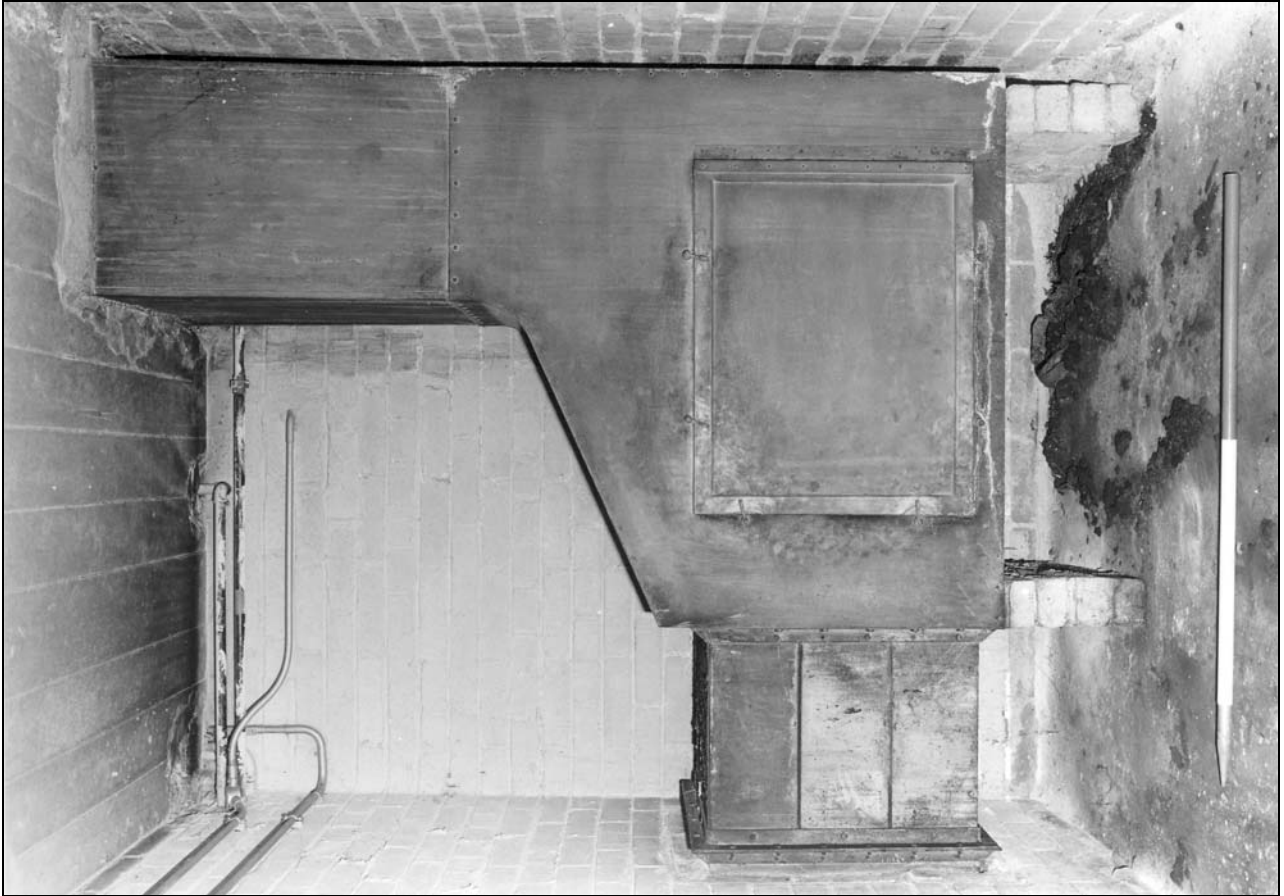
Photo 77: Basement: main air duct at foot of intake (film 1, frame 13)

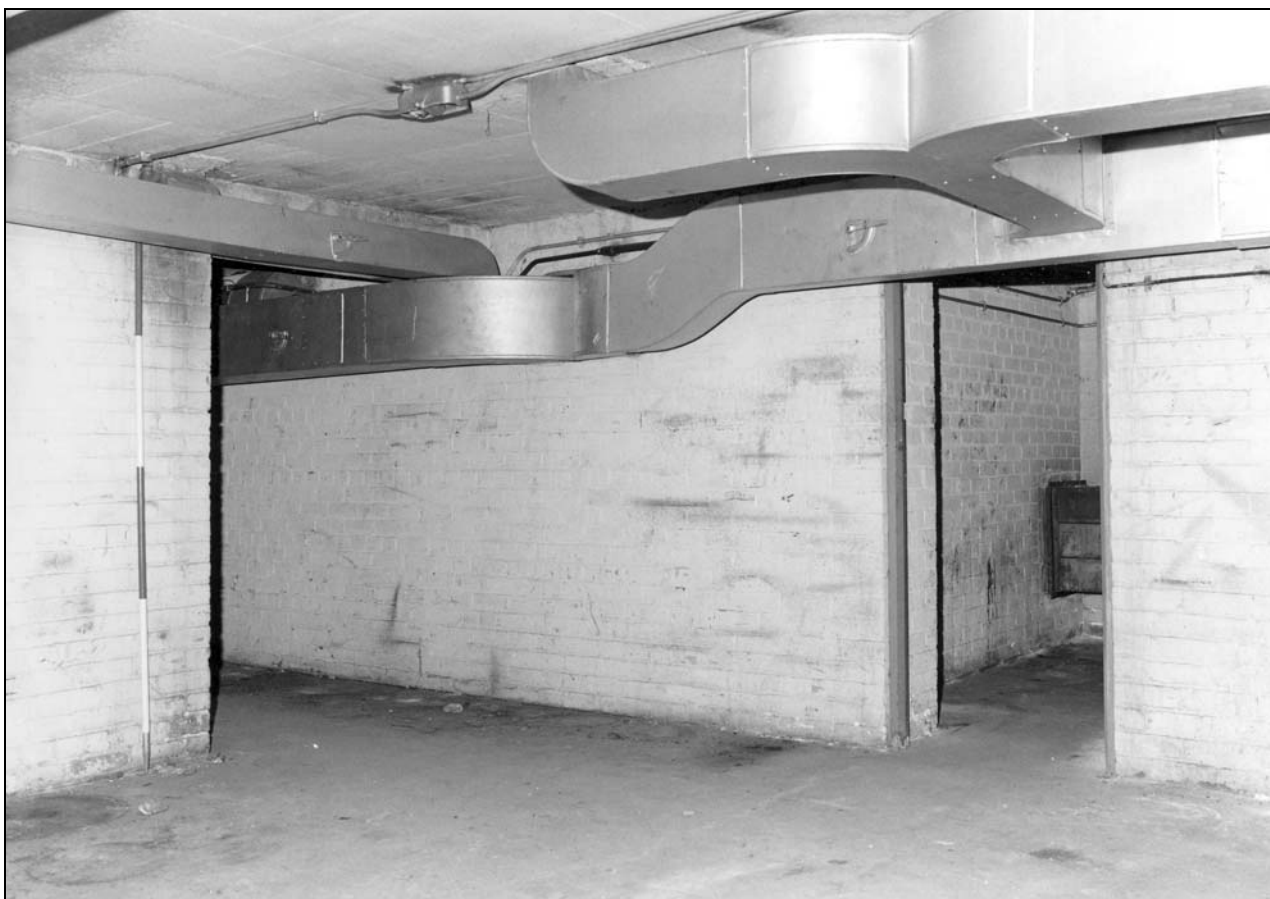
Photo 78: Basement: general view of storage area from the south-west, with overhead ducts supplying “clean lockers” above (film 1, frame 11)

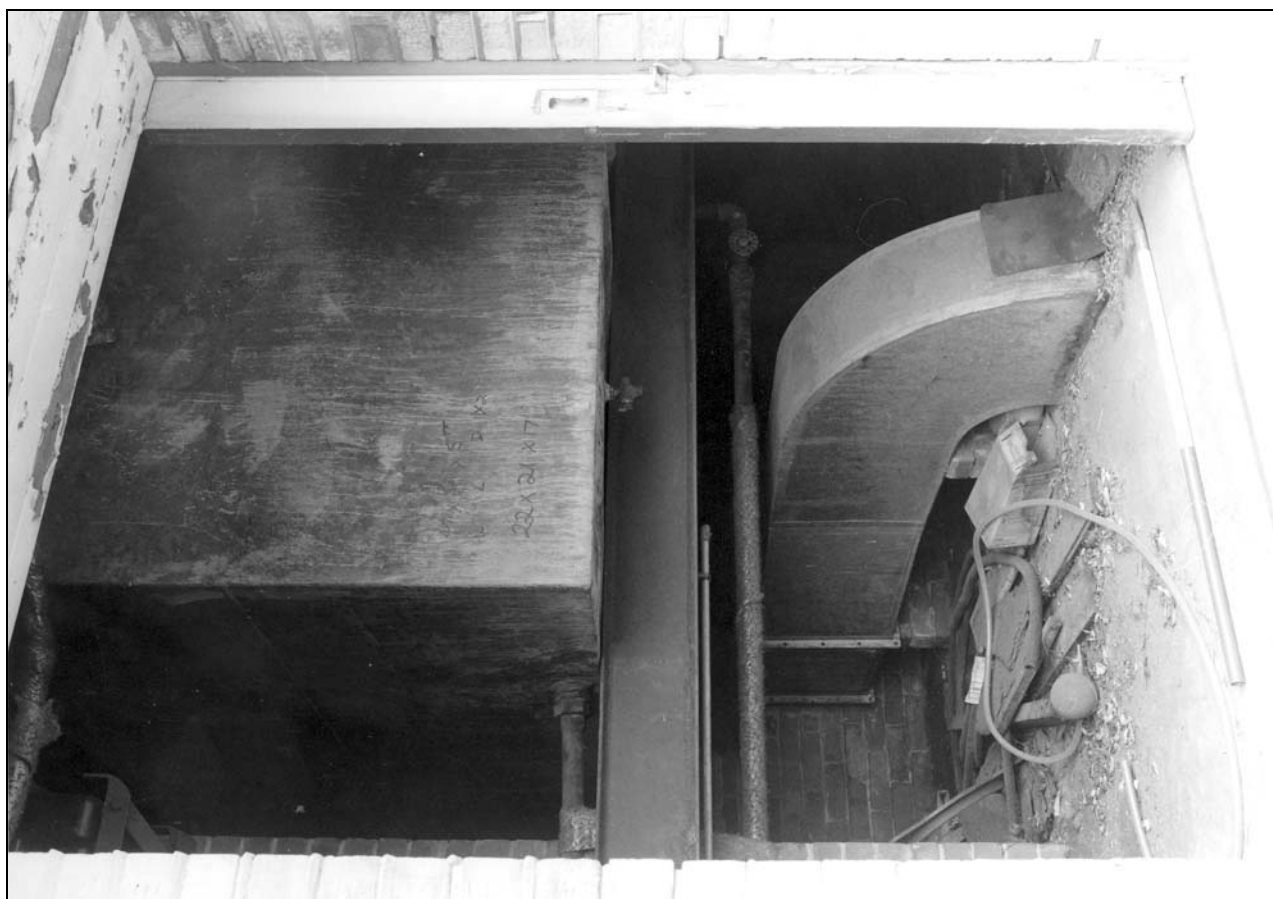
Photo 83: “Tank room” on roof level, from the south-west (film 2, frame 18)
