73 – 75 Hammerton Street
Burnley, Lancashire:
Historic Buildings Record

OASIS project ID: stephenh1-243853

73 – 75 Hammerton Street Burnley, Lancashire: Historic Buildings Record

Two buildings at 73 – 75 Hammerton Street (NGR: SD 83864 32387), within Burnley's Canalside Conservation Area, were recorded in February 2016 for the developer Hurstwood Holdings, before their demolition. Together they form a commercial premises, but include the proprietor's house with attached shop or store room, which was begun in the 1840s but has five identifiable phases of construction, while the other is a former sawmill with attached chimney, of 1859.

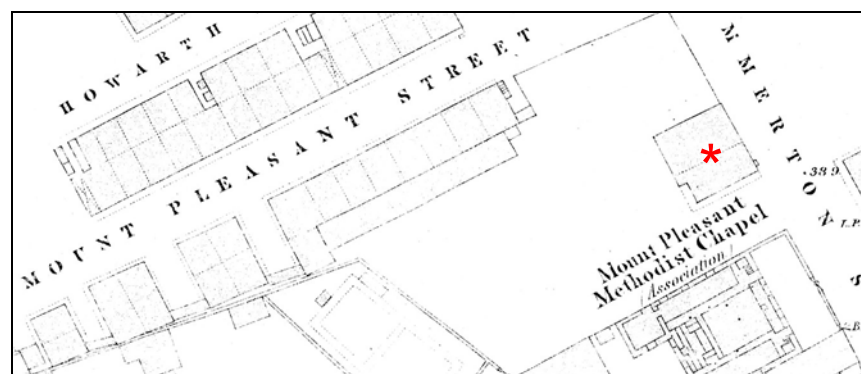
6: OS 1:1056 map, 1851⁵

5.2 The most detailed map of this period is that by the Ordnance Survey, made in 1849 (figure 6), which clearly shows two adjacent buildings at the east corner of the present site, representing most of the present Building 1 (red asterisk), which

must therefore date from the 1840s. To the rear of this was a large open yard or other space, on which Building 2 had yet to be built, though further to the west were a terrace and courts of workers' housing facing onto Mount Pleasant Street (figure 6).

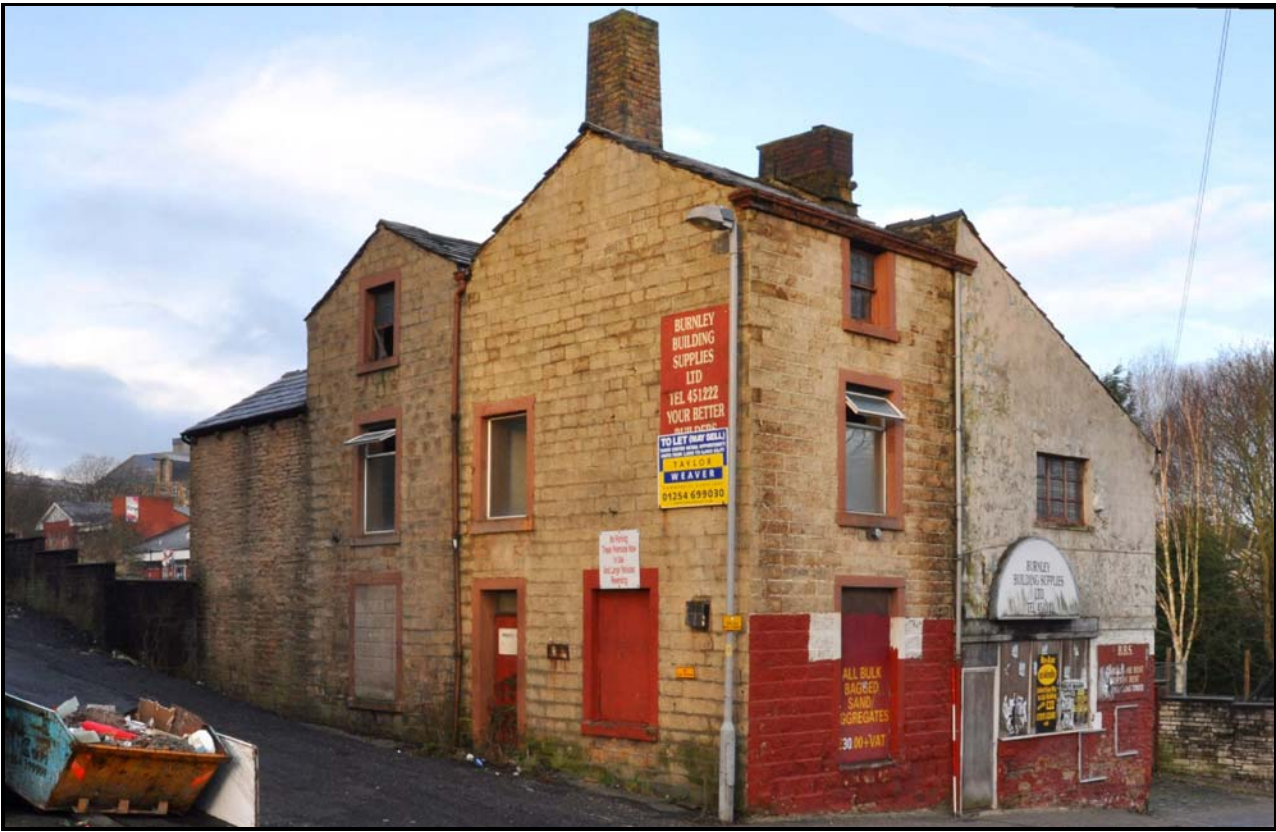
- 7.1 Building 1 dates from a number of construction phases, the earliest of them in the 1840s, and its core is a compact three storey dwelling, which fronts onto Hammerton Street but has a side entrance in the adjacent unnamed street (**1**). Straight joints in the south-east and north-east elevations suggest that the original building had a footprint only 4.5m wide along Hammerton Street and 5.9m deep, and this would have had only a single room on each floor, with the foot of the staircase probably just inside the entrance. This house was in many ways typical of those being built in vast numbers in the town during the mid 19th century, and has walls of coursed, watershot sandstone, with large, plain flat-faced monolithic dressings to the openings. Windows would have been vertical sashes and one example, but probably not original, survives on the second floor facing Hammerton Street. The roof is of stone slate with a sandstone ridge and moulded stone easing troughs to the eaves, and bears a single chimney stack, to the north-west gable. There is now no cellar to the house, but conceivably there was one which has been infilled.

Photo 1: Building 1, from the east

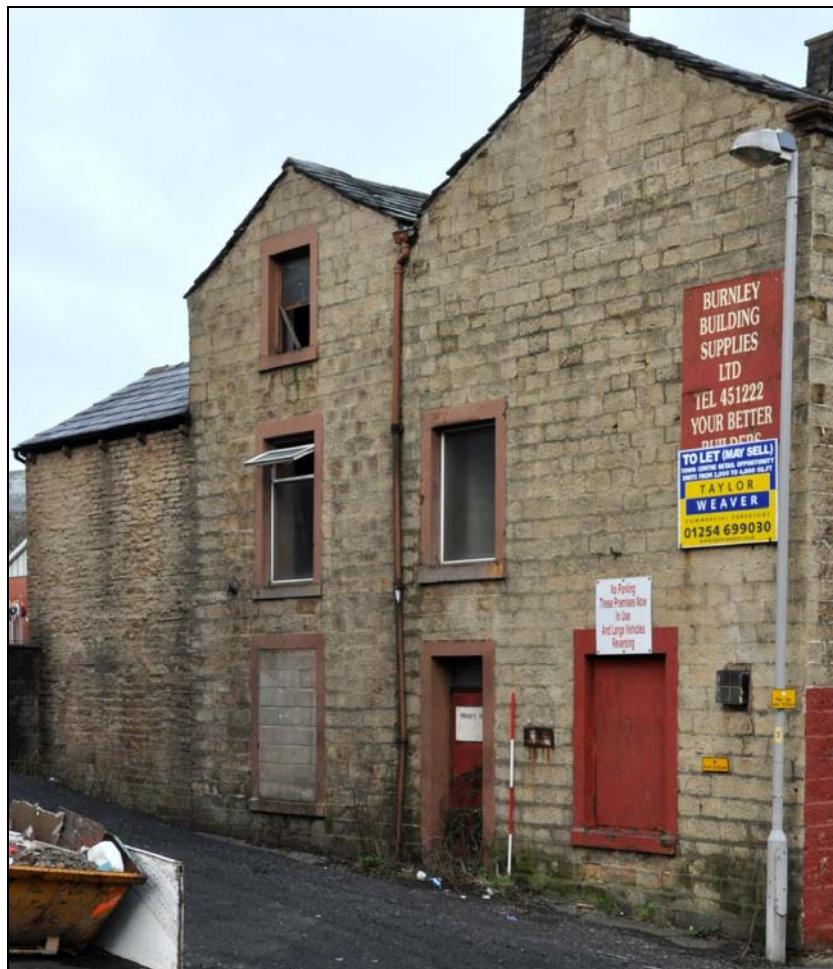
- 7.2 Shortly after construction and by 1849, according to the Ordnance Survey, the house was extended to the rear by a parallel wing (**2**), thereby nearly doubling the accommodation in the house (phase 2). The masonry details are almost identical to those in the original part but a clear straight joint hidden by the present downpipe does show that the two parts are of different dates, and the fact that the front and rear parts have parallel roof ridges, rather than a single ridge perpendicular to Hammerton Street, also suggests that the rear part (phase 2) was not anticipated originally. It may also have been intended to continue the phase 1 building as a terrace to the north-west by the addition of other houses, but if so this was a scheme which was never realised.

Photo 2: South-east side of Building 1, from the south-east

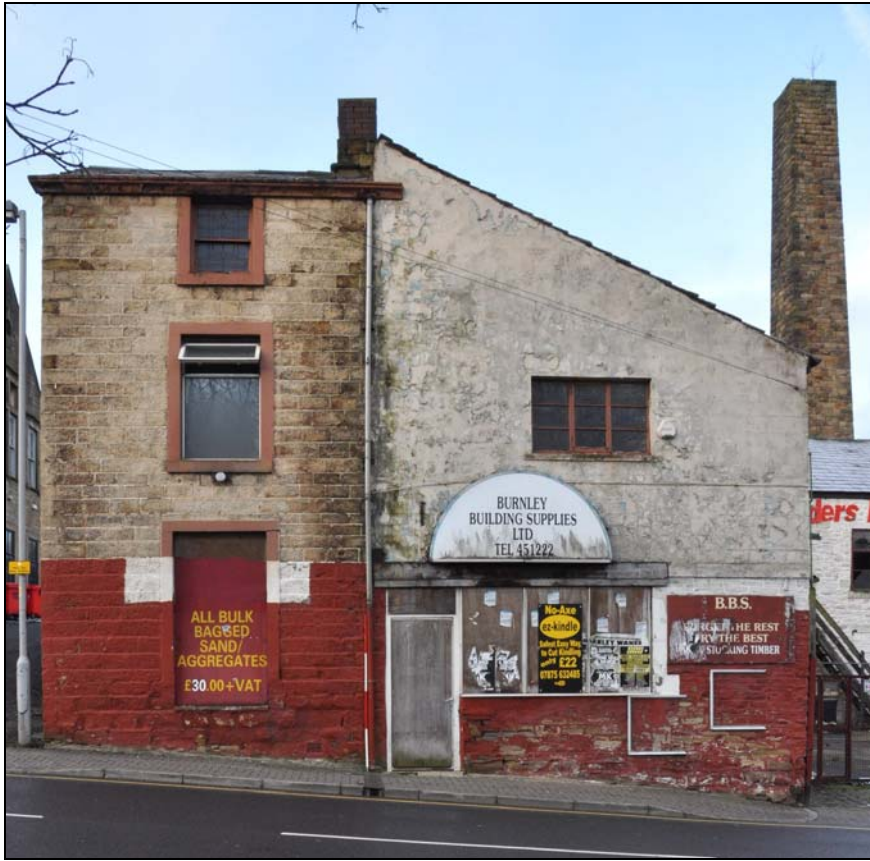
- 7.3 The same source suggests that the house was also extended to the north-west before 1849, by the two storey lean-to structure which still stands today (phase 3) (3), or possibly by another building which the present structure replaced. Its form suggests that it has always had a commercial rather than a domestic function so probably had a shop front to Hammerton Street (as it had in the 1980s, and as it still does today). This is built with less finesse than phases 1 and 2 and has walls of poorer quality stonework and windows with softwood lintels, though these may not be original (4). Its roof is also stone slate (5-6).

Photo 3: Building 1, from the north-east, across Hammerton Street

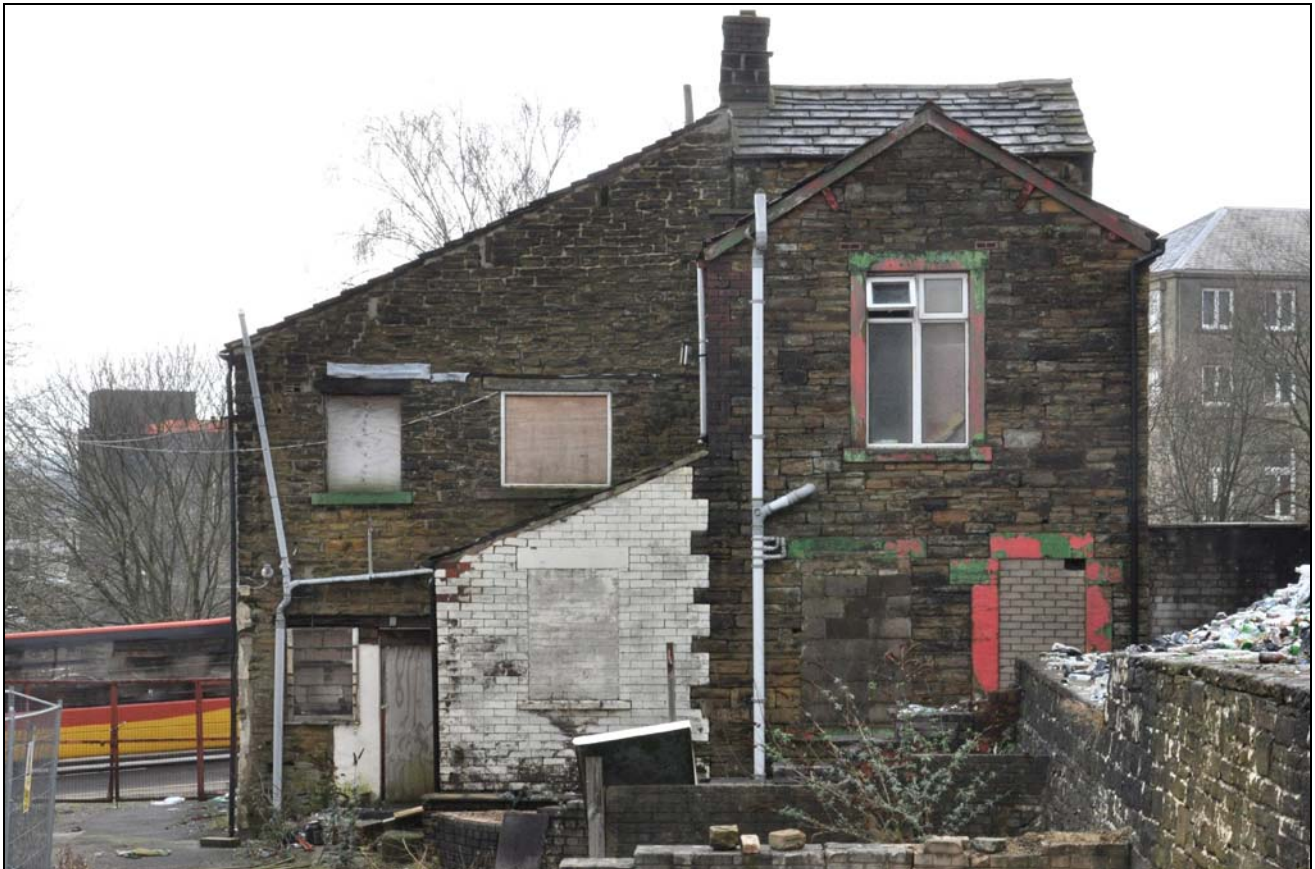
- 7.4 The house was extended again between the 1840s and 1890 by a rear wing of two storeys (phase 4), which seems to have been intended as additional domestic accommodation (7,8); the stonework is not of the same quality as the earlier house and is substituted by brickwork on the north-west elevation, while the roof is blue slate. A further, single storey lean-to extension was built from brick on the north-west side of this, between 1890 and 1910 according to the Ordnance Survey (phase 5) (9).

Photo 7: Building 1, from the south-west

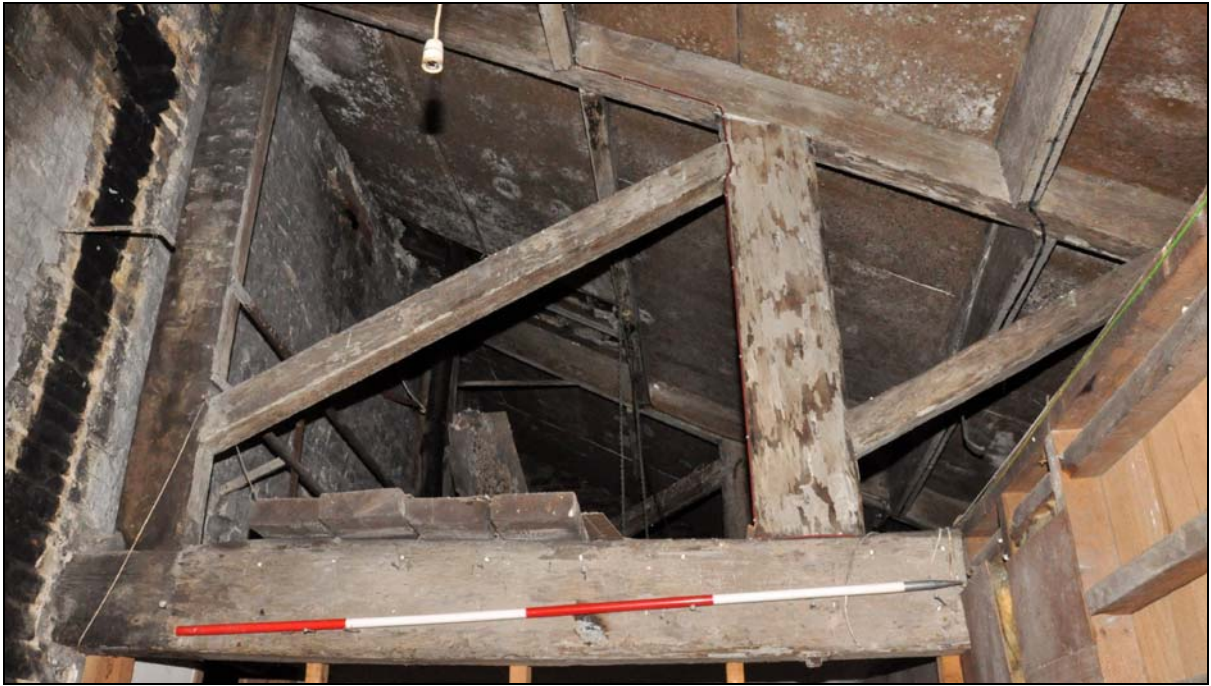
- 7.5 The interior of Building 1 contains few spaces with any historic interest: the ground floors of phases 1, 2 and 3 have been amalgamated to form a single shop space, albeit with an abrupt change of floor level (10,11). However the ground floor of the later rear wing (phase 4) appears largely unaltered, and has an intact rear door, sash window with applied lead, chimney breast with infilled opening, and moulded picture rail, the latter giving it a distinctly domestic character (12-14). The first floor is also largely modern, but raking trusses within the commercial lean-to (phase 3) are exposed, indicative of its non-domestic nature (15).

Photo 15: Building 1 – raking truss over first floor of phase 3, from the north-east

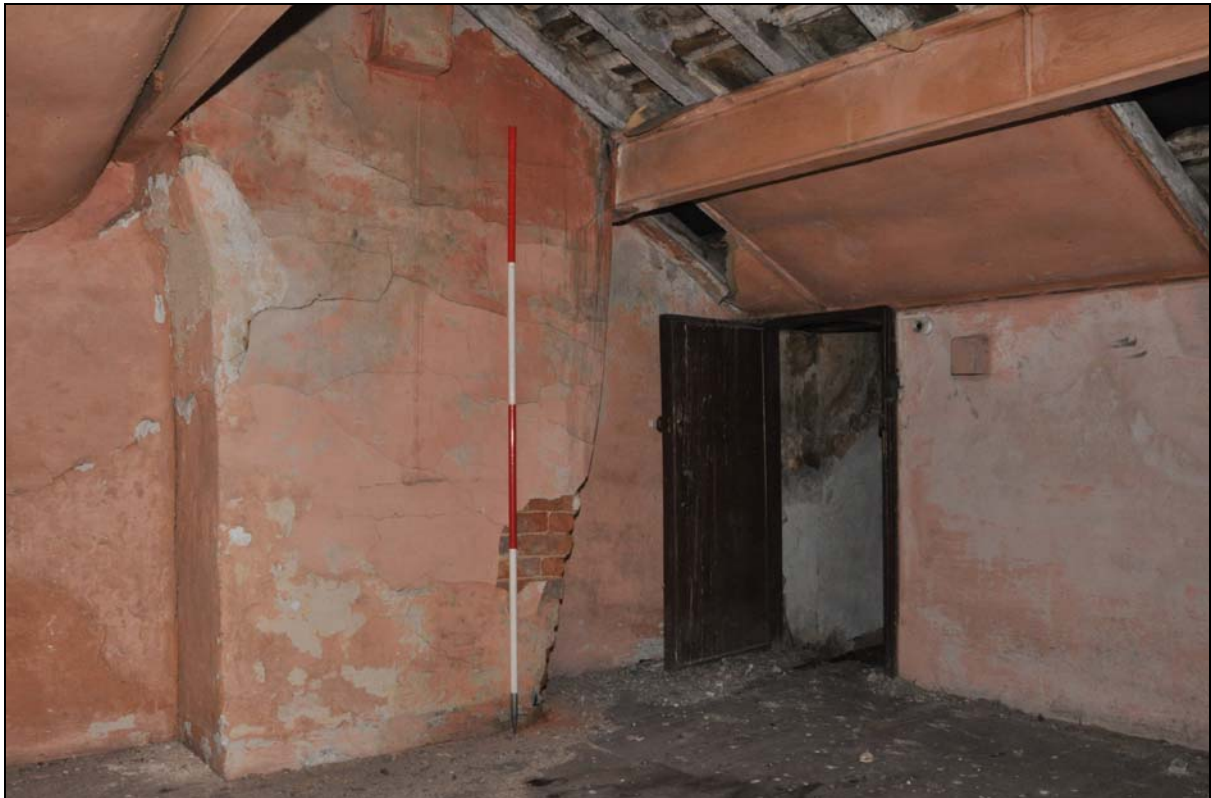
- 7.6 The upper parts of phases 1 and 2 do however contain some areas and fixtures of interest, including the staircase within the former, leading up from the first to the second floor: it has a moulded and ramped handrail (16-17). At its head is a landing with doors off to two attic bedrooms. In the front part of the house (phase 1) there is a mid 20th century bedroom fireplace, a gas lamp bracket, and another sash window with applied leaded panes (18-21), an example of which also survives in the unheated rear part (phase 2) (22-23).

Photo 22: Building 1 – second floor, back room (phase 2), from the south

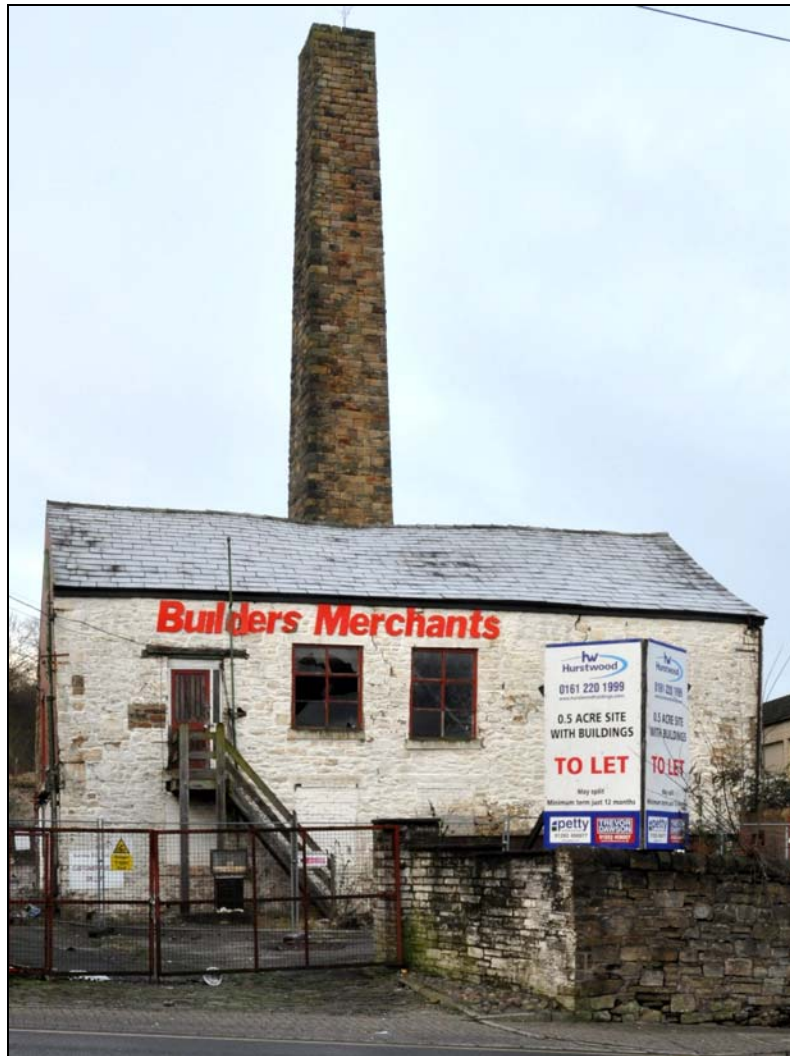
- 7.7 This is a former sawmill with attached chimney, believed to have been built in 1859 (24). The main block measures some 15m by 10m in plan, although it does not have a true rectangular shape, and the surviving structure represents only part of the former extent. The mill is built predominantly from sandstone

Photo 24: Building 2 – general view from the north-east, across Hammerton Street

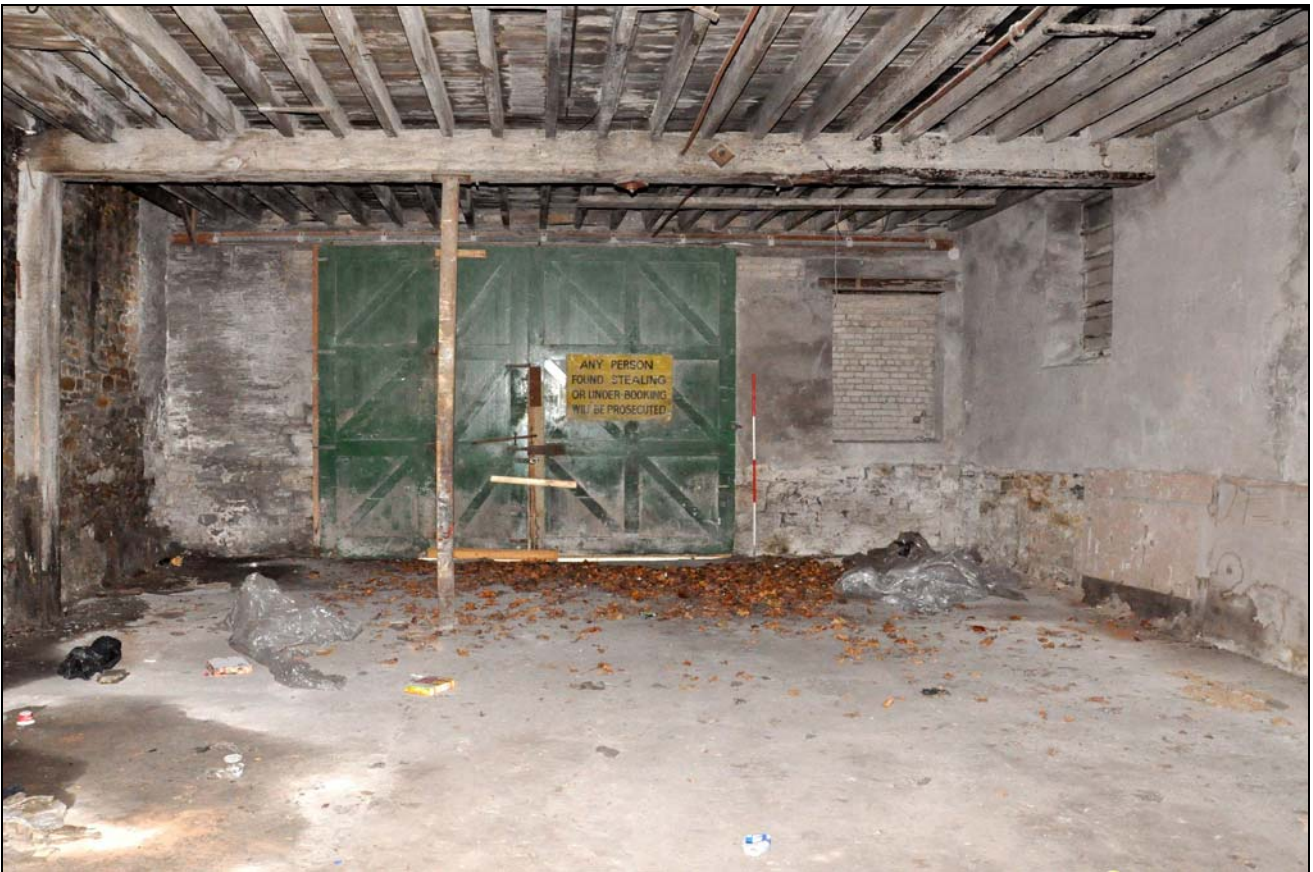
- 7.9 The ground floor of Building 2 is on a single level, except for a small raised area against the south-east wall (36), and the surface is concrete, but it appears from the pattern of openings and render in the north-east wall that this floor level is a modern creation and there was instead formerly a suspended timber floor 1m above this, and also a lower ground floor level somewhat lower down (37,38). The pedestrian door at the south corner is probably original (39,40), but otherwise there is a dearth of fixtures or fittings, or indeed any indications of internal layout or processes (41). The structure of the floor above does appear to be original however, and was clearly designed to carry substantial loads (42). A small separate room adjacent to the chimney may have housed a boiler or engine, as there is a blocked opening into the chimney (43-45).

Photo 36: Building 2 – ground floor, from the south-east

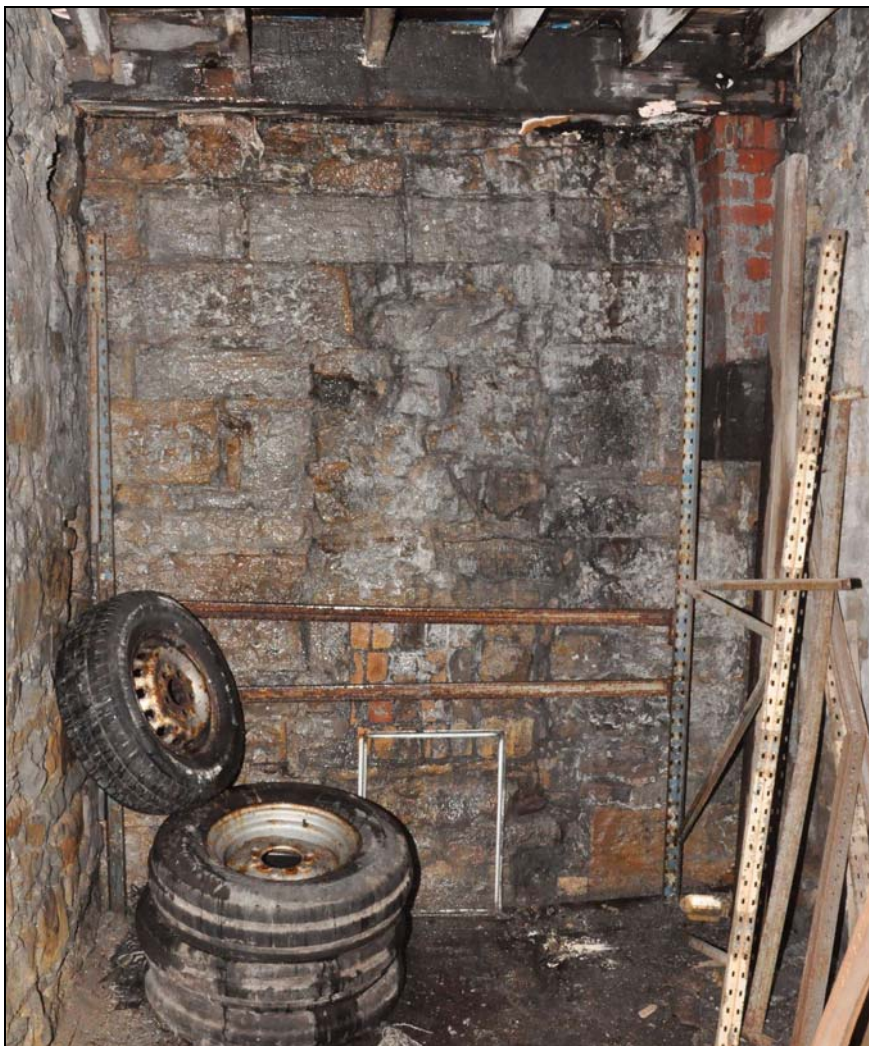
Photo 44: Building 2 – boiler/engine room, from the south-east
