Barn at Blackburn House
Thorpe, North Yorkshire:
Historic Building Record

OASIS project ID: stephenh1-317734

The barn or laithe at Blackburn House (NGR: SE 01266 61932) is stone built and presently four bays long, but appears to have been shortened at its north end. Architectural features suggest an 18th or possibly 17th century origin, but the barn has been partially rebuilt, and the present roof is late 19th or early 20th century, while the interior has a modern hay-loft throughout and lacks historic fixtures or fittings. Recording was carried out for Liz Gamble, before conversion of the building, to fulfil a condition of planning consent from YDNPA.

- 1.1 This report presents the results of the recording of the barn at Blackburn House, at Thorpe, North Yorkshire. It was commissioned by the owner Liz Gamble, to fulfil a condition of planning consent from the Yorkshire Dales National Park Authority (YDNPA), for the conversion of the building. The survey was carried out in May 2018.

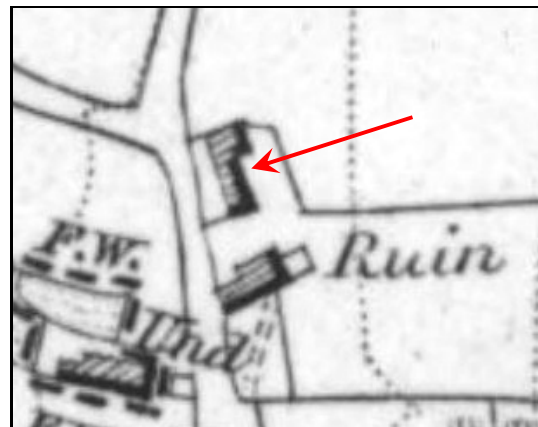
4: OS 1:10560 map, 1853³

7.1 The Ordnance Survey’s first edition 1:10560 map, published in 1853, shows the barn with an L-shaped outline, and perhaps longer than at present at the north end, thereby raising the possibility that the building has been shortened since the mid 19th century (figure 4). The first and second editions of the 1:2500 map, published in 1891 and 1909 (figures 5 and 6) show a plan much closer to the present one, albeit with a shallow projection at the east side, likely to have been some form of porch adjoining the barn’s main entrance.

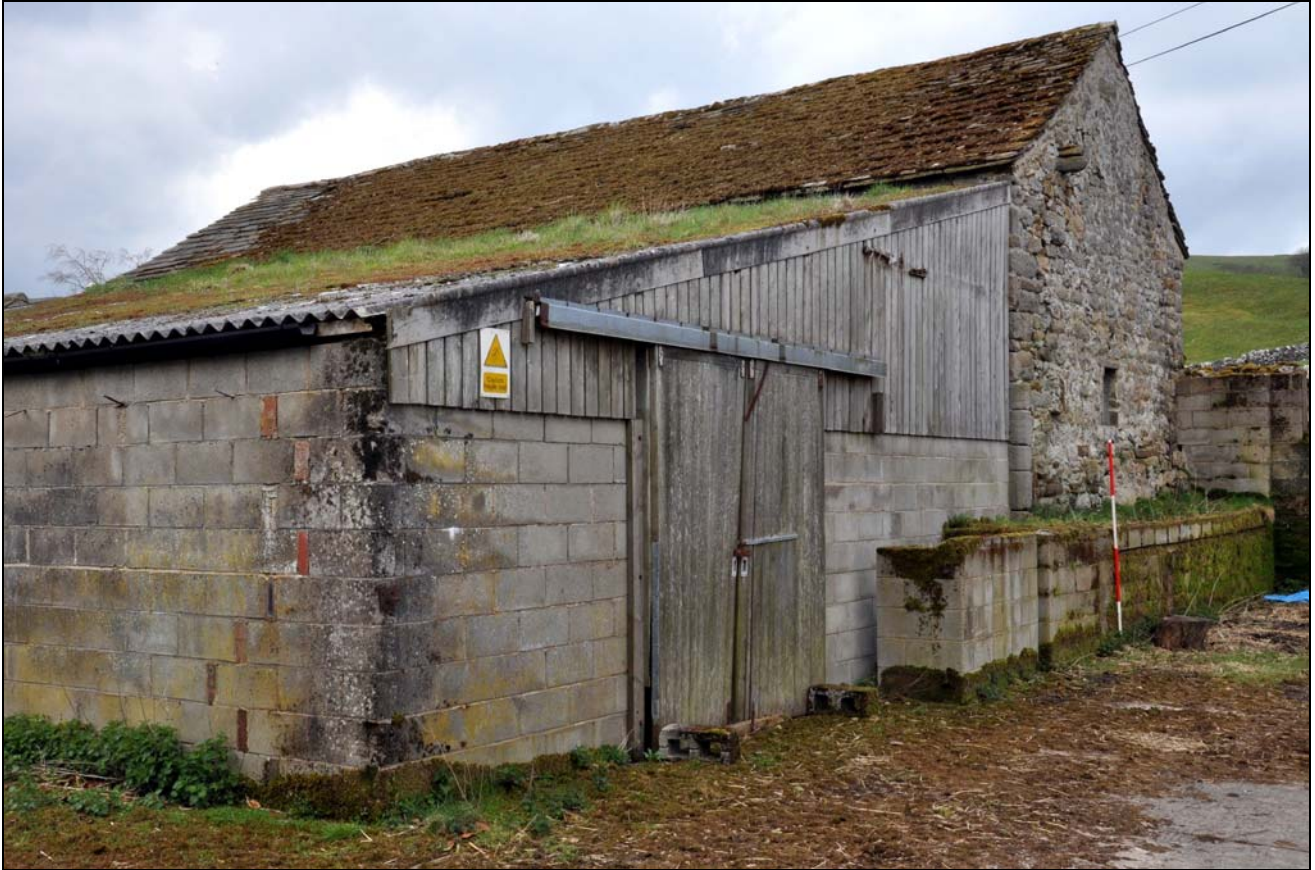
- 9.1 The barn forms part of a small farmstead, with the detached farmhouse to the south, a modern shed adjoining on the east side, and a larger, detached modern shed further to the north, along with concrete yards and slurry pit. The adjoining modern shed conceals the barn's front elevation (**1**), while the rear is also largely hidden from view, by the roadside dry-stone wall, and the modern garage (**2**).

Photo 1: General view of the barn, from the north-east

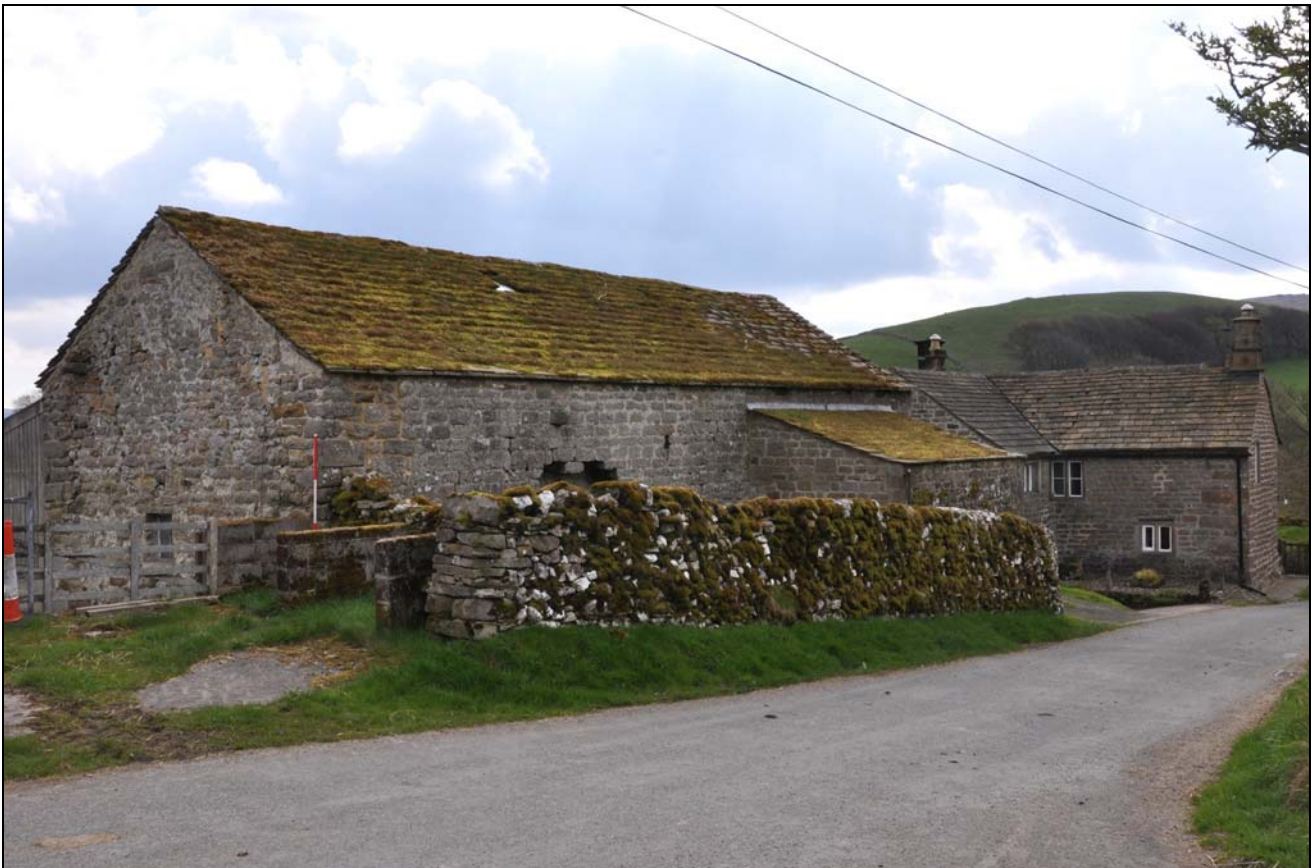
Photo 2: General view of the barn, from the north-west

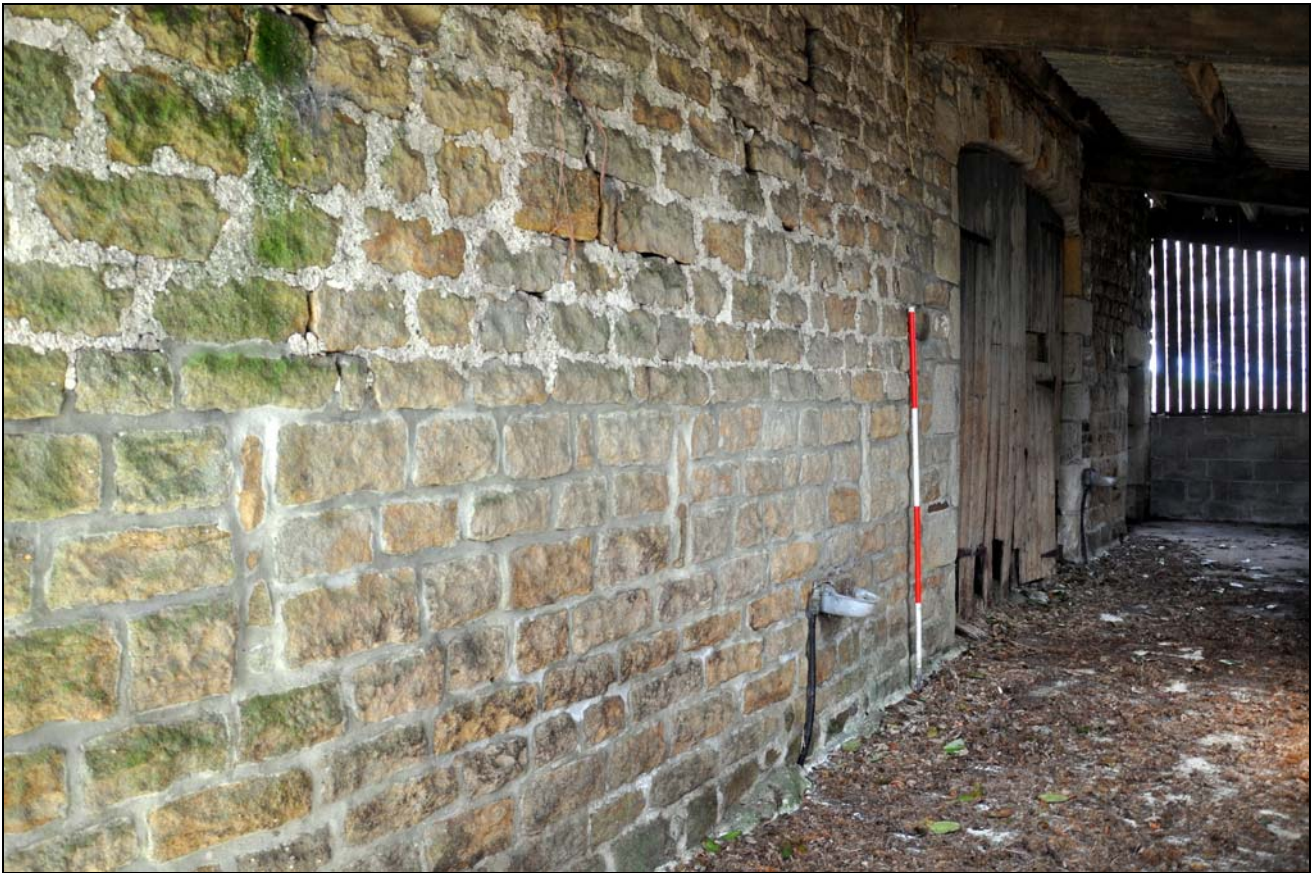
- 9.3 The building's front wall is of well-coursed sandstone or gritstone for the most part (**3**) and incorporates two rows of breathers (many now blocked), as well as the cart entry, in the form of a full-height, wide doorway with shallow segmental arch (**4**). The doorway is designed for outward-opening doors, as jambs and arch are recessed to the exterior (**5,6**), with driven-in iron pintels, to which are attached a variety of strap hinges. The pair of doors themselves have relatively modern softwood planks, which are probably more recent than the earliest parts of the frames.

Photo 3: Front elevation, from the south-east

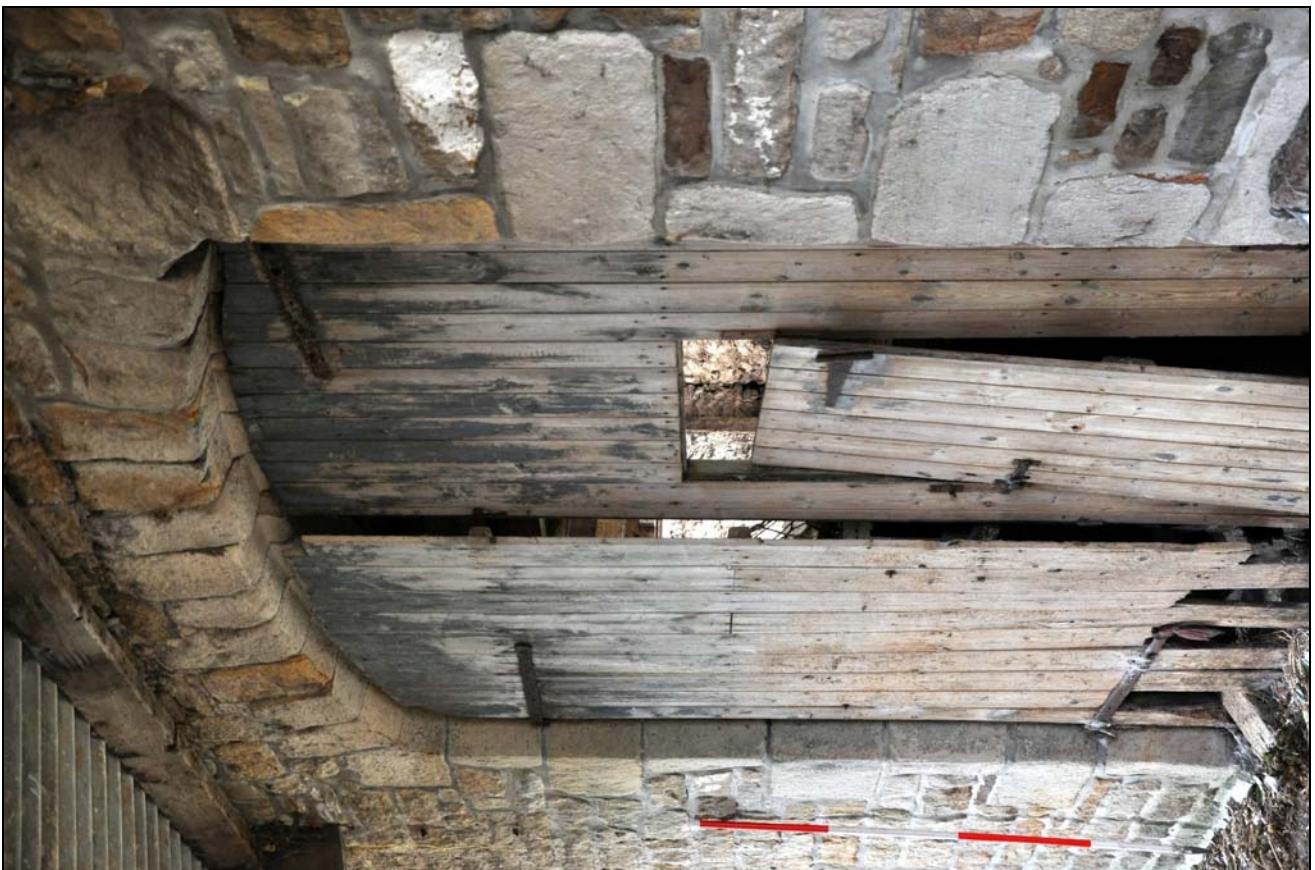
Photo 4: Cart entrance, from the north-east

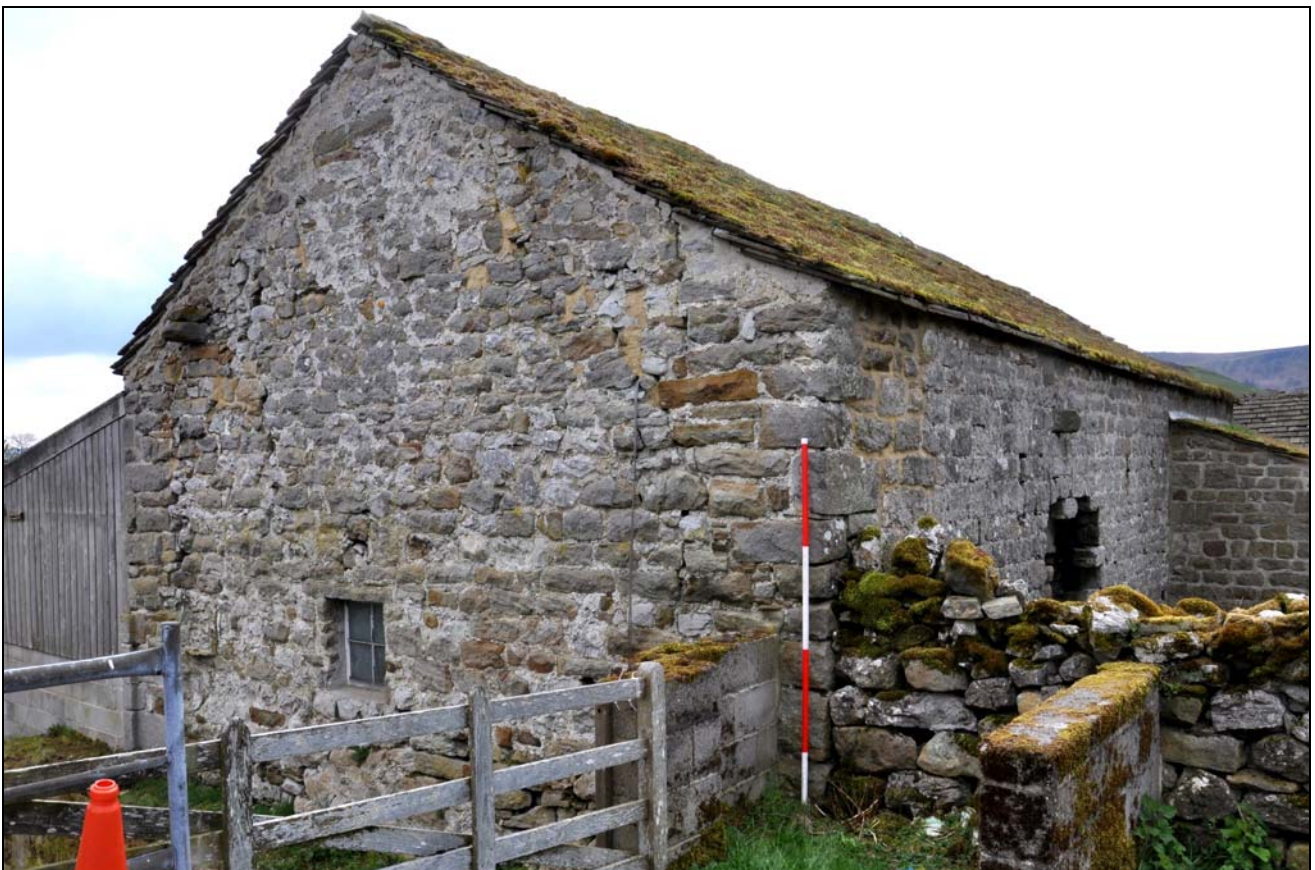
- 9.5 Close to this second doorway is the south jamb of an identical opening, now situated at the barn's north-east corner (**8,9**), with the obvious implication that the building once continued further north than at present. By inference, the present north gable would then have been an internal wall, which probably accounts for its rather ragged stonework, although it has no doubt been subject to some rebuilding, particularly at the quoins (**10,11**). Three further items within this wall are noteworthy: a small, glazed opening, likely to have been inserted as a mucking-out hole; a small, poorly defined, blocked opening close to the partial doorway at the east end; and a stone which projects out from the wall face by about 0.3m above it, with no obvious purpose.

Photo 11: North gable (former internal wall), from the north-west

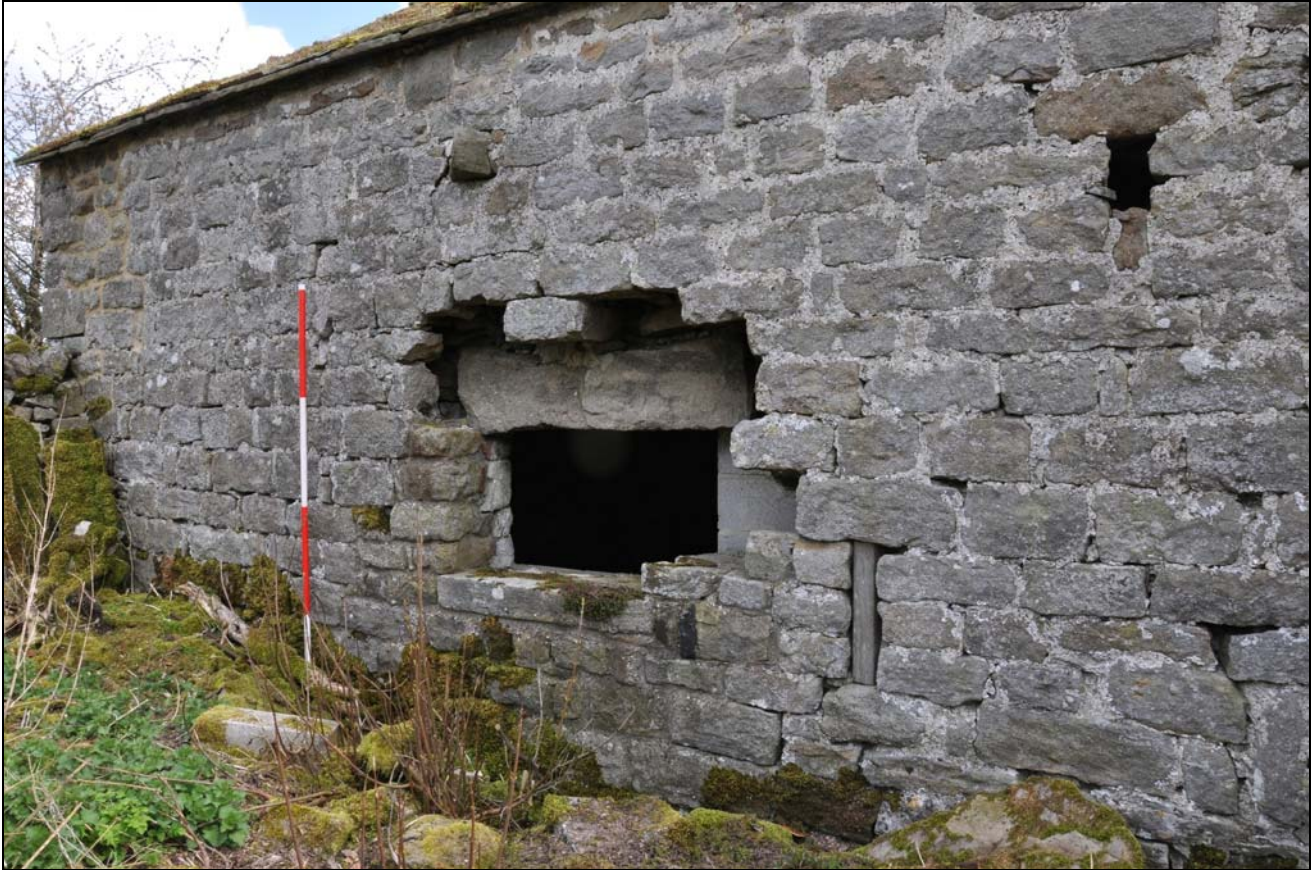
- 9.6 The barn's two other external walls are faced with well-coursed sandstone and gritstone (**12,13**). The rear, west side has two rows of breathers discernible, of two types: two low down in the wall have upright jambs, but the majority have no dressings and are simply formed from gaps within the stonework (**14**). The former appear stylistically to be earlier than the latter, suggesting there are two phases of construction or usage within the building, and this is borne out to some degree by a slight set-back visible within the building (see below). The present poorly formed window opening, altered in recent years, appears to be a former pedestrian doorway (or winnowing doorway). At the south end of the rear, the present stone-built lean-to garage is a recent addition.

Photo 13: Present window (former doorway) in west elevation, with adjacent breathers

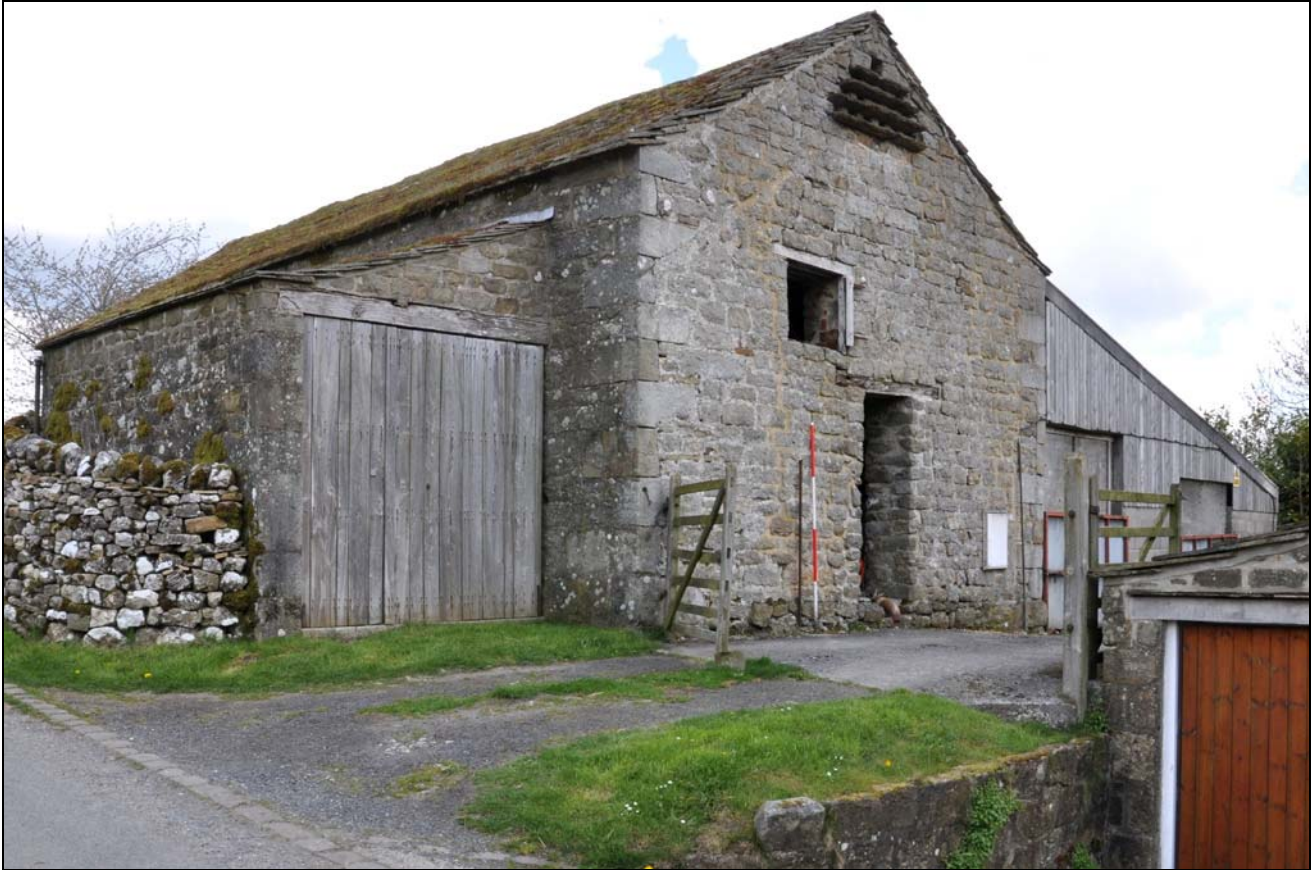
- 9.7 The doorway and forking hole in the south gable are the result of insertion or alteration, but the openings and landing ledges to the pigeon loft above are original (**16-18**).

Photo 16: General view of the barn, from the south-west, with modern garage

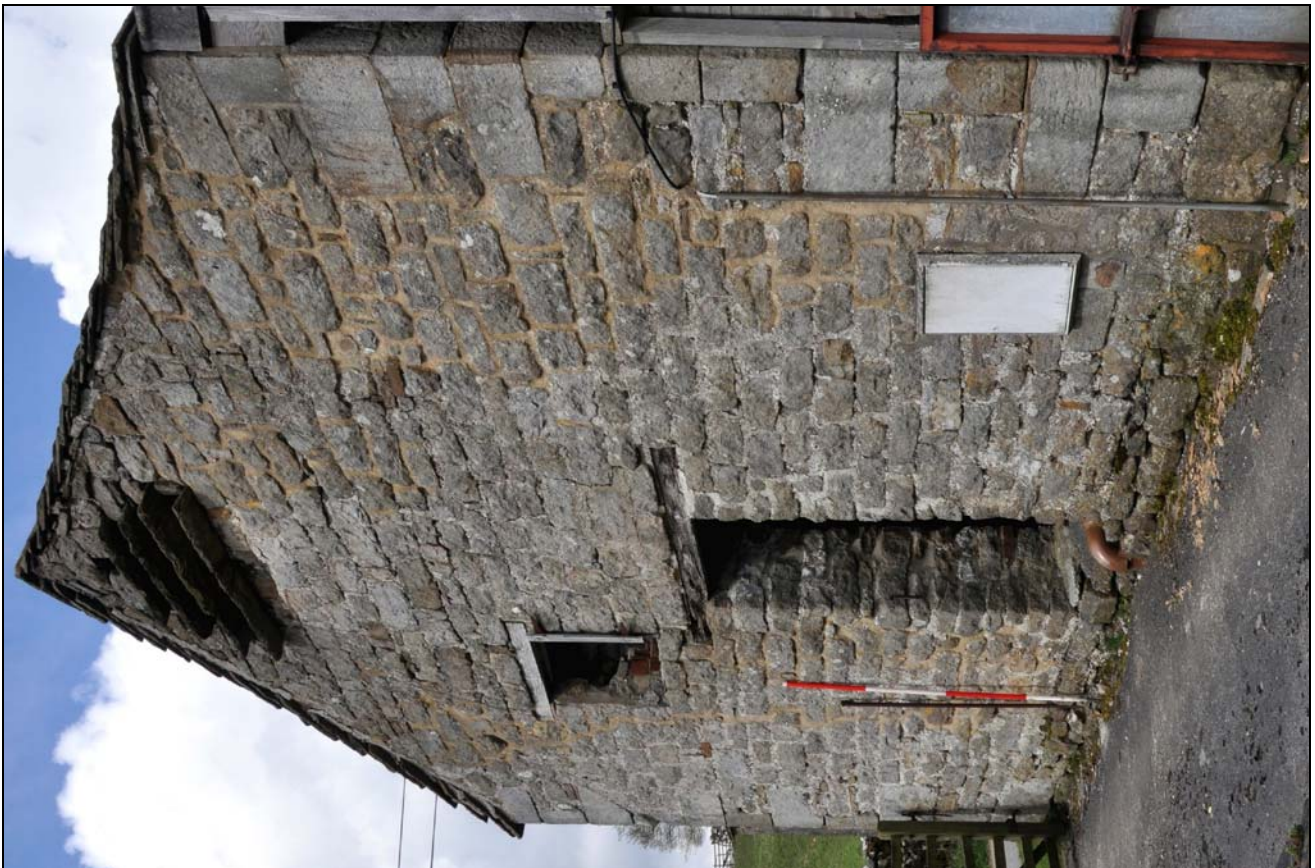
Photo 17: South gable, from the south-east

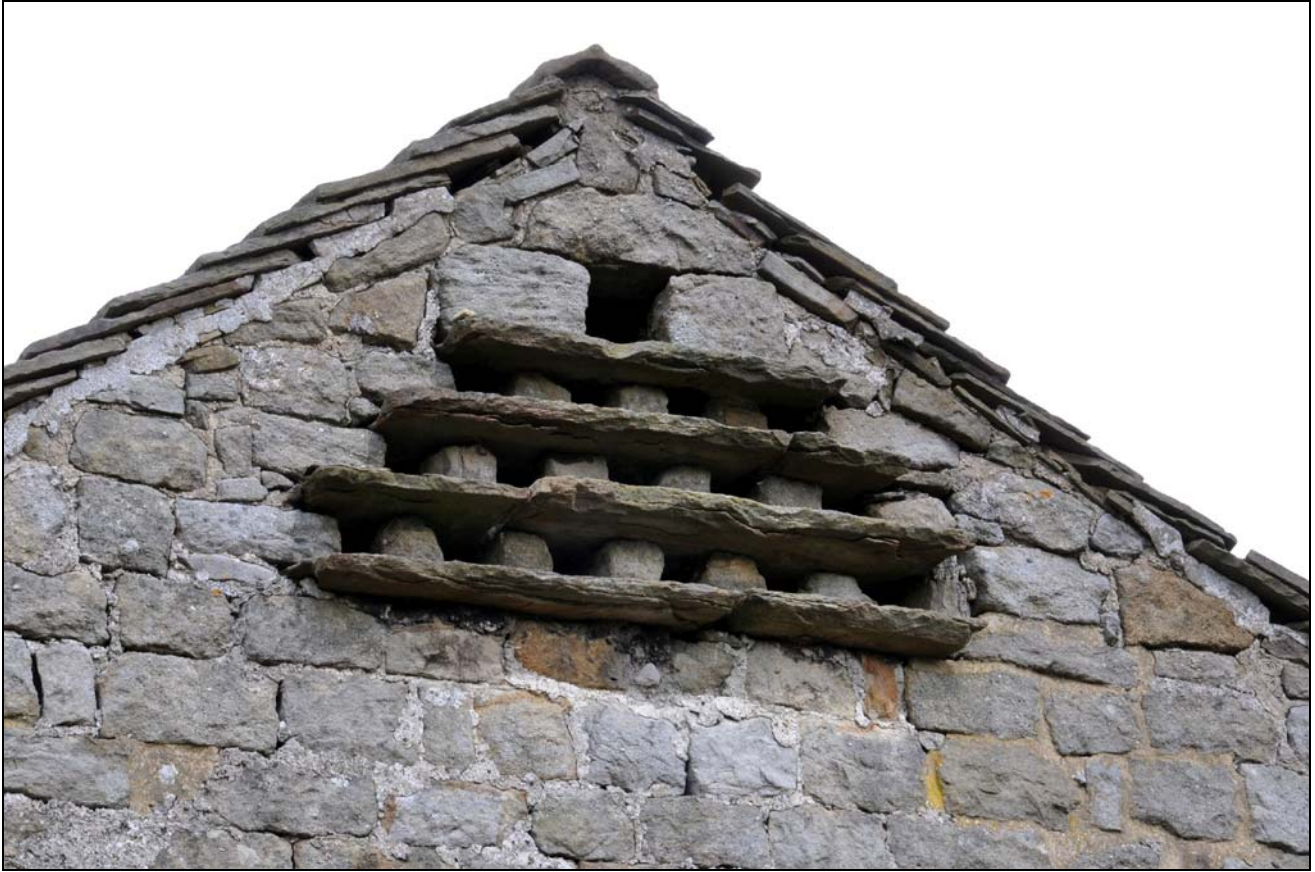
Photo 18: Detail of pigeon loft in south gable

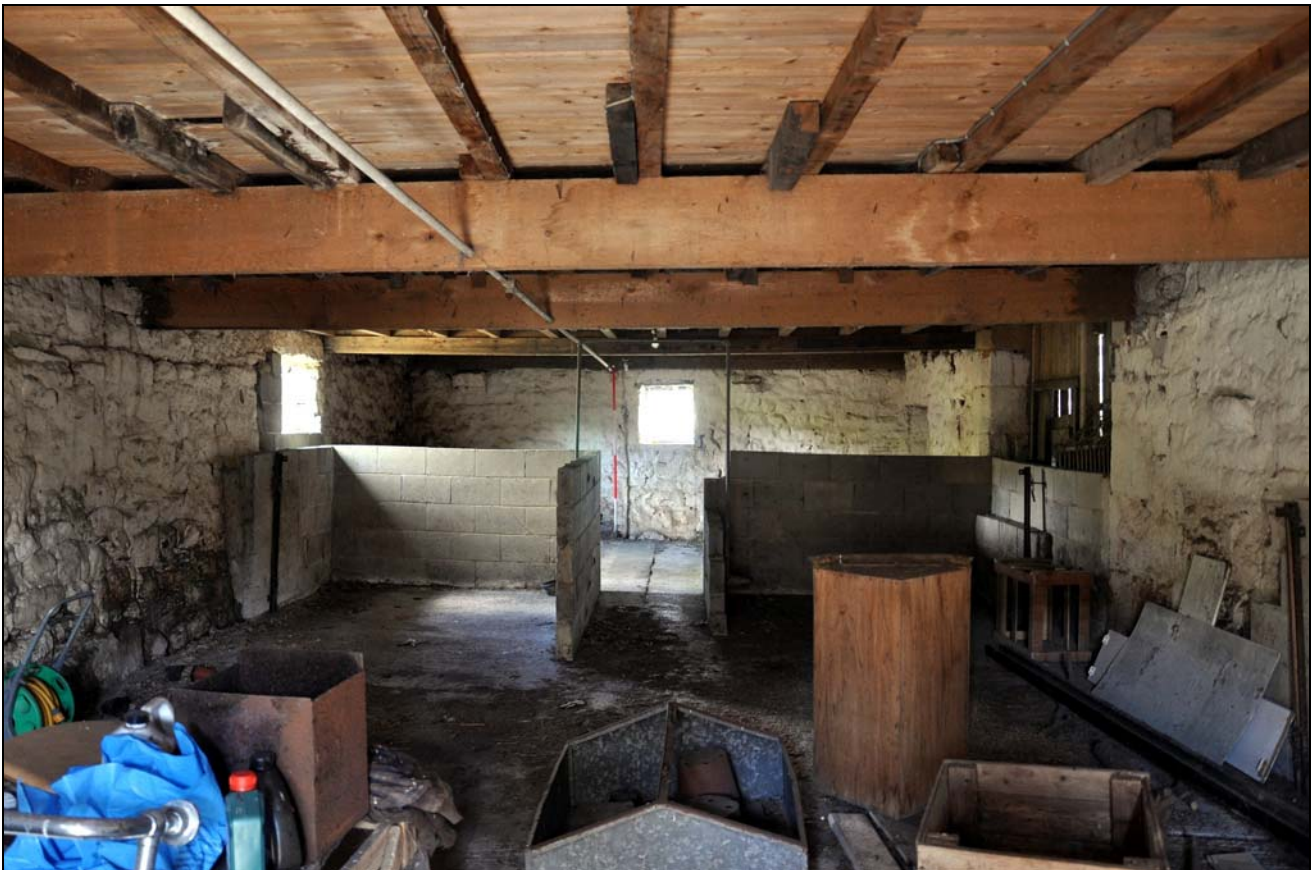
- 9.8 The barn interior has been much altered in the mid or late 20th century. It now has a concrete floor on a single level (up to about 0.3m higher than the historic level), with some blockwork partitions, and an entirely modern, full-length hay-loft which cuts across the cart doorway (**19-21**). The pedestrian doorway at the north-east corner implies the former presence of a shippon within the northern end of the barn, and there are sockets in the east wall which may have held the beams of a hay-loft or baulks within the north bay, over this (**22-24**).

Photo 19: Interior: ground floor, from the south

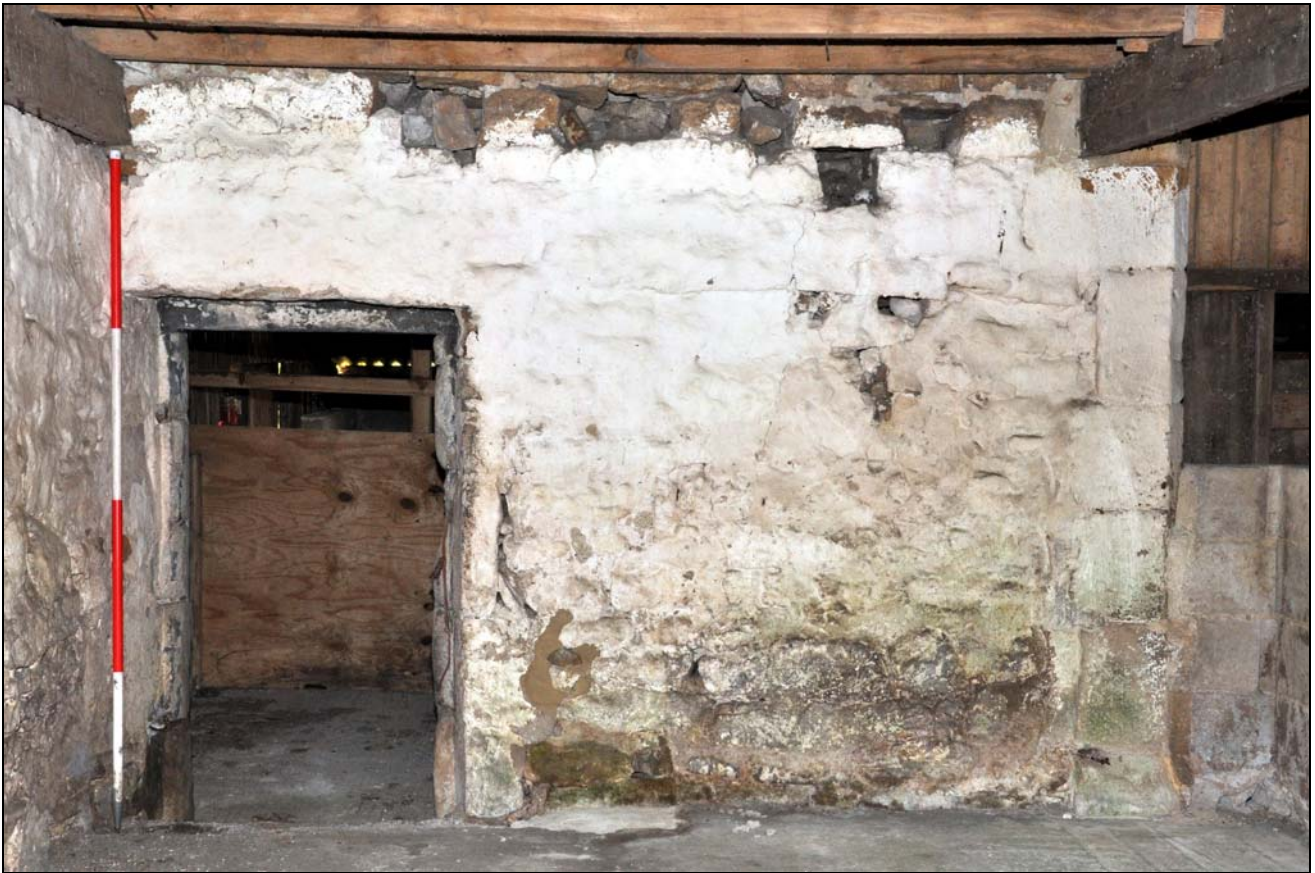
Photo 22: Interior: site of former shippon at north end, from the west

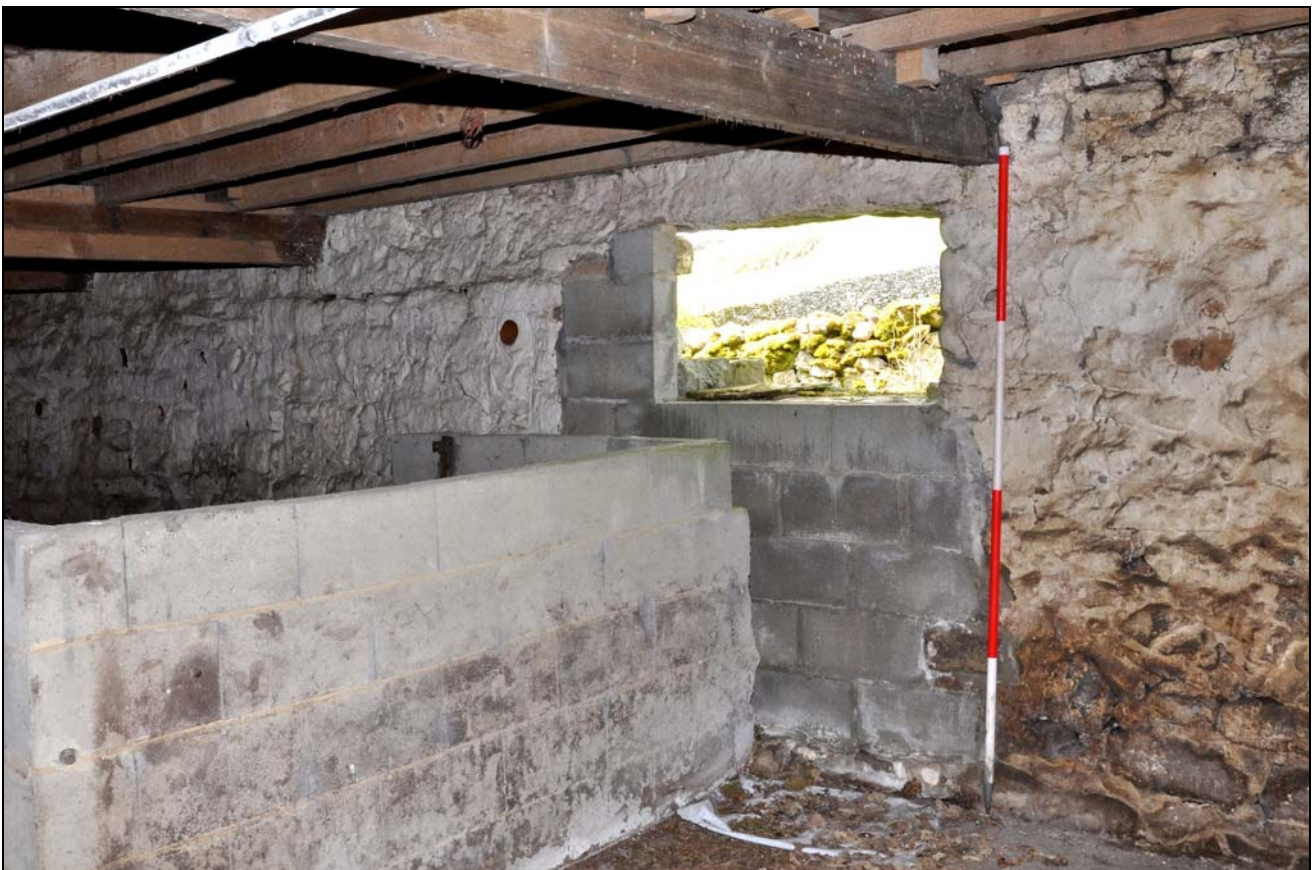
- 9.9 There is a slight set-back in the west wall, south of the present window, which can be interpreted as rebuilding of the upper part of the wall, as noted previously (**25,26**). The ventilation pipes incorporated in this and the east wall opposite occupy the infill of the original, traditional splayed breathers noted externally (**27**).

Photo 25: Interior: former doorway in west wall

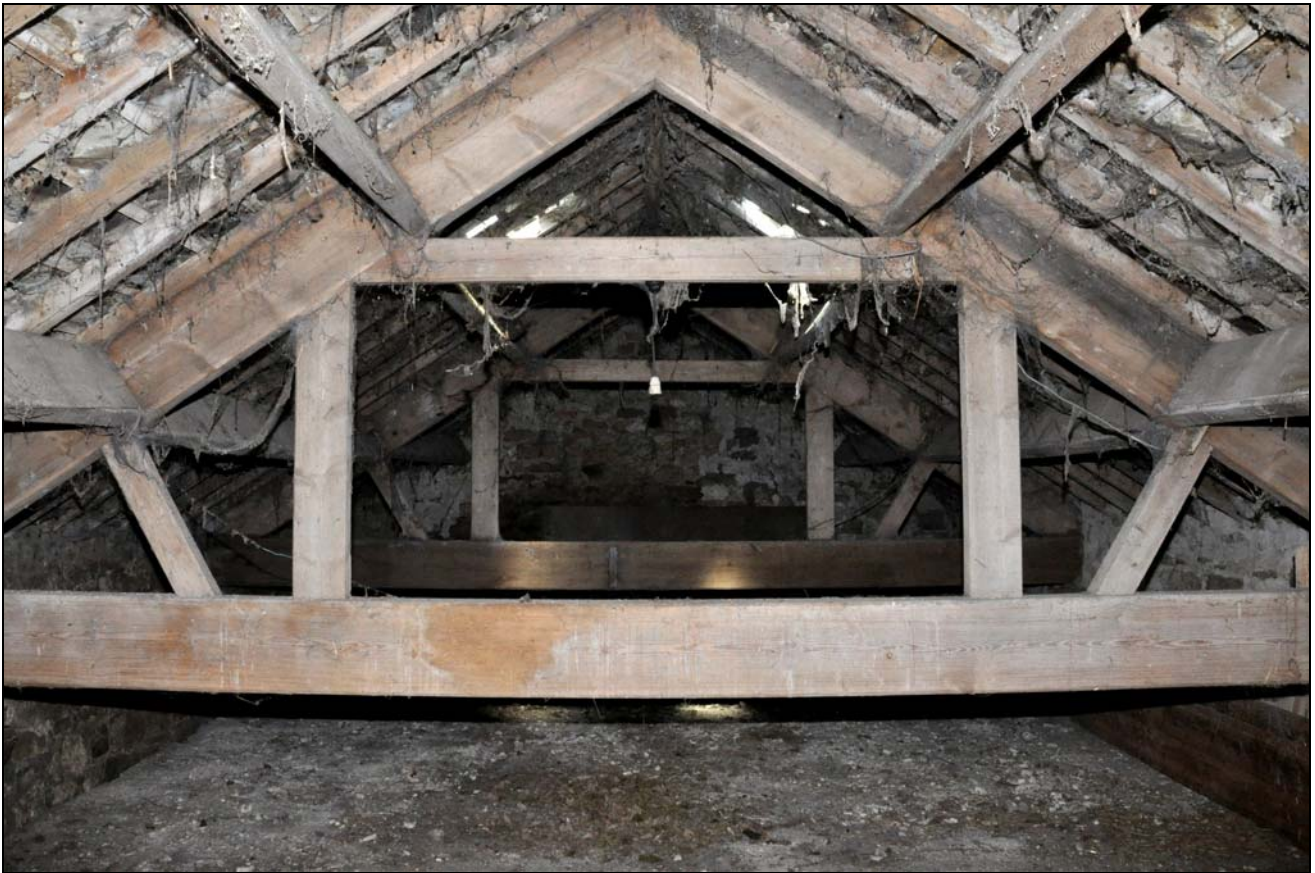
- 9.10 The present roof trusses are late 19th or 20th century and are of square-sawn, imported softwood, of queen strut design **(28-30)**. They do however appear to occupy the approximate positions of their predecessors, for which corbels were incorporated within the stonework **(31)**.
- 9.11 Openings in the south gable represent the pigeon loft indicated externally **(32)**, though there is no sign of any internal timber structure associated with this.

Photo 29: Interior: roof trusses, from the south

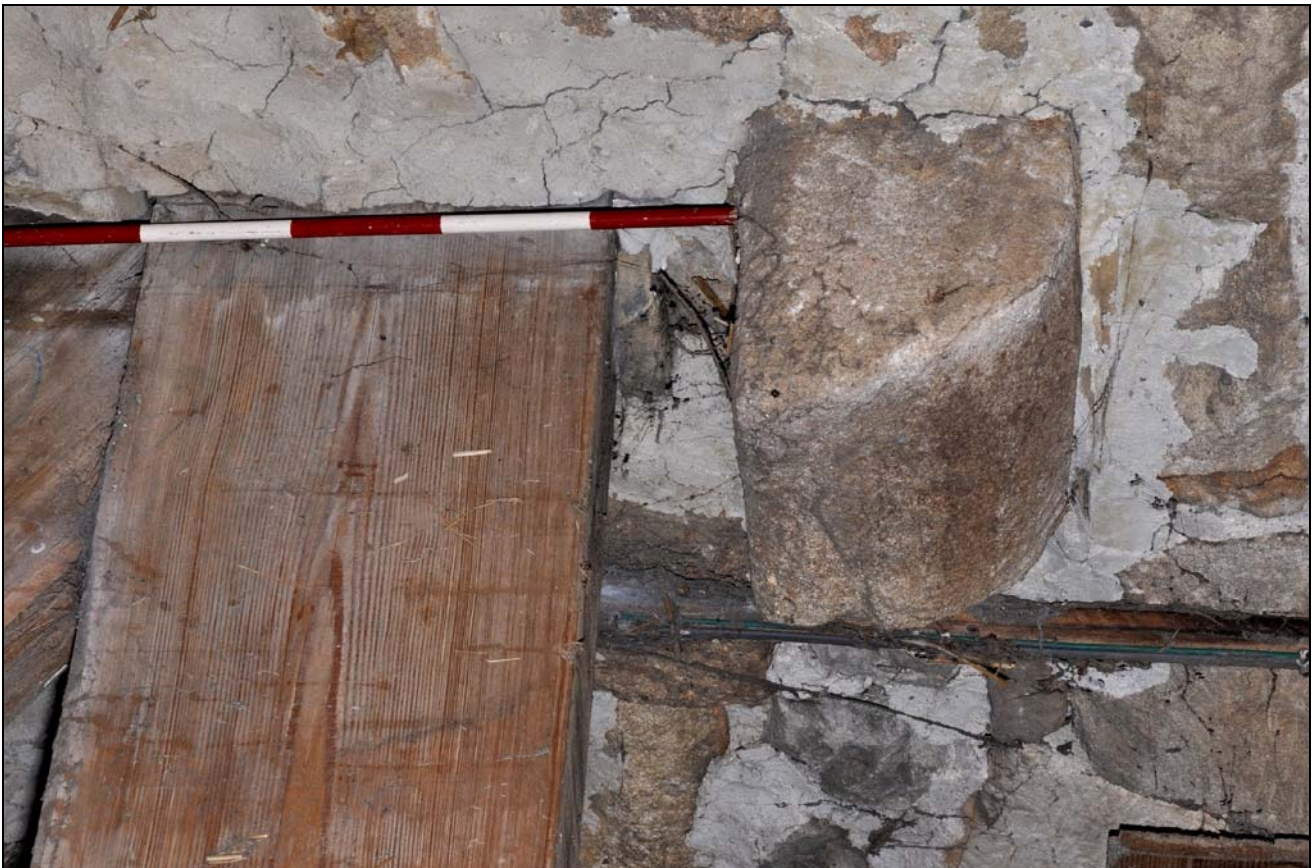
Photo 31: Interior: detail of roof truss corbel in east wall
