123 Smith House Lane
Lightcliffe, Halifax, West Yorkshire:
Structural Watching Brief

March 2019

STEPHEN HAIGH

OASIS project ID: stephenh1-342540

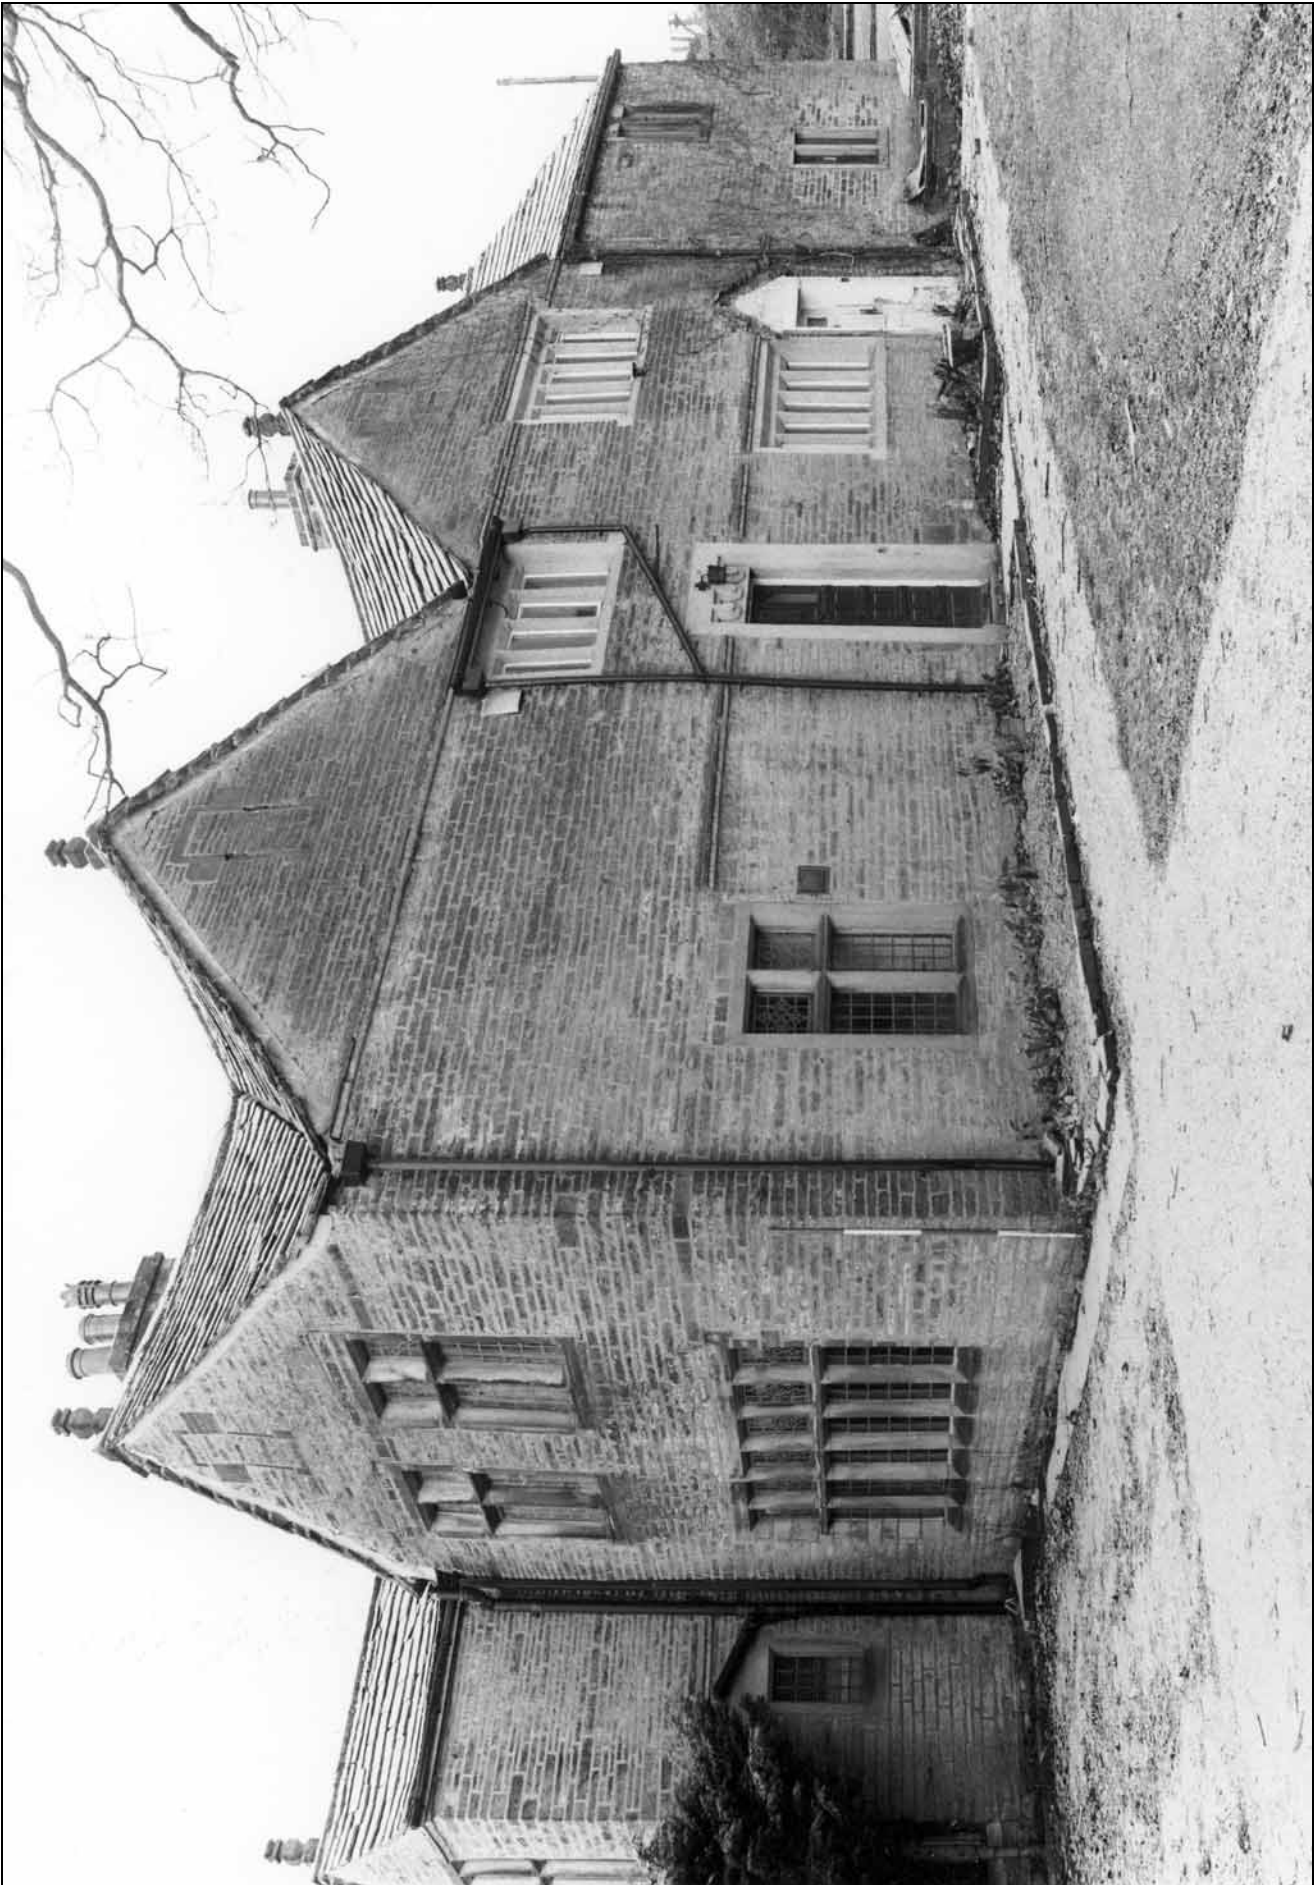
- 8.1 The wing is built from coursed sandstone of local origin, with sandstone ashlar dressings (not all original), and stone slate roof with gable finials. It faces east, its south side being in line with the main house, although set back from the projecting south porch, of which the first floor (but not the ground floor) forms part of no. 123 **(1)**.

Photo 1: The east wing of Smith House, looking north-west (film 1, frame 2)

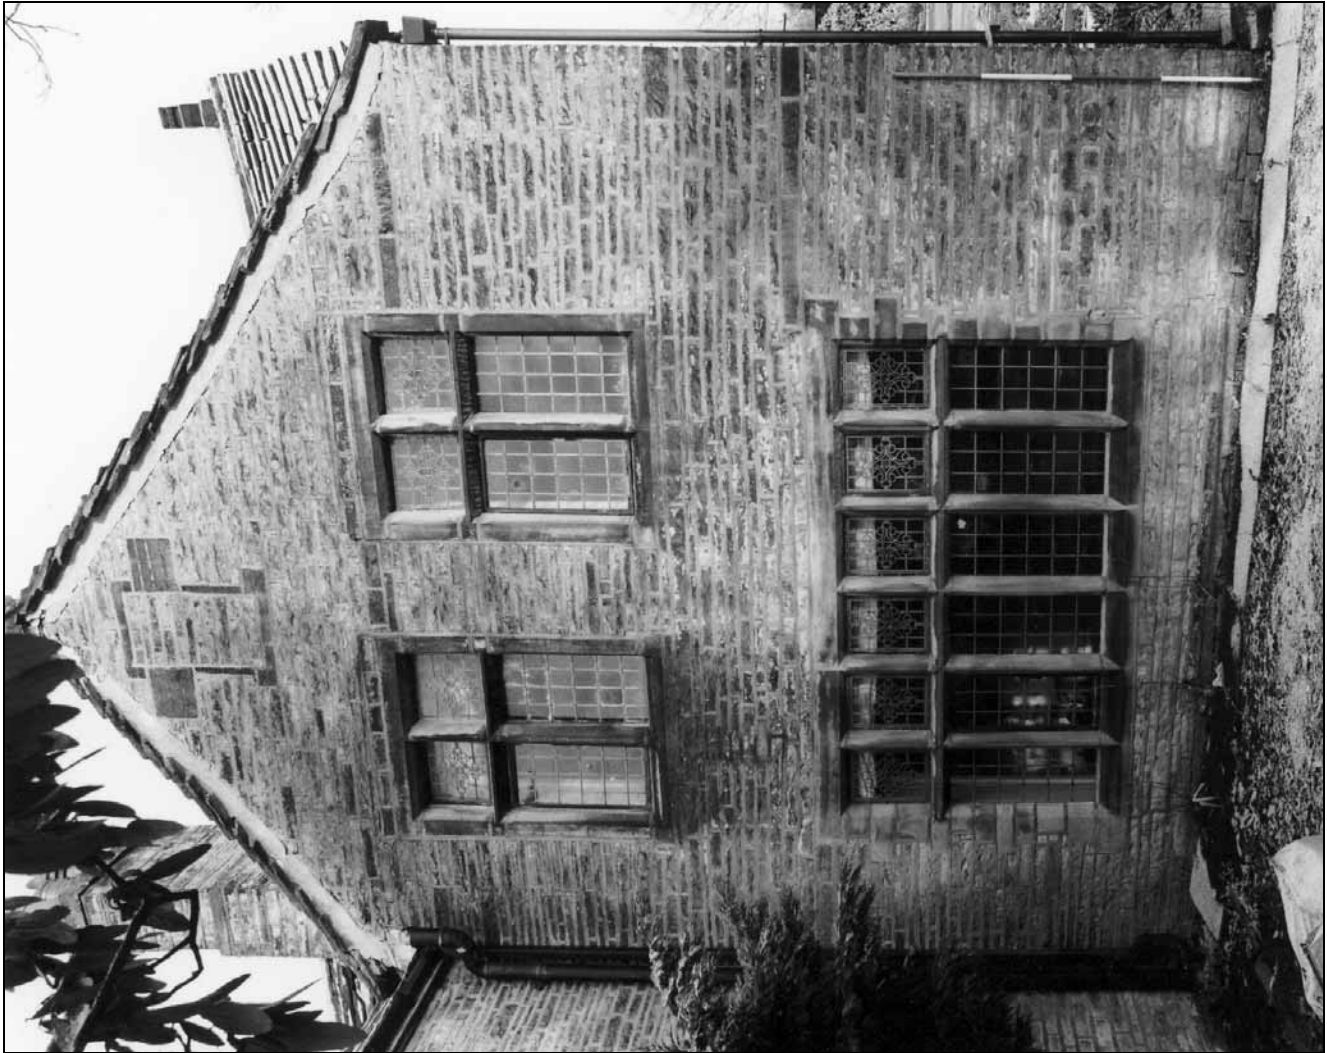
- 8.2 The south end of the east wing, which forms part of the house front, has tall, early 20th century mullioned and transomed windows to both floors, and a blocked single-light opening to the gable **(2)**.

Photo 2: South end of east wing, looking north-west (film 1, frame 1)

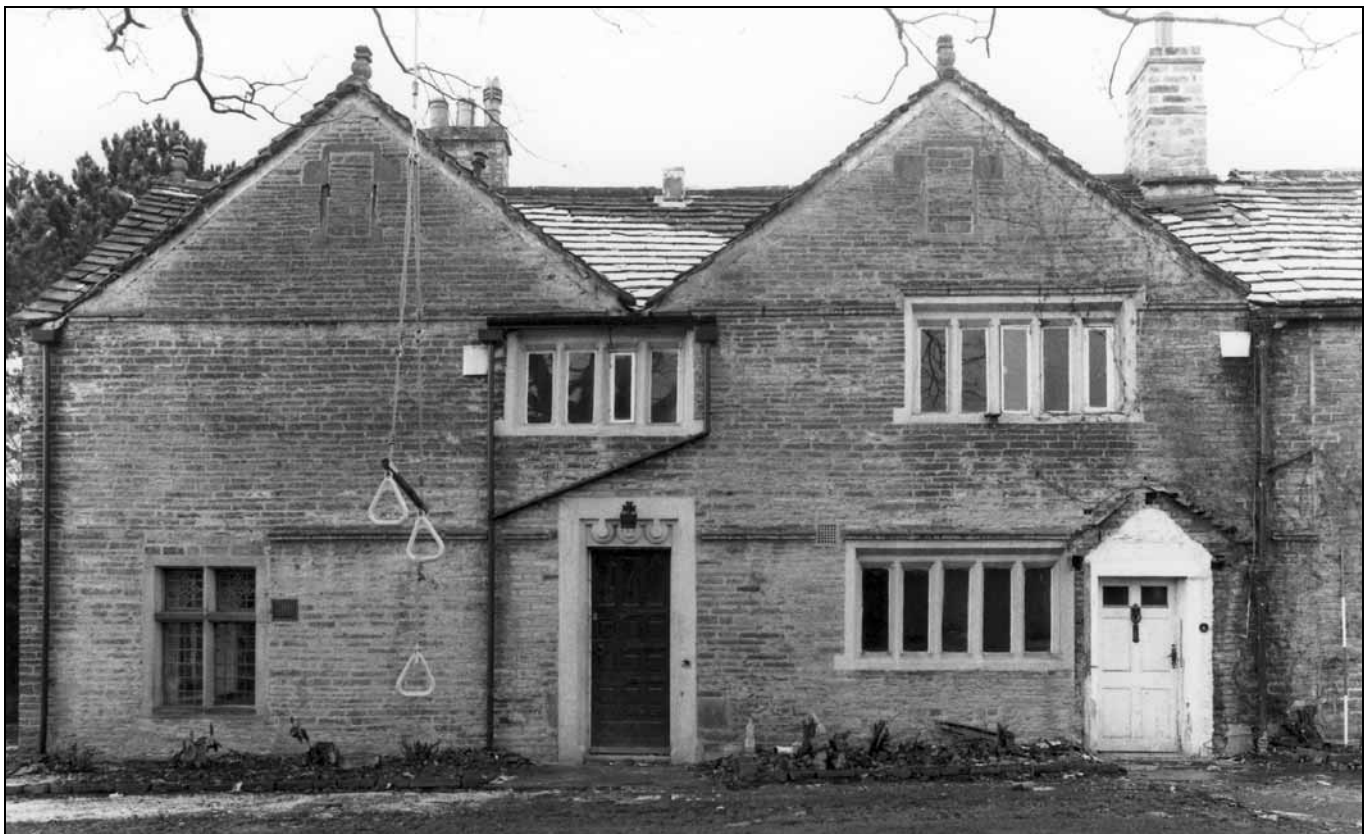
- 8.3 The east side of the wing's 17th century part **(3)** has a central doorway with chamfered jambs and decorated lintel **(4)**, but the height and style of this entrance, and the fact that it breaches the moulded string course, indicate that it is 19th or early 20th century, though it is possibly in the position of an earlier entrance. A second, lower doorway with plain surround is positioned further to the right, and is of 18th century form. Windows in this elevation vary: the ground floor, double-chamfered opening of five lights to the historic kitchen appears intact, as do the similar openings to the first floor, over the taller of which the string course steps. There is also a 20th century cross-window to the historic dining room at the south end, and two blocked openings to the pair of gables, matching that in the south-facing gable.

Photo 3: East wing, east elevation: 17th century part (film 2, frame 4)

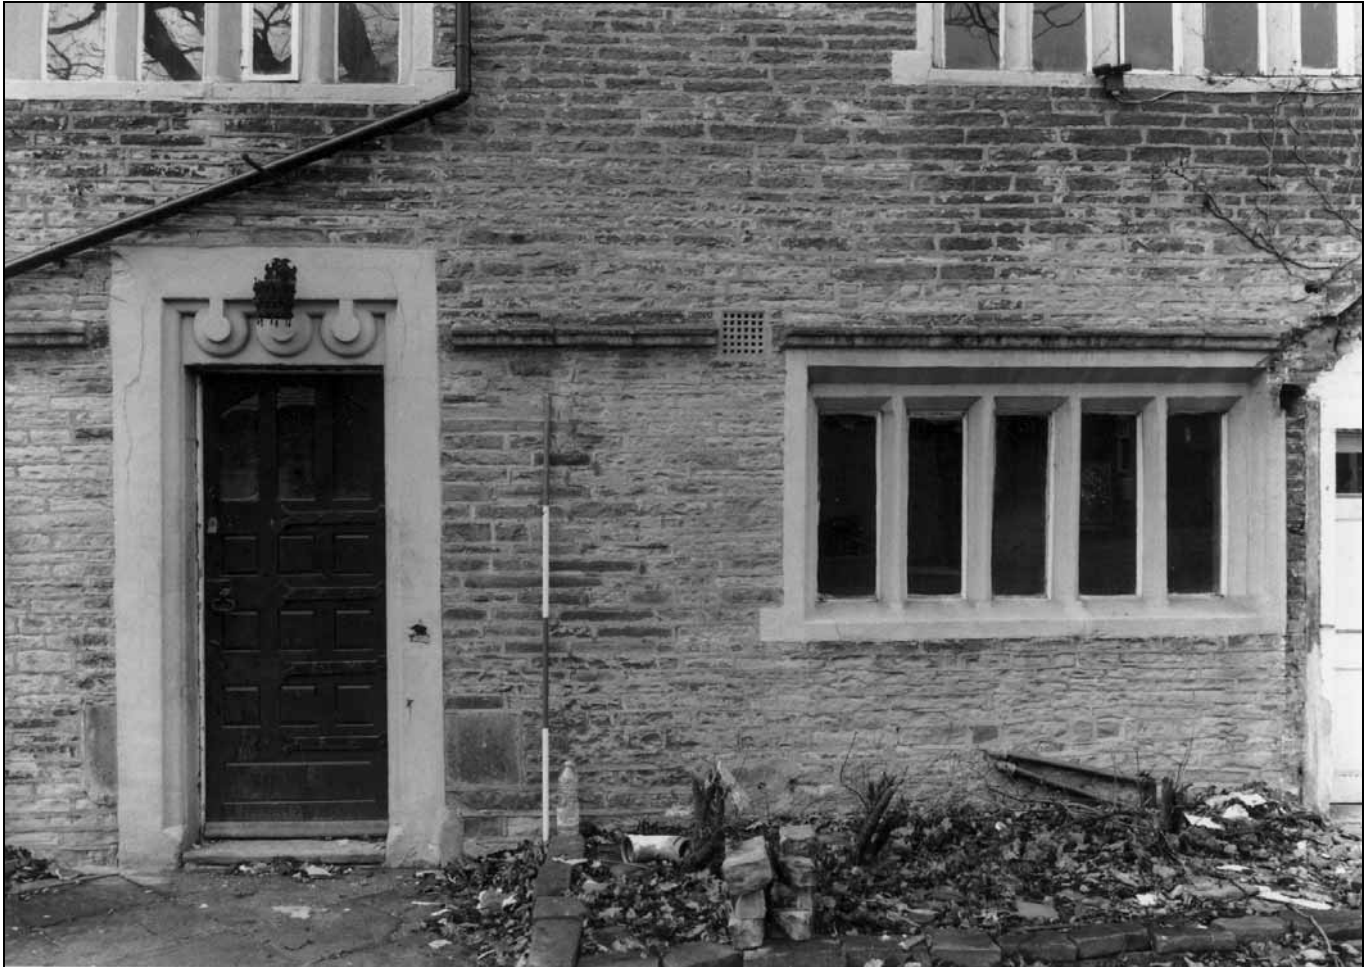
Photo 4: East wing, east elevation: original window and later doorway (film 2, frame 6)

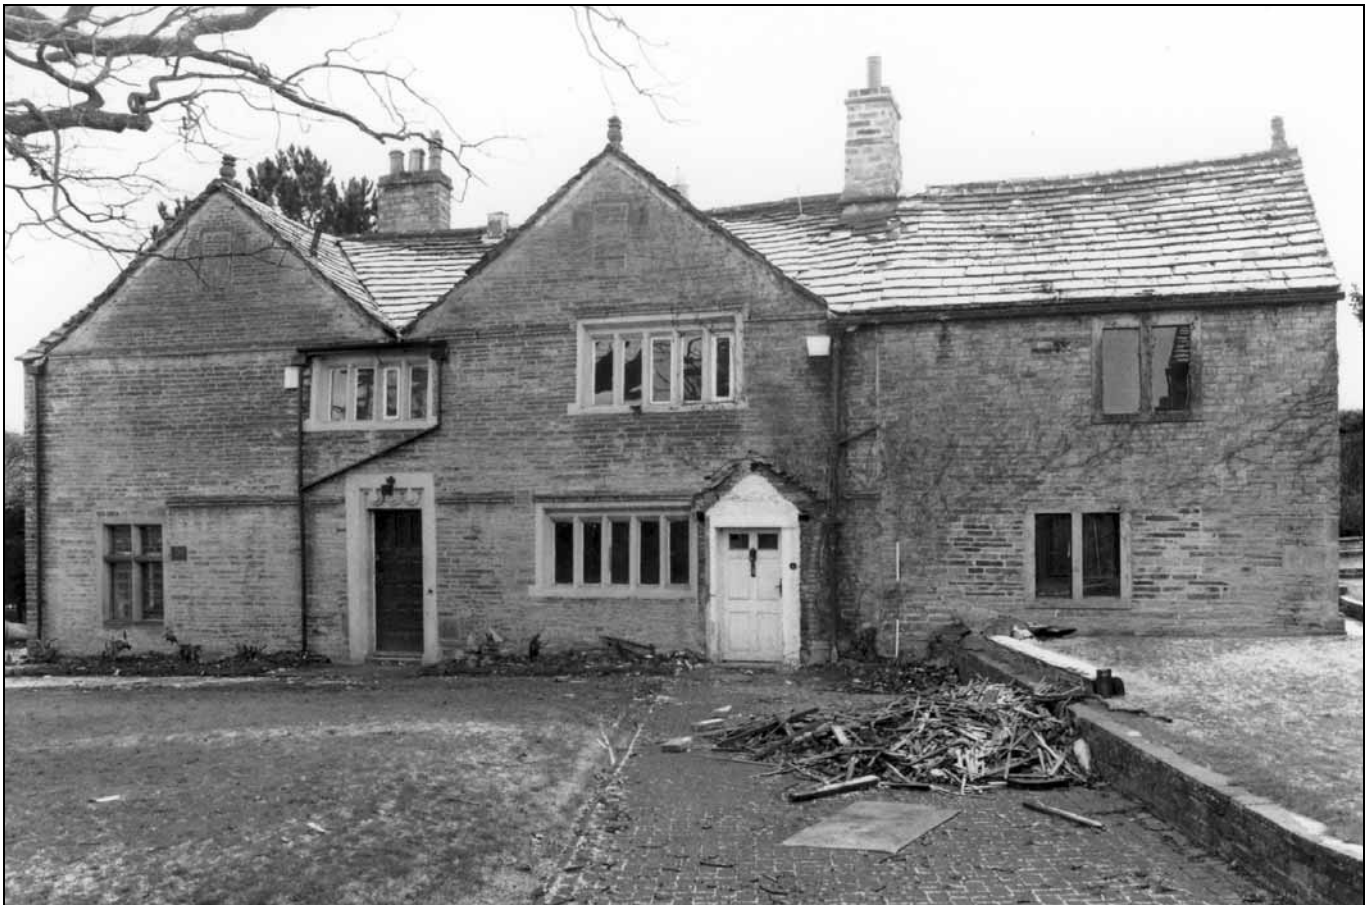
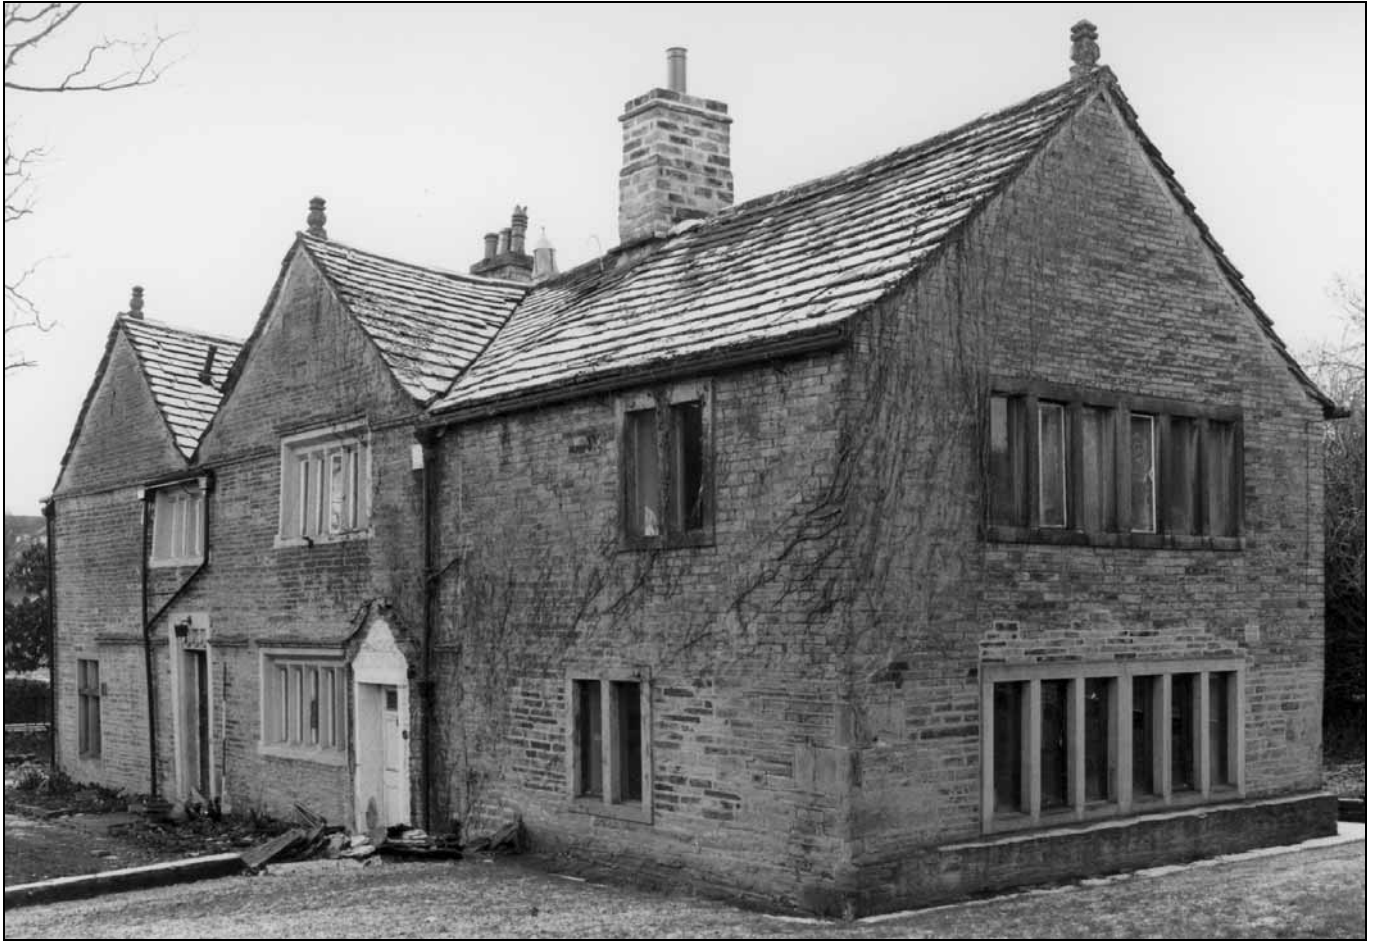
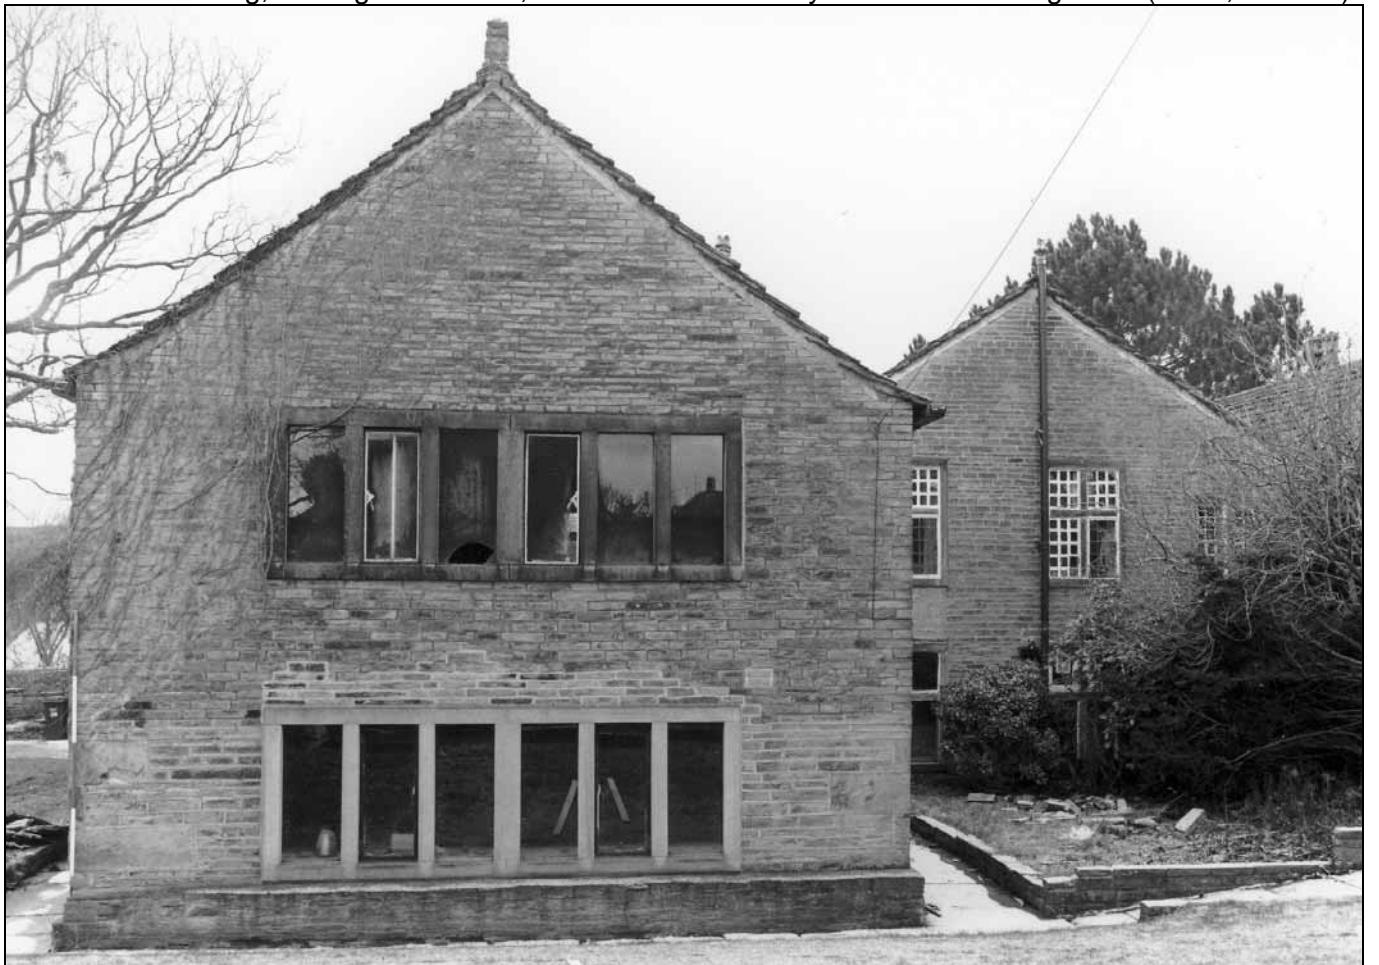
- 8.4 A clear straight joint, together with the end of the string course, indicate the original north end of the wing, beyond which is the late 18th or early 19th century extension **(5-7)**. This addition has large windows with flat-faced surrounds and mullions, at least some of which have been replaced in the 20th century. The upper part of this extension has probably been rebuilt or re-faced, to judge from the fact that the edge-laid quoins at the north end are confined to the lowest part of the wall. As in the east side, the west elevation of the wing has a clear straight joint, showing where the 17th century building ended, and there is a double-chamfered window to the ground floor within this earlier part (the

Photo 5: East wing, east elevation (film 2, frame 5)

Photo 6: East wing, looking south-west, with 18th/19th century extension in foreground (film 2, frame 7)

Photo 7: East wing, north gable (18th/19th century extension) (film 2, frame 8)

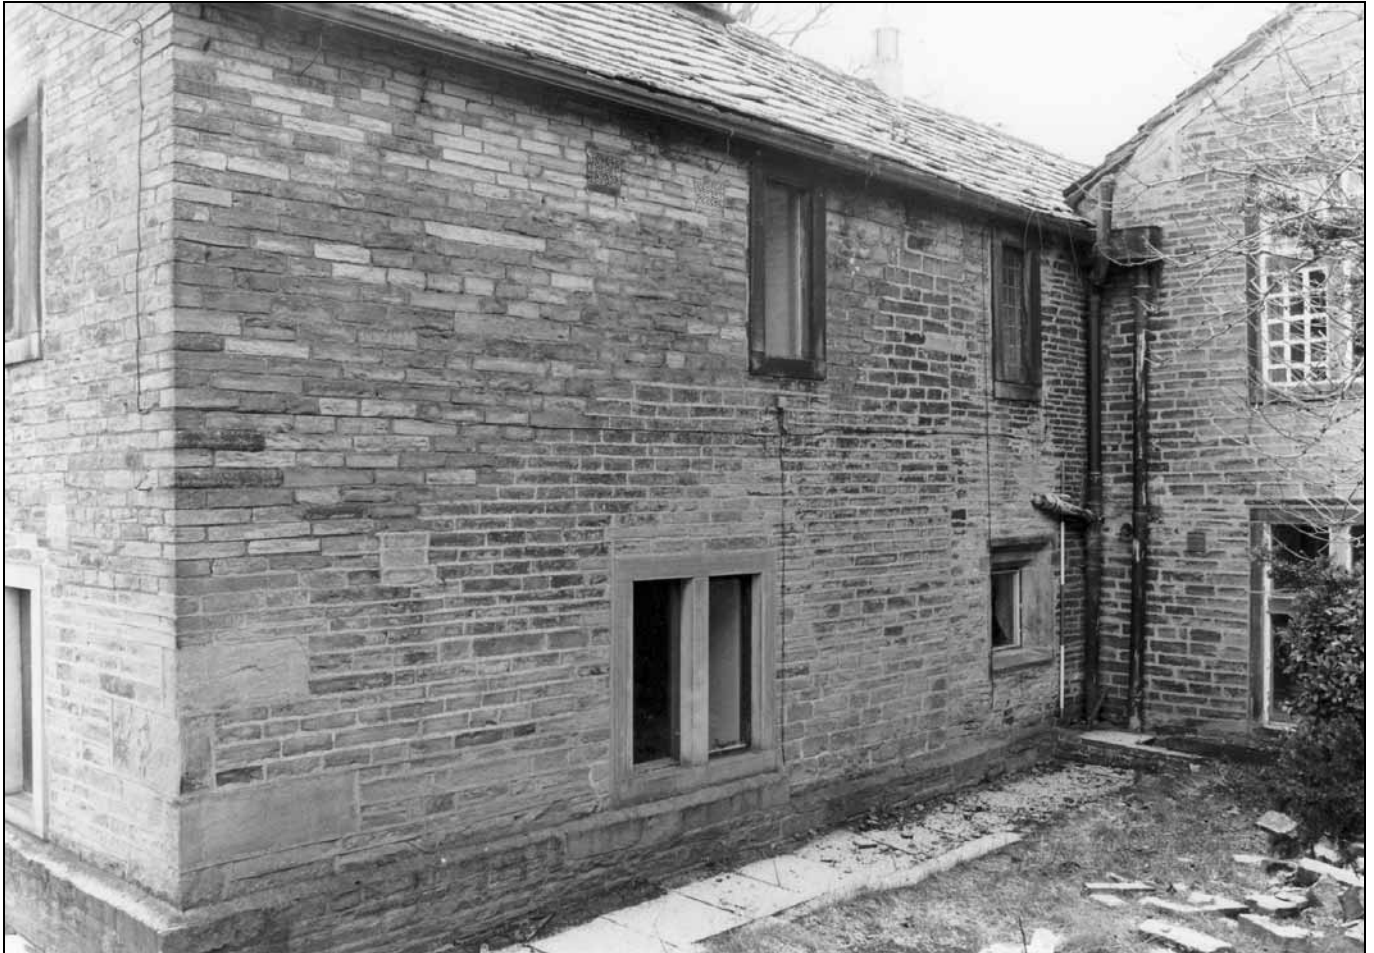
kitchen's fire window), though the opening above it is much later and very different in style (8).

Photo 8: East wing, looking south-east, with 18th/19th century extension in foreground (earlier fire window at lower right) (film 2, frame 11)

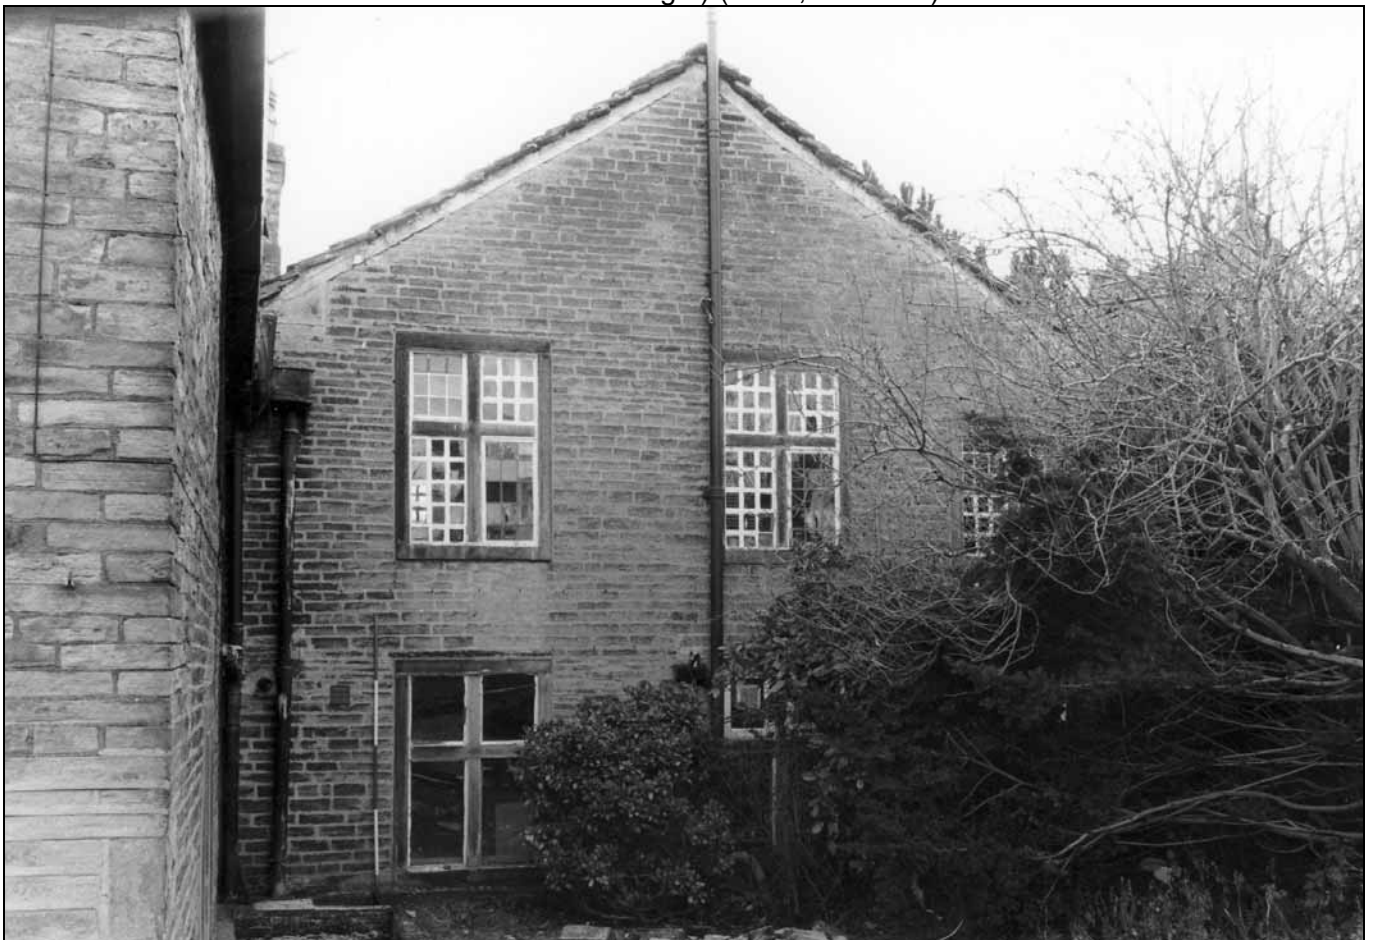
- 8.5 The rear of the main house, which contains part of no.123 on the ground floor (though not on the first floor), forms a two storey gabled block which replaced the original aisle, most likely in the mid 18th century. It has tall cross-windows with flat-faced mullions (9).

Photo 9: Rear of main house, looking south (18th century replacement of aisle) (film 2, frame 13)

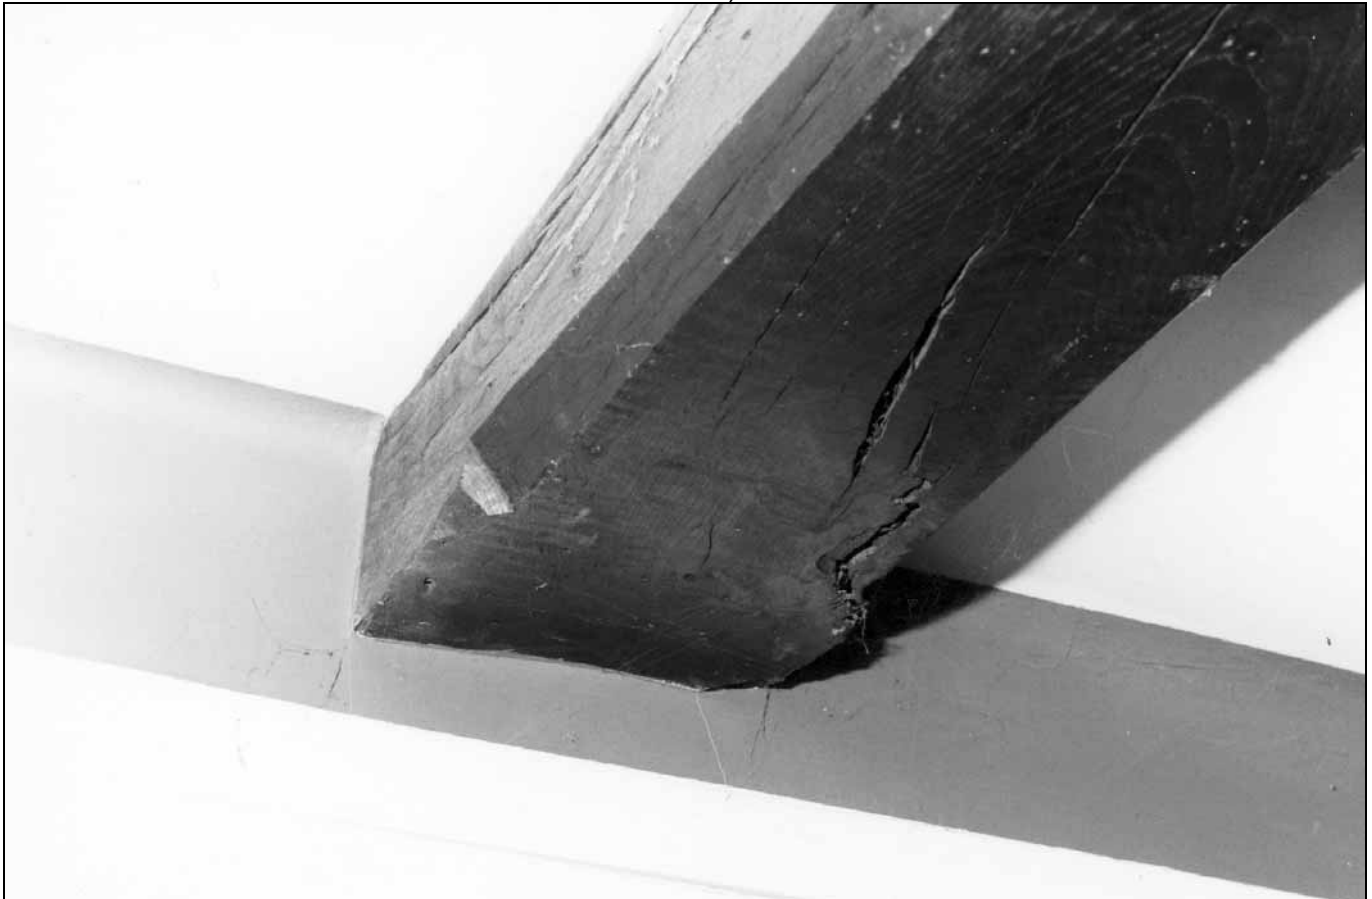
- 8.6 The interior of the east wing has been much altered since the 17th century. The historic "dining room" at the south end appears to have been shortened by its present north wall (although that does coincide with a step up in floor level, which may indicate otherwise), and its character and fixtures are almost entirely 20th century (10-12). However, the two ceiling beams within this room are 17th century, and the north one has plain chamfers and step stops (13).

Photo 13: Stop-chamfered ceiling beam, ground floor of east wing, south room (17th century dining room) (film 1, frame 7)

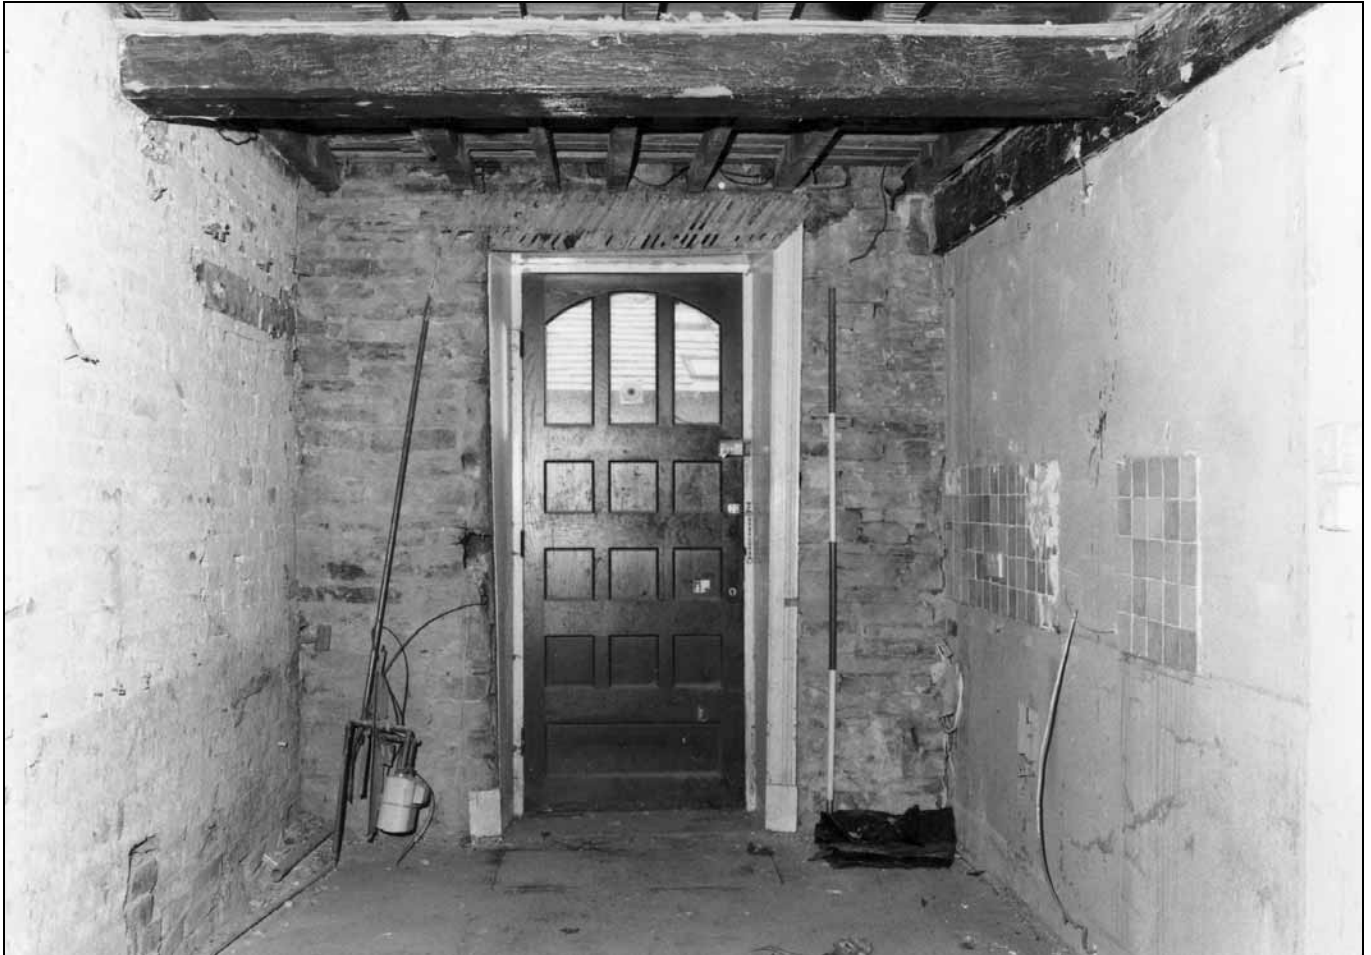
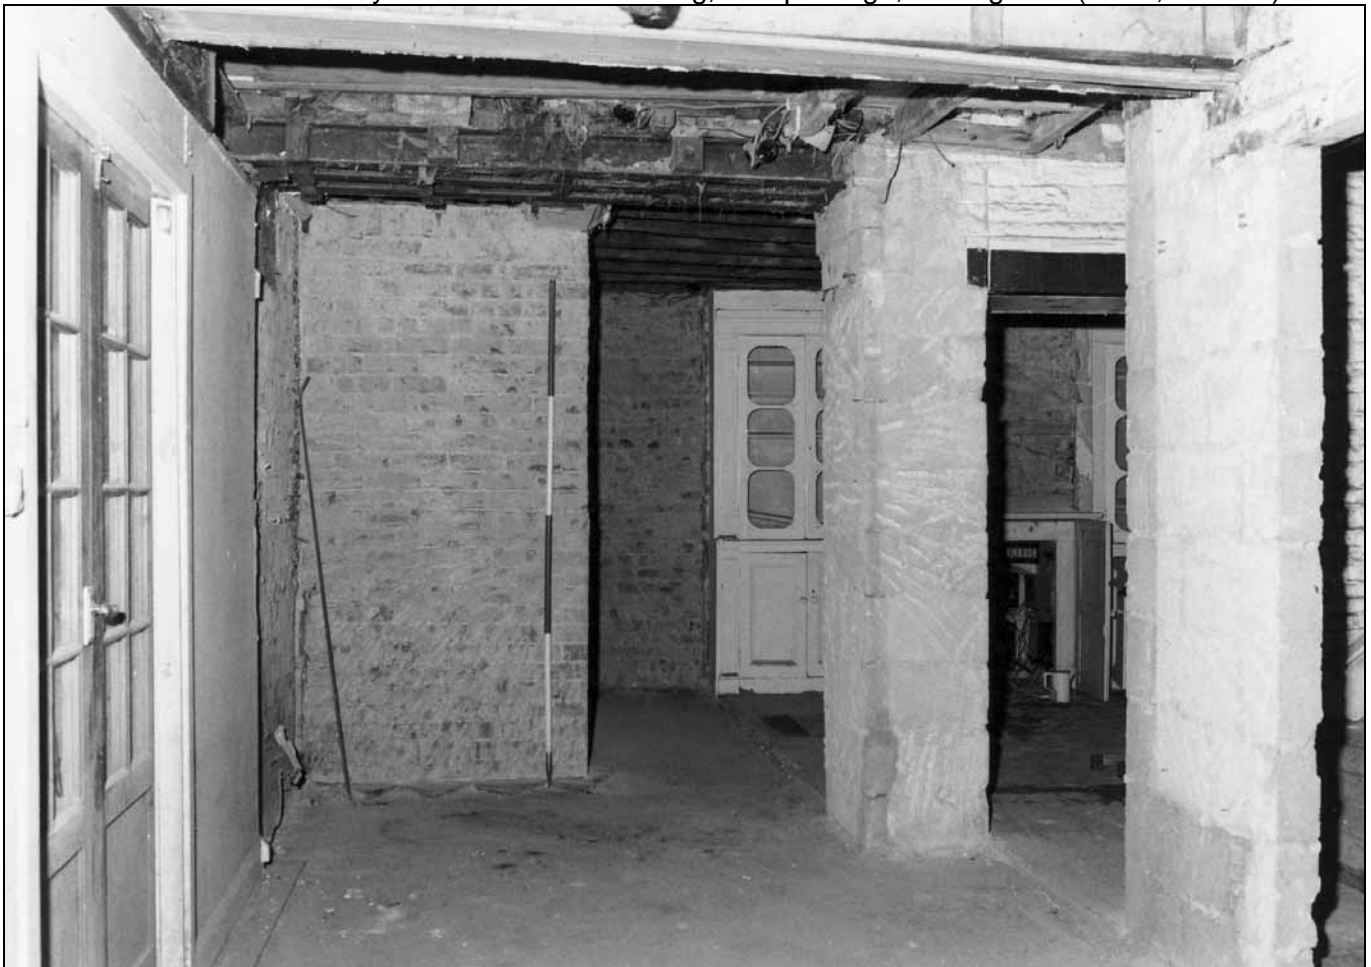
- 8.7 The present room to the north of the dining room forms a wide passage, leading to the tall 19th or 20th century entrance in the east side (14,15). This passage is enclosed from the historic kitchen to the north by a thin brick wall, most likely 19th century, and probably on a different line from its 17th century predecessor; the wall forming the south side of the passage (the north side of dining room) is likely to be of similar construction and date to it. The ceiling beams over this passage are of boxed-in softwood.

Photo 14: Tall doorway in east side of east wing, with passage, looking east (film 1, frame 8)

Photo 15: Passage in east wing, looking west (film 1, frame 10)

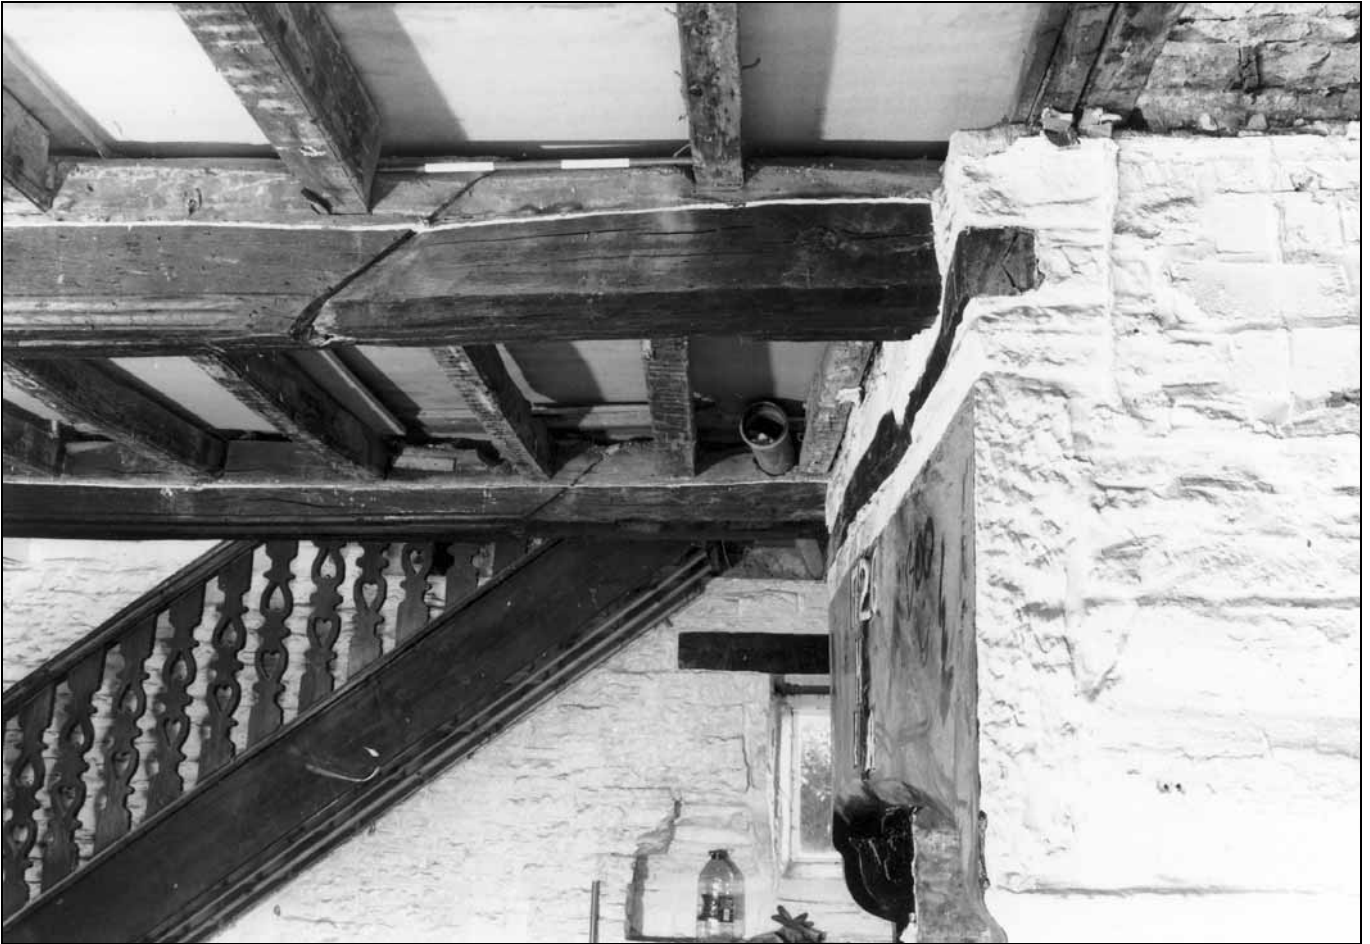
Photo 19: Ceiling beams above 1726 fireplace, with scarf joints (film 1, frame 14)

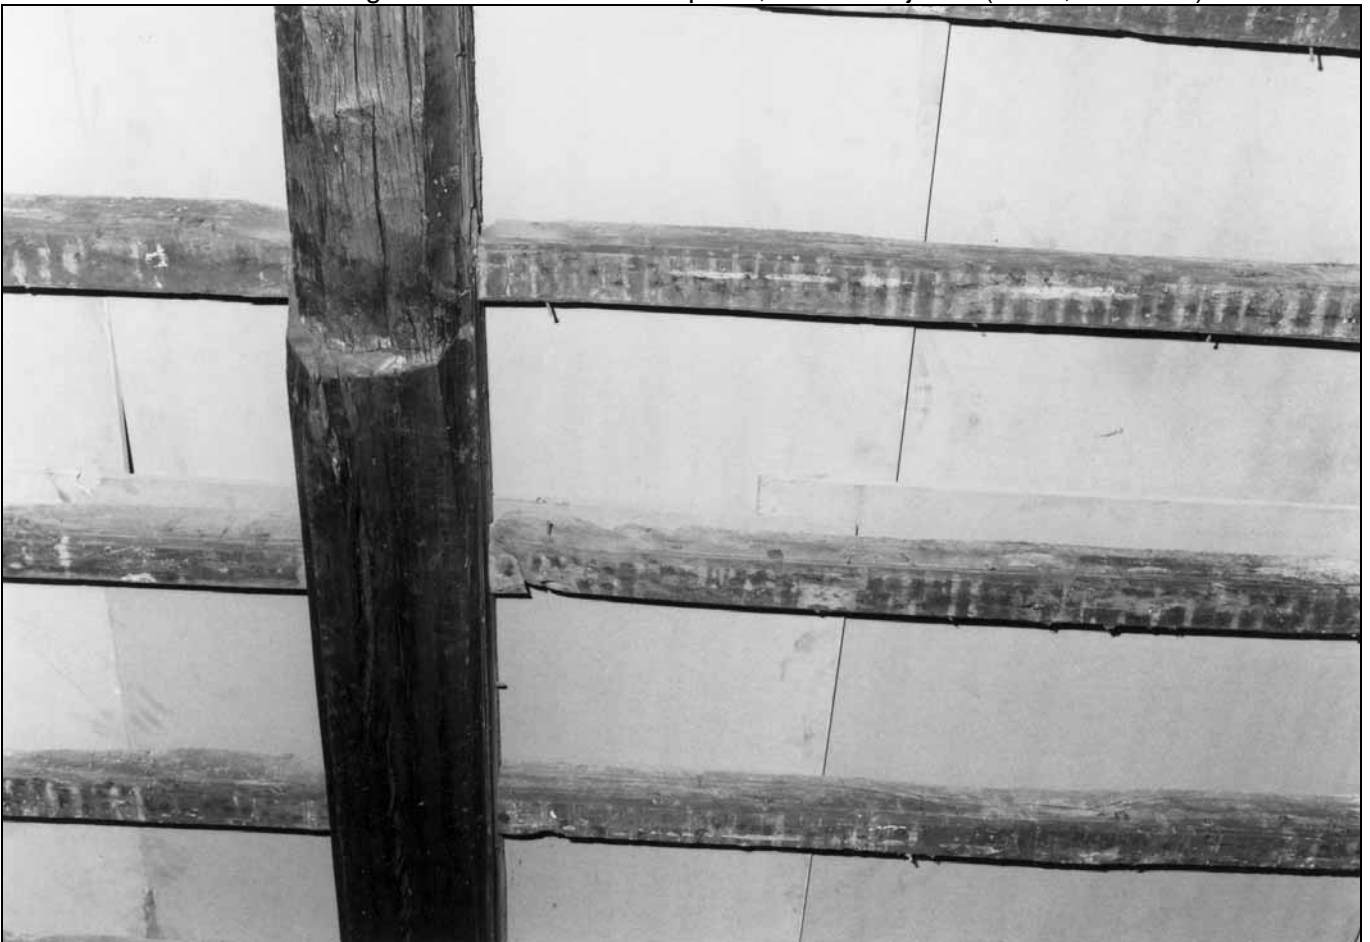
Photo 20: East ceiling beam above 1726 fireplace, with scarf joint, and original, moulded joists (film 4, frame 6)
