123 Smith House Lane
Lightcliffe, Halifax, West Yorkshire:
Structural Watching Brief

March 2019

STEPHEN HAIGH

OASIS project ID: stephenh1-342540

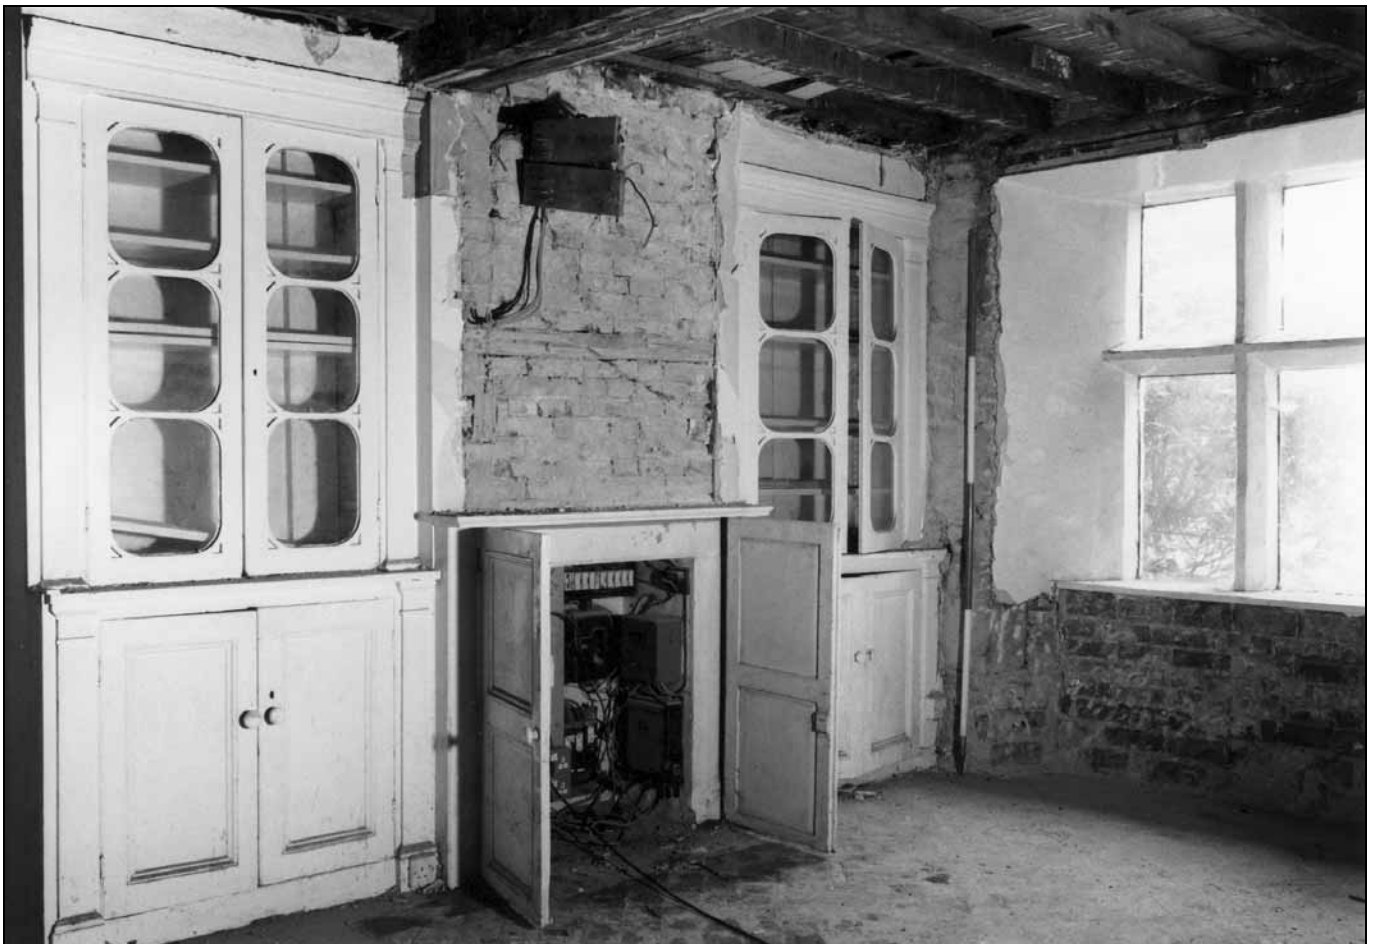
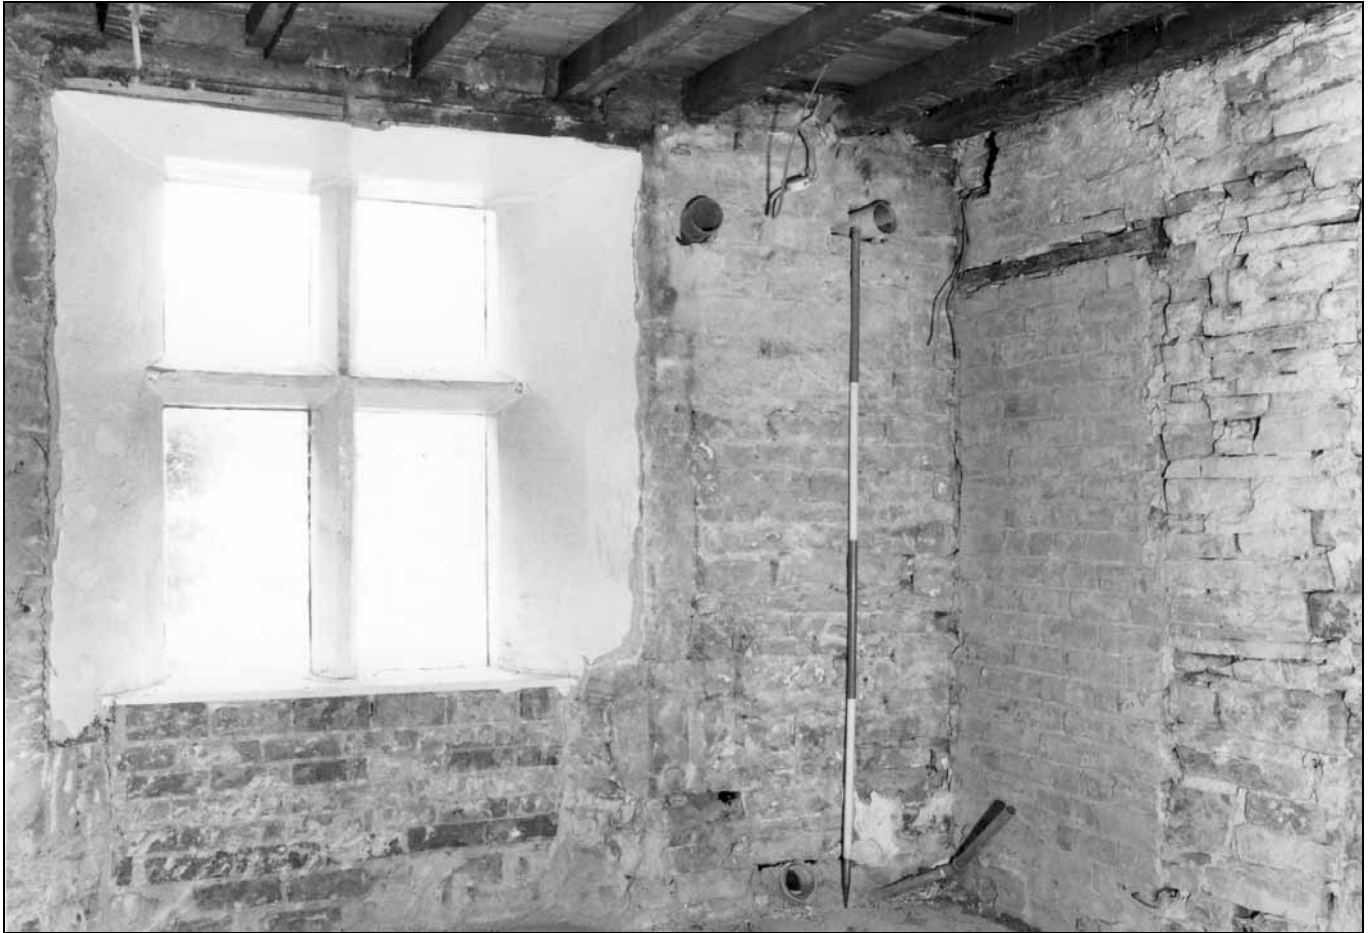
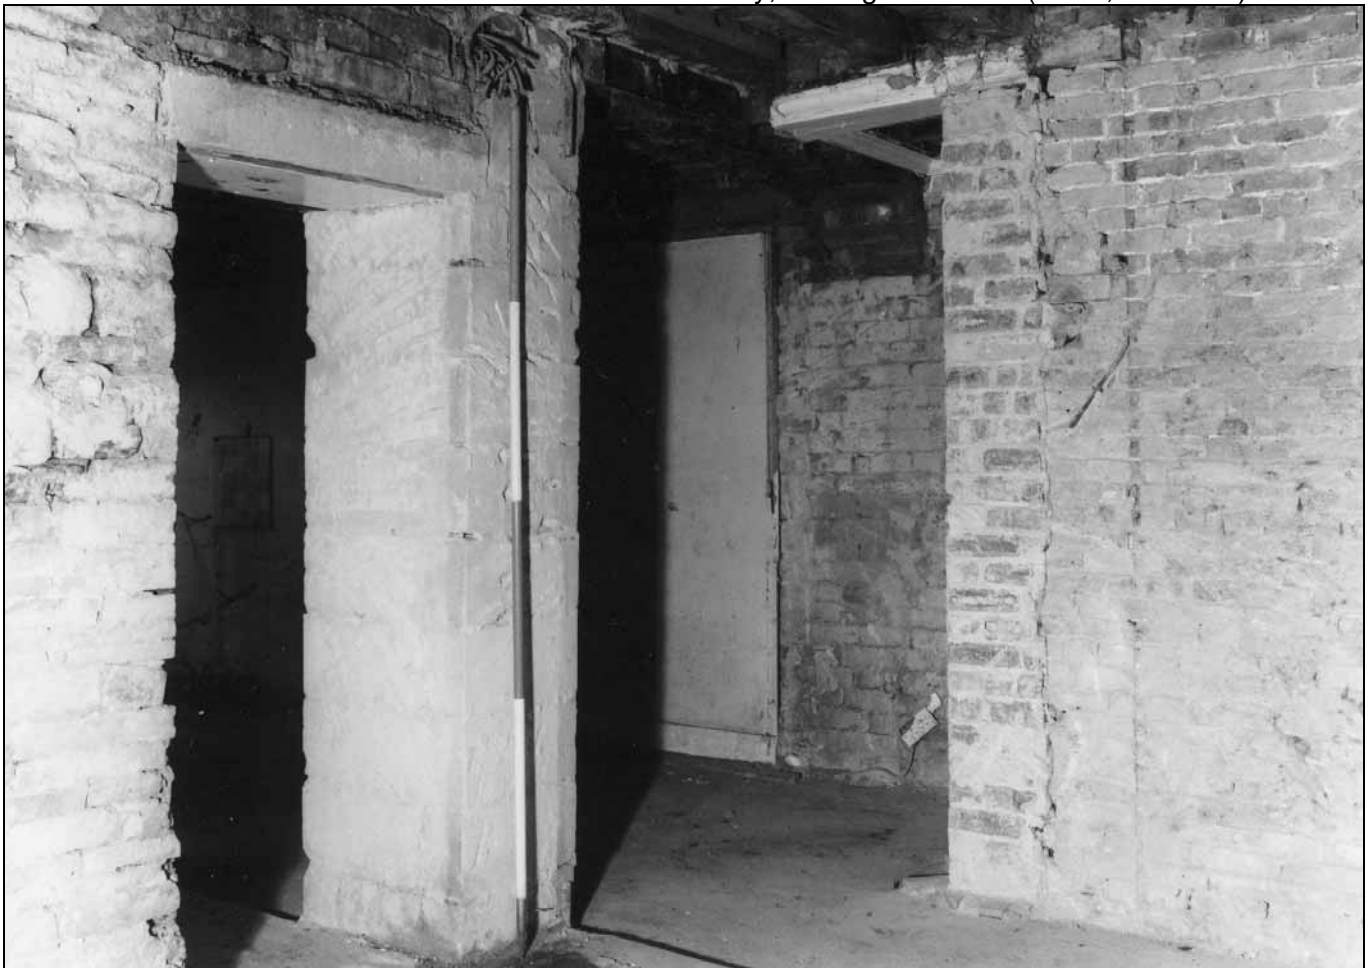
- 8.11 The ground floor of no. 123 (but not the first floor) includes a single room in the rear of the central block behind the housebody, that part of the building which is believed to have replaced the rear aisle in the mid 18th century. This area contains a brick chimney breast with plain stone fireplace, flanked by 20th century wall cupboards. It has a blocked doorway in the north-east corner, formerly leading into the kitchen. The integrity of this room at the south-east corner has been lost by 20th century work, in which substantial parts of the walls have been removed (26-28).

Photo 26: Ground floor room to rear of housebody, looking north-west (film 2, frame 15)

Photo 27: Ground floor room to rear of housebody, looking north-east (film 2, frame 17)

Photo 28: Ground floor room to rear of housebody, looking south-east (film 2, frame 18)

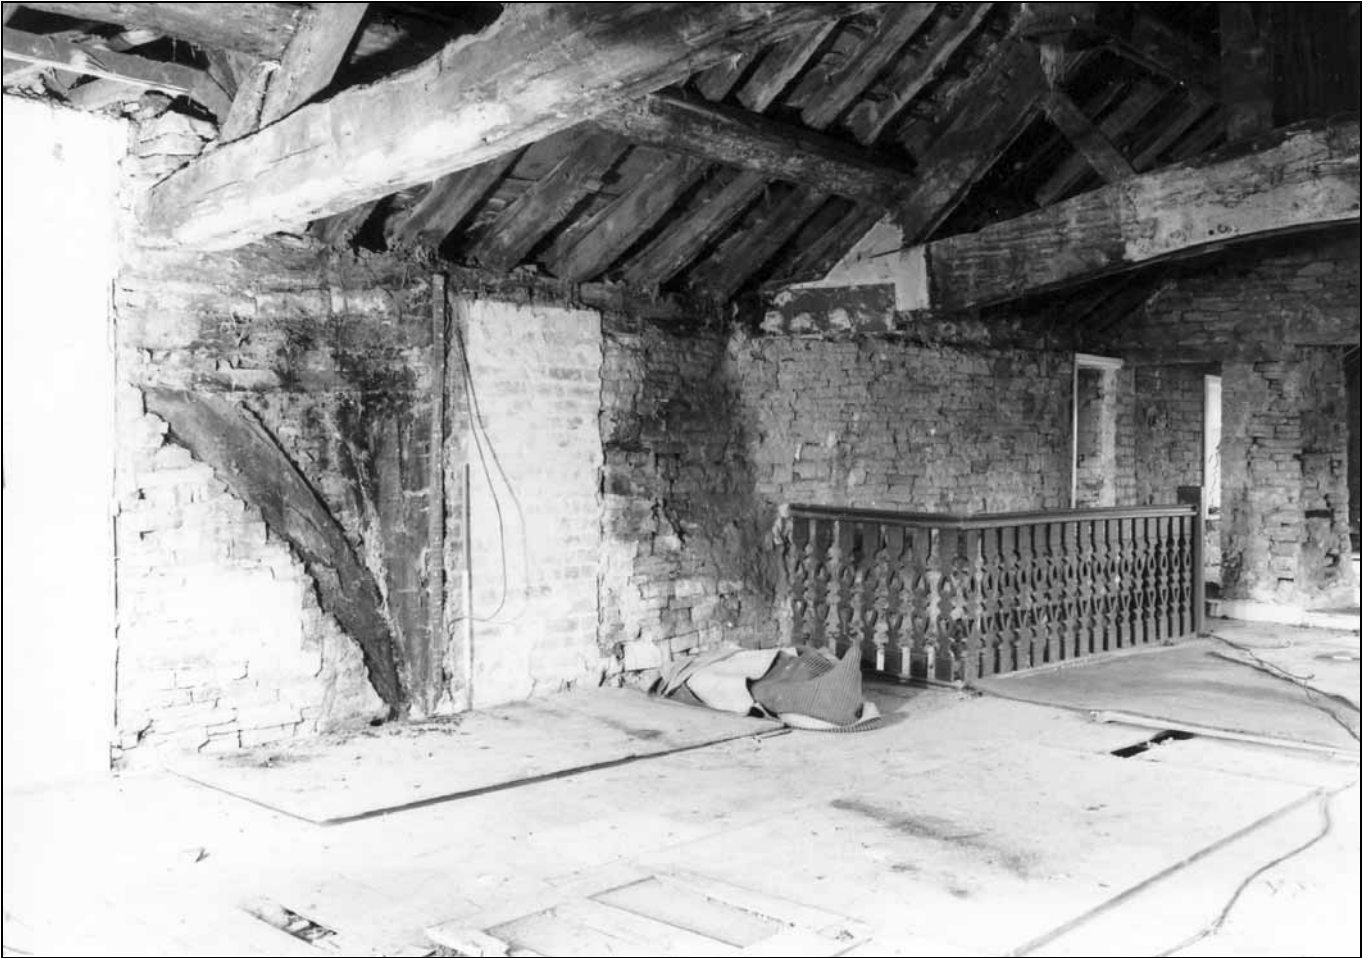
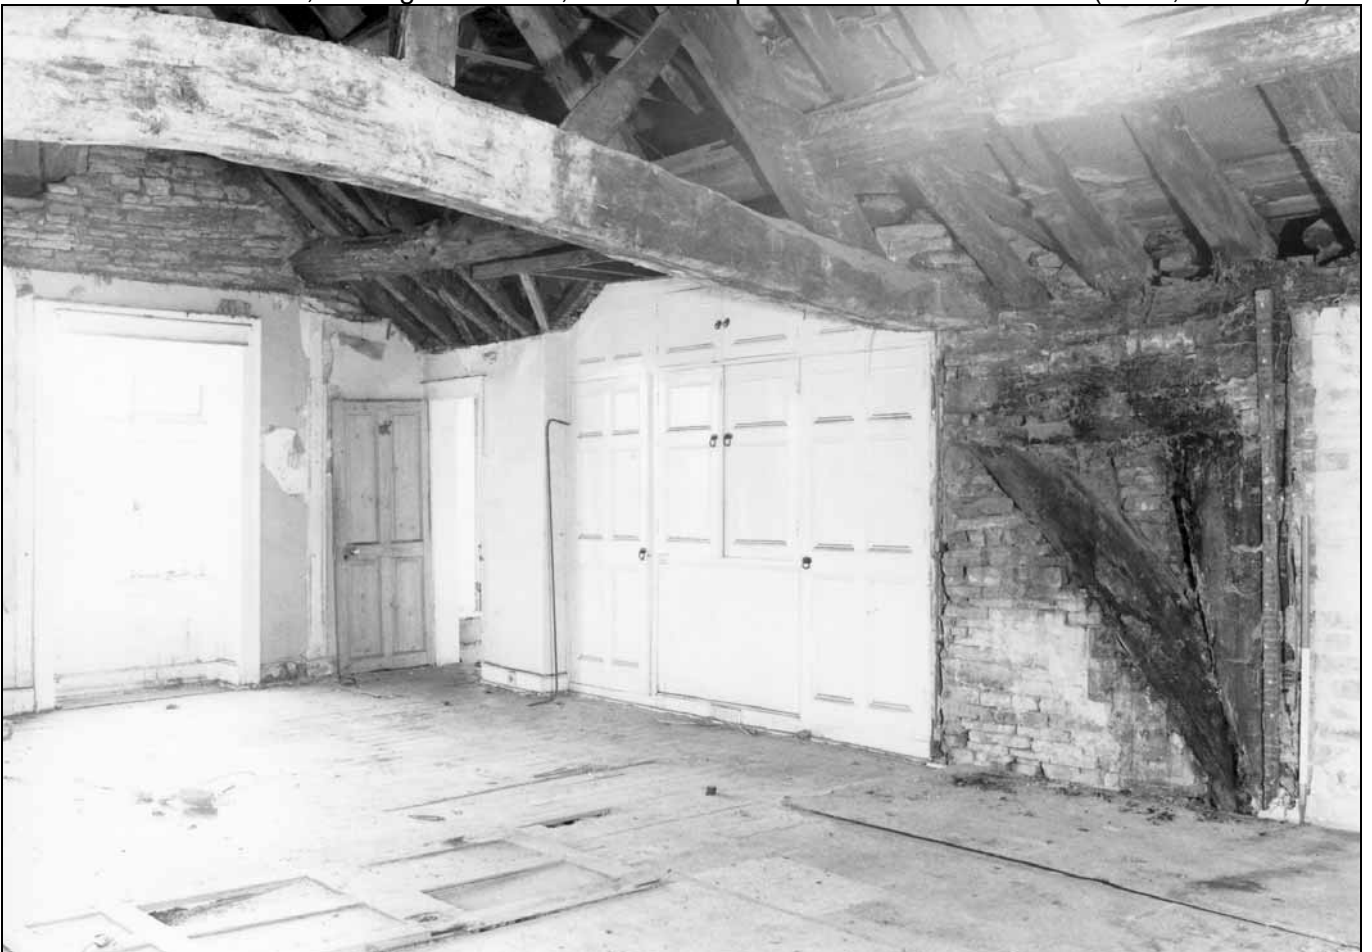
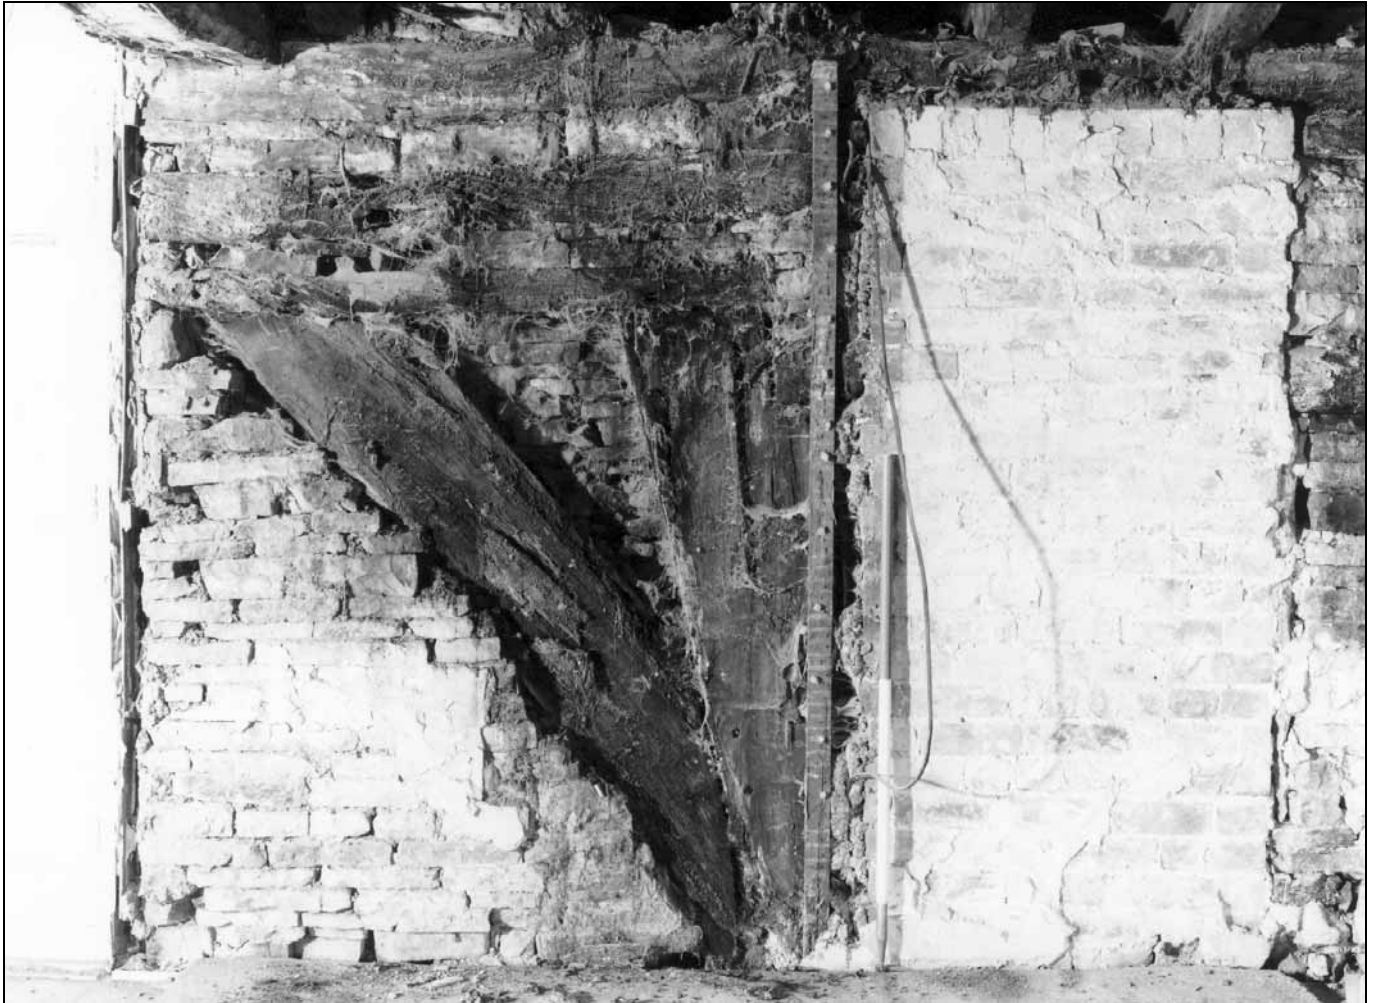
- 8.14 The recent strip-out exposed the splayed head of an arcade post with attached arch brace, in the west side of the wing (31-33). (This remnant rests on a steel lintel over one of the ground floor openings below; the lower part of the post has been removed entirely.) This was not noted in the 1978 RCHME survey, so it is presumed it was not then visible. The horizontal timber attached to the top of the post is only about 100mm deep, so does not appear to be the tie beam, and more likely dates from the stone encasement. The arcade post would have

Photo 31: First floor, looking north-west, with arcade post and arch brace visible (film 3, frame 12)

Photo 32: First floor, looking south-west, with arcade post and arch brace visible (film 3, frame 13)

Photo 33: Detail of top of arcade post and arch brace (film 3, frame 8)

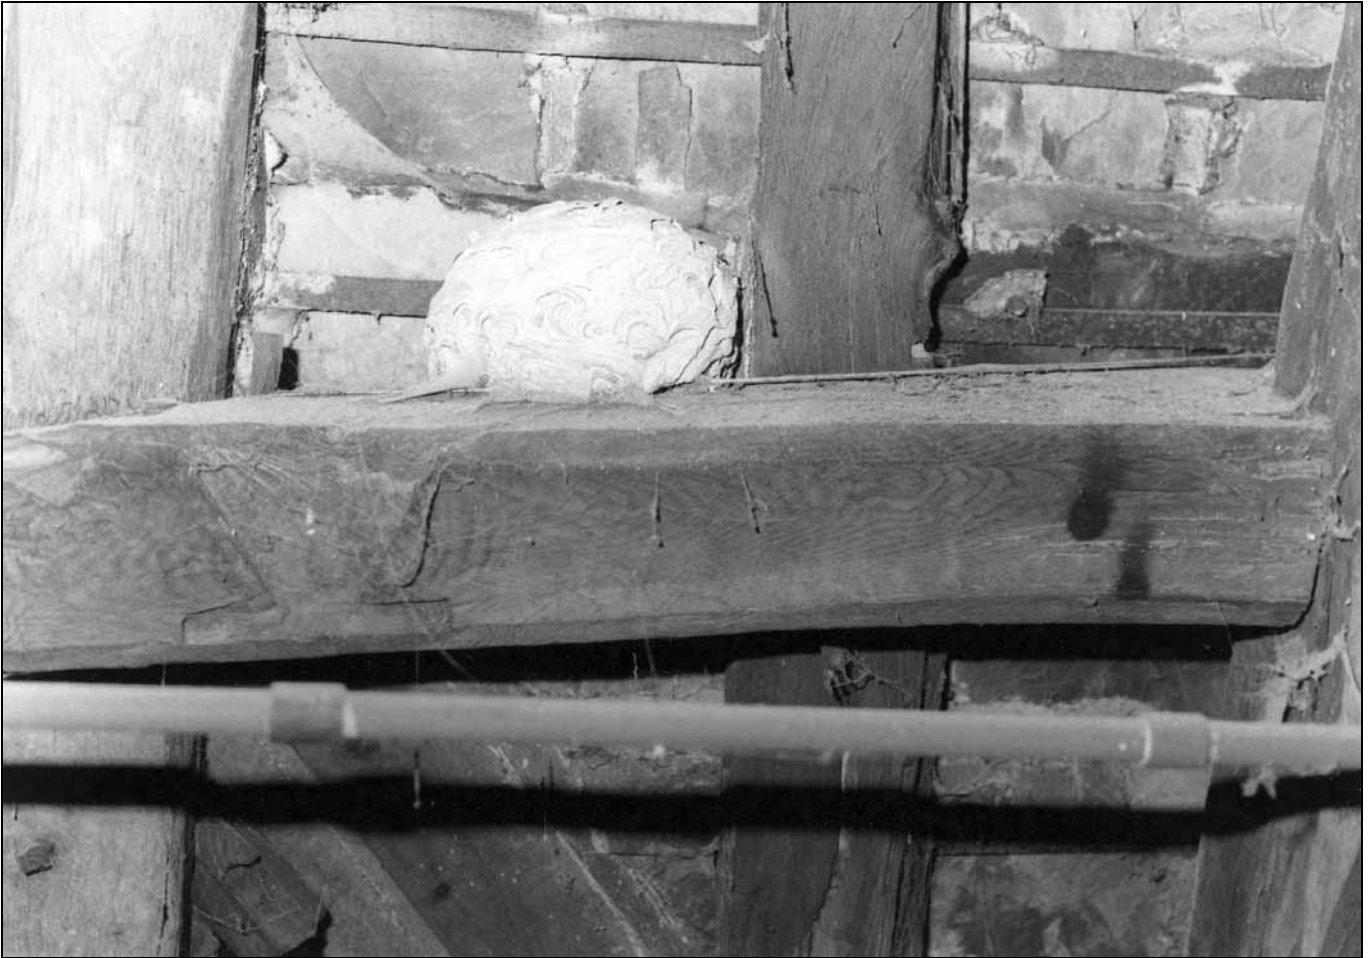
- 8.19 Two examples of scorch or soot marks from candles were observed on roof timbers, which may have been apotropaic in purpose (ie intended to ward off evil). One is on a purlin (48) and one on a principal rafter, where the angle of the burns implies it was marked when the timber had a different orientation (49).

Photo 48: Candle soot marks on purlin, next to south truss, looking west (film 4, frame 8)

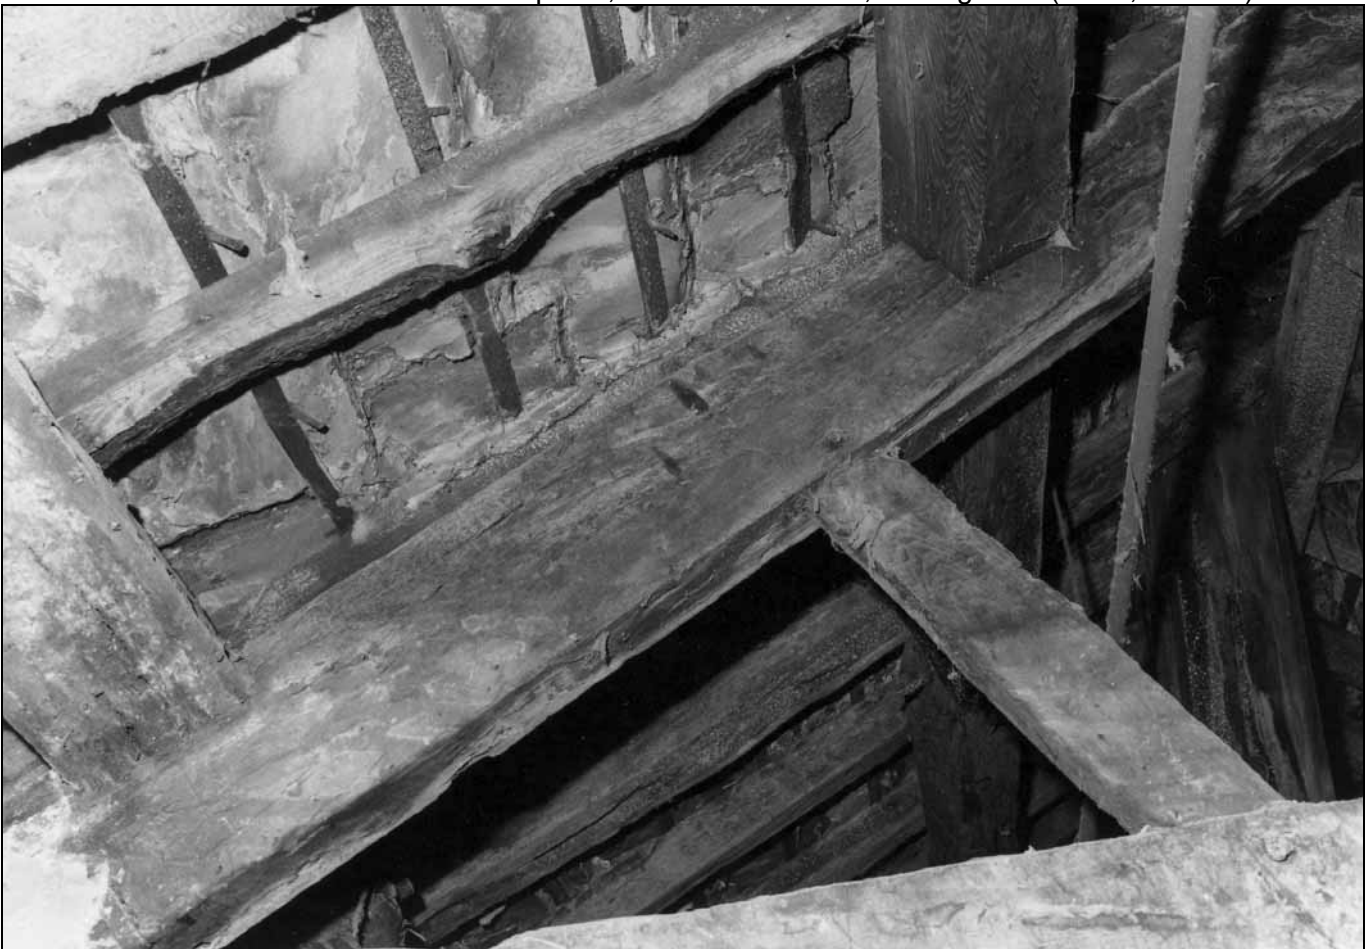
Photo 49: Candle soot marks on south side of west principal rafter, north truss (film 4, frame 12)
