Rob Royd
Beestonley Lane, Stainland, West Yorkshire:
Historic Building Record (Level 2 Survey)

April 2019

STEPHEN HAIGH

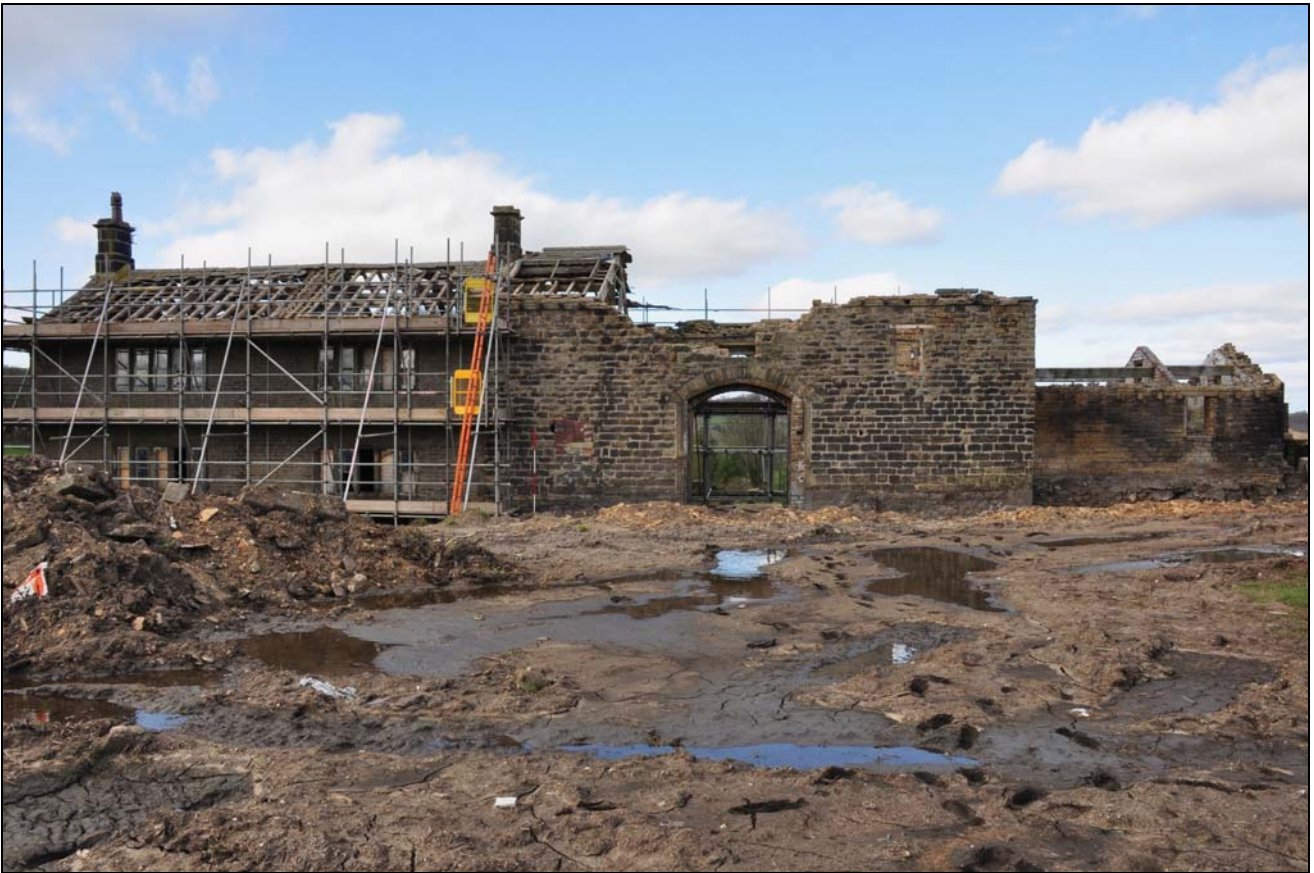
Photo 3: House and barn, from the south

- 8.3 The house itself faces south (**3,4**) and has an L-shaped plan which forms the west end of the otherwise linear range, with barn, stable and pigsty to the east (**5**). It is built from thinly coursed local sandstone, with dressings (including quoins) bearing a fine milled finish, characteristic of the later part of the 18th

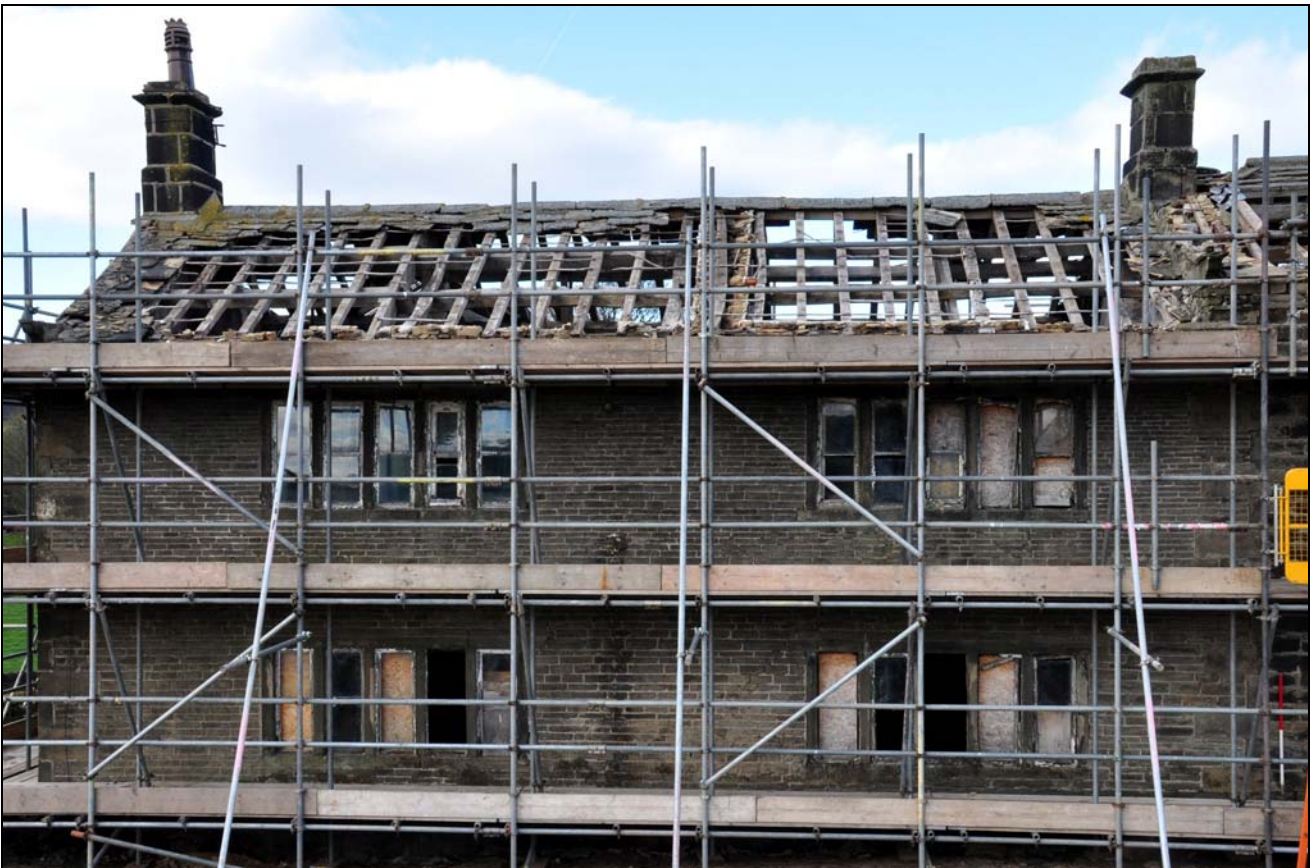
Photo 4: The house front

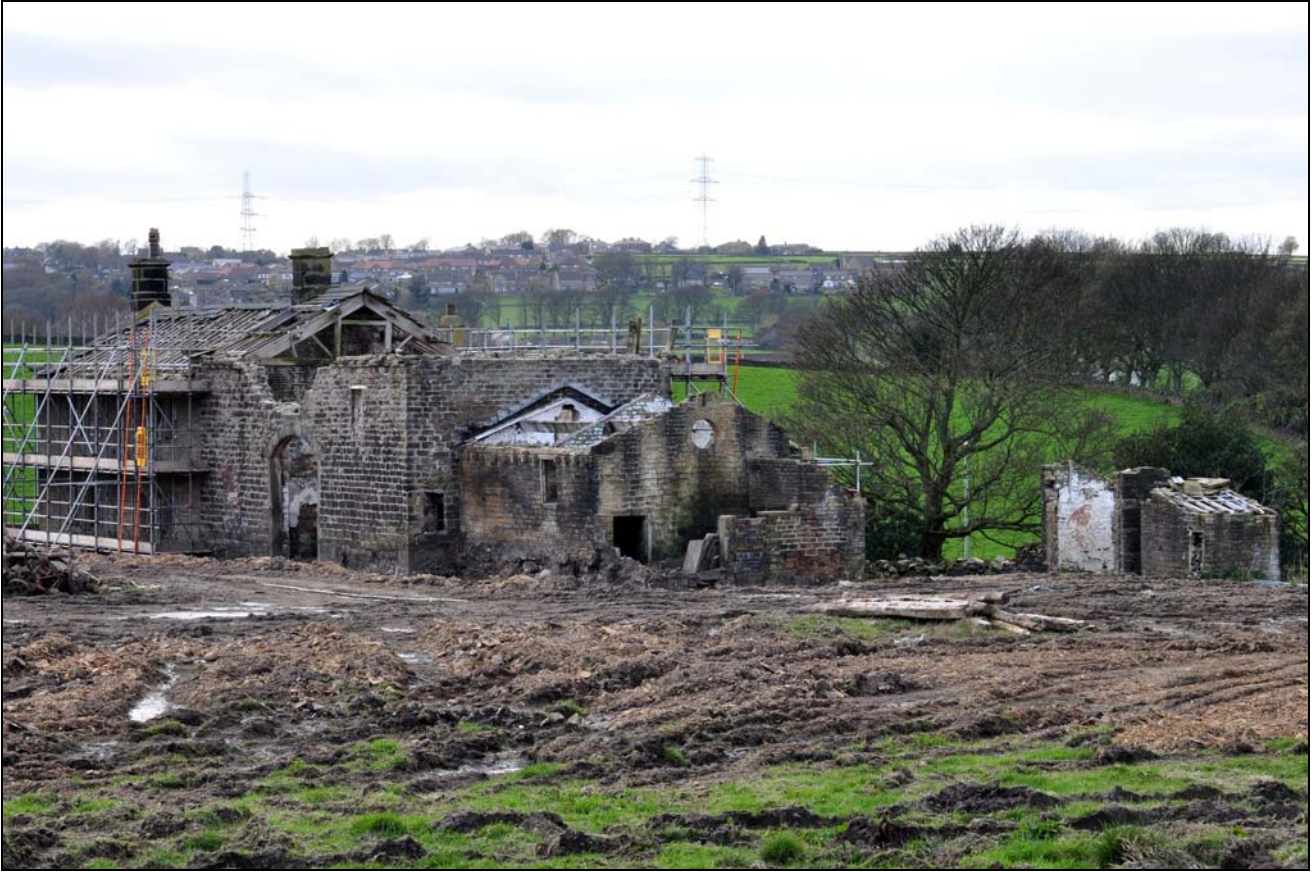
Photo 5: General view from the south-east

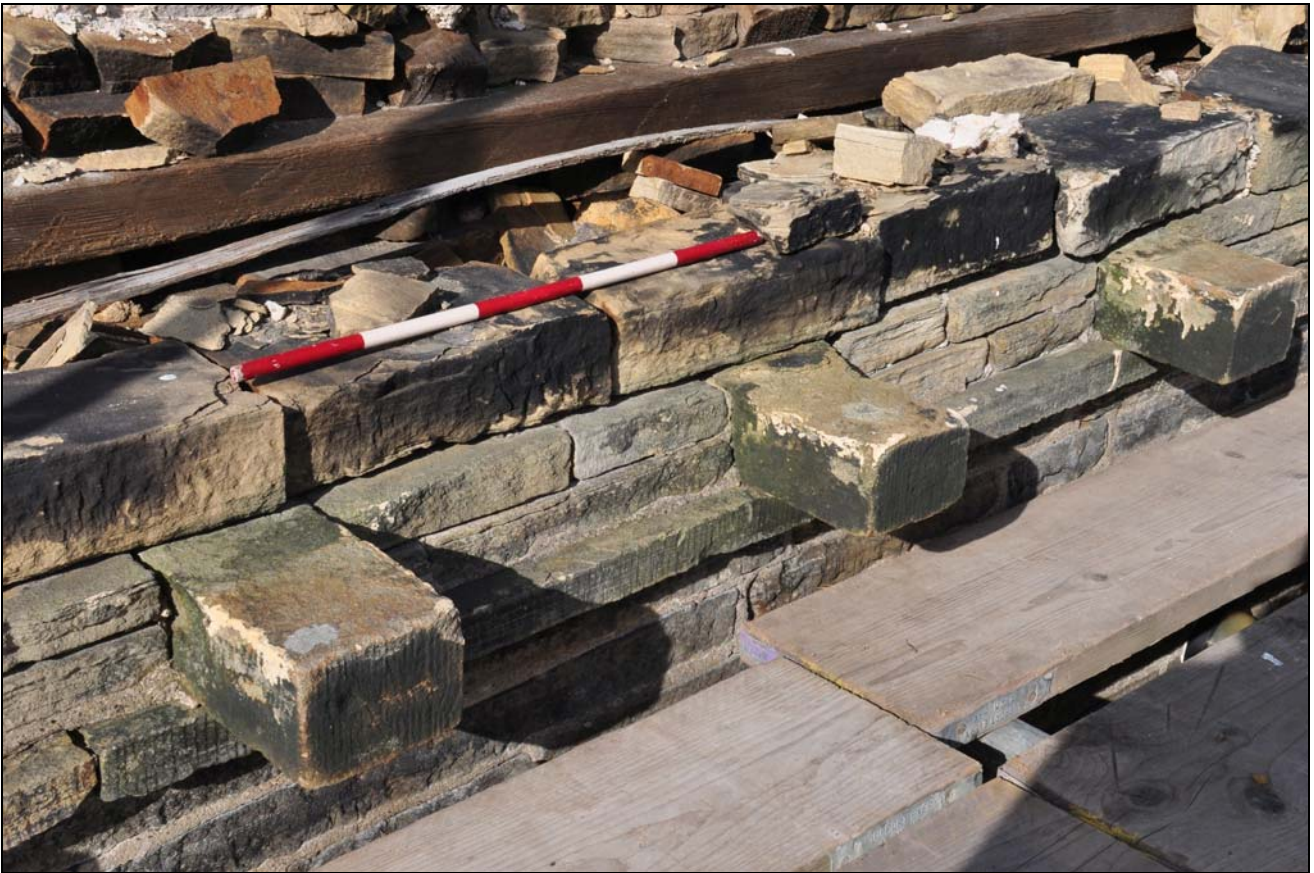
Photo 7: Detail of eaves corbels, south elevation

century **(6)**. There are plain, square corbels to support guttering at the eaves **(7)**, and kneelers with a notched, cyma reversa profile to the front corners **(8)**, those at the east end having been raised when the barn was added. The roof has the remains of its stone slate covering, and two fine gable chimneys **(9)**, together with a third, plainer chimney at the north side of the rear wing's hipped roof **(10)**. Inspection of the roof structure from the scaffolding **(11,12)** indicates that it has king-post trusses with raking struts of square-sawn, imported softwood, in a pattern-book form, and that all rafters are of the same type of timber, but many of the purlins (which are tusk-tenoned), are local oak, a few of them bearing the marks of previous use. The use of imported softwood suggests a construction date following the opening of the nearby Calder and Hebble Navigation, which reached Elland in the 1760s.

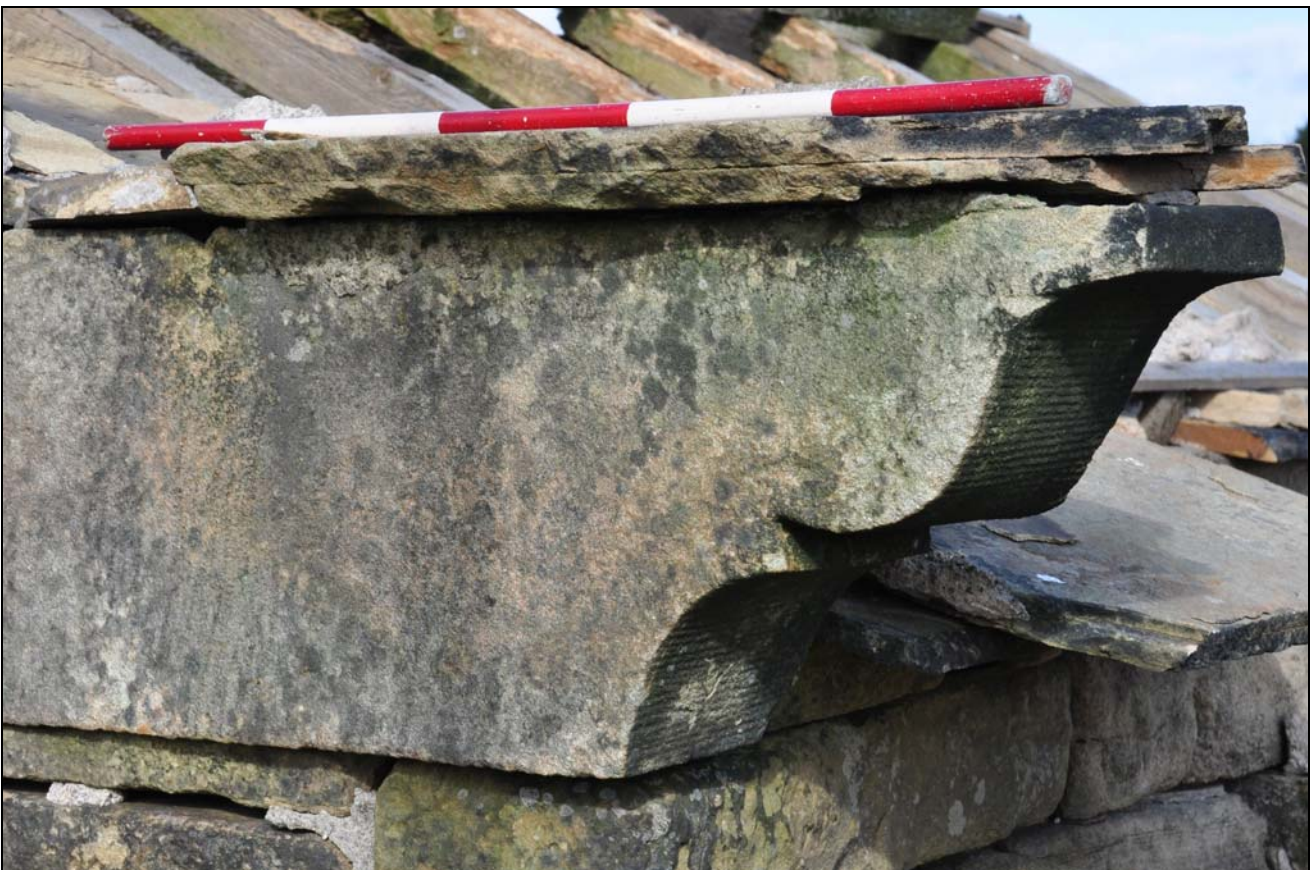
Photo 8: Detail of kneeler, south-west corner of barn

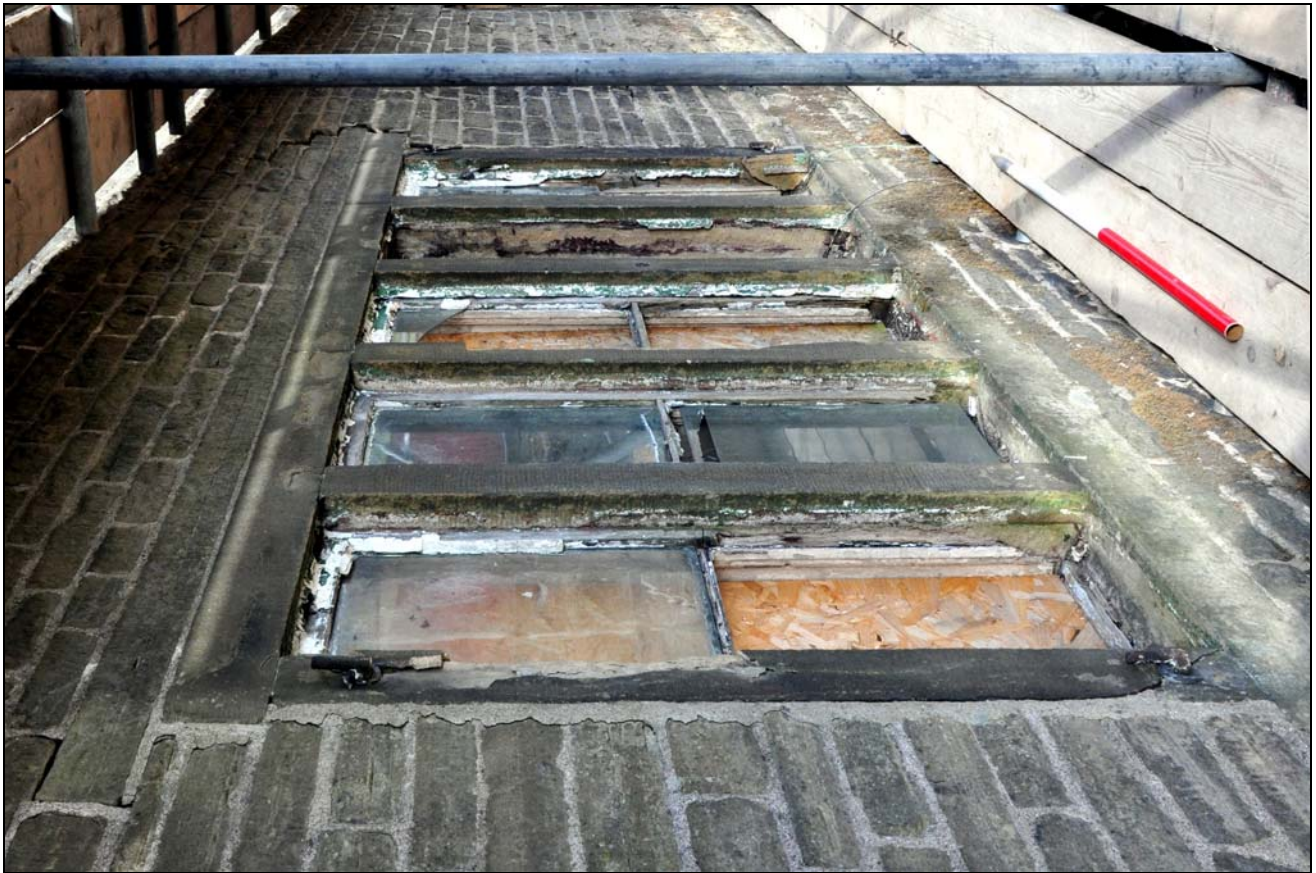
Photo 13: Detail of west, ground floor window to south elevation of house

- 8.4 The house front is of two unequal bays, both of which have five-light windows on each storey, with flush, flat-faced mullions, in a very precise alignment **(13)**; those on the ground floor have iron pintles for external shutters. All the frames are secondary. The west side, which faces the road, has been altered in the 19th century and later pebble-dashed, but retains two original four-light windows to the rear wing, identical to those in the front except for their shorter length **(14)**. In the south part of this elevation are inserted, 19th century window openings for vertical sashes, with large, square-section surrounds with projecting sills. All west-facing ground floor windows are similarly equipped with shutter pintles **(15)**.

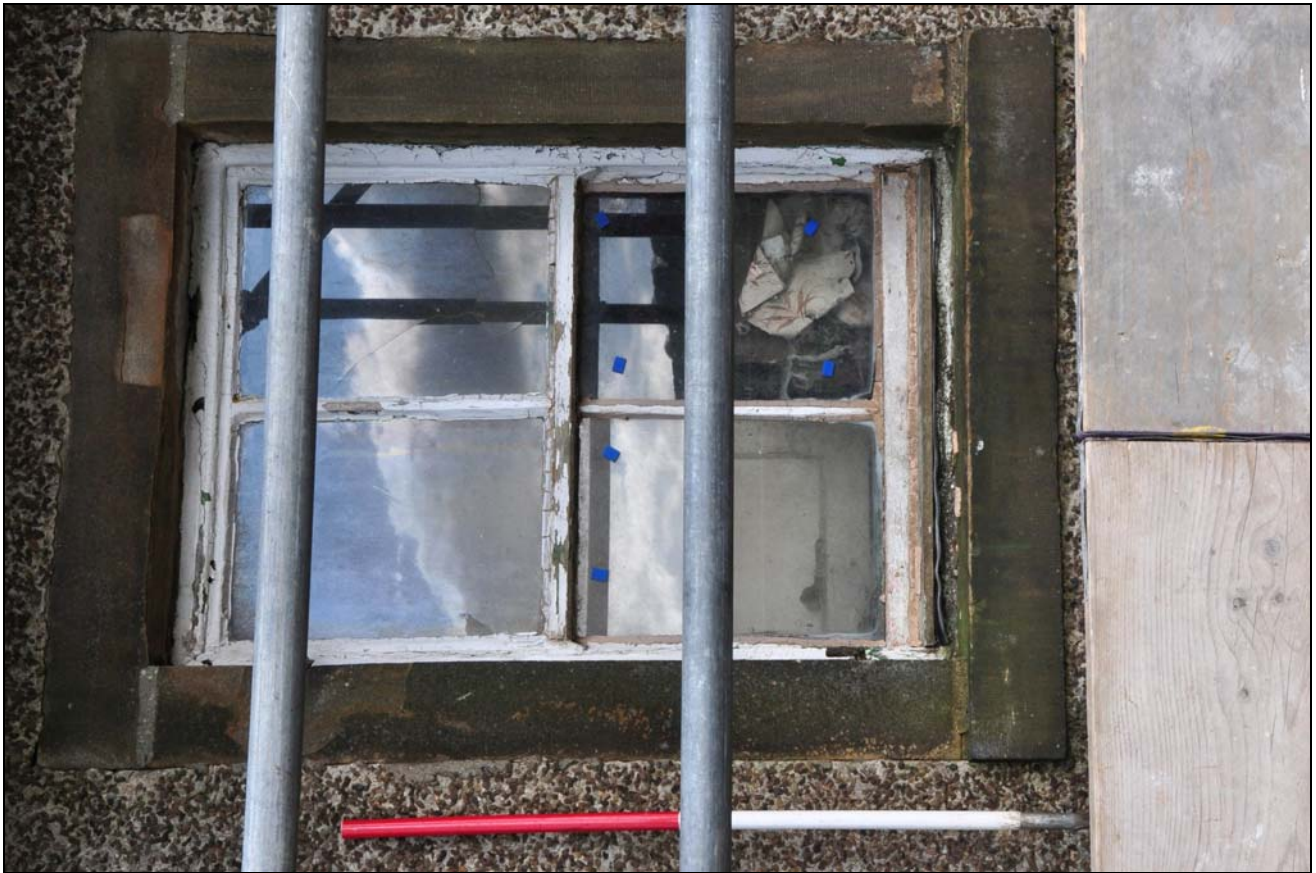
Photo 15: Detail of 19th/20th century ground floor window, west side of house

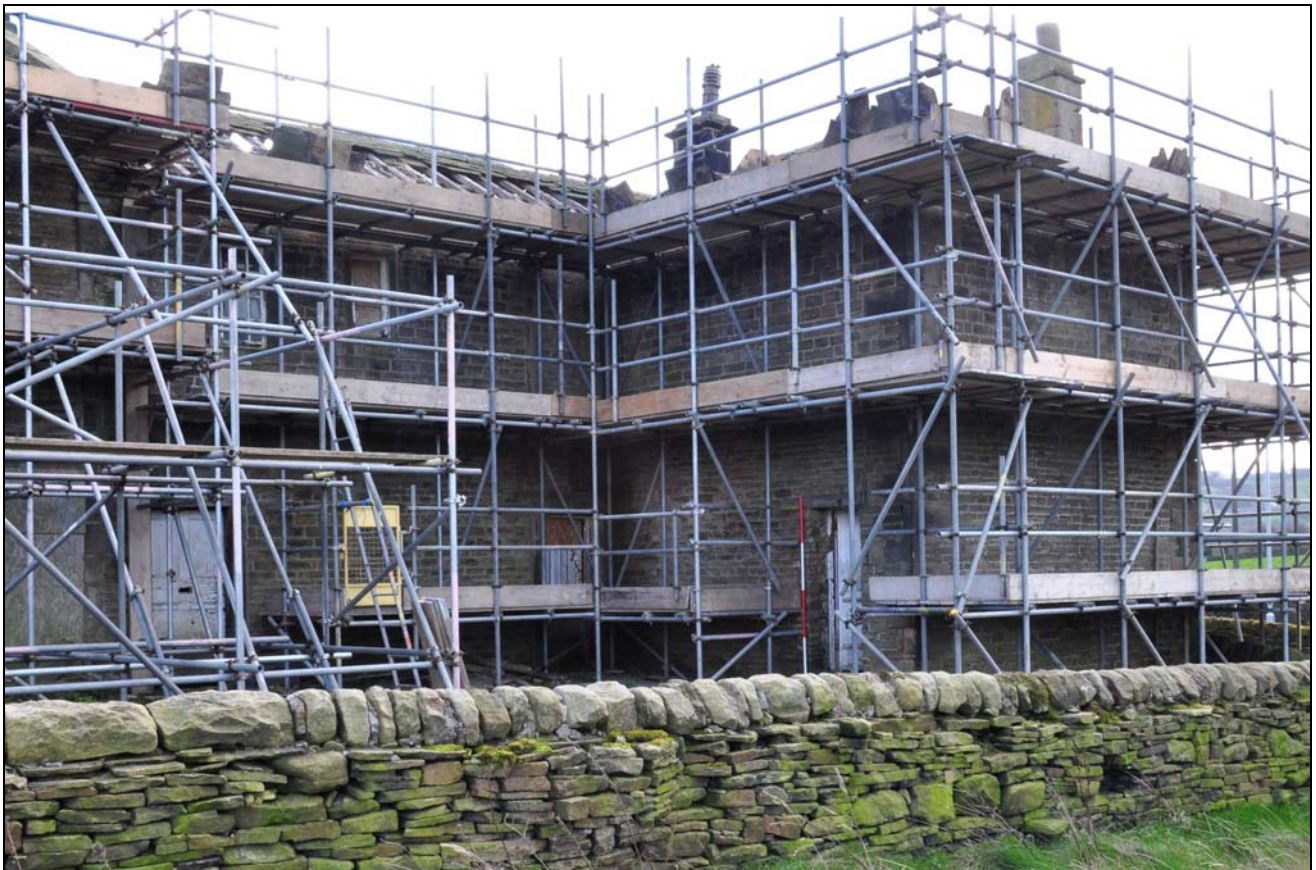
Photo 16: Rear of the house

- 8.5 All entrances to the house are located in the rear **(16,17)**, where the narrower, east end of the house contains two ground floor doorways, as well as a blocked first floor "piece" doorway **(18-12)**. All three have monolithic jambs and are of a uniform appearance, and although the Heritage Statement suggests that the eastern doorway is an insertion, that is not likely, given the lack of disturbance to stonework. The door itself (D1) appears to be original to the house: it is of false-panel construction, ie. of plank form with applied mouldings to the outer face, and is hung on large strap hinges, characteristic of the 18th century **(21)**. The door within the other opening (D2) has been replaced and is of true-panel form, probably late 19th or early 20th century, and fastened by flush hinges to internal joinery. Above it, the first floor "piece" doorway (described as a window in the Heritage Statement) is an obvious indicator of industrial use, and shows that at one time at least part of the upper floor served as a "shop" or textile working area. A third, narrow ground floor doorway has been inserted in the east side of the rear wing **(22)**, perhaps in the early 20th century.

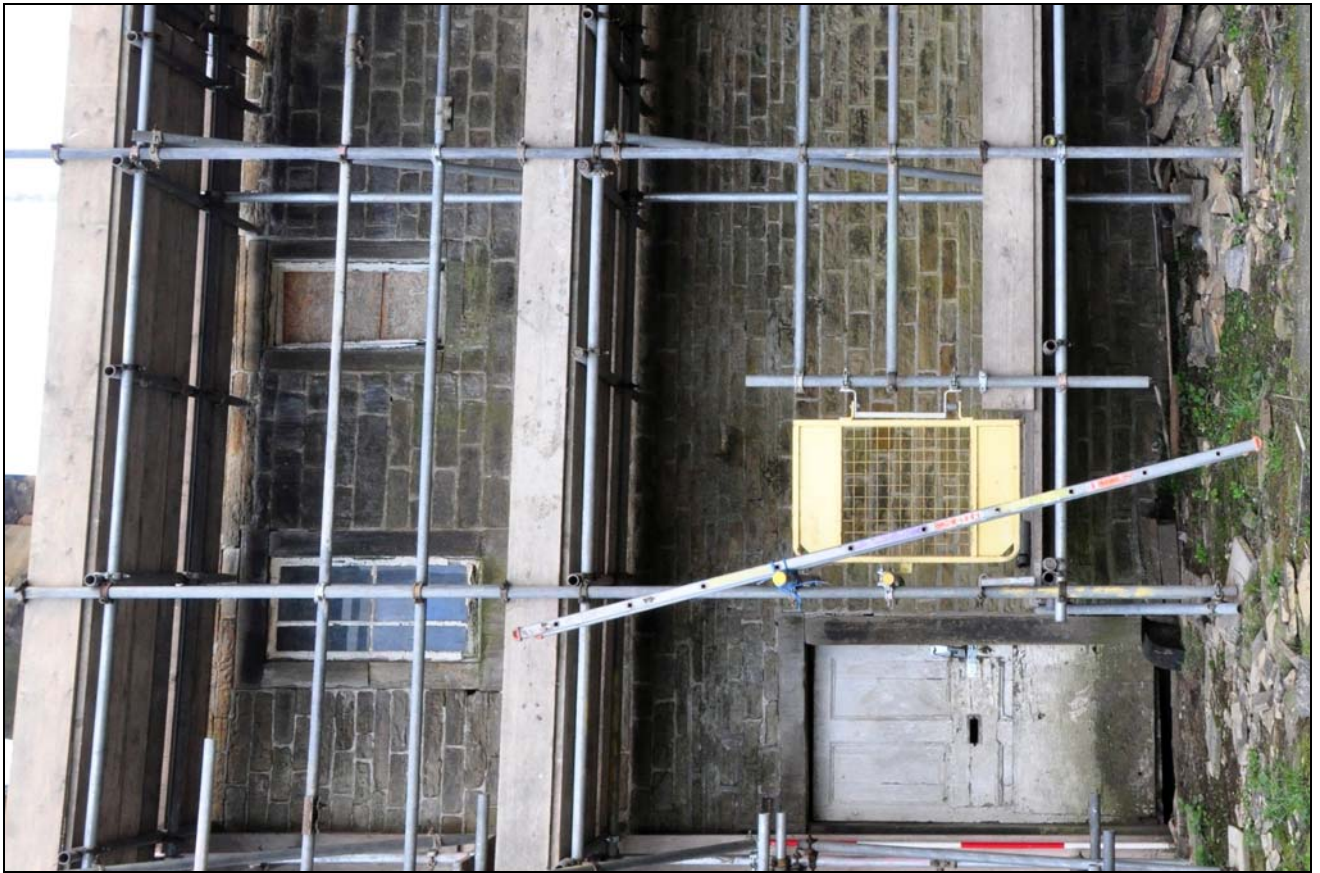
Photo 17: Rear elevation, east end of house

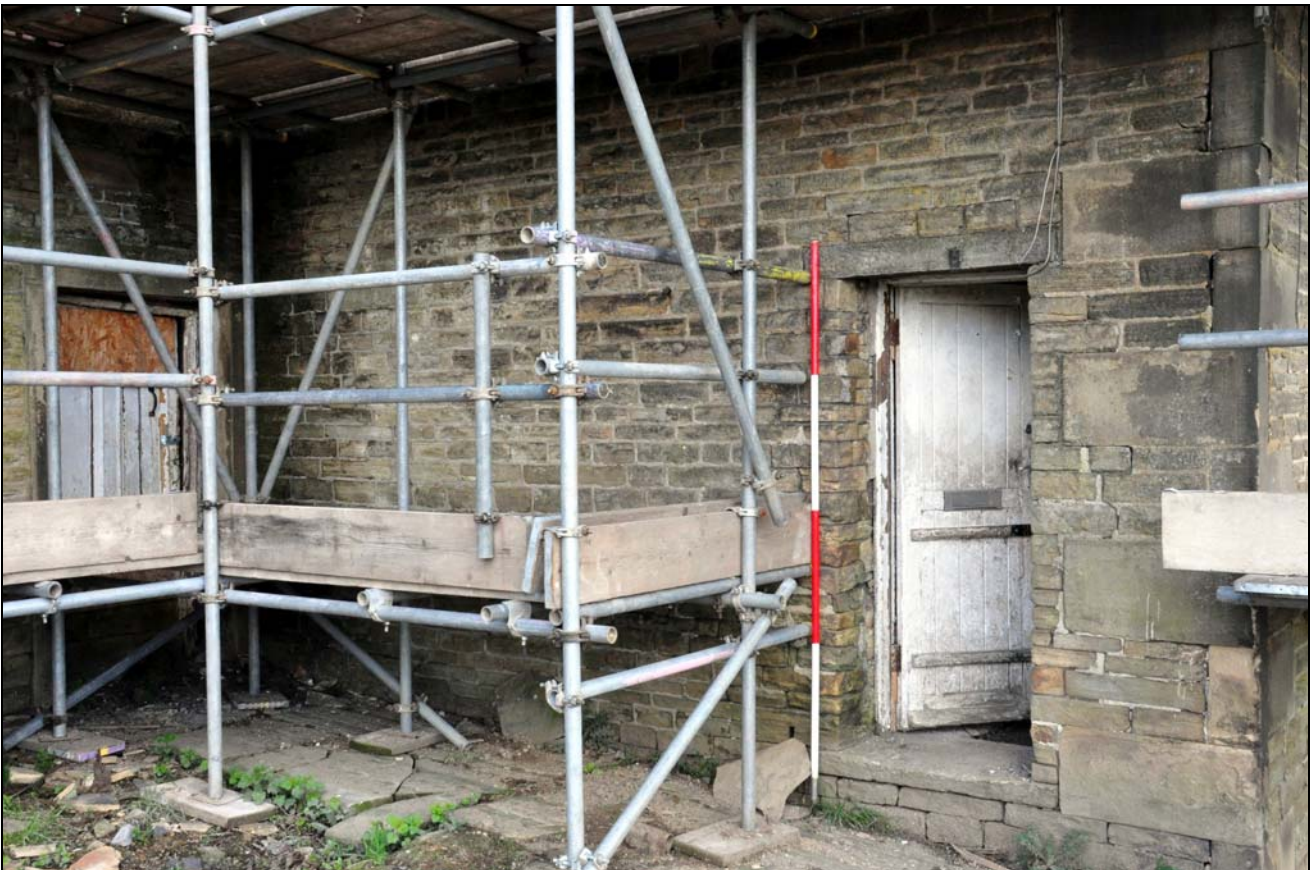
Photo 22: East side of rear wing, with inserted doorway

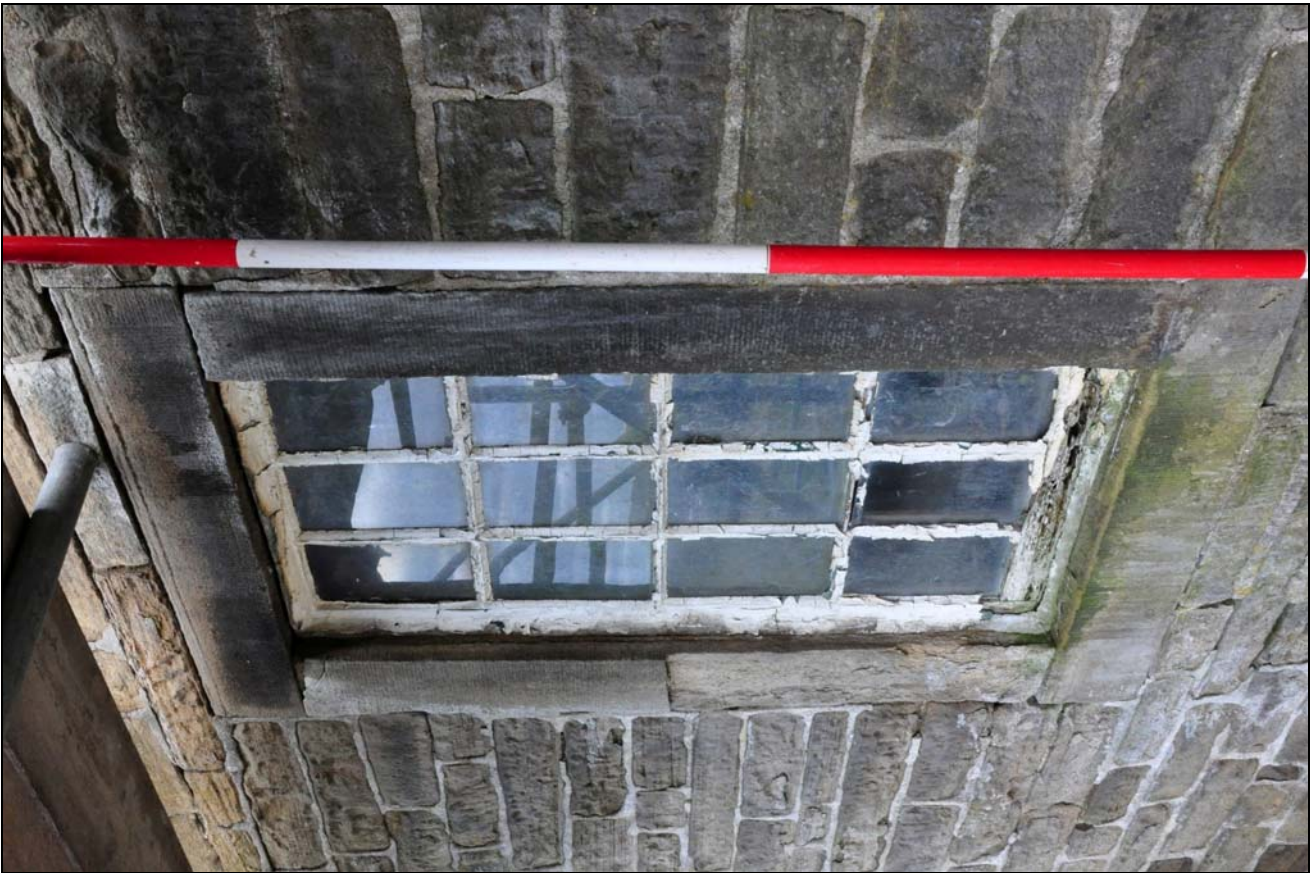
Photo 23: First floor rear window

- 8.6 The two rear first floor windows light the east room; they are of different sizes, but both have similar surrounds and it is not certain that either has been inserted. The east one retains historic small-pane glazing, unlikely to be original **(23)**.

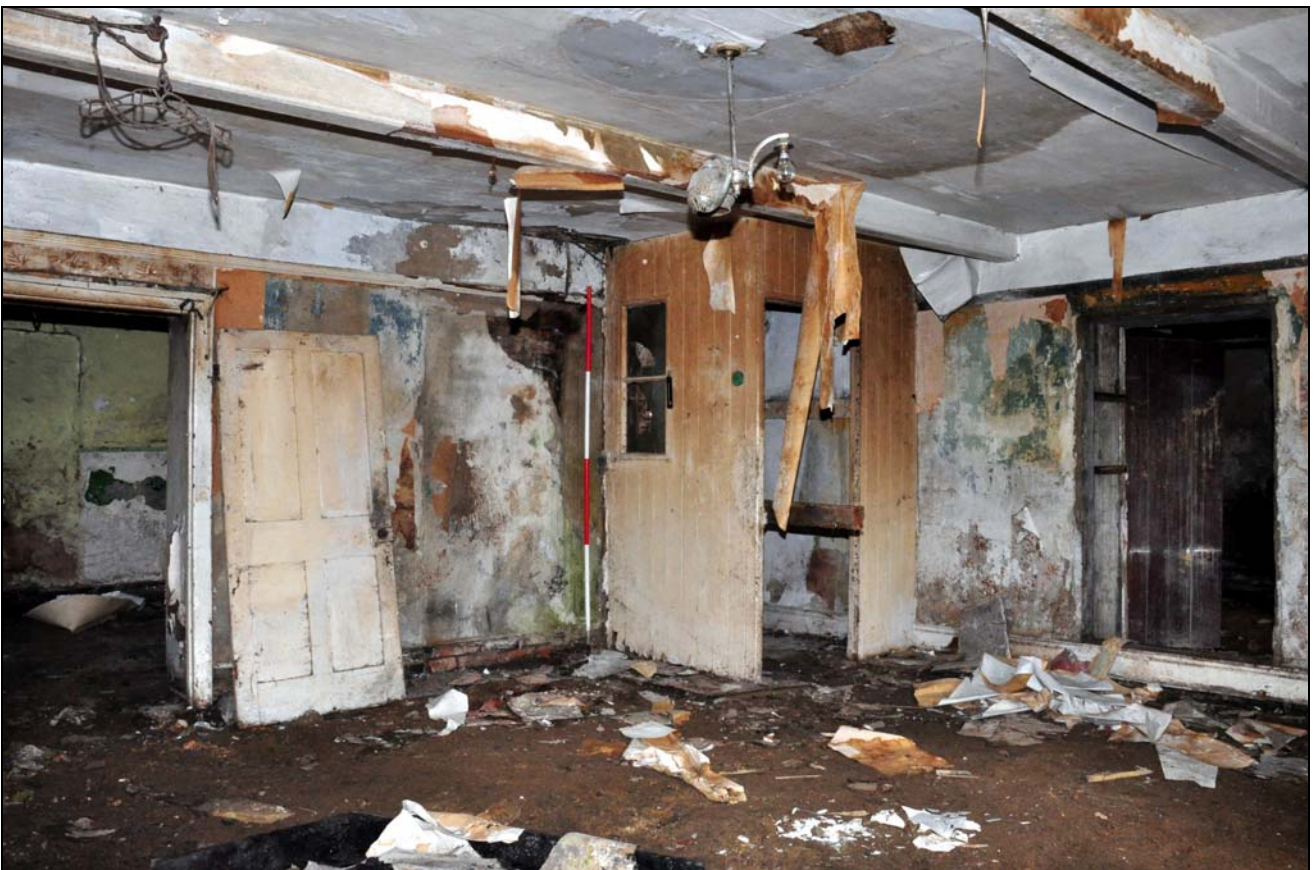
Photo 24: Ground floor, west room, looking north-east

- 8.8 The larger, west room has a small, 19th or 20th century rear vestibule of vertical planks, and doorways connecting it to the east room and rear wing (**24,25**); that to the east room may be an insertion, but has also been blocked for part of its lifetime. There is also a blocked doorway to the head of the cellar steps in the rear wing; the existing north doorway had a four-panel, late 19th or 20th century door fitted, and might possibly have been inserted as a replacement. The room has a chimney breast with original plain stone surround for a small cooking range, now infilled with 20th century brickwork (**26**), and a late 19th century built-in dresser in the north-west corner. Clearly this room was "improved" about the turn of the 20th century, when the two new windows were inserted in the west wall, to either side of the fireplace. The original, south window has joinery of a similar period, and incorporates a seat within its sill. The two ceiling beams are square-sawn softwood, and bear a narrow cyma moulding.

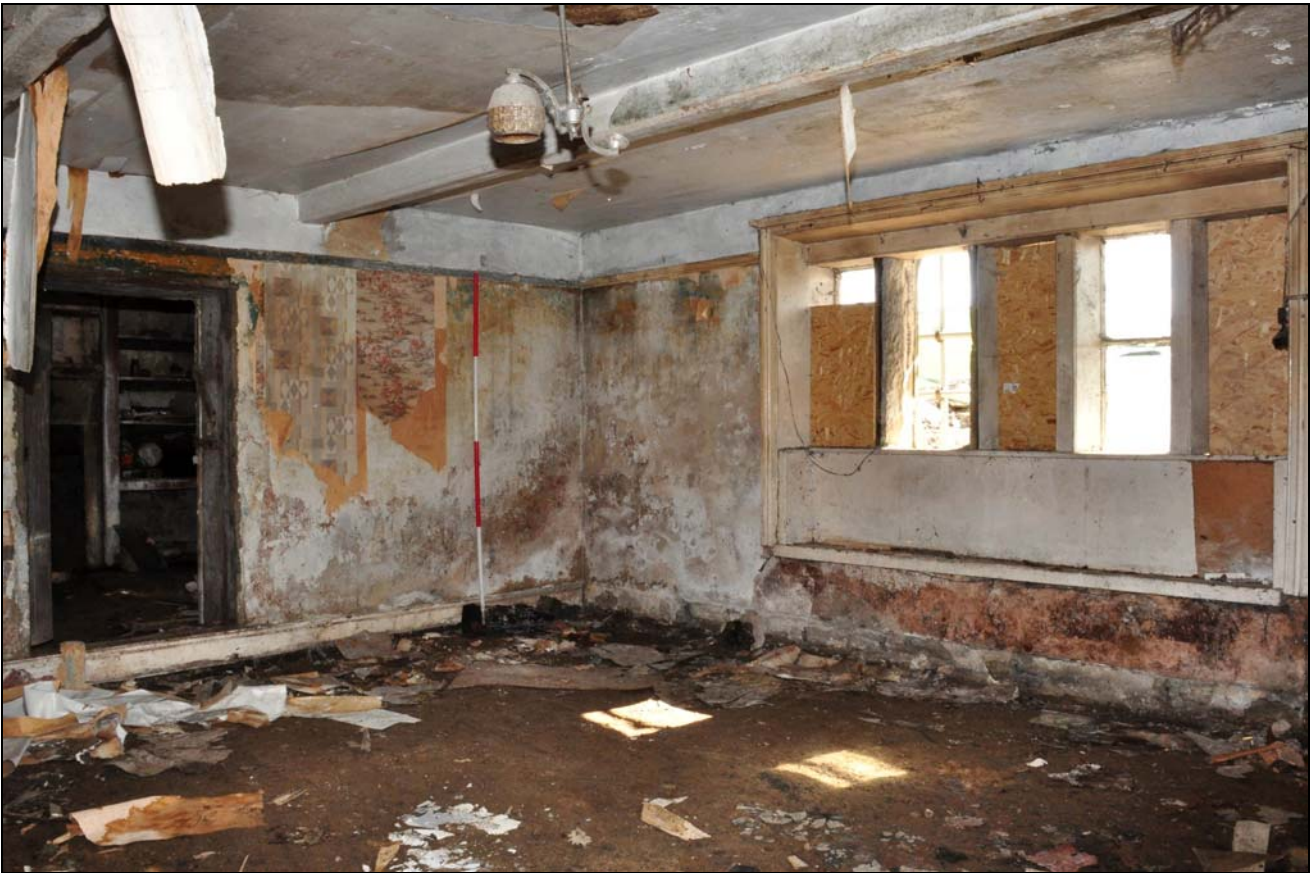
Photo 25: Ground floor, west room, looking south-east

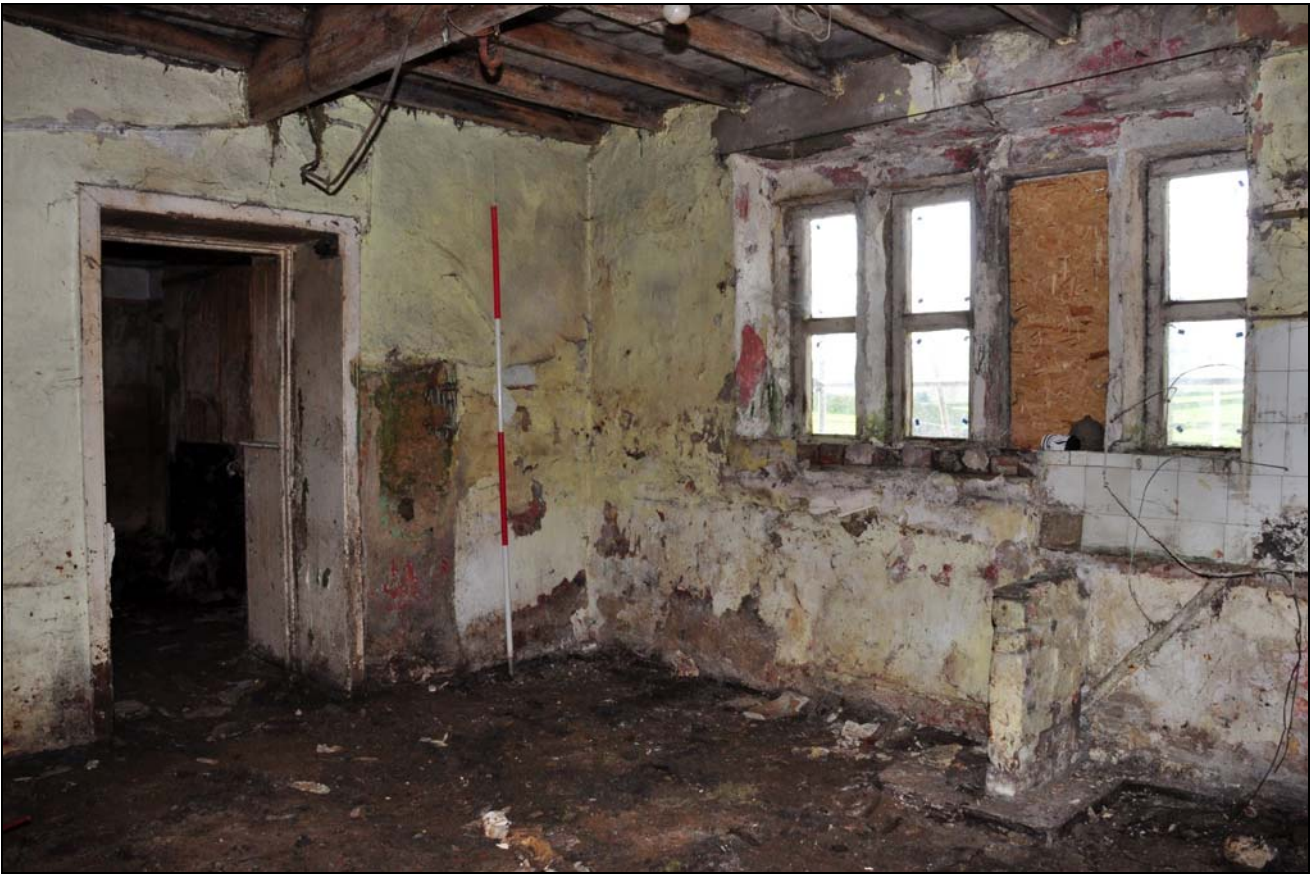
Photo 27: Ground floor, north room, looking south-west

- 8.9 The ground floor of the rear wing provided an unheated service room such as a scullery, originally without its own external entrance (**27,28**). Its ceiling is not underdrawn, and its beams are not moulded. The stone stairs to the first floor are original, and have a simple plank partition around them, as well as stairs to the cellar below. A projecting timber in the south wall forms a bracket of unknown purpose (**29**).

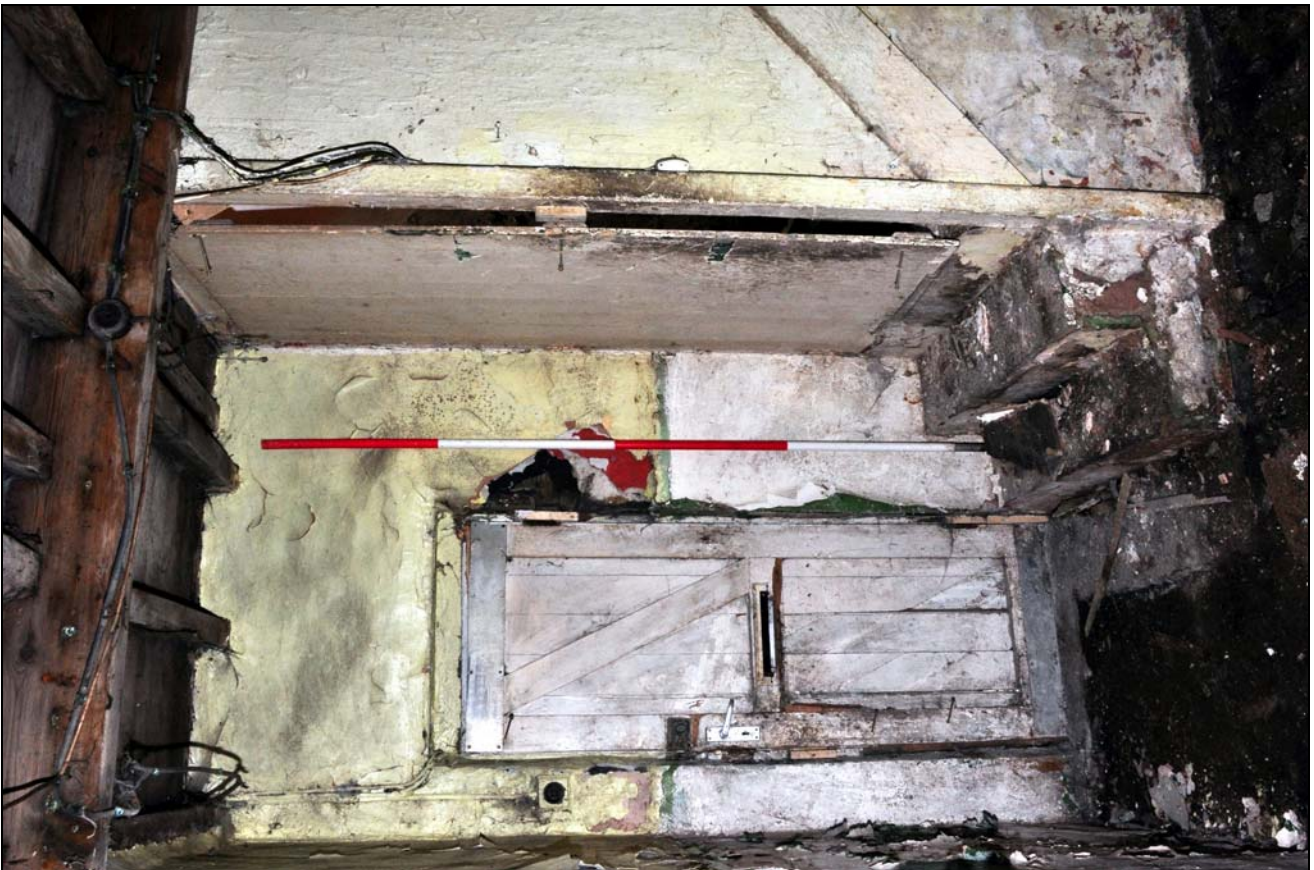
Photo 28: Ground floor, west room, looking north-east (with stairs to first floor)

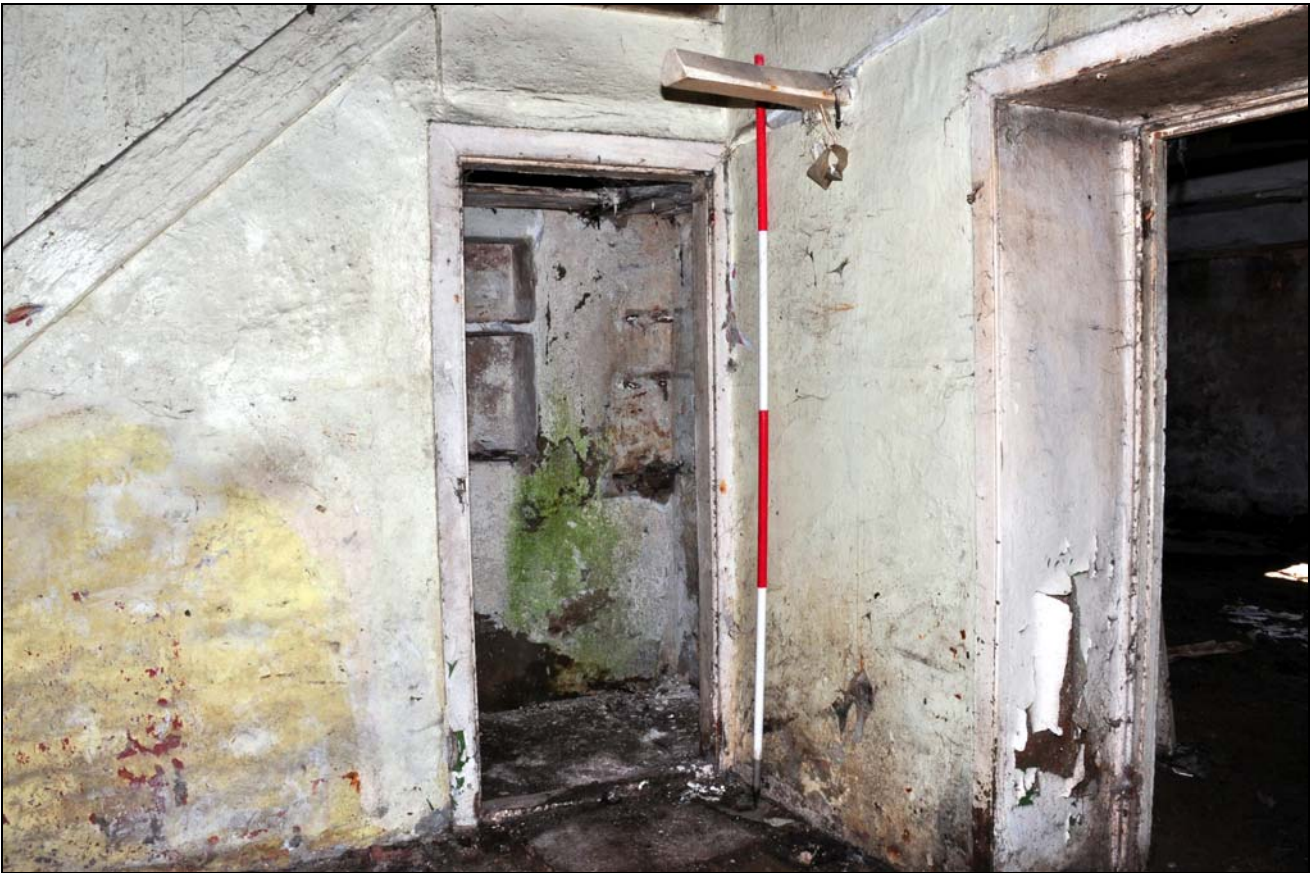
Photo 29: Ground floor, west room, looking south-east (head of cellar stairs)

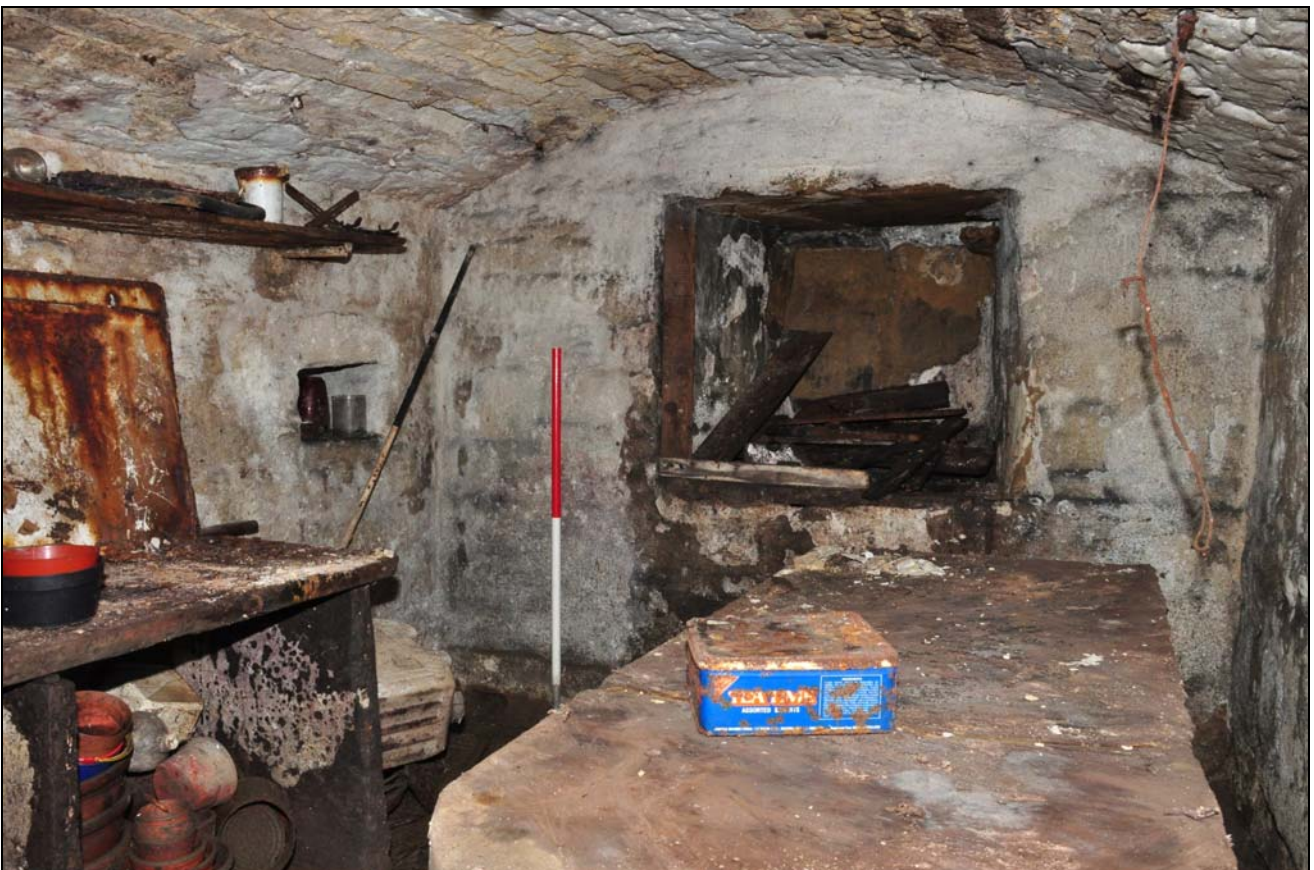
Photo 30: Cellar, looking west

- 8.10 The cellar below the rear wing is a small, barrel-vaulted space with small wall recesses, and two stone benches for food storage and processing. A larger, splayed recess in the west side resembles a blocked window in some respects, but it is located well inside the present building (**30,31**).

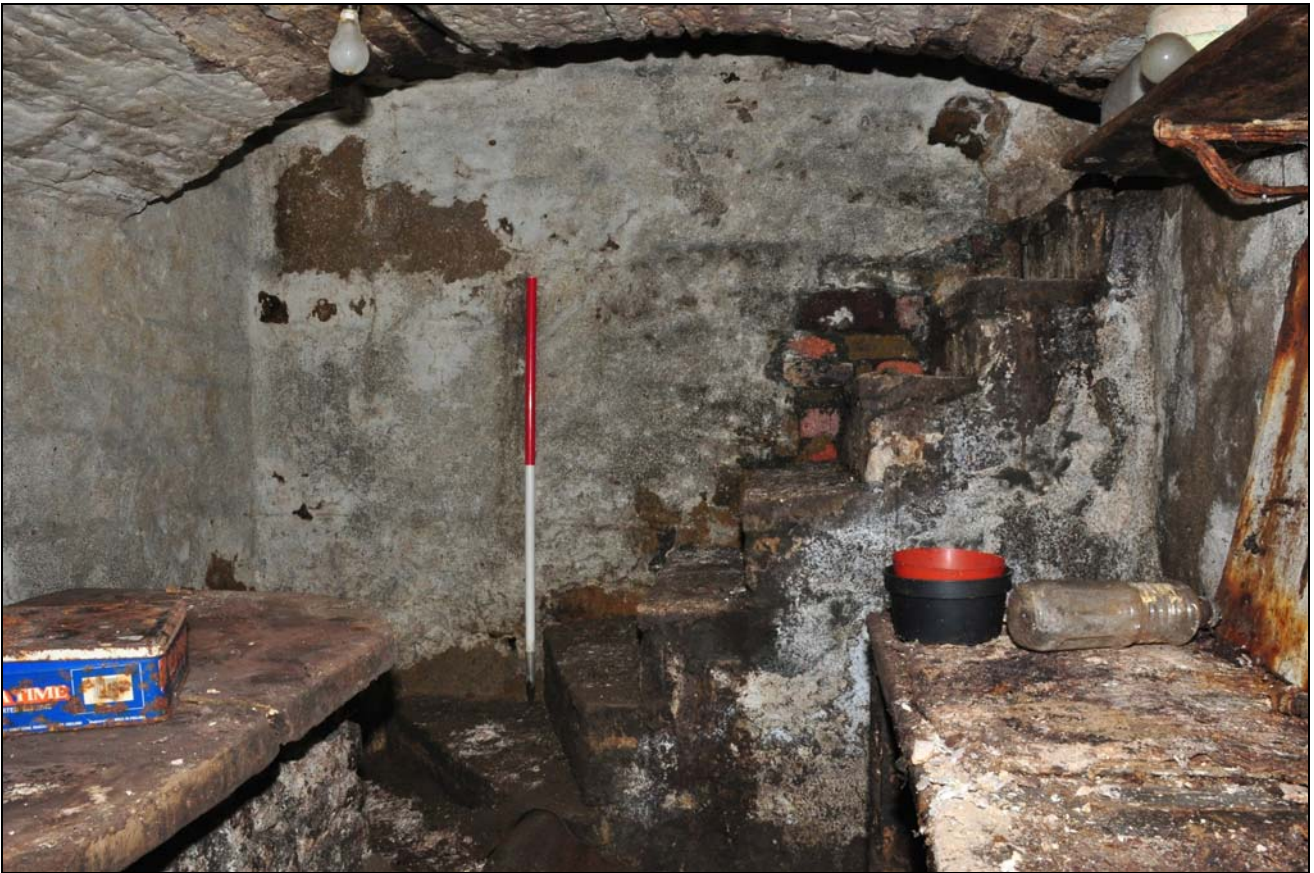
Photo 31: Cellar, looking east
