Rob Royd
Beestonley Lane, Stainland, West Yorkshire:
Historic Building Record (Level 2 Survey)

April 2019

STEPHEN HAIGH

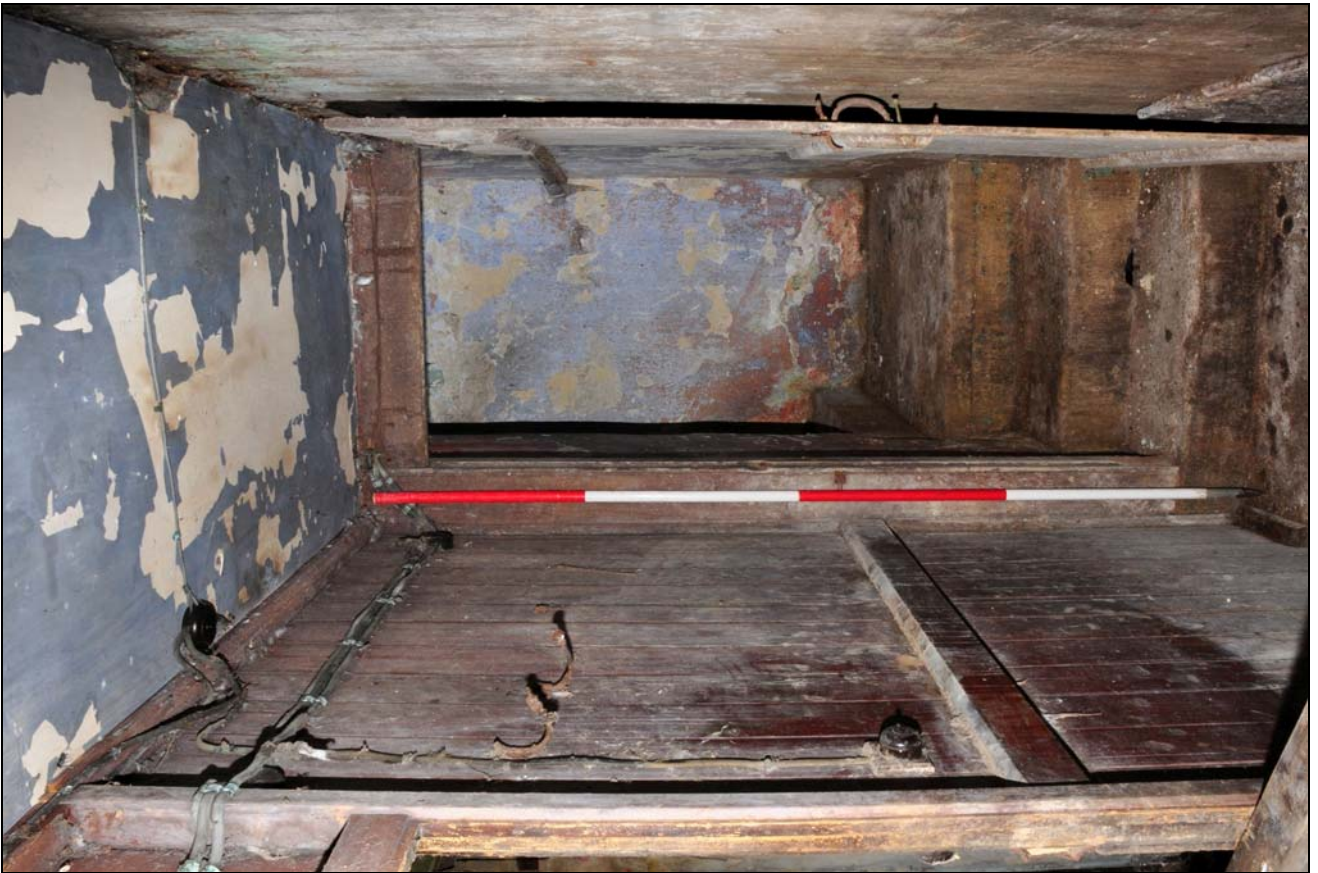
Photo 35: Ground floor, east room: foot of stairs to first floor

- 8.11 In common with its larger, western neighbour, the east ground floor room has a large chimney breast with rectangular opening for a cooking range, though it differs in the presence of a hollow-chamfered mantelshelf (**32**). The surviving cooking range itself is no doubt 19th or 20th century, however. A cupboard to the right of the chimney breast houses a small earthenware sink, and is of similar date. In the north-west corner of the room is a second stone staircase to the first floor, now concealed behind a plank partition, the latter also forming an entrance lobby from the rear doorway (**34,35**).

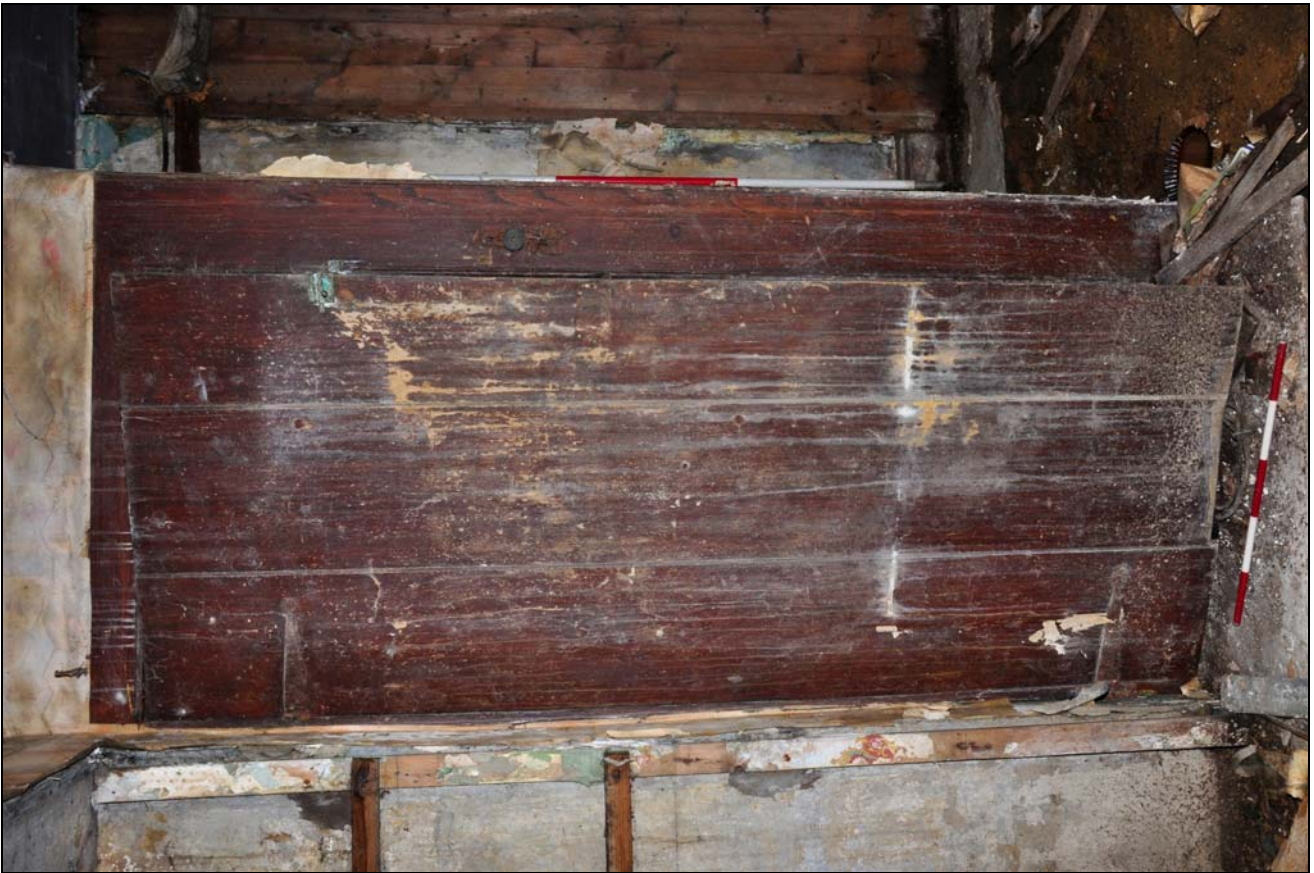
Photo 37: Ground floor, east room: door to cupboard beneath stairs

doorway within the cross-wall was still required, ie. when the house was occupied by a single household. However, a band of uneven plaster at first floor level in the cross-wall may mark where the timber floor has been removed to accommodate the stairs (36), though an alternative explanation is that this marks where a trap door was lowered, to provide more floor space. The plank and batten door to the cupboard beneath the stairs has spoon-head hinges, and is likely to be original to the staircase, if not to the house (37).

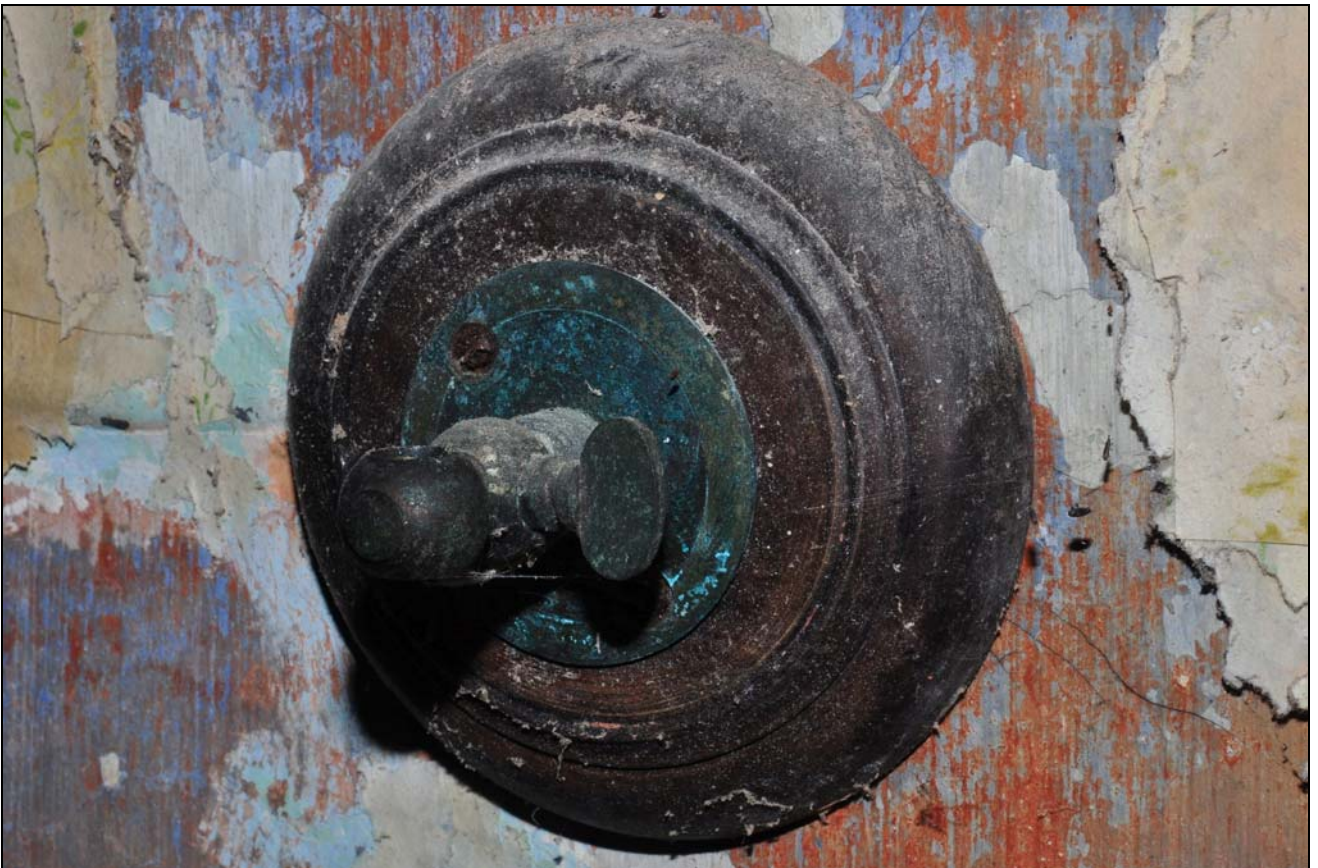
Photo 44: First floor, east room: detail of gas lamp bracket

- 8.13 On the first floor, the former connecting door within the cross-wall remains blocked. The three units of the house now provide four bedrooms, as the front, western room has been made into two, by a simple plank partition on the line of the roof truss, probably an early 20th century change (38,39). Previously the largest room, this was served by the rear “piece” door for taking goods in and out, and must have been at least partly used for weaving and any other cloth working processes which the occupants undertook. The two other rooms may also historically have been put to industrial use in some way, rather than just serving as bed chambers. All three were heated: the front, east room (40-42) has the only exposed fireplace however, which is a late 19th century arch grate (43), set within the original simple stone surround, and which probably replaced an 18th century hob grate. (Elsewhere on the first floor, the two other fireplaces are presently concealed.) There is a 19th or early 20th century gas lamp bracket close to it, one of a small number in the building (44).

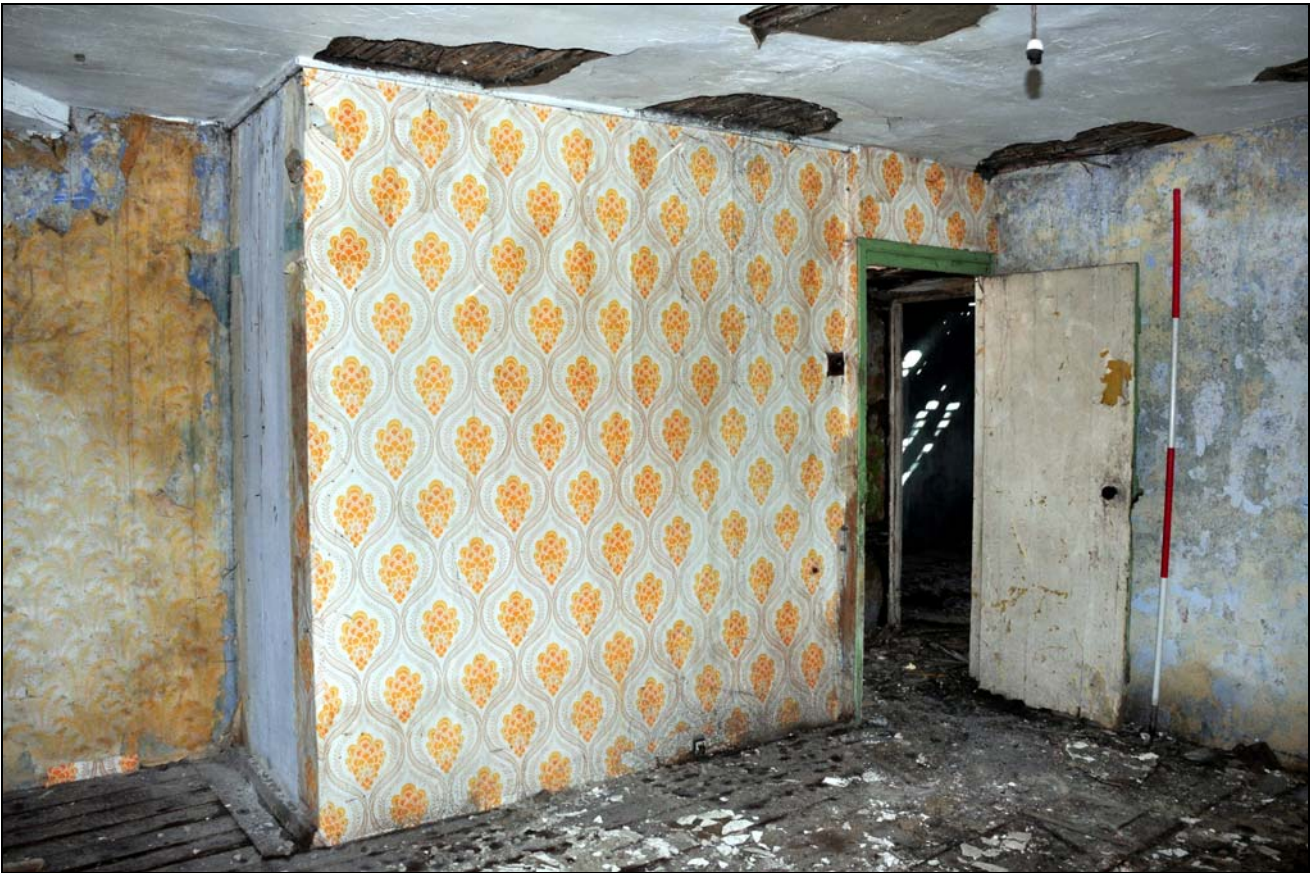
Photo 45: First floor, north room, looking south-east

- 8.14 The rear first floor room remains unaltered as a space (45,46). It is entered from the top of the staircase by a three-plank and batten door with sprung latch; both may be original to the house (47,48). The fireplace lacks a chimney breast, and is concealed by later timber, but appears to have an original stone surround.

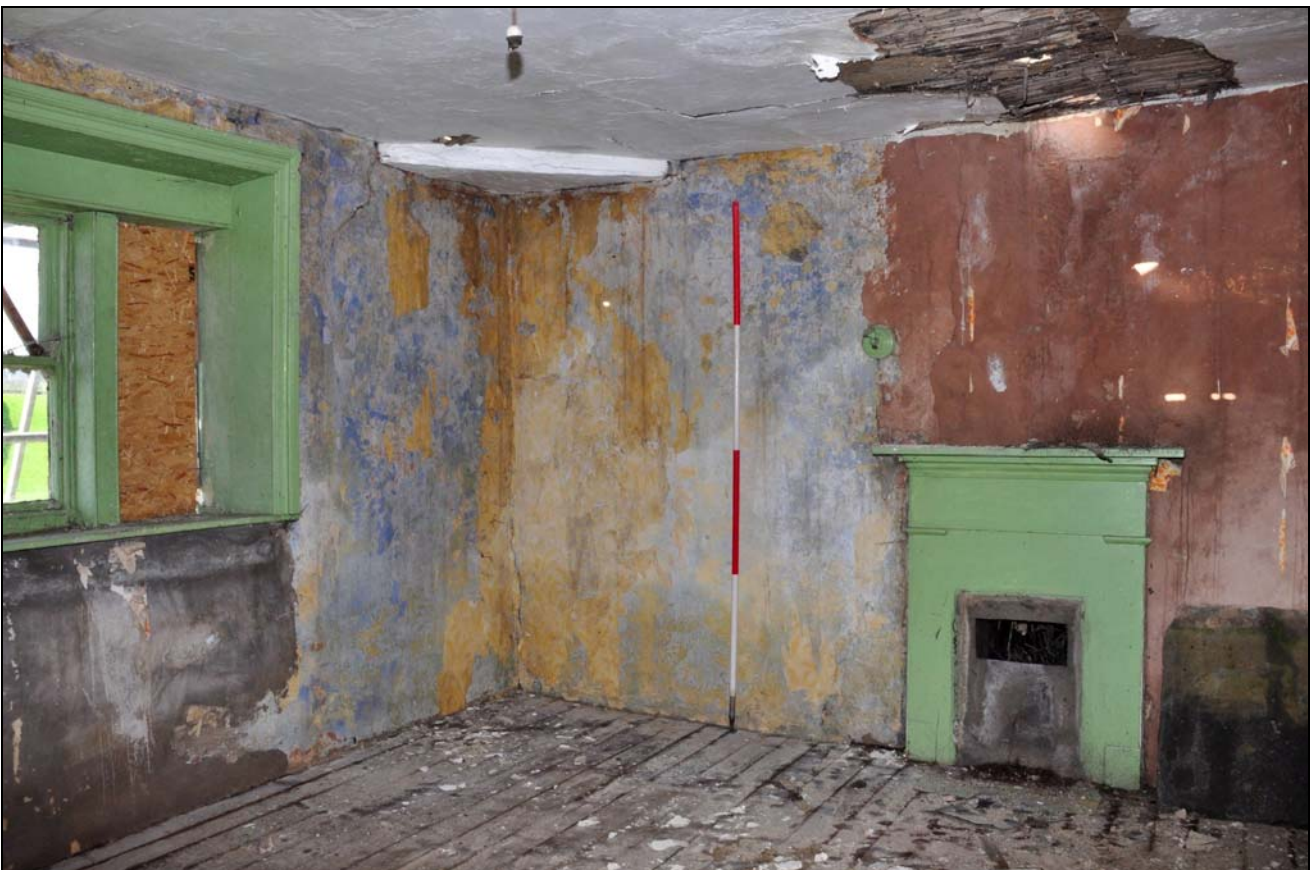
Photo 46: First floor, north room, looking north-west

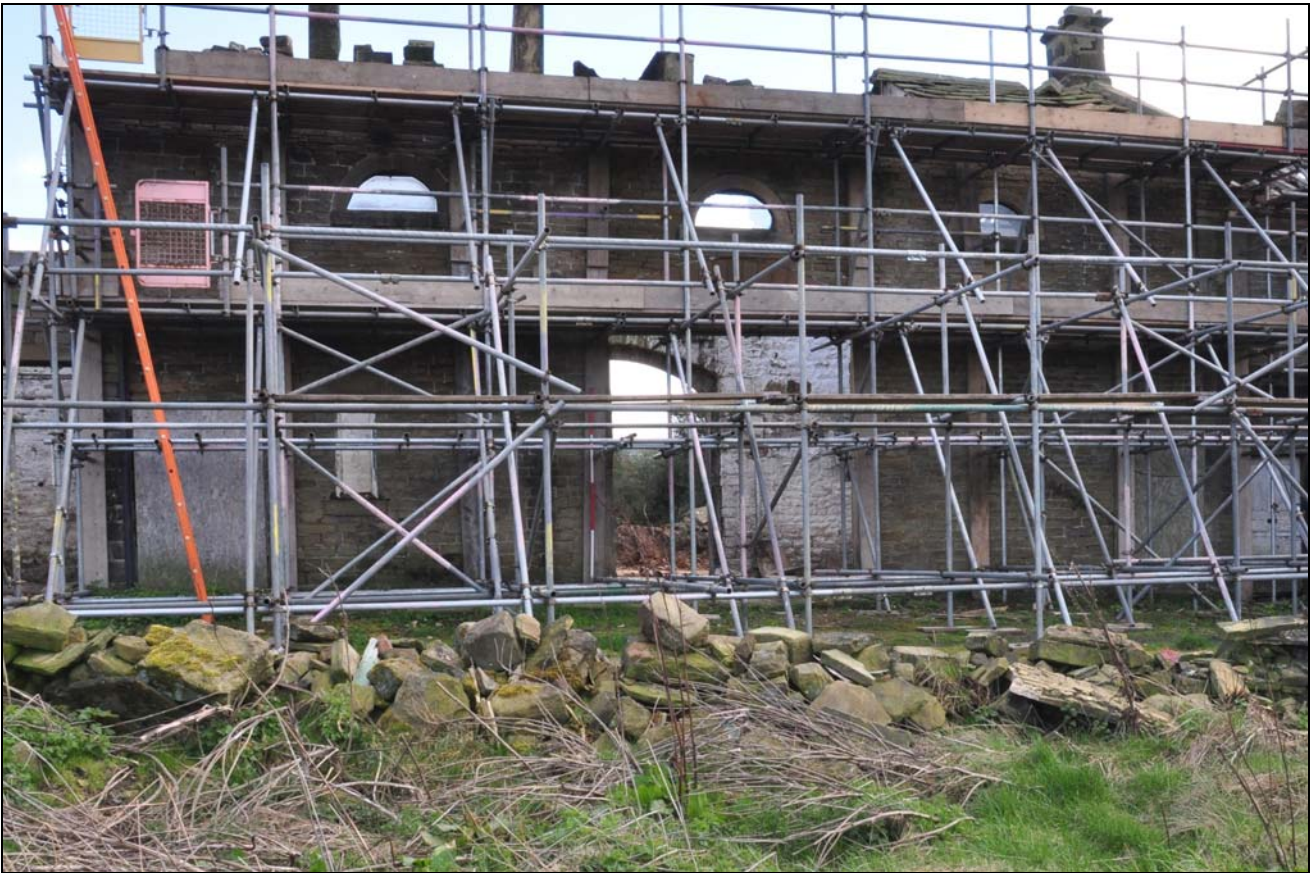
Photo 49: North (front) elevation of the barn

- 8.17 Unlike the house, the barn was built with its architectural front facing north onto the rear yard (49). This side of the building has a large, central cart entrance with tie-stone jambs and segmental arch, with a pair of pedestrian doorways, with monolithic jambs, at either end. A row of three lunettes or semi-circular windows runs close to the eaves (50), and there was (until recent collapse) also a gablet over the central one of these, believed to have contained a Venetian window. A similar lunette was set within the centre of the east gable, where there are also two inserted doorways between the barn and the later adjoining stable (51). The south side has a similar cart entrance (52), which did have a small window over it prior to collapse, but the two window openings to either side are both later insertions.

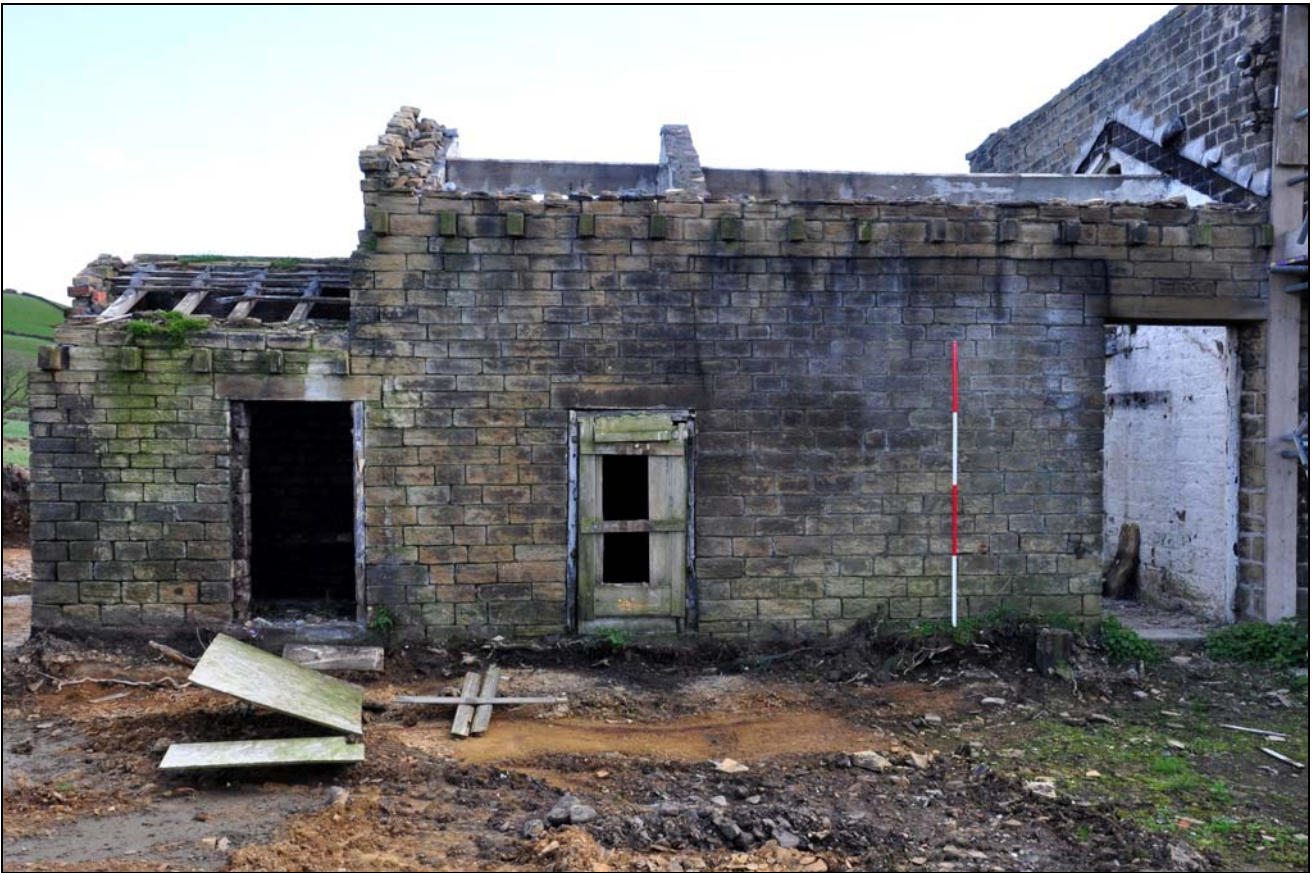
Photo 59: North side of stable and coal stores

- 8.20 Added to the east end of the barn between the 1840s and 1890s (59), this multipurpose building also faces north onto the yard and is functional in form. Walls are of coursed sandstone with some brick to the interior, and have plain eaves corbels, while dressings to doorways and windows are confined to plain ashlar sills and lintels, with the exception of the circular gable window (60,61). The roof is carried on plain softwood purlins, but its stone slate covering has been lost entirely.
- 8.21 The largest part is occupied by a substantial two-stall stable, which formerly had a low loft over. The stalls faced east and were divided below the surviving longitudinal beam (62); an earthenware trough survives to the south stall but there are otherwise almost no stable fixtures in place.

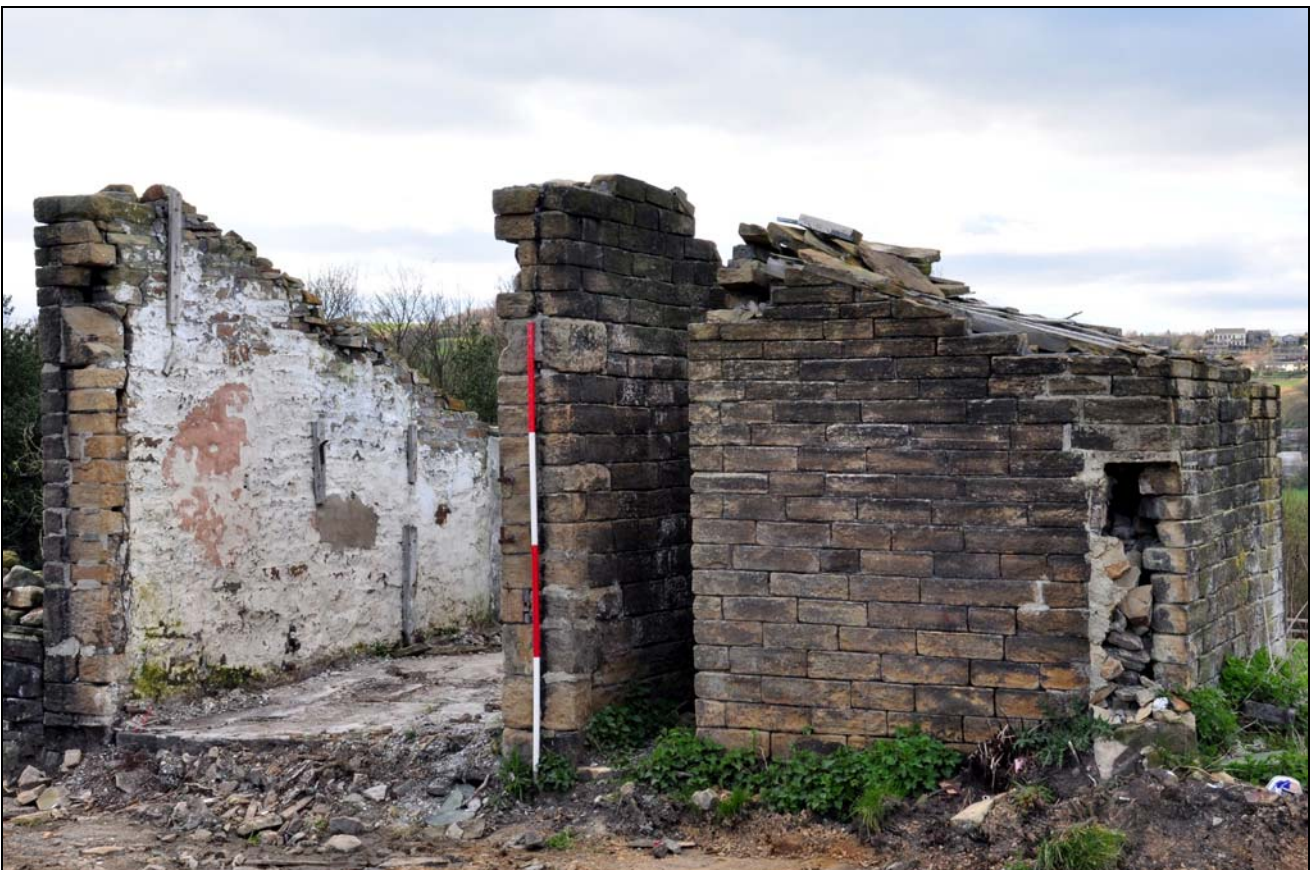
Photo 64: Trap-house and earth closet, looking north-west

- 8.23 North of the stable is an L-shaped structure built from coursed stone, dated by historic maps to the period between 1904 and 1930 (64,65). Both parts have single pitched roofs, and the larger part, which has only a full-width and full-height opening to the south, appears to be a trap-house or perhaps motor garage. The east part is an earth closet, with double-seat (66); this appears to have been the only sanitary facility at the farm until its abandonment in the 21st century.

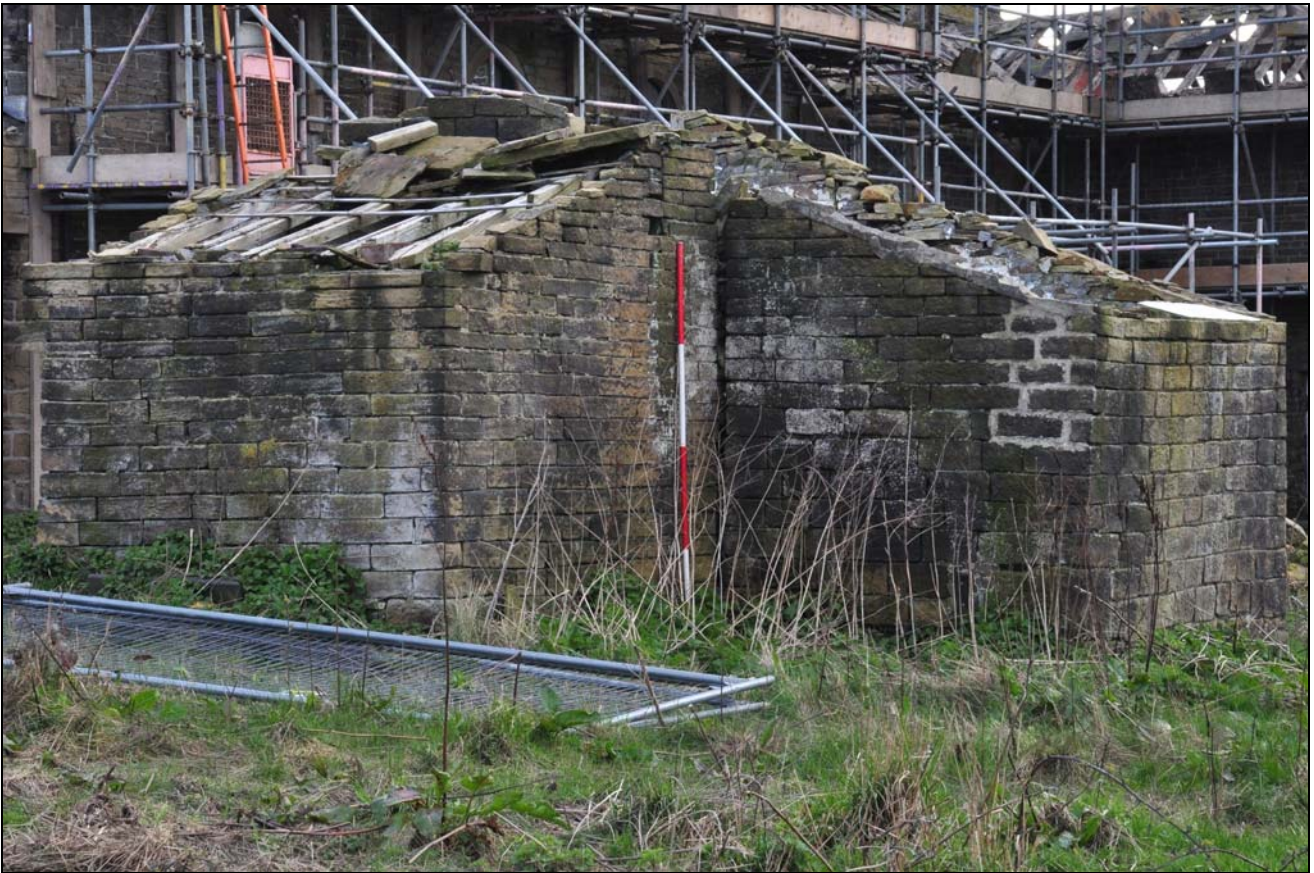
Photo 65: Trap-house and earth closet, looking south-west
